# Building and Timber Pest Inspection Report

Inspection Date: Wed, 11 Feb 2026

Property Address: 43 Jaspers Brush Rd, Jaspers Brush NSW  
2535, Australia

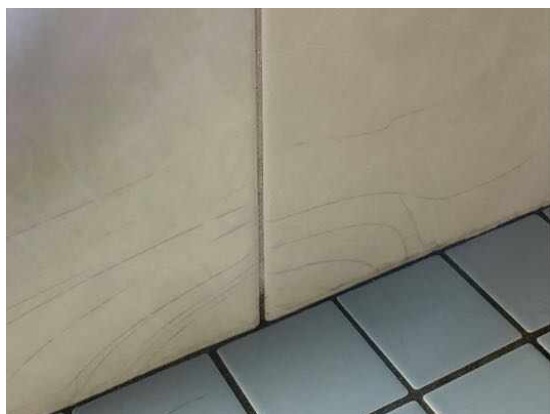
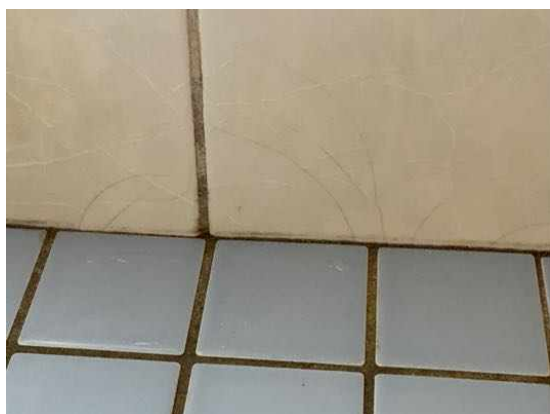
Building: Main Building  
Location: Bathroom  
Finding: Tiles - Cracked or damaged  
Information: Cracking was evident to the tiling in this area at the time of inspection. While the cracking appears to be minor, this area is frequently exposed to water, allowing potential for water penetration into adjoining sections of walls or flooring.

If left unmanaged, water penetration to these areas may lead to subsequent water damage, which is likely necessitate repair work to affected building elements.

A tiling contractor should be appointed to ensure that no further water damage occurs. The re-application of silicone and grouting throughout remaining tile work is also advised, to further protect the area against water penetration.

Where water penetration has led to water damage, appointment of a relevant tradesperson may be required to repair damaged building elements.

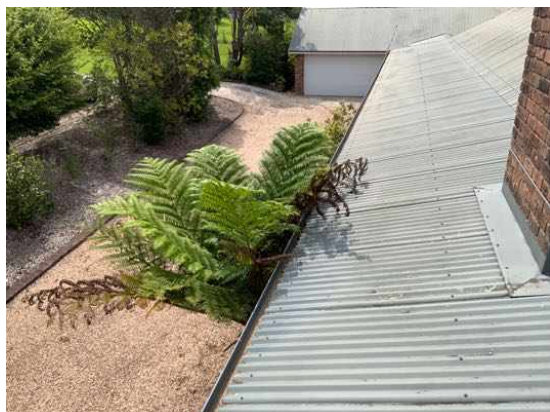
Blocked gutters are likely to lead to high levels of moisture in the affected areas. Such moisture will not only cause rust and decay of the associated building materials, but can also provide conditions that are conducive to termite and timber pest activity. Blockages in gutters should therefore be removed immediately to ensure dry conditions are maintained.

Gutters are a critical part of the building's management of storm water and rain. It is therefore important that they be kept clear to prevent secondary damage to associated building elements, including exterior and interior walls, ceiling linings and any adjoining building elements. Where gutters are blocked, pooling of rainwater is likely to occur, fast-tracking rust and corrosion of the roof plumbing elements.

It is highly advised that all overhanging tree branches be removed as soon as possible to prevent any further damage. Repair and/or replacement of sections of damaged guttering may also be required where the extent of the damage necessitates.

Such works should be performed by the homeowner; however, appointment of a landscape contractor or an arborist may be required. Consultation with a licensed roof plumber is required where guttering has been damaged.

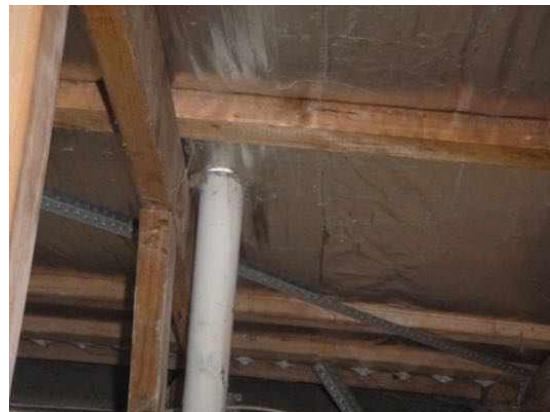
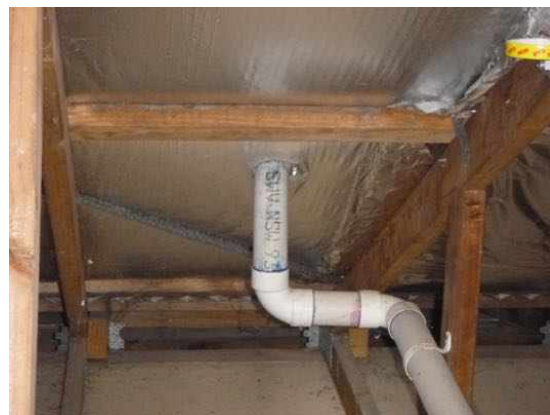
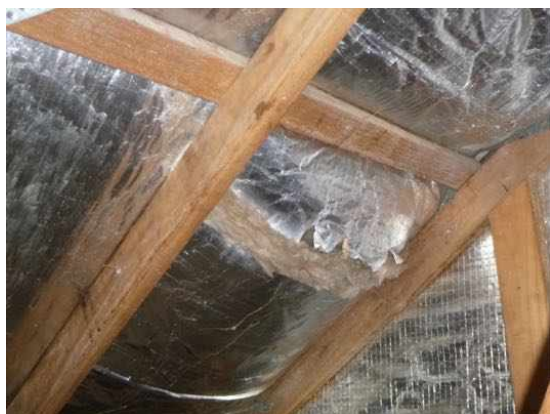
Building: Main Building  
Location: Roof Void  
Finding: Sarking - Damaged or Loose  
Information: Sarking to under the roofing material is damaged, loose or has holes and gaps. Sarking acts as an insulator, helps with noise reduction & is a second barrier against water penetration from broken or slipped tile leaks & condensation.

A Builder, Carpenter or handyman will be able to repair the holes with pieces of sarking and AS4254 tape specific foil tape for this product.

Consult a builder or insulation specialist for further advice.

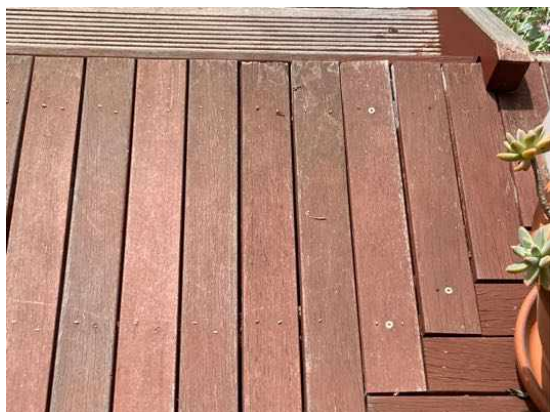
### Finding 3.13

Building:	Main Building
Location:	Deck
Finding:	Nails - Popping to decking (SAFETY HAZARD)
Information:	Numerous popped nails were identified at the time of inspection. Nails and screws are held by the friction between them and the surface that they are applied to. Over time, the nails and screws can back out, which is often a result of general ageing and deterioration of the building structure.

If left unmanaged, internal wall and ceiling sheeting may become loose and unstable, increasing the rate of deterioration of these building elements and creating potential for the development of secondary defects.

Re-fastening of popped nails will help to maintain the stability of these, and associated, building elements. Such minor works will also help to improve the appearance of the affected area and secure the linings. These works should be performed by a qualified carpenter or plasterer at client discretion.

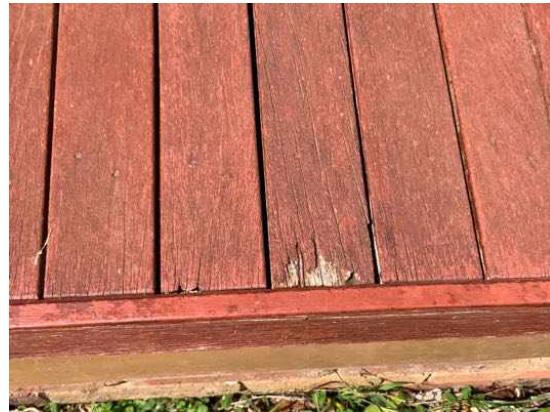
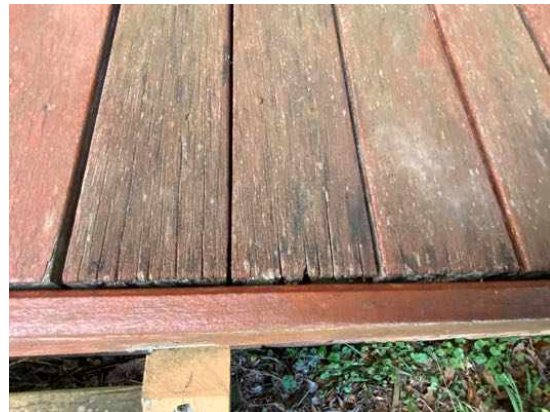
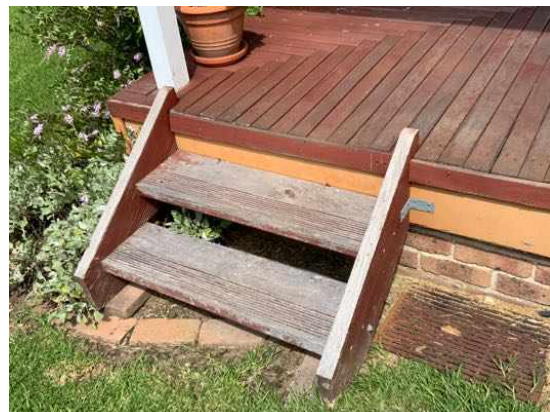
### Finding 3.14

Building:	Main Building
Location:	Deck
Finding:	Wood rot to decking and steps to some areas
Information:	This building element shows evidence of wood rot. Wood rot, also known as Fungal Decay, occurs when timbers and other cellulose building materials are exposed to damp conditions on an ongoing basis. This could be the result of exposure to weathering over a prolonged period of time, or the attraction of excessive moisture from other abutting building materials. Contributing factors also include poor air ventilation in the area.

the useful life of these building elements. Prior to any works being performed, the cause of the moisture that has created the visible wood rot should be identified and addressed in a suitable manner. Replacement of affected timbers may then be a necessary step in protecting surrounding building elements from such deterioration.

A qualified plumber may be appointed to assess the cause of excessive moisture and to provide advice on any remedial works as required. A qualified carpenter or registered builder may also be required to replace affected building materials.

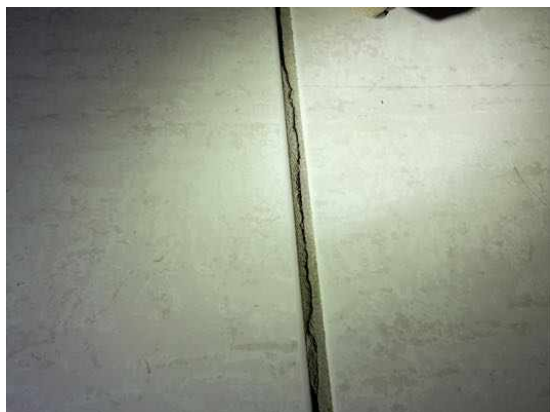
Building:	Main Building
Location:	All Areas
Finding:	Grout - Missing and cracked to some areas
Information:	Grout is missing in this area. Grout is used to protect gaps and crevices in building materials to ensure that they are water-tight and prevent water penetration to the associated structures.

Where grout is missing, a tiling contractor should be appointed immediately to apply grout and re-apply any silicone where necessary. Failure to do so is likely to lead to water damage to the surrounding area.

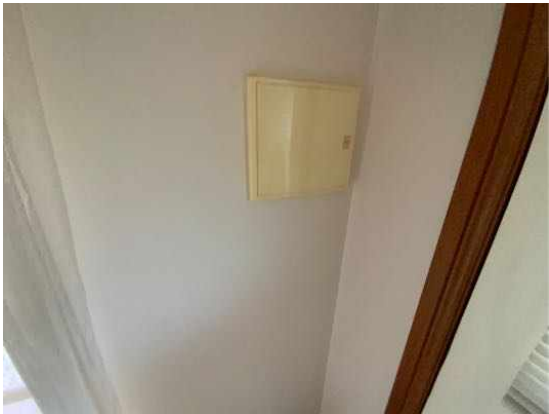
A durable notice should be placed in the switchboard unit to indicate current termite barriers. At the time of inspection, it appeared as though no termite management system has been installed, with no evidence to suggest preventative works taking place.

The client may consider gaining further advice from a pest controller as to the costs and procedures involved with this application. It is recommended that obtaining such advice be a short-term priority.

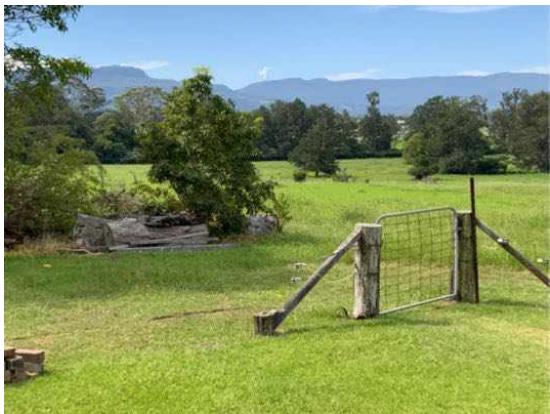
### Finding 6.05

Building: Main Building  
Location: All Areas  
Finding: Trees within 50m of the property  
Information: Trees within 50m of the property can be conducive to termite activity. It is recommended an invasive inspection of all trees with 50m to the property be carried out by a qualified pest control expert.

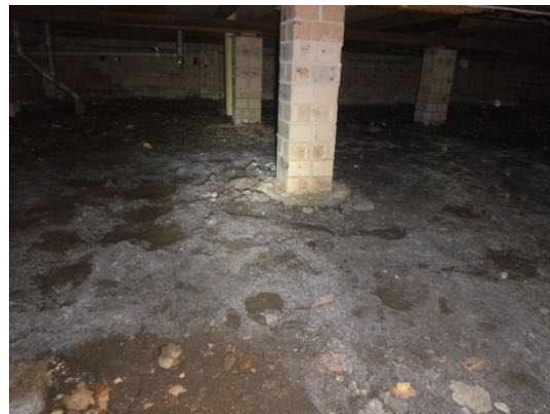
**Finding 6.06**

Building: Main Building  
Location: Subfloor  
Finding: Subfloor - Lack of ventilation

The initial step in improving ventilation is to ensure that the subfloor area is free of any debris or stored items. Where ventilation is still inadequate, it is advised to ensure that all vents are clear of blockages, and additional vents may be installed.

The client may also consider mechanical ventilation (powered fans) to improve subfloor airflow. Remedial works should be conducted as a matter of urgency to protect against the development of potentially harmful subfloor conditions.

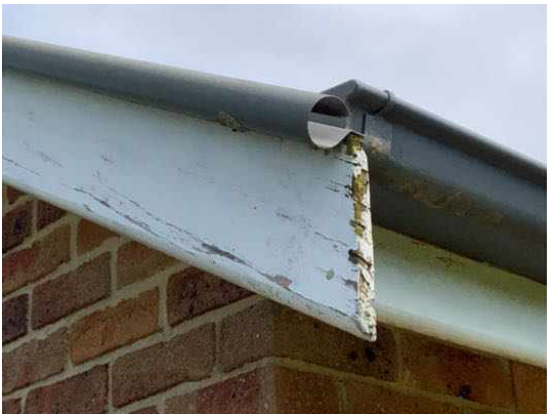
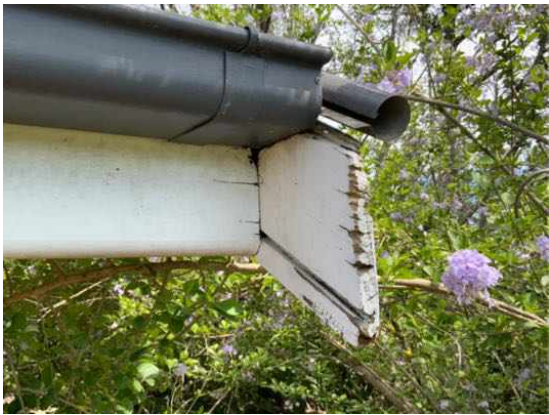
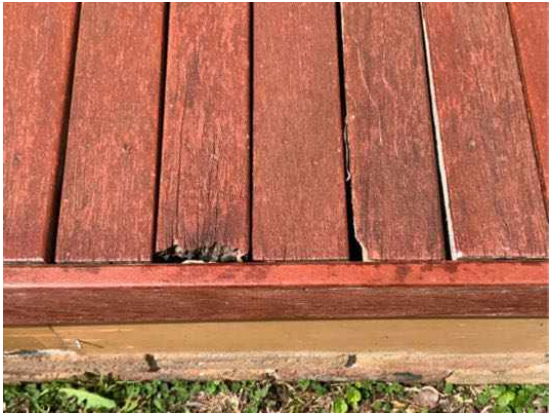
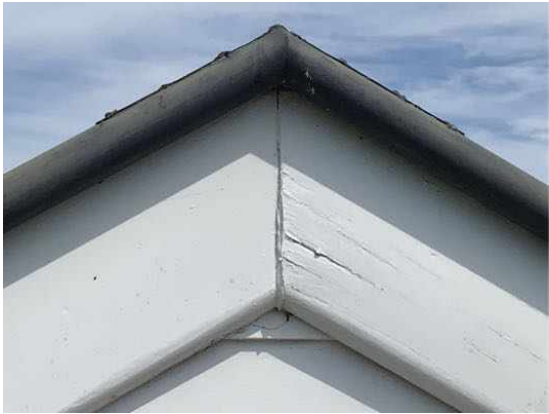
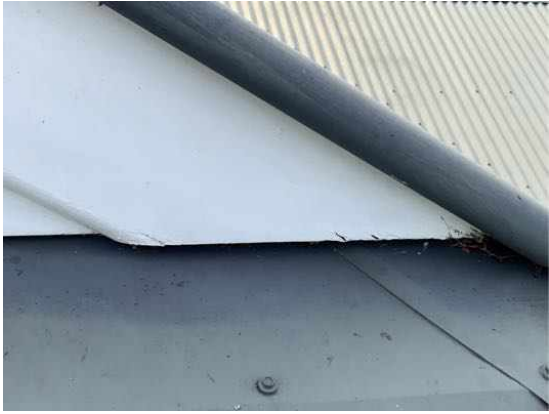
In this case although the affected timber element is in a decaying state the extent of any visible damage appears to be localised to a specific area and is yet to spread to other parts of the building element or affect adjoining structures. The fungal decay is therefore likely to be of a relatively superficial nature with minimal impact on the structural integrity or tensile strength of the timber element.
