Building and Timber Pest Inspection Report

Inspection Date: Tue, 24 Mar 2026

Property Address: 30 John St, South Tamworth NSW 2340,
Australia

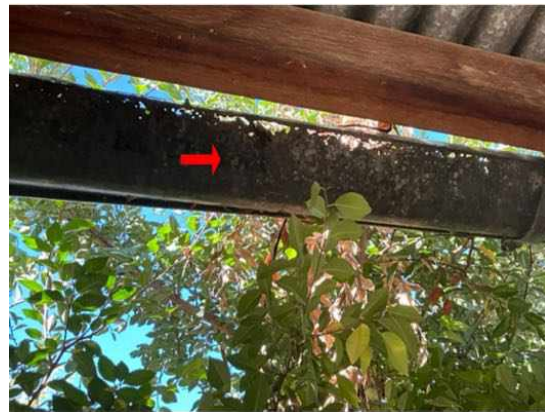
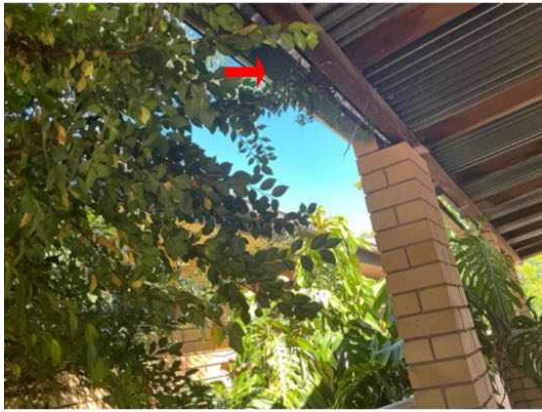
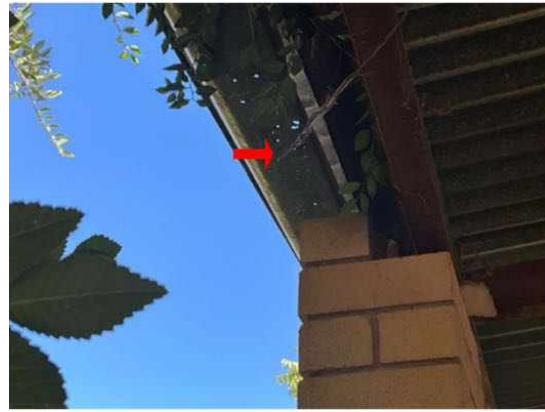
Building: Main Building
Location: Carport
Finding: Gutters Damaged/Deteriorated
Information: Breakage and deterioration occurs generally when the building materials have either aged and decayed with excessive moisture, or as a result of damage (accidental or deliberate).

Repair and/or replacement of these materials is advised to ensure that additional secondary defects do not arise as a consequence. Such works are necessary, as all building elements play a key role in the operation and function of the overall structure and its performance.

A licensed roof plumber should be appointed to repair or replace the affected building element prior to any subsequent damage being caused.

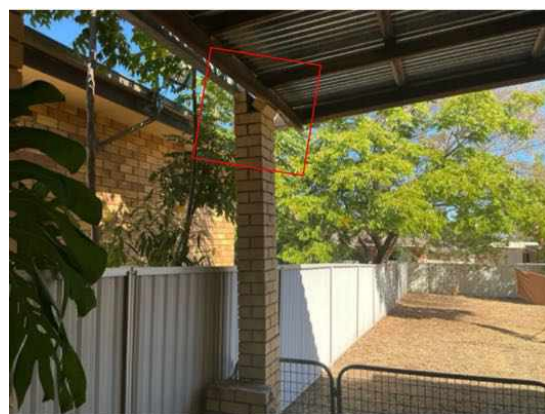
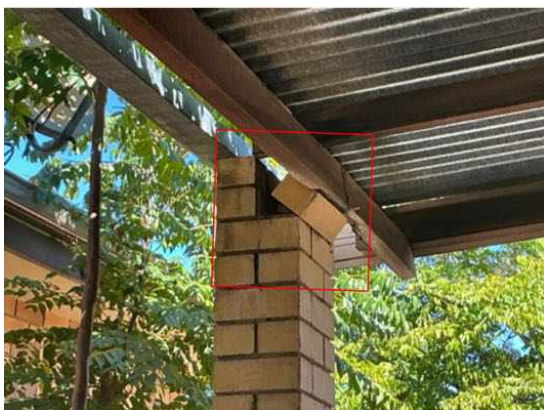
Finding 2.02

Building:	Main Building
Location:	Carport
Finding:	Brick Pier - Impact Damaged
Information:	A brick pier supporting the carport structure was observed to be out of plumb, with visible displacement and dislodged brickwork.

The condition appears consistent with possible impact damage, resulting in movement of the pier. This is of concern as the pier forms part of the structural support to the carport roof. While other adjacent piers appear to be in satisfactory condition, the affected pier shows clear signs of structural disturbance.

Masonry elements are required to be constructed plumb, stable, and free from damage that may affect structural performance.

It is recommended that the client arrange for assessment by a suitably qualified structural engineer or builder. Remedial works may include realignment, rebuilding, or replacement of the affected pier to restore structural integrity and ensure the ongoing support of the carport.

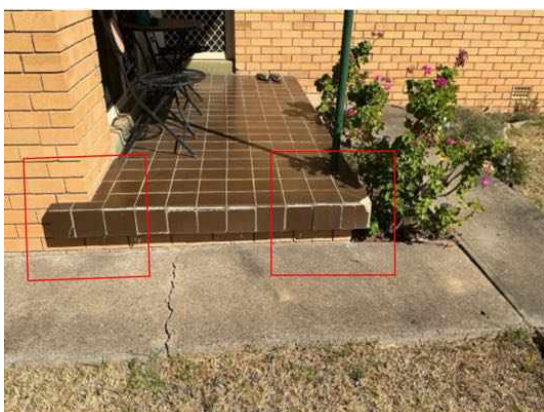
Finding 3.01

Building:	Main Building
Location:	Entry
Finding:	Tiles - Cracked or damaged
Information:	Cracking was evident to the tiling in this area at the time of inspection. While the cracking appears to be minor, this area is frequently exposed to water, allowing potential for water penetration into adjoining sections of of the home.

If left unmanaged, water penetration to these areas may lead to subsequent water damage, which is likely necessitate repair work to affected building elements. This can be seen in the photos.

A tiling contractor should be appointed to ensure that no further water damage occurs. The re-application of silicone and grouting throughout remaining tile work is also advised, to further protect the area against water penetration.

Where water penetration has led to water damage, appointment of a relevant tradesperson may be required to repair damaged building elements.

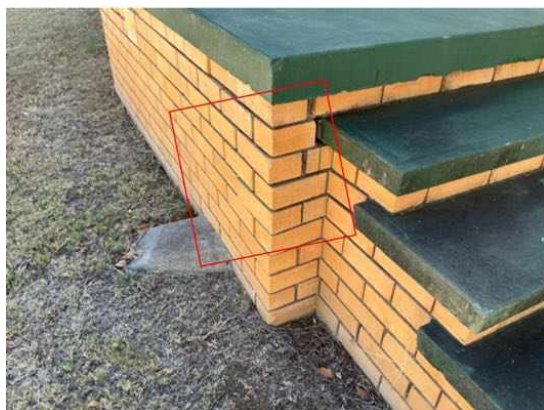
Building: Main Building
 Location: Porch
 Finding: Brickwork - Step cracking
 Information: Step cracking was identified to the brickwork in various areas at the time of inspection. Step cracking, which is similar to other forms of cracking, has a variety of possible causes. However, the most common is the subsidence of adjacent footings.

Step cracking is a relatively common defect, and is most likely to occur adjacent to windows, doors and other openings. Mortar failure in the gaps between affected bricks indicates the stresses and tensions affecting the wall.

Where step cracking is extensive or severe, the client is advised to consult a structural

engineer. Minor step cracking can be used as a warning sign to address factors causing stress to the wall, which can include the effect of surrounding trees, water leaks, soil erosion, or even the presence of reactive soils in the surrounding area.

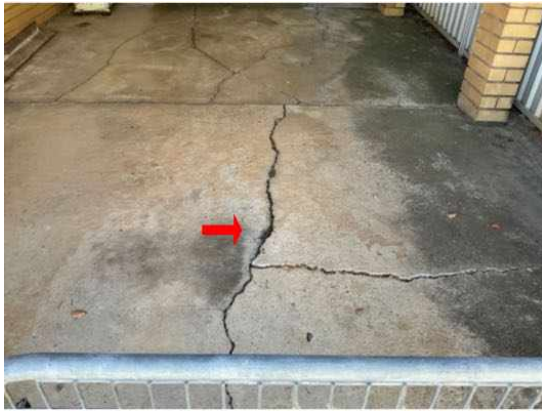
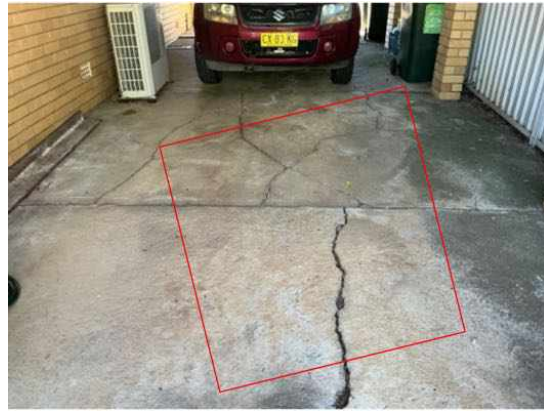
Finding 3.04

Building:	Main Building
Location:	Carport
Finding:	Cracking - Driveway Distinct
Information:	Distinct cracks were identified in external concrete paving. Distinct cracks are generally found in older concrete paving, and may also present as a trip hazard as consequence of an uneven or curved surface.

General age and expected deterioration of the paved areas is a common cause of this type of cracking. However, expansion and contraction of the slab may also have occurred due to environmental factors. Such factors include variable moisture and weather conditions, the presence of trees and their roots having a settling or lifting affect on the soil, or the effect of load bearing, e.g. heavy vehicles over a sustained period of time.

Cracking to this degree may also be due to poor original installation of the concrete. Factors such as poor compaction of the sub surface and/or inadequate reinforcing of the slab may create cracking and other secondary defects.

Repairs are likely to be required to prevent further cracking and to reduce hazards associated with cracking, such as tripping. Monitoring of all cracking should be conducted frequently. Always contact a building inspector should cracks widen, lengthen, or become more numerous.

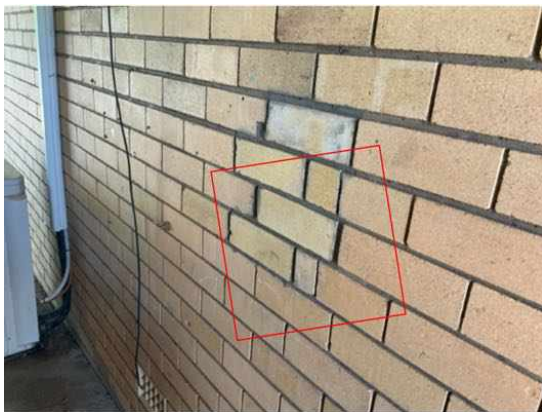
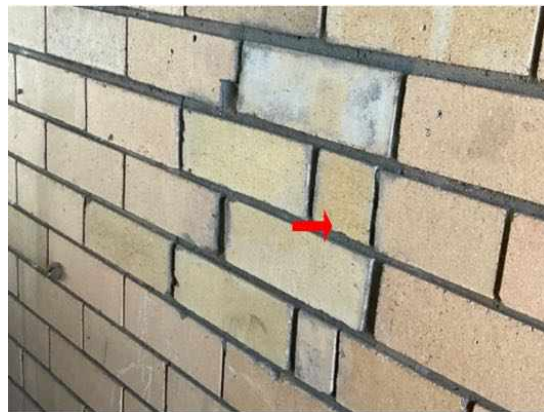
Finding 3.05

Building:	Main Building
Location:	Carport
Finding:	Substandard Repair Works
Information:	The works that have been repaired appear to be completed to a substandard level.

Works that have not been completed finished to a satisfactory level create potential for the development of building defects and may impede on the safety and integrity of the overall structure.

It is highly recommended that the relevant trades be appointed to complete these works and ensure the safety of the area and the longevity of all associated building elements.

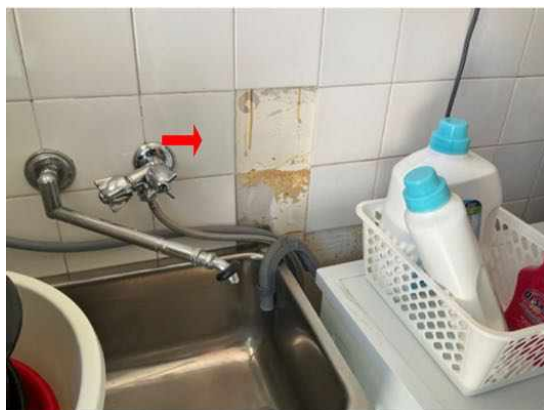
Finding 3.06

Building:	Main Building
Location:	Laundry
Finding:	Damaged/Deteriorated
Information:	Breakage occurs generally when the building materials have either aged and decayed, or as a result of damage (accidental or deliberate).

Repair and/or replacement of these materials is advised to ensure that additional

secondary defects do not arise as a consequence. Such works are necessary, as all building elements play a key role in the operation and function of the overall structure and its performance.

A relevant tradesperson should be appointed to repair or replace the affected building element prior to any subsequent damage being caused.

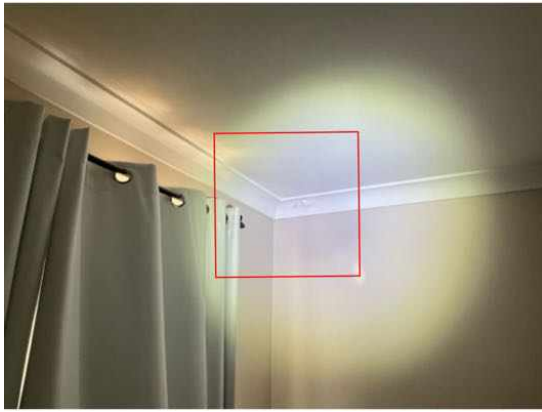
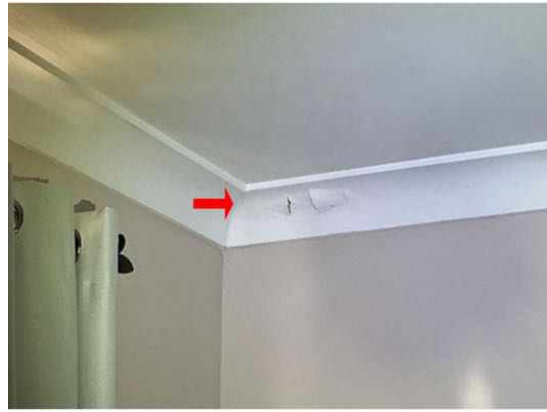
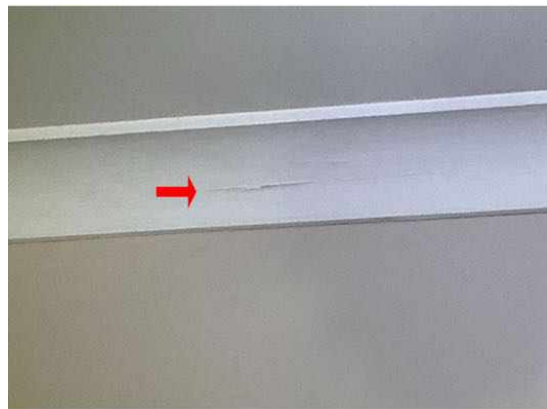
Finding 3.07

Finding: Paint - Interior Deteriorated

Information: The internal paintwork as shown throughout the home, including but not limited to walls, ceilings, architraves, and skirtings, shows signs of wear, damage, or incomplete finishing and requires attention to restore a consistent and protective surface. While issues with internal paintwork are often considered cosmetic in nature, deteriorated or missing paint can also contribute to secondary defects such as staining, moisture absorption, or surface degradation over time.

Areas with flaking, scuffed, or patchy paint should be properly prepared by sanding, filling, and levelling before repainting. In locations where the lack of adequate paint protection has resulted in damage to the underlying surface, further repair or replacement of the affected materials may be necessary prior to painting.

It is recommended that a qualified painting contractor be engaged to carry out the required works to improve the visual presentation of the interior and provide adequate protection for internal surfaces. Alternatively, the homeowner may undertake these works in accordance with manufacturer guidelines and industry best practices.

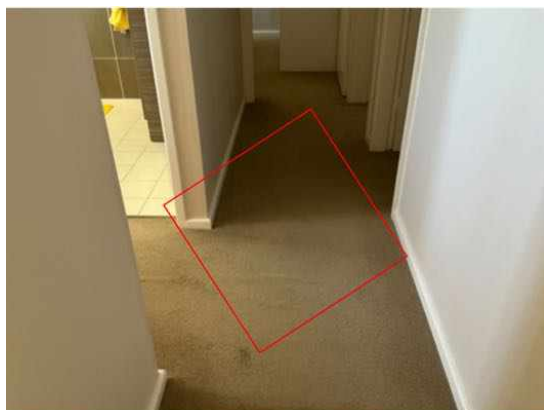
Finding 3.08

Information: The internal flooring was identified as being bouncy as pictured at the time of inspection. A bouncy floor surface generally presents as a discernible change in level as they are walked across, in noisy or creaking flooring, or in consequent movement of surrounding furniture and fixtures.

Bouncy floors generally indicate that the floorboards or the subfloor structures are coming loose from the joists that they are installed on. Bouncy flooring may also be the result of gaps between flooring structures, which require packing.

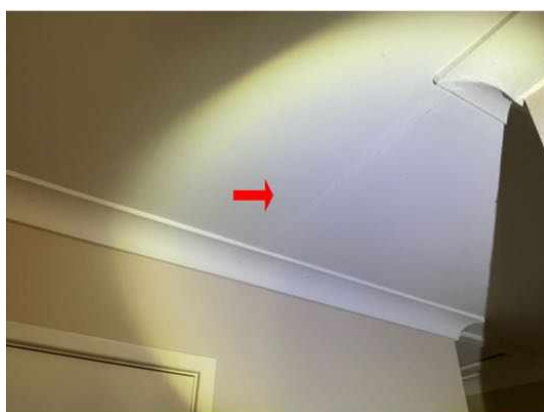
Finding 3.09

Building:	Main Building
Location:	Hall
Finding:	Cracking - Plasterboard
Information:	Fine cracks in plasterboard, while occasionally noticeable, are typically regarded as cosmetic defects and do not usually signify structural damage. These cracks often result from separation between building materials and finishes (e.g., paint, plaster) along joints. In most cases, such cracks can be addressed through minor repairs such as sanding, filling, or repainting, which should be carried out by a qualified painter or general handyman.

However, regular monitoring of these cracks is essential. If any cracks show signs of widening, lengthening, or increasing in number, it is advisable to contact a building inspector for further assessment.

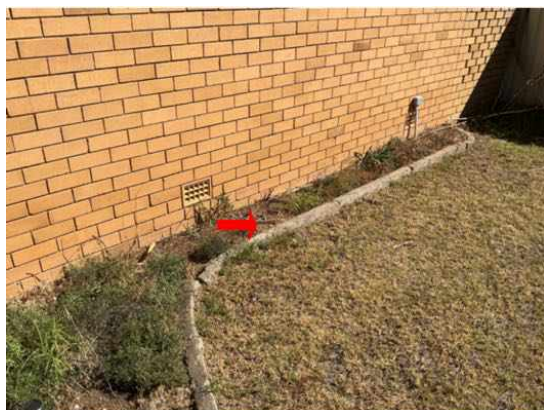
Building: Main Building
 Location: All External Areas
 Finding: Garden Beds - Conditions Conducive to Termites
 Information: Garden beds were observed in direct contact with the building's perimeter across various areas of the property. In some areas, untreated timber and mulch were used. This configuration, combined with regular watering or hosing, creates conditions conducive to termite activity and increases the risk of termite ingress into the structure.

Garden beds placed against external walls, particularly those incorporating untreated timber or excessive mulch, can retain moisture and create hidden entry points for termites. This undermines the effectiveness of termite barriers, compromises weep hole visibility, and elevates the risk of concealed termite activity that may lead to structural damage.

The current placement and construction of garden beds present a termite risk and deviate from best practice recommendations for termite management. Rectification and professional input from both a landscaper and pest management specialist are

advised to ensure the building remains protected while achieving the desired landscape design.

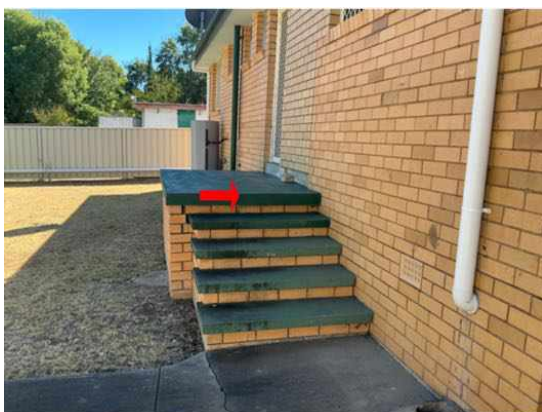
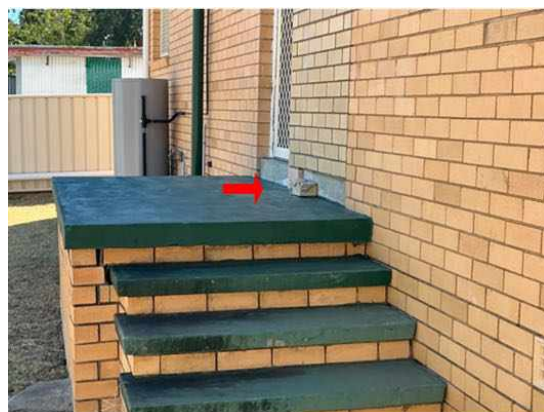
The concrete porch/patios are providing a concealed entry point at the time of the inspection. Where the location of the porch is retrospectively installed against an external wall this will provide a concealed entry point for termites.

The client should consider gaining further advice from a timber pest technician as to treatments required in this area. It is recommended that obtaining such advice be a short-term priority.

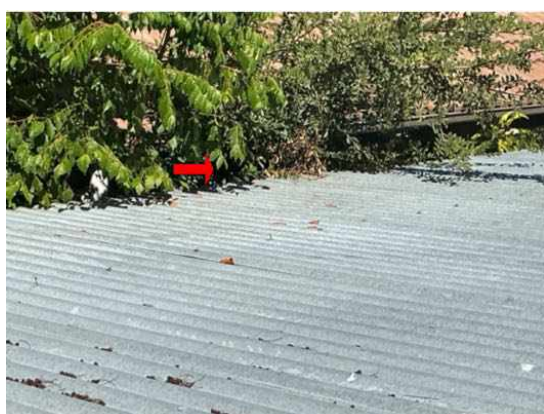
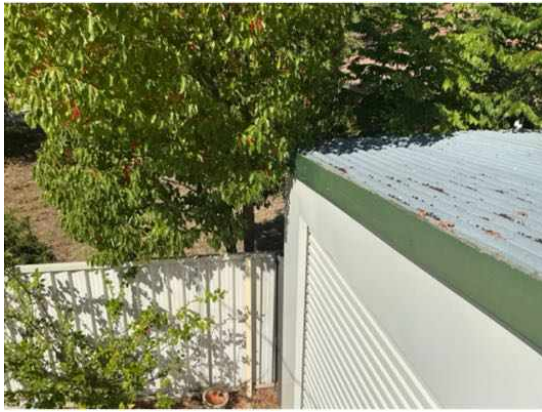
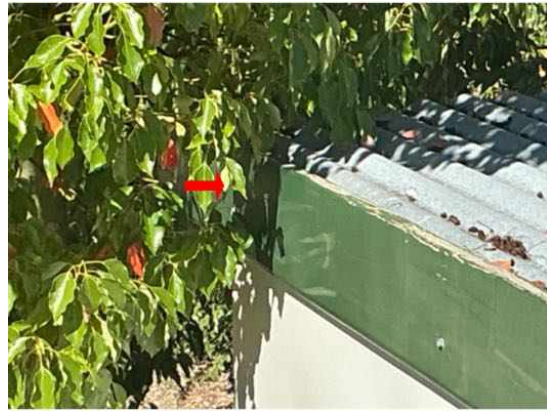
Finding 6.04

Building: Main Building
Location: Carport
Finding: Overhanging Vegetation
Information: Trees and dense vegetation are overhanging the roof and obstructing the gutters, creating a risk of blocked drainage systems and contributing to debris accumulation. In addition to maintenance issues, such conditions increase the risk of moisture retention near the roofline and can create a conducive environment for pests, including termites.

Blocked Gutters and Drainage: Leaves and branches can clog gutters and downpipes, leading to overflow, water damage, and potential ingress into the roof or wall structures.

Property Maintenance: Excessive vegetation may damage roof materials, eaves, or external finishes during wind events, and can hinder access for inspections or repairs.

It is recommended that all overhanging branches and vegetation be trimmed back to create adequate clearance from the building structure and gutters. This will help maintain effective roof drainage and reduce the likelihood of pest activity. If there are concerns about pest presence—especially termites—it is advisable to engage a licensed pest control professional for inspection and, if necessary, treatment.

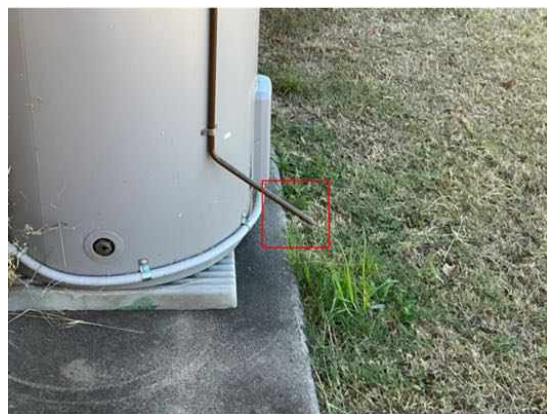
Finding 6.05

Building:	Main Building
Location:	Exterior walls - rear
Finding:	HWS - Disconnected overflow
Information:	The Hot Water System overflow was found NOT to be connected to the storm water drainage and is creating excessive moisture in the surrounding area.

Poorly aligned materials can and will lead to further damage to nearby areas.

It is highly recommended that a licensed plumber be appointed to connect the A/C overflow in order to prevent such an environment from being created. These minor works should be carried out as soon as possible.

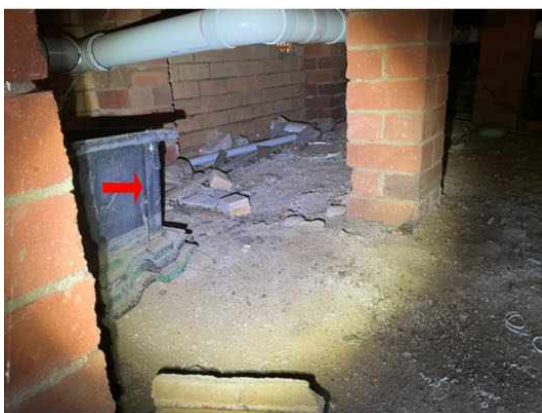
Finding 6.06

Building:	Main Building
Location:	Subfloor
Finding:	Stored Items - Subfloor
Information:	At the time of inspection, various stored items and leftover building materials were observed within the subfloor area of the dwelling. Subfloor areas are required to remain clear and unobstructed to allow for adequate ventilation, routine inspection access, and to prevent the accumulation of moisture and pests.

The storage of materials and general items in this space can obstruct air flow, potentially contributing to poor ventilation and the buildup of damp conditions, which may lead to timber decay, mould growth, or termite activity. Additionally, stored items can conceal defects or damage within the subfloor, delaying their detection and rectification.

It is recommended that all stored items and debris be removed from the subfloor area to maintain compliance with good building practice and to preserve the structural and environmental integrity of the subfloor space.
