Building and Timber Pest Inspection Report

Inspection Date: Tue, 3 Feb 2026

Property Address: 108A Bland St, Kiama NSW 2533, Australia

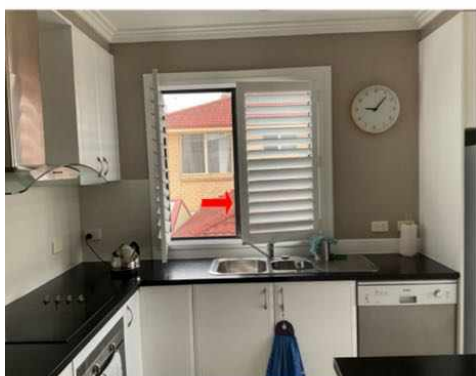
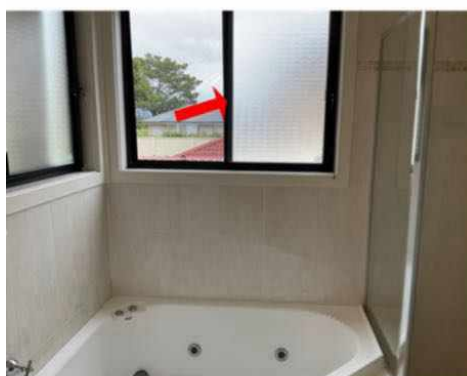
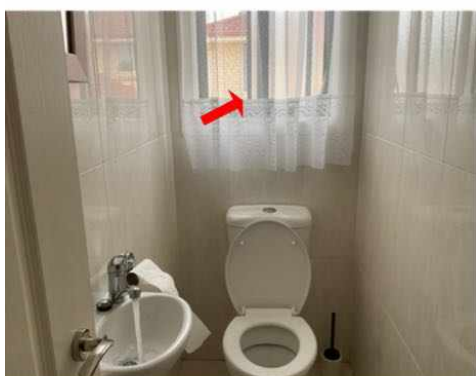
Building: Building 1
Location: Pictured upstairs windows
Finding: Window opening restrictors missing.
Information: The Building Code of Australia rules require all openable windows (where the internal floor is more than 2m above the ground outside) in residential rooms to be fitted with a suitable screen or restrictor. Windows located 1.7m above the floor level do not require protection.

Window restrictors are required where people who are vulnerable to the risk of falling have access to windows. This means all windows above ground level which do not have another fall prevention safety measure in place, such as a balcony or balustrade should have a restrictor.

These need to be added urgently for the safety of all persons.

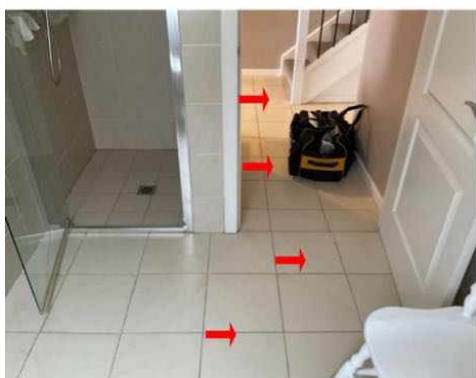
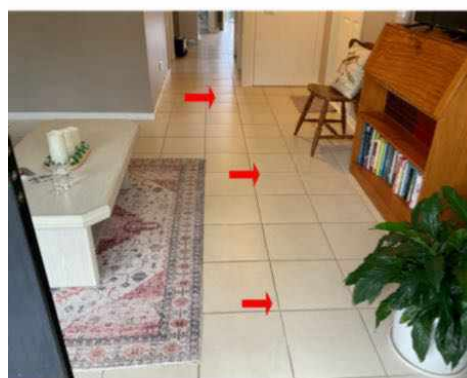
Building:	Building 1
Location:	Pictured tiled areas
Finding:	Tiles - Drummy
Information:	Drummy tiled areas were identified in many areas at the time of inspection. The term 'drummy' refers to tiles that have become detached from their fixing, despite otherwise being in relatively good condition. Such defects are generally caused by physical or moisture damage to the area. Drummy tiled areas may also be a direct result of poor workmanship during the construction process.

Tiled areas may swell and shrink with changes in air humidity if the area has sustained moisture damage. Any exposure to moisture is capable of causing tiled areas to become drummy and/or cracked over a prolonged period of time. Drummy tiled areas generally require removal and replacement of affected tiles, with adequate sealant and grouting.

Specialist trades are available for these types of services. A registered builder may be required to undertake works if damage is extensive or if secondary building defects have resulted. Otherwise, it is advised that a tiling contractor be appointed to perform works as necessary. Immediate action is recommended to ensure that no further damage is sustained in the affected area.

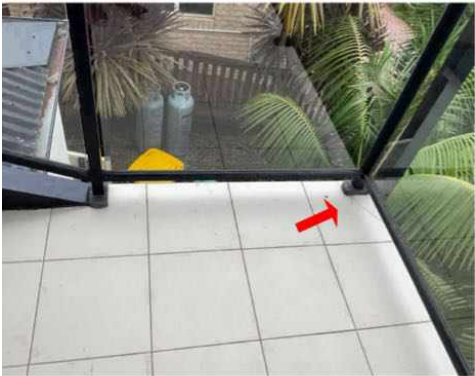
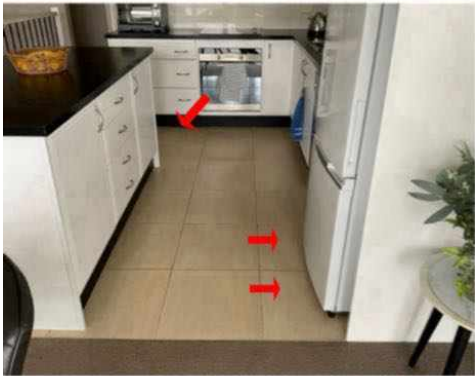
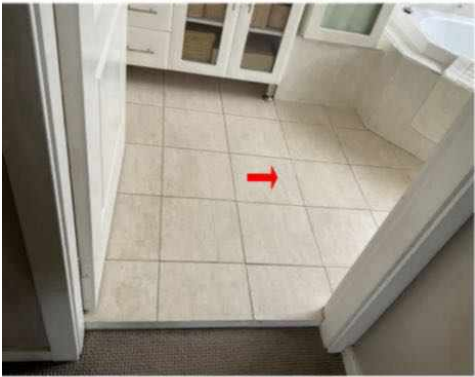
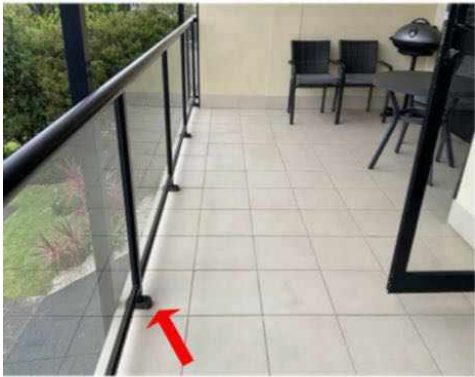
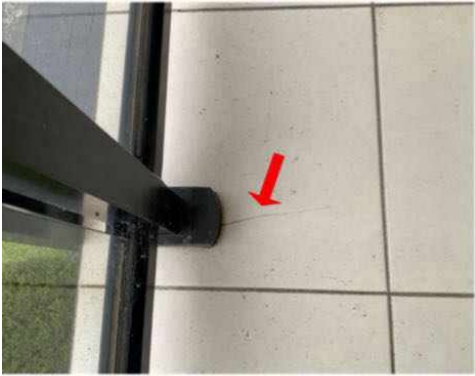
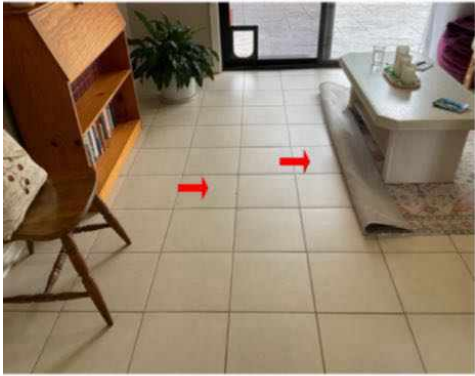
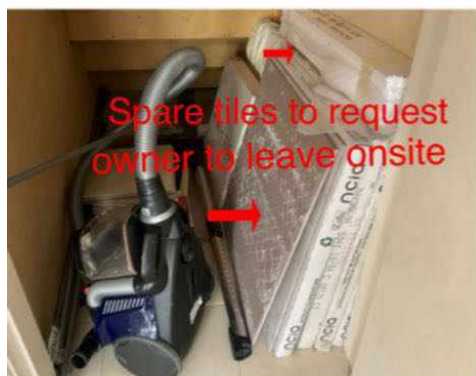
Finding 3.02

Building:	Building 1
Location:	Verandah, Bathroom
Finding:	Tiles cracked
Information:	Cracked tiles were evident in these pictured areas at the time of inspection. It is suspected that this cracking has occurred as a result of minor settlement or impact

damage.

Cracked tiles throughout the household detract from the overall appearance of the affected areas. In wet areas of kitchens and bathrooms, it can lead to water damage of adjoining walls and floors.

Replacement of cracked tiles is recommended as soon as possible. A tiling contractor may be appointed to perform these works. Where cracks become more numerous, contact a licensed building inspector for further investigation.

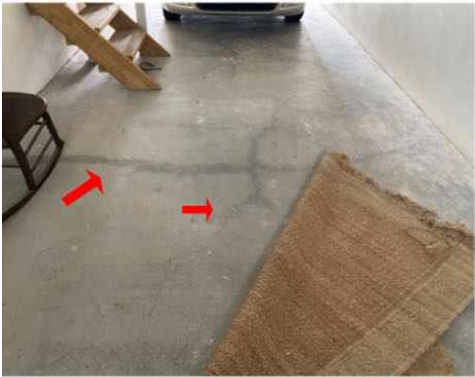
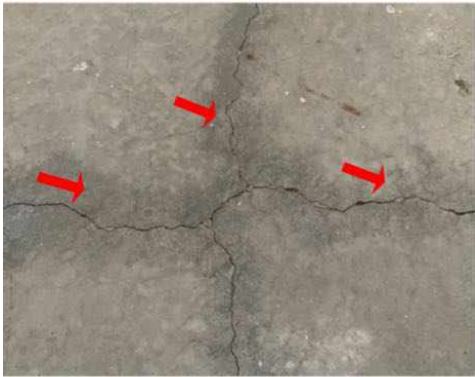
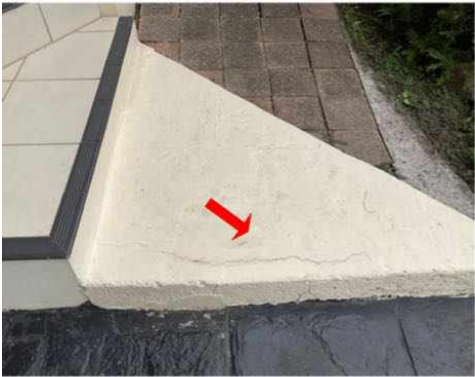
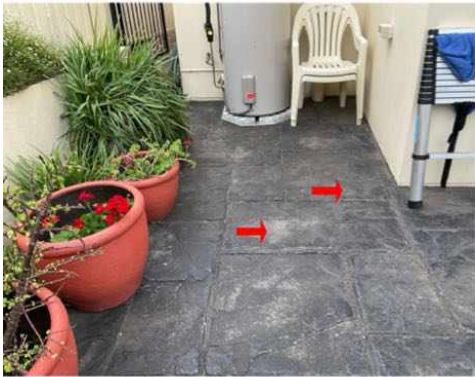
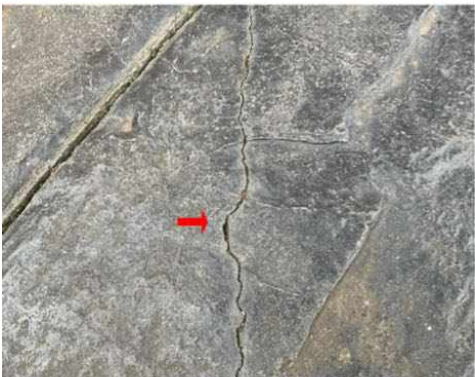
Location: Paved areas
Finding: Crack in concrete slabs - Category 1
Information: Cracks coded as Category 1 was identified in these pictured slabs. A Category 1 crack is described as a fine but noticeable crack, with the slab at an otherwise reasonable level. To be considered Category 1, the approximate width of the crack is less than 1.0mm, or a less than 10mm change in offset when a 3m straight edge is placed over the defect.

Category 1 cracks should be monitored for a period of 12 months. At the end of the monitoring period, identified cracks that are rated greater than Category 2 are considered defects, and require rectification.

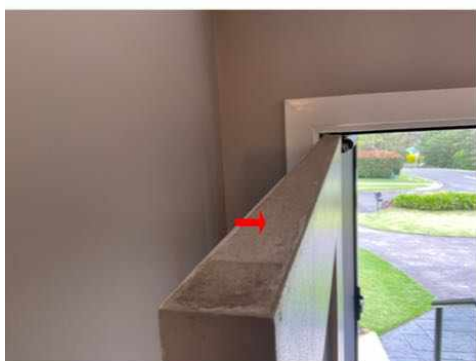
NSW Guide to Standards and Tolerances 9.6 states that “door leaves are defective if they do not have all sides, top and bottom edges sealed/painted

Whilst incomplete or missing paint finish is generally an appearance defect, it can also lead to the development of secondary building defects over time. Incomplete areas of paint finish expose the area to moisture, potentially accelerating the deterioration of underlying building materials.

Incomplete paint finishes should be sanded back, filled, leveled and painted, as applicable. Where inadequate or missing paint protection has led to the deterioration of the associated building element, repair and/or replacement of this building element may be required.

A painting contractor should be appointed as soon as possible to perform necessary works to aid the appearance of the affected area and to ensure the area is protected against further deterioration. Alternatively, the homeowner following manufacturer instructions may perform these works.

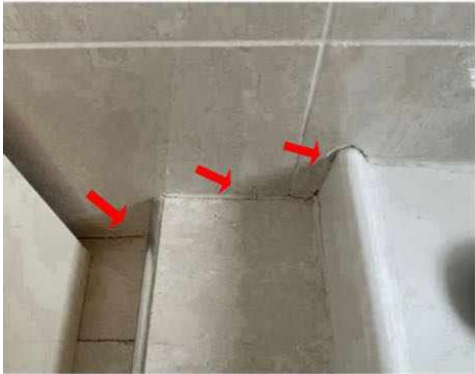
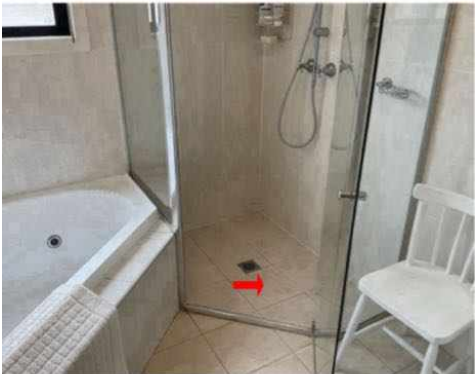
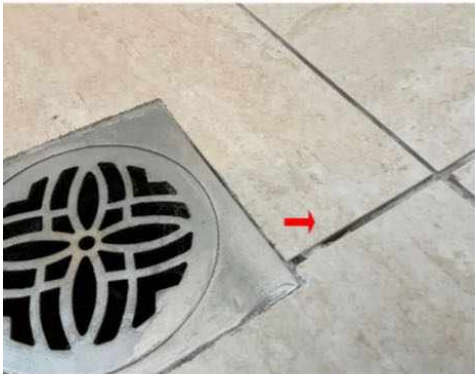
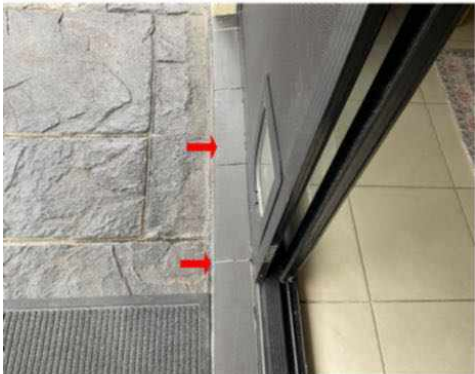
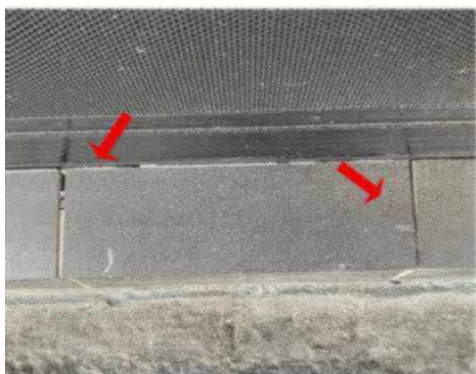
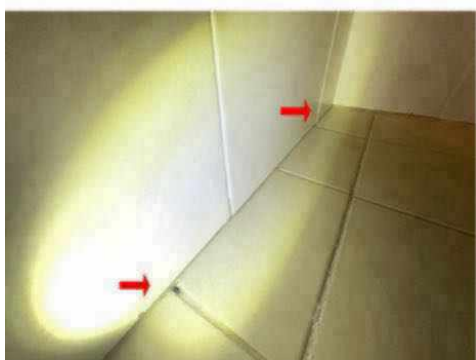
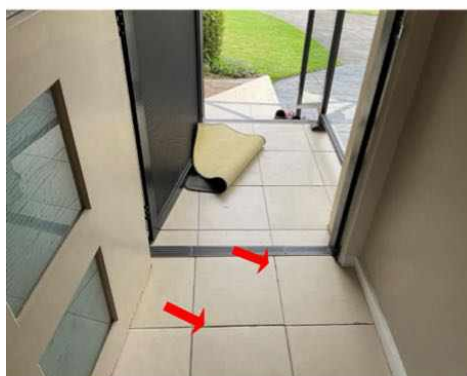
Finding 3.07

Building:	Building 1
Location:	Many areas
Finding:	Sealant and grouting - Missing or damaged
Information:	It was noted on inspection that sealant or grout is degraded to these pictured areas.

Different materials and floor areas move at different rates, generally causing cracking to grout or sealant at this point. A flexible sealant is required to allow for expected expansion and contraction, while keeping the joint water tight and protective of all associated building materials.

any subsequent water damage that is likely to occur. Regular maintenance and replacement of damaged or missing or damaged sealant and grout is highly recommended to the wet areas, as this is a regular wear and tear defect. Sealant and grouting in areas that come into regular contact with water should be maintained for the long term care of your property.

A sealant specialist or tiling contractor should be appointed to complete these works as soon as possible

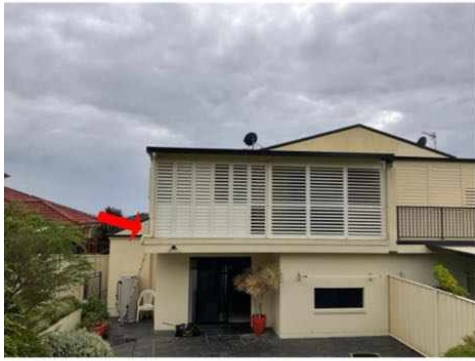
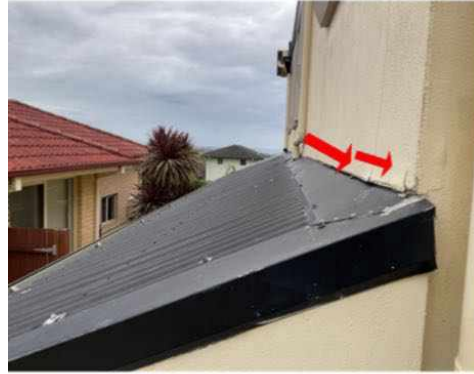
Finding 3.08

Building:	Building 1
Location:	Exterior rear right walls
Finding:	Sealant (external) - missing
Information:	It was noted on inspection that areas of external sealant was missing to small areas of the external walls.

Flexible sealants should be applied to these affected areas to prevent any subsequent water damage that is likely to occur.

A sealant specialist or skilled handy person should be appointed to complete these works as soon as possible

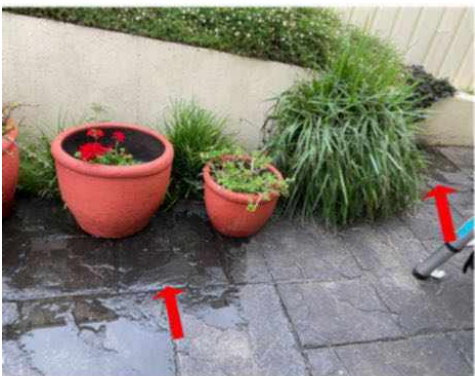
Finding 3.09

Building:	Building 1
Location:	Rear areas
Finding:	Site drainage - Inadequate
Information:	The site drainage in this rear area was found to be slightly inadequate at the time of inspection, creating potential for subsequent water damage to associated building elements. Small areas of water pooled against the right rear retaining walls. It is thought, in heavy rain most water would reach one of the 3 nearby drains.

Where site drainage is inadequate and if large amounts of rainwater does pool in high rain events, the installation of an Agricultural (Aggie) Drain may be required. In this case a qualified plumber should be appointed to further inspect the property and perform any remedial works as necessary. Water damage and secondary defects are likely to occur if left unmanaged.

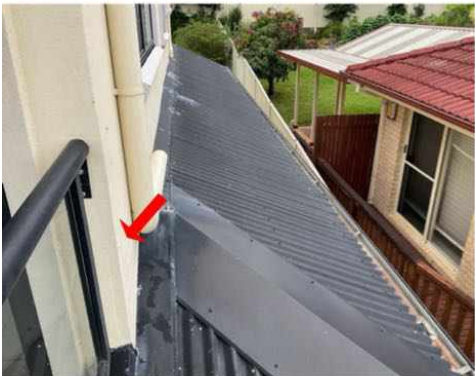
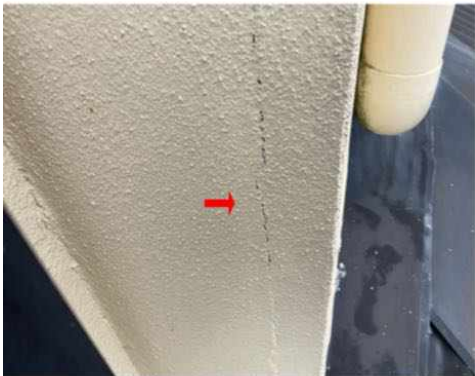
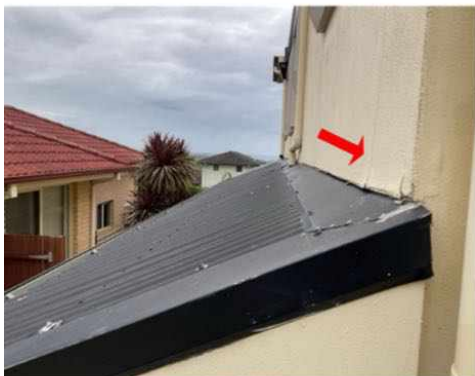
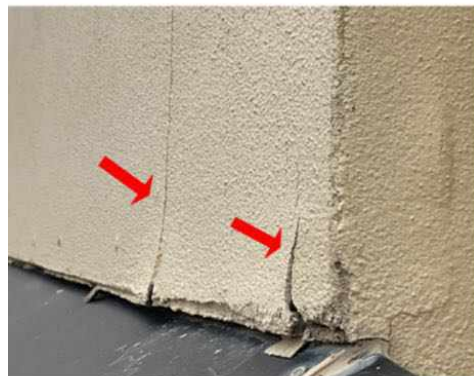
Finding 3.10

Building: Building 1
Location: Small external wall areas
Finding: Render (external) cracking.
Information: It has been observed that cracking to some external rendered surfaces. The degree of damage is described as “slight” noticeable cracks which are easily filled. Cracking of this size are generally less than 5mm in width.

Always contact your building inspector should cracks widen, lengthen, or become more numerous.

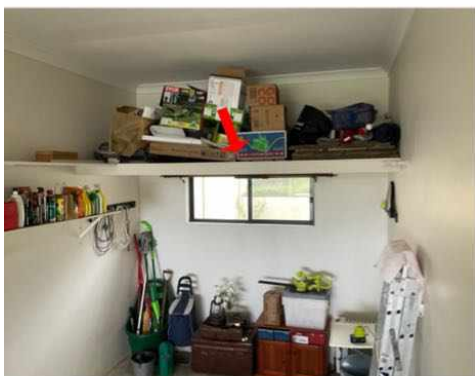
Finding 3.11

Building: Building 1
Location: Garage shelf
Finding: Additional support required
Information: Evidence of sagging were evident on the garage shelf.

A carpenter or skilled handy person would be able to add additional strength to this area for its longevity.

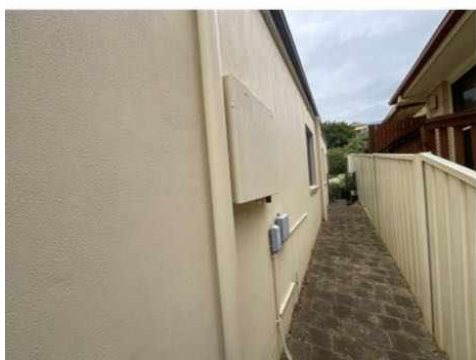
Building: Building 1
 Location: Meter Box
 Finding: Termite Management System - no evidence of a chemical installation
 Information: The application of a post-construction chemical termite barrier is highly recommended for all properties. Such barriers are highly effective in preventing termite attack on any timber building elements throughout the property.

A durable notice should be placed in the switchboard unit to indicate current termite barriers. At the time of inspection, the durable notice was evident with the wrong address and it appeared as though no chemical termite management system has been installed, with no evidence to suggest preventative works taking place since the property was built.

The client may consider gaining further advice from a pest controller as to the costs and procedures involved with a 'chemical' application. It is recommended that obtaining such advice be a short-term priority.

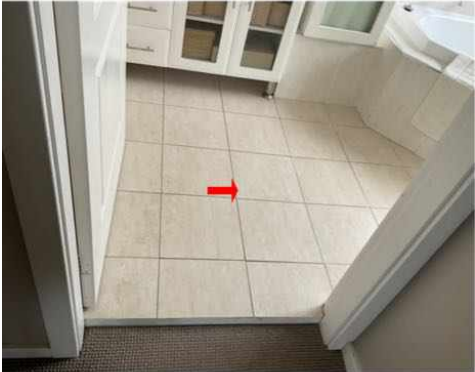
Building: Building 1
 Location: Bathrooms and laundry
 Finding: Waterproofing membranes - Information Only
 Information: Internal Water Proofing Membranes, are crucial in preventing water ingress into the property is important to know that the Membrane System used is to Australian Standards and has been installed correctly.

With older property's where this information is unavailable all wet areas should be monitored. If any leaks, water staining, peeling or bubbling of the paint become evident to any adjacent walls or ceilings below a licensed builder or waterproofing specialist is recommended to investigate further.
