# Building and Timber Pest Inspection Report

Inspection Date: Tue, 27 Jan 2026

Property Address: 98/175 Thorneside Rd, Thorneside QLD  
4158, Australia

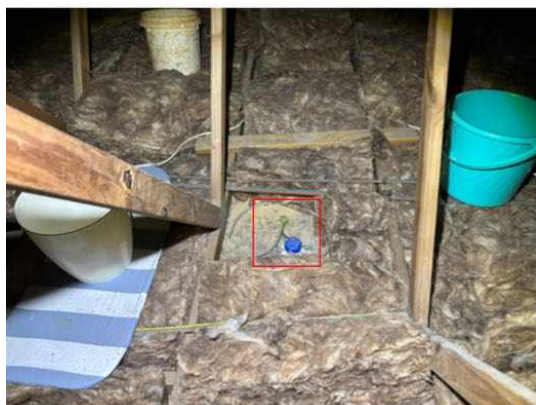
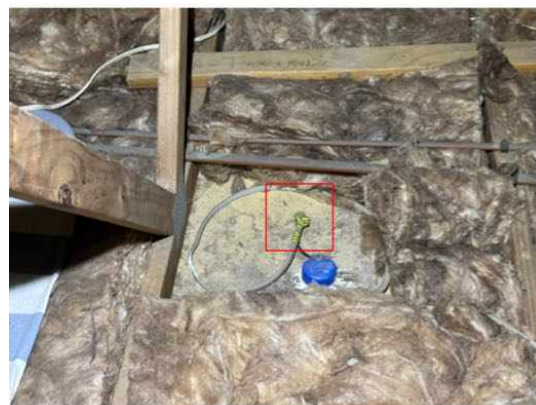
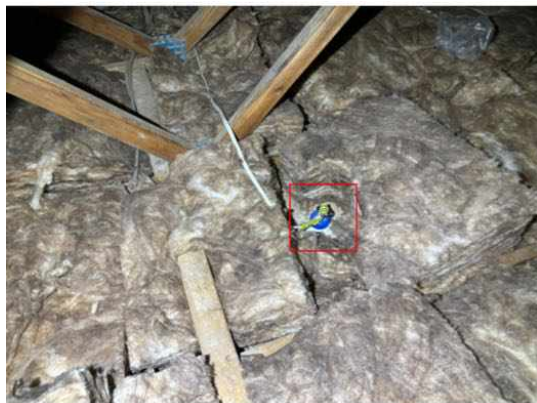
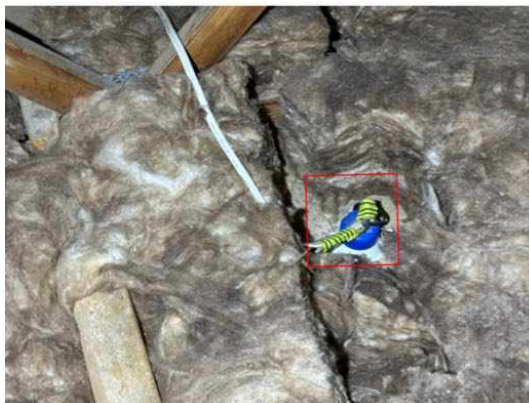
#### Finding 1.01

Building: Main Building  
Location: Roof Void  
Finding: Electrical junction box - Missing  
Information: At the time of the inspection, it was noted that the electrical cable to at least two down-lights were not encased in junction boxes. As these cables are for lights, it must be assumed that they are live when the light switch is turned on.

Junction boxes provide a second insulation barrier to adequately seal off and protect the wires, increasing the safety of the immediate environment and ensuring that the wiring is not damaged.

The absence of junction boxes poses as an electrical safety hazard, providing risk of electrocution. It appears as though wiring in this area has been completed to a substandard level of workmanship, evidenced by the lack of adequate wiring protection.

Appointment of a licensed electrician is highly advised to provide additional information on the risks of unprotected wiring and to install junction boxes and any other elements as required. Such works should be carried out as a matter of urgency; until this time, any persons within this area should exercise a high level of caution.

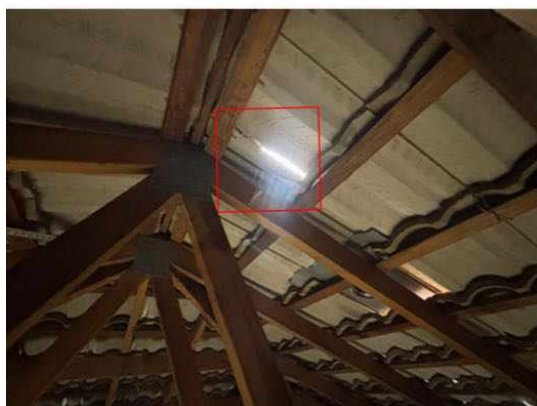
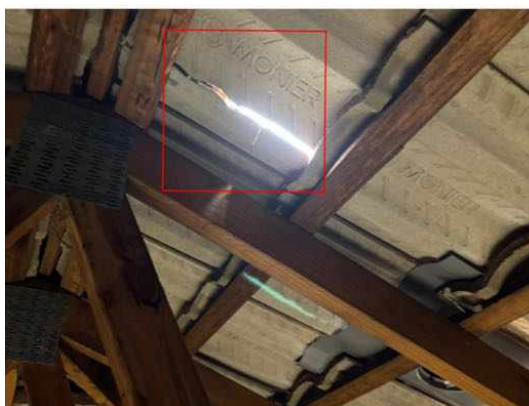
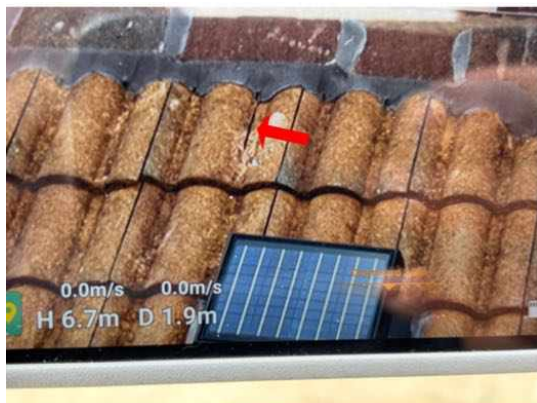
### Finding 3.01

Building:	Main Building
Location:	Roof Exterior
Finding:	Roof exterior - cracked roof tile
Information:	At the time of the inspection, it was noted that a roof tile above the garage area is cracked. This will allow moisture to enter the roof cavity and cause damage to the associated building materials. This may be from hail damage.

This has been noted as a minor defect due to the fact that the body corporate is aware of the hail damage to the tiled roof covering and has taken steps to rectify these issues. The body corporate should be informed that this tile was missed during rectification works.

The cracked roof tile will become a major defect if left unaddressed.

A roofing contractor must be engaged to replace this cracked roof tile. This must be done as a matter of urgency.

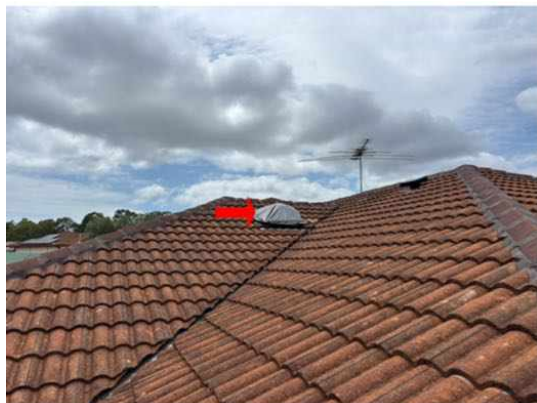
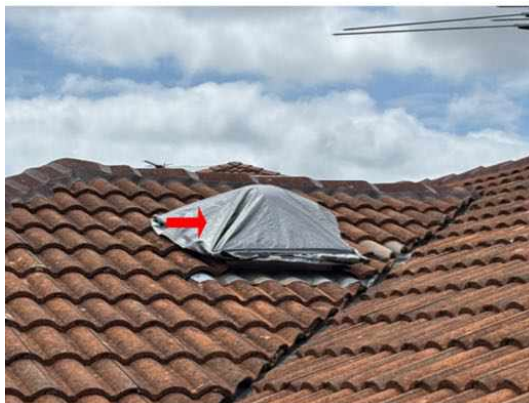
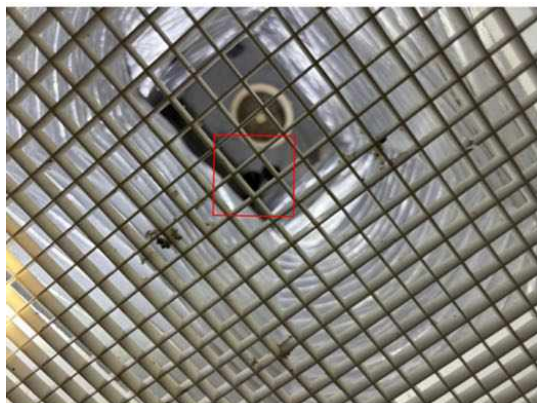
### Finding 3.02

Building:	Main Building
Location:	Roof Exterior
Finding:	Roof exterior - sun tube cover damaged
Information:	At the time of the inspection, it was noted that the cover for the sun tube in the bathroom is damaged and is covered by a tarpaulin. This may be due to hail damage.

This has been noted as a minor defect due to the fact that the body corporate is aware of the damage and is replacing the sun tube cover.

A building maintenance professional or sun tube installer should be engaged to replace the sun tube cover. This should be done as a short term priority.

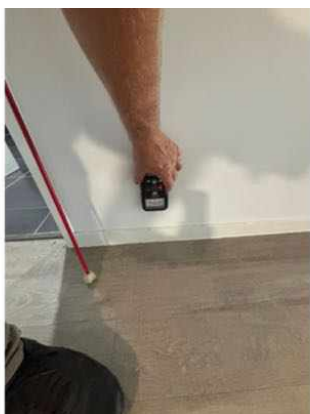
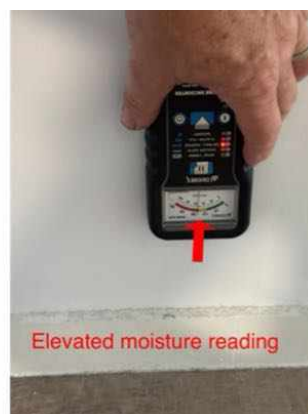
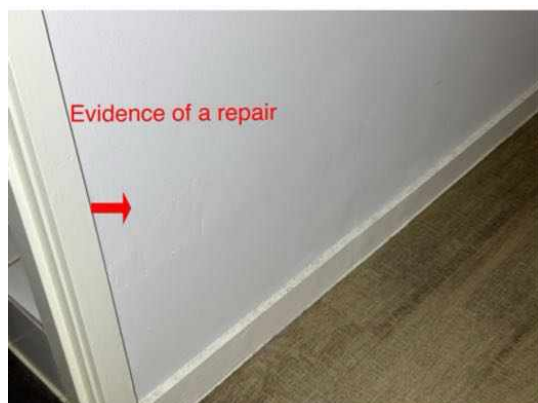
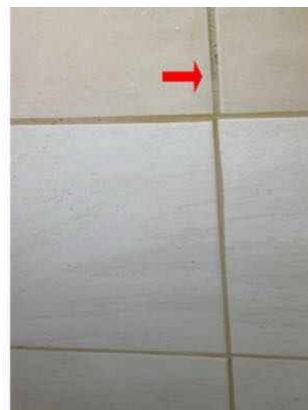
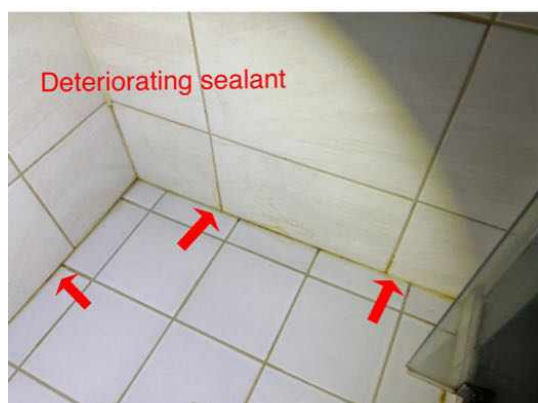
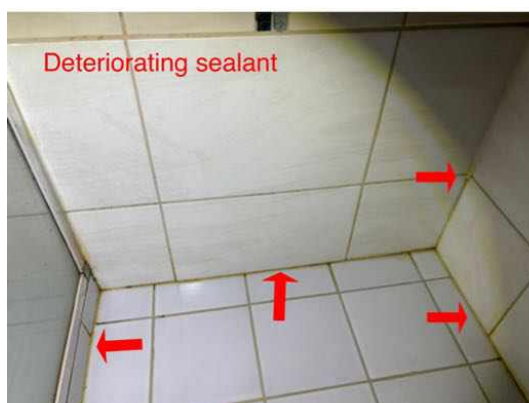
### Finding 3.03

Building:	Main Building
Location:	Bathroom
Finding:	Bathroom - elevated moisture reading
Information:	At the time of the inspection, it was noted that there were elevated moisture readings found to a section of wall lining on the hallway side of the shower wall. A repair in the plasterboard can be seen in this area.

It was found that the bottom two rows of tiles have been replaced in the shower. New grout was installed but only to the bottom two rows of tile. A warranty may still be in place to cover this work. The sealant in the shower cubicle shows signs of deterioration.

A bathroom specialist should be engaged to replace the grout in the shower and seal the wall and floor tiles. This should be done as a short term priority.

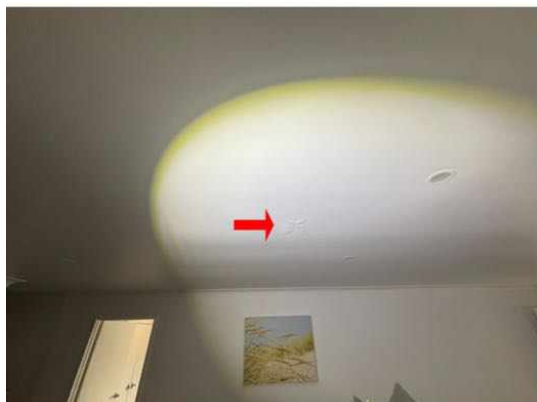
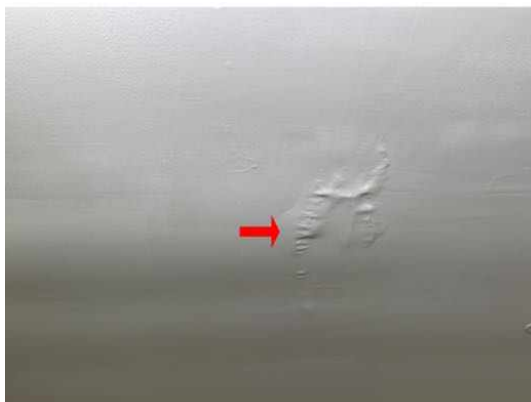
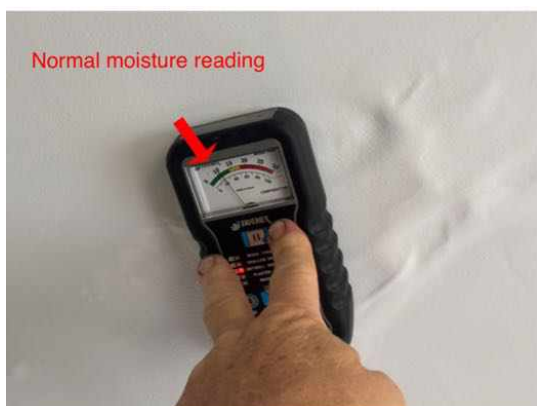
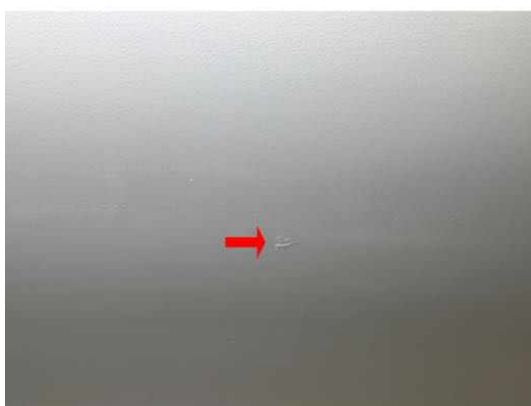
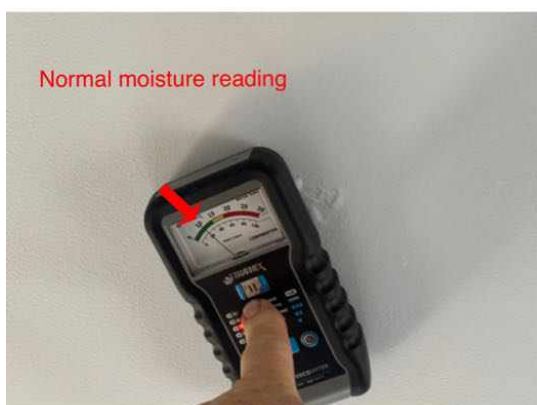
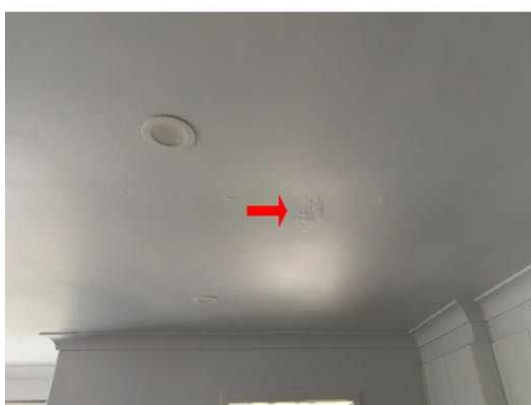
### Finding 3.04

Building:	Main Building
Location:	All Internal Areas
Finding:	Ceiling lining - evidence of moisture damage
Information:	At the time of the inspection, it was noted that there was evidence of moisture damage to sections of the ceiling linings. This may be due to hail damaged roof tiles allowing moisture into the roof cavity.

Normal moisture readings were recorded in these areas during the inspection. It is understood that these repairs will be carried out by the body corporate.

A painting contractor could be engaged to carry out the repairs to the affected areas.

This can be done at the clients discretion.

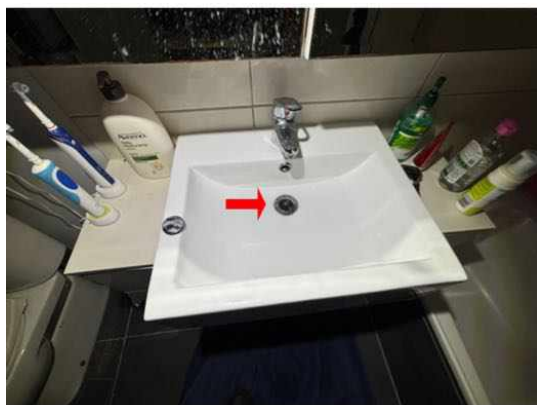
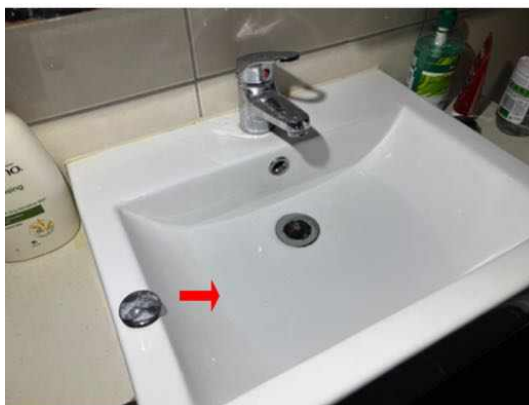
**Finding 3.05**

Building: Main Building  
 Location: Bathroom  
 Finding: Bathroom - slow draining hand basin  
 Information: At the time of the inspection, it was noted that the hand basin in the bathroom was slow draining. This appears to be caused by a partial blockage of the plumbing below the hand basin.

A licensed plumber could be engaged to check the associated plumbing and clear the blockage. This can be done at the clients discretion.

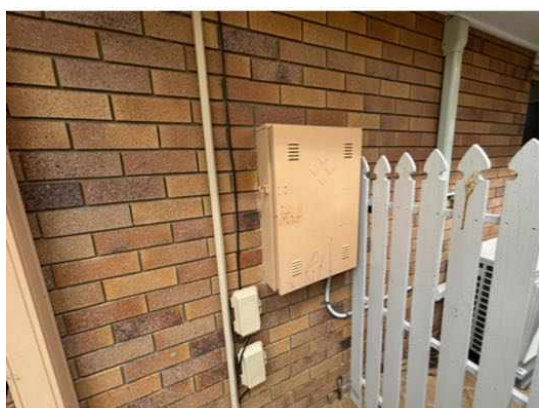
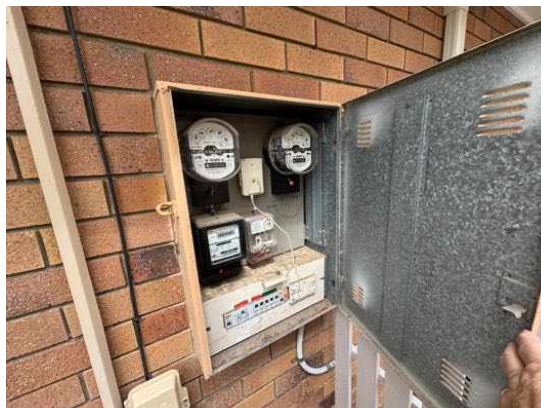
### Finding 6.01

Building:	Main Building
Location:	All External Areas
Finding:	Termite Management System - no evidence of a chemical installation
Information:	At the time of the inspection, no evidence of a chemical termite management system was found. There is no durable notice in the meter box.

A durable notice should be placed in the switchboard unit to indicate current termite barriers. At the time of inspection, it appeared as though no termite management system has been installed, with no evidence to suggest preventative works taking

The client should enquire of the body corporate as to the nature of the termite management plan for the complex and the individual units. Also to confirm that annual termite inspections are being carried out and are up to date.

The application of a post-construction chemical termite barrier is highly recommended for all properties, particularly if live termite activity has been found on the site previously. Such barriers are highly effective in preventing termite attack on any timber building elements throughout the property.

The client may consider gaining further advice from a pest controller as to the costs and procedures involved with this application. It is recommended that obtaining such advice be a short-term priority.

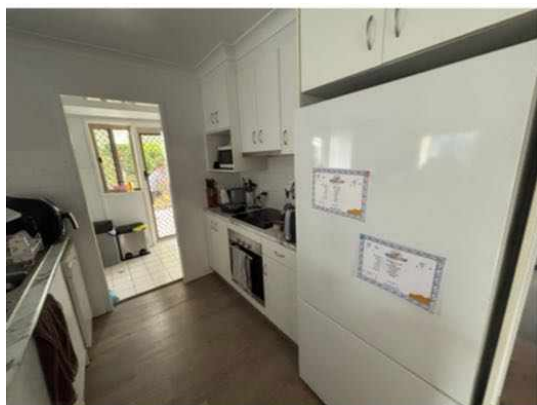
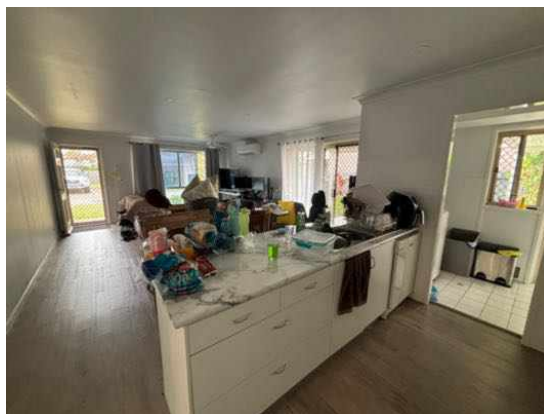
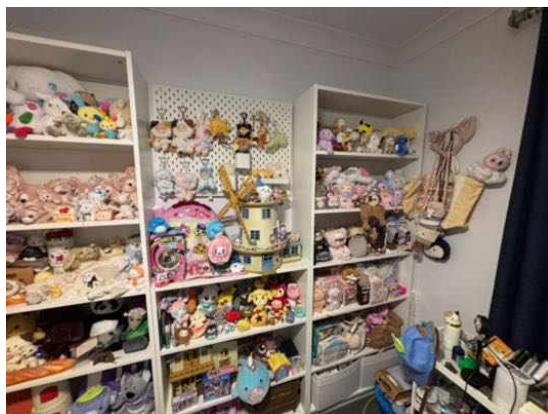
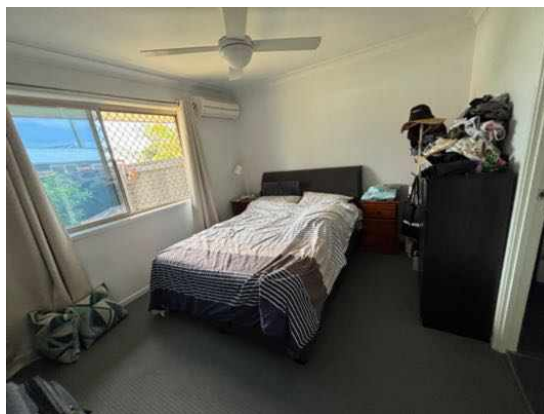
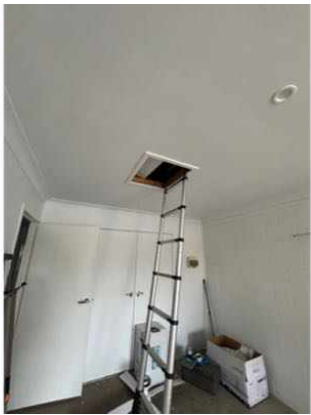
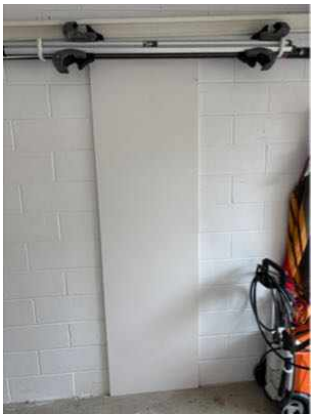
#### Noted Item

Building: Main Building  
Location: All Internal Areas  
Finding: Obstructions and Limitations - Internal areas  
Information: These photographs are an indication of the obstructions and limitations which impeded full inspection of the property of the internal areas at the time of inspection. These obstructions can hide an array of defects and should be removed to allow full inspection to be carried out. A re-inspection is recommended once the areas are made accessible.

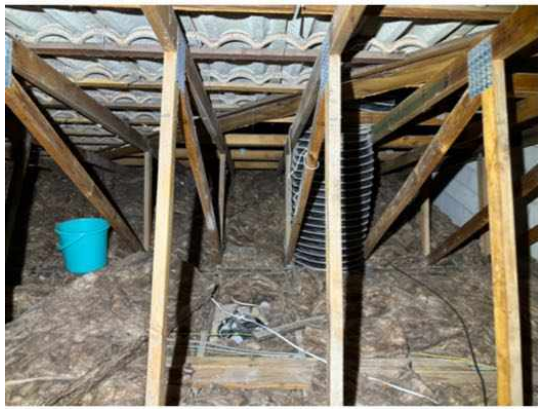
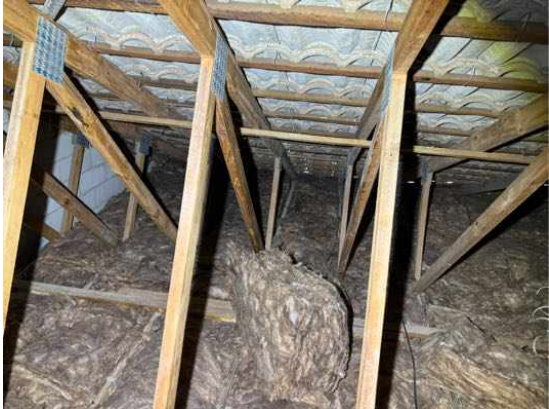
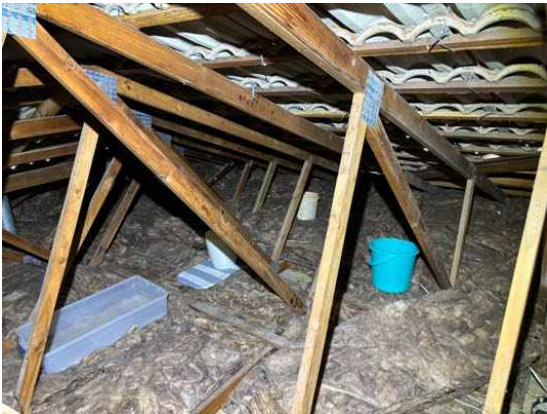
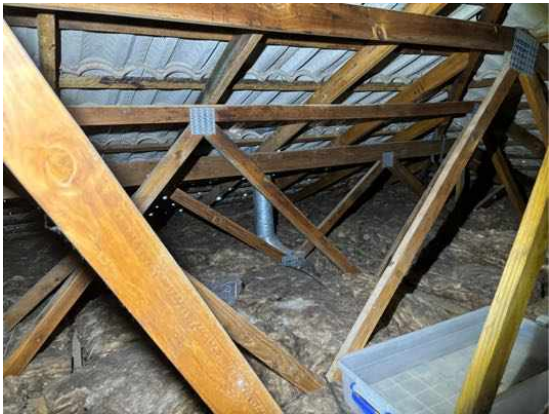
**Noted Item**

Building: Main Building  
Location: Roof Void  
Finding: Obstructions and Limitations - Roof cavity  
Information: These photographs are an indication of the obstructions and limitations which impeded full inspection of the property of the roof cavity

at the time of inspection. These obstructions can hide an array of defects and should be removed to allow full inspection to be carried out. A re-inspection is recommended once the areas are made accessible.
