Building and Timber Pest Inspection Report

Inspection Date: Thu, 26 Feb 2026

Property Address: 103 Eighteenth Ave, Austral NSW 2179,
Australia

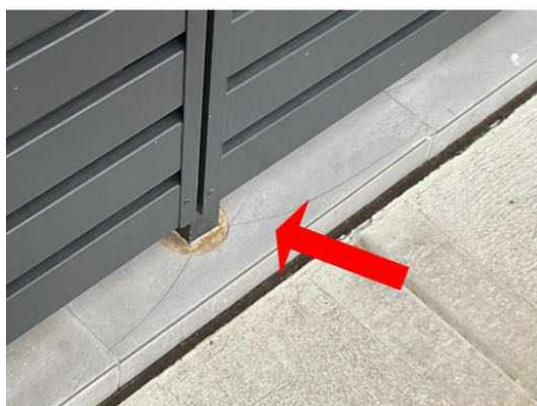
Building: Main Building
 Location: All External Areas
 Finding: Tiles - Cracked or damaged

Information: Cracking was evident to the tiling in this area at the time of inspection. While the cracking appears to be minor, this area is frequently exposed to water, allowing potential for water penetration into adjoining sections of walls or flooring.

If left unmanaged, water penetration to these areas may lead to subsequent water damage, which is likely necessitate repair work to affected building elements.

A tiling contractor should be appointed to ensure that no further water damage occurs. The re-application of silicone and grouting throughout remaining tile work is also advised, to further protect the area against water penetration.

Where water penetration has led to water damage, appointment of a relevant tradesperson may be required to repair damaged building elements.

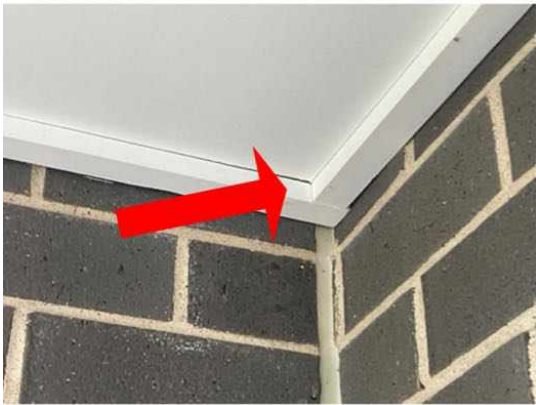
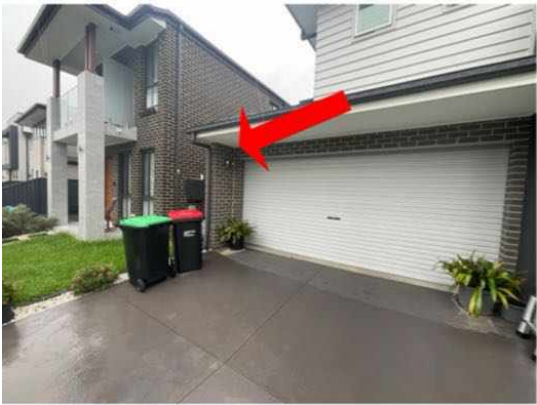
Finding 3.02

Building: Main Building
 Location: All External Areas
 Finding: Beads - Damaged
 Information: Beading acts (like cornice or skirtings) to cover the intersection or joins of building materials. It was noted at the time of inspection that beading in this area has deteriorated. This deterioration is suspected to have been caused by general ageing and frequent exposure to weather, which is expected in a building of this age and condition.

Beading is important in weatherproofing the surrounding building elements and preventing termite or pest ingress. Furthermore, beading works to protect the joins of building materials, which are more susceptible to deterioration and decay.

Repair or replacement of the beading is advised to ensure the protection and longevity of any associated building elements. Such works may be performed by a general handyperson or qualified carpenter.

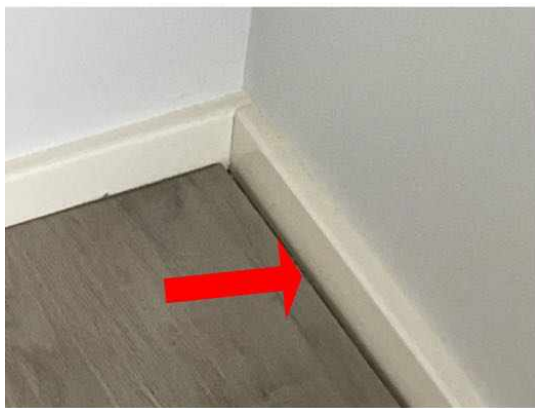
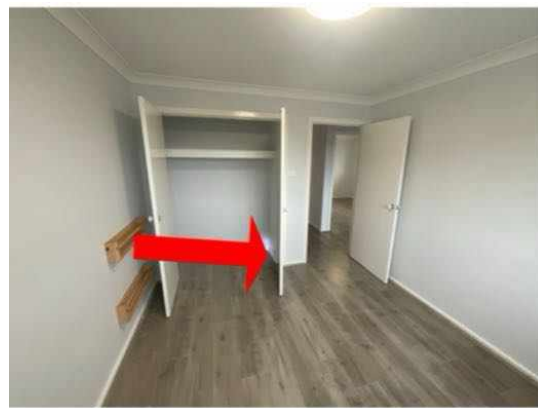
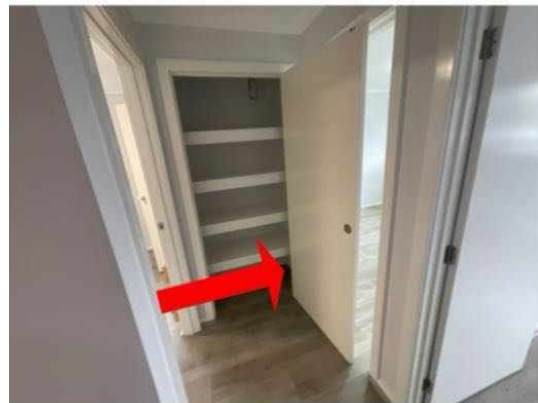
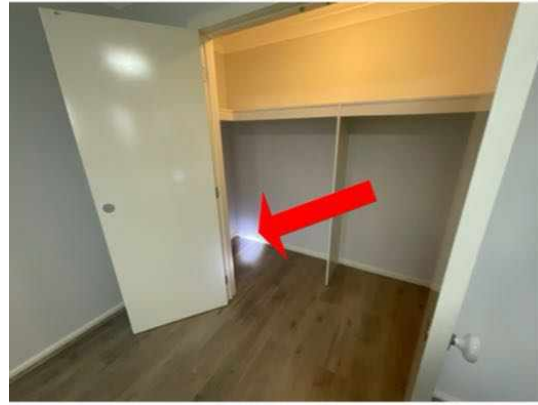
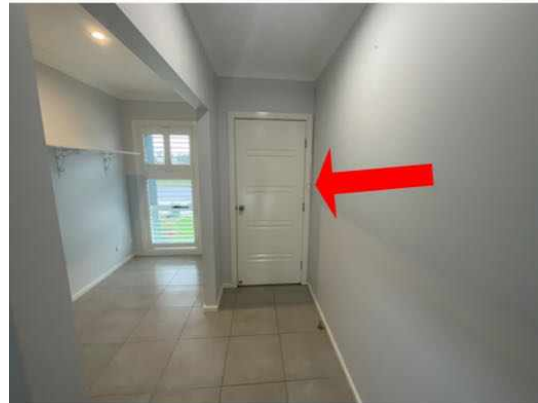
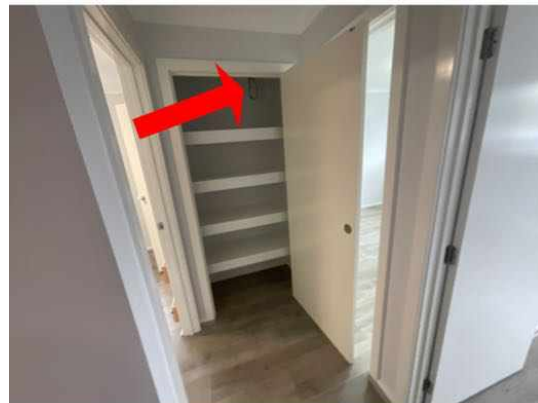
Finding 3.03

Building: Main Building
Location: All Internal Areas
Finding: Installation - substandard or incomplete
Information: The installation of this building element appears to have been completed to a substandard level of workmanship or is incomplete. Generally substandard repairs or installation are related to poor workmanship, the use of inappropriate materials, or a failure to complete installation to a suitable standard.

Where installation is substandard and/or incomplete, the client should contact the responsible trade to undertake rectification. Unfinished and substandard building works are likely to degrade more quickly and may create potential for secondary defects to associated building elements.

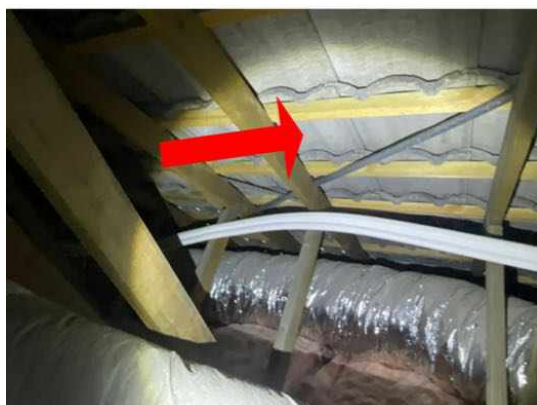
Finding 3.04

Finding: Sarking - Missing

Information: Sarking is missing under the roof sheeting. Sarking acts as an insulator that helps with noise reduction and protects against water penetration. Sarking plays a key role in the operation and function of the overall roofing structure and its performance.

Although not a requirement at the time of construction, replacement of any missing building element is advisable (although this can be quite expensive to do after the time of construction). Where sarking is missing, regular inspections of the roof tiles for cracking and potential moisture penetration is required.

Sarking may be retrospectively fitted by a registered builder at the discretion of the client.

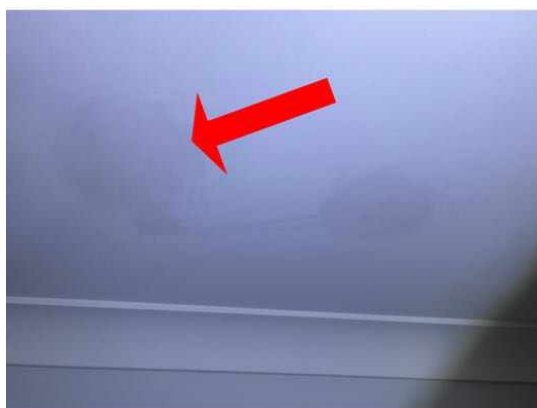
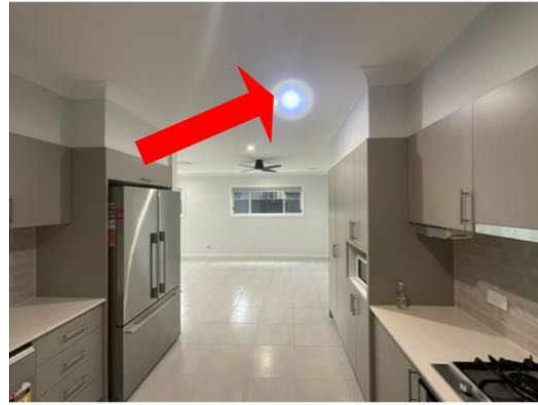
Building:	Main Building
Location:	All Internal Areas
Finding:	Paint finish - Substandard
Information:	The paint finish in this area was found to have been completed to a substandard level. Substandard painting is generally classified as an appearance defect. However, the substandard appearance may also be indicative of poor surface preparation and substandard workmanship.

If this applies, further areas of poor and incomplete finishes could develop over time. Furthermore, substandard paint finishes in areas exposed to moisture, e.g. external areas or wet areas, could lead to deterioration of underlying building materials.

Substandard paint finishes should be sanded back, filled, leveled and repainted, as applicable. Where inadequate paint protection has led to the deterioration of the associated building element, repair and/or replacement of this building element may be required.

A painting contractor should be appointed as soon as possible to perform necessary works to aid the appearance of the affected area and to ensure that the area is protected against further deterioration. Alternatively, the homeowner following manufacturer instructions may be able to provide this service.

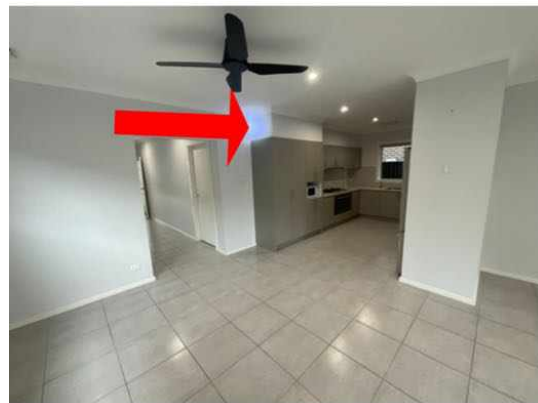
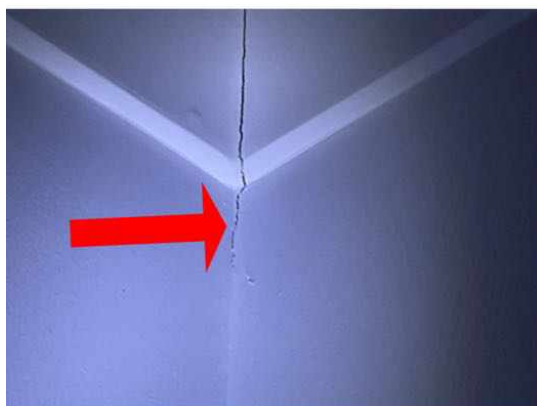
Finding 3.07

Building:	Main Building
Location:	All Internal Areas
Finding:	Cracking - Damage Category 1 - Fine (up to 1mm)
Information:	Although fine cracks are quite noticeable, they are often only considered to be an appearance defect, and usually do not indicate any structural damage. Generally, the cause of a fine crack is indicative of a separation between building materials and finishes (e.g. paint, plaster, etc.) along joints.

Cracking of this nature can generally be repaired with minor sanding, filling and/or repainting. Such works should be performed by a qualified painter or a general handyman.

Monitoring of all cracking should be conducted frequently. Always contact a building inspector should cracks widen, lengthen, or become more numerous.

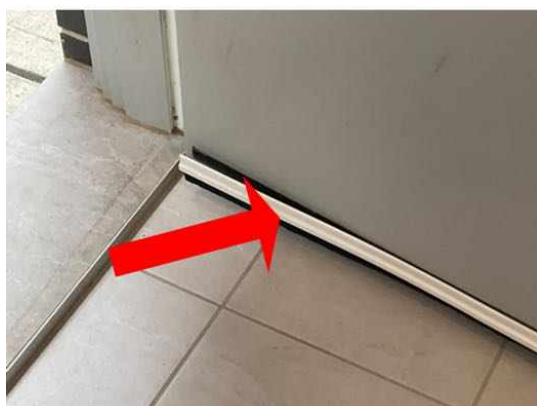
Finding 3.08

Building:	Main Building
Location:	Laundry
Finding:	Bottom seal of entry door - inadequate
Information:	The bottom seal of the door is inadequate at the time of inspection, allowing water to enter the interior of the building. This defect compromises the weatherproofing of the door, potentially leading to water damage, moisture-related issues, and reduced energy efficiency.

Mandates that external doors must be designed and installed to prevent water penetration under wind and rain conditions. A properly fitted bottom seal is critical to

- Install or replace the bottom seal of the door with a compliant weatherproof seal that prevents water from entering the interior during rain or wind conditions.
- Ensure that the seal is durable and appropriately fitted without affecting the door's functionality or accessibility.
- Test the door seal after installation under simulated wet conditions to confirm effectiveness.

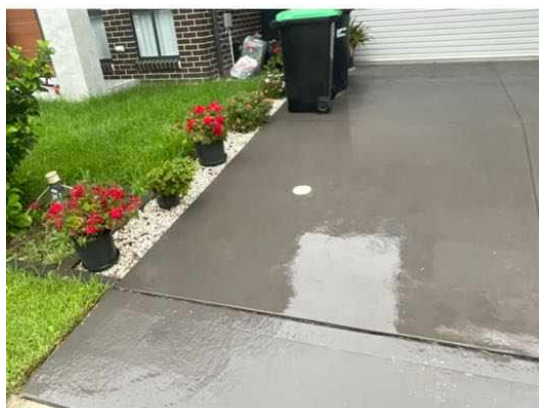
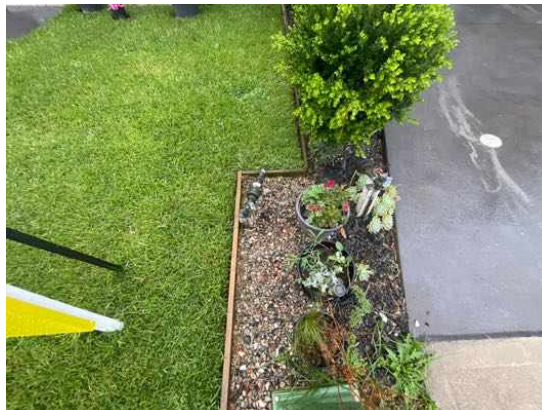
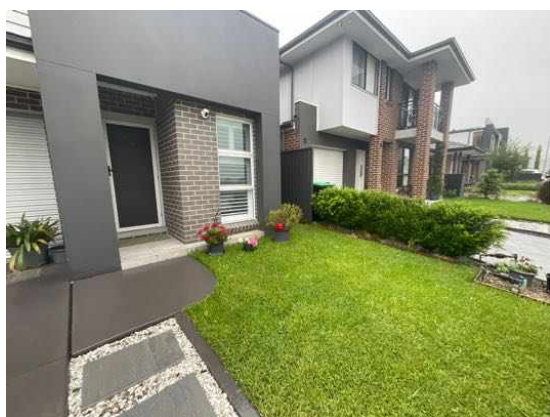
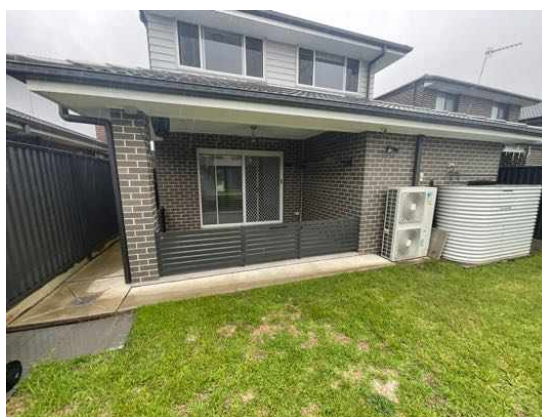
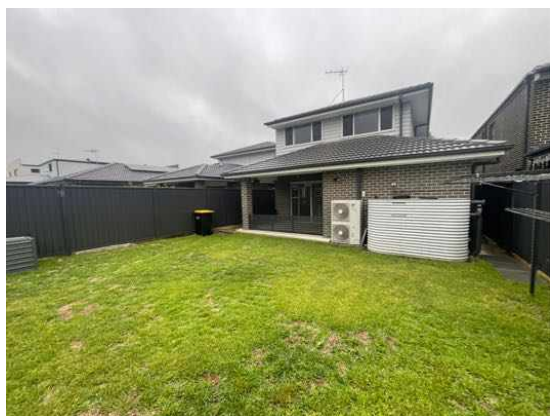
Building:	Main Building
Location:	All Areas
Finding:	Garden Beds - Conditions Conducive to Termites
Information:	Garden beds were found to be evident in the garden area. These garden beds can

include untreated timber, and with a combination of moisture from watering hosing can make conditions conducive to termite activity and termite ingress.

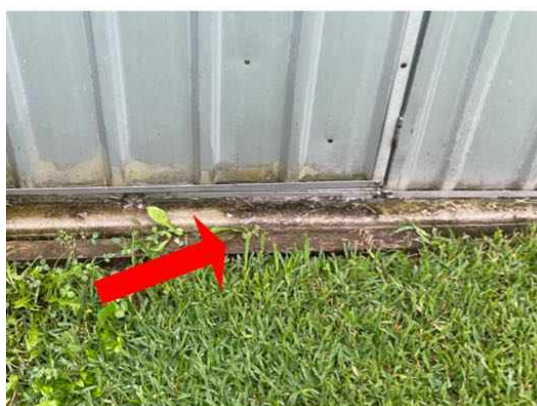
Finding 6.02

Building:	Main Building
Location:	All Areas
Finding:	In ground contact
Information:	Any timbers in direct ground contact provide opportunity for concealed termite entry and are likely to be subject to premature rot and decay as the soil retains moisture or damp conditions against the timbers.

Remove untreated timber that is in direct contact with external grounds. Consider replacement with more durable materials i.e. treated timber or non timber elements. Frequent pest inspections are advised to readily identify any termite activity in these areas.

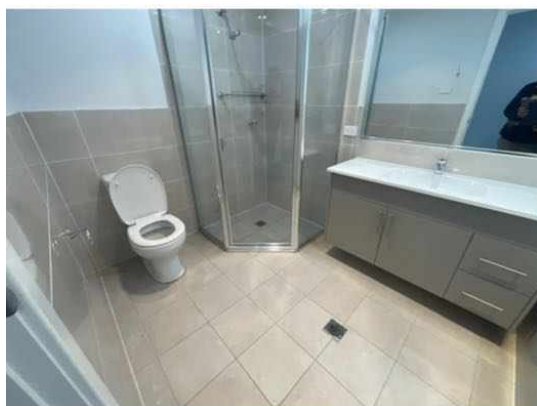
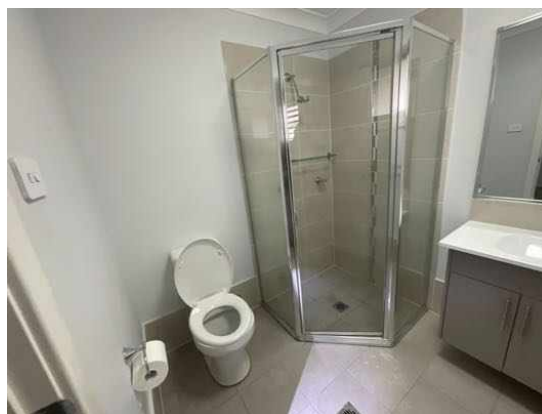
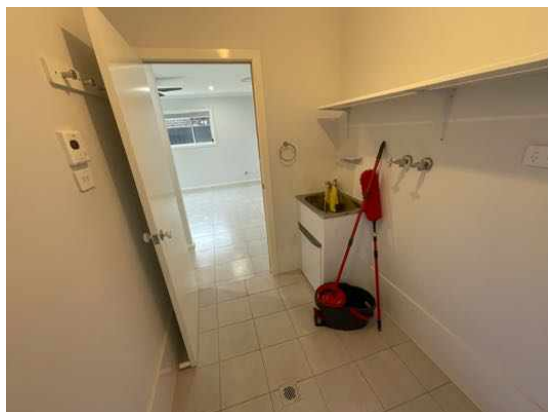
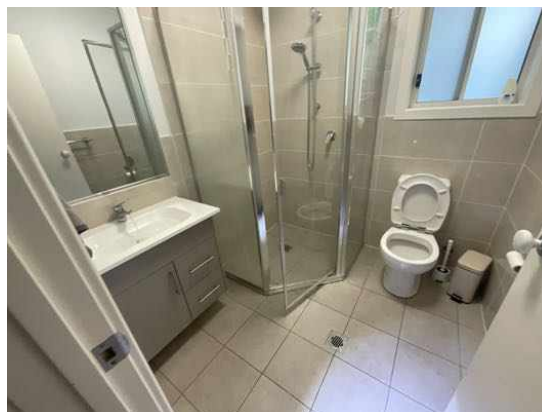
Building:	Main Building
Location:	All Areas
Finding:	Water Proofing Membranes - Information Only
Information:	Internal Water Proofing Membranes, are crucial in preventing water ingress into the property is important to know that the Membrane System used is to Australian Standards and has been installed correctly. Please refer to the original Building Documents or Maintenance Schedule for the relevant information including; - Membrane used and Manufacturers Specifications. - The Installer and Installation Certification. Especially with older property's where this information is unavailable, all wet areas should be monitored. Generally new waterproofing with a certificate may only have a guarantee of 8yrs. If any leaks, water staining, peeling or bubbling of the paint become evident to any adjacent walls or ceilings below a licensed builder or waterproofing specialist is recommended to investigate further.

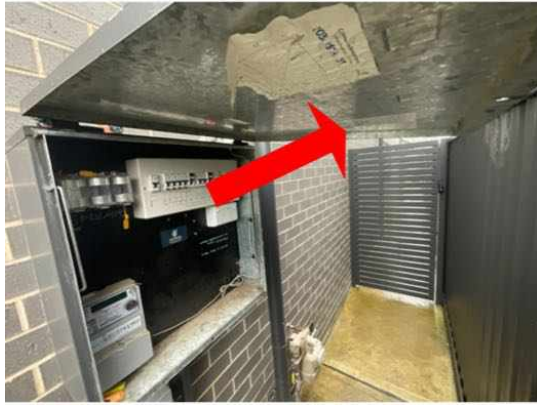
Building:	Main Building
Location:	All Areas
Finding:	Evidence of a chemical treated zone barrier was identified
Information:	During inspection of the property, it was noted that works to install a chemical treated zone barrier had previously been completed. A chemical treated zone barrier is likely to ensure effective protection against termites.

However, we strongly recommend annual inspections of the barrier and surrounding areas as there are several factors that can lead to deterioration of the barrier and decrease its effectiveness.

Where a Termite Management System has been identified, the client should identify to the type of barrier, date of installation, warranty conditions and any documentation provided by a builder or past owner. Consult the company who installed the barrier to confirm whether the system is still under warranty.
