# Building and Timber Pest Inspection Report

Inspection Date: Mon, 30 Mar 2026

Property Address: 2/30 Doomben Ave, Eastwood NSW 2122,  
Australia

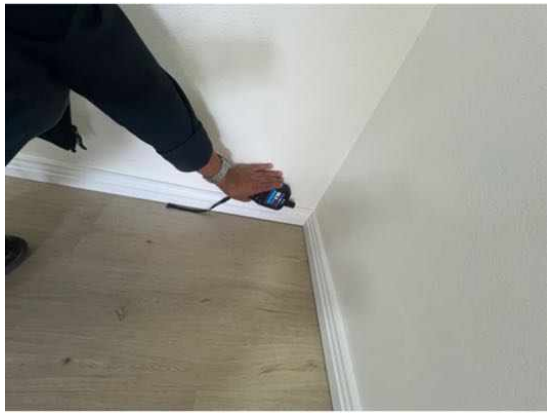
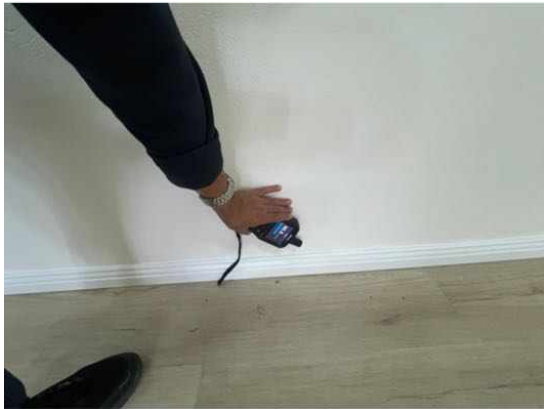
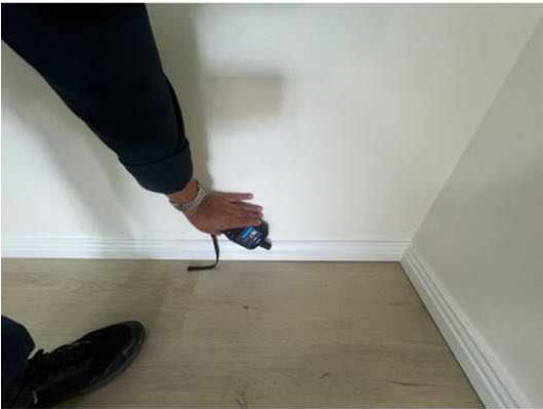
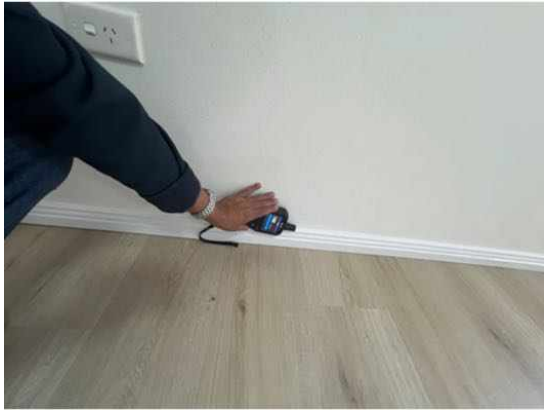
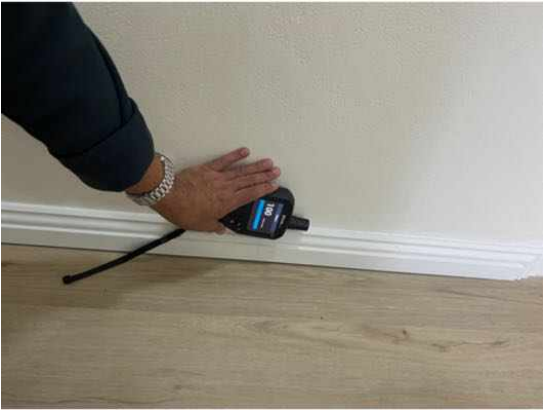
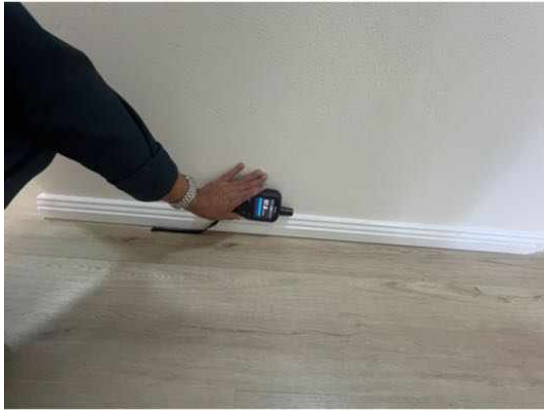
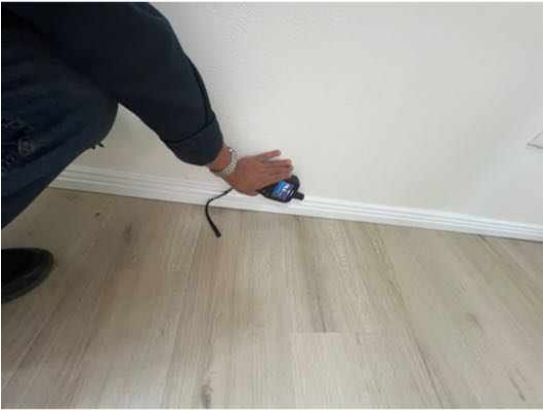
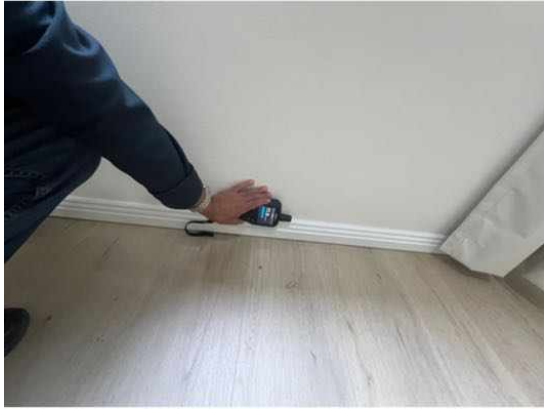
**Finding 3.02**

Building: Main Building  
Location: All Internal Areas - Lounge , bedroom  
Finding: Elevated Moisture – Further Investigation Recommended  
Information: Elevated moisture readings were detected in several locations at the lower walls with some areas also showing signs of minor deterioration or repairs. although no significant structural damage was evident at the time of inspection, dampness can contribute to deterioration if left unaddressed. A further investigation by a licensed plumber or waterproofing specialist is recommended to confirm the source and ensure no concealed issues are developing.

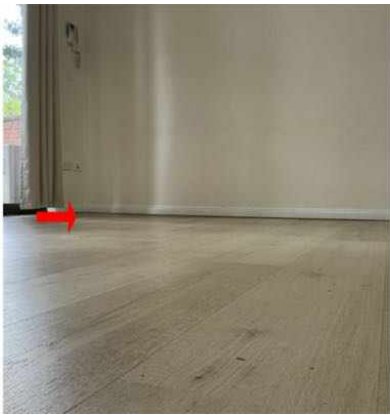
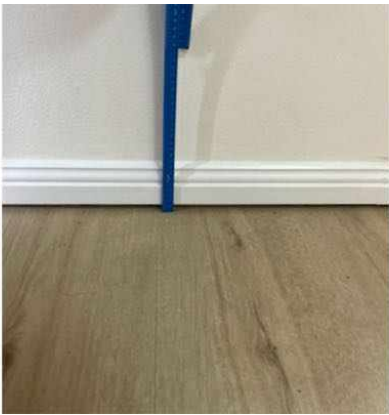
Finding 3.03

Building: Main Building  
Location: All Internal Areas  
Finding: Gap in skirting and flooring  
Information: A consistent gap is visible between the skirting and timber floorboards, with shrinkage and spacing evident across the floor surface. This condition is typically associated with natural timber movement or minor settlement. This may cause potential accumulation of dust and potential pest. Monitoring is recommended and contact a licensed builder if gap widens.

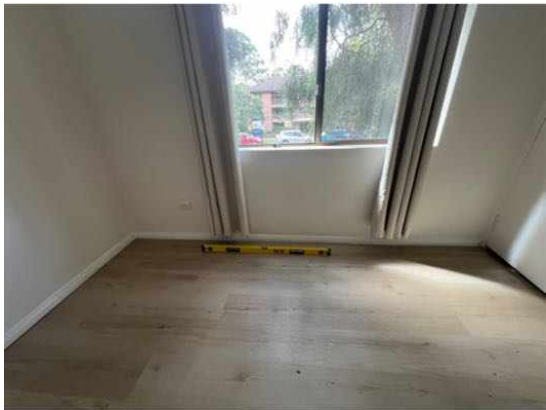
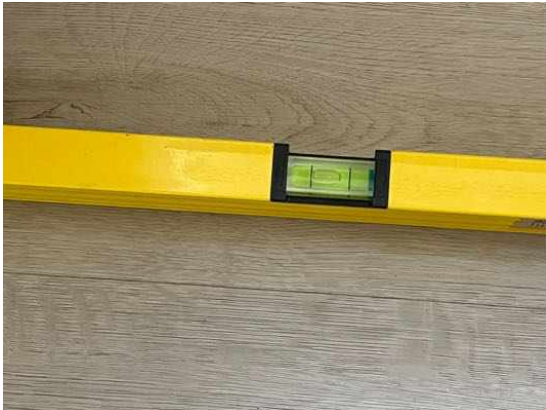
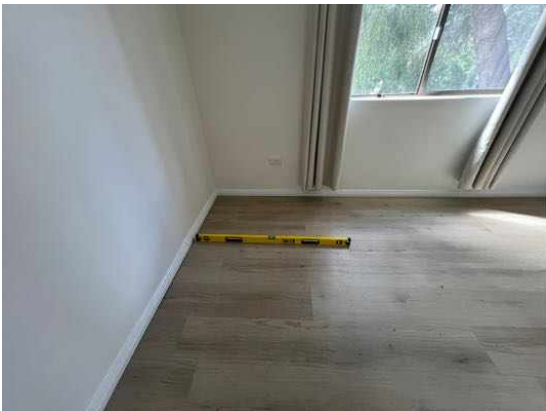
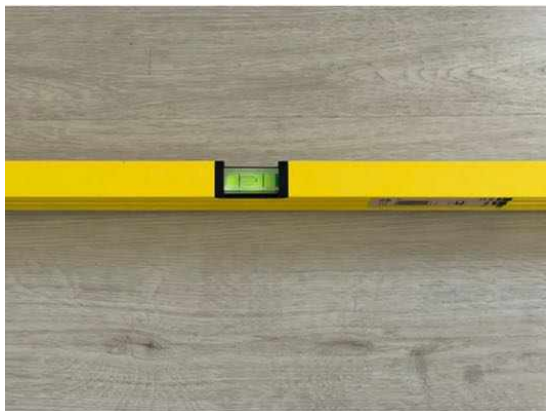
**Finding 3.04**

Building: Main Building  
Location: All Internal Areas  
Finding: Uneven Laminate Floor  
Information: The timber/laminate flooring shows cracking and separation at the board joints near the wall, consistent with movement, inadequate installation allowances, or possible moisture effects, and requires repair or replacement by a flooring contractor to prevent further deterioration and potential trip hazards.

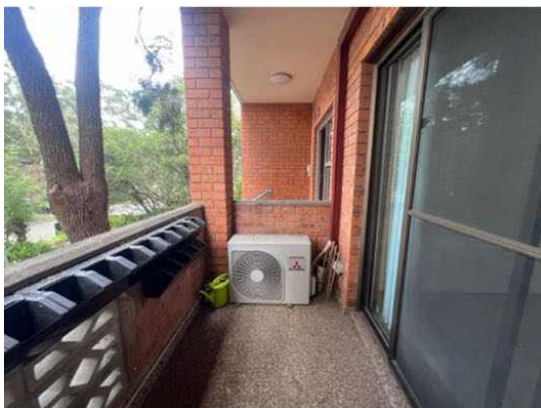
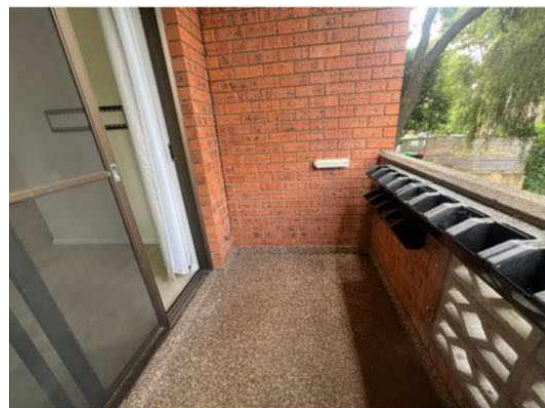
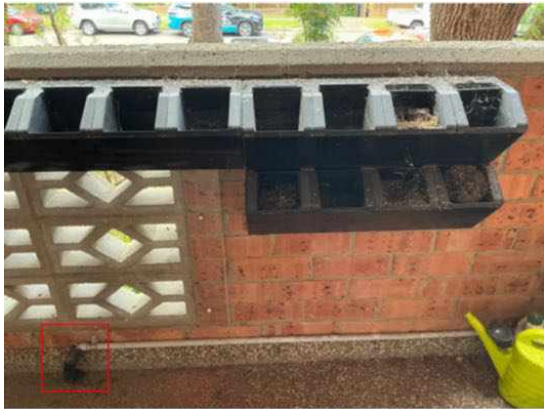
### Finding 3.06

Building: Main Building  
 Location: Balcony  
 Finding: Balcony Drainage  
 Information: A drainage hole (void) was observed directly aligning with an external pipe on the outside of balcony, indicating an overflow, however it appeared to be connected to the aircon overflow. No drain was noted in the balcony. A licensed plumber should be engaged to inspect the outlet detail, seal the internal tiling edges, and confirm ongoing weatherproofing integrity and overall balcony drainage provisions.

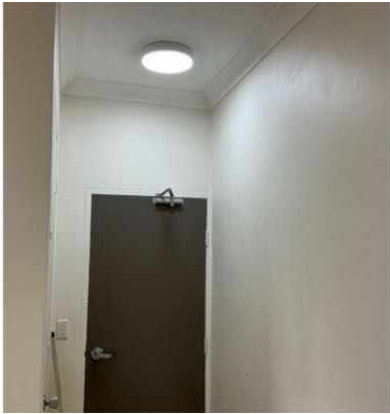
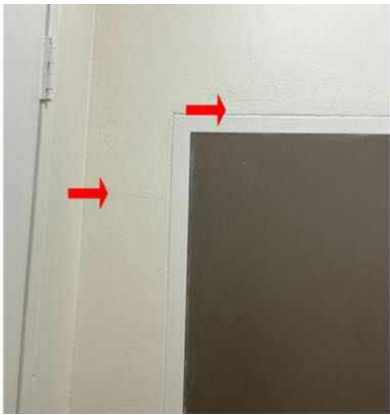
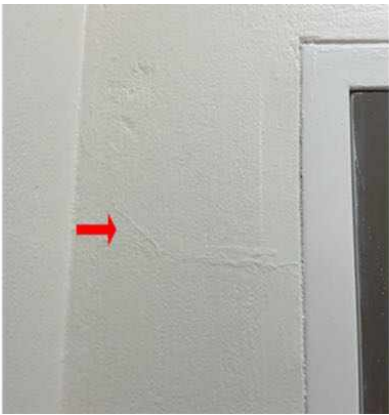
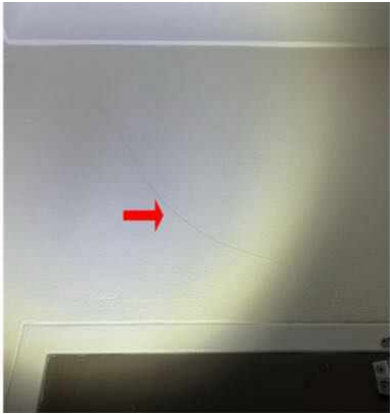
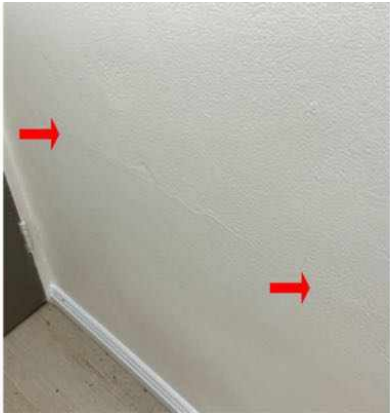
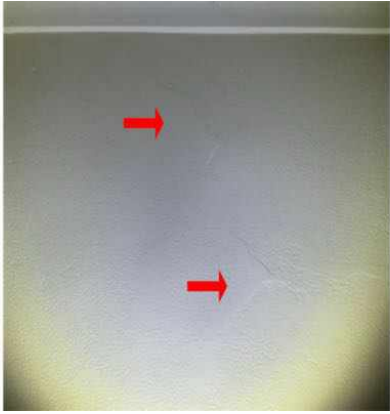
**Finding 3.07**

Building: Main Building  
Location: All Internal Areas  
Finding: Cracks to internal render - Category 1 and past repairs  
Information: It has been observed that cracking to internal rendered surfaces has occurred. The degree of damage falls within Category 1, described as fine cracks that do not need repair and which are less than 1.0mm in width limit.

Evidence of previous repairs was also identified extent of which cannot be determined in visual non-invasive inspection

. Always contact your building inspector should cracks widen, lengthen, or become more numerous.

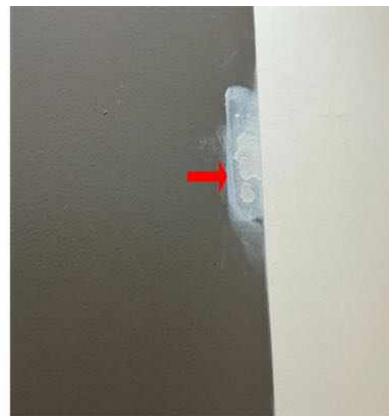
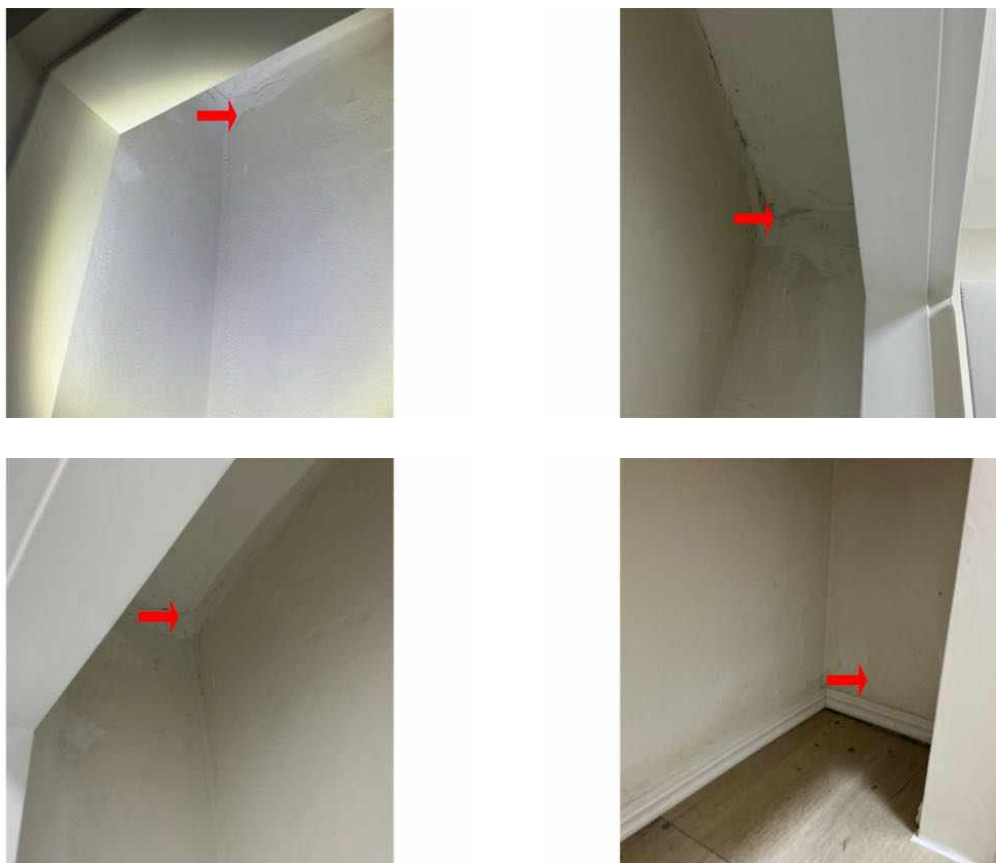
Building:	Main Building
Location:	All Internal Areas
Finding:	Paint finish and hairline cracking to some areas
Information:	The paint finish in this area was identified as being incomplete at the time of inspection

including some hairline minor cracking.

Whilst incomplete or missing paint and minor cracking and imperfections in finish is generally an appearance defect, it can also lead to the development of secondary building defects over time. Incomplete areas of paint finish expose the area to moisture, potentially accelerating the deterioration of underlying building materials.

Incomplete paint finishes should be sanded back, filled, leveled and painted, as applicable. Where inadequate or missing paint protection has led to the deterioration of the associated building element, repair and/or replacement of this building element may be required.

A painting contractor should be appointed as soon as possible to perform necessary works to aid the appearance of the affected area and to ensure the area is protected against further deterioration. Alternatively, the homeowner following manufacturer instructions may perform these works.

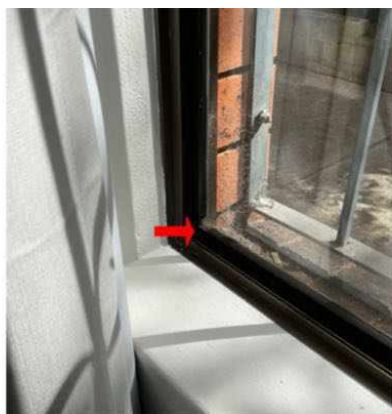
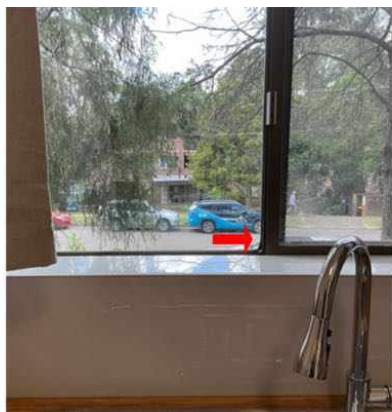
Building: Main Building  
Location: Bedrooms, Kitchen  
Finding: Building element - Damaged - window seal damaged  
Information: Breakage occurs generally when the building materials have either aged and decayed, or as a result of damage (accidental or deliberate).

Repair and/or replacement of broken elements is advised to ensure that additional secondary defects do not arise as a consequence. Such works are necessary, as all building elements play a key role in the operation and function of the overall structure and its performance.

A relevant tradesperson should be appointed to repair or replace the affected building element prior to any subsequent damage being caused.

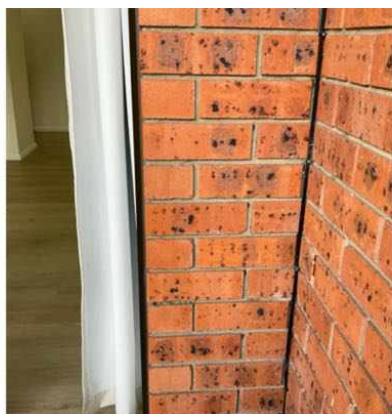
### Finding 3.14

Building:	Main Building
Location:	Balcony
Finding:	Brickwork - Deteriorated mortar
Information:	Mortar, or 'bedding', is the material which fills joints and intersections between bricks in masonry walls and structures. Sections of mortar in this brickwork were identified as having deteriorated, which is generally expected for a property of this age and condition.

Mortar may deteriorate as a result of age of building materials, minor movement of bricks, or frequent exposure to weathering. Mortar should be replaced to ensure that bricks remain in their intended location and to prevent gaps, which would allow water or moisture ingress and secondary damage as a result.

Mortar deterioration can be addressed by a bricklayer where areas of deterioration are localised and easily accessible. Alternatively, appointment of a registered builder is advised, to repoint large areas of decaying mortar. Where secondary structural defects have become evident, consultation with a structural engineer may be required.

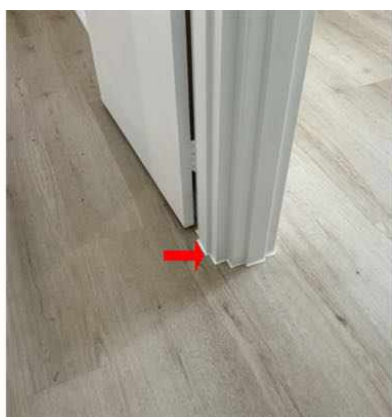
### Finding 3.15

Building:	Main Building
Location:	All External Areas
Finding:	Installation - substandard or incomplete - Excessive silicone use and workmanship
Information:	The installation of this building element appears to have been completed to a substandard level of workmanship or is incomplete. Generally substandard repairs or installation are related to poor workmanship, the use of inappropriate materials, or a failure to complete installation to a suitable standard.

Where installation is substandard and/or incomplete, the client should contact the responsible trade to undertake rectification. Unfinished and substandard building works are likely to degrade more quickly and may create potential for secondary defects to associated building elements.

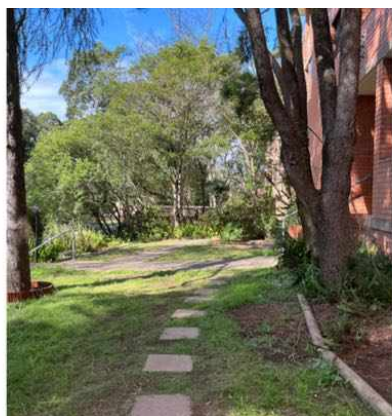
### Finding 6.01

Building:	Main Building
Location:	All External Areas
Finding:	Trees within 50m
Information:	Trees within 50m of the property can be conducive to termite activity. It is recommended an invasive inspection of all trees with 50m to the property be carried out by a qualified pest control expert.

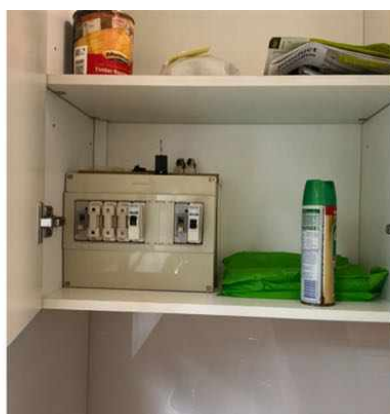
Building: Main Building  
 Location: Kitchen  
 Finding: Electrical switchboard - Old ceramic fuses  
 Information: The electrical switchboard while appearing to have adequate safety switches installed has old ceramic fuses in place.

While this on its own on is not considered a defect it is noted for the clients consideration that a switchboard upgrade may be required in the short to mid term to improve the functionality of the electrical system. A licensed electrician could be appointed to provide quotation for the works at the client's discretion which may in turn expose other required works to bring the system up to a compliant state.
