Building and Timber Pest Inspection Report

Inspection Date: Tue, 3 Mar 2026

Property Address: 2A Bellevue St, Coburg VIC 3058, Australia

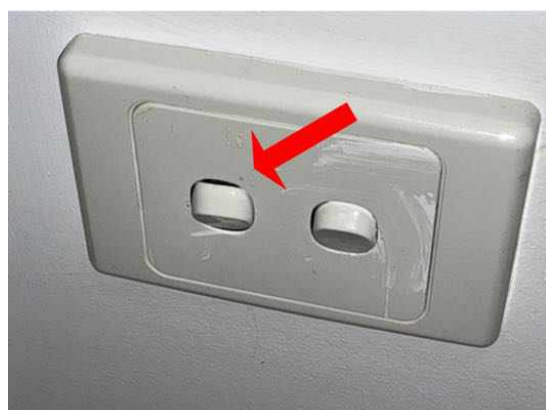
| Finding: | Electrical fitting - Broken |
| Information: | The electrical fitting in the WC was found to be broken at the time of inspection. Breakage occurs generally when the building materials have aged and decayed, but may also be indicative of impact damage to the building element (accidental or deliberate). |

Left unmanaged, the fitting is unlikely to cause further damage to surrounding building elements. However, the broken fitting does expose electrical works, and may create a safety hazard if there is potential contact with persons in the area.

Repair and/or replacement of the broken fitting is advised. A Licensed electrician should be appointed to repair/replace the fitting immediately.

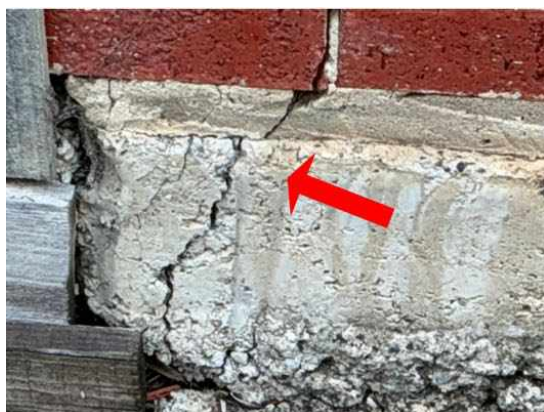
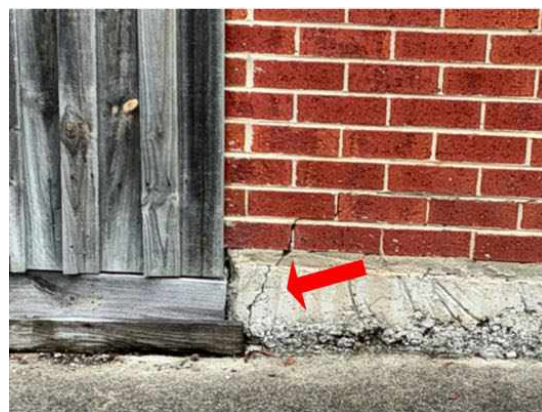
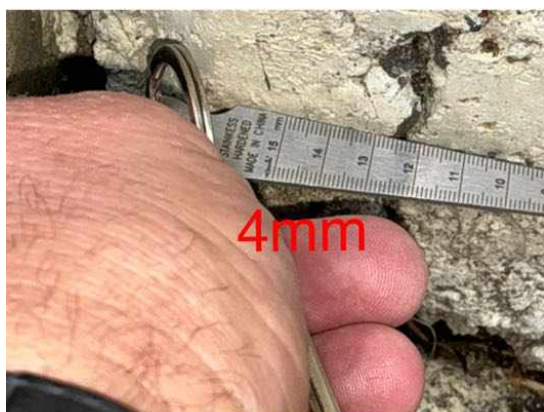
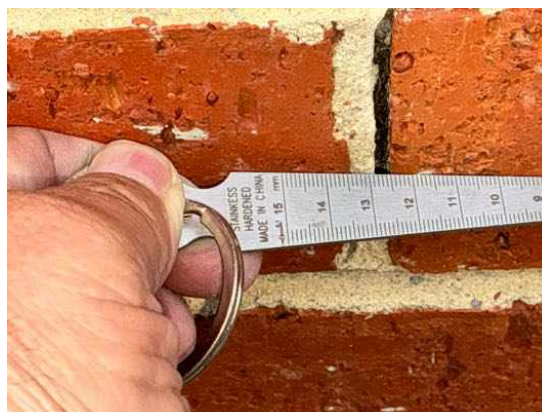
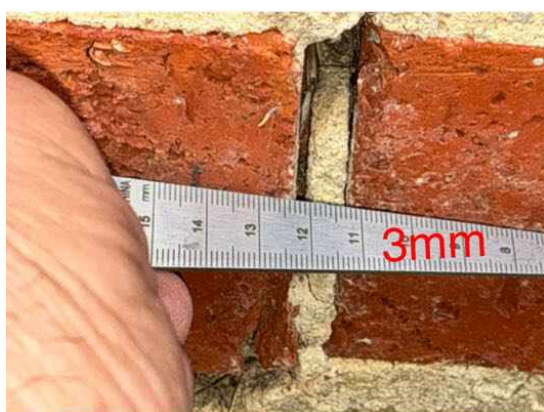
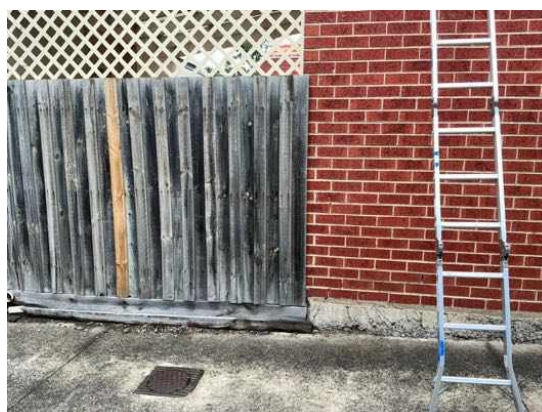
| Finding: | Cracking - Damage Category 3 - Repair Required (5mm-15mm or a grouping or cluster of cracks of 3mm or more) |
| Information: | Cracks of this type are likely to have been caused by minor, expected movement of building elements, but may also have a structural cause that is more significant. Cracking of this degree may result in doors and windows sticking or jamming, but may have more serious implications, such as fracturing service pipes. Weather tightness (the ability to resist rain and wind) is also often impaired, creating potential for the development of secondary defects. |

A crack of this size may be repaired. However, these repairs may also include further works, such as easement of associated window and door frames that are jamming, as well as more extensive filling, sanding and/or repainting.

It is highly recommended to gain quotations on repair and restoration works that are required. Always contact your building inspector should cracks widen, lengthen or become more numerous.

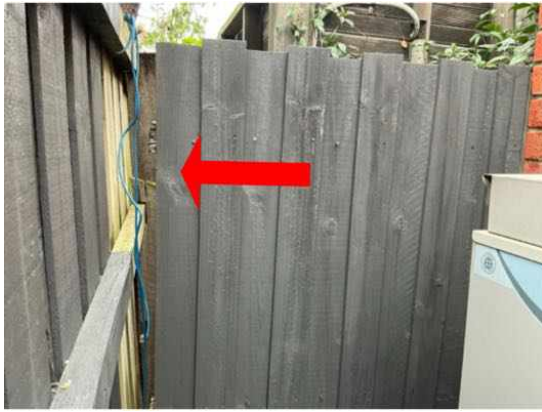
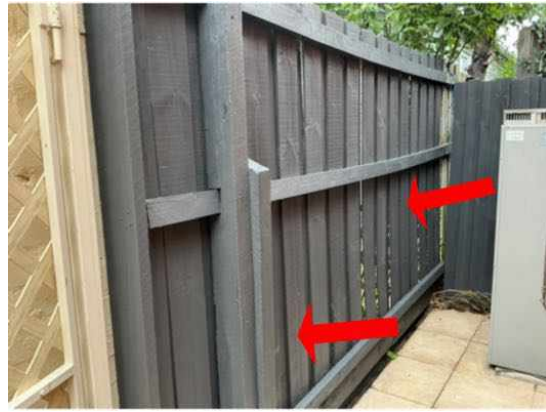
Finding 3.01

Building: Main Building
 Location: All External Areas
 Finding: Fencing - Deteriorated
 Information: It was noted at the time of inspection that sections of the fencing throughout the property have deteriorated. Typically fencing deteriorates due to age and or wear, rot and or rust which is generally expected for a structure of this age, due to prolonged exposure to weather conditions. Sometimes inadequate installation or maintenance can be to blame.

If left unattended, it is likely that further damage will occur. It is suspected that repair of several elements of the fencing may be required however replacement may be a consideration of the client also.

A licensed fencing contractor should be appointed to provide further advice and perform rectification works as necessary.

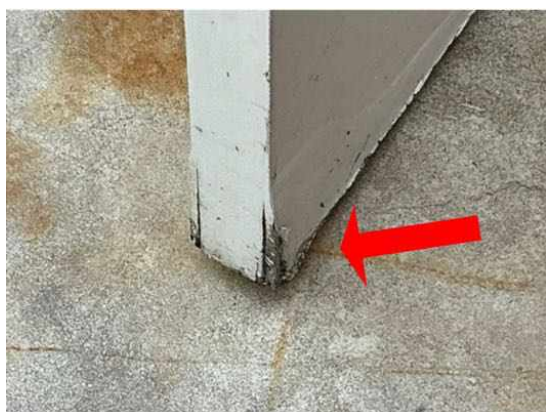
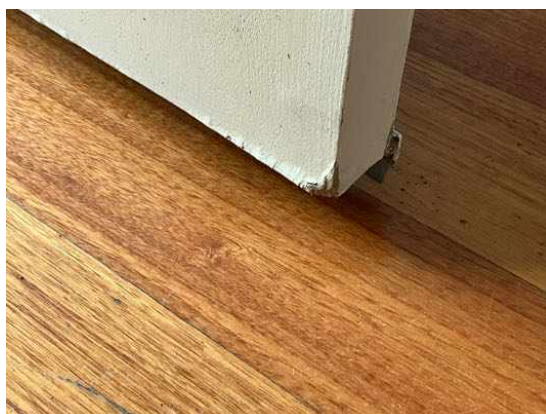
Building: Main Building
 Location: Garage
 Finding: External door/weather deteriorated
 Information: It was noted that the external door to the garage and front entry have sustained some moisture damage and has prematurely deteriorated the door.

Unattended to the door could further deteriorate and reduce the security and operation of the door.

A qualified carpenter and painter should be engaged to review at the clients discretion

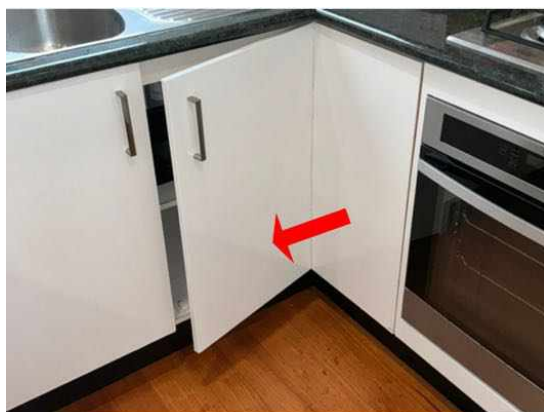
Information: It was observed that many cabinet doors to the kitchen require adjustment as they appear to be binding

Unattended to the doors will continue to jam and operate ineffectively, which in time could cause further damage to the doors

A qualified carpenter should be engaged to review at the owners discretion

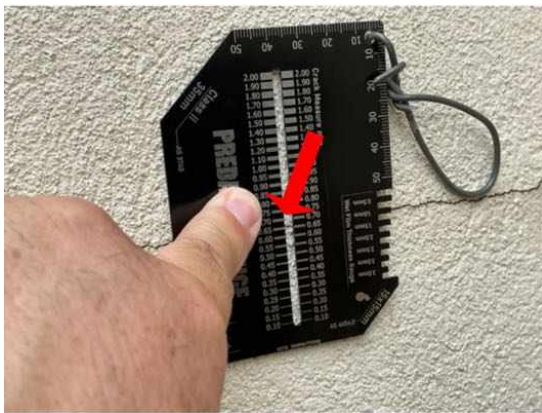
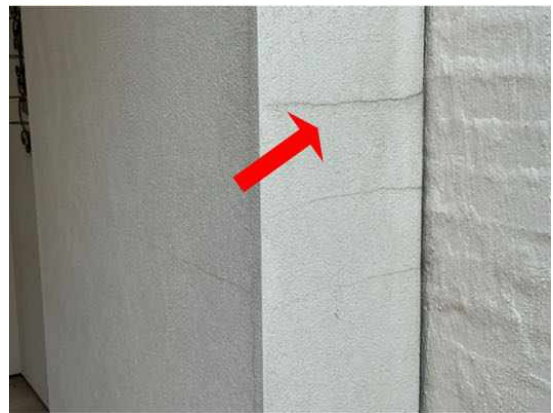
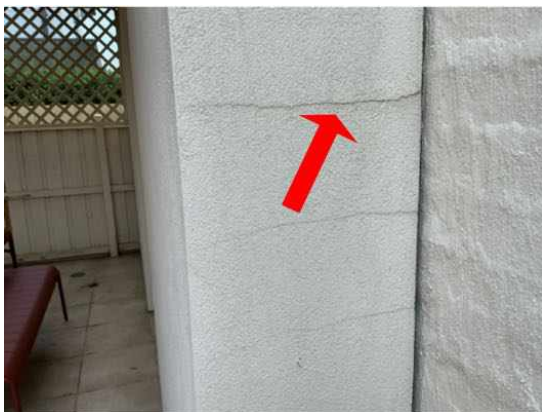
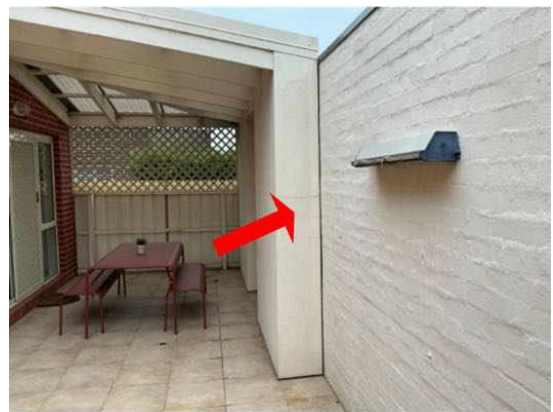
Finding: Cracks to internal render - Category 1

Information: It has been observed that cracking to internal rendered surfaces has occurred. The degree of damage falls within Category 1, described as fine cracks that do not need repair and which are less than 1.0mm in width limit.

Damage of this category is not considered a defect for rectification. Always contact your building inspector should cracks widen, lengthen, or become more numerous.

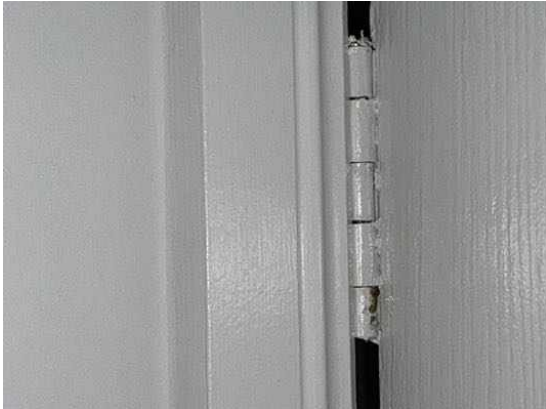
Building: Main Building
 Location: All Internal Areas
 Finding: Poor quality painting work
 Information: It was observed at the time of the inspection that the building has recently been repainted. The overall paintwork is demonstrating poor workmanship and appears to be incomplete.

Although anaesthetic defect it detracts from the overall appearance of the building and demonstrates poor quality workmanship

The owners should engage a professional painting contractor to review at their discretion

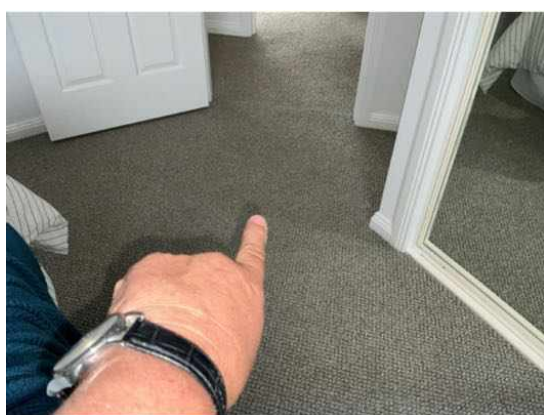
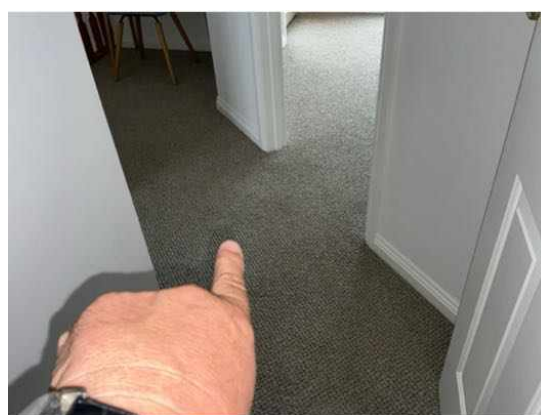
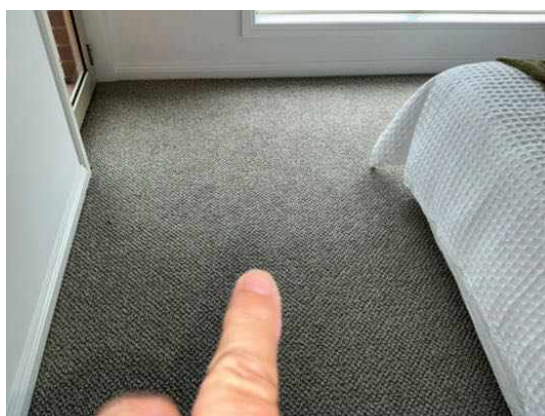
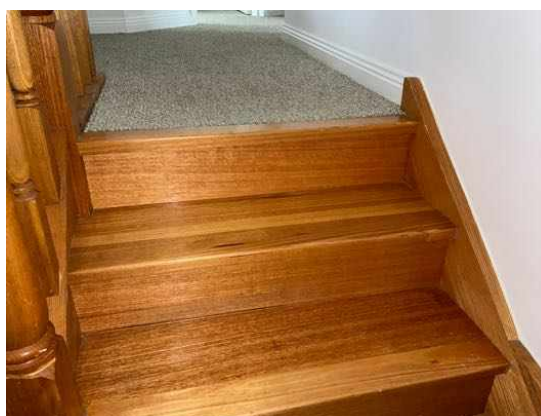
| Information: | It was observed that the timber floors throughout the building are creaking and noisy when walked upon. |

Squeaking floors are generally an aesthetic defect which reduces the amenity of the building.

A general handyman or carpenter should be engaged to review at the owners discretion

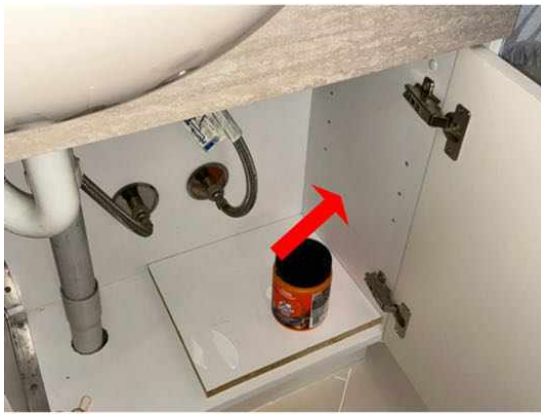
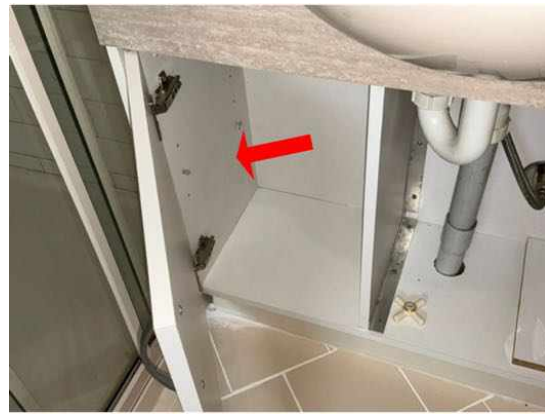
Finding 3.15

| Finding: | Cabinet shelf missing |
| Information: | It was noted that the cabinet shelf was missing in the bathroom vanity. |

The shelf's adds extra storage to the cabinet and keeps the contents tidy and out of sight.

A cabinet maker should review at the owners discretion.

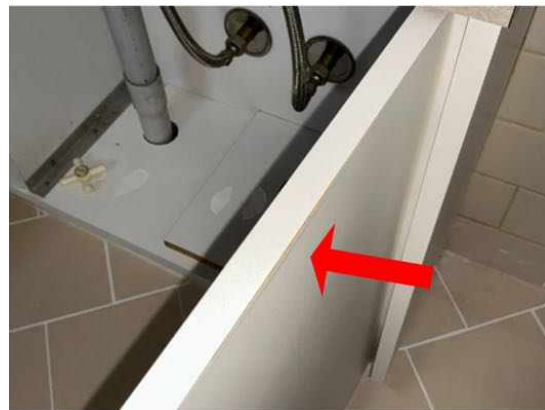
Finding 3.16

Building: Main Building
 Location: Bathroom
 Finding: Cabinet edge tape
 Information: It was observed that the tape to the bathroom cabinet has sustained some previous water damage

Edge tape is required to prevent the ingress of moisture to the substrate of the cabinet carcass preventing swelling and premature deterioration of the cabinet structure

A qualified cabinet maker should be engaged to review at the clients discretion

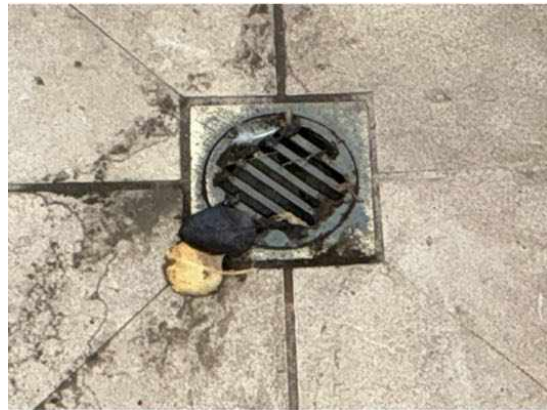
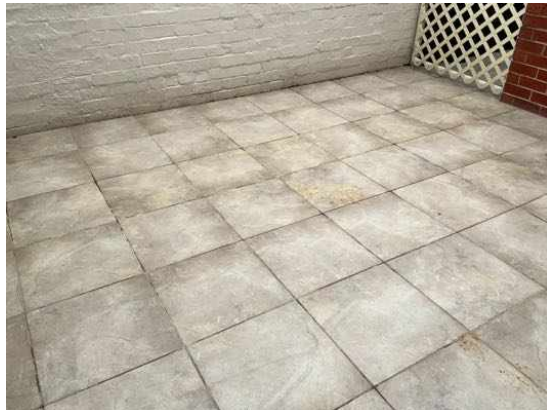
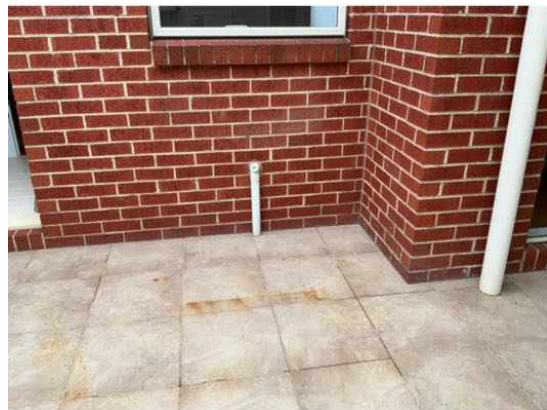
Finding 3.17

Building: Main Building
 Location: Yard - Back
 Finding: Site drainage - Inadequate
 Information: The site drainage in patio area was found to be inadequate at the time of inspection, creating potential for subsequent water damage to associated building elements.

It is important that water does not lie against the base of walls; surrounding paths and ground levels should be sloped to drain water away from walls. Downpipes should not discharge stormwater onto lower walls or plinths. Stormwater should be carried away by large, regularly cleaned drains. Ground levels may need to be lowered to expose a buried DPC.

Where site drainage is inadequate, installation of an Agricultural (Aggie) Drain may be required. A qualified plumber should be appointed to further inspect the property and perform any remedial works as necessary. Water damage and secondary defects are likely to occur if left unmanaged.

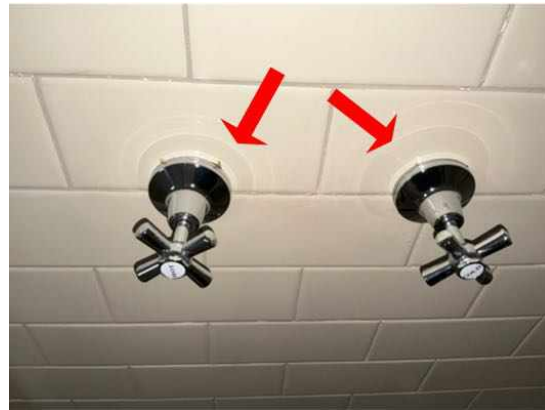
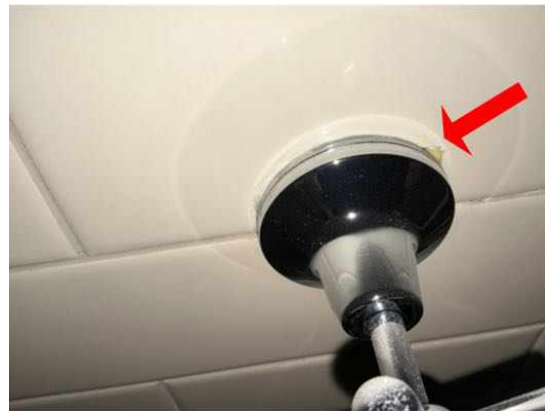
Finding 3.18

Building: Main Building
 Location: Bathroom
 Finding: Tiles cut short of tap flange
 Information: It was noted at the time of the inspection that the tiles in the bathroom shower closet were cut short and were exposed at the tap flanges. It appeared that the overcuts had been sealed at the time of the inspection and leaking from these exposed tile cuts is not suspected

This is an aesthetic defect and a demonstration of poor workmanship.

A Qualified ceramic tiler should be engaged to review at the owners discretion.

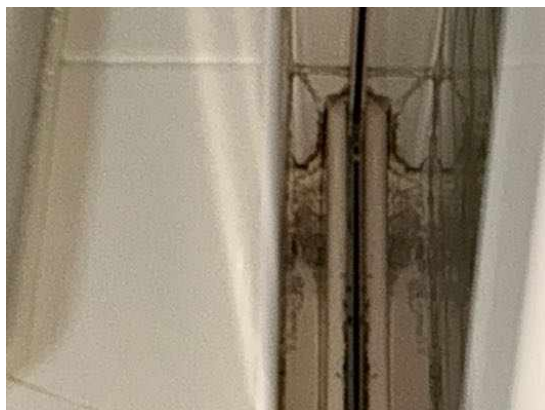
Finding 3.19

Building: Main Building
 Location: Bathroom
 Finding: Minor mould
 Information: It was observed that a small amount of mould was present in the sealant at the bottom of the spa bath. This is minor in nature and requires a through clean prior to use of the shower. It is noted that this area would be very difficult to clean due to accessibility between the shower screen and the spa bath.

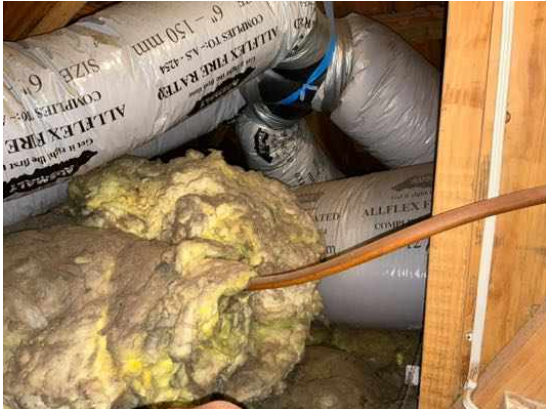
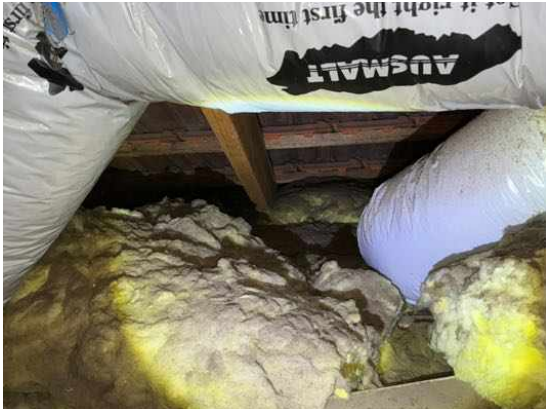
Finding 3.20

| Finding: | Insulation - Missing-disturbed |
| Information: | Upon inspection of the roof void it was noted that insulation is not present or disturbed. |

Insufficient insulation will result in a comparatively higher cost to heat and cool a property as there is a lack of Insulation (or uneven coverage of insulation) which works as a barrier to heat transfer. This helps to keep out unwanted heat in summer and preserves warmth inside your home in winter. It can also help soundproof your home from unwanted airborne noise transfer.

Where insulation is absent, the area does not meet current Australian Standards. Installation of adequate insulation is required and should be conducted as soon as possible.

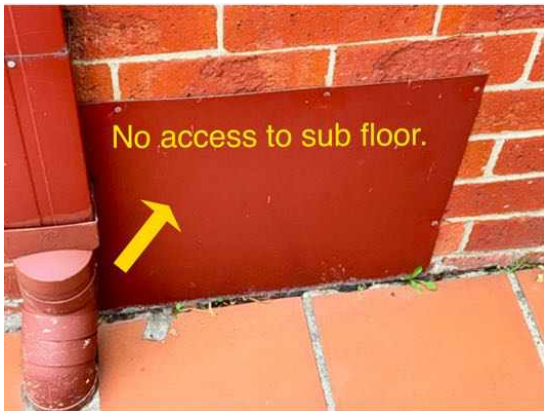
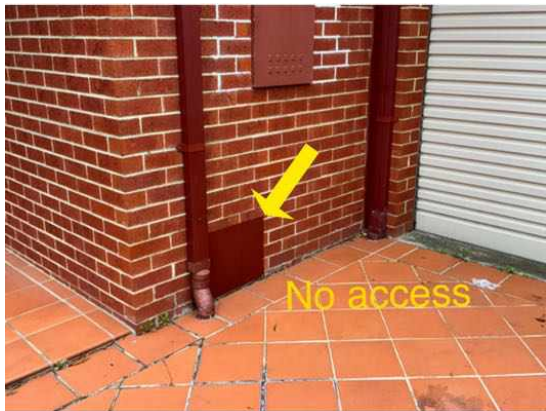
Finding 3.21

Building: Main Building
 Location: Subfloor
 Finding: No access to subfloor area
 Information: It was observed at the time of the inspection that there was no access to the subfloor. The subfloor access doorway was fastened closed with a metal plate. It is strongly advised that a further invasive inspection be undertaken on the panel is removed.

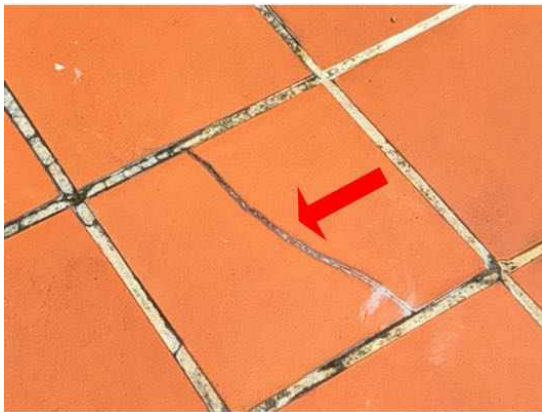
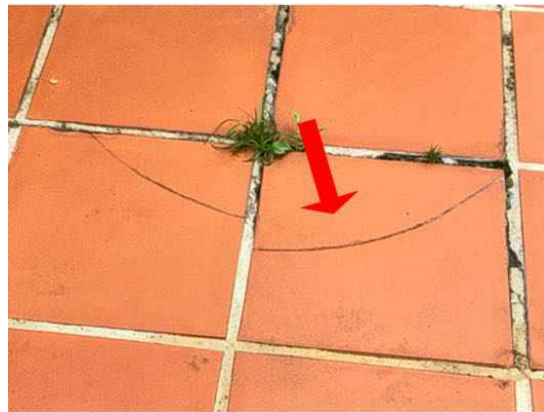
Finding 3.22

Building: Main Building
 Location: Driveway
 Finding: Cracked floor tiles- driveway
 Information: Cracking in the floor tiles was evident in the driveway at the time of inspection. It is suspected that this cracking has occurred as a result of minor settlement or shrinkage of the slab.

Cracked tiles throughout detract from the overall appearance of the affected areas however it is unlikely to create or lead to any secondary defects.

While not considered a matter of urgency, replacement of cracked floor tiles is recommended at the clients discretion. A tiling contractor may be appointed to perform these works. Where cracks become more numerous, contact a licensed building inspector for further investigation.

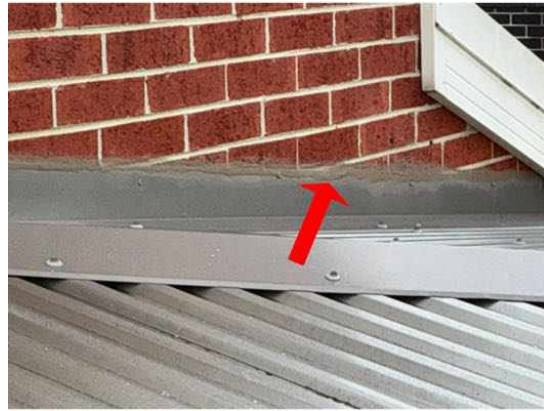
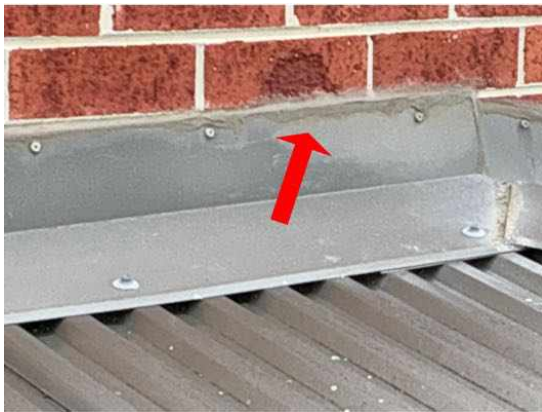
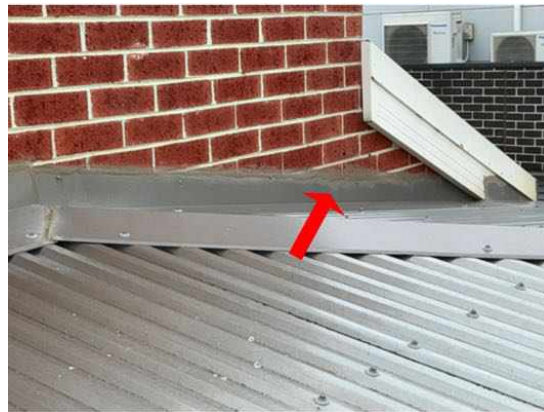
| Information: | It was noted at the time of the inspection that the roof flashings to the pergola where it about the house were inadequate and appeared to be poor handyman quality workmanship. The owners should confirm the presence of a building permit for this pergola structure. |

The over flashing or pressure flashing was missing and the fixings were suspected to be non-compliant

A registered roof plumber should be engaged to review at the owners discretion

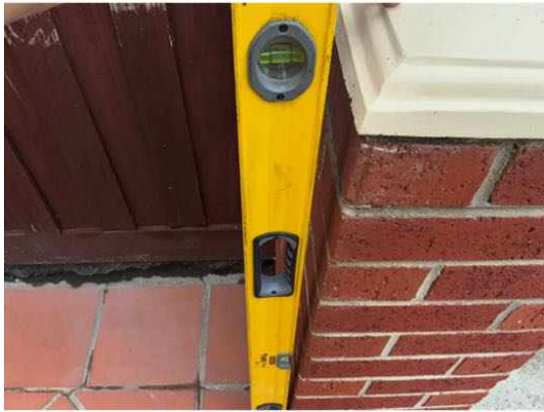
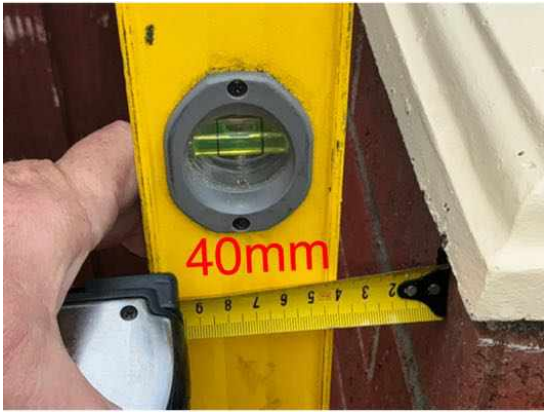
Finding 3.26

Information: It appears that the brick front fence pillar has been affected by movement of the foundations, often referred to as sinking or subsidence. Whilst a degree of movement is expected in brick pillars over time, especially as environmental conditions change and buildings 'settle' after construction, this degree of movement requires attention.

General subsidence is usually initiated by changes in soil moisture content. The most critical factor is identifying the specific causes, and identifying if this is a recurring or ongoing problem, or one that has been resolved by previous works in the past.

Subsidence can have complex and varying causes, which will influence the required remedial works.

A Registered Builder should be engaged to review as soon as possible

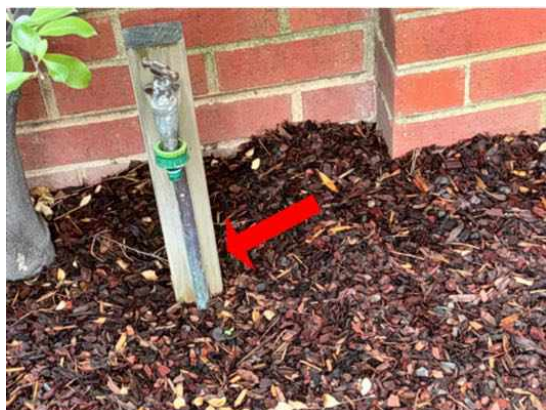
rot and/or fungal decay if left unattended creating attraction for subterranean termites to infest the timbers from surrounding areas.

If untreated or non-durable timbers are found to be in a hazardous environment it is highly advised that replacement of these building elements be performed as soon as possible to aid the protection of the property against termite / timber pest attack.

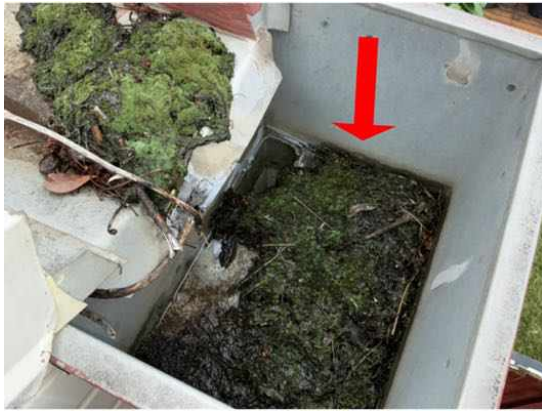
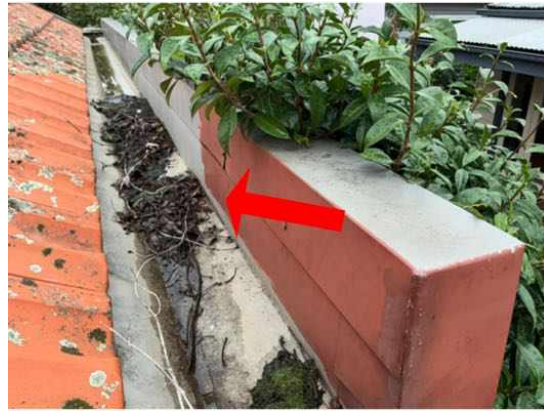
Blocked gutters are likely to lead to high levels of moisture in the affected areas. Such moisture will not only cause rust and decay of the associated building materials, but can also provide conditions that are conducive to termite and timber pest activity. Blockages in gutters should therefore be removed immediately to ensure dry conditions are maintained.

Consult a Licensed Plumber for further specific advice on remedial works that may be required. In the interim, it is highly advised that blocked gutters be removed by the homeowner or a general handyperson as a matter of urgency.

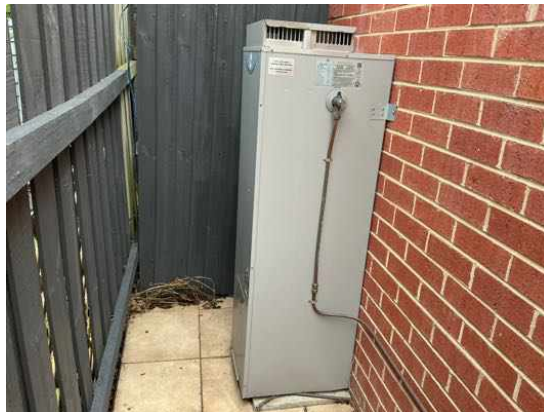
Finding 6.08

Such leaking creates an environment which is conducive to an array of defects including water damage to associated building materials and the attraction of termites or timber pest infestation.

A Licensed plumber should be engaged to review as soon as possible

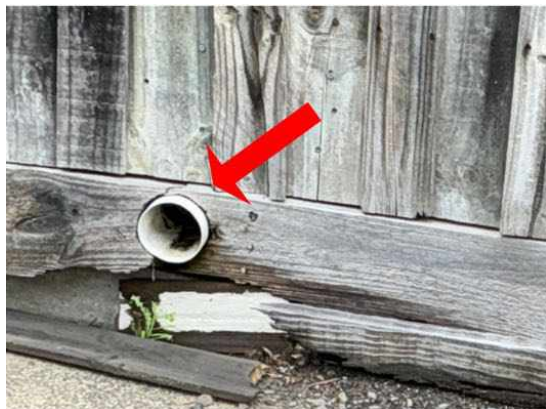
Finding 6.09

Non connected downpipes can cause moisture to enter the building, mould, flooding, foundation soil movement and be conducive to termite infestation

A registered drainage plumber should be engaged to review at the owners discretion.

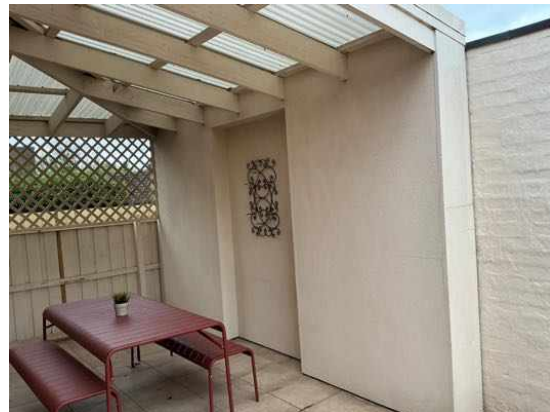
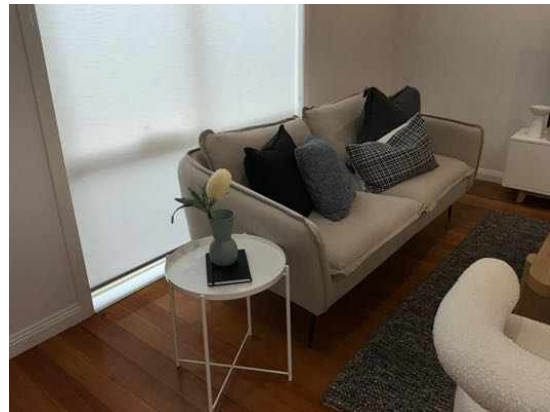
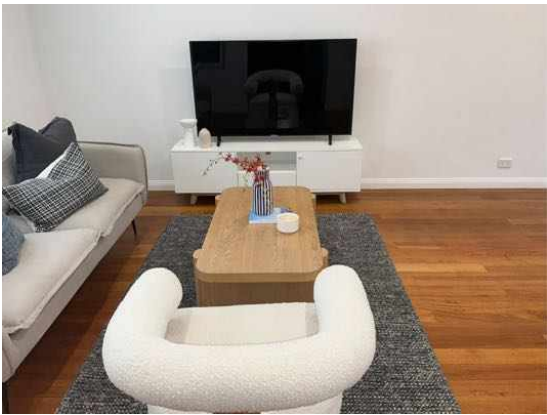
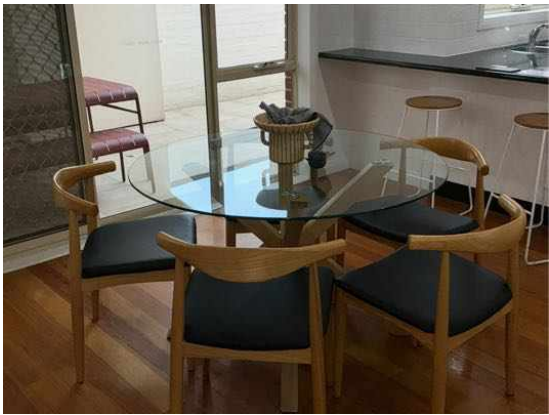
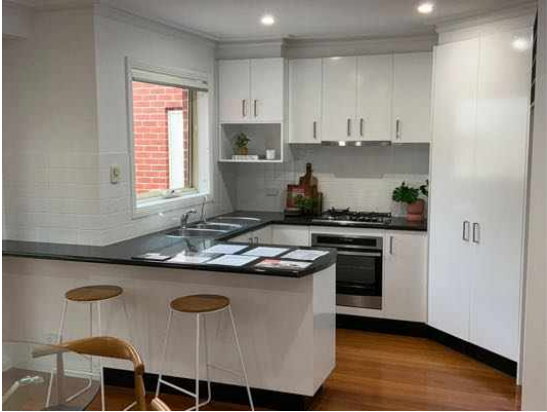
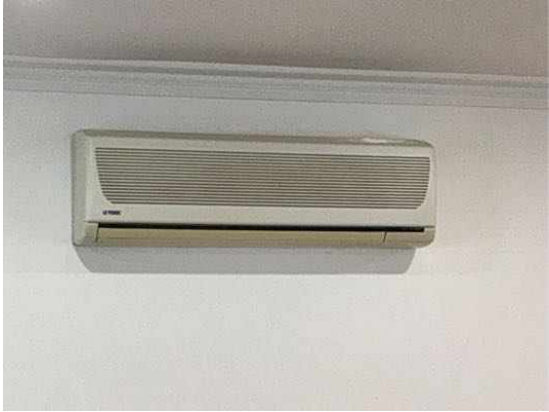
Noted Item

Building: Main Building
Location: All Areas
Finding: Additional Photos - Obstructions and Limitations
Information: These photographs are an indication of the obstructions and limitations which impeded full inspection of the property at the time of inspection. These obstructions can hide an array of defects and should be removed to allow full inspection to be carried out. A re-inspection is recommended once the areas are made accessible.
