# Building and Timber Pest Inspection Report

Inspection Date: Thu, 12 Mar 2026

Property Address: 25 Stanley St, Blacktown NSW 2148,  
Australia

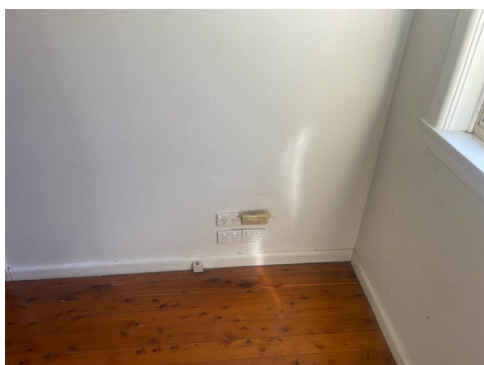
#### Finding 1.02

Finding: Electrical Socket – Broken and Unsafe Condition

Information: An electrical socket was observed to be broken at the time of inspection. The cover plate and protective components were damaged, leaving the socket in a compromised condition.

Broken electrical fittings can expose live wiring or conductive parts, presenting a potential electric shock hazard to occupants. This is considered a serious safety issue that requires urgent attention.

It is strongly recommended that a licensed electrician be engaged as soon as possible to repair or replace the damaged socket to restore safe and compliant operation.

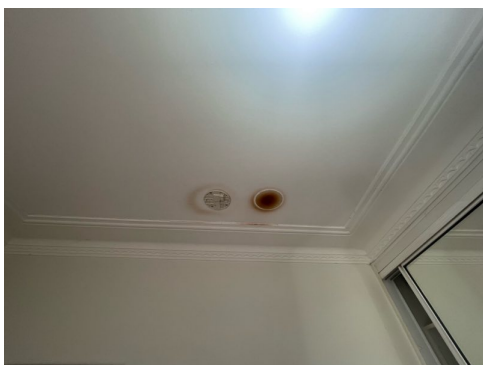
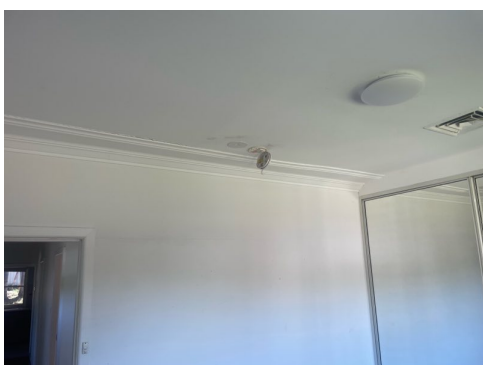
### Finding 1.03

Information: At the time of inspection, a fire alarm system was not installed and/or was not operational within the dwelling. The absence or non-functioning of a fire alarm system presents a significant safety hazard, as it may delay the early detection of fire and reduce the available warning time for occupants to safely evacuate the premises.

Fire alarm systems are a critical life-safety measure intended to provide early warning in the event of fire, particularly during sleeping hours. Without a functional system, occupants may be exposed to an increased risk of injury or loss of life due to smoke inhalation or fire spread.

This matter is considered a safety issue and requires prompt attention. It is recommended that the installation and/or rectification of the fire alarm system be carried out by a suitably qualified and licensed contractor to ensure the system is provided and operating in accordance with the applicable regulatory requirements at the time of installation.

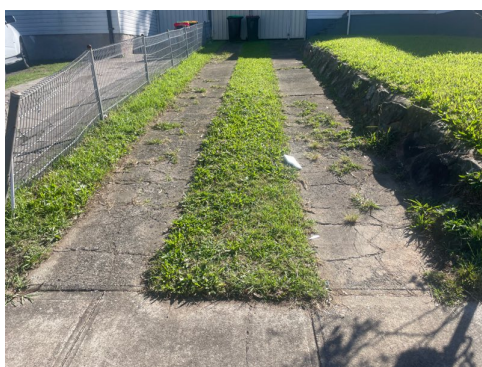
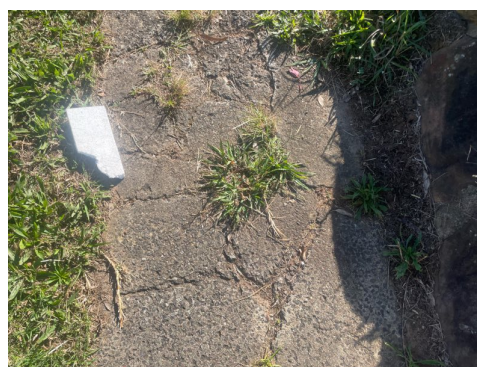
### Finding 2.01

Finding: Cracking - External Concrete Paving Damage Category 3 - Wide Cracks (2mm - 4mm)

Information: Wide cracks were identified in external concrete paving. Wide cracks are significant and are likely to lead to the development of safety hazards and secondary defects if left unmanaged.

General age and expected deterioration of the paved areas is a common cause of this type of cracking. However, expansion and contraction of the slab may also have occurred due to environmental factors.

Such factors include variable moisture and weather conditions, the presence of trees and their roots having a settling or lifting affect on the soil, or the effect of load bearing, e.g. heavy vehicles over a sustained period of time.

Cracking to this degree may also be due to poor original installation of the concrete. Factors such as poor compaction of the sub surface and/or inadequate reinforcing of the slab may create cracking and other secondary defects.

Wide cracks may also have a more significant structural cause, such as subsidence of soils.

Where the crack is located adjacent to structural elements of the building, the advice of a Structural Engineer is advisable before undertaking repairs. Significant repair and likely replacement of the concrete paving is probable.

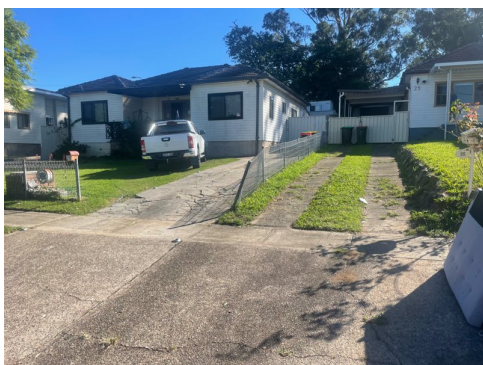
## Finding 2.02

Finding: Perimeter Fence – Impact Damage

Information: During inspection, the perimeter fence, constructed from a steel frame with corrugated steel infill panels, was noted to have sustained damage due to an impact load. The affected section shows distortion and misalignment, with visible bending that reduces both its presentation and structural integrity.

The damaged area appears consistent with force applied directly to the panels and frame.

This has resulted in an uneven surface and compromised finish, detracting from the overall appearance of the boundary structure.

This defect was identified along the perimeter fence during the inspection. It is recommended that a competent contractor be engaged to assess the extent of the damage and carry out necessary repairs or replacement to restore the fence to a serviceable and presentable condition.

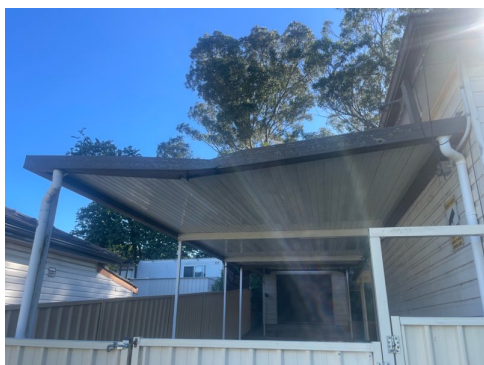
### Finding 2.03

Finding: Roof gutter – Damage observed

Information: At the time of inspection sections of the roof guttering were found to be damaged. The gutter is dented and misshaped in areas and may be pulling away from the fascia in places. This type of damage can change the way water flows and prevents the gutter from working as designed during rainfall.

Damaged gutters can cause water to overflow and discharge down external walls or over the edges of the roof.

Over time this can lead to staining and decay of fascia and eaves linings and may contribute to moisture issues around the base of the building including possible dampness in walls or slab movement. Overflowing water can also create slip hazards on paths and entry areas.

Further assessment and repair of the affected guttering by a licensed roof plumber or roofing contractor is recommended.

Works may include straightening, re-fixing or replacing damaged sections so that water is collected and discharged correctly to the downpipes and stormwater system. Repairs should be carried out as a priority before periods of heavy rain.

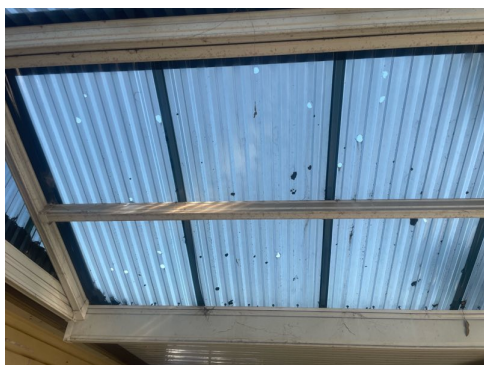
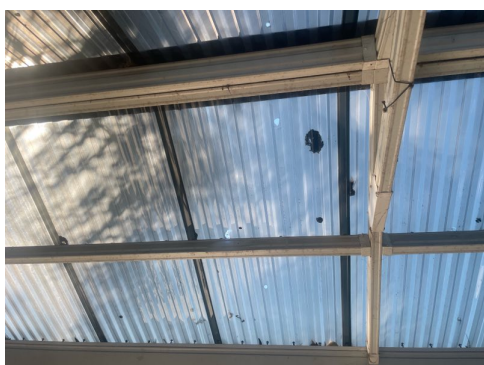
### Finding 2.04

Finding: Corrugated Roof Sheeting – Damaged Clear Sheeting

Information: During inspection of the exterior roof covering, sections of the clear corrugated roof sheeting were found to be cracked and damaged. This material is typically used for skylight or patio roofing and is often made of polycarbonate or fibreglass, both of which can become brittle over time due to UV exposure and temperature changes.

The damage allows potential water ingress and reduces the weatherproofing performance of the roof.

In addition, cracks and surface deterioration may compromise the sheet's strength, posing a risk of breakage under load or during maintenance.

It is recommended that the damaged clear sheets be replaced by a qualified roofing or patio contractor. When replacing, a UV-stabilised polycarbonate or similar high-durability product should be used to ensure long-term resistance to weathering and maintain light transmission.

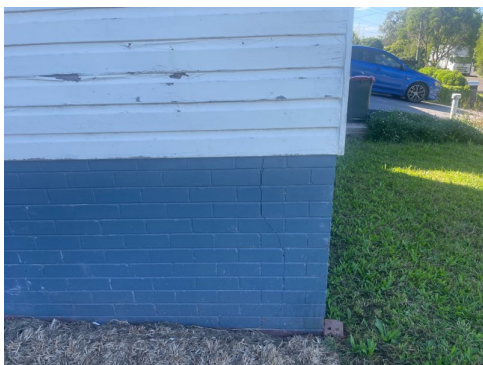
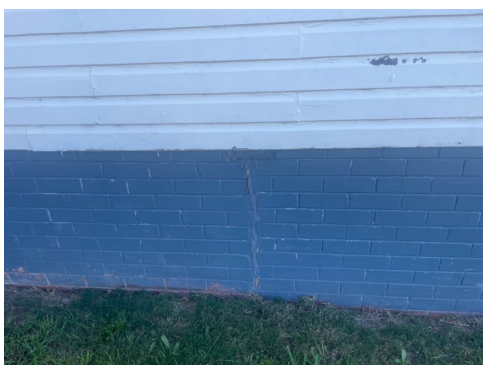
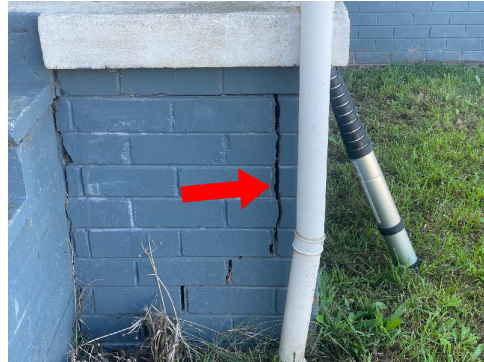
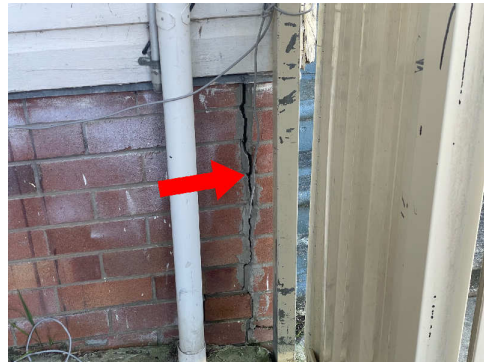
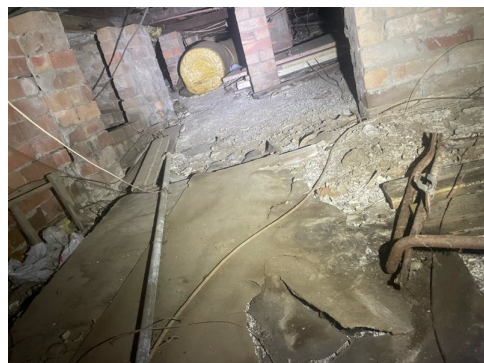
### Finding 2.05

Finding: Brick Pier / External Wall – Leaning Pier and Cracking

Information: A brick pier supporting the dwelling was observed to be leaning at the time of inspection. In the same general area, a noticeable crack was also observed to the external wall associated with the main structure.

This condition is significant because the brick pier appears to have moved out of plumb and may no longer be providing adequate support as intended.

The associated wall cracking is consistent with structural movement, settlement, displacement, or deterioration affecting the supporting elements of the building.

As a result, the defect is considered a major structural concern and may also present a safety risk if movement is ongoing or the support capacity has been reduced. Further movement may lead to additional cracking, distortion, and instability to the affected part of the structure.

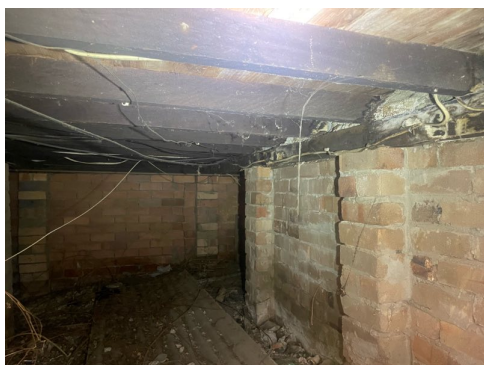
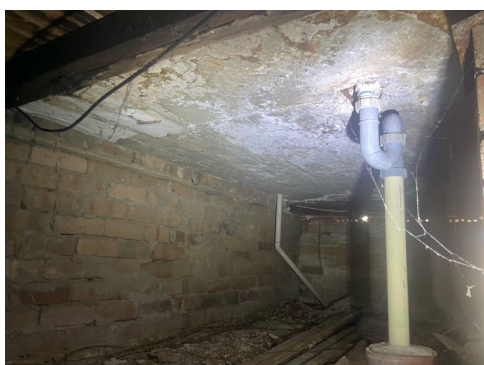
### Finding 2.06

Finding: Subfloor Area Under Bathrooms – Timber Deterioration and Wood Rot

Information: The subfloor structures located beneath the bathrooms are showing signs of deterioration and wood rot (fungal decay) affecting the timbers. It is suspected that this defect has developed as a result of prolonged damp conditions in the subfloor, most likely linked to bathroom wet area use, plumbing leaks, or inadequate ventilation.

Damp conditions cause timbers to lose their strength and capacity to support loads, reducing the ability of the subfloor structures to bear the weight of the building as originally intended.

If left untreated, the deterioration will worsen over time, leading to serious structural faults in the flooring above, along with a range of secondary defects such as uneven floors, cracking finishes, or localised settlement.

The presence of wood rot in this location is also conducive to termite infestation. As timber stumps and bearers may be in direct contact with damp soil, concealed termite entry is possible.

Once timbers become weakened by rot, their natural resistance is reduced, making them far more vulnerable to attack. Rectification or replacement of affected elements is required, and where deterioration is widespread, sections of the subfloor structure may need full replacement. Consultation with a structural engineer or a registered builder specialising in re-stumping and subfloor repairs is strongly recommended without delay.

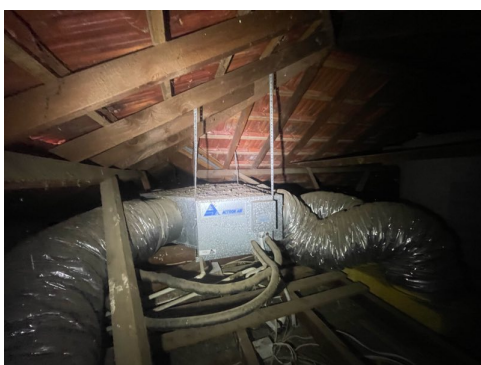
### Finding 2.10

Finding: Sarking - Missing

In addition, insulation that is not properly placed can reduce soundproofing performance.

To achieve consistent coverage and optimum performance, the insulation should be re-fitted correctly throughout the roof void. A licensed contractor can adjust or top up the insulation as required to ensure full coverage and improved energy efficiency.

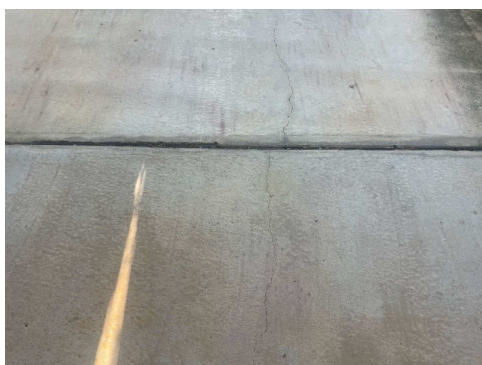
### Finding 3.02

| Finding: | Cracking - Damage Category 2 - Noticeable (up to 5mm) |
| Information: | <p>Noticeable cracks are a common occurrence as a result of many primary defects. Such causes may include age, general wear and tear, expected building movement, general expansion/contraction of building materials in different weather conditions, and/or minor failings in the installation or application of building materials.</p> <p>Noticeable cracks may result in minor sticking or jamming of associated doors and windows, which require easement. However, noticeable cracks are easily filled and repaired. A plasterer can be consulted to install an expansion joint at this point to allow for this movement during different weather conditions.</p> <p>Monitoring of all cracking should be conducted frequently. Always contact a building inspector should cracks widen, lengthen, or become more numerous. Additionally, your building inspector should also be contacted if associated building elements such as doors and windows become more difficult to operate over time.</p> <p>Relevant tradespeople, such as carpenters, painters and plasterers, should be appointed to perform remedial works, as deemed necessary.</p> |

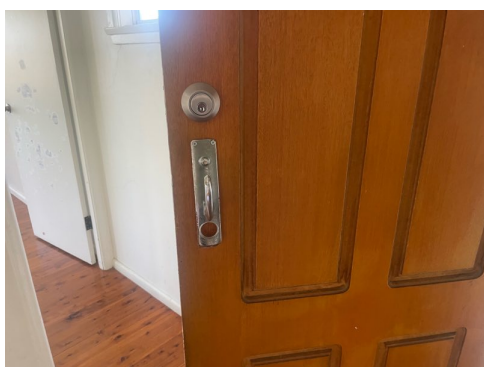
### Finding 3.03

This type of defect often happens due to normal wear and tear poor installation or loose or missing screws over time. A loose or missing handle can affect the correct operation of the door and may reduce security and privacy and in some cases create a minor safety risk if the door cannot be opened or closed easily.

Repair or replacement of the affected door handle by a suitably qualified tradesperson is recommended. Works may include tightening and refixing the existing hardware or installing a new handle set so that the door operates smoothly and the opening can be used and secured as intended.

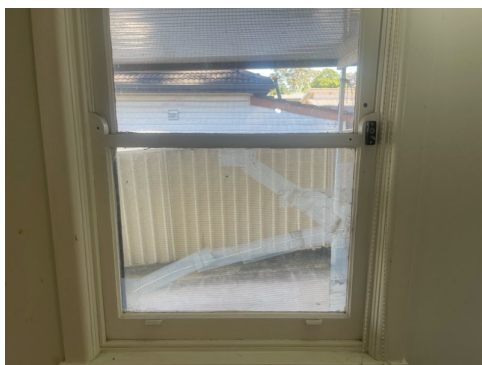
### Finding 3.04

If laminated, the interlayer may continue to hold the glass together even if further cracking occurs, but this does not eliminate the need for rectification.

It is recommended that a qualified glazing professional be engaged to further assess the extent of the damage and advise whether repair (if feasible) or replacement is required to maintain safety and performance standards.

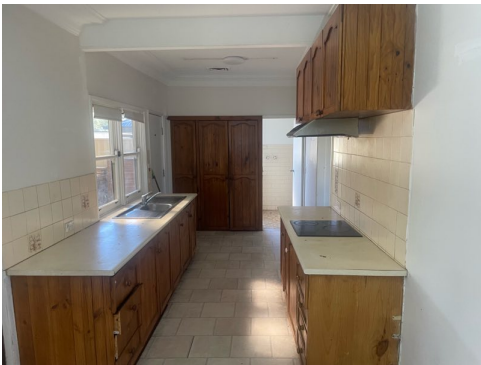
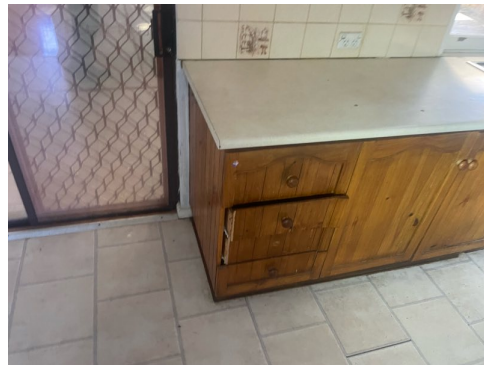
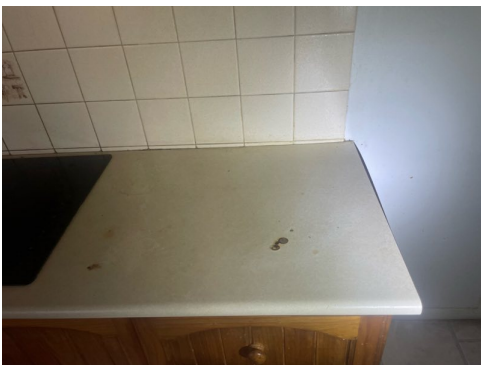
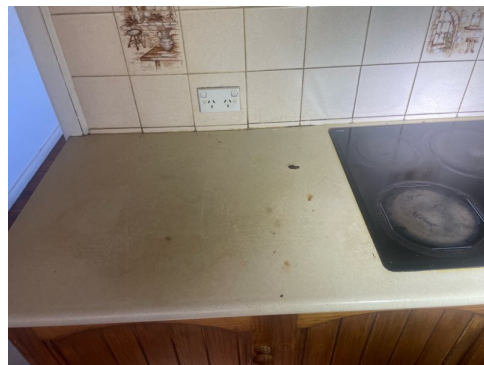
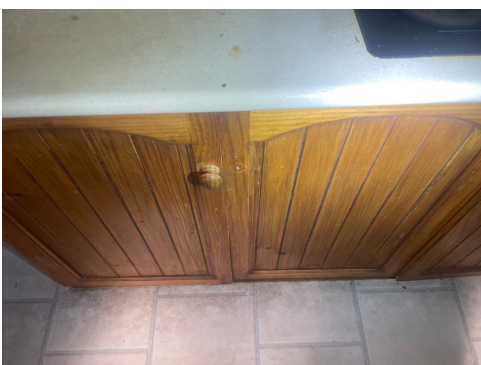
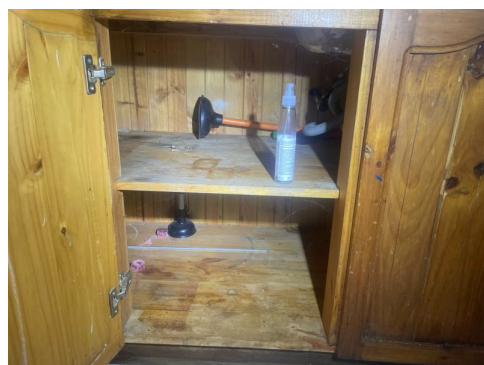
### Finding 3.06

In some areas, the defects also compromise safe and practical use.

It is recommended that the damaged cabinetry be repaired or, where beyond reasonable repair, replaced. A qualified cabinetmaker or relevant tradesperson should be engaged to restore the cabinetry to a safe, functional, and serviceable condition.

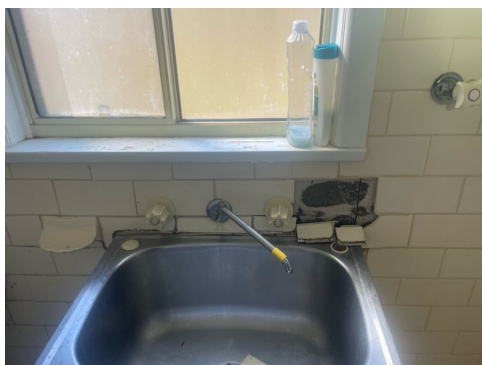
### Finding 3.08

If left unaddressed, water damage can worsen over time, resulting in compromised cabinetry, mould contamination, odours, and potential structural damage to surrounding elements. This also increases the risk of health concerns and additional repair costs.

It is recommended that a licensed plumber investigate the source of the leak and rectify any defective pipework, taps, or seals. Following remediation, the vanity unit and any affected finishes should be repaired or replaced as required, ensuring the area is properly waterproofed to prevent recurrence.

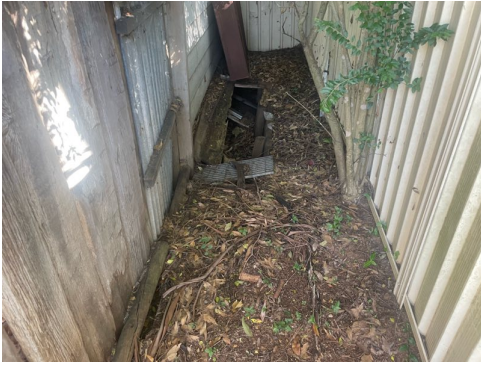
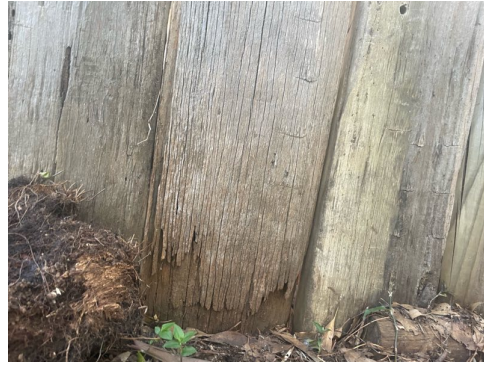
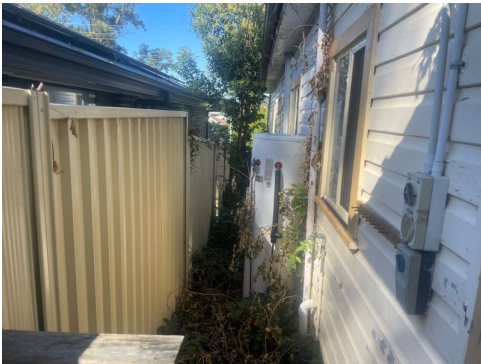
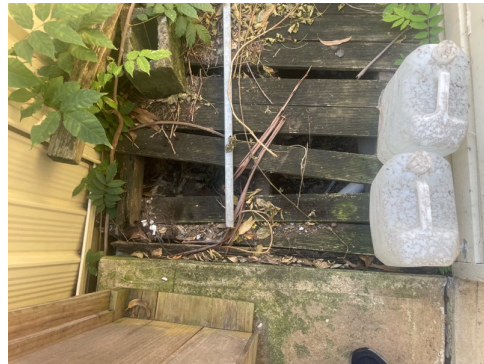
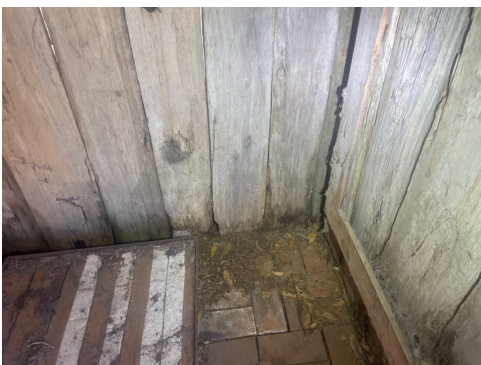
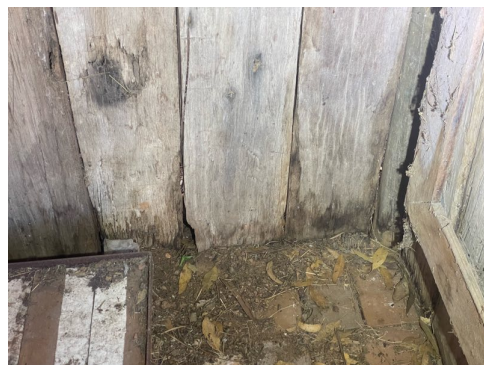
### Finding 6.06

Wood decay is more susceptible to termite attack and these timbers should be replaced to limit termite attack.

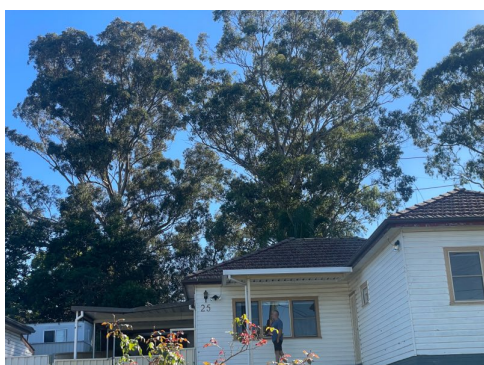
### Finding 6.07

Information: There are a number of large trees/stumps within 30m of the house which may contain natural termite activity. It is important to monitor these areas to ensure no natural activity is allowed to progress into the main house. Regular inspections are recommended. Consider test drilling any large trees. A pest controller can be contacted to carry out such testing at the owners discretion.
