Building and Timber Pest Inspection Report

Inspection Date: Mon, 2 Feb 2026

Property Address: 4 Davidson Ave, Forestville NSW 2087,
Australia

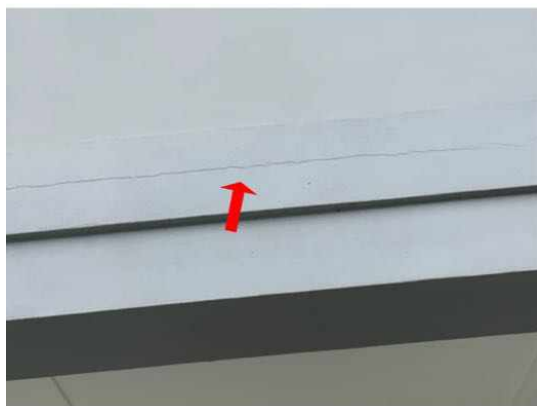
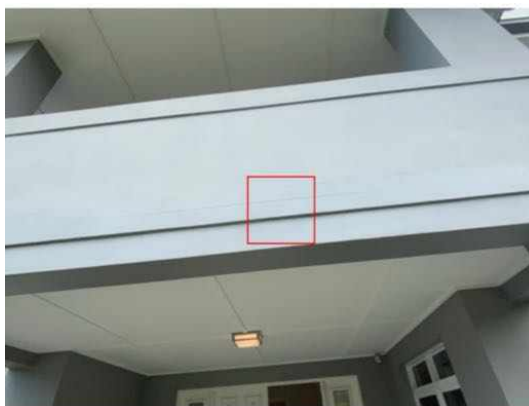
Finding 3.01

Building: Main Building
 Location: Exterior walls - front
 Finding: Cracks to external render - Category 2
 Information: It has been observed that cracking to external rendered surfaces has occurred. The degree of damage falls within Category 2, described as noticeable cracks which are easily filled. Cracking of this size are generally less than 5mm in width.

Category 2 damage is required to be monitored for a period of 12 months. After the monitoring period, a crack rated at Category 2 or above is considered a defect requiring rectification.

Always contact your building inspector should cracks widen, lengthen, or become more numerous.

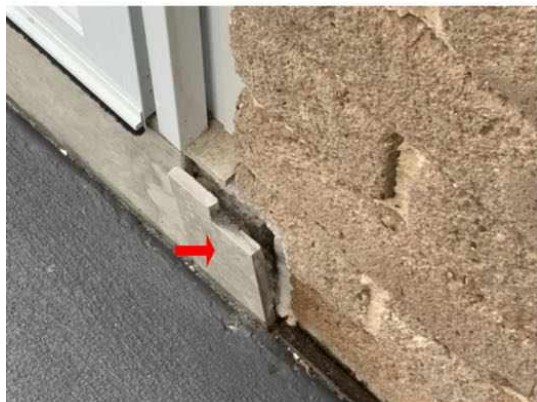
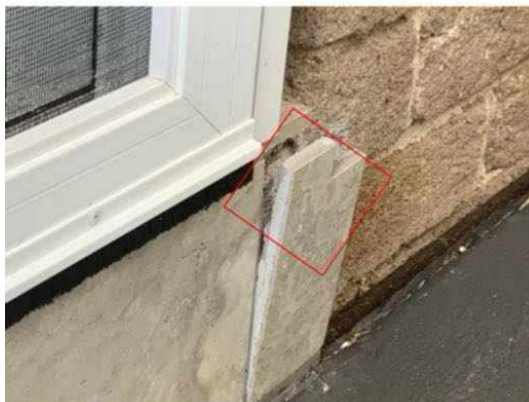
Finding 3.02

Building: Main Building
 Location: Exterior walls - left side
 Finding: Skirting tiles - damaged
 Information: Skirting tiles were damaged in this area at the time of inspection. Complete tiled

skirting is important in preventing water ingress into the adjoining walls and flooring, protecting the areas against potential water damage. The incomplete skirting also detracts from the overall appearance of the area.

If left unmanaged, water ingress into adjoining areas may have major implications, and may potentially necessitate works to other building elements in the long-term future.

It is highly recommended that a tiling contractor be appointed to complete these minor works as soon as possible to prevent such damage from occurring.

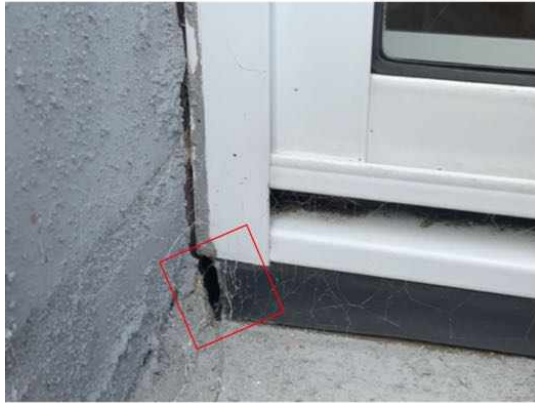
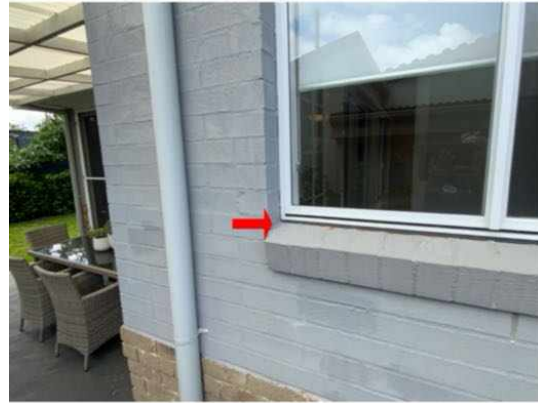
Finding 3.03

Building:	Main Building
Location:	Exterior walls - left side
Finding:	Window seals - deteriorated
Information:	The window seal has been installed short due to substandard workmanship, which can allow water ingress into the wall cavity.

Where window seals have deteriorated, the window is no longer weather-tight; rain penetration and subsequent water damage is therefore likely to ensue. Insulation of the area against external weather conditions will also be compromised.

It is recommended that all deteriorated window seals be replaced by a general handyman or sealant expert to prevent any damage .

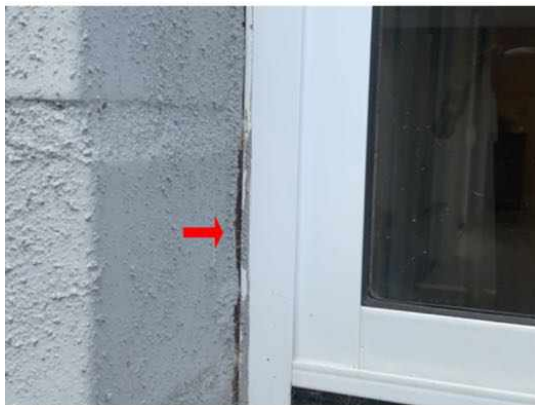
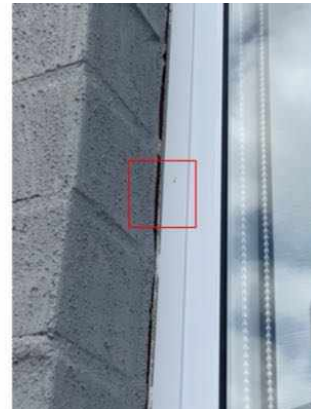
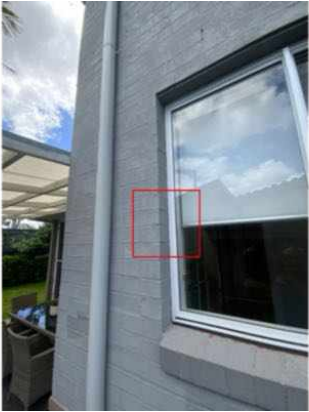
Finding 3.04

Finding: Window- Gap

Information: A significant gap was identified between the window and the window frame in this area. Where large gaps to the side of the window frames appear, it may indicate settlement in the frame work.

A gap to the side of the window may also indicate movement of the foundation of the property, which is a common occurrence and does not indicate structural damage.

A general handyman should be appointed to perform remedial works .(seal the gap)

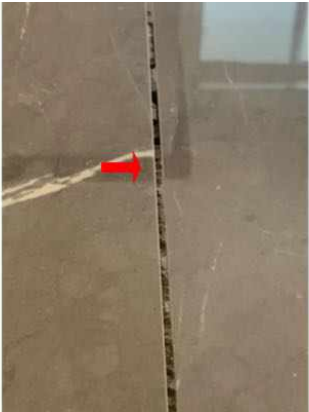
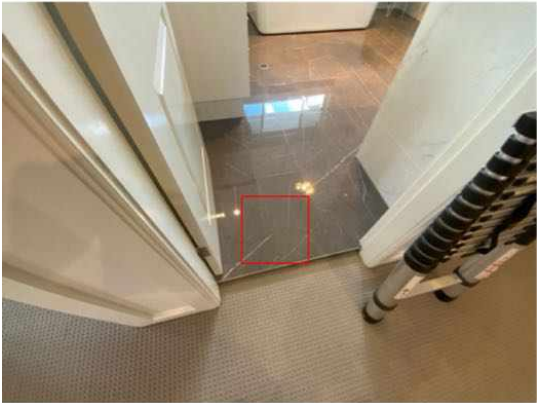
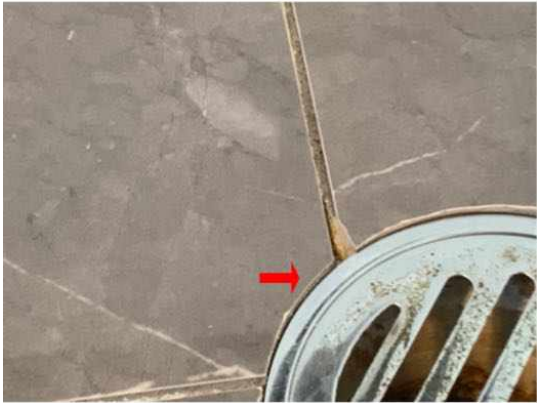
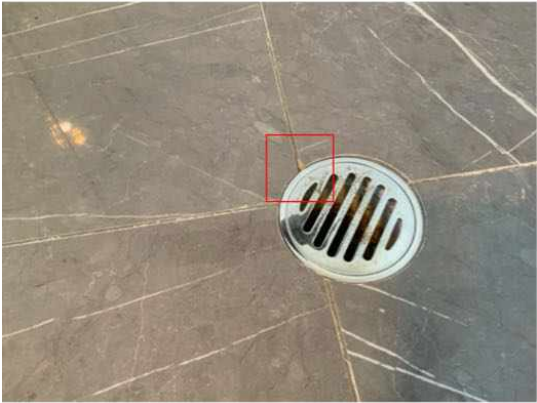
Finding 3.05

Building: Main Building
Location: Bathroom
Finding: Grout - Missing
Information: Grout is missing in this area. Grout is used to protect gaps and crevices in building materials to ensure that they are water-tight and prevent water penetration to the associated structures.

Where grout is missing, a tiling contractor should be appointed immediately to apply grout and re-apply any silicone where necessary. Failure to do so is likely to lead to water damage to the surrounding area.

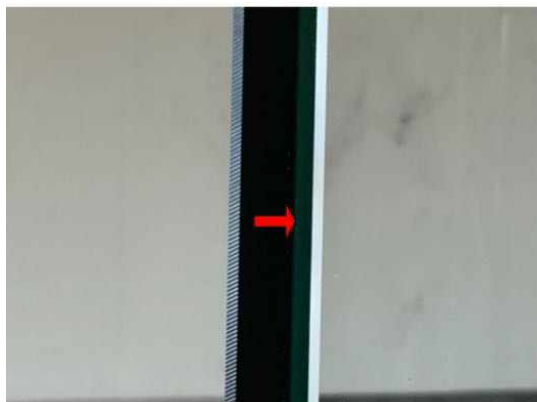
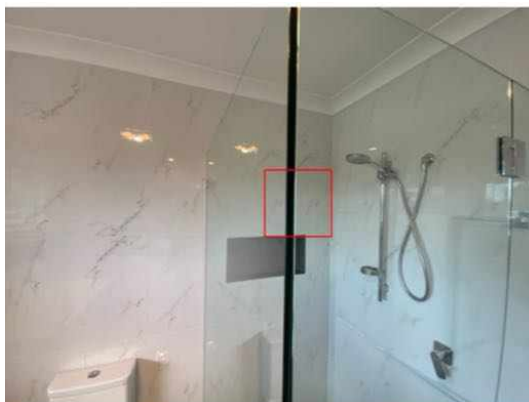
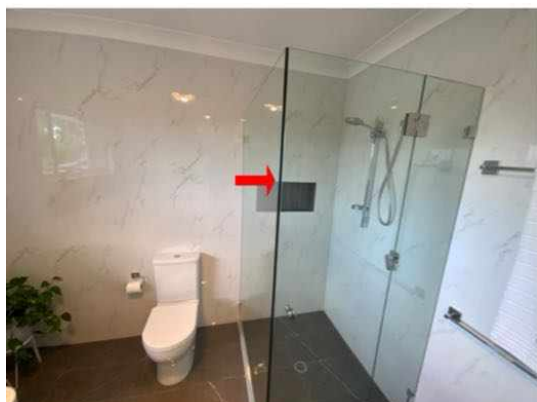
Finding 3.06

Building:	Main Building
Location:	Bathroom
Finding:	Door - Binding
Information:	Binding of the shower screen door is evident during standard operation. This defect inhibits the functionality of the affected door as well as creating potential for secondary defects to associated building elements, such as damage to the glass door it self.

A door that binds may have several causes, ranging from minor defects, such as poor installation of the door or deteriorated hinges.

For minor causes, a qualified glazier or general handyperson should be appointed to perform minor rectification works at client discretion.

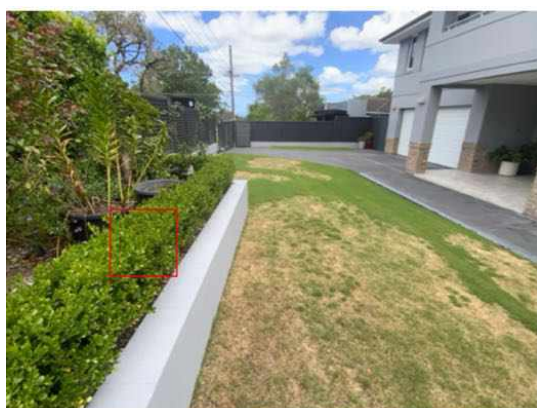
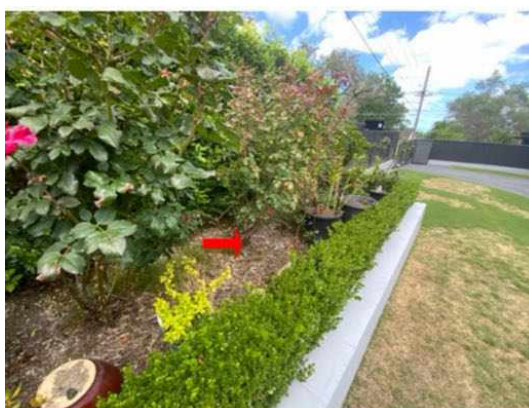
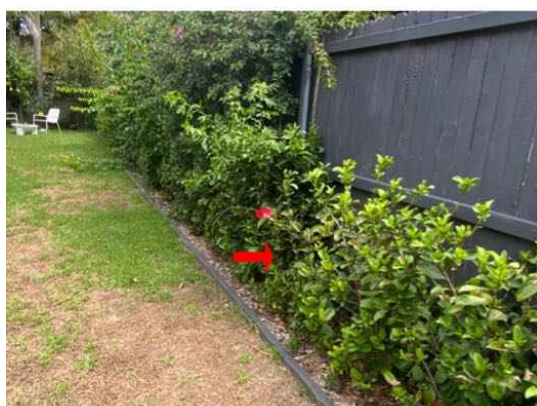
Finding 6.01

Building:	Main Building
Location:	All Areas
Finding:	Garden Beds - Conditions Conducive to Termites
Information:	Garden beds were found to be evident in the garden area. These garden beds can include untreated timber, and with a combination of moisture from watering hosing can make conditions conducive to termite activity and termite ingress.

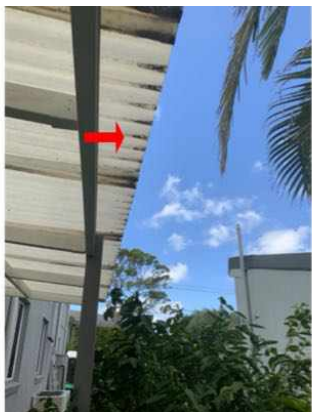
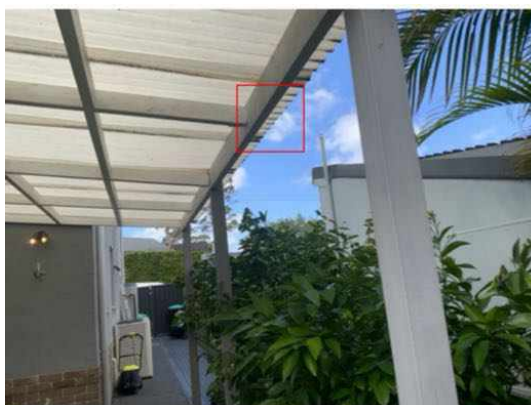
Finding 6.02

Building:	Main Building
Location:	Exterior walls - left side
Finding:	Roof plumbing - Missing
Information:	Some sections of the roof are not adequately drained via gutters and downpipes. Gutters and downpipes that are not installed adequately are likely to result in excessively damp conditions against the exterior surfaces and around the base perimeter of the building.

Excessive moisture creates an environment which accelerates the deterioration of building elements in the area, as well as being conducive to termite and pest

infestation. Such an environment is likely to necessitate repair and/or replacement of building elements, which are prone to sustaining wood rot, rust or corrosion.

A roofing plumber should be appointed as soon as possible to install relevant roof plumbing materials. Depending on the extent of the damage, repair and/or replacement of damaged building elements may be required.

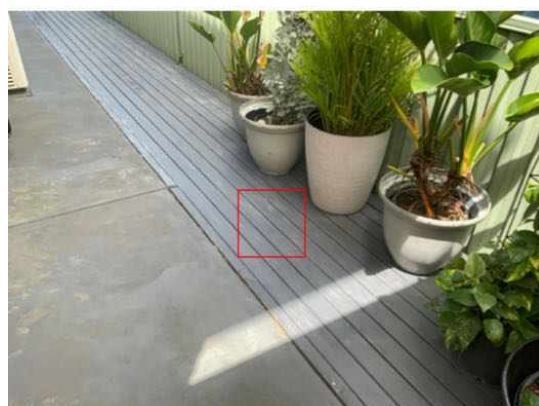
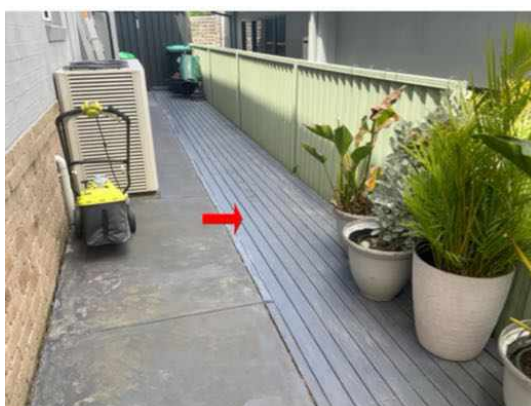
Finding 6.03

Building: Main Building
 Location: Exterior walls - left side
 Finding: Building materials in direct ground contact - conducive to termites
 Information: Where timber elements are in direct contact with the ground and consequently moisture or dampness they become conducive to termite activity. Whether timber is used as a building element part of a fencing structure or stored as an unused item they can provide an environment that is attractive to termite infestation.

When met with excessive moisture timber begins to decay and develop wood rot. Any timbers that are in direct contact with external grounds especially if left untreated or non-durable also provide ingress for subterranean termites into that particular element.

The removal of any such materials that may be conducive to termite activity should be removed as soon as possible to minimise the risk of termite attack.

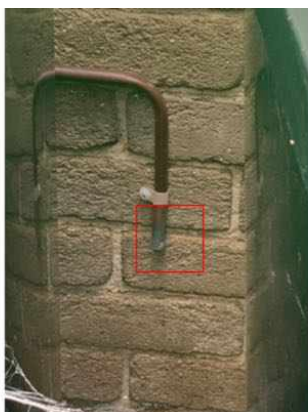
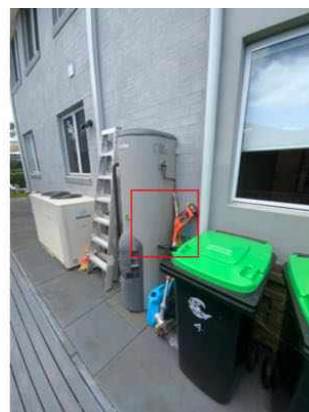
Finding 6.04

Building:	Main Building
Location:	Exterior walls - left side
Finding:	HWS Overflow - Not Connected
Information:	The Hot Water System (HWS) overflow was found to be disconnected from storm water drainage and is creating excessive moisture in the surrounding area.

These damp conditions can lead to secondary defects such as rot, rust or corrosion of associated building elements, the formation of fungal decay, or even the creation of potential slip hazards. When coupled with poor site drainage, pooling of water may also attract termite activity to this area.

It is highly recommended that a licensed plumber be appointed to connect the HWS overflow in order to prevent such an environment from being created. These minor works should be carried out as soon as possible.

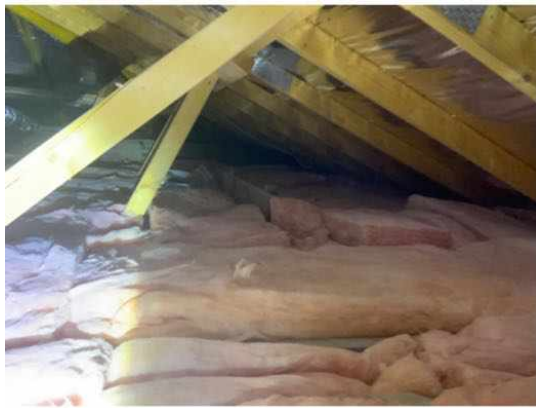
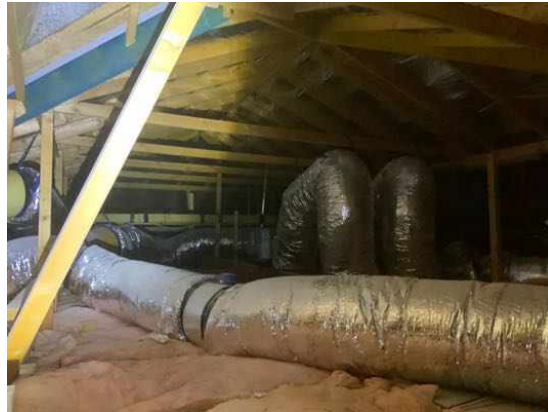
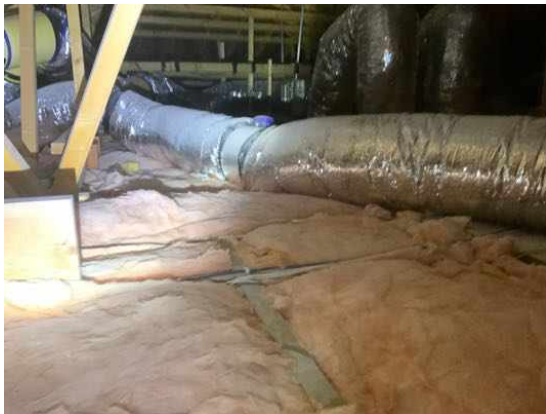
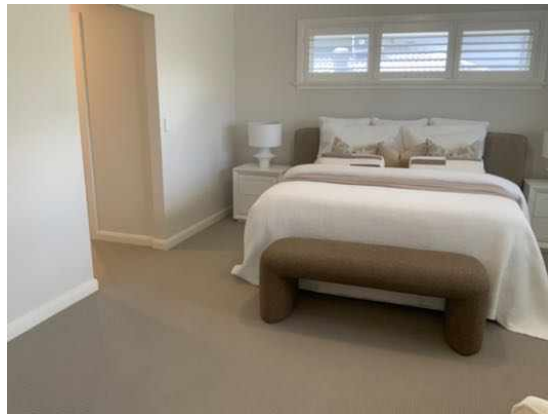
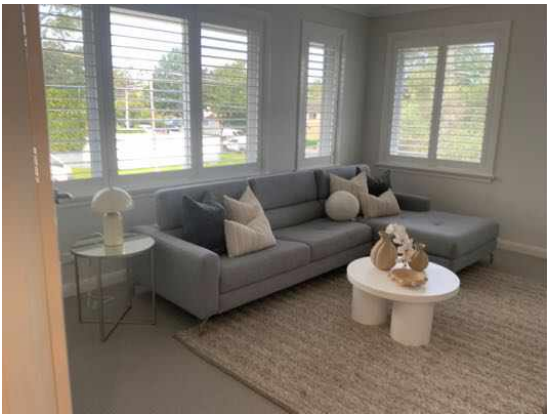
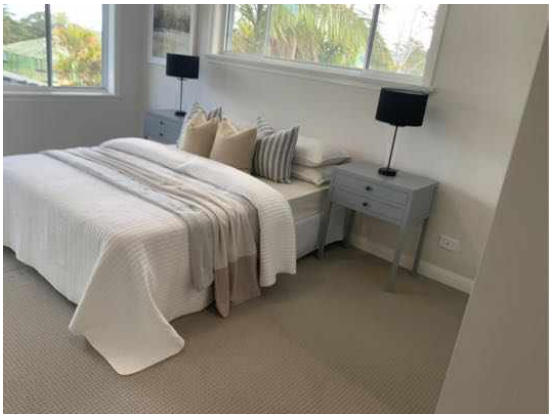
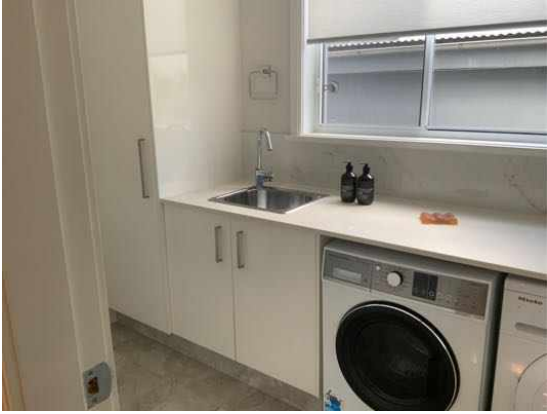
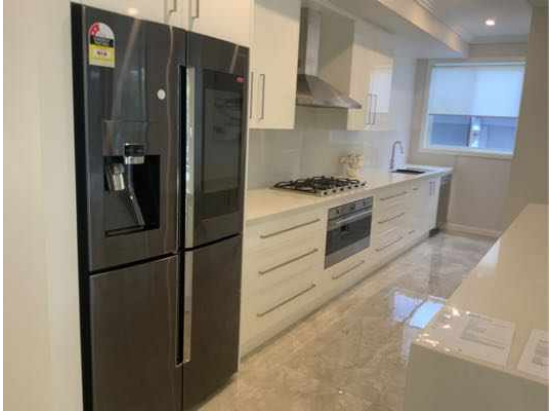
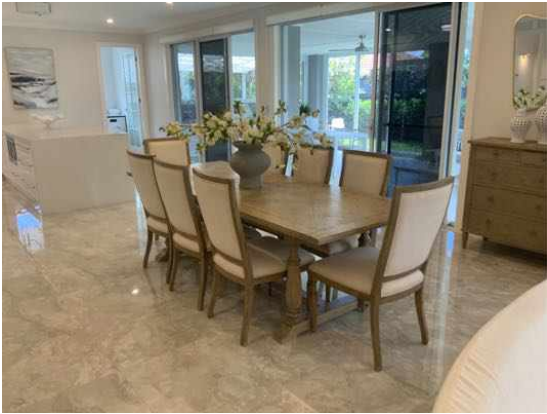
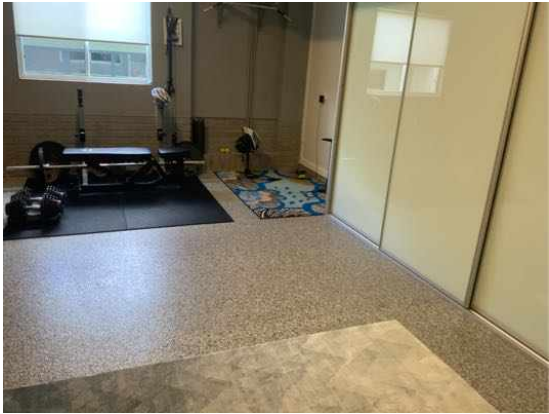
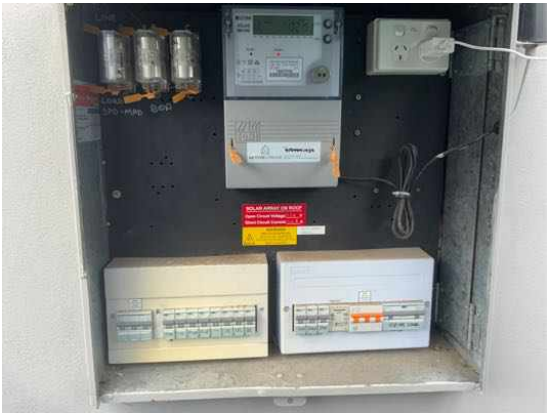
Building: Main Building
Location: All Areas
Finding: Additional Photos - Obstructions and Limitations
Information: These photographs are an indication of the obstructions and limitations which impeded full inspection of the property at the time of inspection. These obstructions can hide an array of defects and should be removed to allow full inspection to be carried out. A re-inspection is recommended once the areas are made accessible.
