Building and Timber Pest Inspection Report VR

Inspection Date: Wed, 11 Feb 2026

Property Address: 2/22 Oatlands St, Wentworthville NSW
2145, Australia

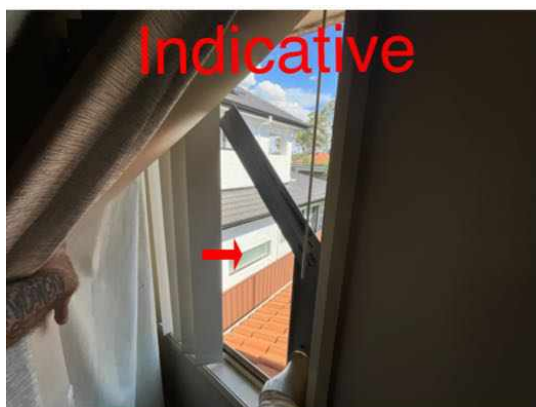
Building:	Main Building
Location:	Upstairs Windows
Finding:	Window restrictions - Missing
Information:	Window restrictors were found to be missing.

The National Construction Code (NCC) requirements apply to all openable bedroom windows in residential buildings, including hotels, motels and for all windows in early childhood centres.

Windows need to be locked at 12.5cm when the devices are engaged. The safety devices must be robust and child proof. The alternative is security screens such as bars or grills on the windows so long as they have gaps no bigger than 12.5cm. Flyscreens do not comply unless they are the reinforced security type and capable of resisting the very strong outward pressure which would prevent a child falling through. The laws apply to openable windows in a building within 1700mm of the internal floor and if the internal floor is more than 2m above the ground floor outside.

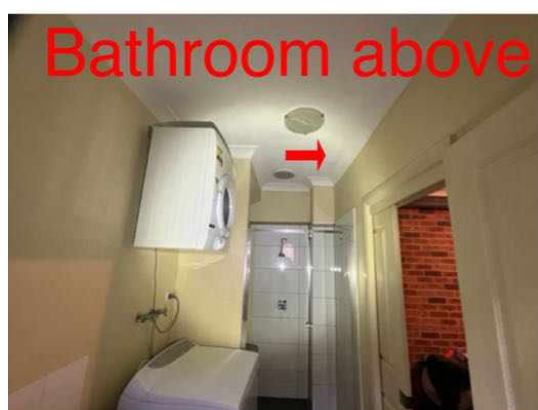
Finding: Water staining

Information: Water staining was evident in this area at the time of inspection. Water staining indicates that surfaces have been exposed to excessive moisture over time. The minerals and other elements in the water lead to staining, which may graduate to corrosion and deterioration if left unmanaged.

While mostly an appearance defect, water staining can be indicative of more serious defects, which may be currently concealed by other building elements.

A licensed plumber must be consulted to identify the cause of the staining and to provide advice on any reparation works that may be required. Replacement of any broken or damaged structures is advised.

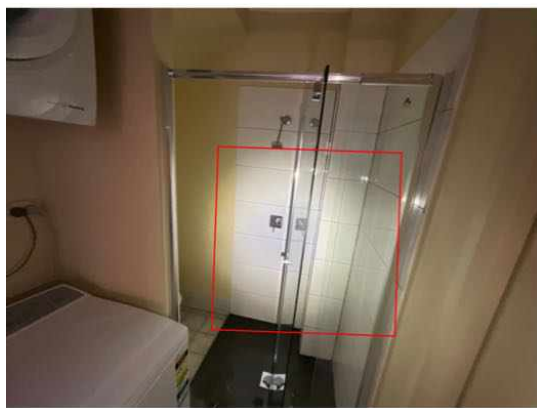
Finding 3.02

Building: Main Building

It is highly recommended that the client makes immediate arrangements to have the plumbing work inspected to ensure compliance.

A bathroom specialist must be appointed immediately for further consultation.

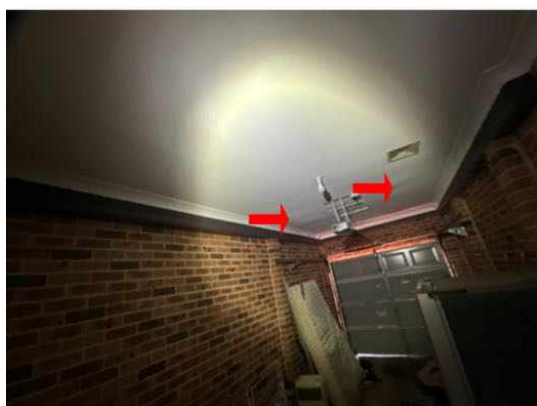
Information: Sections of the ceiling were found to be sagging at the time of inspection. Sagging to the fixed ceiling structure generally indicates that the building materials have swollen, due to contact with water, or that fixings (e.g. nails or glue) have become loose and require reattachment.

Where minor sagging is evident, comparatively minor works, such as re-gluing of ceiling sheets, may be required. Such works may be performed by relevant tradespeople, such as plasterers and painters. Where excessive moisture has caused the roofing structure to swell and sag, the source of the water leak should primarily be identified prior to any remedial works being performed.

The appropriate action should be taken by the client as soon as possible to ensure that any potential further damage is limited.

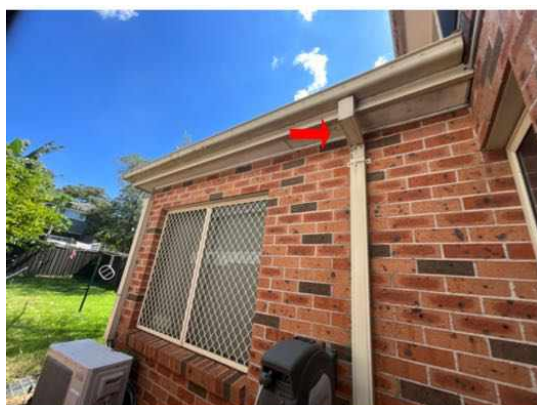
Finding 3.05

Building:	Main Building
Location:	Rear right corner
Finding:	Eaves/Roof plumbing -- water damages
Information:	Water damage is generally an indication of excessive moisture being present, usually via a leak. It is suspected that gutter blockages causing stormwater to backflow into the eaves causing water damages. This is additionally conducive to termite activity due to the damp conditions.

Where water damage is evident, the primary requirement is to identify and rectify the source of the leak. Gutters must be kept clear of any blockages moving forward. A roofing plumber should be appointed for further assessment if the problem persists.

Once the leak is repaired, consultation with relevant tradespeople, including carpenters, plasterers and painters, is advised.

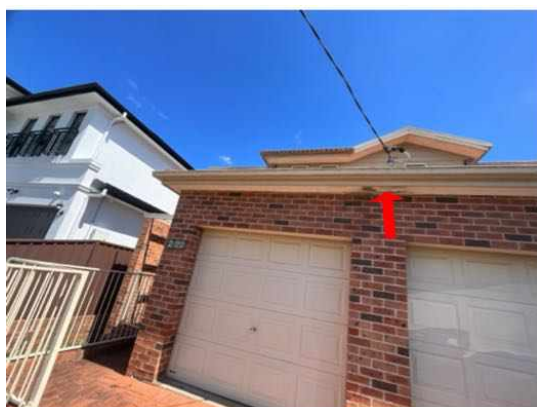
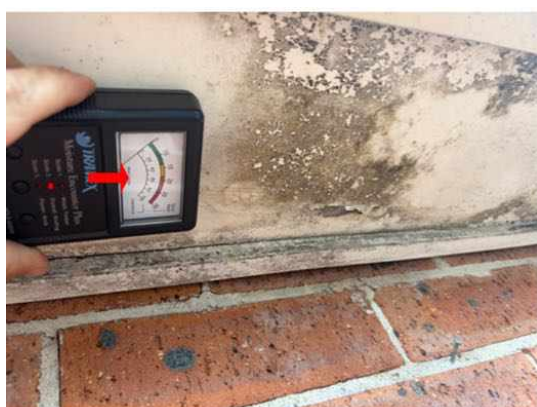
Finding 3.06

Building:	Main Building
Location:	Garage
Finding:	Water leak - Inactive
Information:	Water leaks generally occur when a particular area of the property is not weather- or

water-tight. While the damage in this area appears to be from an old inactive water leak, the area should be monitored frequently for the recurrence of any dampness.

Repair and / or replacement of previously affected building elements is at client discretion. Consider a further invasive inspection: removal of obstructions around the damaged area may reveal further damage which has been concealed. A more significant or major defect may be identified at this time.

Where recurrence of an active water leak is identified, a licensed roofing plumber should be appointed immediately to rectify the leak and advise on any further preventative works as necessary.

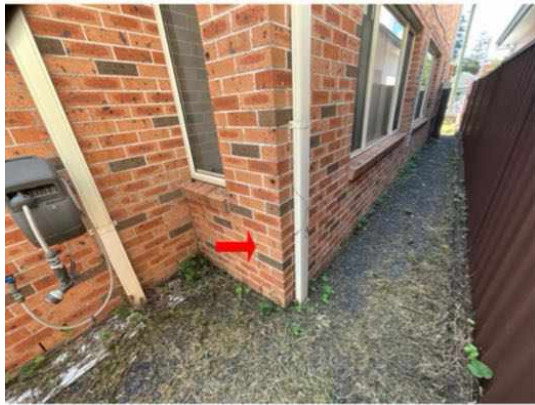
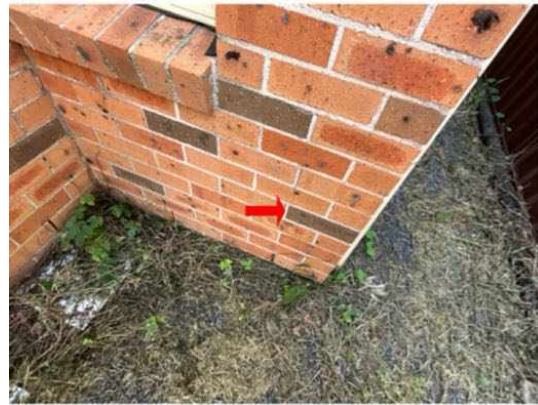
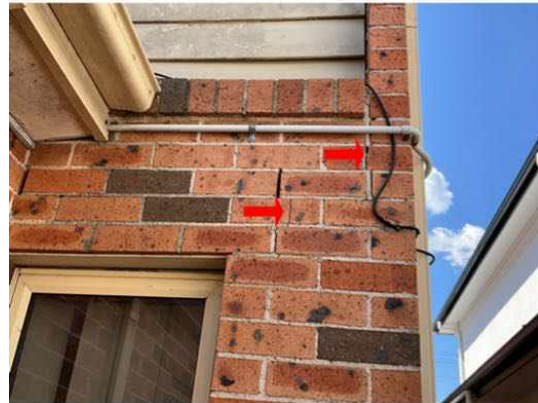
Building: Main Building
Location: Rear right corner
Finding: Damage to Masonry Walls (Cracks)- Category 2
Information: It has been observed that damage to masonry walls caused by movement of slabs, footings, or other causes, has occurred. The degree of damage falls within Category 2, described as noticeable cracks which are easily filled. Such cracking may cause doors and/or windows to stick slightly, and are generally less than 5mm in width.

Damage of this category is required to be monitored for a period of 12 months, after which time a crack rated at Category 2 or above is considered a defect requiring rectification, such as minor repairs and repointing. Always contact your building inspector should cracks widen, lengthen, or grow more numerous.

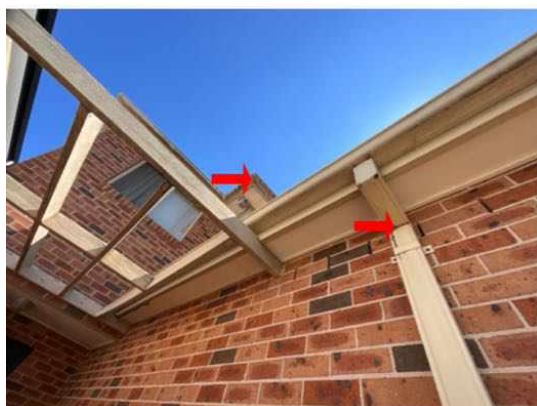
Finding 3.09

Building:	Main Building
Location:	Multiple areas of roof plumbing
Finding:	Water leak - External
Information:	Water leaks were found to be present to exterior plumbing work. Leaks are generally caused by deterioration of the plumbing elements over time, due to exposure to weather conditions, but may have also been caused by minor impact damage.

Such leaking creates damp conditions in the affected area, causing potential for water pooling and subsequent water damage if left unattended. These conditions may also attract termite attack, particularly if the area is subject to minimal levels of sun throughout daylight hours.

It is highly advised that a licensed plumber be appointed to rectify any water leaks that may be present. Areas of repair and replacement of plumbing fittings and fixtures may be required and, as such, a quotation should be sought.

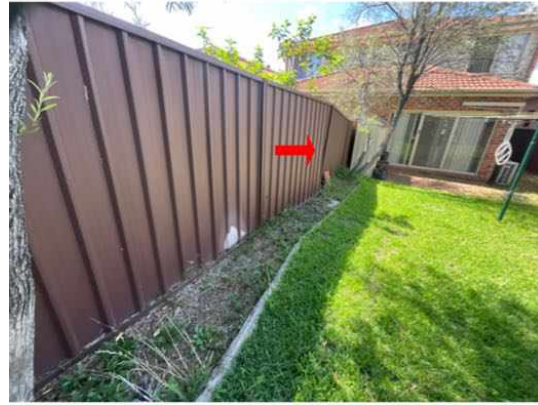
Finding 3.10

Finding: Fencing - Deteriorated

Information: It was noted at the time of inspection that sections of the fencing in this area has deteriorated. Typically fencing deteriorates due to age and or wear, rot and or rust which is generally expected for a structure of this age, due to prolonged exposure to weather conditions. Sometimes inadequate installation or maintenance can be to blame.

If left unattended, it is likely that further damage will occur. It is suspected that repair of several elements of the fencing may be required however replacement may be a consideration of the client also.

A licensed fencing contractor should be appointed to provide further advice and perform rectification works as necessary.

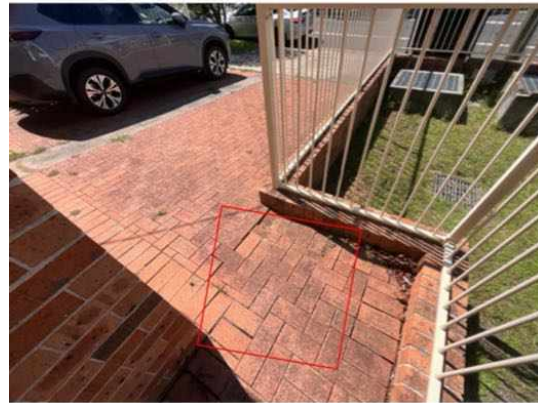
Finding 3.11

Building: Main Building
 Location: Porch
 Finding: Paving — Uneven
 Information:

Sections of the external paved area are uneven, which may develop into a trip hazard. It appears as though the area has been subject to rough installation, or that paving sections have lifted due to movements in the foundation.

Left unmanaged, the May develop into a safety hazard due to trip and fall.

Re-paving of the area is required to remedy this situation. Further consultation with a specialist concreter is advised.

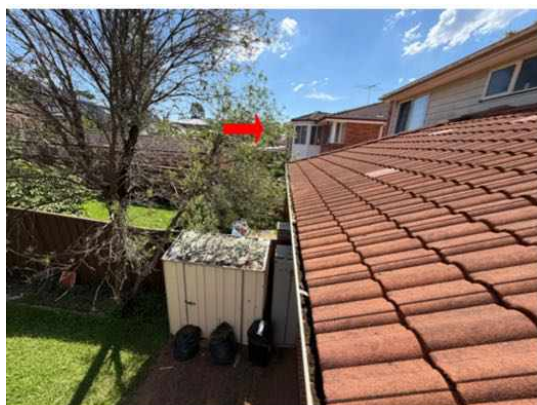
Finding 3.12

Building: Main Building
 Location: Roof Exterior
 Finding: Trees - Overhanging and filling gutters
 Information:

therefore important that they be kept clear to prevent secondary damage to associated building elements, including exterior and interior walls, ceiling linings and any adjoining building elements. Where gutters are blocked, pooling of rainwater is likely to occur, fast-tracking rust and corrosion of the roof plumbing elements.

It is highly advised that all overhanging tree branches be removed as soon as possible to prevent any further damage. Repair and/or replacement of sections of damaged guttering may also be required where the extent of the damage necessitates.

Such works should be performed by the homeowner; however, appointment of a landscape contractor or an arborist may be required. Consultation with a licensed roof plumber is required where guttering has been damaged.

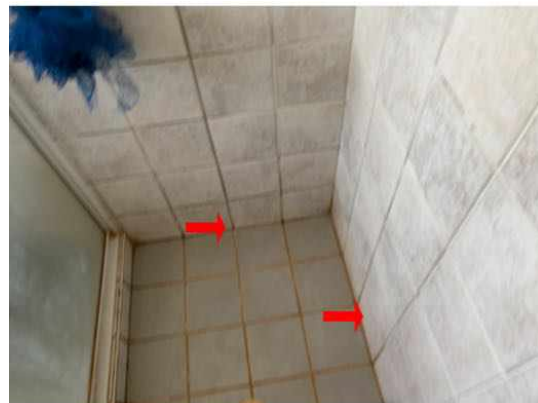
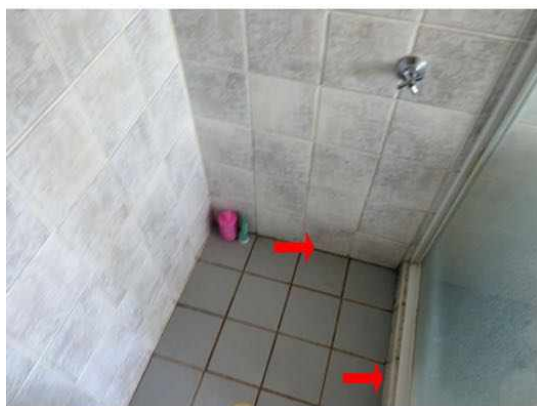
Building: Main Building
 Location: All Wet Areas
 Finding: Sealant and grouting - Missing or damaged
 Information:

It was noted on inspection that sealant or grout is degraded to this area.

Different materials and floor areas move at different rates, generally causing cracking to grout or sealant at this point. A flexible sealant is required to allow for expected expansion and contraction, while keeping the joint water tight and protective of all associated building materials.

Flexible and mould resistant materials should be applied to affected areas to prevent any subsequent water damage that is likely to occur. Regular maintenance and replacement of damage or missing or damaged sealant and grout is highly recommended to the wet areas, as this is a regular wear and tear defect. Sealant and grouting in areas that come into regular contact with water should be maintained for the long term care of your property.

A sealant specialist should be appointed to complete these works as soon as possible.

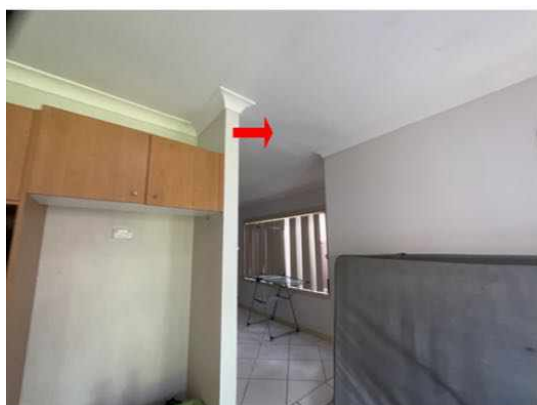
Finding 3.15

Building:	Main Building
Location:	Kitchen
Finding:	Cracking - Damage Category 1 - Fine (up to 1mm)
Information:	Although fine cracks are quite noticeable, they are often only considered to be an appearance defect, and usually do not indicate any structural damage. Generally, the cause of a fine crack is indicative of a separation between building materials and finishes (e.g. paint, plaster, etc.) along joins.

Cracking of this nature can generally be repaired with minor sanding, filling and/or repainting. Such works should be performed by a qualified painter or a general handyman.

Monitoring of all cracking should be conducted frequently. Always contact a building inspector should cracks widen, lengthen, or become more numerous.

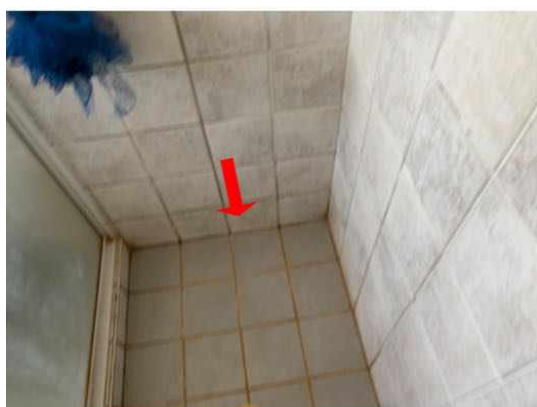
Finding 3.16

Building:	Main Building
Location:	Bathroom, ensuite
Finding:	Shower damp - Sealant and grout
Information:	Damp is evident to the lower 400mm of wall to the shower alcove. This defect is quite

common, and is suspected to have been caused by moisture permeating or leaching through the grouting and sealant in this area, which shows evidence of deterioration. Leaking pipes within the wall is also a possible cause however this seems unlikely in this instance as there is no moisture build up around the taps or transferring to the other side of the wall. There appears to be no sealant around the tap spindles which may be a small contributing factor.

Unmanaged damp in the shower recess is likely to facilitate the formation and development of mould and fungi growth, decaying associated building materials and compromising their structural integrity of associated elements. It is important to address damp conditions, as the World Health Organisation notes that excess moisture leads - on almost all indoor materials - to growth of microbes such as moulds, fungi and bacteria, which subsequently emit spores and other matter into the indoor air. Exposure to these contaminants is associated with a wide range of respiratory and other health-related problems. Damp conditions also create a conducive environment for termite infestation.

Consultation with a bathroom sealant specialist is advised immediately to identify the cause of damp and to perform remedial works as required.

Always ensure that sealant and grout is in good condition to prevent any moisture issues occurring in the future.

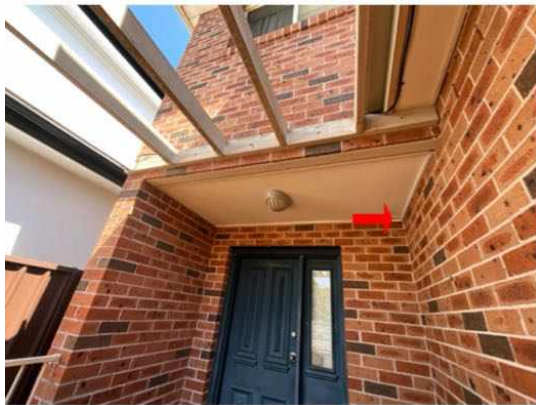
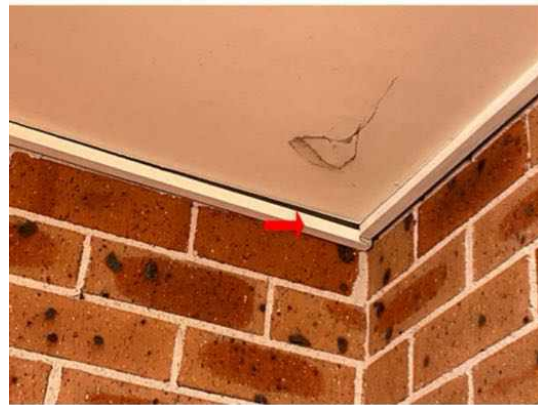
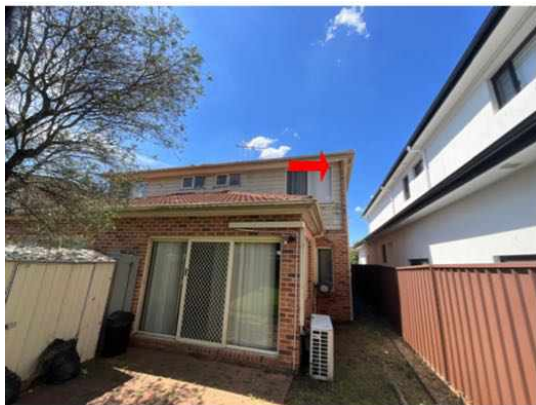
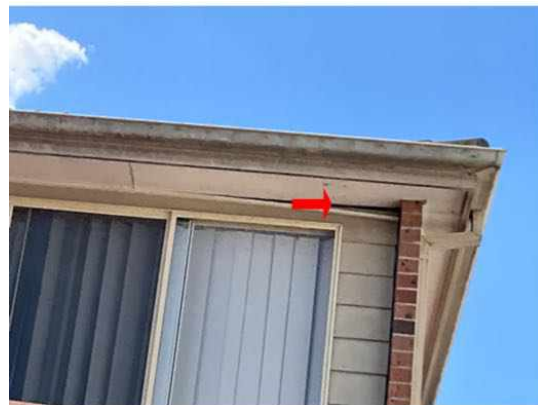
Building: Main Building
 Location: Multiple areas
 Finding: Beads - Damaged
 Information: Beading acts (like cornice or skirtings) to cover the intersection or joins of building materials. It was noted at the time of inspection that beading in this area has deteriorated. This deterioration is suspected to have been caused by general ageing and frequent exposure to weather, which is expected in a building of this age and condition.

Beading is important in weatherproofing the surrounding building elements and preventing pest ingress. Furthermore, beading works to protect the joins of building materials, which are more susceptible to deterioration and decay.

Repair or replacement of the beading is advised to ensure the protection and longevity of any associated building elements. Such works may be performed by a general handyman or qualified carpenter.

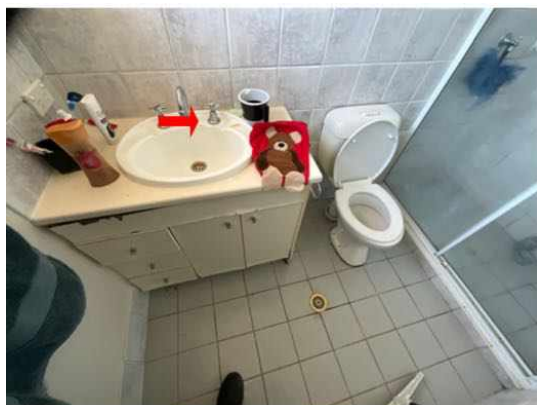
Finding 3.19

Building: Main Building
 Location: Ensuite
 Finding: Basin - Cracked
 Information: Cracking was evident to the basin at the time of inspection, which is suspected to

As the cracking provides potential ingress for water, secondary water damage may occur to associated cabinetry, walls or flooring, if the cracking is left unmanaged.

Consultation with a plumber regarding basin repair or replacement is required. Remedial works may be required to protect against any further damage.

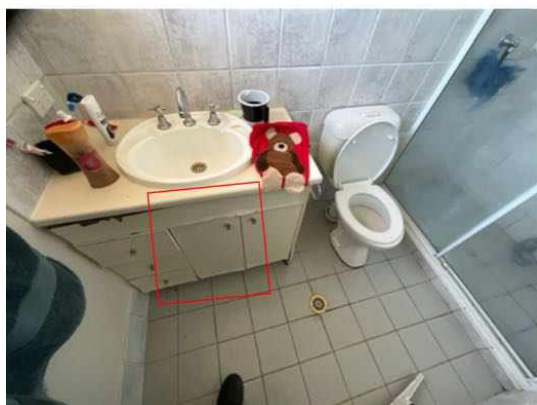
Finding 3.20

Building:	Main Building
Location:	Ensuite, bathroom
Finding:	Cupboard/vanity - Swollen/Water Damaged
Information:	Water damage was identified inside the vanity/cupboards in this area and it was also found to be swollen. Water damaged/swollen building elements generally indicate that the building materials have been affected by excessive moisture over a prolonged period of time, and have swollen as a result. A licensed plumber should be engaged to assess where the moisture is coming from and carry out any rectification as soon as possible. Replacement of the vanity/cupboards is also advised by a licensed cabinetmaker.

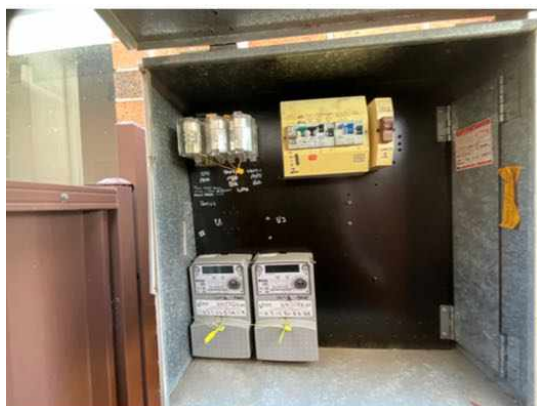
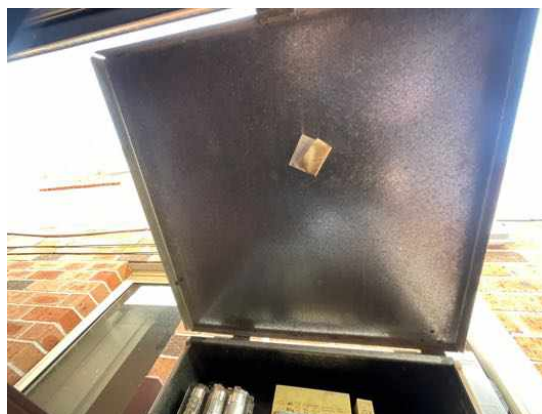
A durable notice should be placed in the switchboard unit to indicate current termite barriers. At the time of inspection, it appeared as though no termite management system has been installed, with no evidence to suggest preventative works taking place.

The client is highly recommended to retain a strata copy in relation to any active termite management systems, warranties and other details.

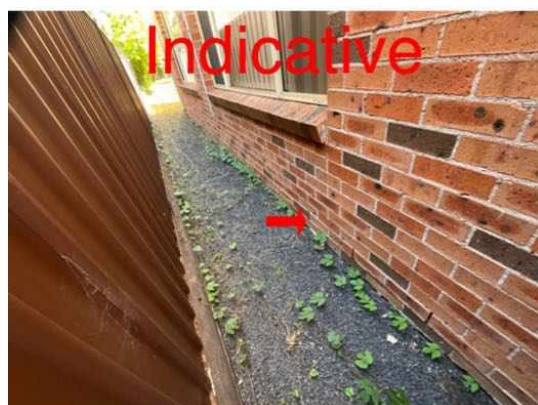
Finding 6.02

Not able to comment. A very high proportion of termite attacks are over the edge of both Infill and other concrete slabs types. Covering the edge of a concrete slab makes concealed termite entry easy. Infill slab type construction has an even higher risk of concealed termite ingress as the slab edge is concealed due to the construction design and cannot be exposed. The type of slab may only be determined by assessment of the construction plans by a qualified person e.g. Builder, Architect. Construction Plans may be obtainable by your local Council or Builder. Termite activity and or damage may be present in concealed timbers of the building. We strongly recommend frequent regular inspections in accordance with AS 3660.2. Where the slab edge is not fully exposed or the slab is an infill slab or the slab type cannot be determined then we strongly recommend inspections every 3 to 6 months in accordance with AS 3660.2 or AS 4349.3.

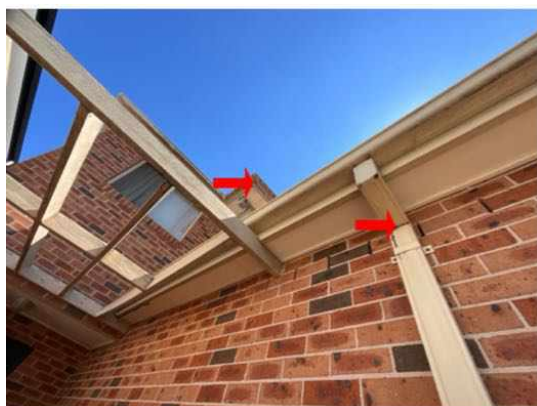
Finding 6.03

Building:	Main Building
Location:	Slab penetrations
Finding:	Service penetrations
Information:	Services into home can allow for concealed termite entry without additional or adequate termite protection.

It is highly advised that a licensed plumber be appointed to rectify any water leaks that may be present. Areas of repair and replacement of plumbing fittings and fixtures may be required and, as such, a quotation should be sought.
