# Building and Timber Pest Inspection Report

Inspection Date: Thu, 12 Feb 2026

Property Address: 23 Lewis St, Euroa VIC 3666, Australia

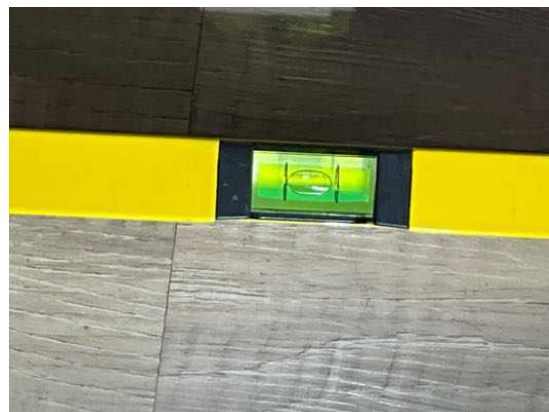
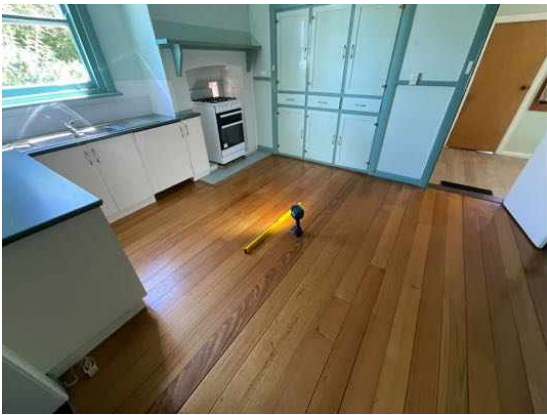
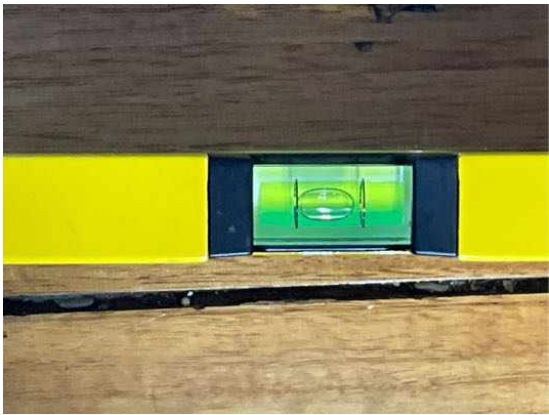
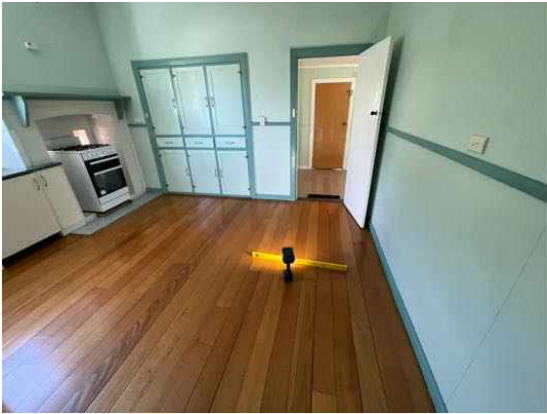
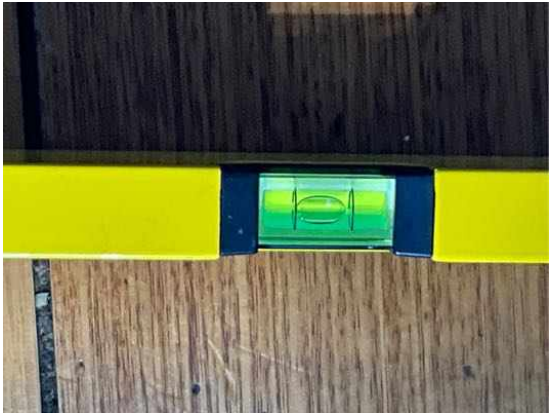
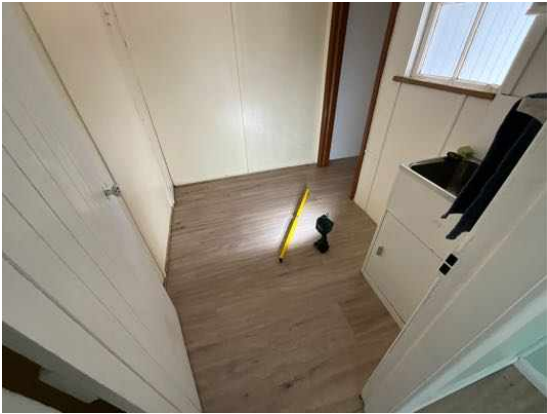
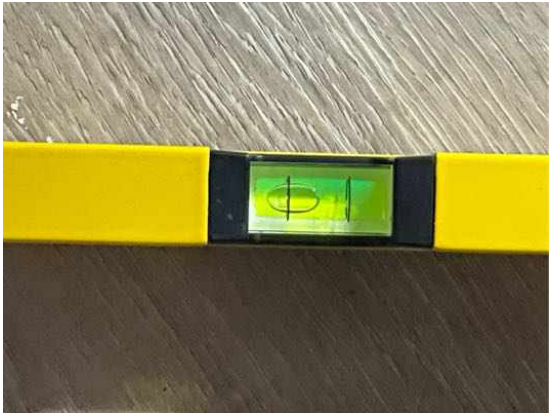
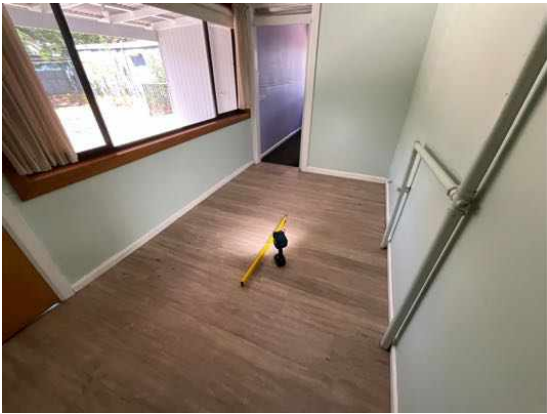
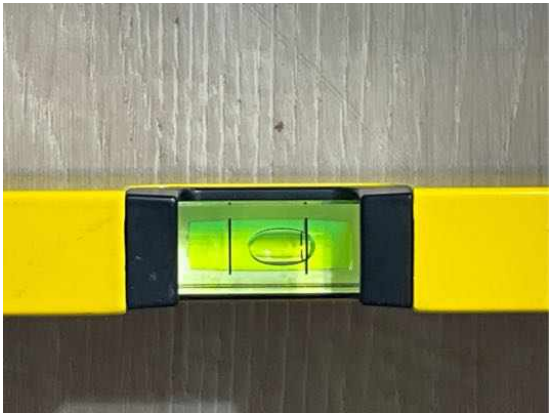
Building: Building 1  
Location: All Internal Areas  
Finding: Flooring - Uneven  
Information: The internal flooring in this area is out of level and uneven. Uneven flooring is likely to indicate minor defects such as expected movement of the foundations of the property, but may also indicate subsidence of the associated subfloor stumps.

It is advised that the flooring be closely monitored to identify any further movement. Where flooring remains relatively unchanged for an extended period of time (i.e. several months), it is likely that this defect has been caused by expected movement of the foundations of the property.

However, where flooring is uneven further, potentially invasive inspection of the subfloor structures and stumps in this area is required. In this case, works to repair are likely to be required, and would be carried out by a registered builder specialising in re-stumping.

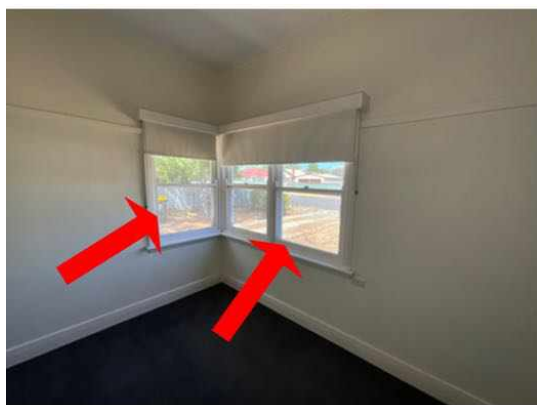
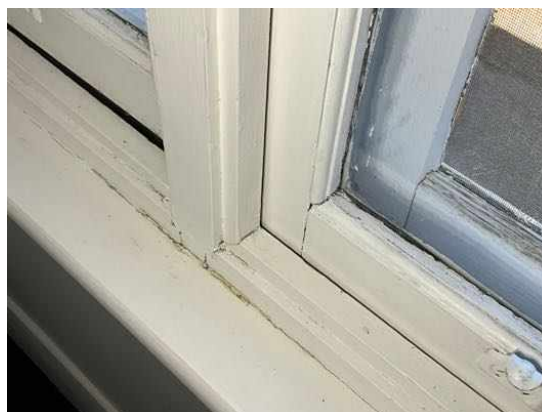
Finding 3.02

Building: Building 1  
 Location: Various timber windows  
 Finding: Windows - Stiff to slide  
 Information: Several windows throughout the property were jammed and difficult to operate at the time of the inspection. Windows provide ventilation to the adjoining area and should be at a fully operational level to ensure user comfort. Restricted function of the window may also pose as a potential safety hazard if required for emergency egress from the building.

Generally, factors such as general age of the building element and a lack of maintenance are the usual causes for this type of defect.

Replacement of window hardware or frame may be required, as well as minor repairs and cleaning. A registered builder or general handy person will be required to repair the affected windows.

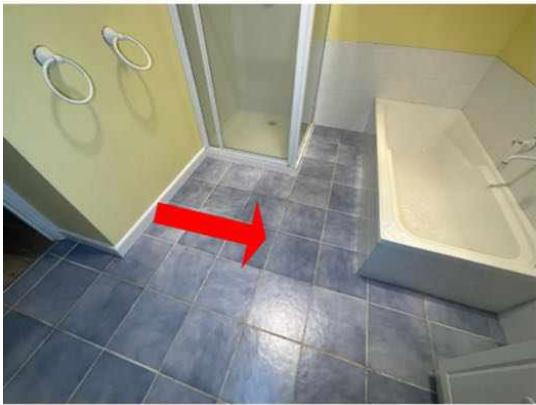
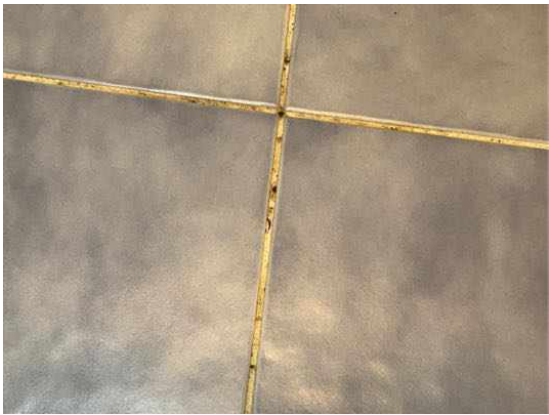
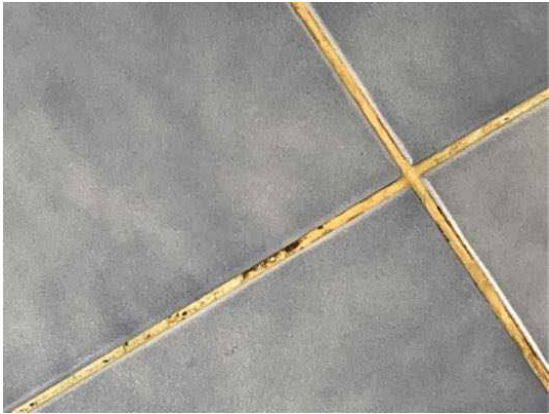
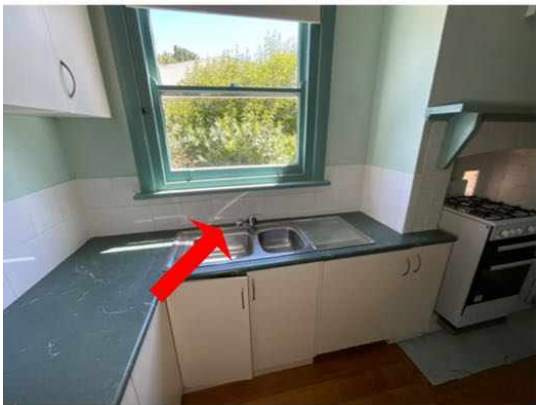
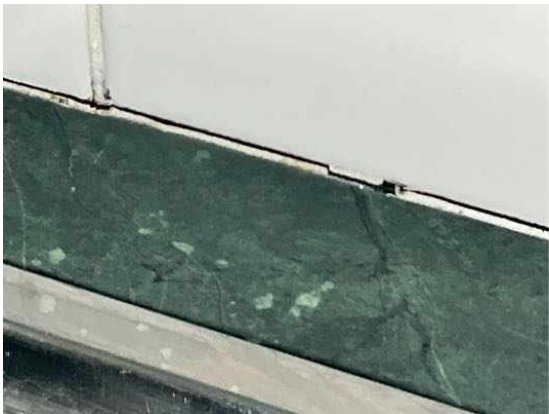
### Finding 3.03

Building: Building 1  
 Location: Bathroom, kitchen  
 Finding: Inadequate sealant or Grout  
 Information: This area has a lack of effective Sealant or Grout. This is allowing the ingress of water to the structure inside the wall.

The presence of water encourages Termite attack, Mould and Fungal Decay.

A Tiler or General Handy person must be contacted as soon as possible to effect repairs and prevent further deterioration.

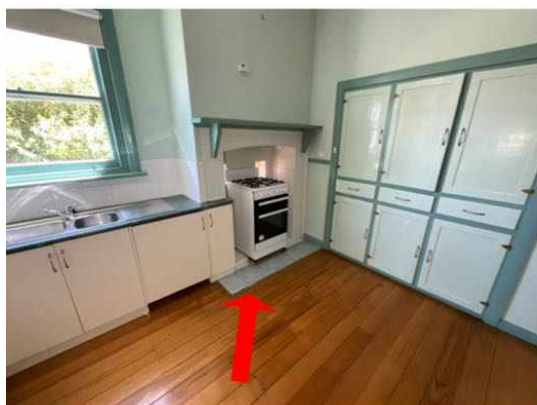
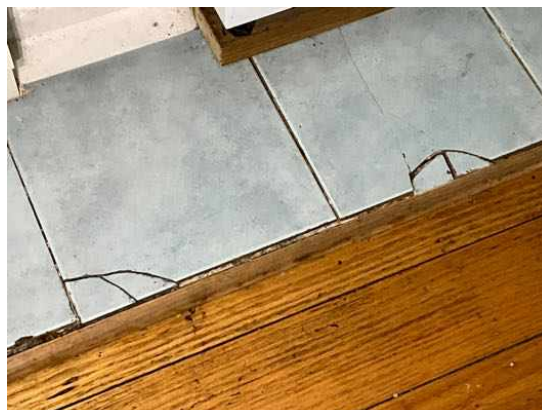
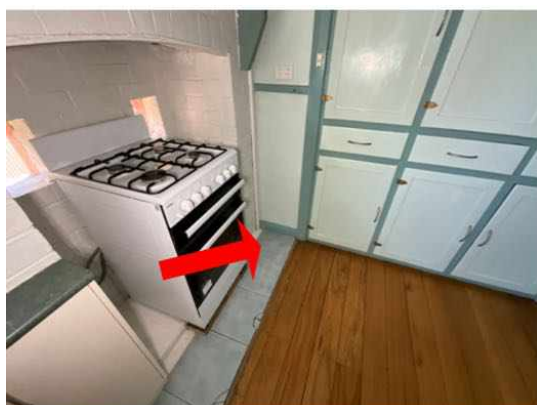
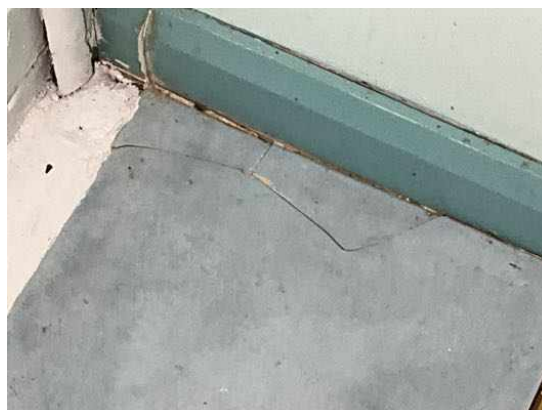
**Finding 3.04**

Building: Building 1  
Location: Kitchen  
Finding: Cracked floor tiles  
Information: Cracking in the floor tiles was evident in this area at the time of inspection. It is suspected that this cracking has occurred as a result of minor settlement or impact damage.

Cracked tiles throughout the household detract from the overall appearance of the affected areas however it is unlikely to create or lead to any secondary defects.

While not considered a matter of urgency, replacement of cracked floor tiles is

recommended at the clients discretion. A tiling contractor may be appointed to perform these works. Where cracks become more numerous, contact a licensed building inspector for further investigation.

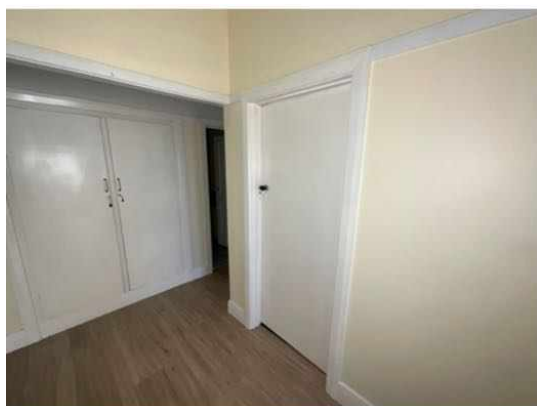
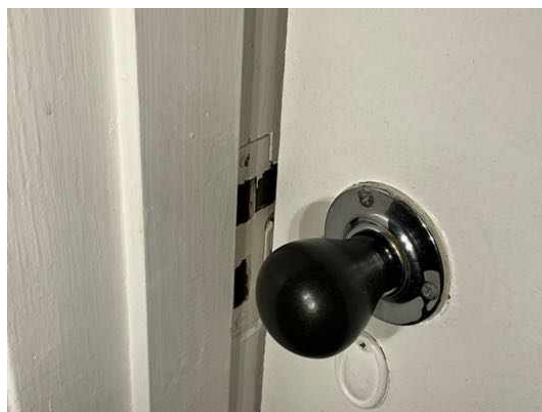
### Finding 3.05

Building: Building 1  
 Location: Bedroom - Master  
 Finding: Door - Striker plate misaligned  
 Information: The striker plate to this door appears to have become misaligned and has consequently resulted in the door's operation being compromised.

This is a common defect and is expected in a property of this age, whether being due to substandard installation or general deterioration of the door hardware.

Readjustment of the striker plate is recommended at client discretion. Works such as these can be completed by a general handyman or qualified carpenter.

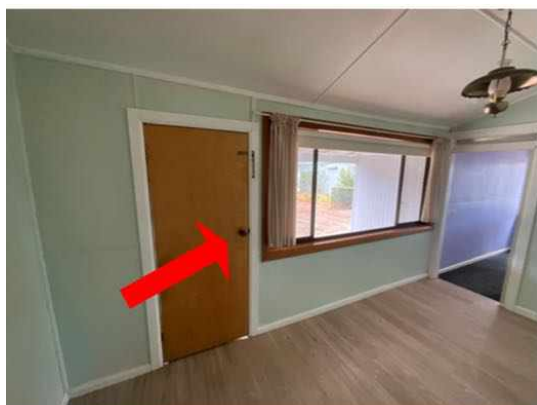
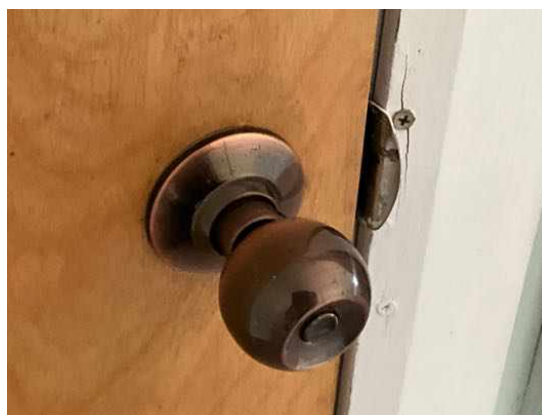
### Finding 3.06

Building:	Building 1
Location:	Back door
Finding:	Door handle- Not latching
Information:	It was noted that the door in this area was not latching during operation at the time of inspection.

It is suspected that this defect has occurred due to minor issues with the associated hinges. Such damage is identified as general wear and tear, which is expected for building elements of this age.

A qualified carpenter or general handyperson may be appointed to perform rectification works as necessary, at client discretion.

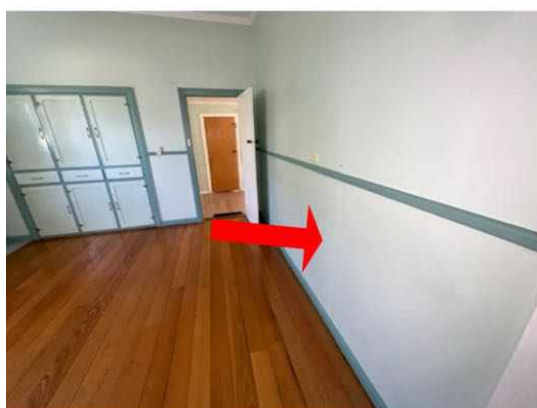
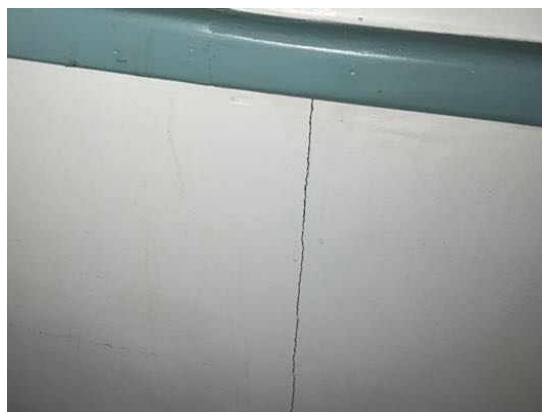
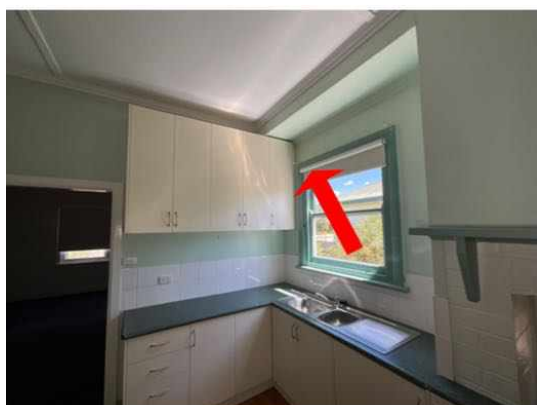
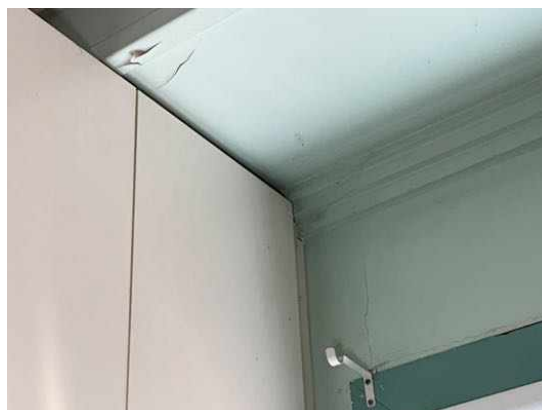
### Finding 3.07

Building:	Building 1
Location:	Kitchen
Finding:	Cracking - Damage Category 1 - Fine (up to 1mm)
Information:	Although fine cracks are quite noticeable, they are often only considered to be an appearance defect, and usually do not indicate any structural damage. Generally, the cause of a fine crack is indicative of a separation between building materials and

Cracking of this nature can generally be repaired with minor sanding, filling and/or repainting. Such works should be performed by a qualified painter or a general handyman.

Monitoring of all cracking should be conducted frequently. Always contact a building inspector should cracks widen, lengthen, or become more numerous.

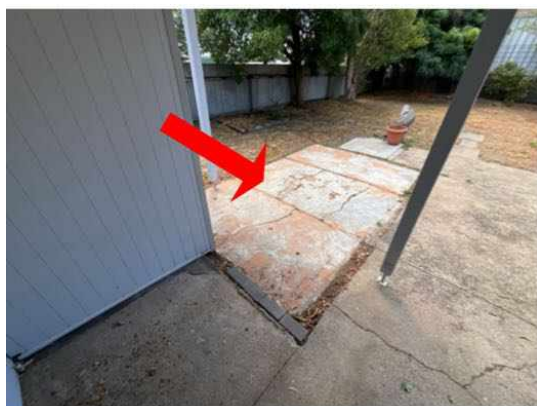
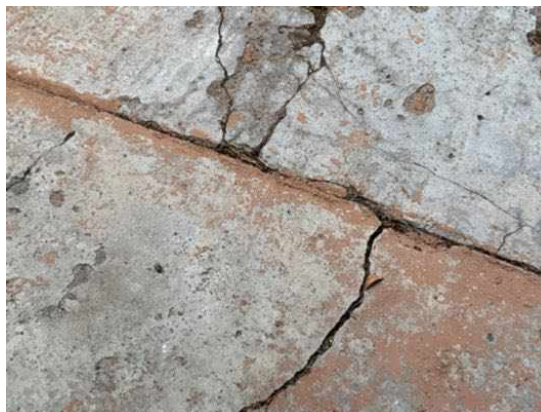
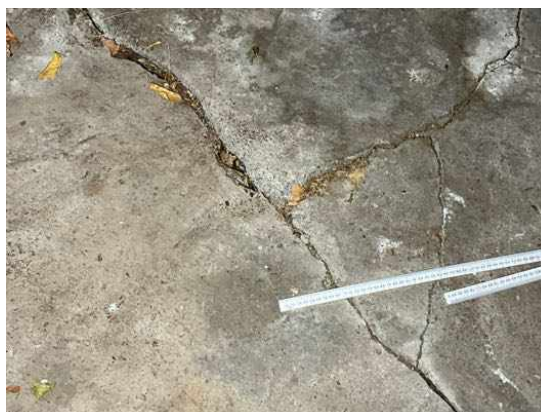
### Finding 3.08

Building:	Building 1
Location:	Yard - Back, garage
Finding:	Cracking - External Concrete Paving Damage Category 4 - Gaps in Slab (4mm - 10mm +)
Information:	Gaps in the slab were identified in external concrete paving. Gaps in the slab are significant and are likely to lead to the development of safety hazards and secondary defects if left unmanaged, such as the creation of a trip hazard.

General age and expected deterioration of the paved areas is a common cause of this type of cracking. However, expansion and contraction of the slab may also have occurred due to environmental factors. Such factors include variable moisture and weather conditions, the presence of trees and their roots having a settling or lifting affect on the soil, or the effect of load bearing, e.g. heavy vehicles over a sustained

Cracking to this degree may also be due to poor original installation of the concrete. Factors such as poor compaction of the sub surface and/or inadequate reinforcing of the slab may create cracking and other secondary defects. Gaps in the concrete paving may also have a more significant structural cause, such as subsidence of soils.

Where gaps in the concrete paving are adjacent to structural elements of the building, the advice of a Structural Engineer is advisable before undertaking repairs. Significant repair and likely replacement of the concrete paving is probable.

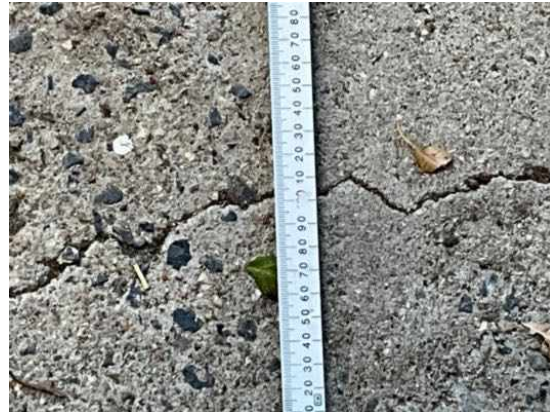
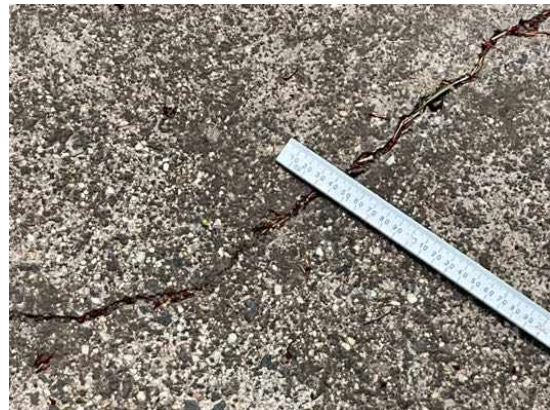
### Finding 3.09

Building:	Building 1
Location:	Verandah, driveway
Finding:	Cracking - External Concrete Paving Damage Category 1 - Fine (less than 2mm)
Information:	Fine cracks were identified in external concrete paving. Although fine cracks are quite noticeable, they are often only considered to be an appearance defect, and usually do not indicate any structural damage. To be considered a Category 1 or fine crack, the crack is found to be less than 2mm in width.

Generally the cause of a hairline crack in existing concrete paving such as driveways and pathways is indicative of the expansion and contraction of the concrete. Such

causes are generally due to environmental factors, such as moisture levels, weather conditions, root systems of nearby trees or the soil types on which they are laid.

Fine cracks may also be due to poor original installation of the concrete. Factors such as poor compaction of the sub surface and/or inadequate reinforcing of the slab may create cracking and other secondary defects.

Monitoring of all cracking should be conducted frequently. Always contact a building inspector should cracks widen, lengthen, or become more numerous.

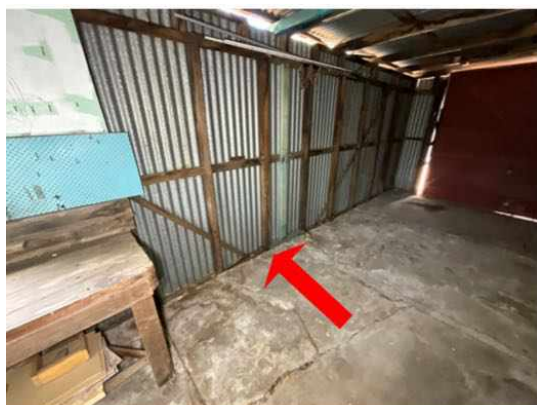
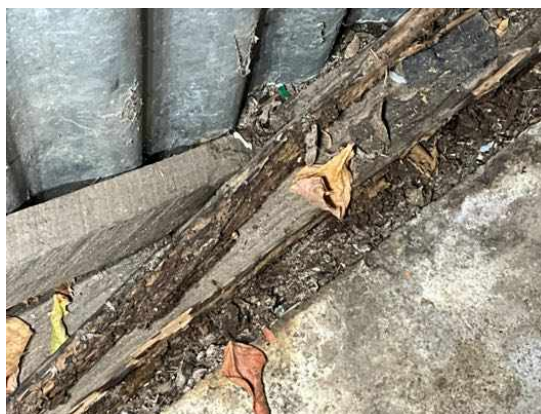
Building:	Building 1
Location:	Garage
Finding:	Evidence of termite damage - minor
Information:	Despite no live termite or timber pest activity being indicated, previous termite damage

was found to have affected this area. This damage is considered to be inactive and is minor in nature.

It is advised that the area be visually inspected frequently to ensure that the condition of affected building materials does not worsen. At the time of inspection, damage is not structural and is only considered to be superficial.

A building contractor may be appointed to provide a further invasive inspection if further damage is evident.

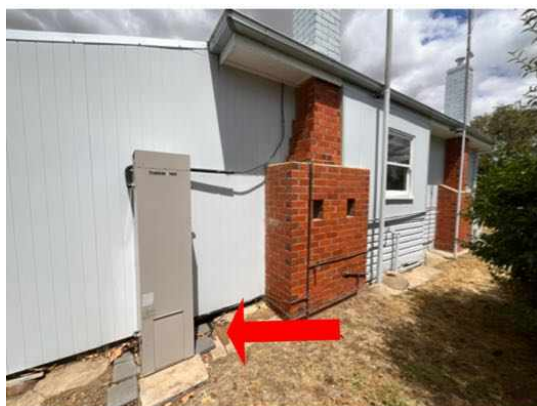
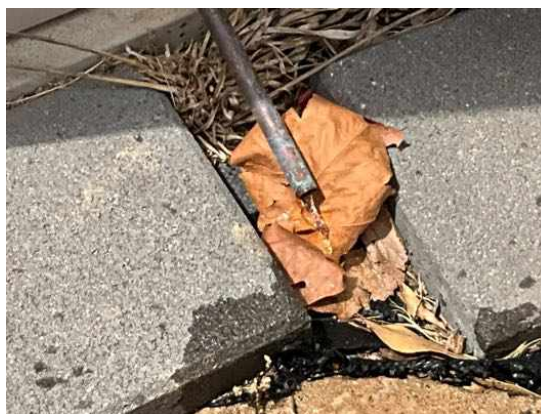
### Finding 6.01

Building:	Building 1
Location:	Yard - Side
Finding:	HWS Overflow - Not Connected
Information:	The Hot Water System (HWS) overflow was found to be disconnected from storm water drainage and is creating excessive moisture in the surrounding area.

These damp conditions can lead to secondary defects such as rot, rust or corrosion of associated building elements, the formation of fungal decay, or even the creation of potential slip hazards. When coupled with poor site drainage, pooling of water may also attract termite activity to this area.

It is highly recommended that a licensed plumber be appointed to connect the HWS overflow in order to prevent such an environment from being created. These minor works should be carried out as soon as possible.

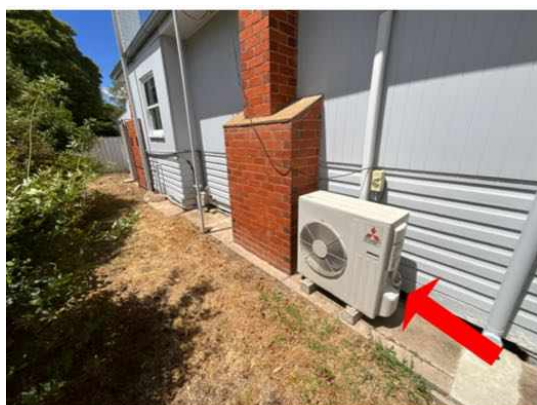
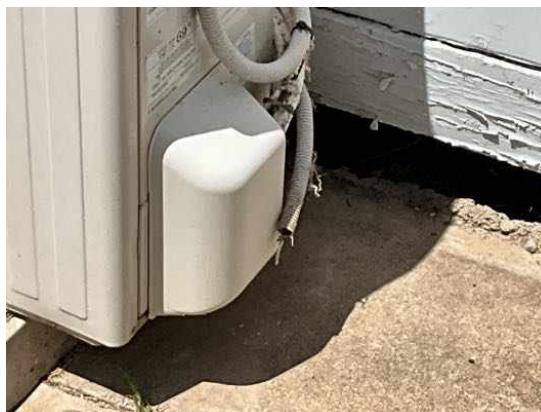
### Finding 6.02

Building: Building 1  
 Location: Yard - Side  
 Finding: Air conditioner - Disconnected overflow  
 Information: The Air Conditioner (A/C) overflow was found to be disconnected from storm water drainage and is creating excessive moisture in the surrounding area.

Such leaking creates an environment which is conducive to an array of defects, including water damage to associated building elements and the attraction of termite or timber pest infestation.

It is highly recommended that a licensed plumber be appointed to connect the A/C overflow in order to prevent such an environment from being created. These minor works should be carried out as soon as possible.

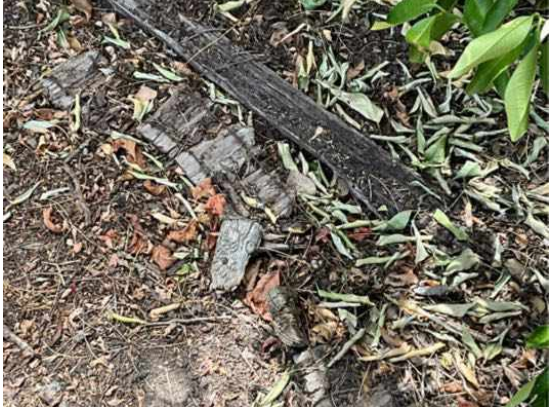
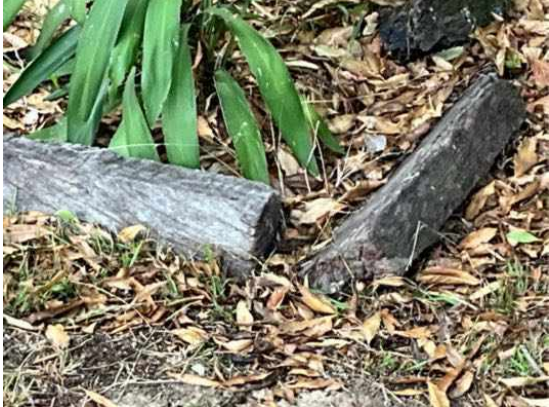
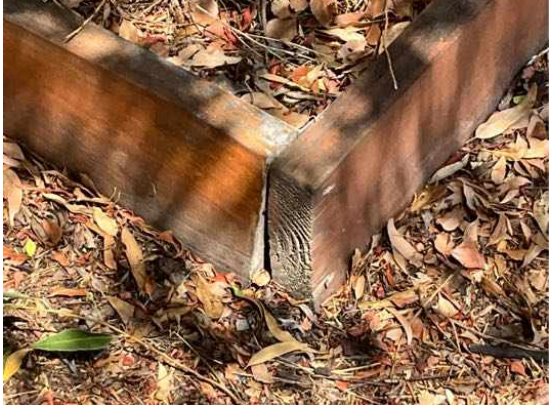
### Finding 6.03

Building: Building 1  
 Location: Yard - Back, driveway  
 Finding: Untreated or non-durable timbers in a hazardous environment  
 Information: To reduce the risk of timber pest attack it is essential that timber used in a hazardous environment (e.g. in direct contact with the ground or frequently exposed to damp

conditions) is of sufficient durability and/or is adequately preservative treated.

Untreated timbers in direct contact with the ground are likely to develop severe wood rot and/or fungal decay if left unattended creating attraction for subterranean termites to infest the timbers from surrounding areas.

If untreated or non-durable timbers are found to be in a hazardous environment it is highly advised that replacement of these building elements be performed as soon as possible to aid the protection of the property against termite / timber pest attack.

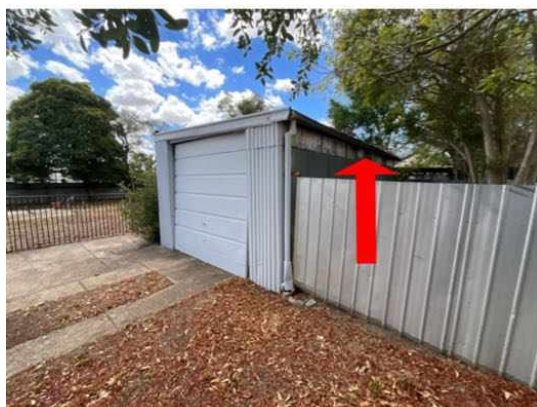
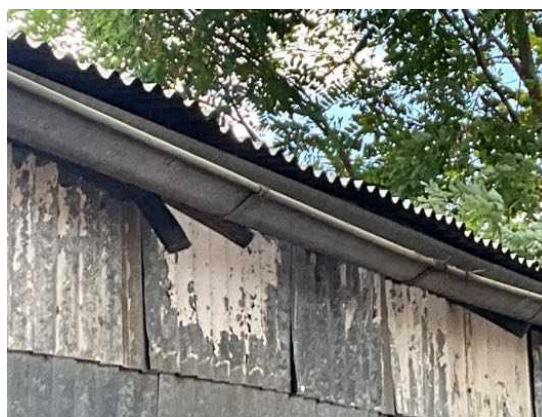
**Finding 6.04**

Location: Garage  
 Finding: Gutters- Deteriorated  
 Information: The guttering and some downpipes have deteriorated.

Although not a major problem now, they will deteriorate further if left for an extended period.

Sagging can be seen in the gutter.

A Licensed Plumber should be engaged as soon as possible to advise on any repairs or maintenance that may be required.

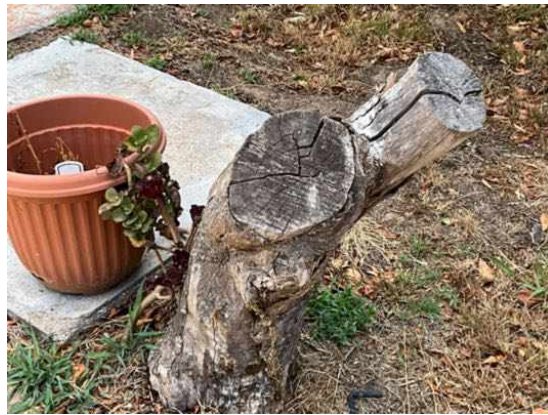
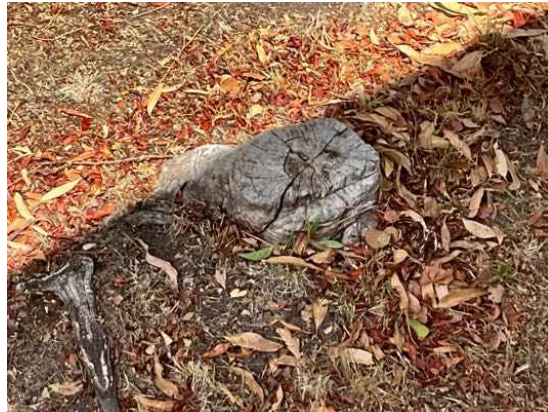
### Finding 6.05

Building: Building 1  
 Location: Yard - Back, driveway  
 Finding: Tree Stump in Ground  
 Information: Any tree stumps in the yard not removed during the tree removal process provides the opportunity for Termite infestation and is likely to be subject to decay from damp conditions against the stump.

All tree stumps should be removed by professional tree removal services where possible. Meanwhile regular inspections are advised to identify any termite activity in the areas identified.

Services for tree stump removal should be contacted as soon as possible to reduce the risk of timber pest attack.

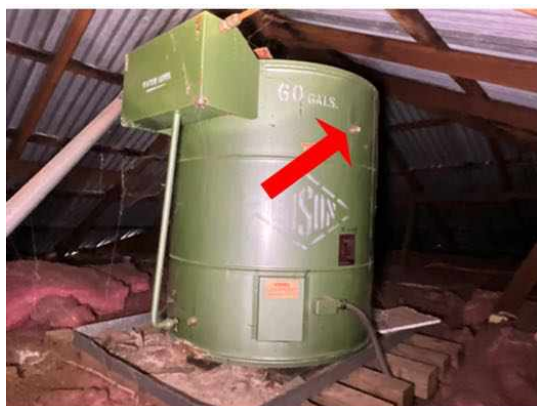
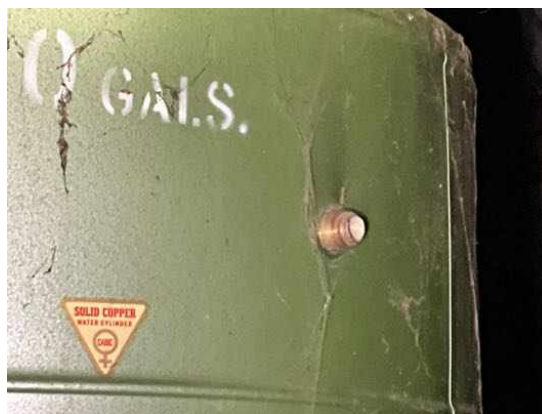
### Finding 6.06

Building:	Building 1
Location:	Roof Void
Finding:	Gravity-Fed HWS - Disconnected
Information:	It was noted at the time of inspection that a disconnected gravity-fed hot water system (HWS) remains in this area.

Despite this plumbing structure being unused, it is likely to be storing residual water, and is therefore susceptible to rust and corrosion. If allowed to continue, rust and corrosion is likely to lead to damage to adjoining building elements, and may also make the area susceptible to termite or timber pest activity.

While it is a costly exercise to remove the disused gravity-fed HWS, it is advisable in the short-term future to prevent any further damage to the area. Further consultation with a licensed plumber is required to gain further advice on removal of the structure.

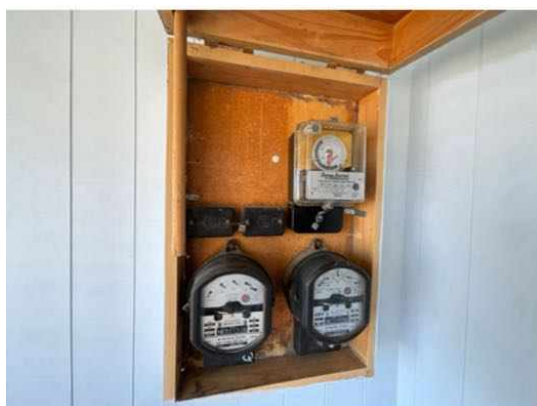
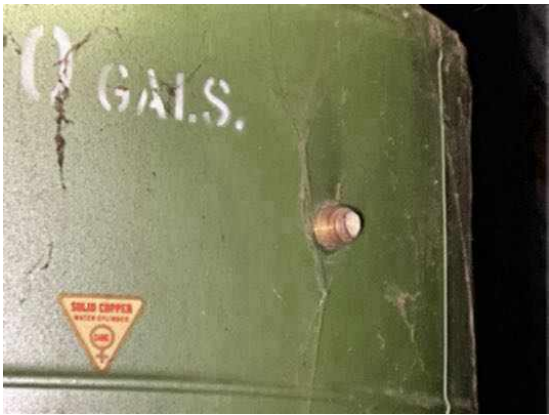
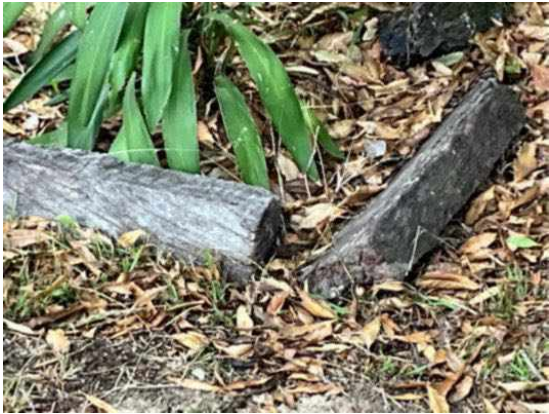
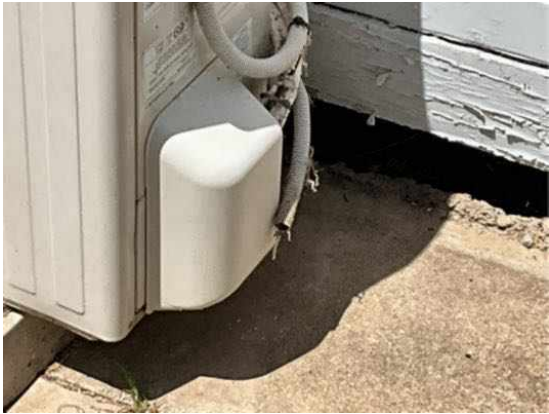
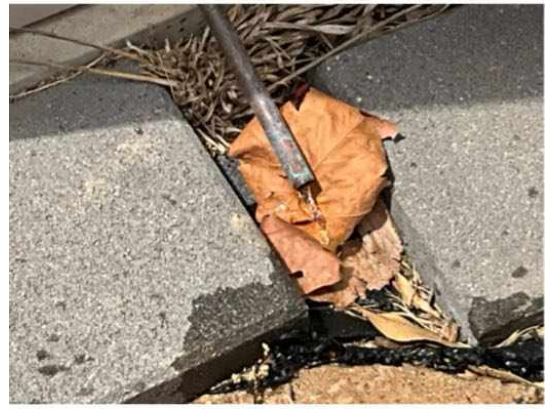
### Finding 6.07

Building:	Building 1
Location:	All External Areas
Finding:	Termite Management System - no evidence of a chemical installation
Information:	The application of a post-construction chemical termite barrier is highly recommended for all properties, particularly if live termite activity has been found on the site previously. Such barriers are highly effective in preventing termite attack on any timber building elements throughout the property.

A durable notice should be placed in the switchboard unit to indicate current termite barriers. At the time of inspection, it appeared as though no termite management system has been installed, with no evidence to suggest preventative works taking place.

The client may consider gaining further advice from a pest controller as to the costs and procedures involved with this application. It is recommended that obtaining such advice be a short-term priority.

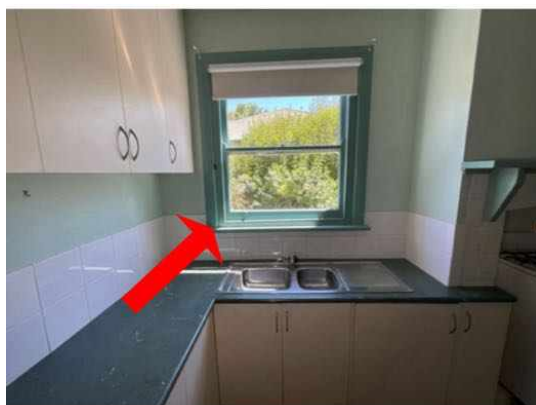
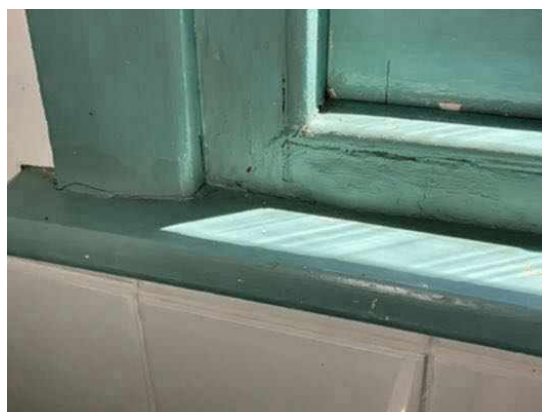
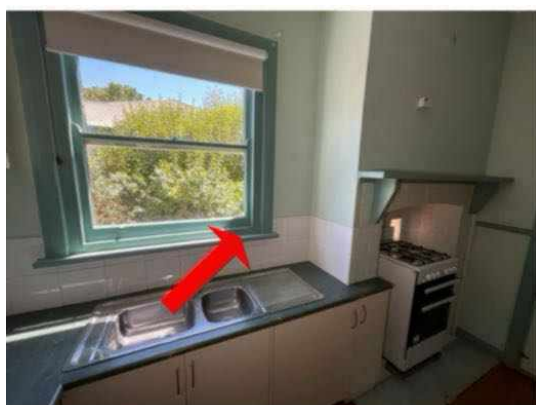
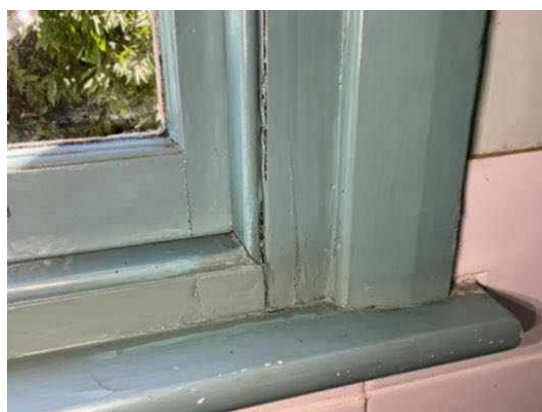
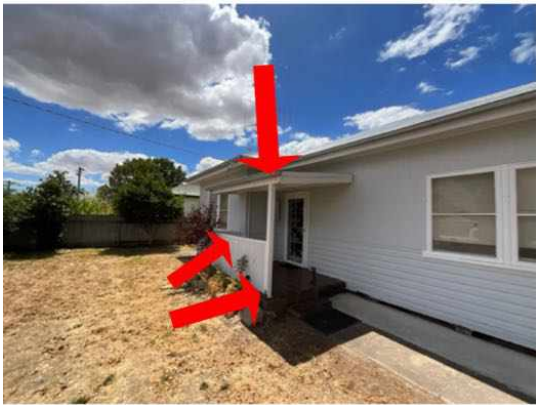
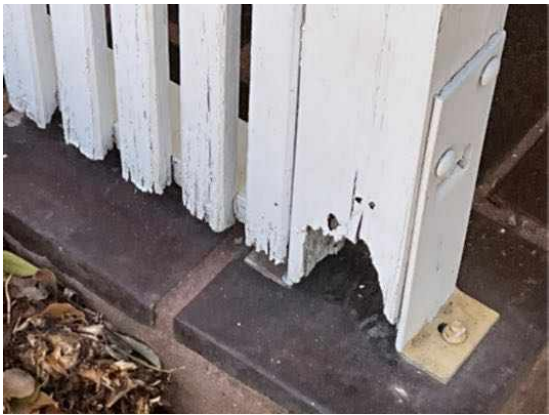
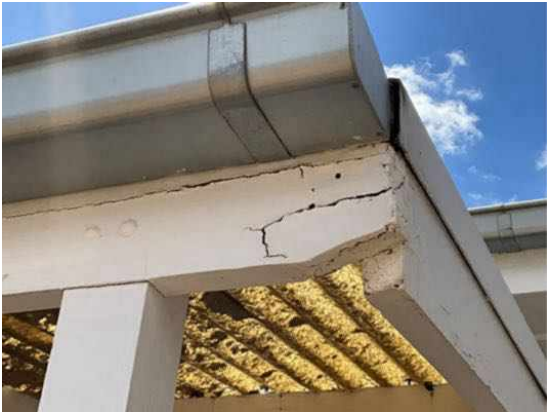
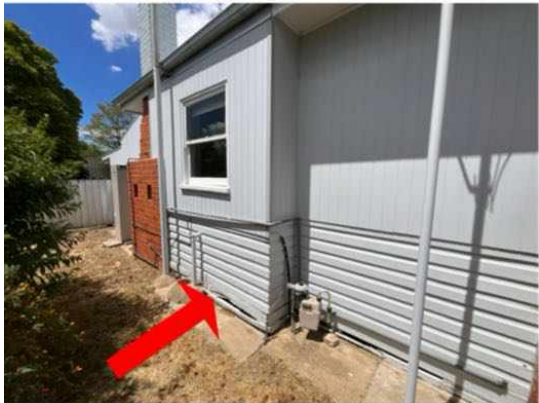
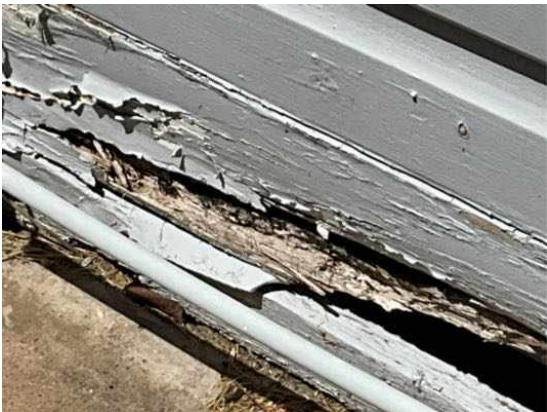
### Finding 7.01

Building:	Building 1
Location:	Kitchen, entry
Finding:	Fungal decay - present (localised)
Information:	Fungal decay also known as wood decay or wood rot generally refers to the deterioration of timber elements when in contact with excessive levels of moisture for a prolonged period of time.

The development of fungal decay is accelerated by temperatures in the range of 5degreeC to 40degreeC as well as the presence of oxygen. Generally fungal decay develops on timber elements that are in use in an external environment which are exposed to rain penetration.

In this case although the affected timber element is in a decaying state the extent of any visible damage appears to be localised to a specific area and is yet to spread to other parts of the building element or affect adjoining structures. The fungal decay is therefore likely to be of a relatively superficial nature with minimal impact on the structural integrity or tensile strength of the timber element.

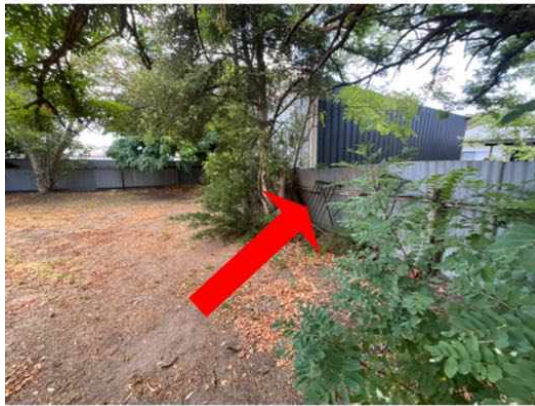
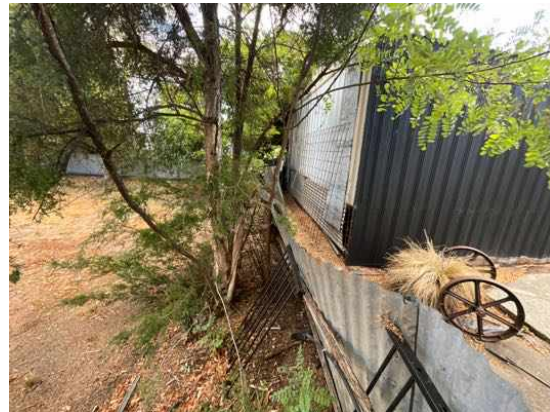
Building: Building 1  
 Location: Yard - Back  
 Finding: Fence  
 Information: The fence in this area has deteriorated. Sections are poorly supported.

A handyman or fence specialist should be contacted as required to restore the area to original condition and prevent further deterioration.

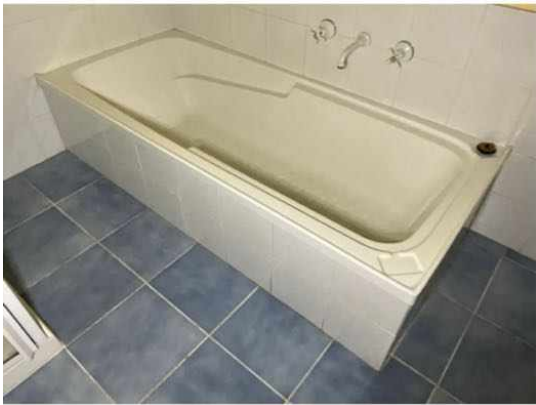
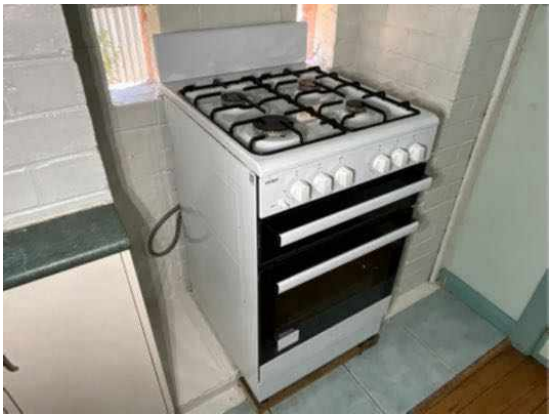
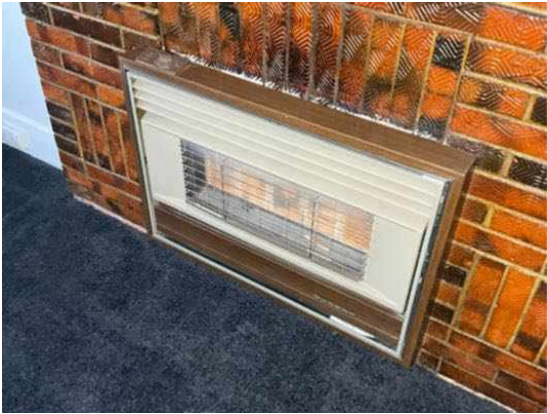
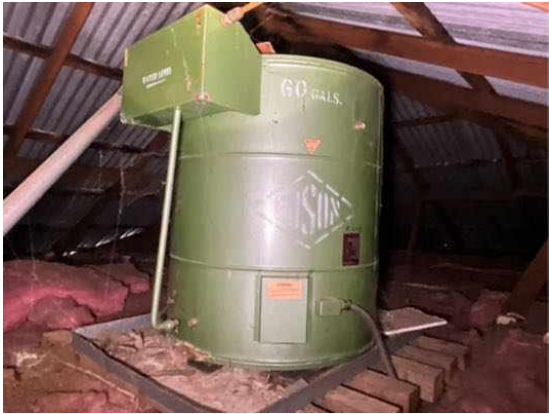
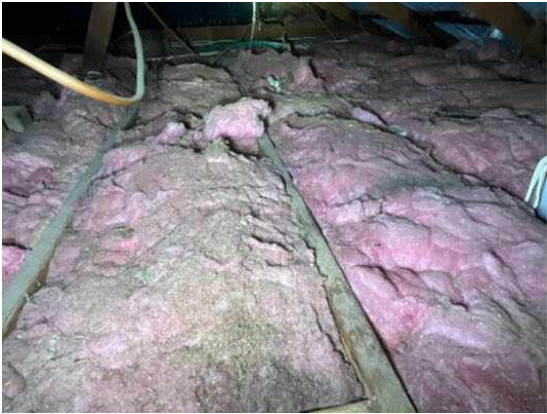
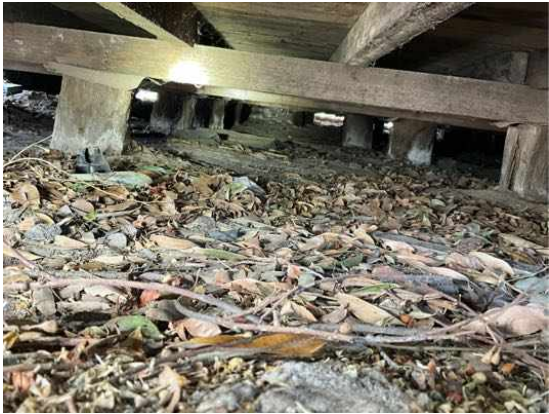
Building: Building 1  
 Location: All Areas  
 Finding: Additional Photos - Obstructions and Limitations  
 Information: These photographs are an indication of the obstructions and limitations which impeded full inspection of the property at the time of inspection. These obstructions can hide an array of defects and should be removed to allow full inspection to be carried out. A re-inspection is recommended once the areas are made accessible.
