Building and Timber Pest Inspection Report

Inspection Date: Tue, 10 Feb 2026

Property Address: 84 Hamblynn Rd, Elizabeth Downs SA 5113,
Australia

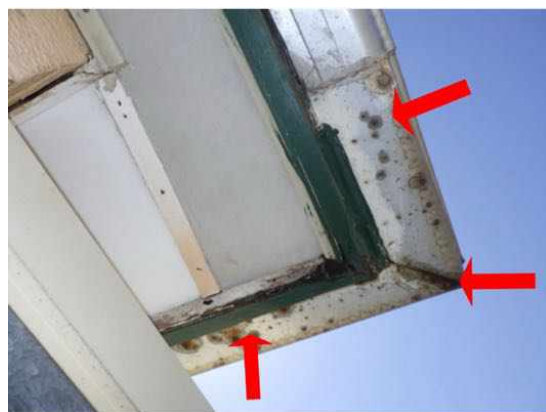
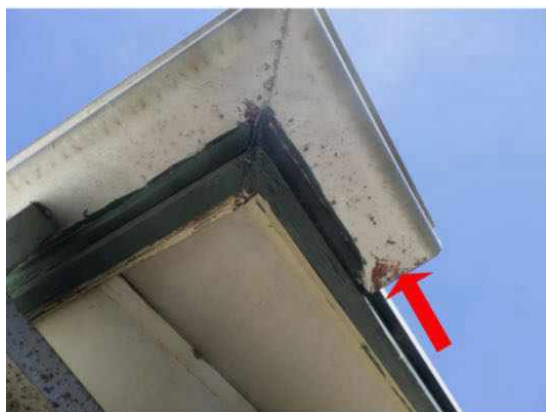
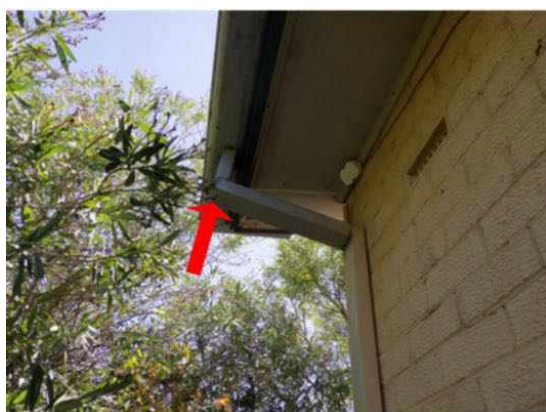
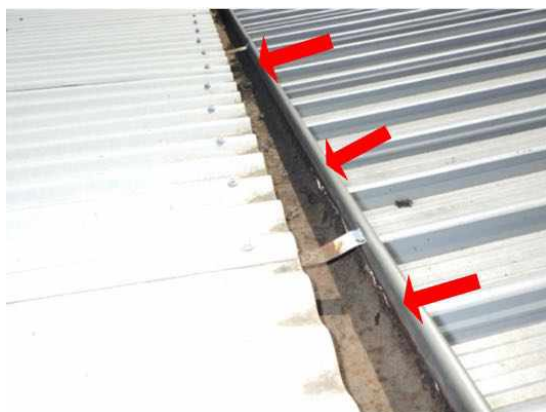
Building: Building 1
Location: Roof Exterior
Finding: Roof plumbing - Rusted or corroded
Information: The roof plumbing has areas of rust and corrosion throughout large sections of the guttering and down-piping. It is suspected that this has been caused by blockages, resulting in pooling or standing water, that have prematurely rusted elements of the roof plumbing.

Rusted roof plumbing will generally develop holes and leaks that can affect other building elements with poor drainage of storm water.

Poorly drained roof areas will also lead to damp conditions surrounding the base perimeter of the building which, if left unmanaged, can lead to a range of secondary building defects.

Repair and/or replacement of rusted roof plumbing is highly required in order to reinstate the roof drainage system to a fully operational level.

To further maintain these areas, gutters should be cleaned frequently, allowing the avoidance of any partial blockages.

A licensed plumber or specialist roof restoration company should be appointed to undertake these works. It is advised that such works be completed as soon as possible to prevent any further damage and deterioration.

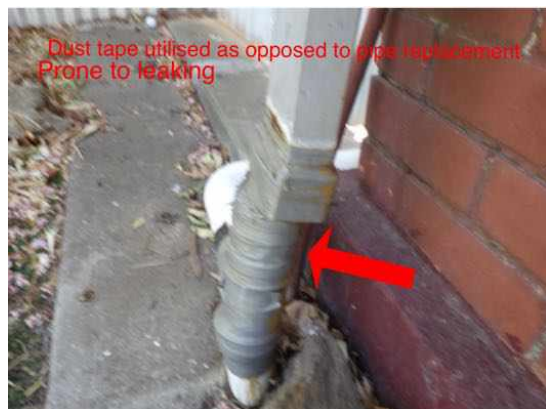
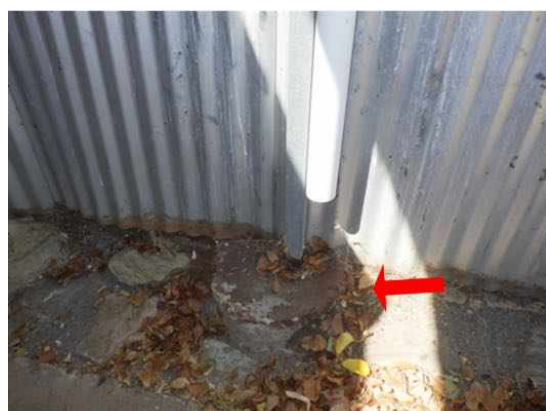
Finding 3.01

become excessively damp, potentially creating an environment that is susceptible to rust and corrosion of surrounding building elements, as well as attracting termites and other pests.

It is highly recommended that a plumber be appointed to further inspect the area and to install adequate drainage equipment where necessary.

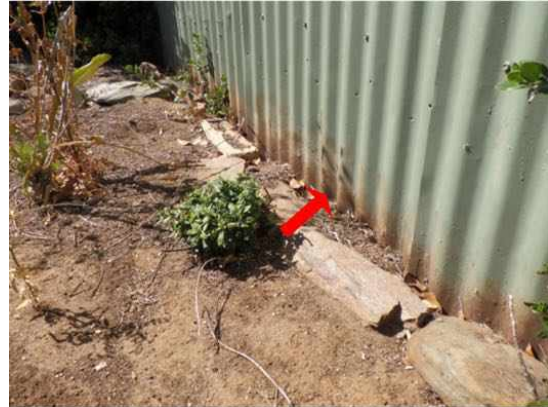
Finding 3.02

Building:	Building 1
Location:	All External Areas
Finding:	Fencing - Deteriorated
Information:	It was noted at the time of inspection that sections of the fencing throughout the property have deteriorated. Typically fencing deteriorates due to age and or wear, rot and or rust which is generally expected for a structure of this age, due to prolonged exposure to weather conditions. Sometimes inadequate installation or maintenance can be to blame.

If left unattended, it is likely that further damage will occur. It is suspected that repair of several elements of the fencing may be required however replacement may be a consideration of the client also.

A licensed fencing contractor should be appointed to provide further advice and

perform rectification works as necessary.

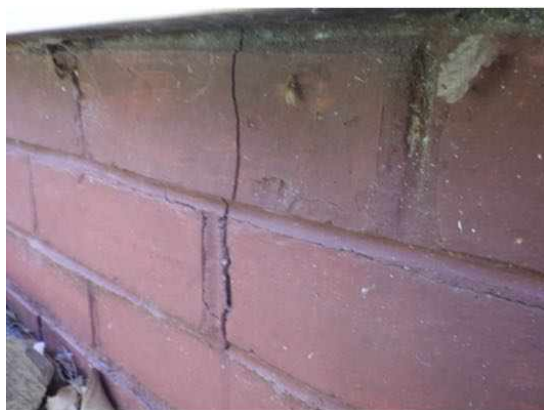
Finding 3.03

Building:	Building 1
Location:	Exterior walls
Finding:	Brickwork - Cracking [Fine]
Information:	There were fine cracks evident to the external brickwork at the time of inspection.

Although fine cracks are quite noticeable, they are often only considered to be an appearance defect and usually do not indicate any structural damage. Generally, the cause of a fine crack is indicative of a separation between brickwork and mortar throughout the structure, but single bricks may also show cracks of this nature.

Cracking of this nature can generally be repaired with minor filling and should be conducted by a qualified bricklayer.

Always contact a building inspector should cracks widen lengthen or become more numerous.

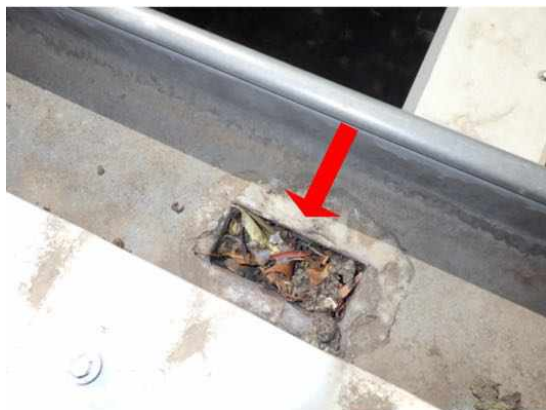
Finding 3.04

Building:	Building 1
Location:	Roof Exterior
Finding:	Gutters/stormwater - Blocked
Information:	Roof plumbing structures, such as guttering and downpipes, should be free of all debris to prevent blockages. Blockages of the guttering and downpipes will lead to pooling and accumulated water overflows, which is likely to subsequently flood eaves and exterior walls.

Blocked gutters are likely to lead to high levels of moisture in the affected areas. Such

moisture will not only cause rust and decay of the associated building materials, but can also provide conditions that are conducive to termite and timber pest activity. Blockages in gutters should therefore be removed immediately to ensure dry conditions are maintained.

Consult a Licensed Plumber for further specific advice on remedial works that may be required. In the interim, it is highly advised that blocked gutters be removed by the homeowner or a general handyperson as a matter of urgency.

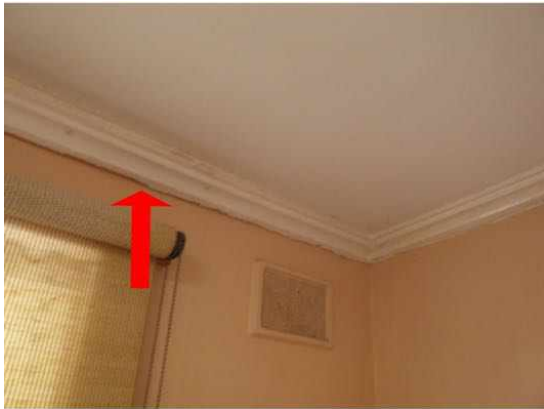
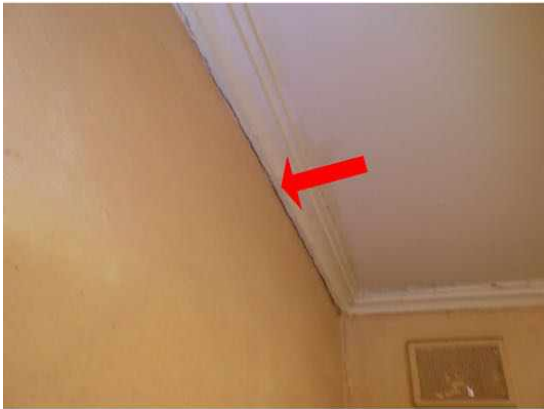
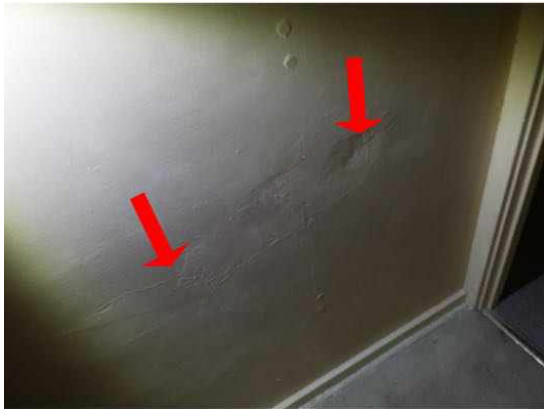
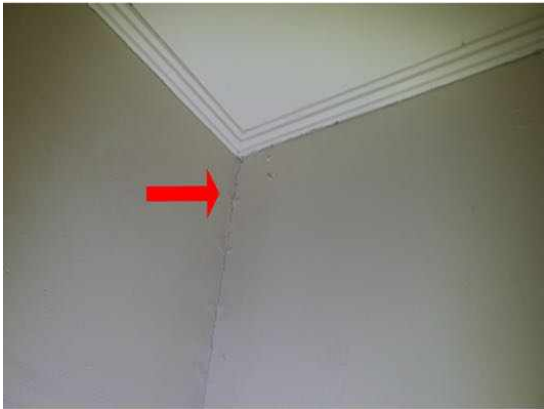
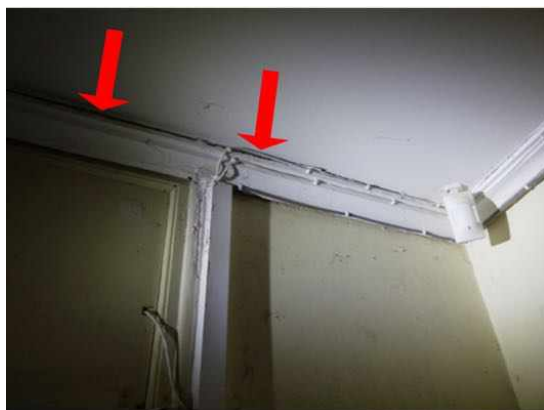
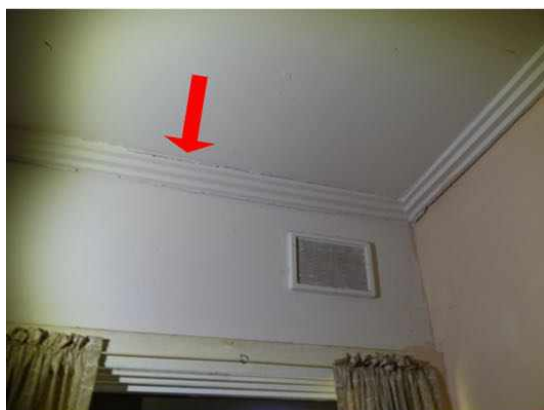
Finding 3.05

Building:	Building 1
Location:	All Internal Areas
Finding:	Cracking and repairs, Walls and ceilings
Information:	Several cracks and or crack repairs were evident throughout the internal walls and ceilings of the property.

Although fine cracks are quite noticeable, they are often only considered to be an appearance defect and usually do not indicate any structural damage. Generally, the cause of a fine crack is indicative of minor expected movement of a structure of this age however as repairs have been carried out, it is impossible to know the extent of any cracking.

Cracking of this nature can generally be repaired with minor filling and should be conducted by a qualified painting contractor

Always contact a building inspector should cracks widen lengthen or become more numerous.

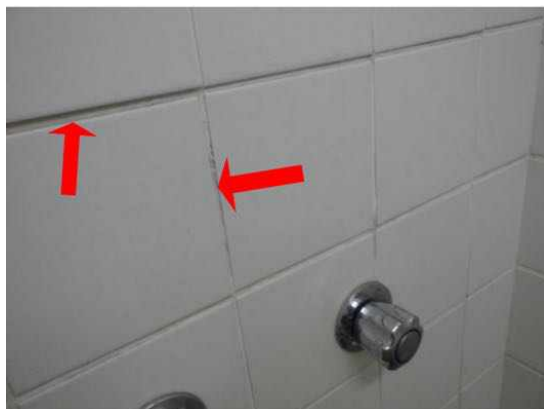
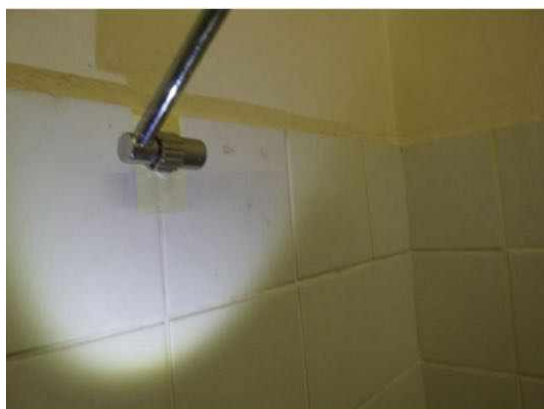
Finding 3.06

Building:	Building 1
Location:	Bathroom
Finding:	Sealant and grouting - Regular maintenance
Information:	It was noted on inspection that sealant and grout has small areas of deterioration evident to the shower alcove at the time of inspection.

Silicone and grout generally need repair at least every 5 years and as such close monitoring should be carried out in the future after repairs are carried out.

Different materials and floor areas move at different rates, generally causing cracking to grout or sealant at this point. A flexible sealant is required to allow for expected expansion and contraction, while keeping the joint water tight and protective of all associated building materials.

Flexible and mould resistant materials should be applied to affected areas to prevent any subsequent water damage that is likely to occur. Regular maintenance and replacement of damage or missing or damaged sealant and grout is highly recommended to the wet areas, as this is a regular wear and tear defect. Sealant and grouting in areas that come into regular contact with water should be maintained for the long term care of your property.

A sealant specialist or tiling contractor should be appointed to complete these works

as soon as possible

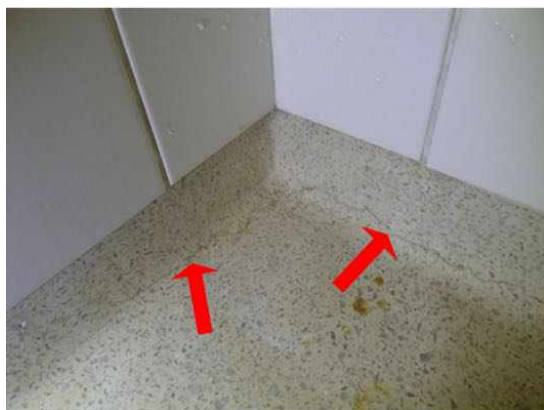
Finding 3.07

Building:	Building 1
Location:	Bathroom
Finding:	Terrazzo - Cracked
Information:	Cracking in the floor was evident in the shower area at the time of inspection. It is suspected that this cracking has occurred as a result of general old age and old construction methods.

Cracked tiles throughout the household detract from the overall appearance of the affected areas, as well as creating potential for water penetration to adjoining building elements. If left unmanaged, water damage may occur as a result of constant water penetration over a prolonged period of time.

While not considered a matter of urgency, repairs are recommended by a terrazzo repair specialist.

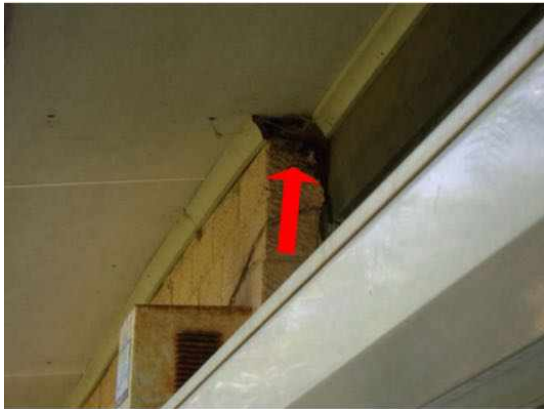
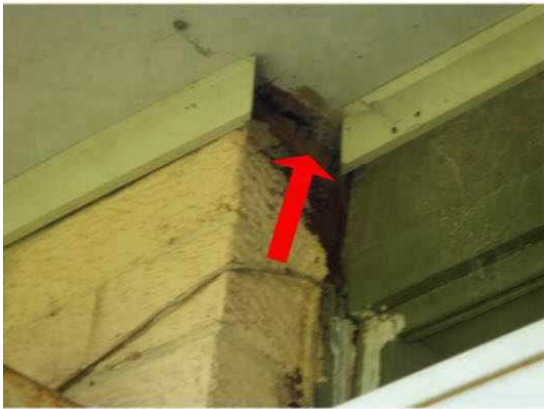
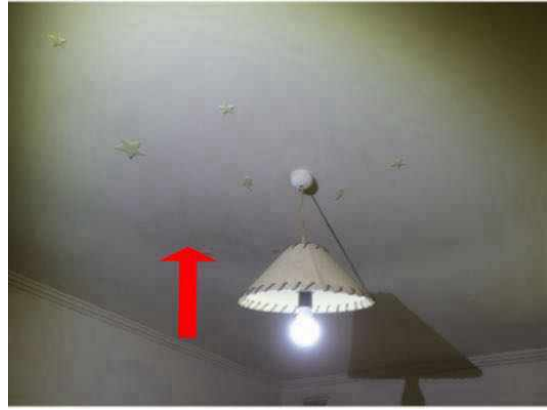
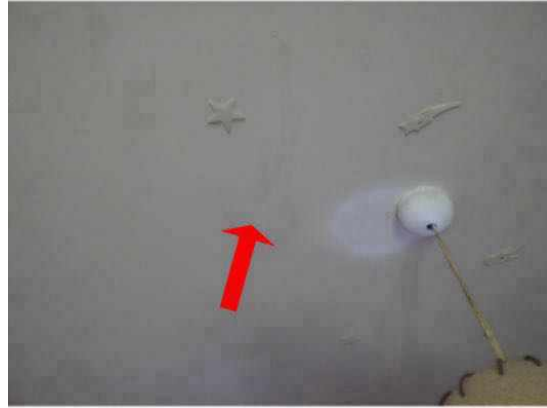
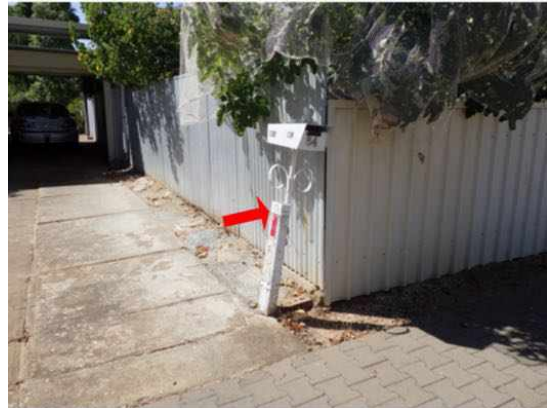
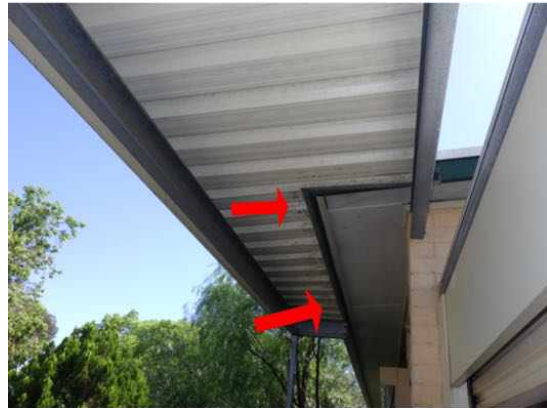
Finding 3.08

Building: Building 1
 Location: All Areas
 Finding: Minor defects present
 Information: There were several age and maintenance related defects evident to the dwelling at the time of inspection. These defects include but are not limited to

- Back porch concrete cracking
- Missing external cornice preventing weathertight seal.
- Fan not functional in bathroom
- Missing tiles beside bath mixer and taps.
- Gaps beside windows.
- Water staining from old water leak.
- Lock not functional.
- Letter box leaning
- Slightly corroded roof sheets.

Appropriate licensed trades people could be appointed to make repairs at the discretion of the client.

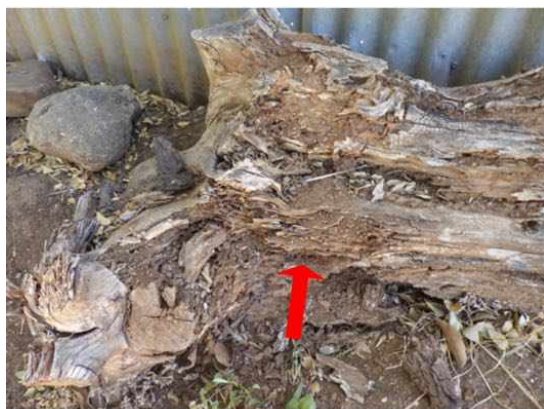
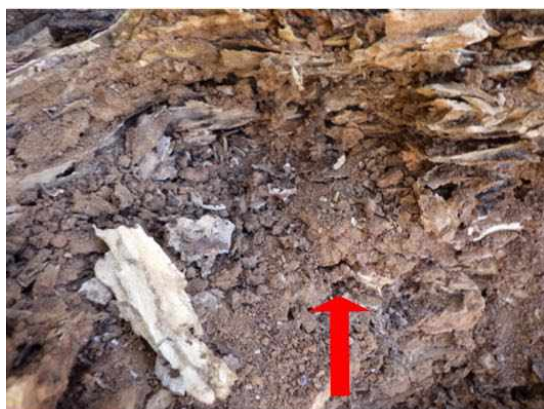
Building:	Building 1
Location:	Yard - Back
Finding:	Evidence of termite damage - minor
Information:	Despite no live termite or timber pest activity being indicated, previous termite damage was found to have affected this area. This damage is considered to be inactive and is minor in nature.

It is advised that the area be visually inspected frequently to ensure that the condition of affected building materials does not worsen. At the time of inspection, damage is not structural and is only considered to be superficial.

A building contractor may be appointed to provide a further invasive inspection if further damage is evident.

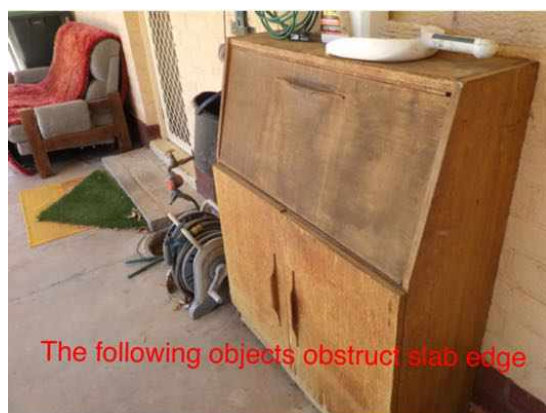
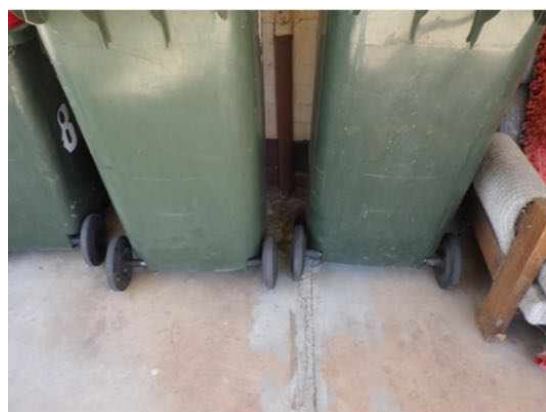
Finding 6.01

If the slab edge is not properly exposed there is a high risk of concealed termite attack which your inspector will likely not be able to see. Sometimes, in order to determine the type of slab, a suitably qualified person such as an architect or builder may be required to consult construction plans.

Where the slab edge cannot be properly inspected, it is highly recommended that termite or timber pest inspections be carried out every 6-12 months to aid protection of the property against infestation and termite treatment advice is followed closely.

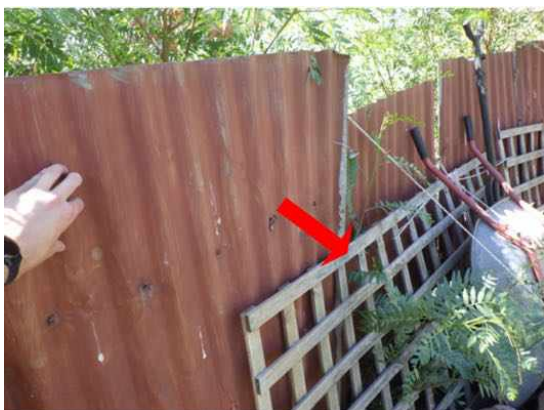
Finding 6.02

Building:	Building 1
Location:	All External Areas
Finding:	Untreated or non-durable timbers in a hazardous environment
Information:	To reduce the risk of timber pest attack it is essential that timber used in a hazardous environment (e.g. in direct contact with the ground or frequently exposed to damp conditions) is of sufficient durability and/or is adequately preservative treated. Additionally any timber lying around or timber stumps should be removed.

Untreated timbers in direct contact with the ground are likely to develop severe wood rot and/or fungal decay if left unattended creating attraction for subterranean termites to infest the timbers from surrounding areas.

If untreated or non-durable timbers are found to be in a hazardous environment it is highly advised that replacement of these building elements be performed as soon as possible to aid the protection of the property against termite / timber pest attack. Failing this close monitoring is recommended in an attempt to identify termite infestation at an early stage.

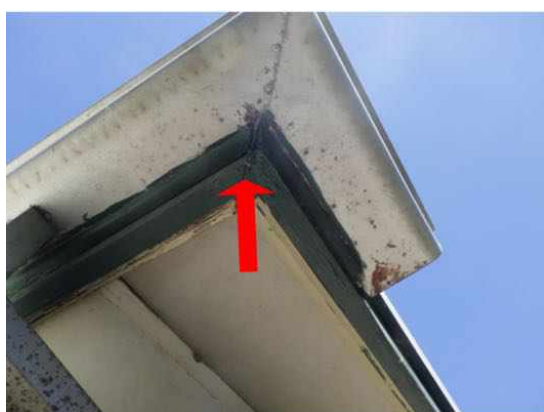
Building:	Building 1
Location:	Roof Exterior
Finding:	Fascias - Wood rot
Information:	Wood rot was found to be affecting fascias and barges throughout the roof, evidenced by the presence of deterioration on the surface in some areas. Wood rot, also known as Fungal Decay, occurs when timbers and other cellulose building materials are exposed to damp conditions on an ongoing basis.

It is likely that this wood rot has developed as a result of faults in the roof plumbing, creating excessive moisture in this areas.

Frequent exposure to rain and other weather conditions also make fascias and barges susceptible to accelerated deterioration.

Early intervention and regular maintenance will prolong the useful life of these building elements. Prior to any works being performed, the cause of the moisture that has created the visible wood rot should be identified and addressed in a suitable manner.

It is advised that a roof plumber be appointed to inspect all roof plumbing and subsequently identify the cause of the wood rot. Replacement of affected fascias and barges may then be a necessary step in protecting surrounding building elements from such deterioration.

A qualified plumber may be appointed to assess the cause of excessive moisture and to provide advice on any remedial works as required. A qualified carpenter or may also be required to replace affected building materials.
