# Building and Timber Pest Inspection Report

Inspection Date: Wed, 18 Mar 2026

Property Address: 20 Greendale Ave, Pymble NSW 2073,  
Australia

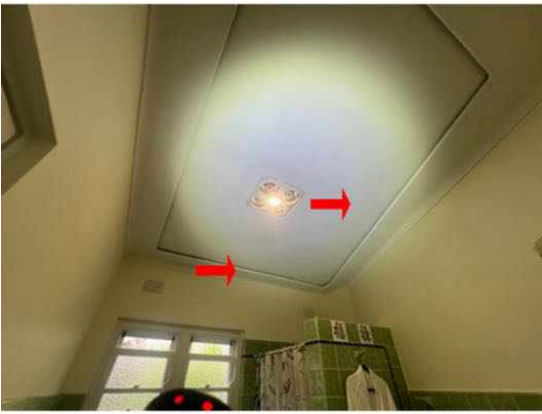
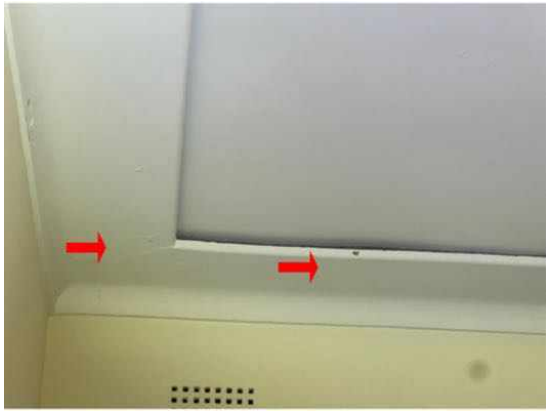
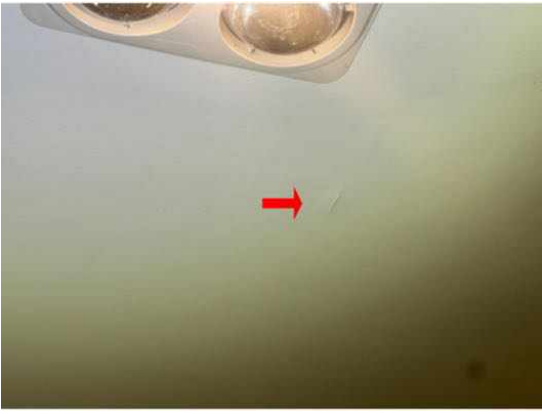
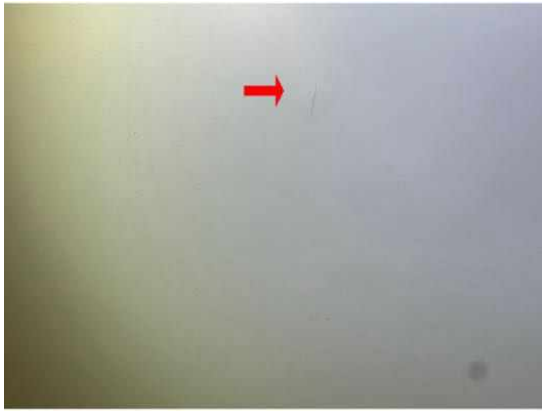
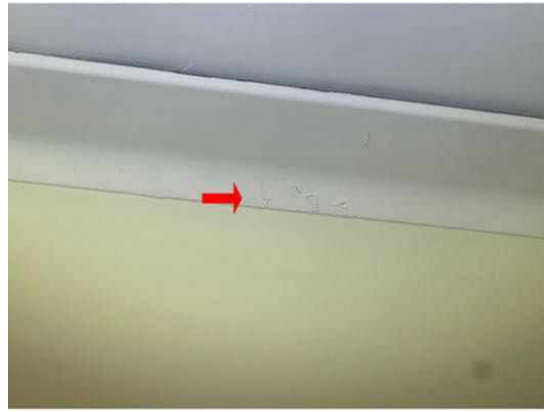
Building: Main Building  
Location: All Internal Areas - Lower area, bathroom, dining , chimney wall, bathroom 2  
Finding: Painted surface - Bubbling and water staining - Multiple Areas  
Information: Sections of paint in this area was found to have bubbled and deteriorated. Paint bubbling is generally an indication of excessive moisture in the area, that is currently hidden by the painted surface.

The presence of excessive moisture can have major implications on associated building elements if left unattended. While only seemingly minor at this stage, the damage cannot be determined due to the paint obstructing any further inspection of the damage.

It is highly advised that the affected paint be cleaned to allow a further, more invasive inspection by a licensed plumber. Failure to act on this defect may necessitate major works in the future.

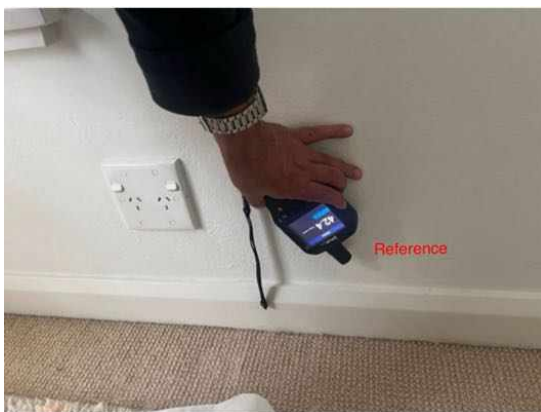
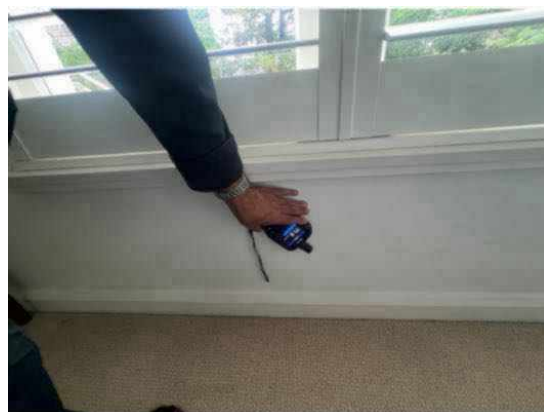
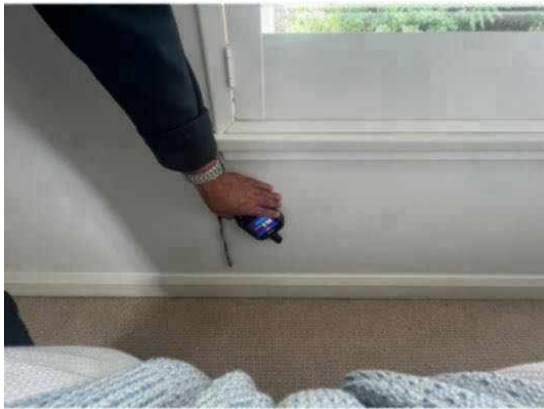
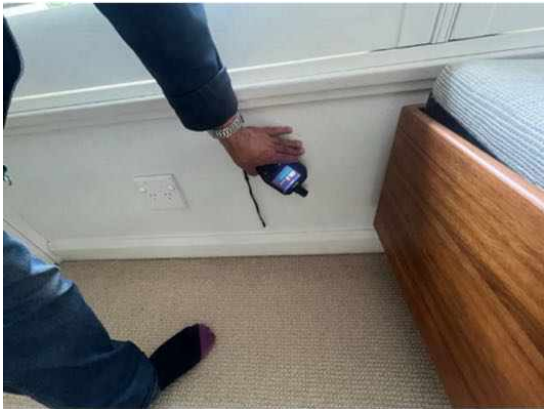
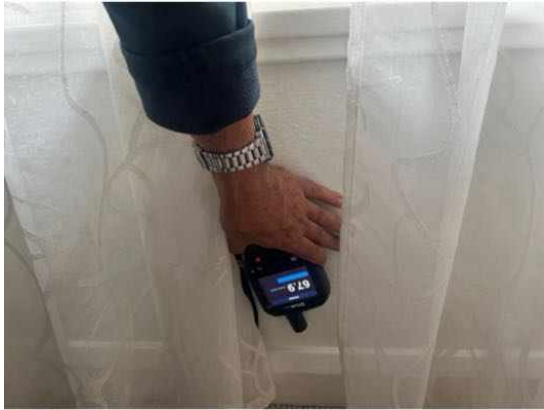
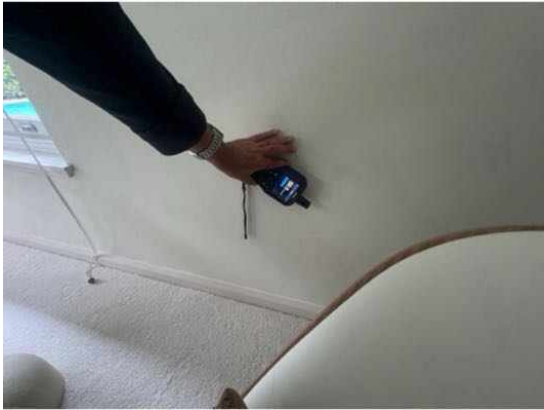
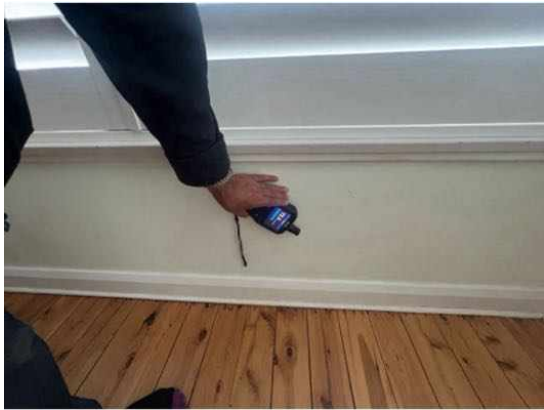
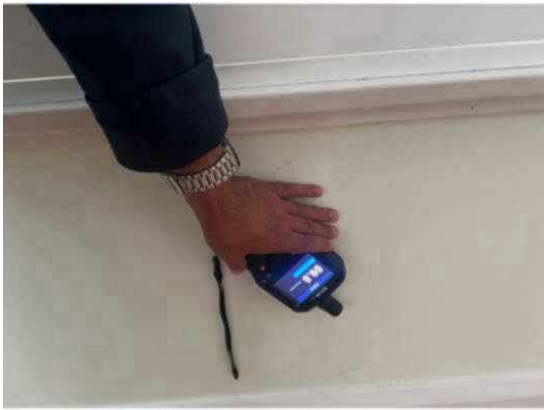
### Finding 3.01

Building:	Main Building
Location:	All Internal Areas - Bedrooms front , kids bedroom , hallway , formal dining , ceiling front bedrooms
Finding:	Elevated Moisture – Further Investigation Recommended
Information:	Elevated moisture readings were detected in several locations, with some areas also showing minor deterioration while others did not present visible surface issues, although no significant structural damage was evident at the time of inspection, dampness can contribute to deterioration if left unaddressed. Inspector was not able to inspect the external wall due to space constraints. A further investigation by a licensed plumber or waterproofing specialist is recommended to confirm the source and ensure no concealed issues are developing.

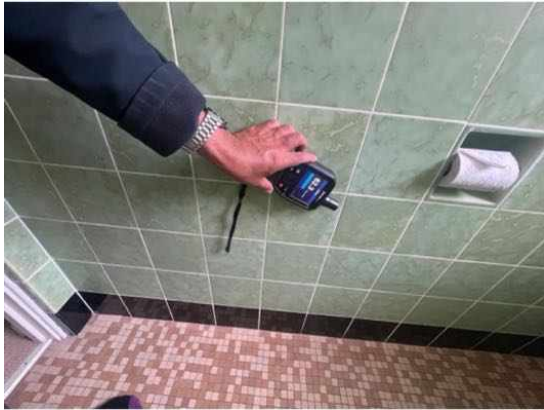
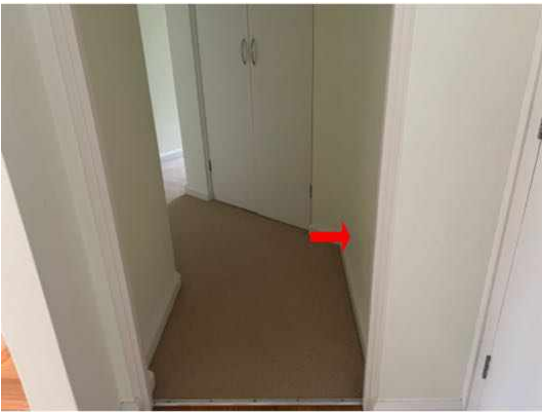
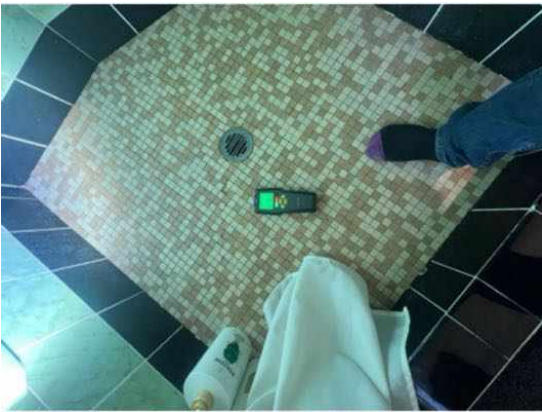
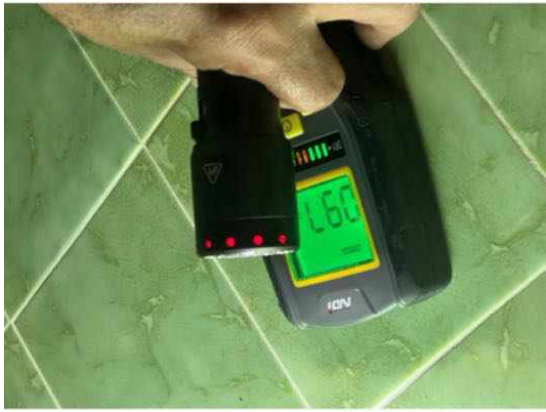
**Finding 3.02**

Building: Main Building  
Location: Bathrooms  
Finding: Elevated Moisture Bathroom & Back of shower - Further investigation required (Possible waterproofing)  
Information: Elevated moisture levels were detected to tiled surfaces in bathroom/shower areas. This may be due to porous or missing grout, cracked tiles or recent use, however the possibility of waterproofing membrane failure or plumbing leaks cannot be excluded. Persistent moisture ingress can lead to concealed damage, including timber rot and mould growth. Further investigation by a licensed plumber and/or waterproofing contractor is recommended as soon as possible. The back of shower area also showed elevated moisture but no visible deterioration was evident at the time of inspection.

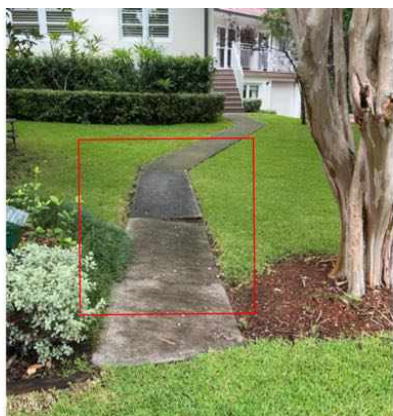
Information: Sections of the external paved area are uneven, creating a potential trip hazard. It appears as though the area has been subject to rough installation, or that paving sections have lifted due to movements in the foundation of the property.

Where paving creates a trip hazard, personal injury may ensue if due caution is not taken by all persons within this area.

Re-paving of the area is required as soon as possible to remedy this situation. Further consultation with a specialist concreter is advised.

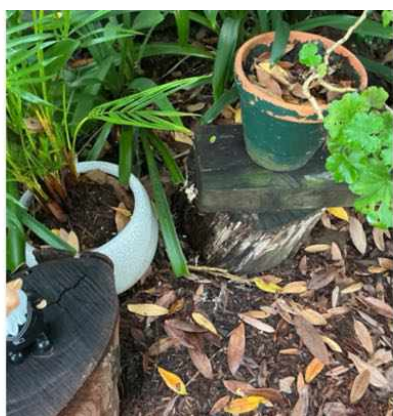
Building:	Main Building
Location:	All External Areas
Finding:	Wood rot to some areas
Information:	This building element shows evidence of wood rot. Wood rot, also known as Fungal Decay, occurs when timbers and other cellulose building materials are exposed to damp conditions on an ongoing basis. This could be the result of exposure to weathering over a prolonged period of time, or the attraction of excessive moisture from other abutting building materials. Contributing factors also include poor air ventilation in the area.

Wood rot is often associated with general damp problems and is evidenced by a 'musty' smell or mould and mildew occurring on surfaces. If left unmanaged, damp conditions can lead to further health problems and the decay of timbers will continue.

Early intervention and regular maintenance, particularly of exterior timbers, will prolong the useful life of these building elements. Prior to any works being performed, the cause of the moisture that has created the visible wood rot should be identified and addressed in a suitable manner. Replacement of affected timbers may then be a necessary step in protecting surrounding building elements from such deterioration.

A qualified plumber may be appointed to assess the cause of excessive moisture and to provide advice on any remedial works as required. A qualified carpenter or registered builder may also be required to replace affected building materials.

Even though Liverpool termite activity was not visible. A further invasive inspection by a licensed termite technician its also highly recommended to eliminate possibility of potential termite activity.

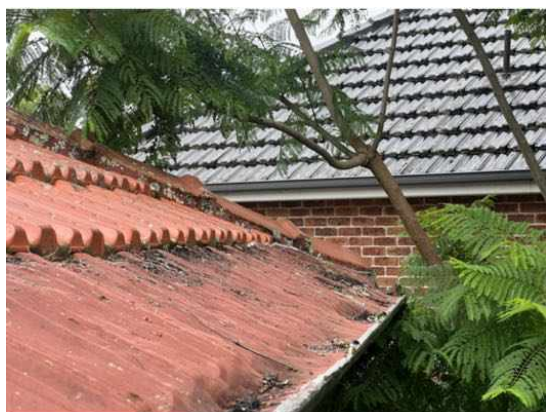
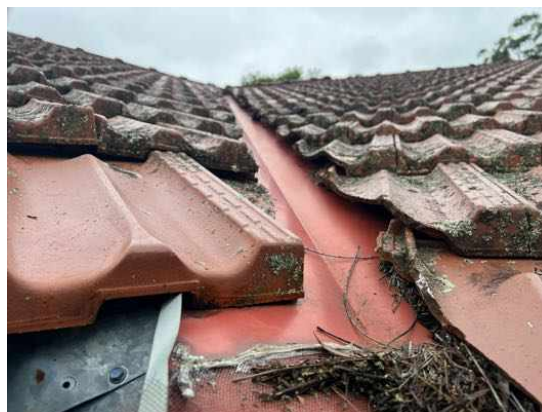
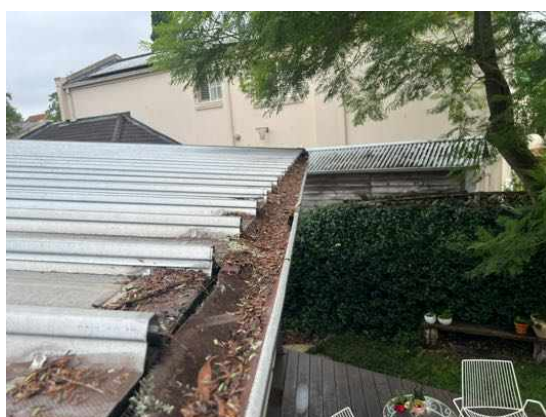
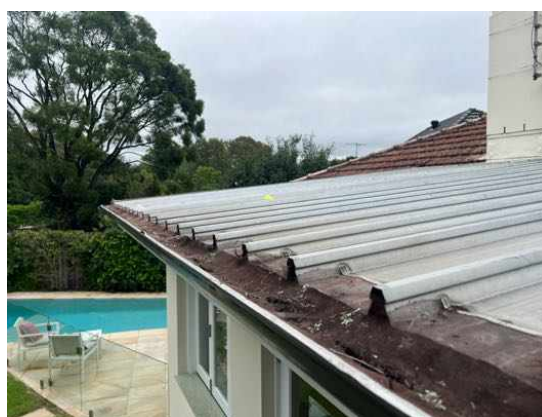
Finding 3.12

Blocked gutters are likely to lead to high levels of moisture in the affected areas. Such moisture will not only cause rust and decay of the associated building materials, but can also provide conditions that are conducive to termite and timber pest activity. Blockages in gutters should therefore be removed immediately to ensure dry conditions are maintained.

Consult a Licensed Plumber for further specific advice on remedial works that may be required. In the interim, it is highly advised that blocked gutters be removed by the homeowner or a general handyperson as a matter of urgency.

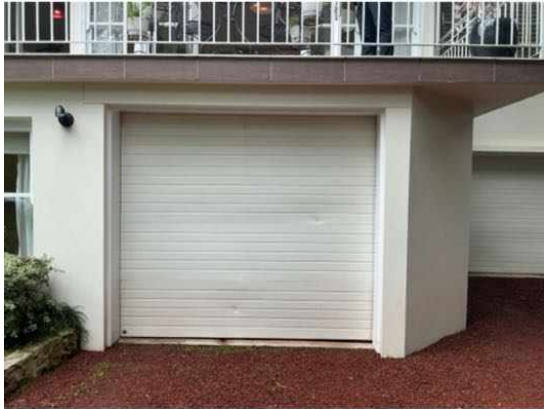
**Finding 3.13**

Building: Main Building  
Location: All External Areas  
Finding: Building element - Damaged - Garage door dented , chipped render right side , fence slight lean and damage , hole not sealed garage , side gate binding  
Information: Breakage occurs generally when the building materials have either aged and decayed, or as a result of damage (accidental or deliberate).

Repair and/or replacement of broken elements is advised to ensure that additional secondary defects do not arise as a consequence. Such works are necessary, as all building elements play a key role in the operation and function of the overall structure and its performance.

A relevant tradesperson should be appointed to repair or replace the affected building element prior to any subsequent damage being caused.

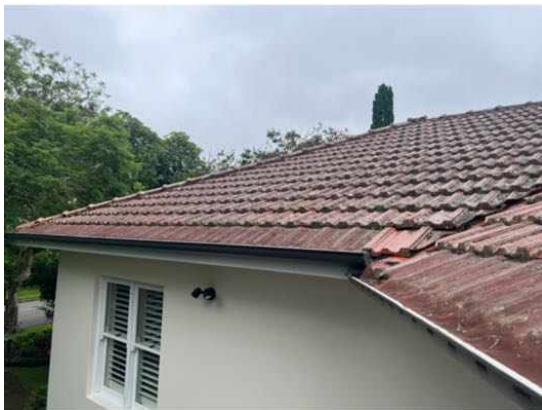
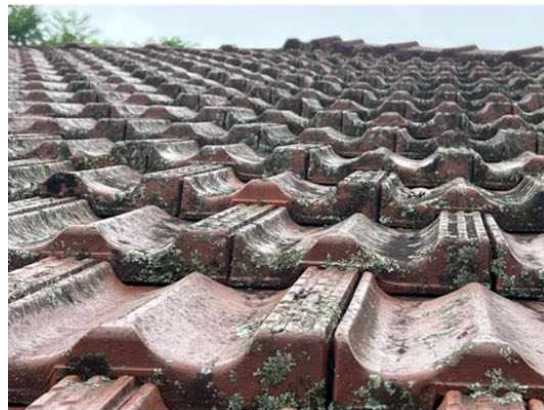
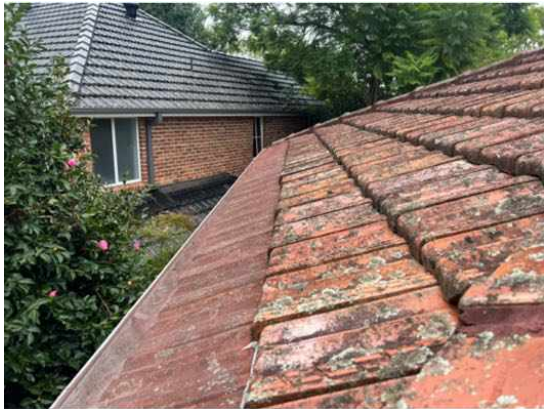
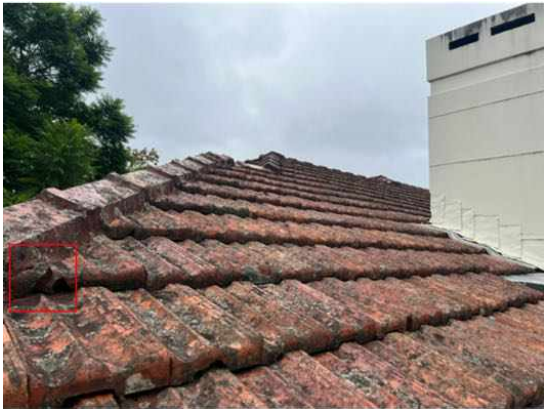
### Finding 3.25

Building:	Main Building
Location:	Roof Exterior
Finding:	Moss growth and surface deterioration
Information:	The tiled roof shows misaligned and/or broken tiles, widespread lichen/moss growth, and surface deterioration, with potential for water ingress due to compromised tile alignment and valley gutter obstruction. A roof tiler should attend to realignment and repair, and maintenance contractors should clean and treat the roof within the short term.

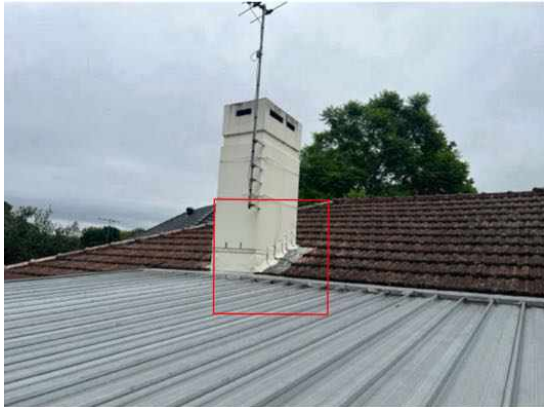
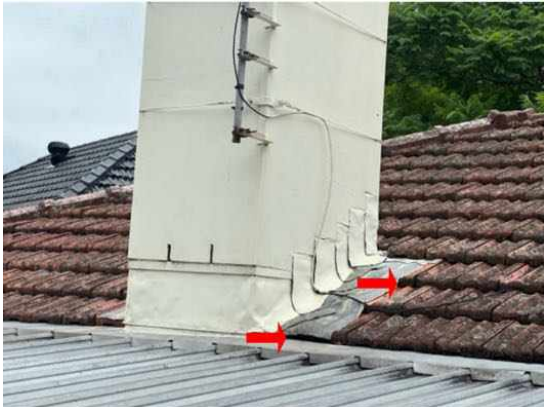
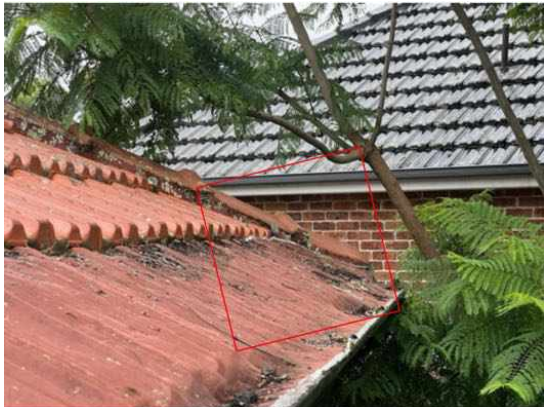
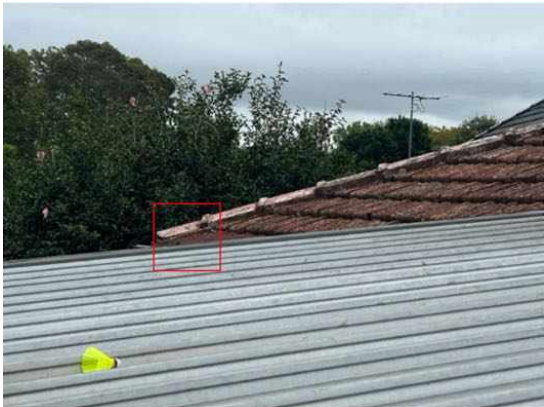
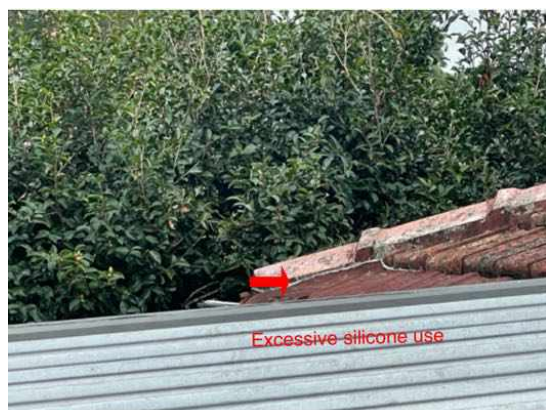
**Finding 3.26**

Building: Main Building  
Location: Roof Exterior  
Finding: Flashing defective -poor installation  
Information: The flashing appears inadequately installed, with visible gaps and/or lifting. The junction does not appear fully weather-tight, increasing the risk of moisture ingress into the wall cavity or roof structure over time. Defective flashing installation can lead to concealed deterioration if not addressed. Recommend assessment and rectification by a qualified roofing contractor to ensure compliant and effective weatherproofing.

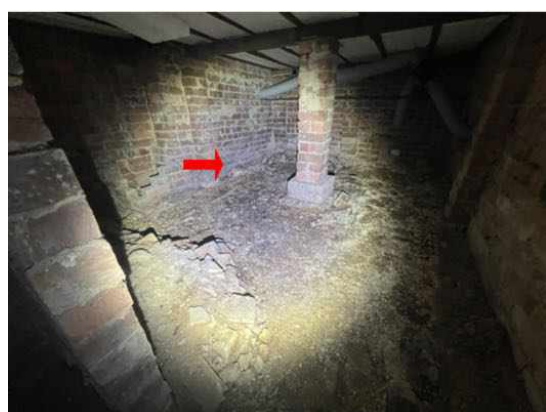
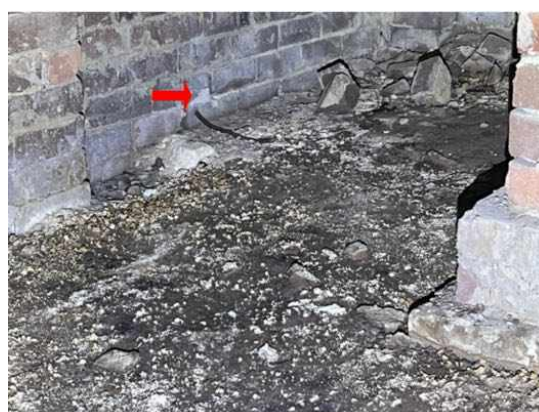
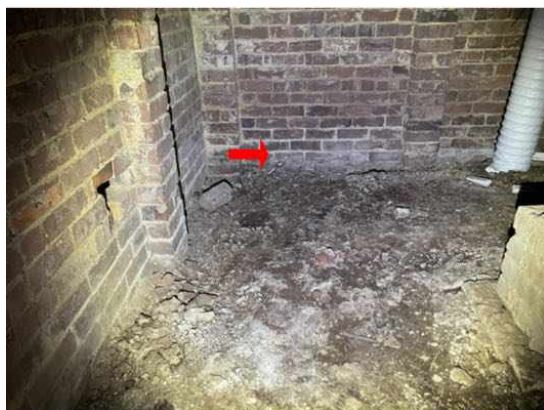
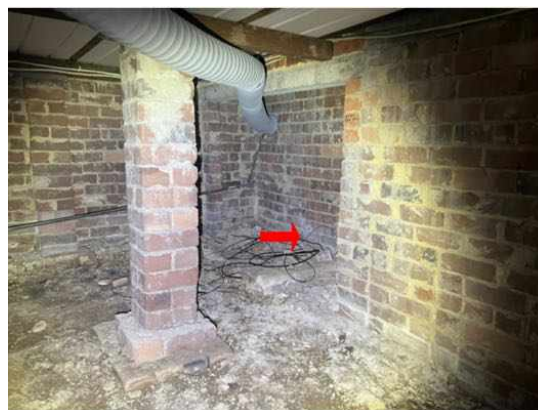
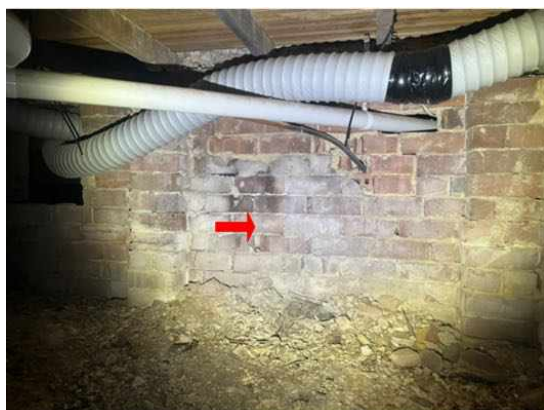
### Finding 3.27

Building:	Main Building
Location:	Subfloor
Finding:	Subfloor Moisture and Efflorescence
Information:	efflorescence and visible damp staining were observed along the lower brickwork within the subfloor, indicating active or historic rising damp.

The presence of salt deposits and discolouration suggests that moisture is migrating through the masonry via capillary action, likely due to inadequate subfloor drainage or ventilation

These conditions may contribute to further degradation of mortar joints, promote mould growth, and increase the risk of timber pest activity if left unaddressed. The area should be further assessed by a damp remediation specialist, and improvements to subfloor ventilation (in place) and moisture control are recommended

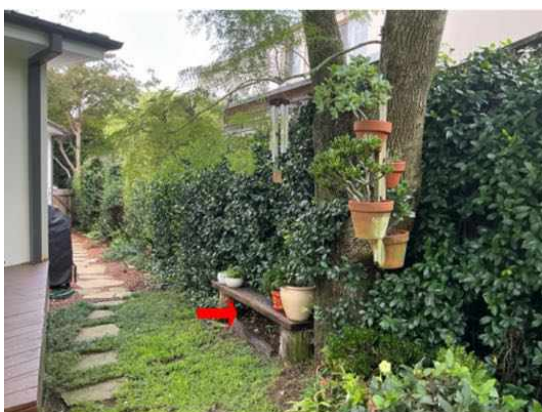
This pattern of damage is highly consistent with termite activity, particularly where the external surface remains intact while internal timber is eaten away.

A further invasive inspection by a licensed timber pest technician is recommended to check for any concealed activity.

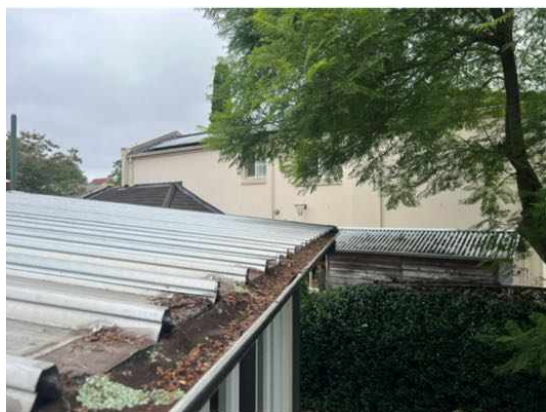
Blocked gutters are likely to lead to high levels of moisture in the affected areas. Such moisture will not only cause rust and decay of the associated building materials, but can also provide conditions that are conducive to termite and timber pest activity. Blockages in gutters should therefore be removed immediately to ensure dry conditions are maintained.

Consult a Licensed Plumber for further specific advice on remedial works that may be required. In the interim, it is highly advised that blocked gutters be removed by the homeowner or a general handyperson as a matter of urgency.

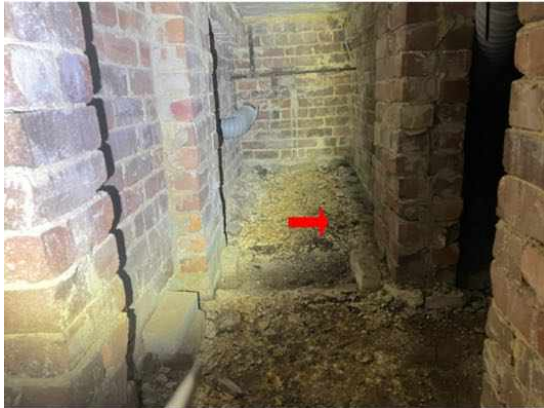
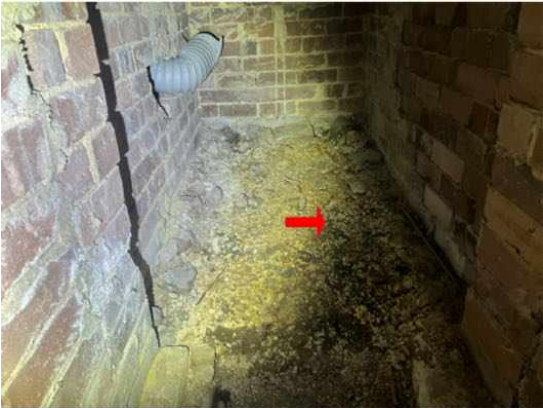
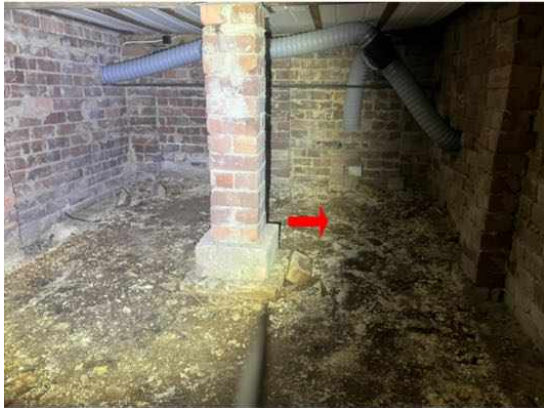
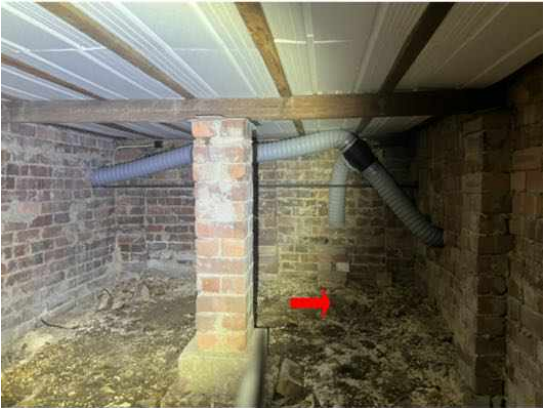
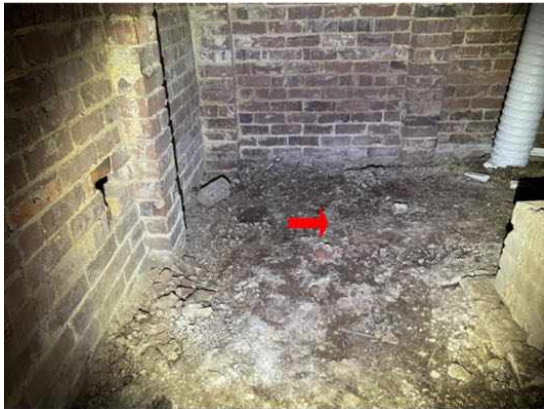
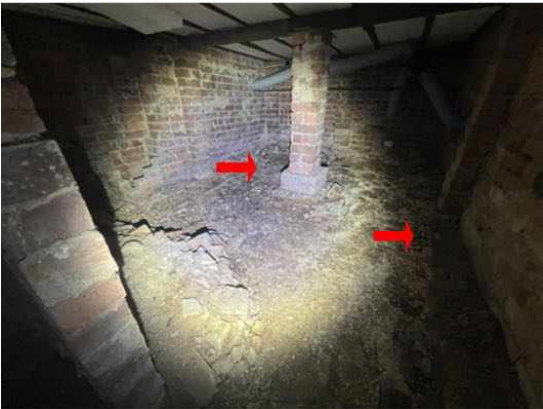
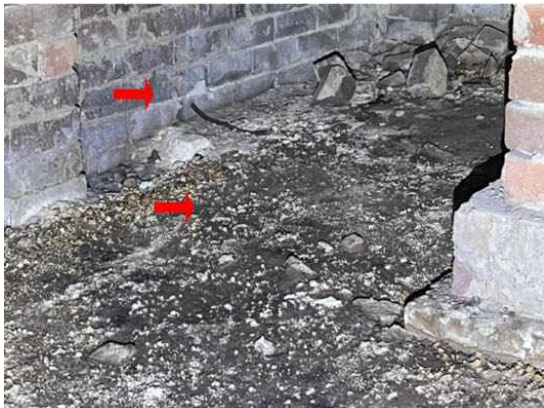
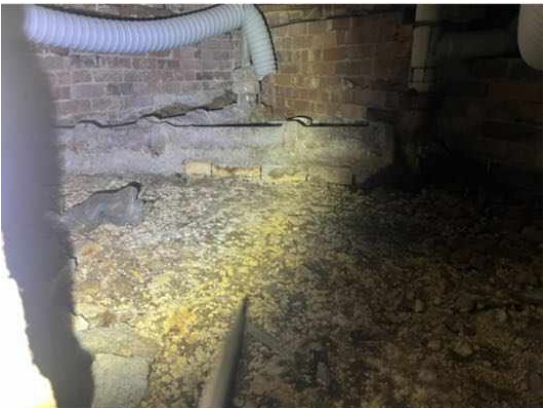
Subfloor ventilation can be improved in most cases by addressing the causes such as exposing subfloor vents installing additional new vents installing mechanical (forced airflow) ventilation and removing debris from the subfloor.

A registered builder should be appointed as soon as possible to perform these works as necessary.

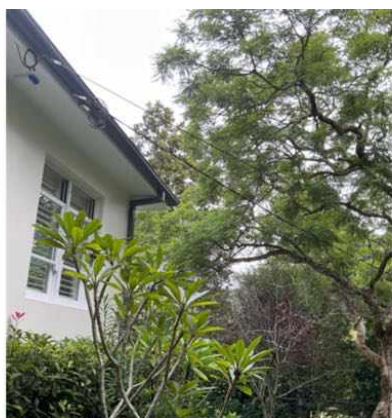
Building:	Main Building
Location:	All External Areas
Finding:	Tree Branches
Information:	A mature tree is located in close proximity to the dwelling, with overhanging branches extending above the roofline and guttering, which increases the risk of leaf debris accumulation, gutter blockages, and overflow during rainfall, as well as potential damage to roofing, fascia, and stormwater components during high winds, ongoing shading and debris can also contribute to elevated moisture conditions and accelerated deterioration of roof coverings. While no direct structural damage attributable to the tree was evident at the time of inspection, the proximity of branches represents a risk item rather than a defect, and periodic pruning by a suitably qualified arborist is recommended to maintain adequate clearance from the roof and stormwater system and to reduce the likelihood of future damage or maintenance issues.
