Building and Timber Pest Inspection Report

Inspection Date: Thu, 26 Mar 2026

Property Address: 7 Erin Ave, Berkeley Vale NSW 2261,
Australia

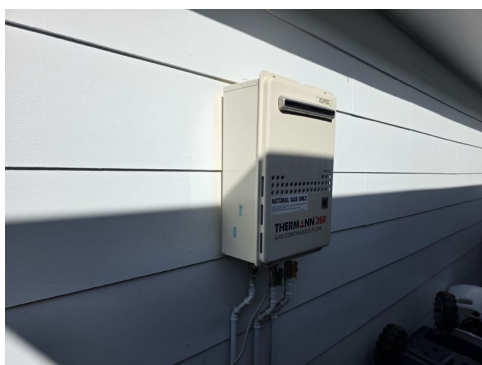
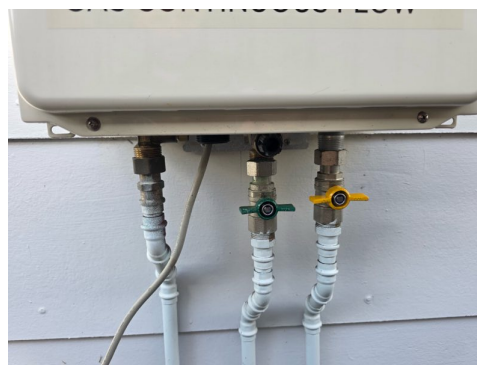
Finding 1.01

Building:	Main Building
Location:	Exterior walls - left side
Finding:	Gas odour at hot water unit – External wall
Information:	<p>A faint gas smell was detected at the gas hot water unit. The odour dissipated after the gas supply was turned off. This presents a safety hazard and may indicate a gas leak.</p> <p>A licensed plumber should be engaged to carry out further investigation and rectify as required. This should be addressed without delay.</p>

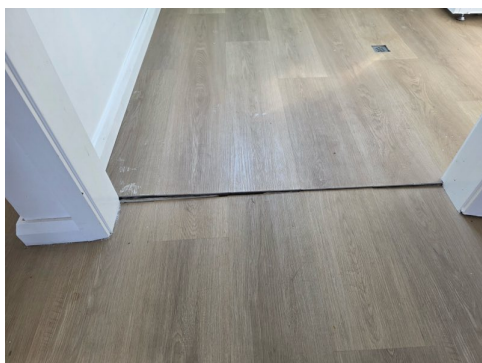
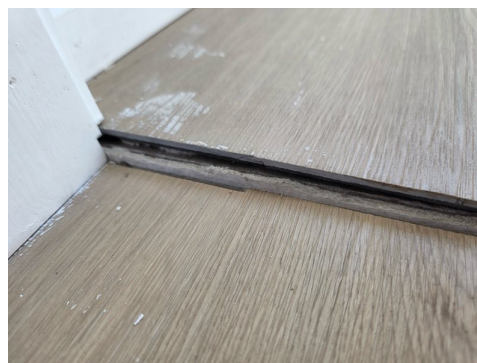
Finding 1.02

Building:	Main Building
Location:	Laundry
Finding:	Exposed flooring transition and exposed suspected asbestos – Laundry doorway
Information:	<p>Laminate flooring appears to have been installed over existing mosaic tiles in the laundry. At the doorway to the living room, there is a height discrepancy and exposed fibrous cement material suspected to contain asbestos is exposed.</p> <p>Exposed edges and potential asbestos-containing material present a safety hazard if disturbed. A licensed builder should be engaged to carry out further investigation and rectify as required. This should be addressed without delay.</p>

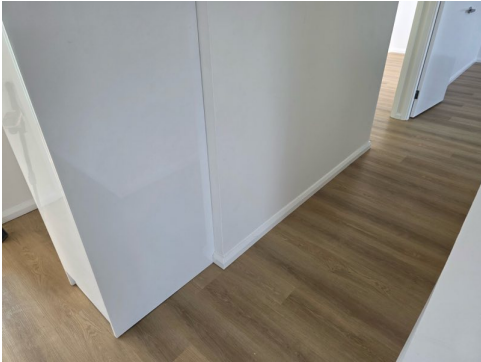
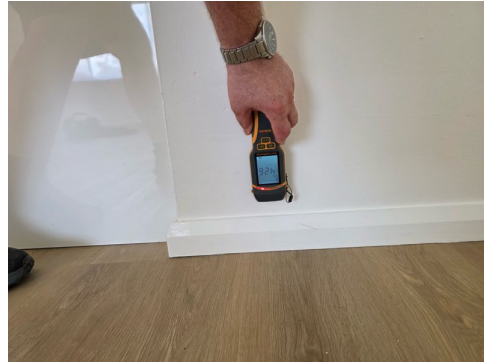
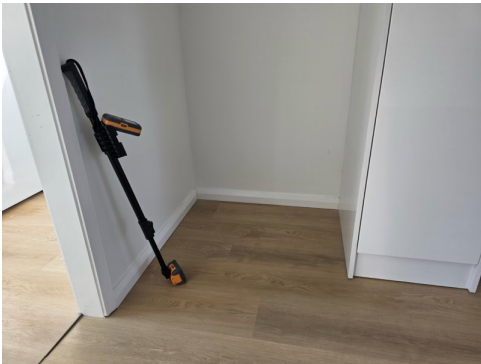
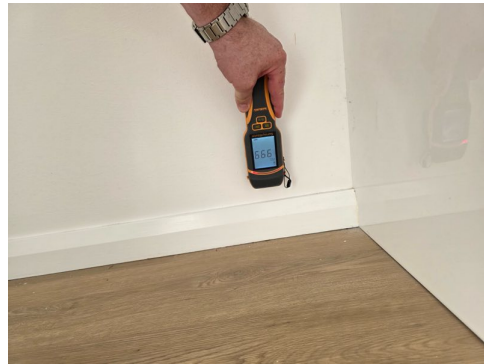
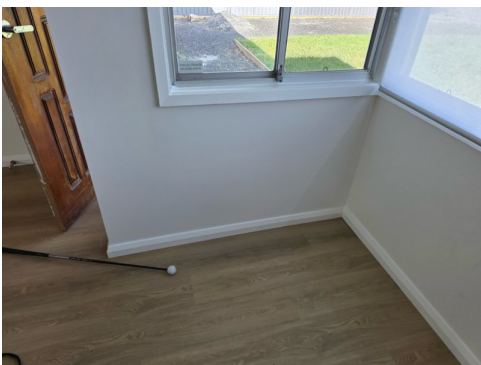
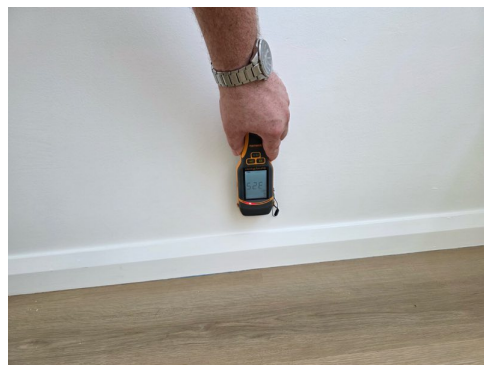
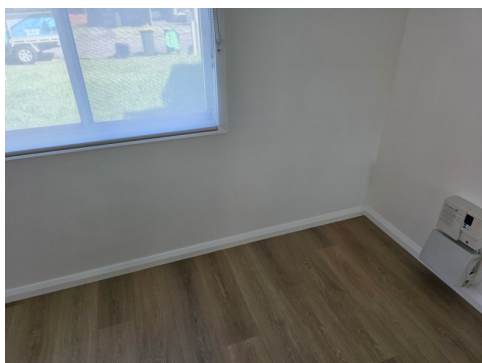
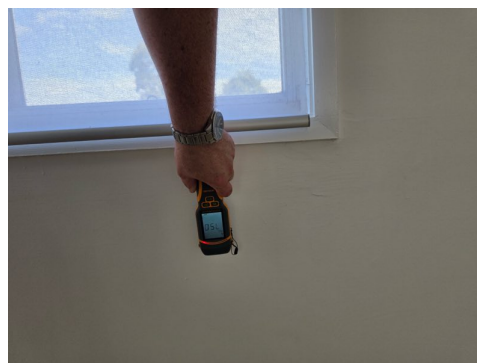
Finding 3.01

Building:	Main Building
Location:	All Internal Areas
Finding:	Elevated moisture readings and unsealed window junctions – Internal walls
Information:	<p>Elevated moisture readings were detected to multiple internal walls, including areas adjacent to the shower. Widespread elevated readings were also noted which may be influenced by recent painting, and the source could not be confirmed. Windows have not been sealed where they meet the weatherboards. Small gaps are present at these junctions.</p> <p>Unresolved moisture may indicate concealed leaks or environmental conditions and may lead to material deterioration if persistent. Unsealed junctions can allow water ingress, which may contribute to elevated moisture within wall cavities. A licensed builder should be engaged to carry out further investigation and rectify as required. This should be addressed as soon as practicable. Photos are indicative of defect throughout.</p>

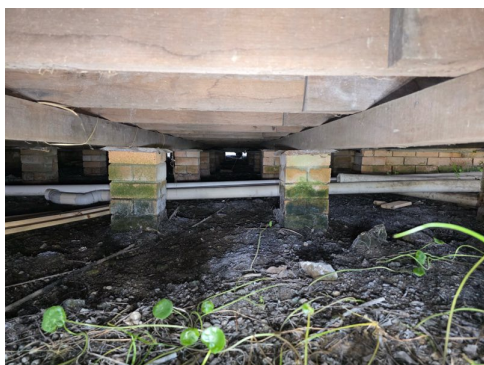
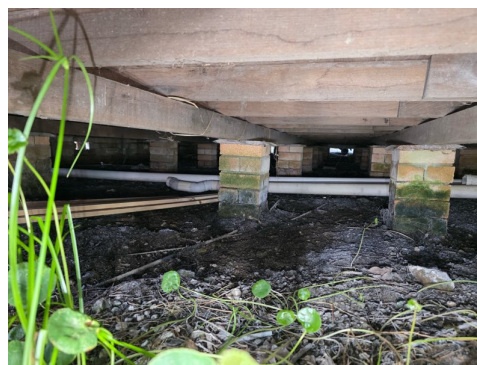
Finding 3.02

Information: The subfloor area showed signs of persistent moisture. Although no surface water was present at the time of inspection, the ground remained damp and multiple brick piers showed green organic growth at their bases, indicating ongoing exposure to moisture. The subfloor appears open along most sides, suggesting that cross ventilation is generally adequate.

Given the relatively flat nature of the site, additional drainage may have limited effectiveness, and these conditions may reflect the typical moisture profile of the property. While no immediate impact was observed, ongoing dampness may contribute to internal moisture issues over time if conditions change. It is recommended that the area be monitored, and if signs of internal dampness or deterioration develop, a licensed builder should be engaged to assess and advise as required.

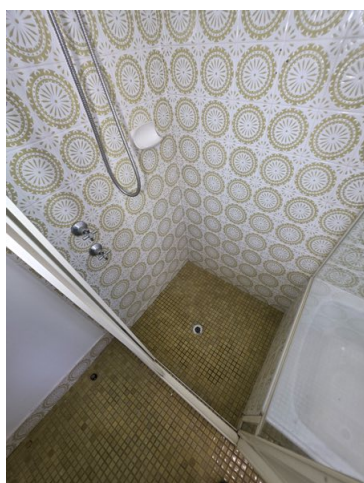
Finding 3.03

Finding: Deteriorated sealing and minor grout loss – Bathroom

Information: Sealant is deteriorated or missing in the shower and bath areas, and there are small sections of missing grout. The bathroom appears otherwise serviceable. Failed sealing can allow water ingress into wall and floor substrates, potentially leading to concealed damage over time.

A licensed plumber should be engaged to carry out further investigation and rectify as required. This should be addressed without delay and prior to regular use recommencing after occupancy.

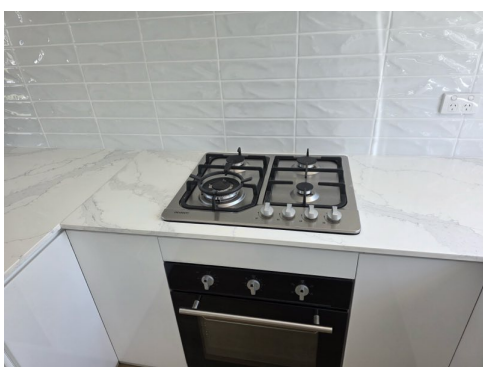
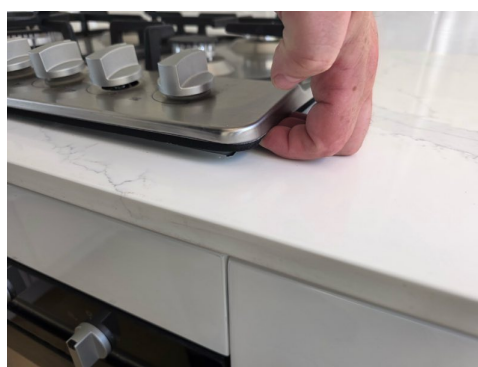
Information: The cooktop is not properly secured to the benchtop and can be lifted slightly. Installation appears incomplete or inadequate.

An unsecured cooktop may shift during use, creating a risk of gas leakage or damage to connections. A licensed plumber should be engaged to carry out further investigation and rectify as required. This should be addressed without delay.

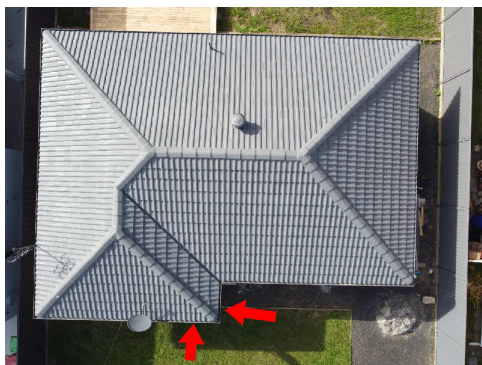
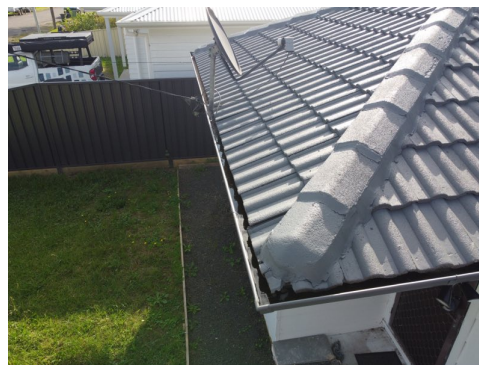
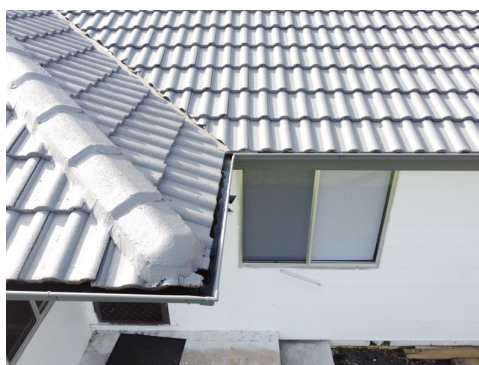
Finding 3.05

Information: Standing water was observed in the guttering at the front of the dwelling.

Poor drainage can contribute to overflow and moisture-related issues. A licensed builder should be engaged to assess and rectify as required. This should be addressed as soon as practicable.

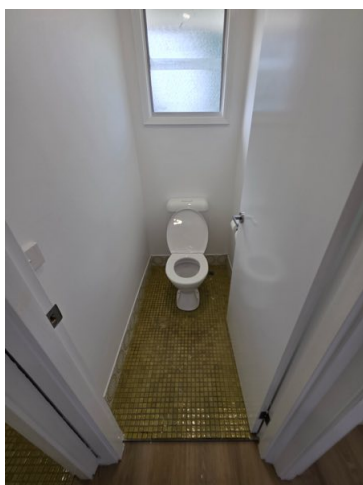
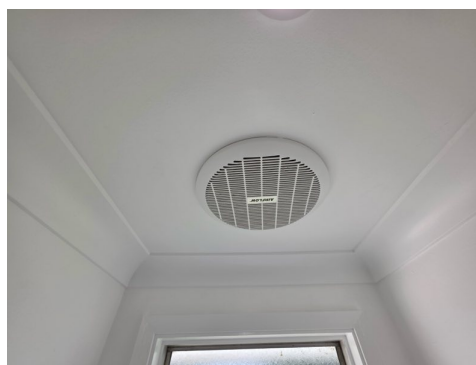
Information: The exhaust fan in the WC produced a slight humming noise when operated but did not appear to extract air. Inadequate ventilation can contribute to moisture build-up and deterioration of finishes.

A licensed electrician should be engaged to assess and rectify as required. This should be addressed as soon as practicable.

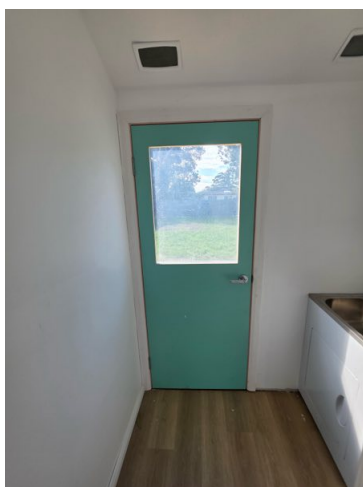
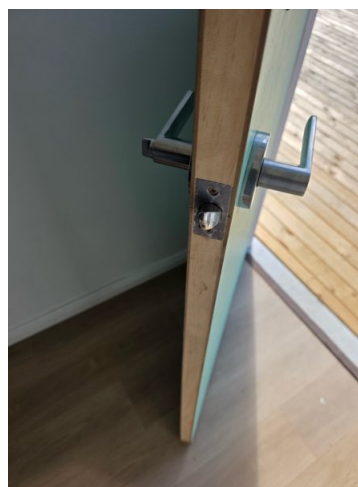
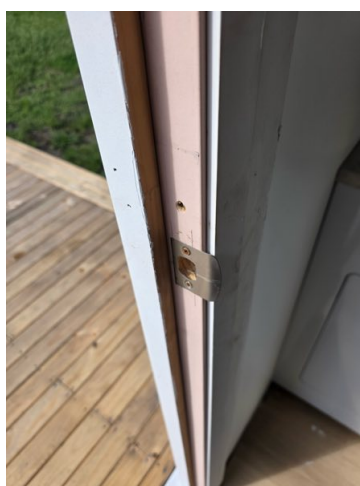
Finding 3.08

Information: The laundry door and associated architraves have not been painted. The surfaces are unfinished but otherwise appear intact.

Unpainted surfaces are more susceptible to wear and moisture absorption over time. A licensed builder should be engaged to assess and rectify as required. This should be addressed at the owner's discretion.

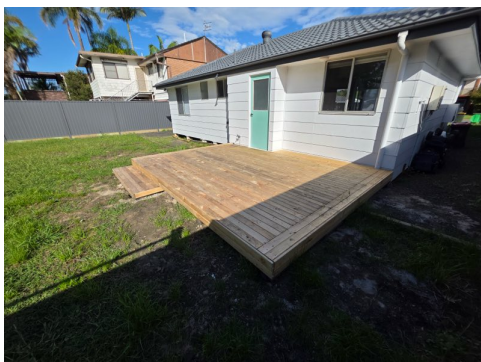
**Finding 3.09**

Information: The deck timbers have not been painted or sealed and are exposed to the elements. Unprotected timber is susceptible to weathering, moisture ingress, and premature deterioration.

A licensed builder should be engaged to assess and rectify as required. This should be addressed as soon as practicable.

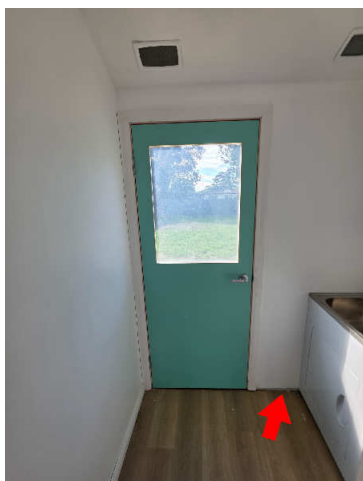
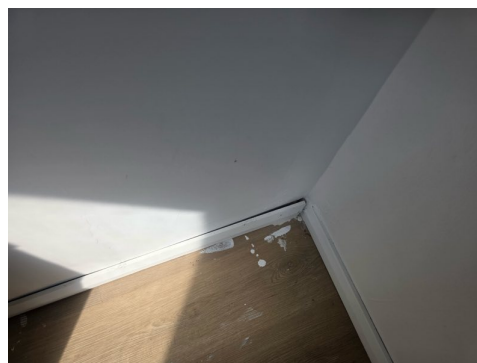
Finding 3.10

Finding: Missing and loose skirting – Laundry

Information: Skirting is missing beside the laundry door, and a separate section of skirting is loose. The affected areas appear localised to the laundry.

Loose or missing skirting can lead to minor damage at wall bases and allow debris or moisture ingress at floor junctions. A qualified carpenter should be engaged to assess and rectify as required. This should be addressed at the owner's discretion.

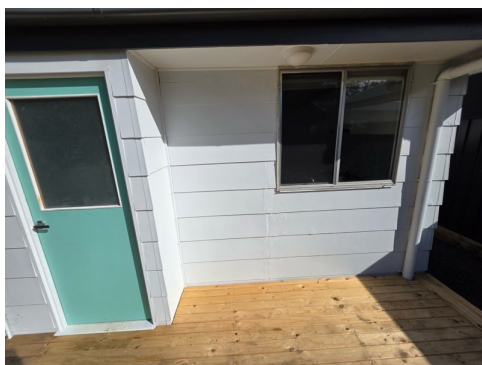
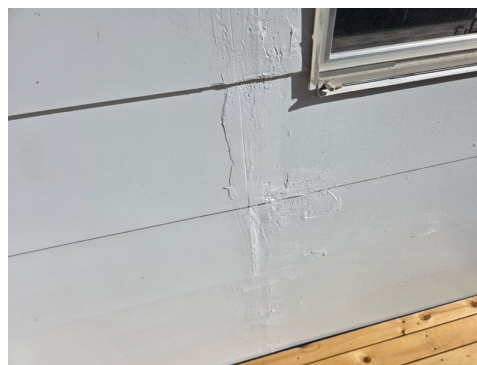
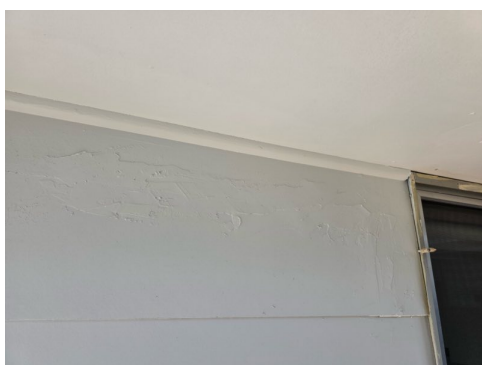
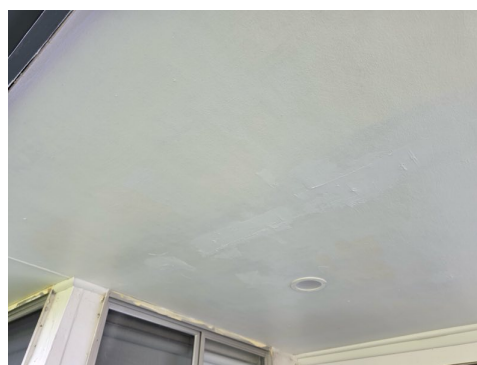
Finding: Poorly finished weatherboard and soffit repairs – External

Information: Weatherboards beneath the kitchen window and other sections have been patched and painted without adequate surface preparation, and the soffit repair has not been sanded or repainted, resulting in a rough and uneven finish. Poor finishing may lead to premature coating failure and reduced weather resistance.

A qualified painter should be engaged to assess and rectify as required. This should be addressed as soon as practicable.

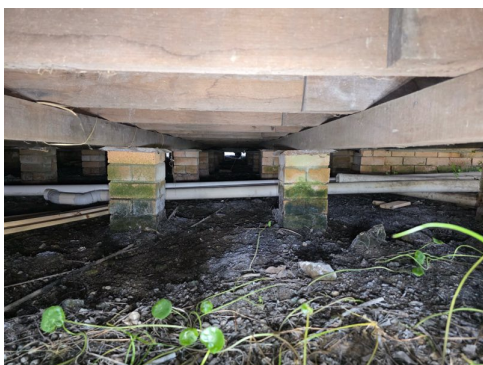
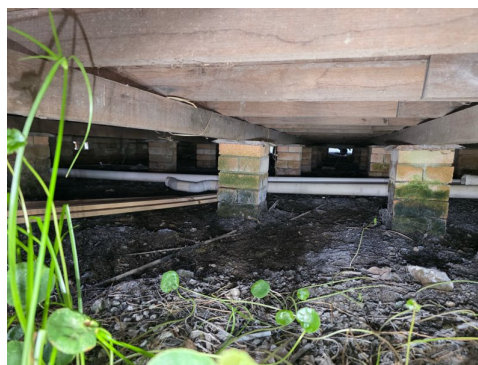
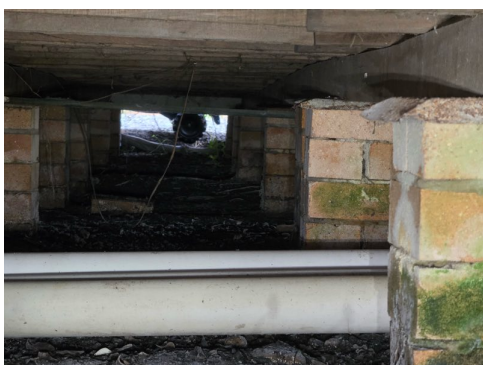
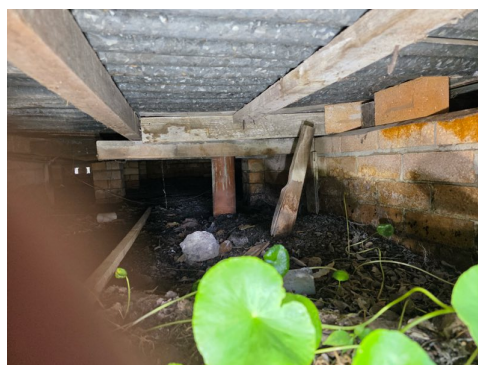
Building:	Main Building
Location:	Subfloor
Finding:	Damp subfloor - conditions conducive to termites

Information: Conditions conducive to timber pest activity were observed in the subfloor area. The ground was noted to be damp, and persistent moisture may attract termites and promote conditions favourable to timber decay.

It is recommended that regular timber pest inspections be carried out by a licensed pest controller at intervals not exceeding 12 months.

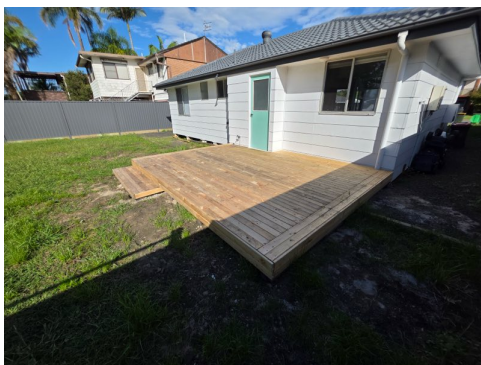
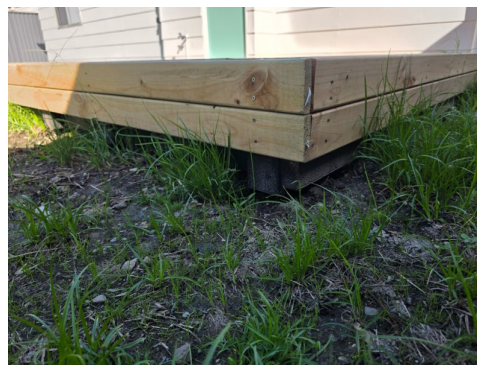
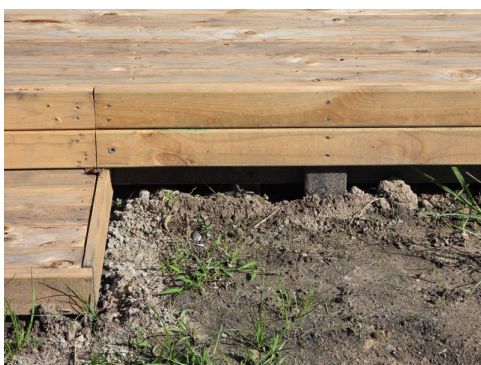
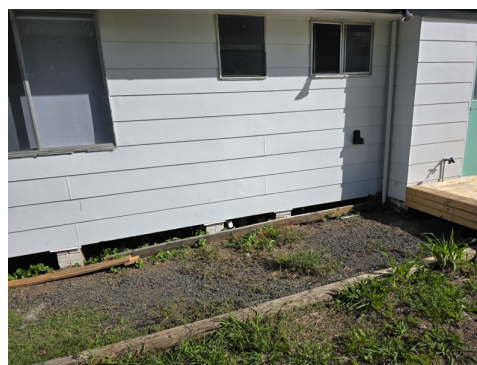
Finding 6.02

Building: Main Building
Location: All External Areas
Finding: Ground - Timber materials in direct ground contact

Timber elements in direct contact with the ground, and consequently exposed to moisture or dampness, create conditions conducive to termite activity. Whether timber is used as part of a building structure, such as a fence or retaining wall, or stored as unused material, it can attract termite infestations.

To minimize the risk of termite attack, it is recommended to remove any materials that could foster termite activity. If removal is impractical or undesirable, it is strongly advised that termite or timber pest inspections be conducted every 6 to 12 months to protect the property from potential infestation.

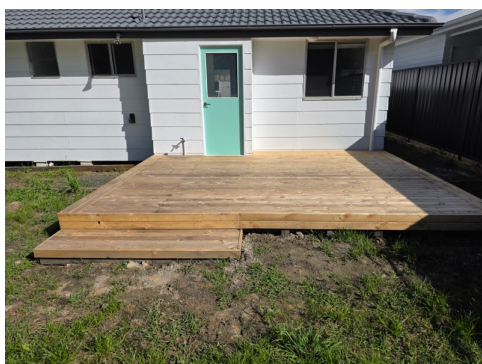
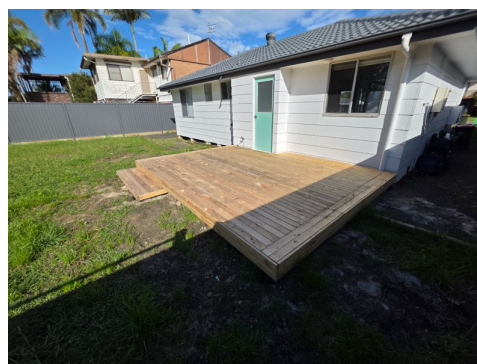
Finding 6.03

Information: The substructure of the decking in rear of the property was not accessible for inspection due to low clearance, ground contact, or cladding. Inaccessible areas such as this prevent a full visual inspection and create conditions conducive to concealed termite entry or timber decay, as any damage or activity may remain undetected until it becomes extensive.

Where practical, the deck should be modified to allow adequate clearance and access for future inspection. Where modification is not possible, the risk of concealed attack remains. In such cases, it is essential that a licensed pest controller establish an ongoing termite management plan and carry out regular timber pest inspections every 6–12 months.

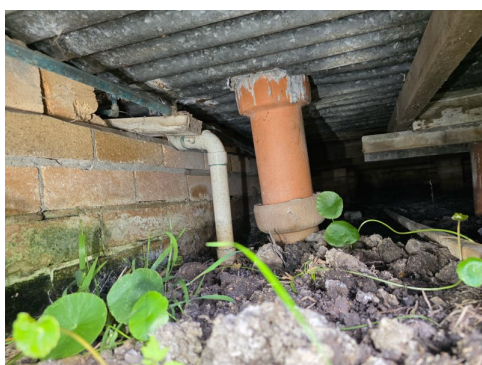
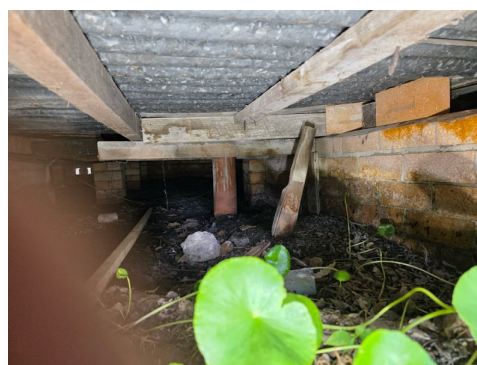
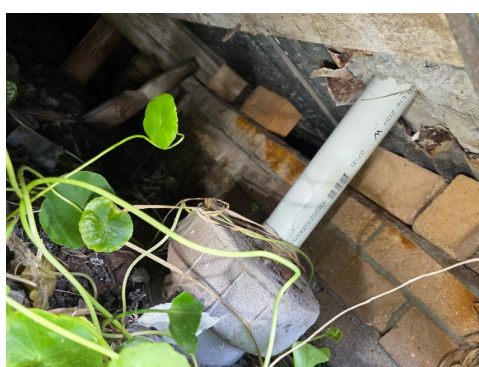
Information: Earthenware pipework was observed within the subfloor. Its condition could not be confirmed at the time of inspection.

Earthenware pipes are commonly affected by ground movement and root intrusion over time, which may lead to cracking or blockages. It may be worthwhile engaging a licensed plumber to carry out a camera inspection to assess the condition of the pipework.

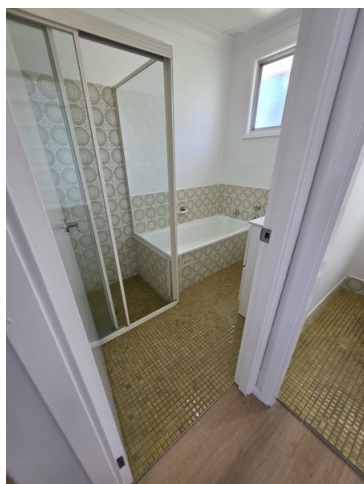
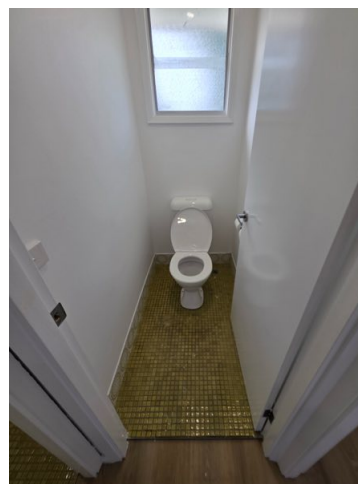
Information: Reporting on asbestos is outside the scope of this inspection. Suspected asbestos-containing material (ACM) was observed in the bathroom and WC wall linings, along the laundry internal door threshold and in the meter box. Based on our experience in the building industry, there is a higher risk that the identified building elements contain asbestos, particularly given that any home constructed prior to 1990 may contain asbestos in various forms.

No sample testing has been undertaken to confirm the presence of asbestos. We strongly recommend a separate Asbestos Inspection and Condition Audit be carried out by a licensed assessor, which may include laboratory testing for definitive confirmation.

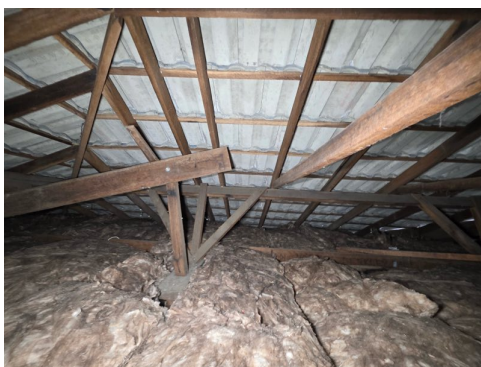
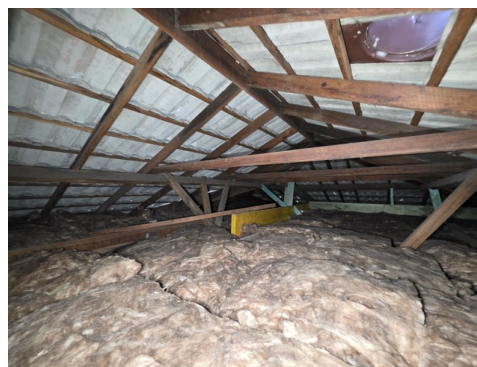
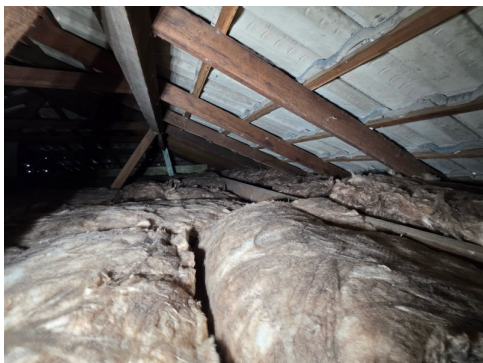
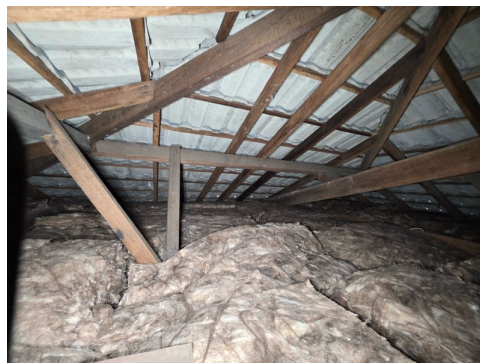
Finding: Access - Roof void

Information: The roof void was not entered due to size restrictions, access limitations, and/or safety concerns. Inspection was carried out from the internal access hatch only, with observations limited to what could be safely viewed and photographed from this position.

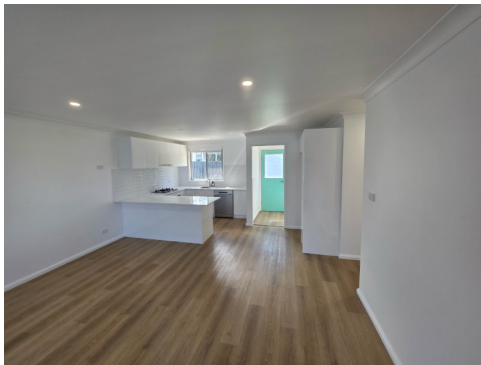
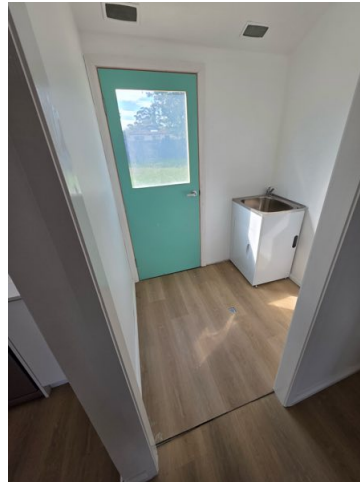
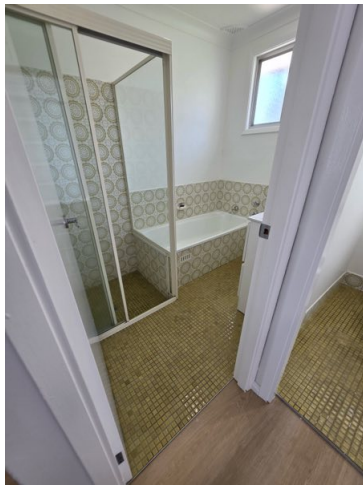
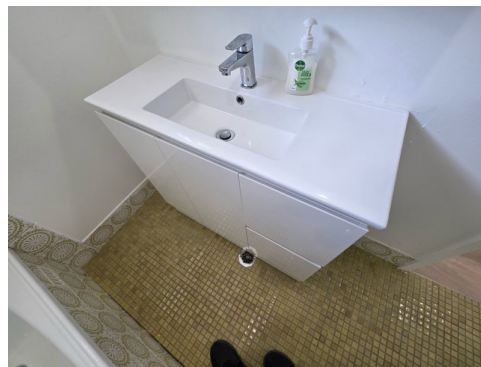
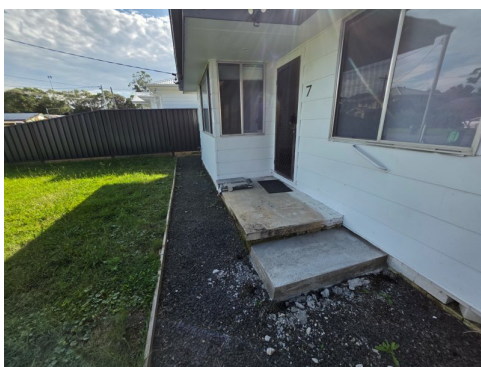
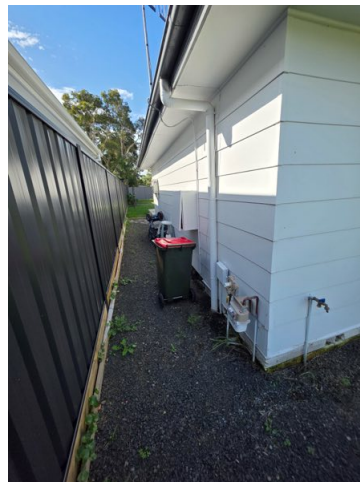
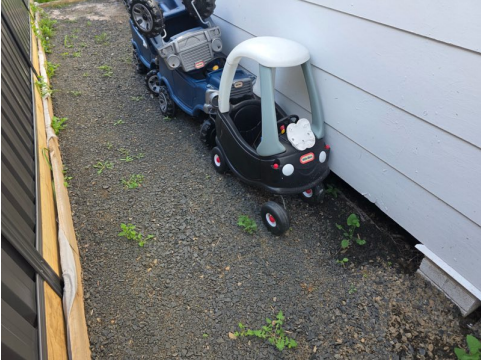
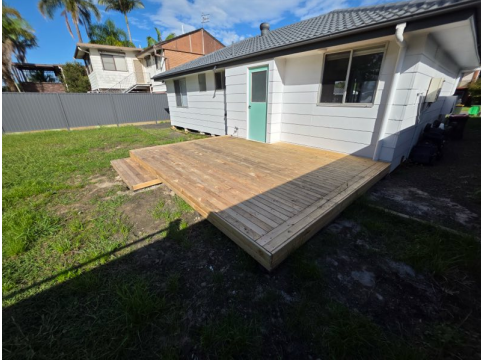
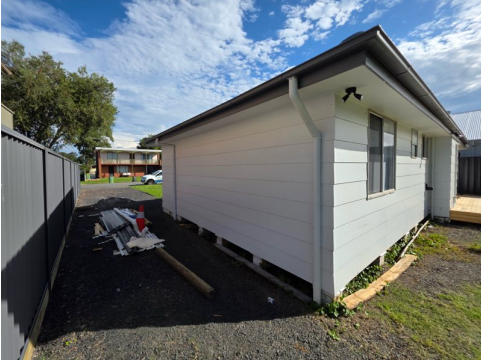
Finding: Additional Photos - Obstructions and Limitations

Information: These photographs are an indication of the obstructions and limitations which impeded full inspection of the property at the time of inspection. These obstructions can hide an array of defects and should be removed to allow full inspection to be carried out. A re-inspection is recommended once the areas are made accessible.
