Building and Timber Pest Inspection Report

Inspection Date: Tue, 17 Feb 2026

Property Address: 6/6 Stypandra Pl, Springwood NSW 2777,
Australia

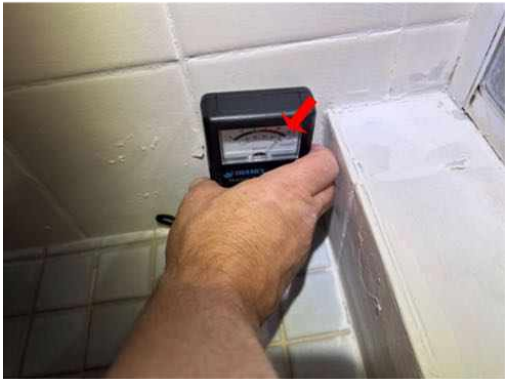
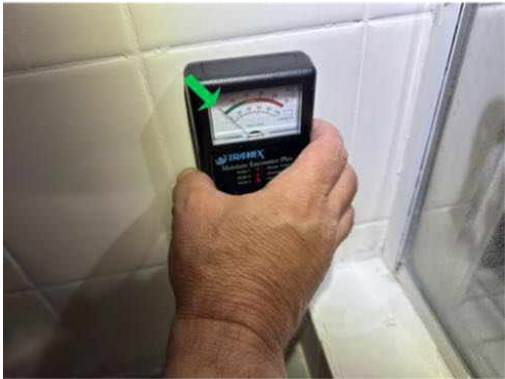
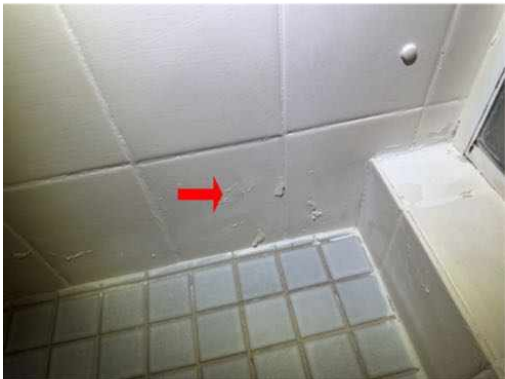
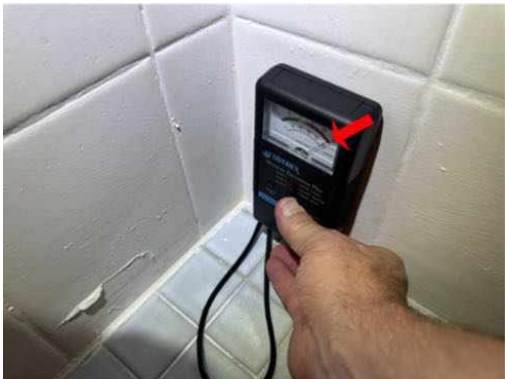
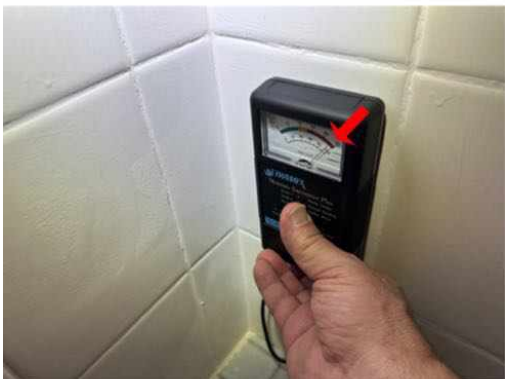
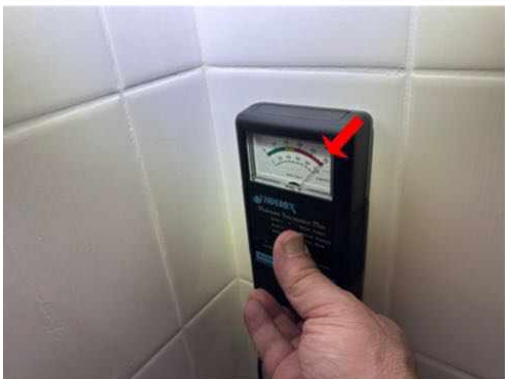
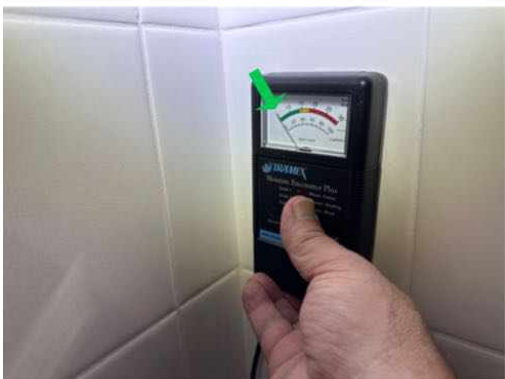
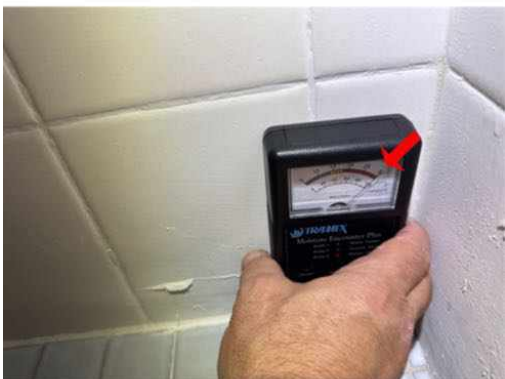
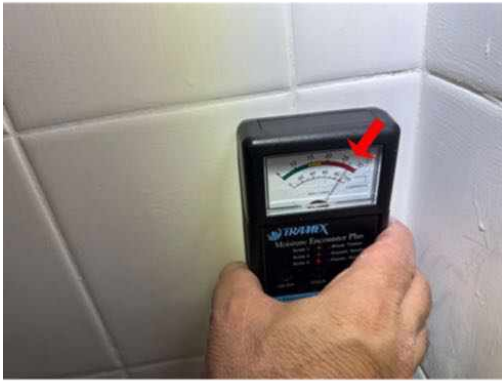
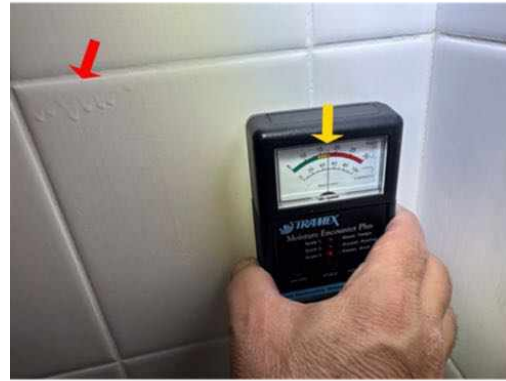
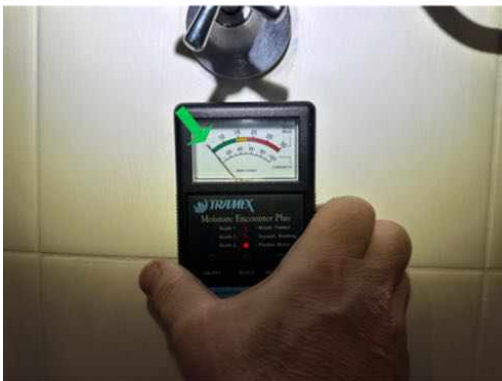
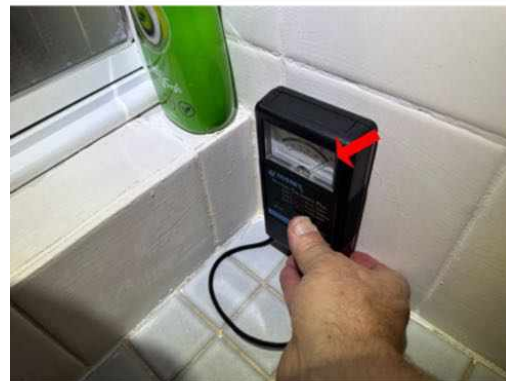
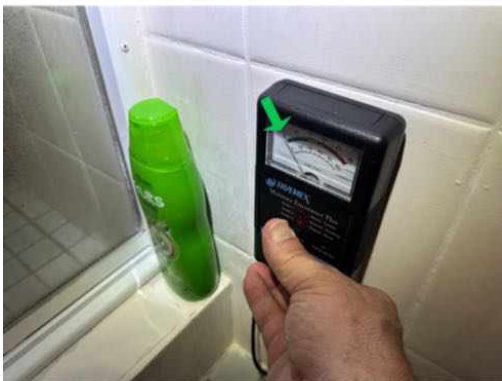
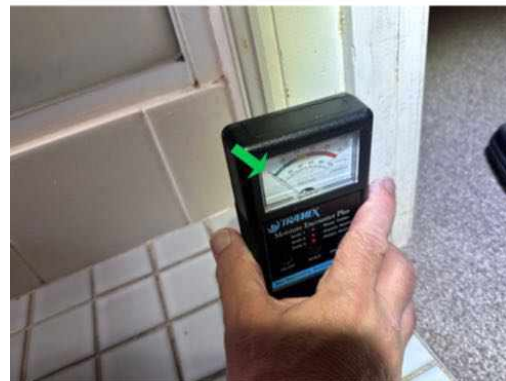
Building: Main Building
Location: Bathroom > Centre Right
Finding: Moisture meter: used in Shower area.
Information: A moisture meter was used during the inspection and isolated spots of excessive moisture was detected to accessible walls inside the property at the time of inspection.

It was noted on inspection that sealant or grout is in fair condition and it appears that the alcove area has been painted with a tile paint, sealer, with some areas requiring maintenance.

Different materials and floor areas move at different rates, generally causing cracking to grout or sealant at this point. A flexible sealant is required to allow for expected expansion and contraction, while keeping the joint water tight and protective of all associated building materials.

Flexible and mould resistant materials should be applied to affected areas to prevent any subsequent water damage that is likely to occur. Regular maintenance and replacement of damage or missing or damaged sealant and grout is highly recommended to the wet areas, as this is a regular wear and tear defect. Sealant and grouting in areas that come into regular contact with water should be maintained for the long term care of your property.

Monitoring the area is advised and if any visual signs of excessive moisture appear (peeling paint, mould) then consultation with a qualified plumber or bathroom specialist would be advised to identify the cause of damp and to perform remedial works as required.

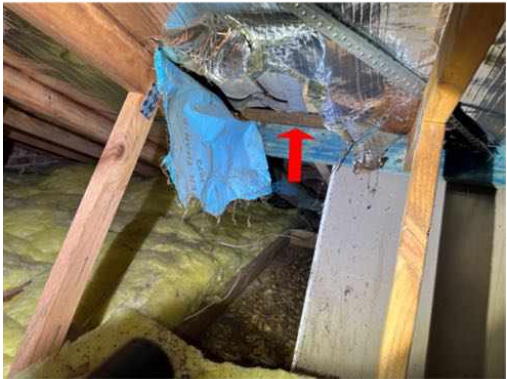
Finding 3.01

Building:	Main Building
Location:	Roof Void > All Areas
Finding:	Evidence of Vermin
Information:	Evidence of pests or rodents were present in the roof space at time of inspection including animal pings and odor. Rodents can cause issues ranging from smells and stains through to physical damage to wiring and other elements in the roof void. A licensed pest controller should be appointed to free the roof void of any pests and to

install deterrents or seal access points to ensure that rodents can not enter the roof space as easily.

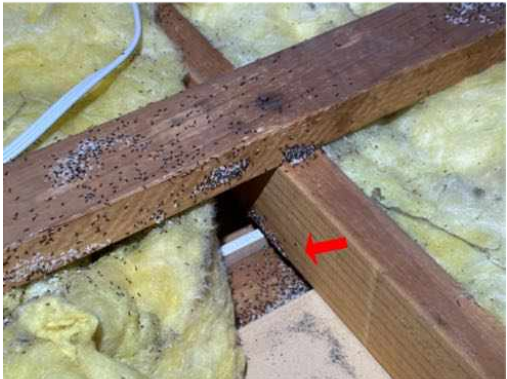
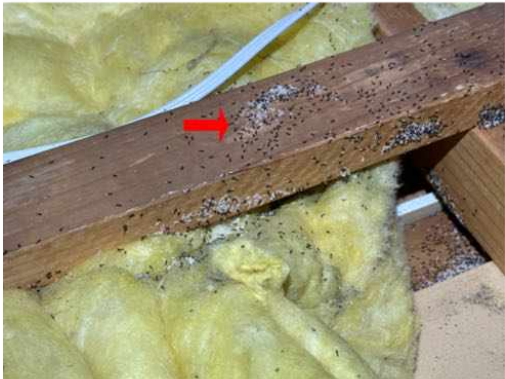
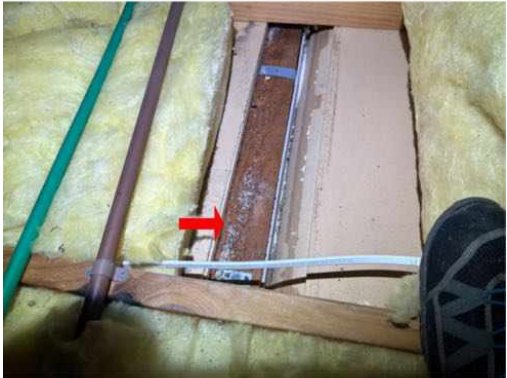
Finding 3.02

Building: Main Building
Location: Roof Void > Rear Right
Finding: Ant Infestation: roof void
Information: At the time of inspection it appeared that a species of black ants had infested the property around roof space of the bedroom 2. It is recommended that a pest control technician be appointed to clear the roof void of ants.

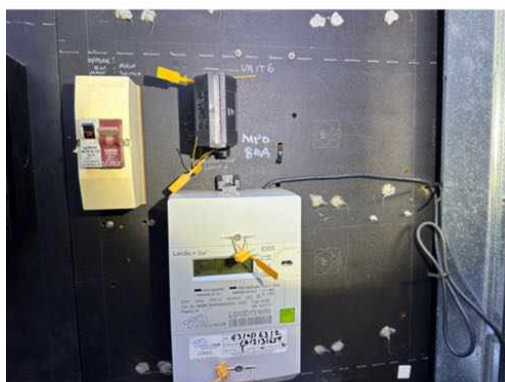
Building: Main Building
 Location: Electrical circuit box > Centre Left
 Finding: Termite Management System - no evidence of a chemical installation
 Information: The application of a post-construction chemical termite barrier is highly recommended for all properties, particularly if live termite activity has been found on the site previously. Such barriers are highly effective in preventing termite attack on any timber building elements throughout the property.

A durable notice should be placed in the switchboard unit to indicate current termite barriers. At the time of inspection, it appeared as though no termite management system has been installed, with no evidence to suggest preventative works taking place.

The client may consider gaining further advice from a pest controller as to the costs and procedures involved with this application. It is recommended that obtaining such advice be a short-term priority.

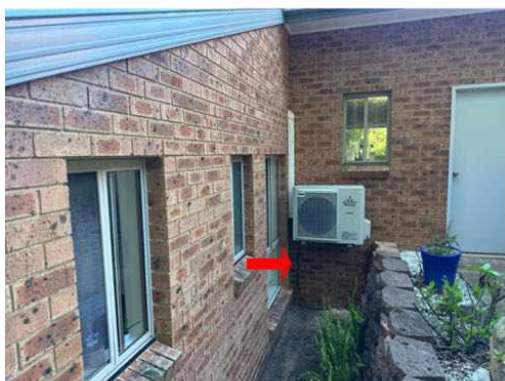
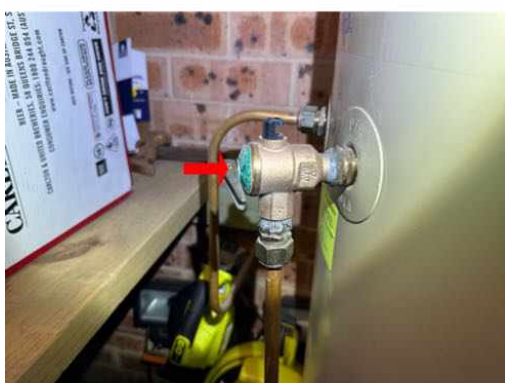
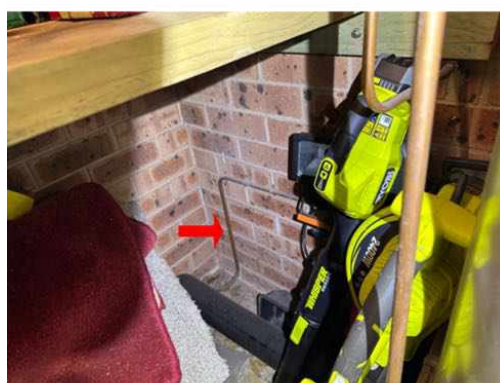
Finding 6.02

Building: Main Building
 Location: Exterior walls - rear > Rear Left
 Finding: HWS Overflow - Not Connected
 Information: The Hot Water System (HWS) overflow was found to be disconnected from storm water drainage and is creating excessive moisture in the surrounding area.

These damp conditions can lead to secondary defects such as rot, rust or corrosion of associated building elements, the formation of fungal decay, or even the creation of potential slip hazards. When coupled with poor site drainage, pooling of water may also attract termite activity to this area.

It is highly recommended that a licensed plumber be appointed to connect the HWS overflow in order to prevent such an environment from being created. These minor works should be carried out as soon as possible.

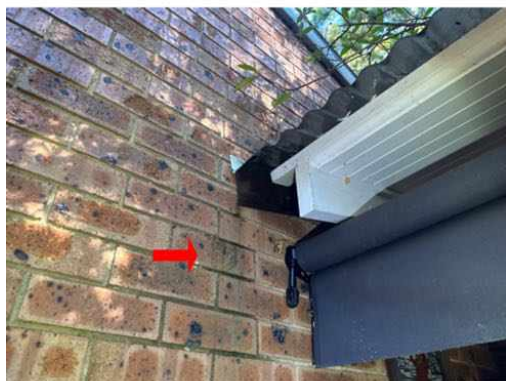
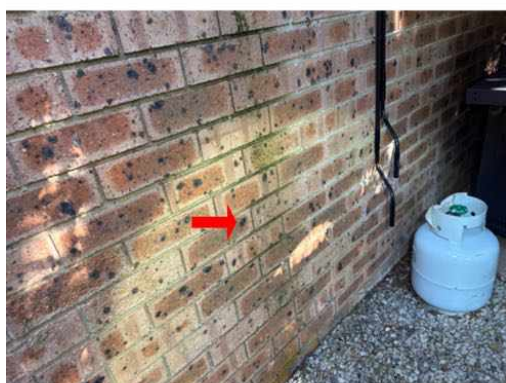
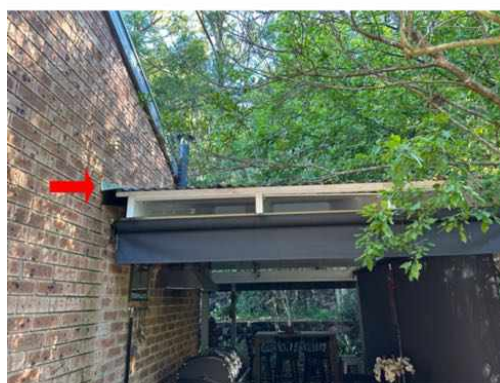
Finding 6.03

Building:	Main Building
Location:	Exterior walls - right side > Centre Right
Finding:	Water staining
Information:	Water staining was evident in this area at the time of inspection. Water staining indicates that surfaces have been exposed to excessive moisture over time. The minerals and other elements in the water lead to staining, which may graduate to corrosion and deterioration if left unmanaged.

While mostly an appearance defect, water staining can be indicative of more serious defects, which may be currently concealed by other building elements.

Where water staining is active, a licensed plumber must be consulted to identify the

cause of the staining and to provide advice on any reparation works that may be required. Replacement of any broken or damaged structures is advised.

Conversely, where water staining is old and inactive, affected building materials may be repaired or replaced at client discretion. A qualified carpenter or registered builder may be appointed to perform these works.

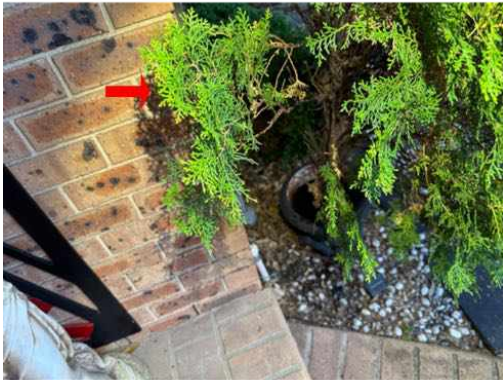
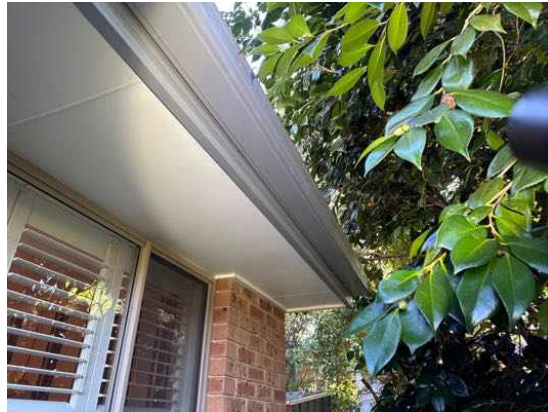
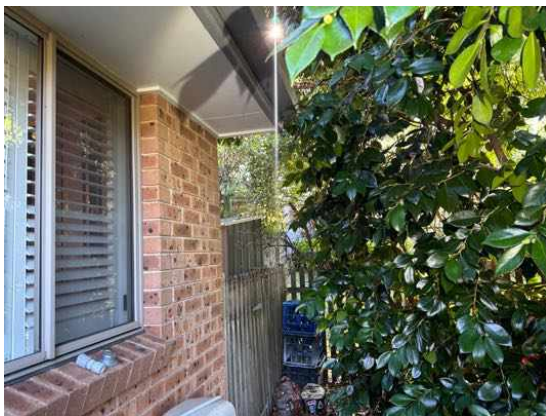
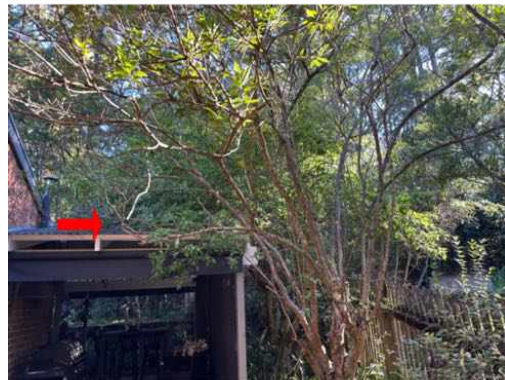
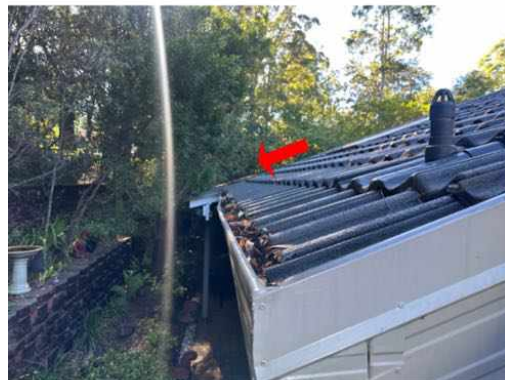
Finding 6.04

Building:	Main Building
Location:	All Areas > All Areas
Finding:	Bridging - Vegetation
Information:	Where vegetation obstructs inspection of building elements, also known as bridging as it provides a bridging point for the access of termites, full inspection can not be achieved. Consequently moisture or dampness may be present and the areas becomes conducive to termite activity. Plants against or very close to buildings provide cover, shade and can provide an environment that is attractive to termite infestation.

The removal of any such materials that may be conducive to termite activity should be carried out as soon as possible and arrange re inspection to minimize the risk of

termite attack.

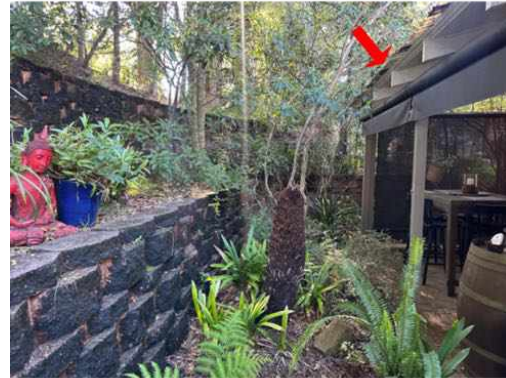
Finding 6.05

Building:	Main Building
Location:	Roof Exterior > Rear Right
Finding:	Roof plumbing - Missing
Information:	Some sections of the roof are not adequately drained via gutters and downpipes. Gutters and downpipes that are not installed adequately are likely to result in excessively damp conditions against the exterior surfaces and around the base perimeter of the building.

Excessive moisture creates an environment which accelerates the deterioration of building elements in the area, as well as being conducive to termite and pest infestation. Such an environment is likely to necessitate repair and/or replacement of building elements, which are prone to sustaining wood rot, rust or corrosion.

A roofing plumber should be appointed as soon as possible to install relevant roof plumbing materials. Depending on the extent of the damage, repair and/or replacement of damaged building elements may be required.

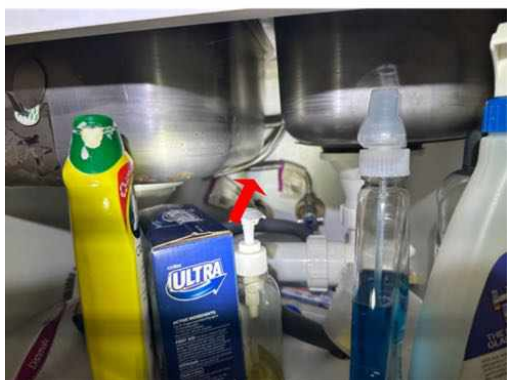
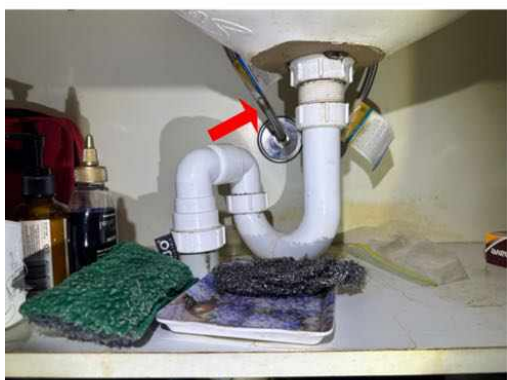
Building: Main Building
 Location: All Areas > All Areas
 Finding: Pipe: Flexible Braided pipes.
 Information: Braided Stainless Steel Flexi connector hose are popular in modern home fit outs because they can be bent into shape. They started to be installed in the early two thousands and their use is now extremely widespread in contemporary construction and renovations.

It is recommended that the Flexi pipes to be replaced at the owners discretion to avoid an "escape water incident" which may lead to water damage to other building elements in the home.

This work can be undertaken by a licensed plumber, general handy person at the owners discretion.

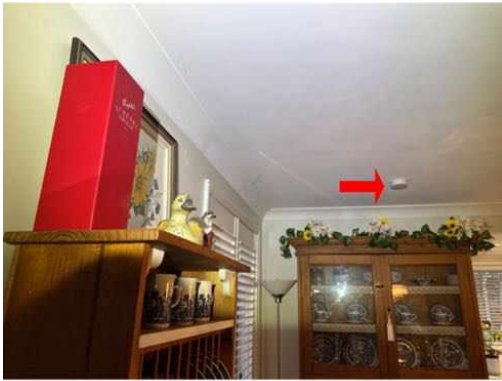
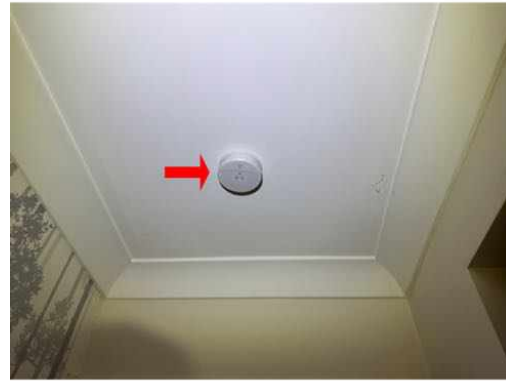
Building:	Main Building
Location:	Hallway > Centre
Finding:	Smoke Detectors and Alarms
Information:	Reporting on Smoke Detectors or Alarms, including hard wired smoke detection systems and their legislative requirements, is outside the Scope of this Report.

Please note that this defect is highlighted as a caution only. We suspect, based on our experience in the building industry, that the absence of smoke detectors, or their poor condition, should be addressed as a matter of urgency to improve occupant safety.

Always ensure sufficient working and suitable smoke detectors are installed prior to occupying any building. Additionally, it is advised that all smoke detectors be tested by the homeowner on a monthly basis.

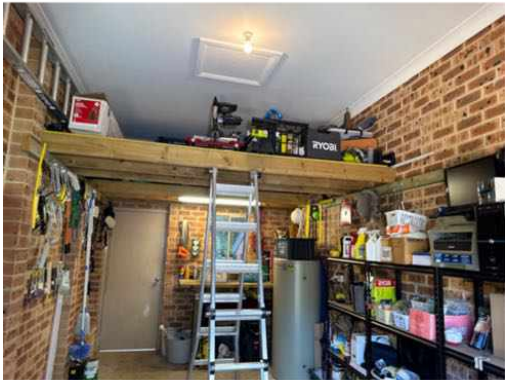
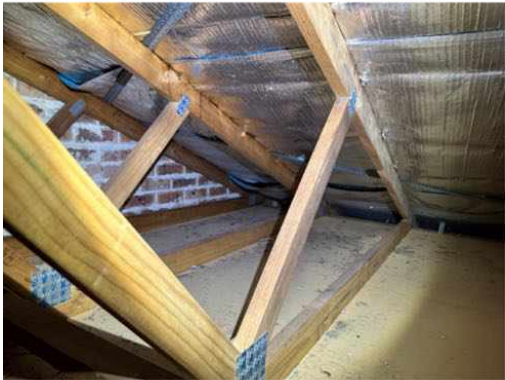
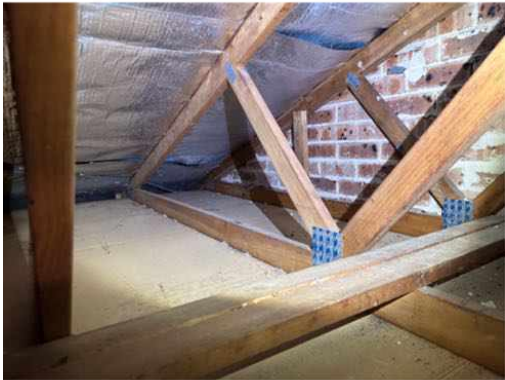
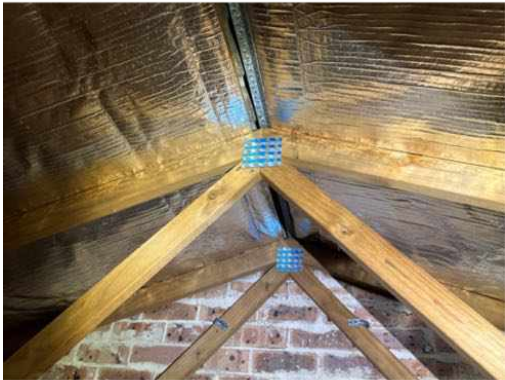
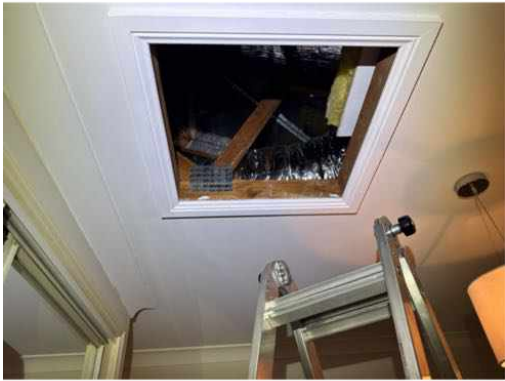
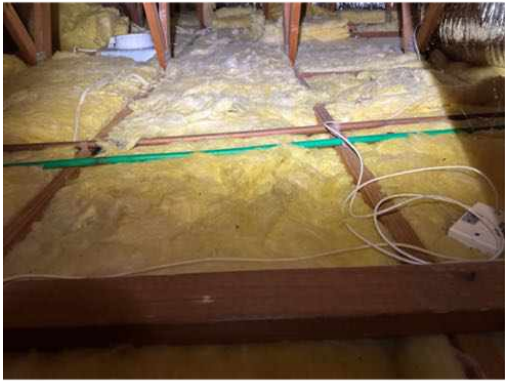
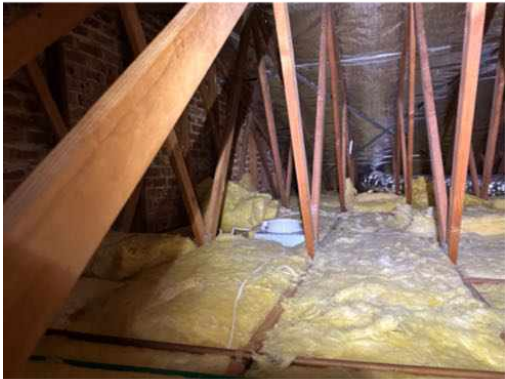
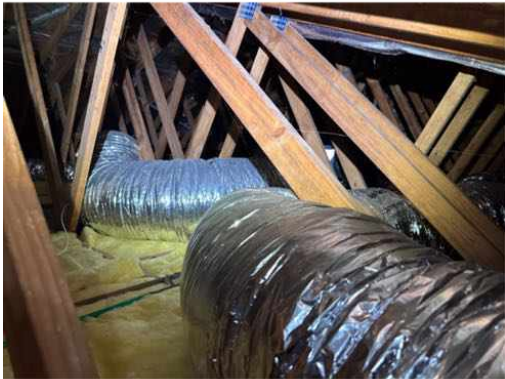
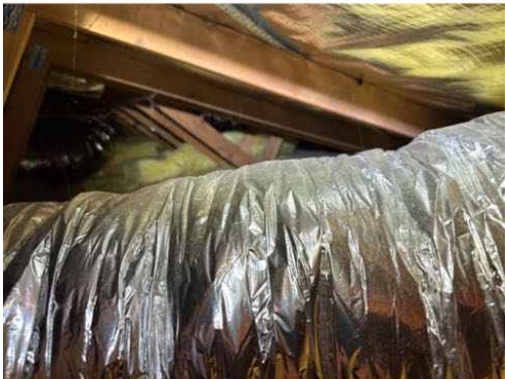
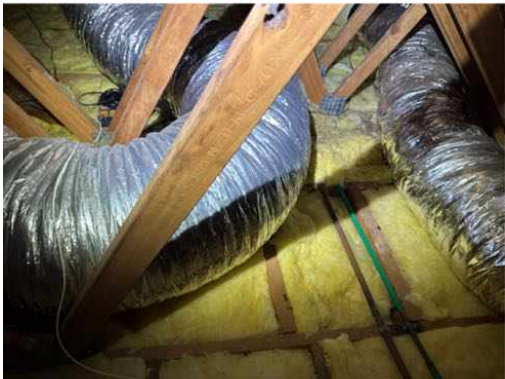
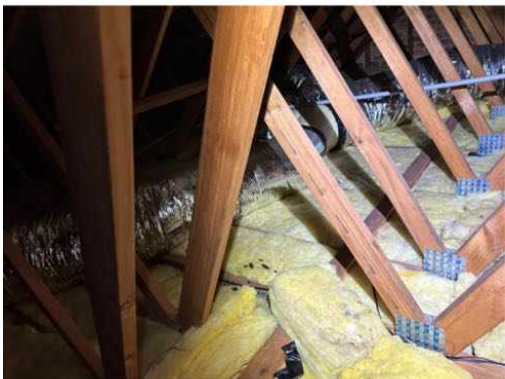
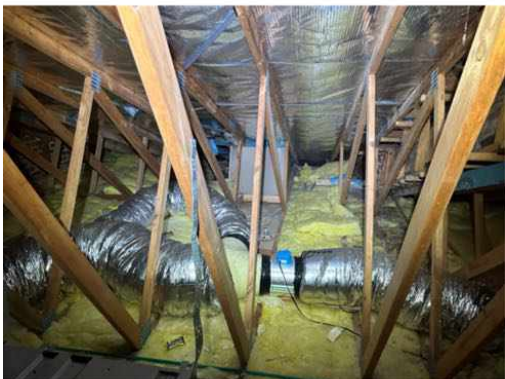
Building: Main Building
Location: All Areas > All Areas
Finding: Roof void: limited access.
Information: Limited access to the roof void was present due to facts including but not limited to access hatch size or placement, insulation, air conditioning ductwork, for this reason inspection to the roof void was minimal and a range of defect's from minor to major may not be visible at the time of inspection.
