Building and Timber Pest Inspection Report

Inspection Date: Thu, 19 Feb 2026

Property Address: 108 Alfred Rd, Chipping Norton NSW 2170,
Australia

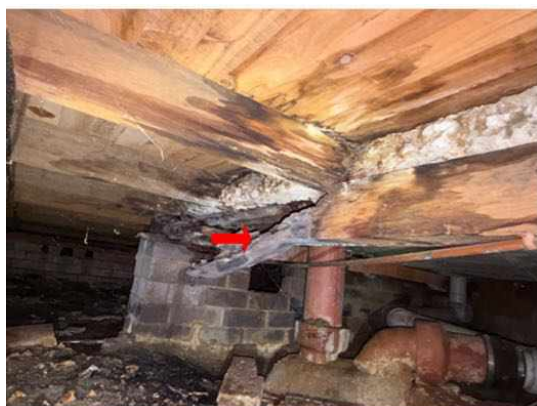
Building:	Main Building
Location:	Subfloor
Finding:	Subfloor structure— Timber rot
Information:	The subfloor structure under the bathroom is showing signs of deterioration and wood rot (fungal decay) of the timbers. It is suspected that this defect has developed as a result of ongoing water leak from the bathroom above at some stage.

Damp conditions cause the timbers to fail, resulting in the subfloor structures failing to bear the load (or weight) of the building as originally intended. Without repairs and maintenance, including potential replacement of affected elements, it is likely that serious structural faults will result, as well as an array of minor defects.

The presence of wood rot to the subfloor structure is also conducive to termite infestation. Replacement of the affected timber building element is required urgently by a licensed builder. A licensed plumber should also be appointed for further assessment to ensure any active water leaks are addressed.

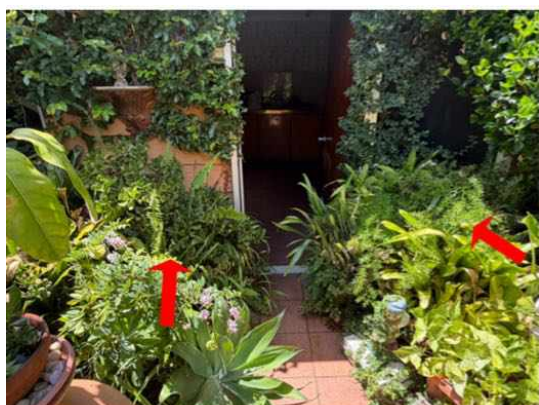
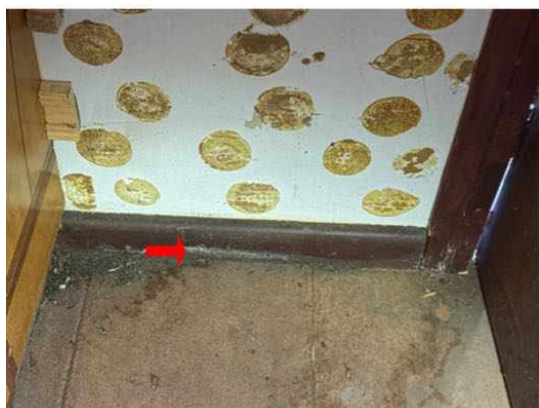
Building:	Main Building
Location:	Garage
Finding:	Exterior walls - Lateral damp
Information:	Lateral penetrating damp refers to the sideways movement of moisture, predominantly from the surrounding ground, which tends to affect basement walls and other earth-retaining walls. The implications of unmanaged damp range from mould fungi growth, wood rot and decaying building materials, to finishes including lifting, bubbling, peeling and staining of paint, plaster and wallpaper.

It is important to address damp conditions as the World Health Organisation notes that excess moisture leads - on almost all indoor materials - to the growth of microbes

Structural waterproofing barriers or tanking barriers are often used to protect internal surfaces against the effects of lateral penetrating dampness. These types of work are generally undertaken where the source of the penetrating damp cannot be prevented.

Immediate consultation with a licensed plumber is advised to address the cause of the damp and to perform remedial works as necessary.

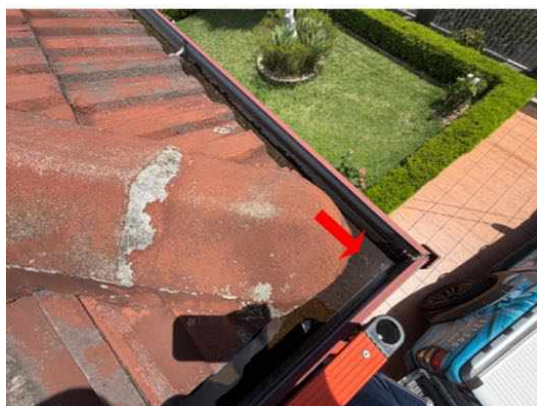
Building: Main Building
 Location: Front Elevation
 Finding: Gutters - Water pooling
 Information: Water was found to be pooling in sections of the roof guttering. This is generally a secondary defect caused by blocked or partially blocked gutters. Furthermore

inadequate fall to the adjacent downpipe could also be the underlying cause.

Water pooling is likely to lead to rust and water damage to associated structures if left unattended. This excess dampness is additionally conducive to termite activity.

Any areas of guttering that shows evidence of water pooling should be checked for partial or full blockages or otherwise appropriate fall to the downpipe must be applied accordingly. Any secondary damage that may have occurred as a result must be rectified. Depending on the extent of the damage, building elements may require repair and/or replacement to ensure adequate roof drainage and function of exterior plumbing system.

A roofing plumber must be appointed as soon as possible if inadequate fall to downpipe is deemed to be the cause. It is highly advised that all gutters be maintained on a frequent basis to ensure the condition of roof plumbing.

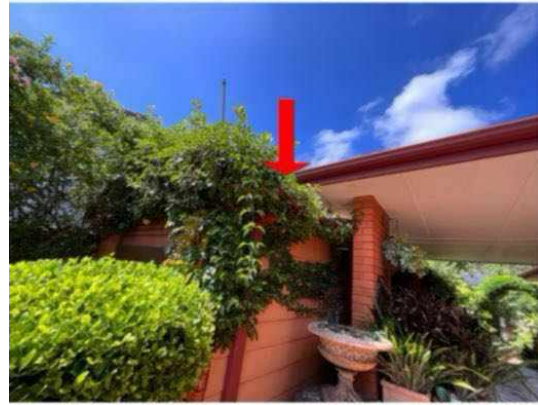
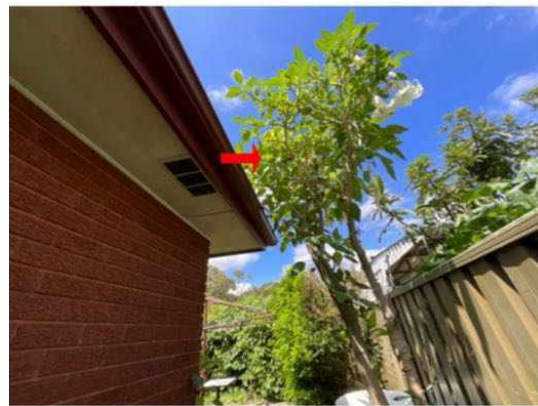
Building:	Main Building
Location:	Roof Exterior
Finding:	Trees - Overhanging and filling gutters
Information:	Overhanging trees often result in excessive amounts of leaf debris accumulating in gutters.

Gutters are a critical part of the building's management of storm water and rain. It is therefore important that they be kept clear to prevent secondary damage to associated building elements, including exterior and interior walls, ceiling linings and any adjoining building elements. Where gutters are blocked, pooling of rainwater is likely to occur, fast-tracking rust and corrosion of the roof plumbing elements.

It is highly advised that all overhanging tree branches be removed as soon as possible to prevent any further damage. Repair and/or replacement of sections of damaged guttering may also be required where the extent of the damage necessitates.

Such works should be performed by the homeowner; however, appointment of a

landscape contractor or an arborist may be required. Consultation with a licensed roof plumber is required where guttering has been damaged.

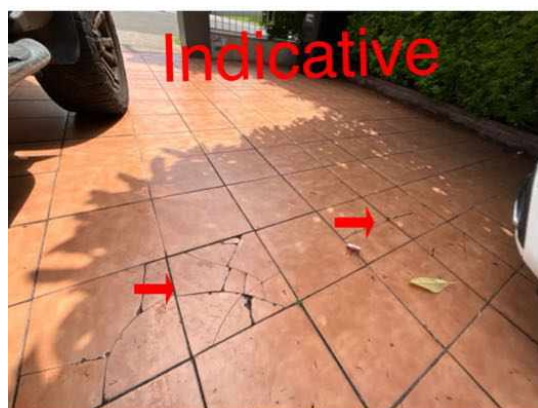
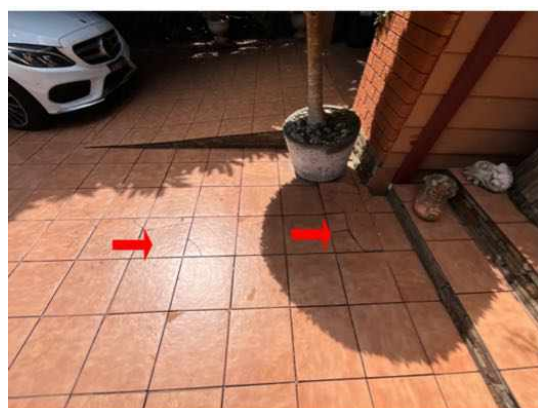
Building: Main Building
 Location: Driveway
 Finding: Cracked floor tiles
 Information:

Cracking in the floor tiles was evident in this area at the time of inspection. It is suspected that this cracking has occurred as a result of minor settlement or shrinkage.

Cracked tiles throughout the household detract from the overall appearance of the affected areas however it is unlikely to create or lead to any secondary defects.

While not considered a matter of urgency, replacement of cracked floor tiles is recommended at the clients discretion. A licensed tiling contractor may be appointed to perform these works. Where cracks become more numerous, contact a licensed building inspector for further investigation.

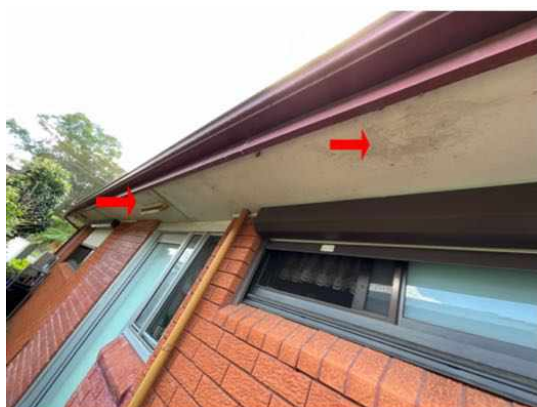
Location: Eaves - LHS
Finding: Mould present - Ventilation
Information: Evidence of mould growth was noted, which is believed to have developed due to excess moisture from the wet areas.

Generally, the client is advised to ensure that the general environment is free of moisture and humidity to aid in the prevention of mould formation and development. Any mould found during the inspection should be cleaned immediately by a cleaning contractor or the homeowner as applicable.

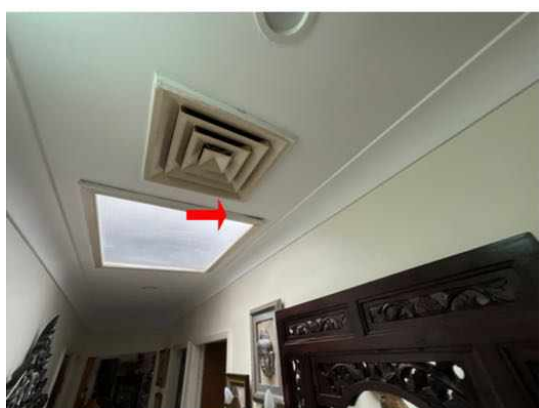
Building:	Main Building
Location:	Hallway
Finding:	Beads - Damaged
Information:	Beading acts (like cornice or skirtings) to cover the intersection or joins of building materials. It was noted at the time of inspection that beading in this area has deteriorated. This deterioration is suspected to have been caused by general ageing and frequent exposure to weather, which is expected in a building of this age and condition.

Beading is important in weatherproofing the surrounding building elements and preventing pest ingress. Furthermore, beading works to protect the joins of building materials, which are more susceptible to deterioration and decay.

Repair or replacement of the beading is advised to ensure the protection and longevity of any associated building elements. Such works may be performed by a general handyperson or qualified carpenter.

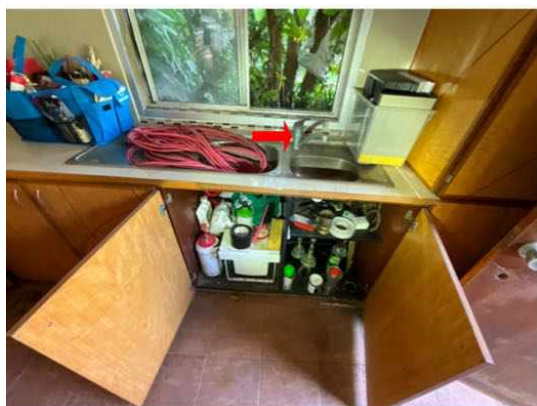
Building:	Main Building
Location:	Garage

Finding: Building element - Not operating
 Information: Non-operational items should be addressed to ensure that the full function of the building structure is available. Where some building elements are not operating as intended, it is possible that secondary building defects could arise due to their non-operation.

Repair and/or replacement of the faulty building element is recommended. It is highly recommended that the relevant tradesperson be engaged to perform any necessary works.

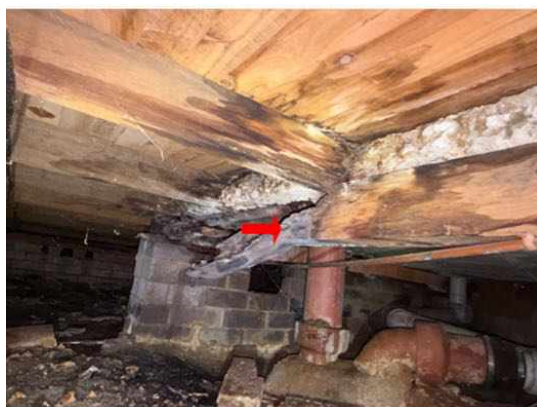
Finding 7.01

Damp conditions cause the timbers to fail, resulting in the subfloor structures failing to bear the load (or weight) of the building as originally intended. Without repairs and maintenance, including potential replacement of affected elements, it is likely that serious structural faults will result, as well as an array of minor defects.

The presence of wood rot to the subfloor structure is also conducive to termite infestation. Replacement of the affected timber building element is required urgently by a licensed builder. A licensed plumber should also be appointed for further assessment to ensure any active water leaks are addressed.
