Building and Timber Pest Inspection Report

Inspection Date: Thu, 26 Mar 2026

Property Address: 14 Illawarra St, Mosman NSW 2088,
Australia

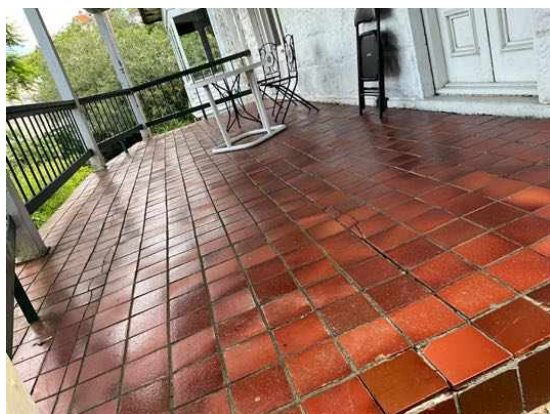
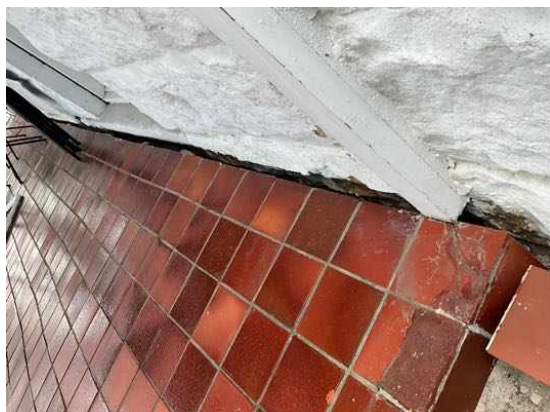
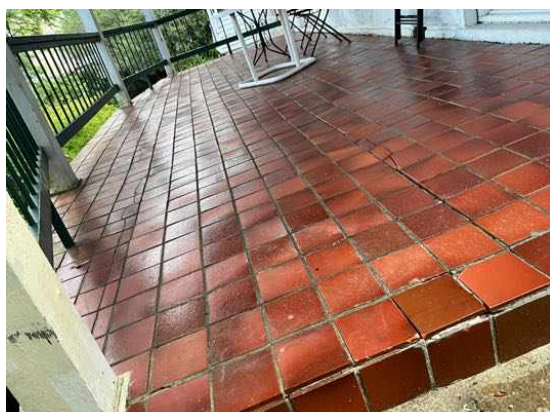
External timber structures are also constantly exposed to weather deteriorates in an exhilarate manner, ongoing assessments are required.

It is highly recommended that a structural engineer further, assess the external timber balcony or a deck to inform the client of its load capacity.

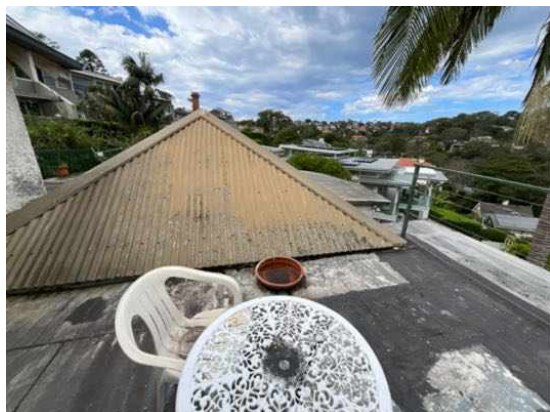
Finding 1.03

Building: Main Building
 Location: Roof Exterior
 Finding: Missing Balustrade
 Information: The upper-level residential balcony/terrace is missing a compliant balustrade to the open edge, creating an unprotected fall from height.

Engage a licensed residential builder to install a compliant balustrade with a minimum height of 1,000 mm, non-climbable design, and capable of resisting prescribed loads. Any glazed balustrade must comply with AS 1288 and be properly integrated with the balcony waterproofing system in accordance with AS 4654.2.

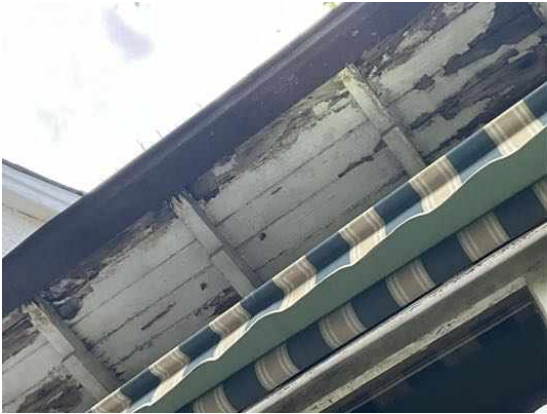
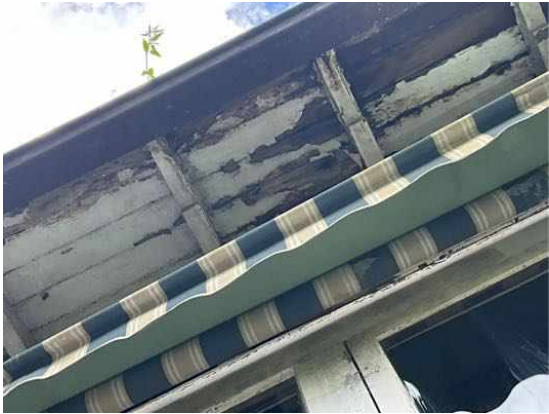
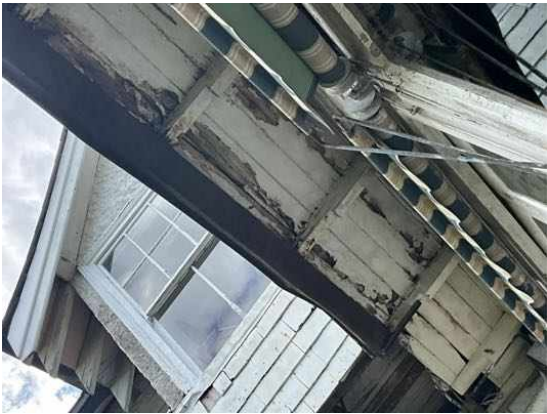
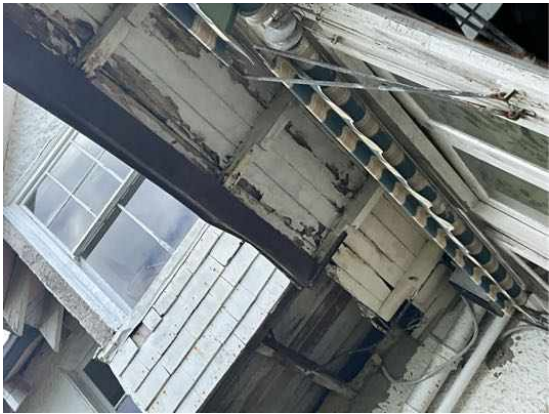
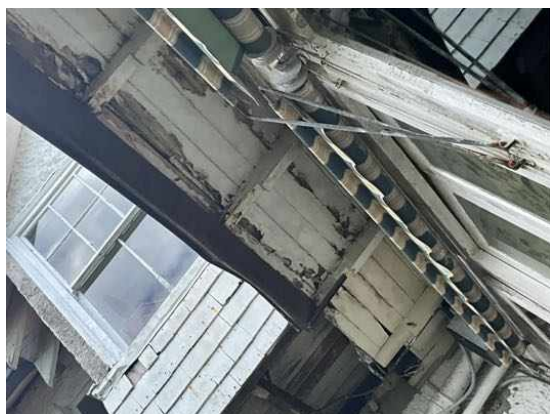
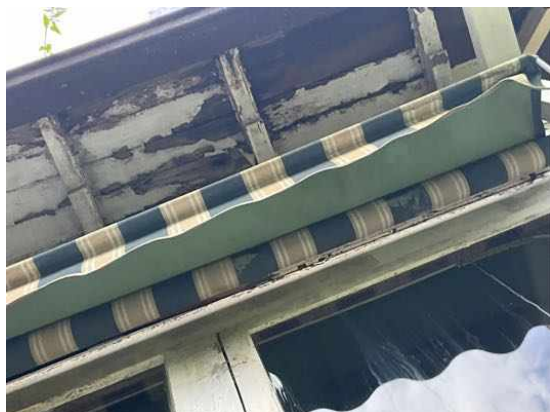
Finding 2.01

Building:	Main Building
Location:	All Areas
Finding:	Rot weakening the timber structure
Information:	Cracks and signs of wood rot have been observed, weakening the timber structure. The deterioration could be due to moisture exposure, aging, or insect infestation, compromising the structural integrity of the timber.

- ****Structural Instability:**** The cracks and wood rot can compromise the load-bearing capacity of the timber, potentially leading to structural failure or collapse, especially in load-bearing walls, beams, or frames.
- ****Safety Hazard:**** Weakening of the timber structure increases the risk of accidents, such as falling debris or collapse, posing a danger to occupants.
- ****Progressive Damage:**** If left unaddressed, wood rot can spread, further degrading the timber and accelerating the risk of structural failure.
- ****Pest Infestation:**** Wood rot can attract pests such as termites, which may cause additional damage.

A structural engineer or professional carpenter should be contacted to assess the extent of the damage. Depending on the severity, repairs may involve replacing the affected timber sections, treating the wood with preservatives, or reinforcing the structure. If there is extensive rot, a specialist in wood restoration or pest control may also be required to prevent further decay or infestation.

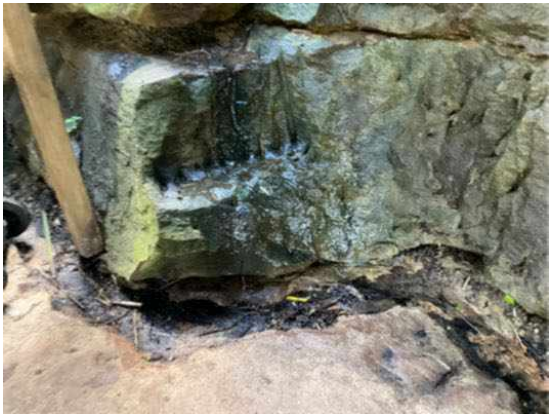
Finding 2.02

Building:	Main Building
Location:	All Areas
Finding:	Site drainage - Poor
Information:	Evidence of poor site drainage was observed, including water pooling around the perimeter of the dwelling and adjacent hardstand areas. This may be due to inadequate site grading, blocked surface drains, or insufficient stormwater management infrastructure.

- Potential water ingress into the subfloor or internal areas.
- Long-term structural damage due to moisture penetration.
- Increased risk of slip hazards, mould growth, and pest activity.

A qualified stormwater engineer should be engaged to assess the existing drainage layout and design a compliant stormwater management solution. This may include regrading surfaces, improving stormwater discharge points, or upgrading the drainage system to ensure effective water runoff during heavy rain events.

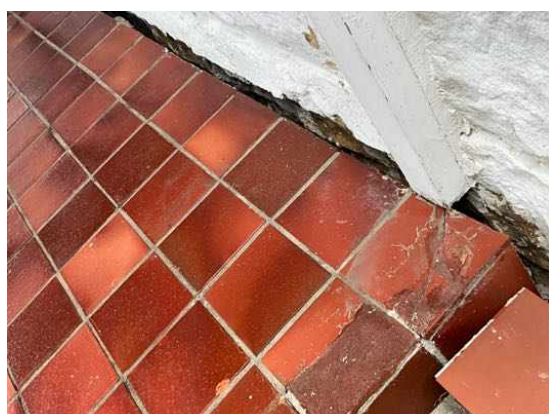
Finding 2.03

Building:	Main Building
Location:	Deck
Finding:	Subsidence - Structure
Information:	It appears that the structure has been affected by movement of the foundations, often referred to as sinking or subsidence. Whilst a degree of movement is expected over time, especially as environmental conditions change and buildings 'settle' after construction, this degree of subfloor movement requires attention.

General subsidence is usually initiated by changes in soil moisture content. The most critical factor is identifying the specific causes, and identifying if this is a recurring or ongoing problem, or one that has been resolved by previous works in the past.

Subsidence can have complex and varying causes, which will influence the required remedial works. It is advised to begin by consulting a structural engineer to determine the required scope of works. This generally includes some form of underpinning, as well as addressing the underlying cause. Consultation with a geotechnical engineer may also be necessary where changes to soil moisture content is apparent.

A Registered Builder specialising in carry out works as advised by an Engineer.

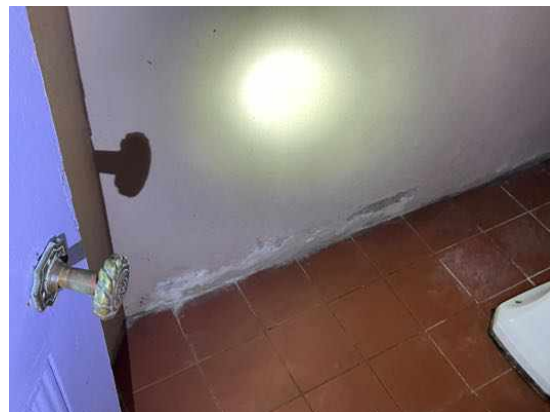
Building:	Main Building
Location:	Laundry / bathroom
Finding:	Water damage
Information:	The area has sustained water damage resulting in potential structural issues. This damage compromises both the aesthetic and functional aspects.

1 ****Plumber:**** If the water damage is due to plumbing issues, a plumber can fix leaks and ensure there are no further water-related problems.

2 ****General Contractor:**** If the damage is extensive and affects the surrounding area, a general contractor can coordinate the repair work, including any related structural or cosmetic repairs.

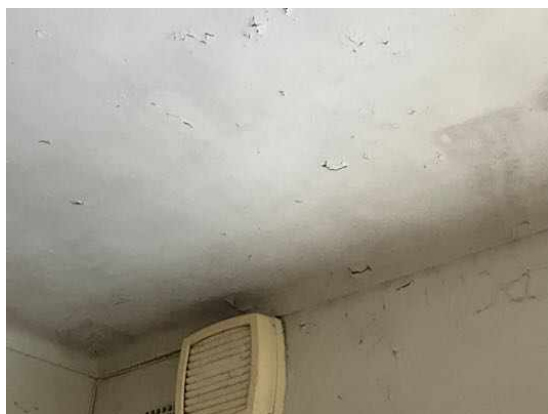
Finding 2.08

Information: Sections of the paint in this area was found to have deteriorated. Paint deteriorating is generally an indication of excessive moisture in the area that is currently hidden by the painted surface.

The presence of excessive moisture can have major implications on associated building elements if left unattended. the damage cannot be determined due to the paint, obstructing any further inspection of the damage.

It is highly advised that the affected paint to be cleaned to allow a further, more invasive inspection by a licensed builder/painter. Failure to act on this defect may necessitate major works in the future.

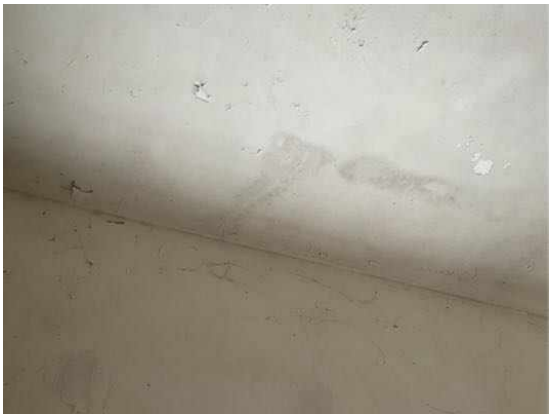
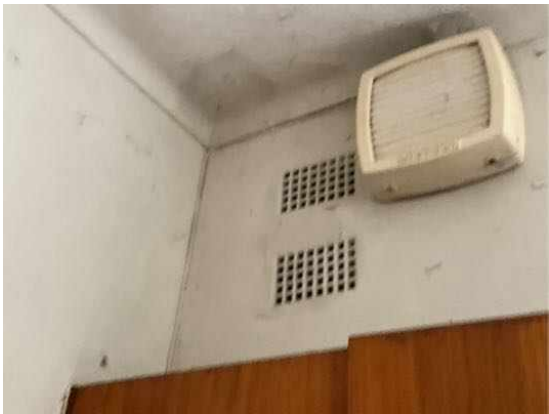
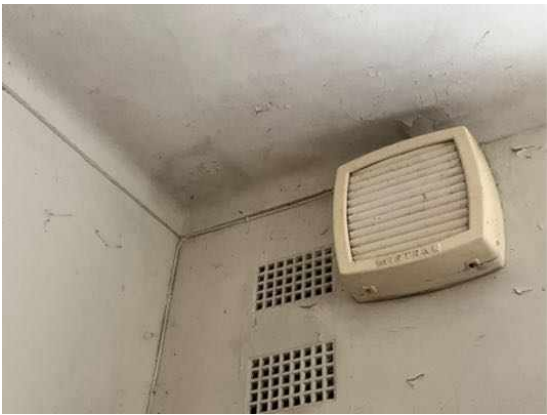
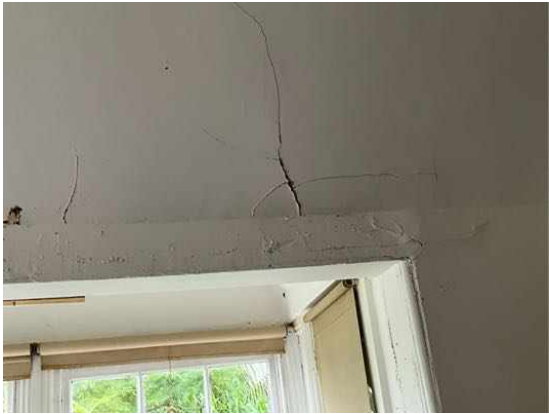
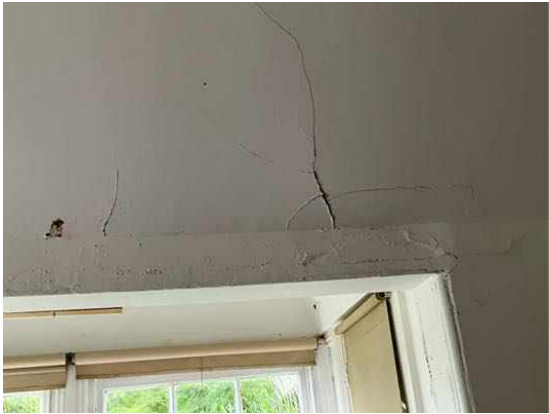
Finding 2.09

Finding: Roof Leaks

Information: The roof has developed leaks, allowing water to penetrate the building envelope. These leaks may be due to damaged or missing shingles/tiles, deteriorated flashing, clogged gutters, or other roof system failures.

A licensed roofing contractor or qualified roofer should be contacted to inspect and repair the roof leaks. They will:

- Identify the source of the leaks and assess the extent of the damage.

- Repair or replace damaged shingles, tiles, flashing, or other roofing materials.
- Ensure proper sealing around roof penetrations, such as vents, chimneys, and skylights.
- Clean and maintain gutters and downspouts to ensure proper drainage.
- Provide recommendations for any additional necessary repairs or preventive measures to avoid future leaks.

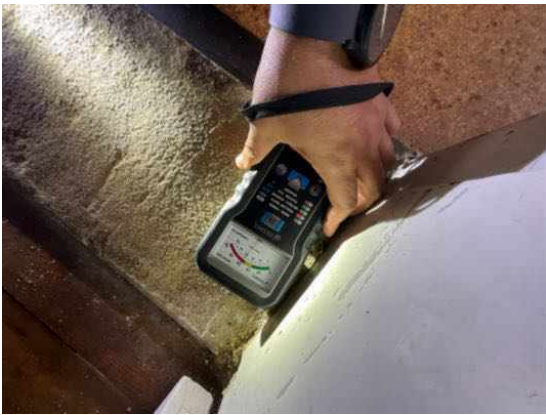
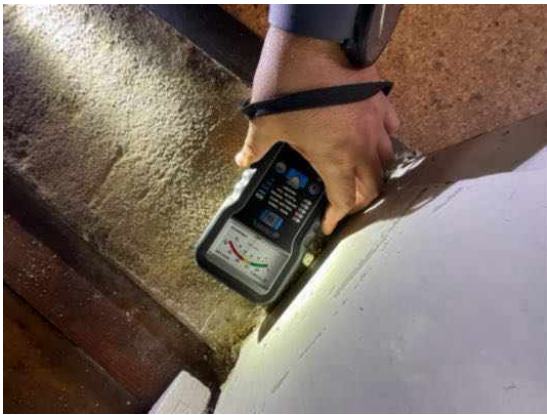
Finding 2.10

Building:	Main Building
Location:	All Areas
Finding:	Damp - Rising
Information:	Rising damp describes the upward movement of water in low sections of building elements (e.g. walls) by capillary action - the movement of water through porous materials such as bricks, sandstone or mortar.

Rising damp is generally managed by the installation of a damp proof course during construction. A Damp Proof Course (DPC) is an impermeable barrier at the base of the wall above ground level. However, many 19th Century buildings have no damp course installed, or the materials have failed. The DPC may have been omitted as a consequence of poor workmanship, or it may have been bridged where materials built up against the side of the house allow moisture ingress above the DPC level.

The first step in addressing rising damp is to diagnose the cause. The identified cause should be addressed first before addressing the appearance and other defects which have resulted from the rising damp. If the original cause is not resolved, further cases of damp are likely to ensue, resulting in secondary defects.

Consultation with a qualified plumber is advised immediately to identify the cause of the damp and perform remedial works as required.

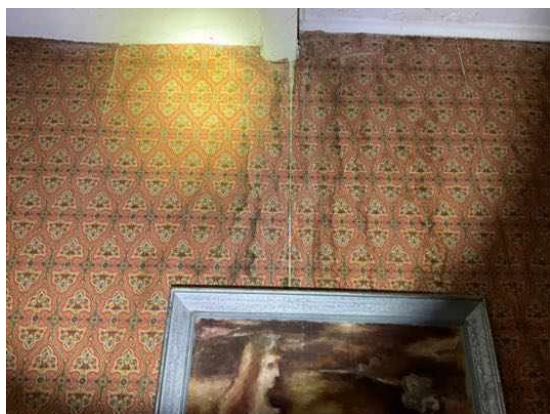
Finding: Water damage

Information: The area has sustained water damage resulting in potential structural issues. This damage compromises both the aesthetic and functional aspects.

1 **Plumber:** If the water damage is due to plumbing issues, a plumber can fix leaks and ensure there are no further water-related problems.

2 **General Contractor:** If the damage is extensive and affects the surrounding area, a general contractor can coordinate the repair work, including any related structural or cosmetic repairs.

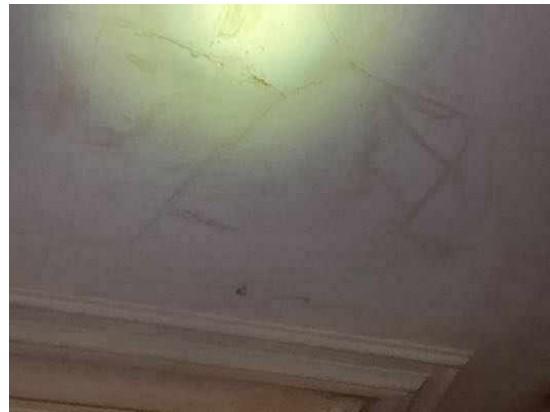
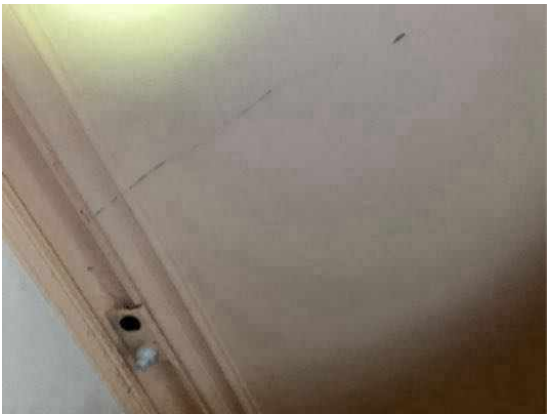
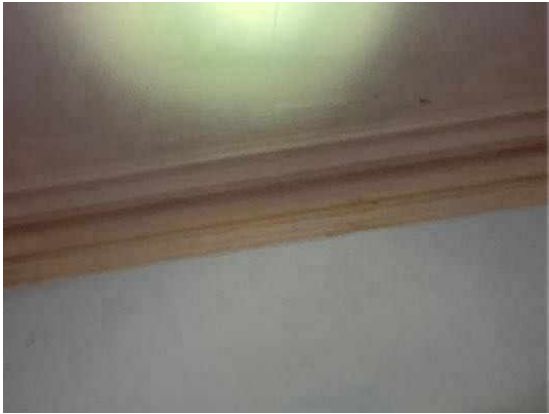
Finding 2.12

Building:	Main Building
Location:	All Areas
Finding:	Structural Cracking - Various locations within the property
Information:	Significant cracks have been observed in Various locations within the property including internal walls, particularly around structural joints and corners. These cracks are consistent with those that may arise from differential settlement, particularly in a house sitting on piers. The cracking pattern and the width of the cracks suggest potential movement of the structural elements, which could indicate subsidence or failure in the foundation support.

****Consequences:**** The observed cracks could compromise the structural integrity of the building if left unattended. This could lead to further deterioration, water ingress, pest intrusion, and potential safety hazards. If the cause is due to foundation movement or subsidence, it could result in significant structural failures, which could be costly to repair.

- **Immediate Inspection by a Structural Engineer:**** A licensed structural engineer should be engaged immediately to assess the extent and cause of the cracking. The engineer will provide a detailed report and recommend appropriate remediation measures.
- **Foundation Specialist Inspection:**** If foundation issues are confirmed, a specialist in underpinning and foundation repair should be consulted. They may recommend solutions such as underpinning, pier replacement, or other foundation stabilization methods.
- **Monitoring:**** If the engineer determines that the movement is ongoing, monitoring equipment may need to be installed to assess further movement over time.

4. **Repair:** Once the underlying cause is identified and stabilized, the cracks can be repaired. This might involve re-plastering, crack stitching, or other appropriate methods as advised by the engineer.

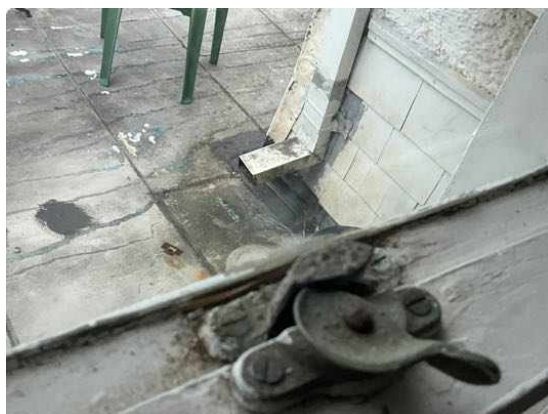
Building:	Main Building
Location:	All Areas
Finding:	Disconnected downpipe
Information:	A notable defect with a disconnected downpipe, compromising the efficient drainage

of rainwater from the roof. This disconnectivity poses an increased risk of water accumulation, potentially leading to foundation erosion, water damage to the property, and a conducive environment for mold growth.”

Engage a qualified and licensed roofing or gutter specialist to address the disconnected downpipe. This professional will reconnect the downpipe to ensure proper water drainage, mitigating the associated risks and preserving the integrity of the property.

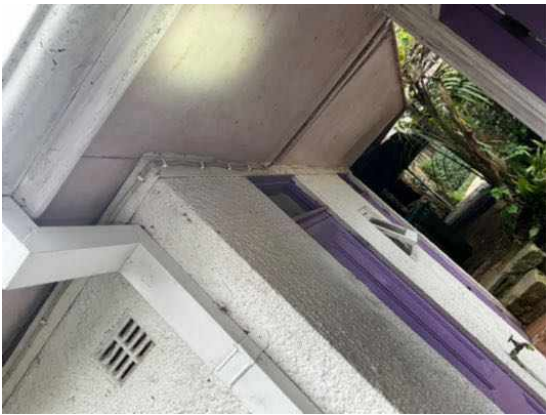
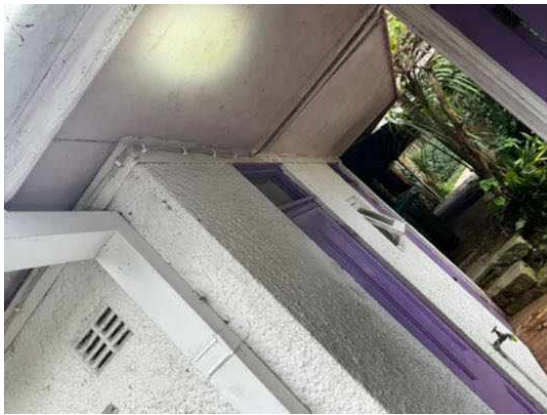
Building: Main Building
 Location: All Areas
 Finding: Timber Pest Damage
 Information: Termite damage and timber decay were observed. The affected timbers show hollowing, delamination, and mud-like residue consistent with termite activity, where in contact with soil, and vegetation is overgrown, providing potential termite access points.

The damage has compromised the structural integrity and may indicate active or previous termite infestation. If left untreated, termite activity could spread to nearby structures, leading to significant hidden timber damage and costly repairs.

Replace all affected timber members using H3/H4 treated pine or non-timber alternatives,

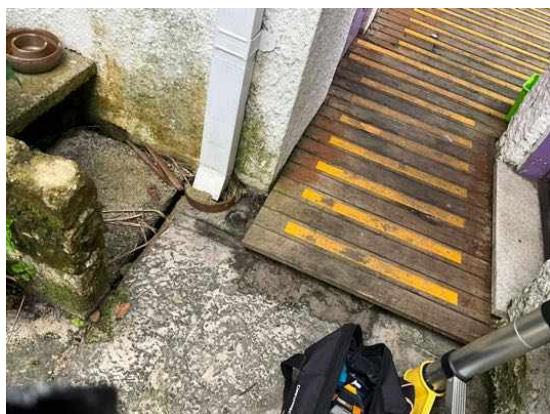
Finding 6.03

Building:	Main Building
Location:	All Areas
Finding:	Downpipes not connected- Conducive conditions for timber pest
Information:	<p>Unconnected downpipes can indeed pose a risk for attracting termites, as they provide a source of moisture near a building's foundation. Termites are attracted to moisture and wood, so it's important to address this issue to prevent potential infestations. Connecting downpipes to the stormwater system or ensuring proper drainage away from the building can help mitigate this a licensed plumber is the most qualified professional to handle plumbing-related tasks, including connecting downpipes to the stormwater system. They have the necessary expertise and tools to</p>

To prevent this, it's important to keep timber elevated and away from direct ground contact. Regular inspections and proper termite control measures are also essential to protect your wooden structures from termite damage.

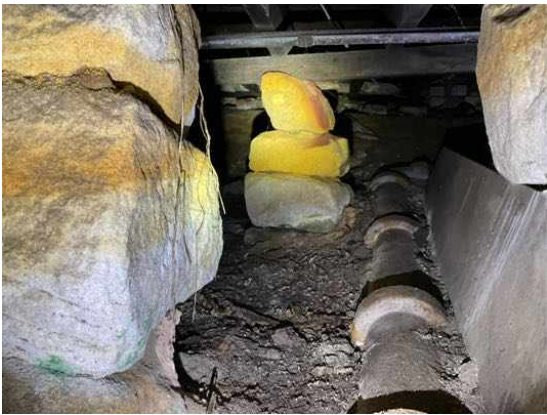
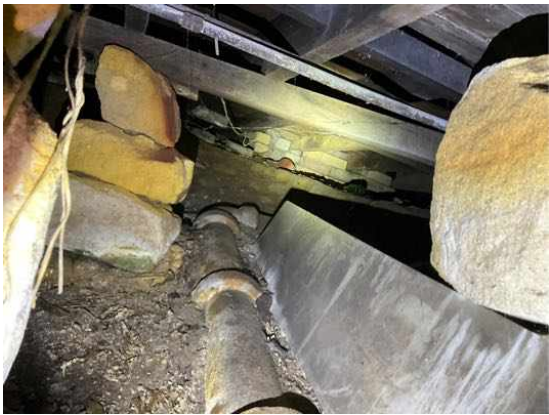
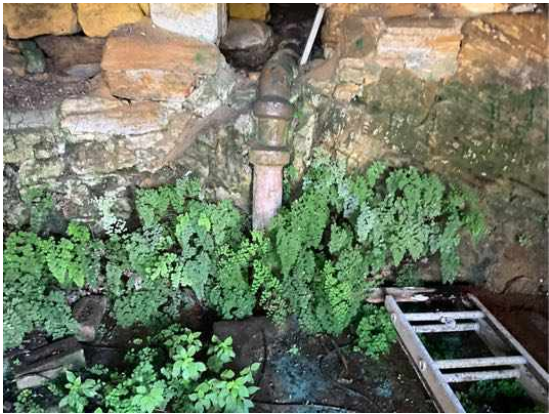
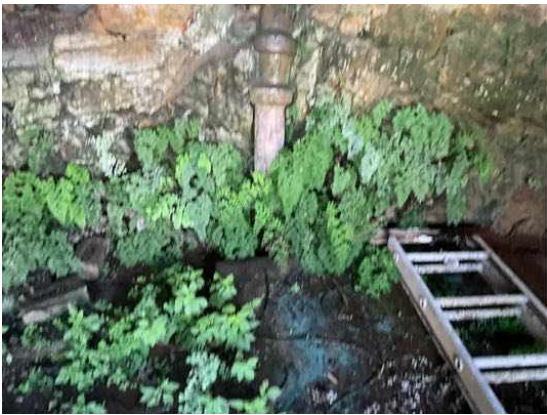
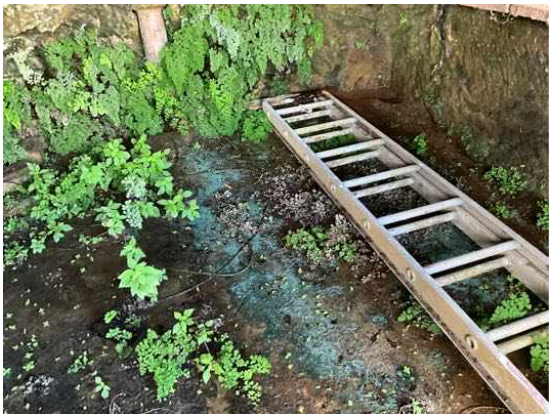
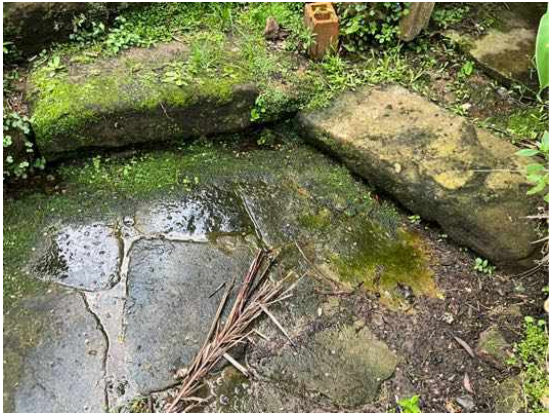
Finding 6.05

Building:	Main Building
Location:	Laundry / bathroom
Finding:	Excessive moisture - Conducive to Timber pest
Information:	Excessive moisture can attract termites and produce conditions that promote fungal growth and wood decay.

Excessive moisture is generally caused by deteriorated inadequate or missing roof drainage leaking plumbing pipes or fixtures poorly plumbed HWS overflows or condenser units and poor site drainage.

A licensed pest control professional specializing in timber pest management should be consulted to assess the extent of the infestation and develop a comprehensive treatment plan. They can implement strategies to eliminate existing timber pests, such as termites and prevent future infestations by addressing underlying moisture issues. Additionally, a qualified contractor or builder may be needed to improve subfloor ventilation, enhance site drainage, repair water-damaged areas, and install ant caps to prevent pest entry points. Regular inspections and maintenance are essential to ensure ongoing protection against timber pests and maintain the structural integrity of the subfloor.

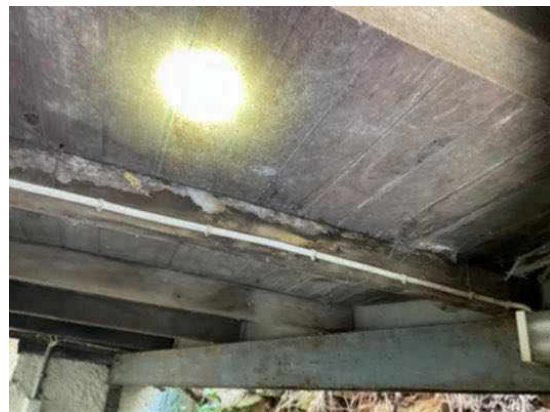
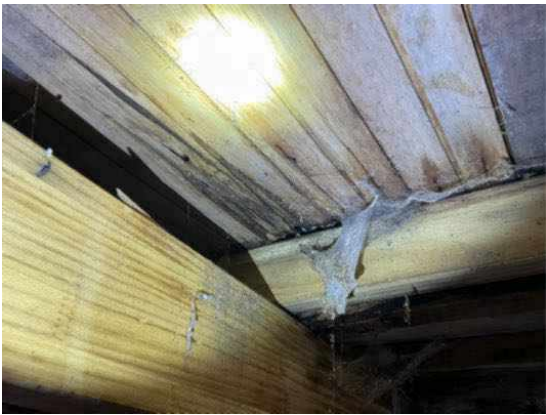
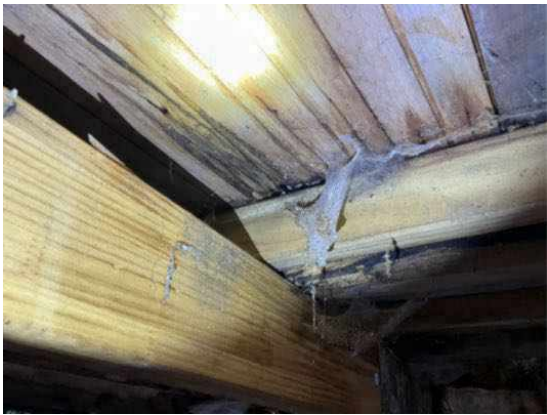
Finding 7.01

Finding: Wood rot

Early intervention and regular maintenance, particularly of exterior timbers, will prolong the useful life of these building elements. Prior to any works being performed, the cause of the moisture that has created the visible wood rot should be identified and addressed in a suitable manner. Replacement of affected timbers may then be a necessary step in protecting surrounding building elements from such deterioration.

A qualified plumber may be appointed to assess the cause of excessive moisture and to provide advice on any remedial works as required. A qualified carpenter or registered builder may also be required to replace affected building materials.
