Building and Timber Pest Inspection Report

Inspection Date: Wed, 11 Mar 2026

Property Address: 11 Myee Rd, Macquarie Fields NSW 2564,
Australia

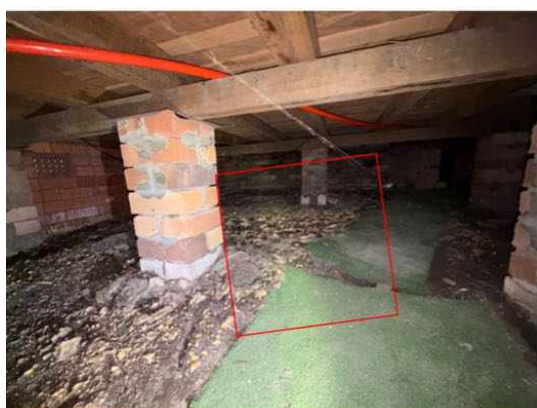
Finding 3.01

Building:	Main Building
Location:	Subfloor
Finding:	Subfloor - Dampness
Information:	Dampness to several sections of the subfloor area was identified. It is suspected that this dampness may be exacerbated by inadequate subfloor ventilation although there maybe other reasons attributing. Dampness is likely to lead to wood decay and general deterioration of structures within the subfloor space. Excessive moisture also creates an environment which is conducive to termite and pest infestation. A licensed electrician should be engaged immediately to install manual ventilation. A licensed plumber should also be appointed to determine whether any active leaks or otherwise poor drainage may also be the underlying cause.

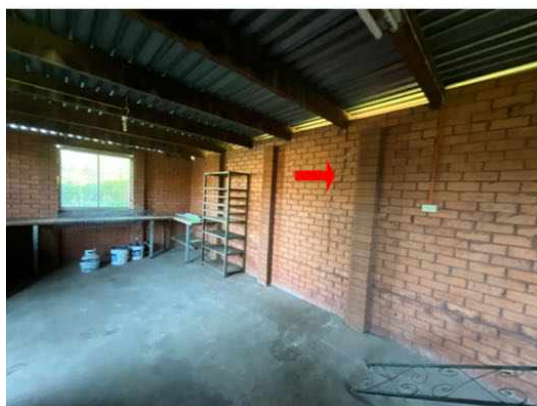
Building:	Main Building
Location:	Garage
Finding:	Damage to Masonry Walls (Cracks)- Category 2
Information:	It has been observed that damage to masonry walls caused by movement of slabs, footings, or other causes, has occurred. The degree of damage falls within Category 2, described as noticeable cracks which are easily filled. Such cracking may cause doors and/or windows to stick slightly, and are generally less than 5mm in width.

Damage of this category is required to be monitored for a period of 12 months, after which time a crack rated at Category 2 or above is considered a defect requiring rectification, such as minor repairs and repointing. Always contact your building inspector should cracks widen, lengthen, or grow more numerous.

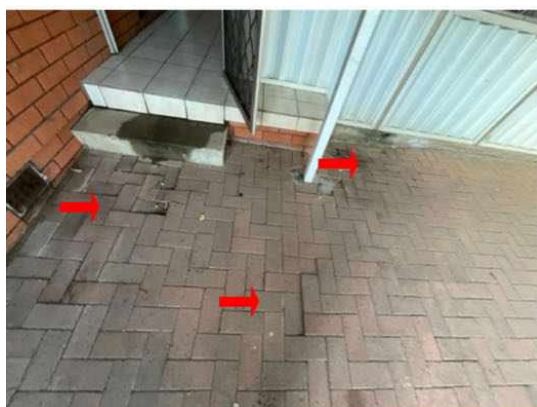
Information: Sections of the external paved area are uneven, which may develop into a trip hazard. It appears as though the area has been subject to rough installation, or that paving sections have lifted due to movements in the foundation.

Left unmanaged, the May develop into a safety hazard due to trip and fall.

Re-paving of the area is required to remedy this situation. Further consultation with a specialist concreter is advised.

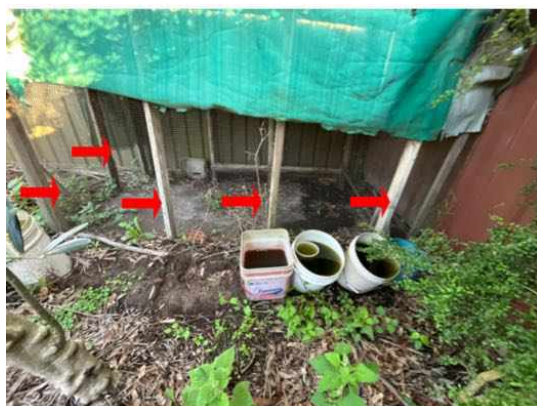
Building:	Main Building
Location:	Chicken coop
Finding:	Untreated or non-durable timbers in a hazardous environment
Information:	To reduce the risk of timber pest attack it is essential that timber used in a hazardous environment (e.g. in direct contact with the ground or frequently exposed to damp conditions) is of sufficient durability and/or is adequately preservative treated.

Untreated timbers in direct contact with the ground are likely to develop severe wood rot and/or fungal decay if left unattended creating attraction for subterranean termites to infest the timbers from surrounding areas.

If untreated or non-durable timbers are found to be in a hazardous environment it is highly advised that replacement of these building elements be performed as soon as possible to aid the protection of the property against termite / timber pest attack.

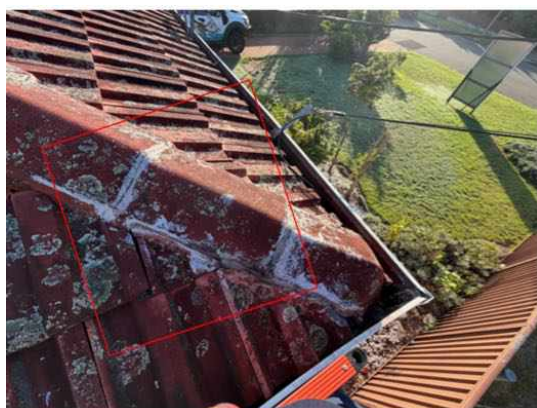
Finding 3.11

Building: Main Building
 Location: Roof Exterior
 Finding: Roof tiles - Weathered
 Information:

Upon inspection of the exterior roofing, the majority of roof tiles were considered to be in a fair condition. While weathering of the tiles is consistent with the age of the property, maintenance works are required.

Isolated areas of mortar have come loose and minor cracking is also present. Re-pointing and re-sealing the may be considered as an interim solution by the client to help preserve and extend the life span of the tiles.

Where left unmanaged, deteriorating roof tiles are likely to lead to a number of secondary defects, including minor water leaks and weather exposure to internal roofing structures.

Consultation with a licensed roofing contractor is highly advised to gain advice on cost of remedial works that may be required in the short to medium term. Remedial works are likely to increase the longevity of the exterior roofing structure.

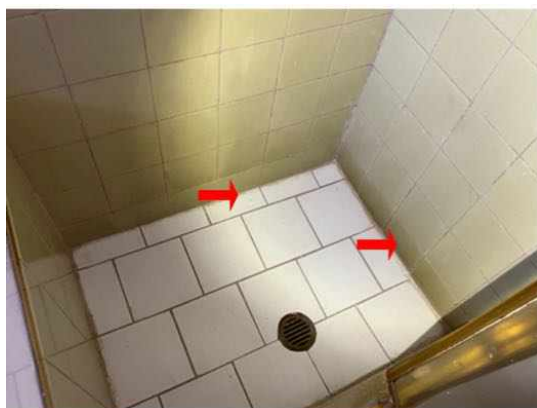
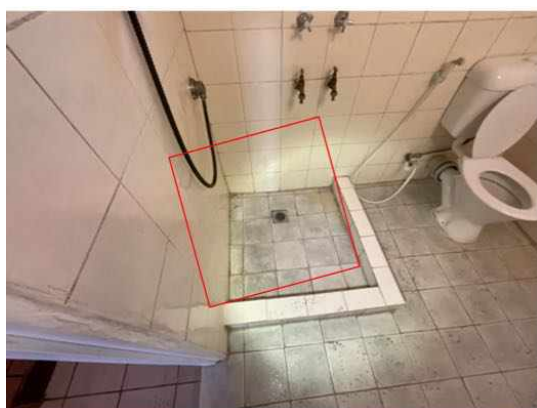
Building:	Main Building
Location:	All Wet Areas
Finding:	Sealant and grouting - Missing or damaged

Information: It was noted on inspection that sealant or grout is degraded to this area.

Different materials and floor areas move at different rates, generally causing cracking to grout or sealant at this point. A flexible sealant is required to allow for expected expansion and contraction, while keeping the joint water tight and protective of all associated building materials.

Flexible and mould resistant materials should be applied to affected areas to prevent any subsequent water damage that is likely to occur. Regular maintenance and replacement of damage or missing or damaged sealant and grout is highly recommended to the wet areas, as this is a regular wear and tear defect. Sealant and grouting in areas that come into regular contact with water should be maintained for the long term care of your property.

A sealant specialist should be appointed to complete these works as soon as possible.

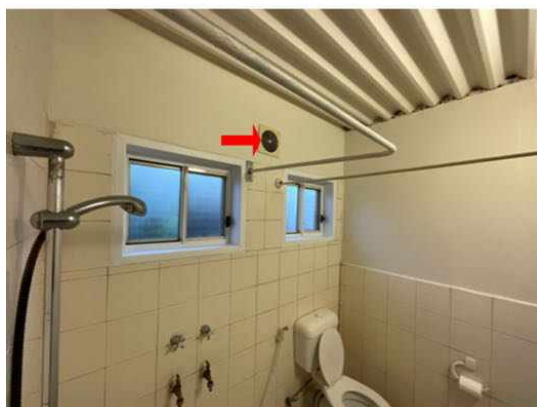
Finding 3.16

Building: Main Building
 Location: Exterior shower
 Finding: Exhaust fan - Not operating
 Information: The exhaust fan in this area appears to be damaged or blocked and is not operating

Where no secondary damage has developed, the Homeowner may undertake minor cleaning of the area and consider replacement of the exhaust fan. Alternatively, consultation with a Licensed Electrician is required to check for any secondary or concealed damage and consider repair or replacement.

Please be advised that a cabinet maker or qualified carpenter may also be required if water damage has occurred and that an additional specialist mould inspection may be required if severe mould has resulted.

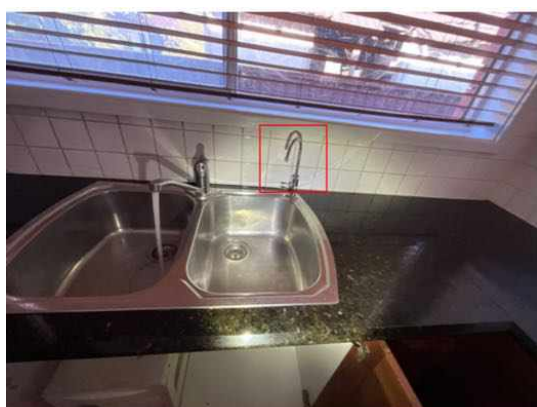
Building:	Main Building
Location:	Kitchen
Finding:	Building element - Not operating
Information:	Non-operational items should be addressed to ensure that the full function of the building structure is available. Where some building elements are not operating as intended, it is possible that secondary building defects could arise due to their non-operation.

Repair and/or replacement of the faulty building element is recommended. It is highly recommended that the relevant tradesperson be engaged to perform any necessary works.

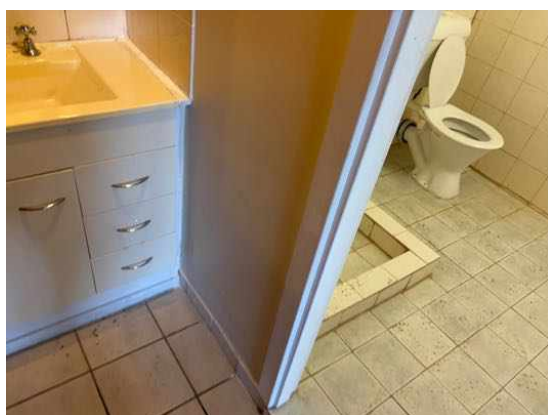
In extreme cases, structural damage may develop due to a prolonged water leak. A

bathroom specialist must be appointed immediately for rectifications.

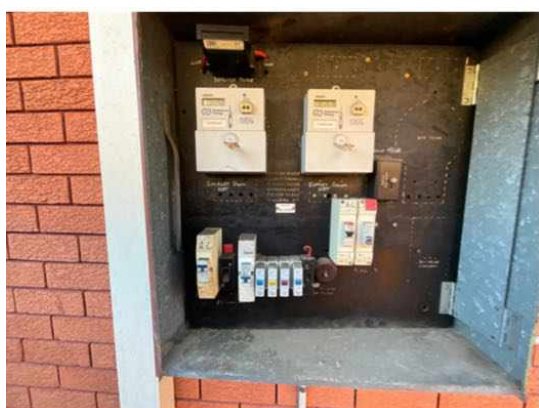
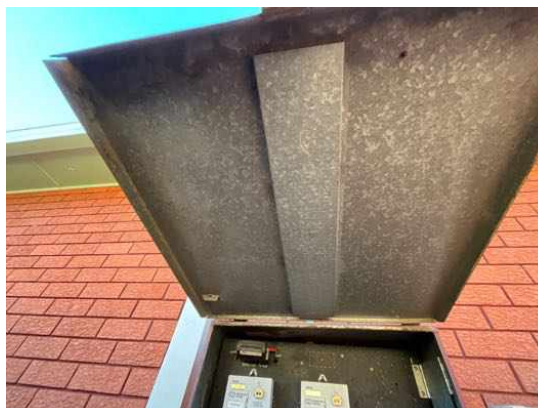
A durable notice should be placed in the switchboard unit to indicate current termite barriers. At the time of inspection, it appeared as though no termite management system has been installed, with no evidence to suggest preventative works taking place.

The client may consider gaining further advice from a pest controller as to the costs and procedures involved with this application. It is recommended that obtaining such advice be a short-term priority.

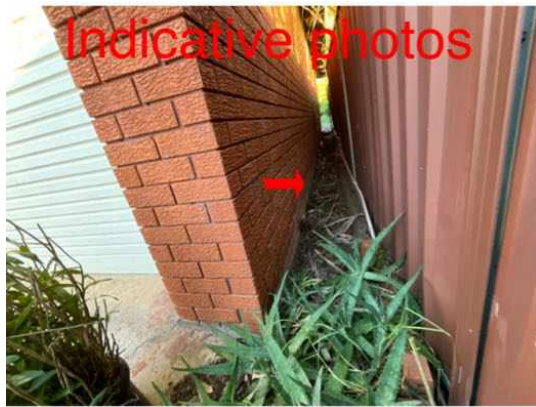
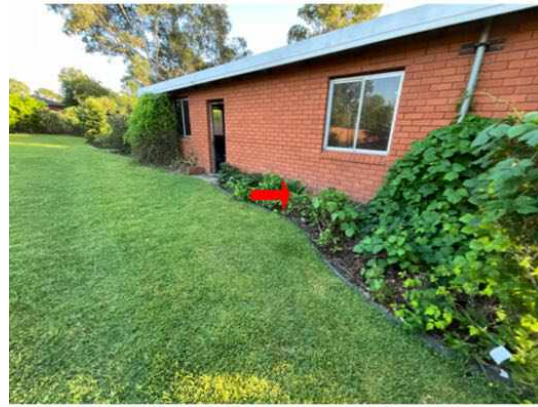
Building: Main Building
 Location: Garage
 Finding: Slab Edge - Exposure
 Information: Slab Edge Exposure: Where external concrete slab edges are not exposed there is a high risk of concealed termite entry. In some buildings built since July 1995 the edge of the slab forms part of the termite shield system. In these buildings an inspection zone of at least 75mm should be maintained to permit detection of termite entry. The concrete edge should not be concealed by render, tiles, cladding, flashings, adjoining structures, paving, soil, turf or landscaping etc. Where this is the case you should arrange to have the slab edge exposed for inspection. Concealed termite entry may already be taking place but could not be detected at the time of the inspection. This may have resulted in concealed timber damage. Does the slab edge inspection zone fully comply?

Not able to comment. A very high proportion of termite attacks are over the edge of both Infill and other concrete slabs types. Covering the edge of a concrete slab makes concealed termite entry easy. Infill slab type construction has an even higher risk of concealed termite ingress as the slab edge is concealed due to the construction design and cannot be exposed. The type of slab may only be determined by assessment of the construction plans by a qualified person e.g. Builder, Architect. Construction Plans may be obtainable by your local Council or Builder. Termite activity and or damage may be present in concealed timbers of the building. We strongly recommend frequent regular inspections in accordance with AS 3660.2. Where the slab edge is not fully exposed or the slab is an infill slab or the slab type cannot be determined then we strongly recommend inspections every 3 to 6 months in accordance with AS 3660.2 or AS 4349.3.
