Building and Timber Pest Inspection Report

Inspection Date: Fri, 23 Jan 2026

Property Address: 27/160 Peter Thomson Cct, Yarrowonga VIC
3730, Australia

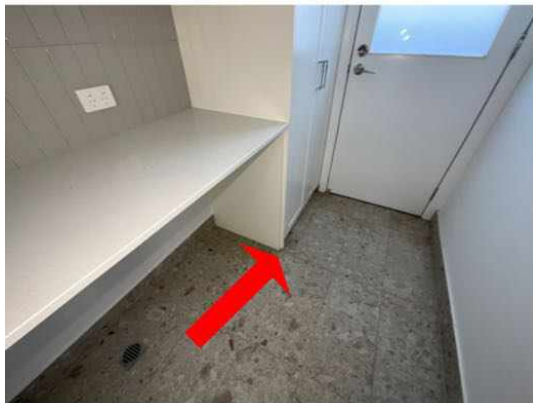
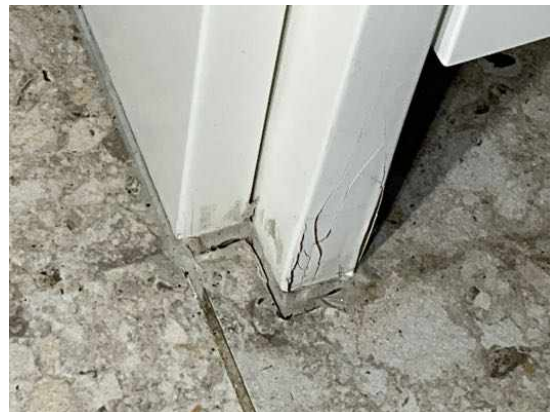
Finding 3.01

Building: Building 1
 Location: Laundry
 Finding: MDF- Moisture affected
 Information: The Particle board (MDF) in this area has been affected by excess moisture. This moisture has caused swelling of the material. A lack of effective paint or other coating has probably allowed the moisture to penetrate and deteriorate the material over time.

In cases of minor swelling a painter or Handy person could re-paint and restore the area.

In cases where the material is structurally compromised a carpenter or General handy person could be contacted to replace the damaged elements and complete all needed restoration.

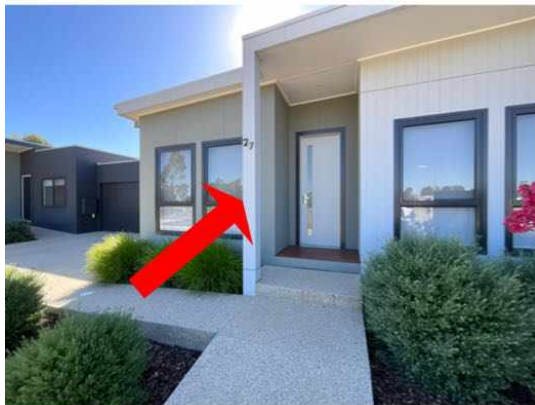
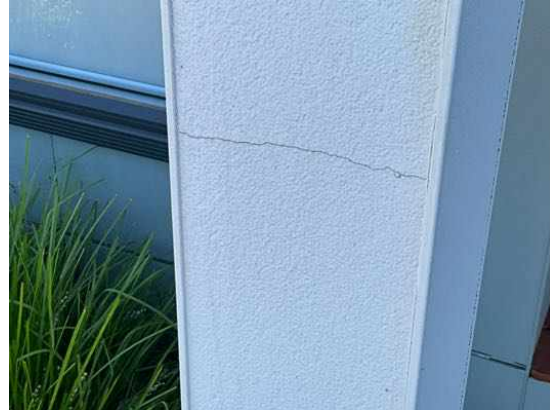
Finding 3.02

Building: Building 1
 Location: Entry
 Finding: Cracking - Damage Category 1 - Fine (up to 1mm)
 Information: Although fine cracks are quite noticeable, they are often only considered to be an

appearance defect, and usually do not indicate any structural damage. Generally, the cause of a fine crack is indicative of a separation between building materials and finishes (e.g. paint, plaster, etc.) along joins.

Cracking of this nature can generally be repaired with minor sanding, filling and/or repainting. Such works should be performed by a qualified painter or a general handyman.

Monitoring of all cracking should be conducted frequently. Always contact a building inspector should cracks widen, lengthen, or become more numerous.

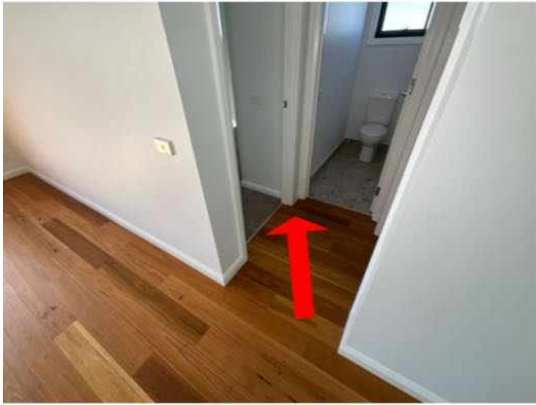
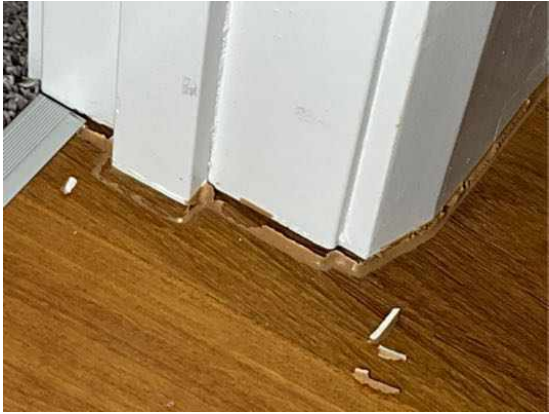
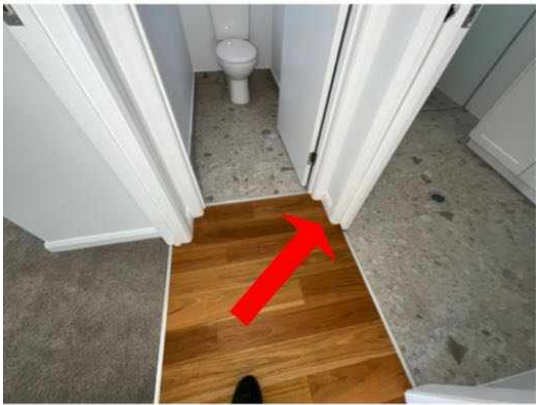
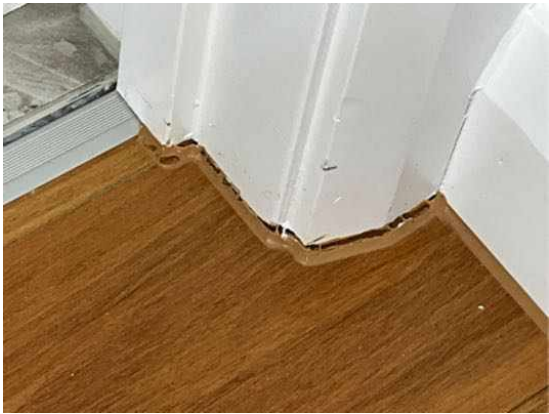
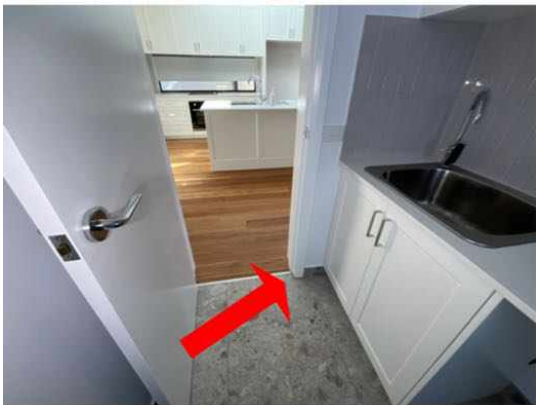
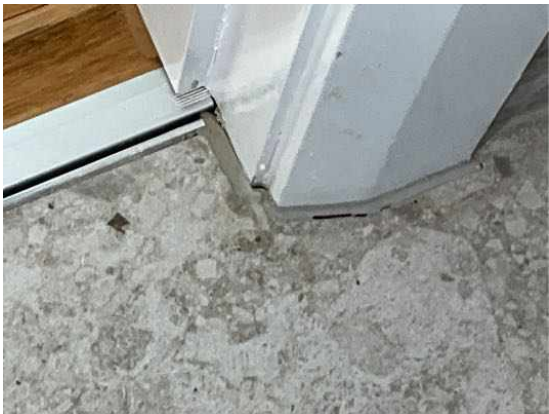
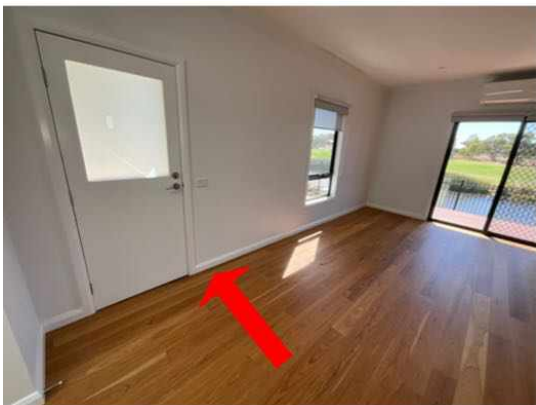
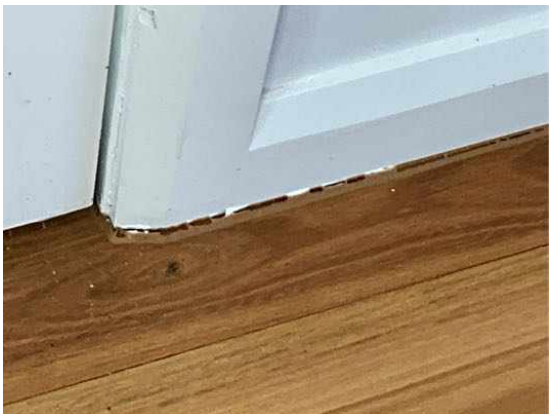
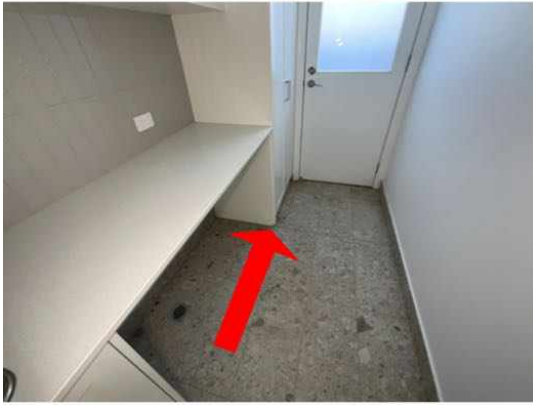
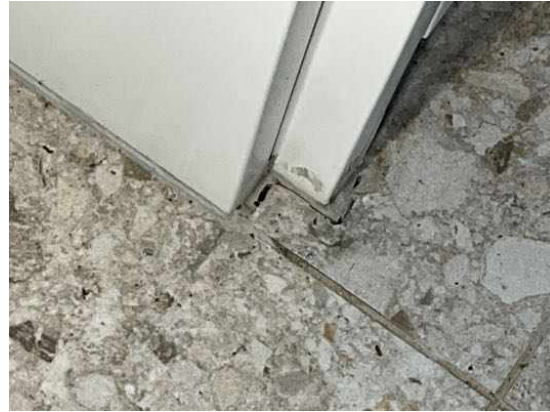
Finding 6.01

Building:	Building 1
Location:	Hall, laundry, living
Finding:	Inadequate sealant or Grout
Information:	This area has a lack of effective Sealant or Grout. This is allowing the ingress of water to the structure inside the wall.

The presence of water encourages Termite attack, Mould and Fungal Decay.

A Tiler or General Handy person must be contacted as soon as possible to effect repairs and prevent further deterioration.

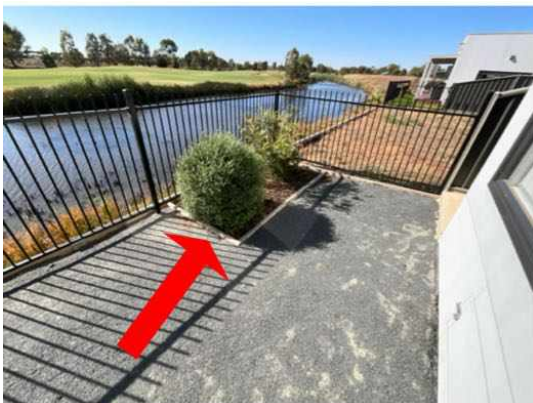
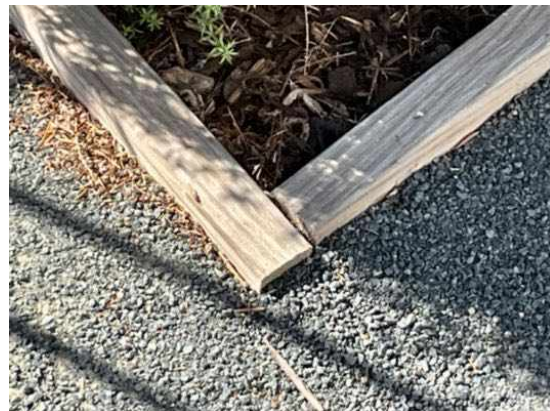
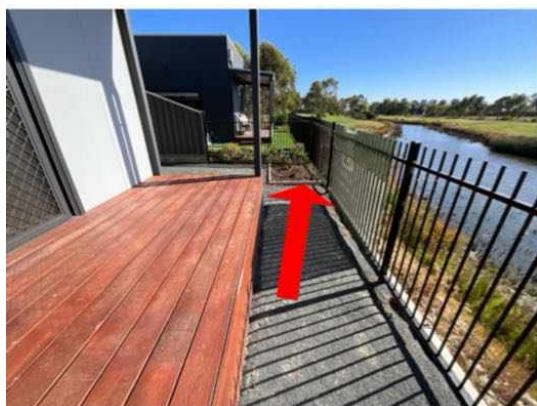
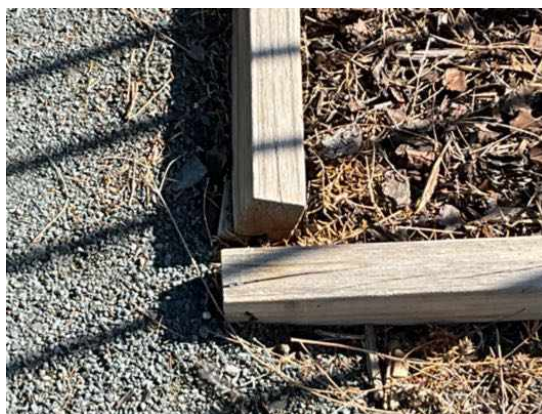
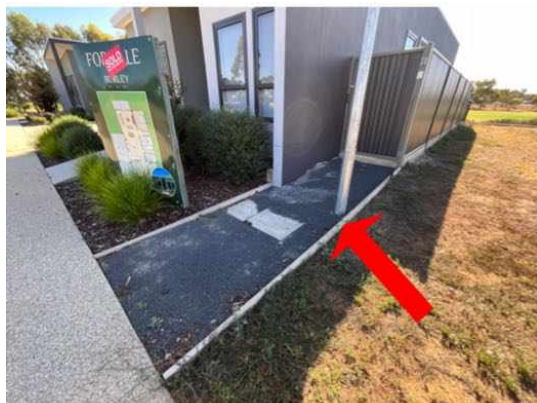
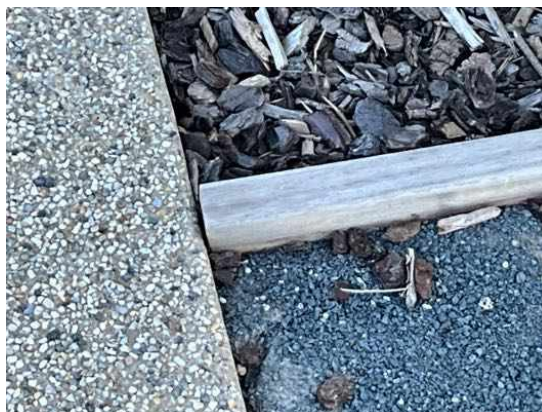
Finding 6.02

Building:	Building 1
Location:	Yard - Back, front
Finding:	Untreated or non-durable timbers in a hazardous environment
Information:	To reduce the risk of timber pest attack it is essential that timber used in a hazardous environment (e.g. in direct contact with the ground or frequently exposed to damp conditions) is of sufficient durability and/or is adequately preservative treated.

Untreated timbers in direct contact with the ground are likely to develop severe wood rot and/or fungal decay if left unattended creating attraction for subterranean termites to infest the timbers from surrounding areas.

If untreated or non-durable timbers are found to be in a hazardous environment it is highly advised that replacement of these building elements be performed as soon as possible to aid the protection of the property against termite / timber pest attack.

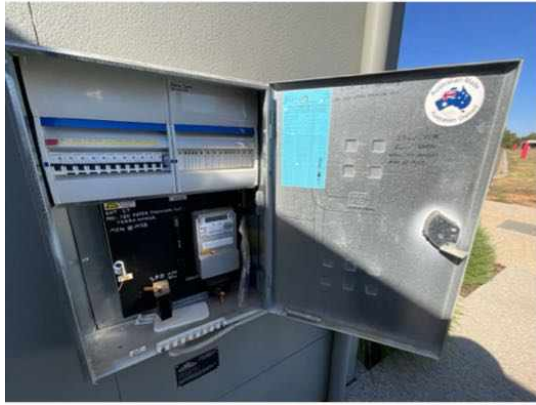
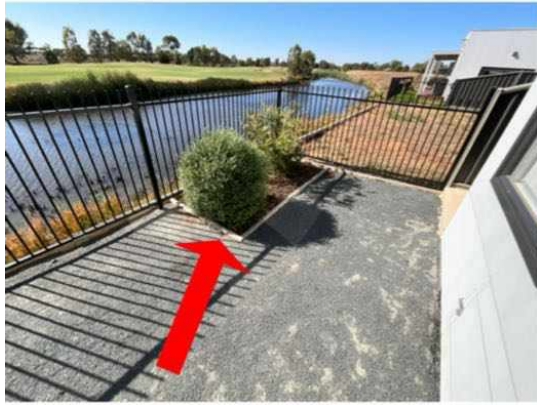
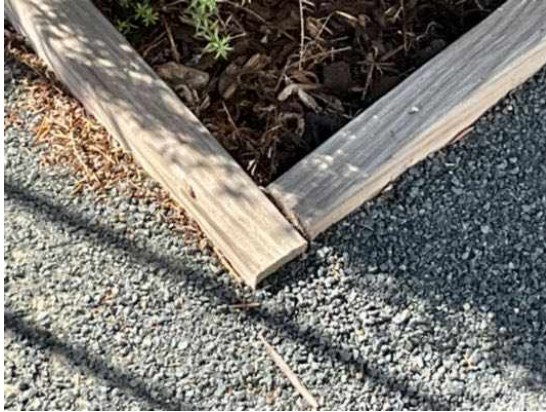
Finding 6.03

Building:	Building 1
Location:	All External Areas
Finding:	Termite Management System - no evidence of a chemical installation
Information:	The application of a post-construction chemical termite barrier is highly recommended for all properties, particularly if live termite activity has been found on the site previously. Such barriers are highly effective in preventing termite attack on any timber building elements throughout the property.

A durable notice should be placed in the switchboard unit to indicate current termite barriers. At the time of inspection, it appeared as though no termite management system has been installed, with no evidence to suggest preventative works taking place.

The client may consider gaining further advice from a pest controller as to the costs and procedures involved with this application. It is recommended that obtaining such advice be a short-term priority.

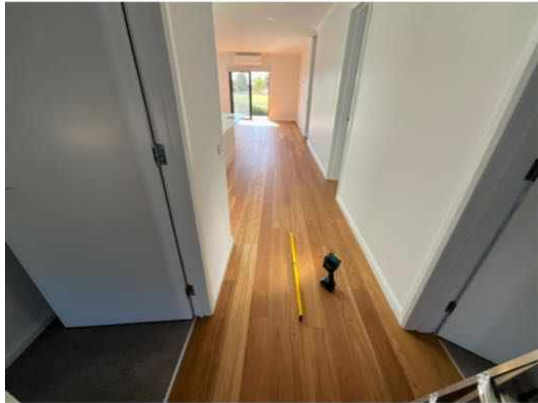
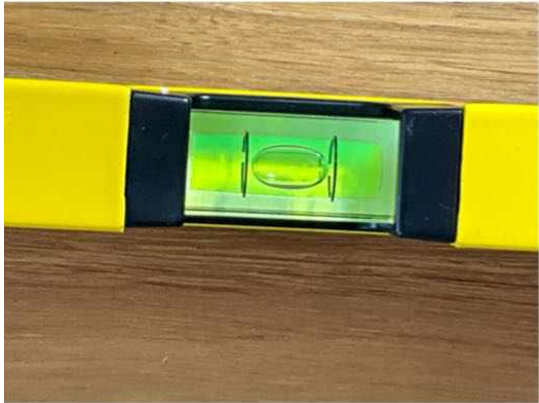
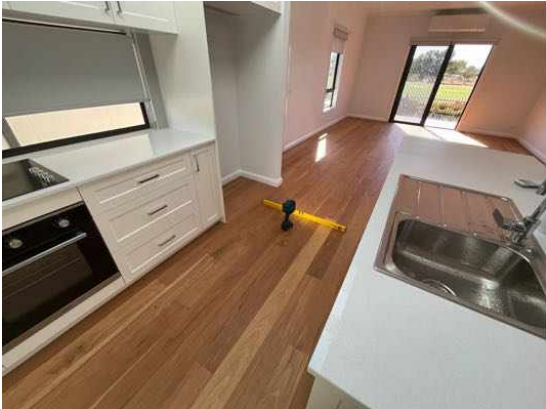
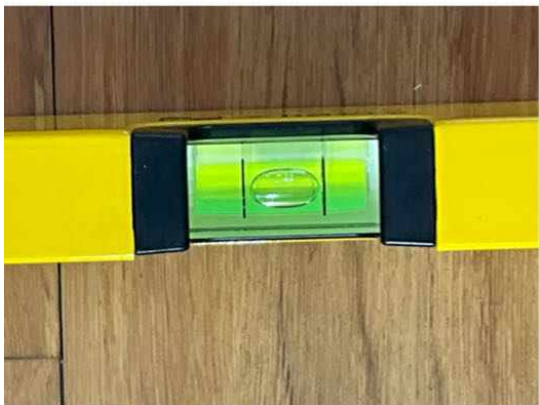
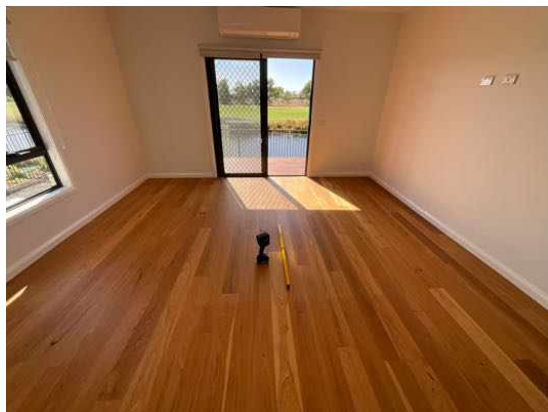
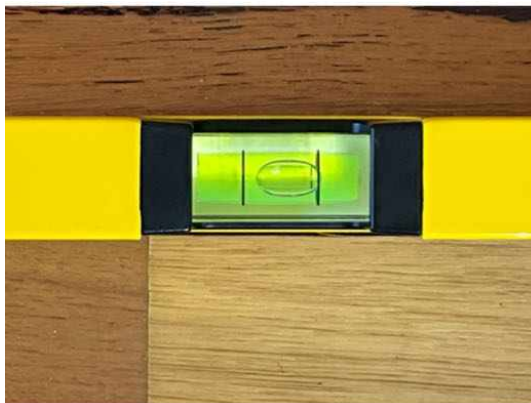
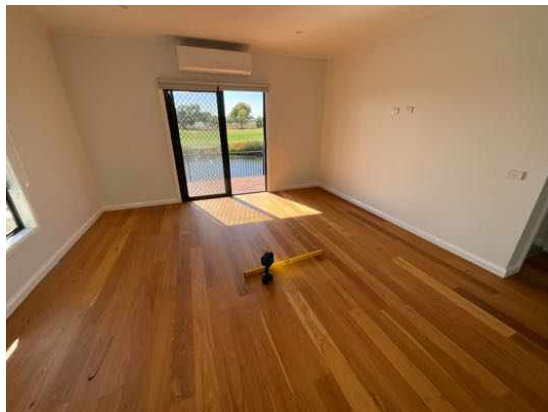
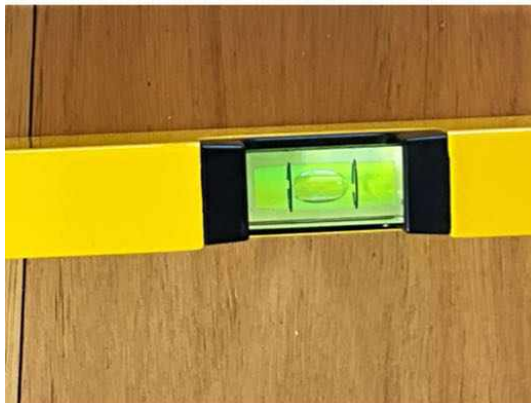
Building: Building 1
Location: All Internal Areas
Finding: Flooring- generally level
Information: The internal flooring in this area is generally level and even. Where slightly uneven flooring is present it is likely to indicate minor defects such as expected movement of the foundations of the property.

No immediate action is needed.

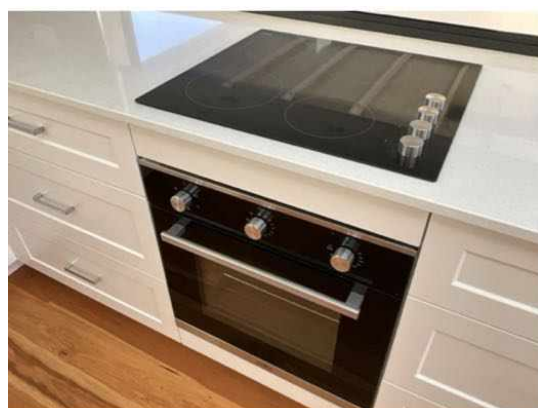
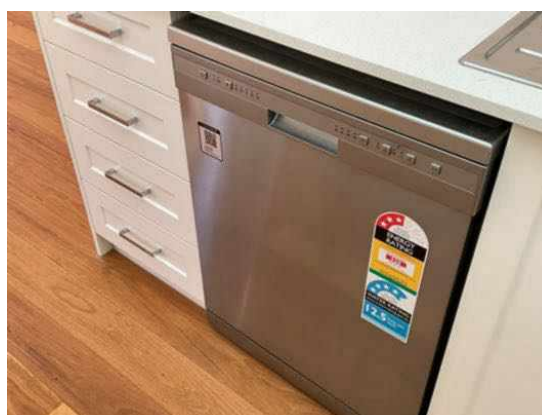
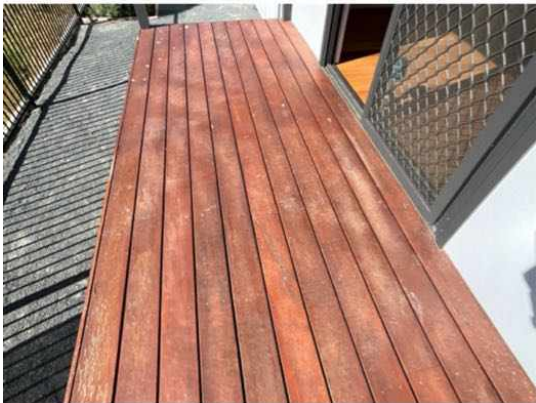
Building: Building 1
Location: All Areas
Finding: Additional Photos - Obstructions and Limitations
Information: These photographs are an indication of the obstructions and limitations which impeded full inspection of the property at the time of inspection. These obstructions can hide an array of defects and should be removed to allow full inspection to be carried out. A re-inspection is recommended once the areas are made accessible.
