## Building Inspection Report

Inspection Date: Fri, 20 Feb 2026

Property Address: 11 Paxton Link, Pakenham VIC 3810,  
Australia

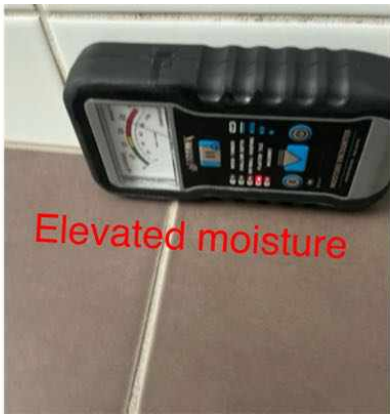
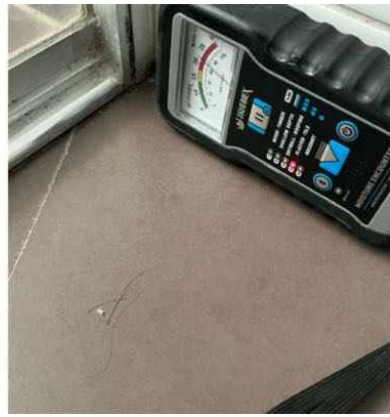
#### Defects 3.01

Building: Main Building  
 Location: Ensuite - Master  
 Finding: Shower damp and Deteriorated Grout/Sealant – Shower Alcove  
 Information:

Dampness was observed to the lower approximately 300 mm of the wall within the shower alcove. The affected area corresponds with sections of deteriorated grout and degraded sealant to the tiled surfaces and junctions. The condition is commonly associated with moisture permeating through failed grout lines or compromised sealant; however, concealed plumbing leakage within the adjoining wall cavity cannot be ruled out without further investigation. Localised mould growth was also noted to sections of grout and sealant.

Excess moisture within shower recesses can lead to the development of mould, fungi, and bacterial growth, as well as deterioration of associated building materials including wall linings, framing, and finishes. Movement between adjoining materials (e.g., wall and floor junctions) often results in cracking of rigid grout, and flexible sealant is required at junctions to accommodate expansion and contraction while maintaining watertightness. If left unmanaged, ongoing damp conditions may compromise structural elements and pose potential health concerns due to microbial growth.

Immediate assessment by a licensed plumber or bathroom specialist is recommended to determine the source of moisture and undertake necessary remedial works. This may include moisture testing, plumbing checks, removal and replacement of deteriorated grout and sealant, and application of flexible, mould-resistant sanitary-grade silicone at junctions. Where mould growth is extensive, further evaluation by a suitably qualified environmental health or mould specialist should be considered. Ongoing maintenance of grout and sealant to wet areas is essential to preserve watertight integrity and prevent recurrence.

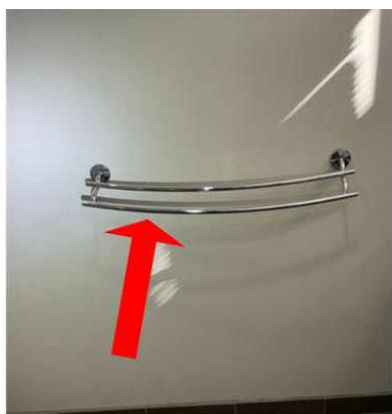
### Defects 3.03

Building:	Main Building
Location:	Ensuite - Master
Finding:	Towel rail - loose
Information:	The towel rail was found to be loose at the time of inspection. While not a major operational defect, function can deteriorate if the problem is left unmanaged.

It is advised that the homeowner performs remedial works to re-attach the towel rail to its original fixing. A general handyperson may be required to perform these works.

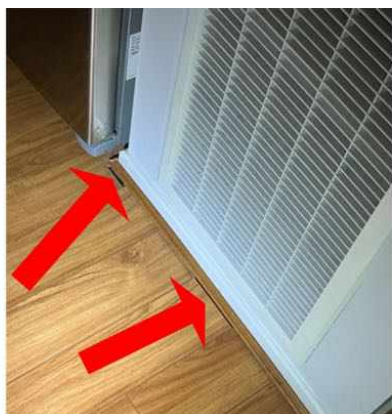
### Defects 3.04

Building:	Main Building
Location:	Kitchen
Finding:	Minor Gap – Internal Finish
Information:

A minor gap was observed to the affected internal junction. The separation appears small and consistent with normal building movement, material shrinkage, or minor installation tolerances.

Such gaps are generally cosmetic in nature and do not indicate structural concern at the time of inspection. However, they may detract from the overall finish quality and allow minor dust accumulation.

If considered unsightly, a qualified handyman or relevant trade specialist can apply a suitable flexible sealant or undertake minor adjustment works to achieve a neat and uniform finish.

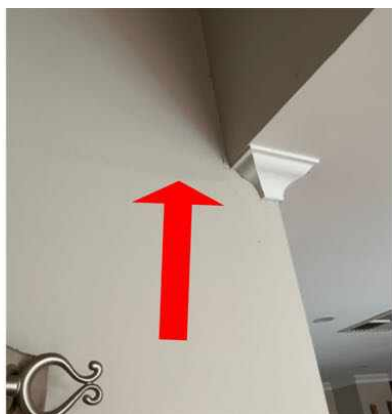
### Defects 3.05

Building:	Main Building
Location:	Gallery
Finding:	Minor Settlement Cracking – Plaster Wall (Kitchen Area)
Information:	Minor cracking was observed to the plaster wall facing the kitchen at the time of inspection. The cracks appear narrow and consistent with typical settlement and movement-related cracking that commonly develops in residential dwellings over time.

Such cracking is generally cosmetic in nature and is often attributable to normal building movement, material shrinkage, and seasonal expansion and contraction. No evidence was observed at the time of inspection to suggest structural failure associated with these cracks.

If improved presentation is desired, a qualified plasterer or painter can undertake cosmetic rectification works including filling, sanding, and repainting to achieve a smooth and uniform finish. Ongoing monitoring is recommended to ensure the cracks do not progressively widen.

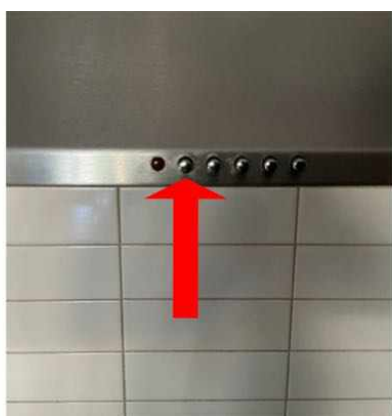
### Defects 3.06

Building: Main Building  
 Location: Kitchen  
 Finding: Defective Rangehood Light Switch – Kitchen  
 Information:

At the time of inspection, the rangehood light switch was found to be defective. When manually pressed, the light would illuminate; however, it did not remain engaged once released and would immediately switch off.

This condition indicates a likely fault within the switch mechanism or associated internal electrical components. A malfunctioning switch may result in unreliable operation and could indicate wear or internal failure of the unit.

It is recommended that a licensed electrician inspect the rangehood assembly and repair or replace the faulty switch as required to restore proper and safe operation.

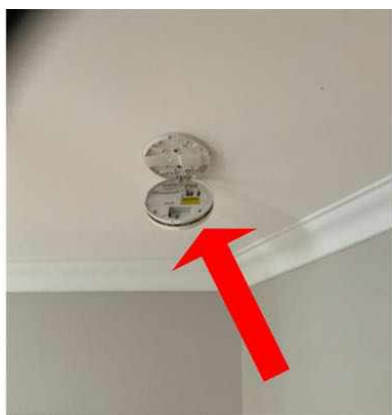
### Defects 3.09

Building:	Main Building
Location:	Hallway 2
Finding:	Smoke Alarm Non-Operational
Information:	During inspection, the smoke alarm appeared to have been opened and did not appear to be operational at the time of inspection. Smoke alarms are essential safety devices and must be fully functional in accordance with current building regulations and Australian Standards.

It is recommended that a licensed electrician inspect and test the smoke alarm, and carry out any necessary repairs or replacement to ensure it is fully operational.

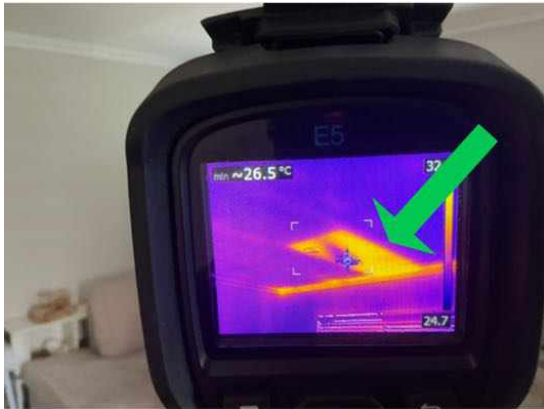
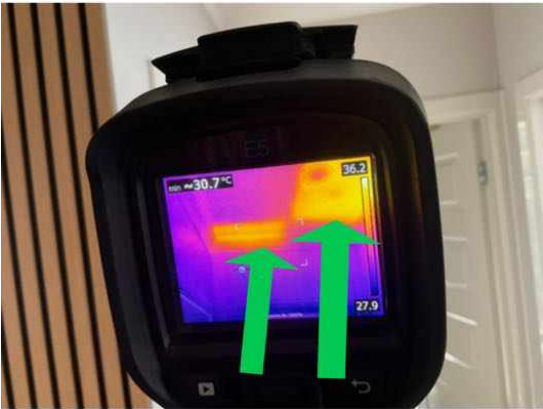
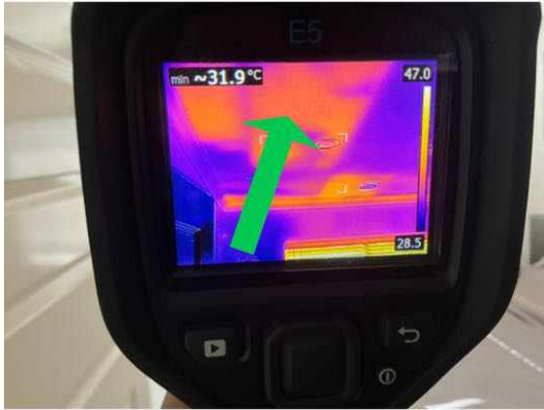
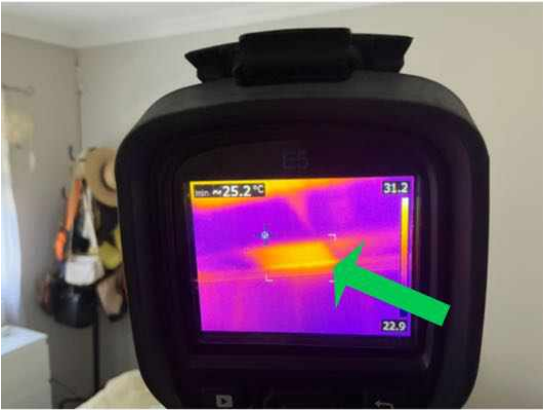
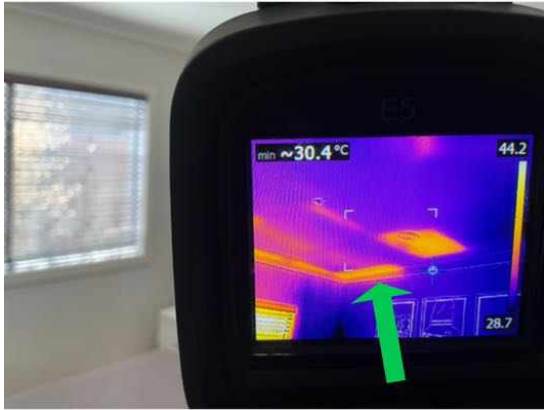
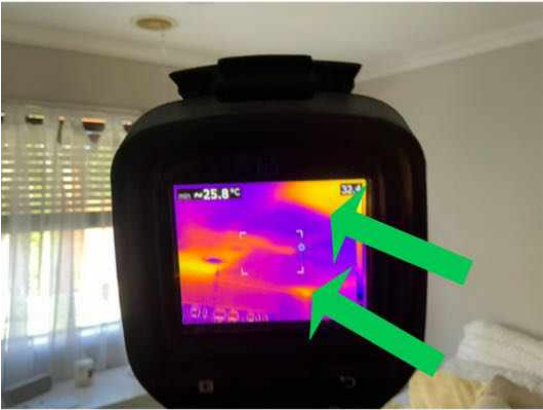
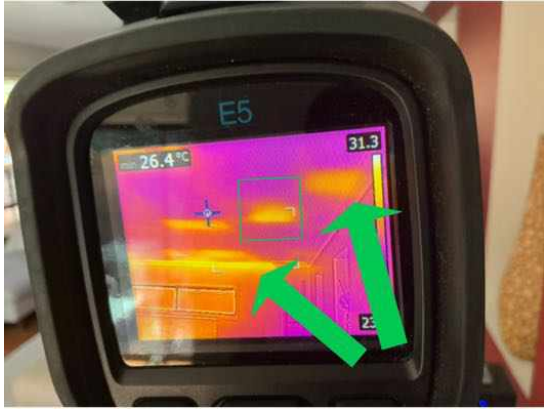
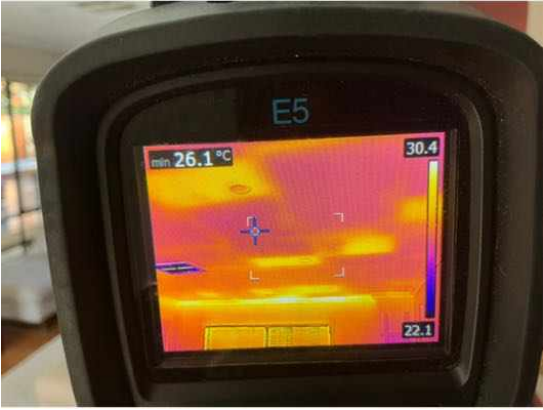
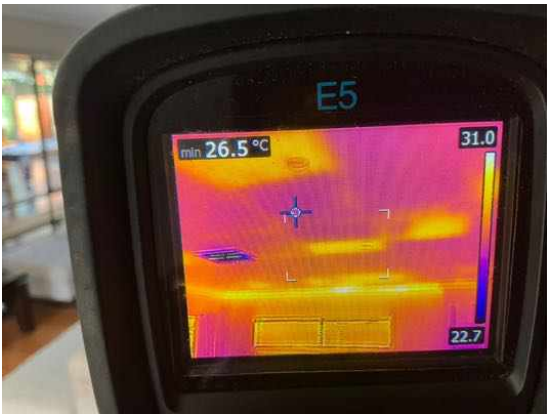
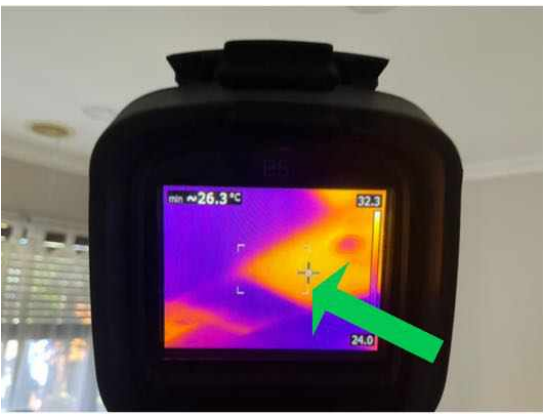
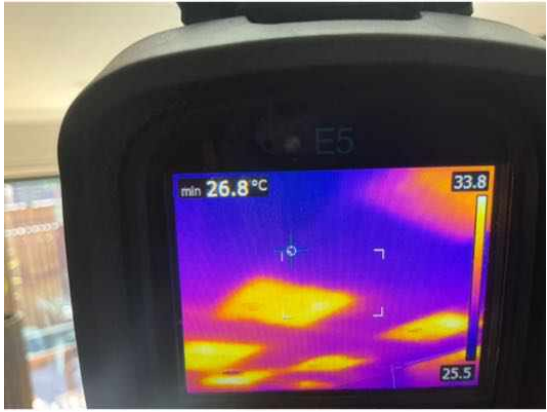
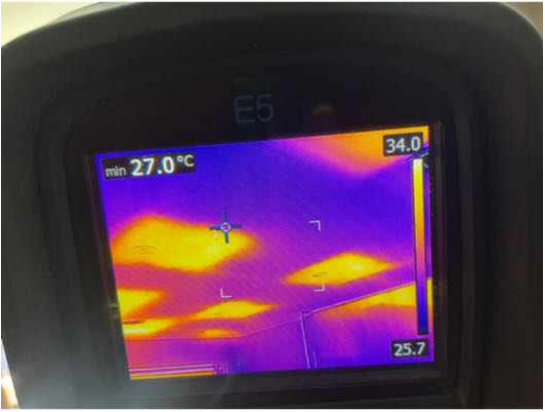
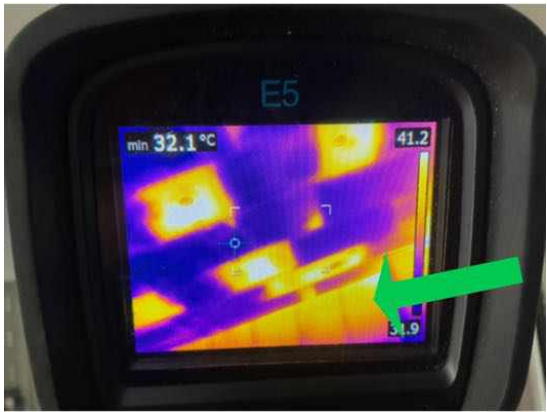
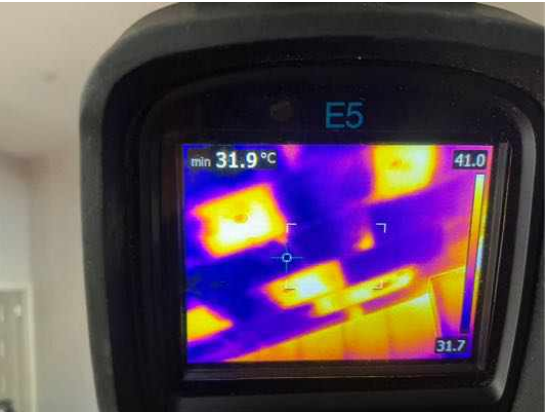
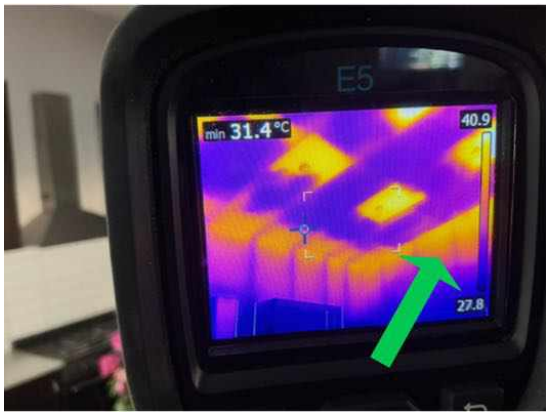
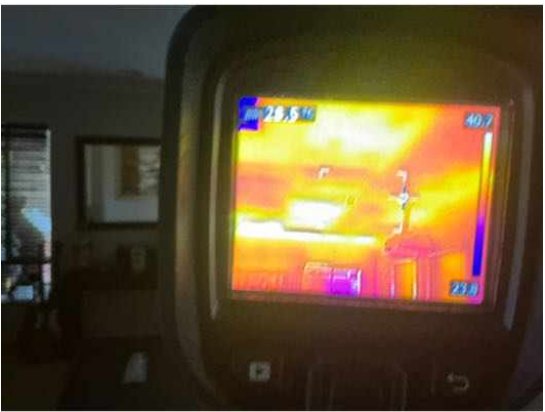
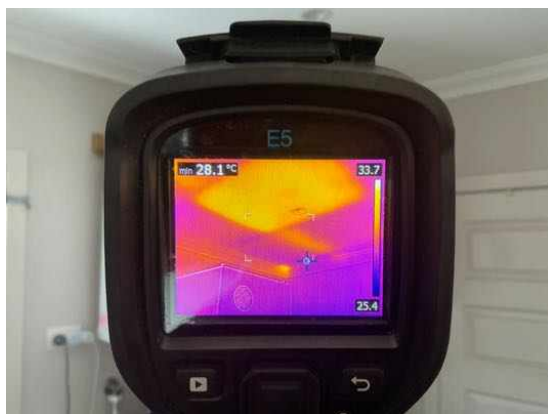
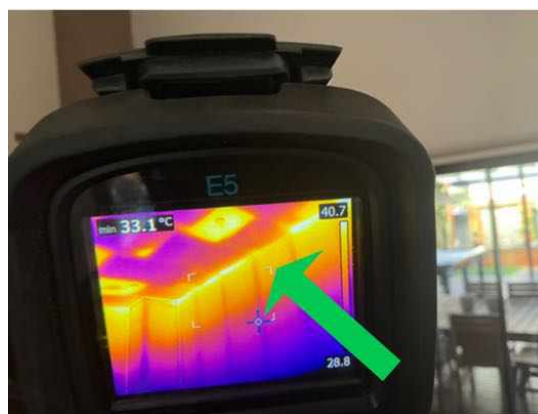
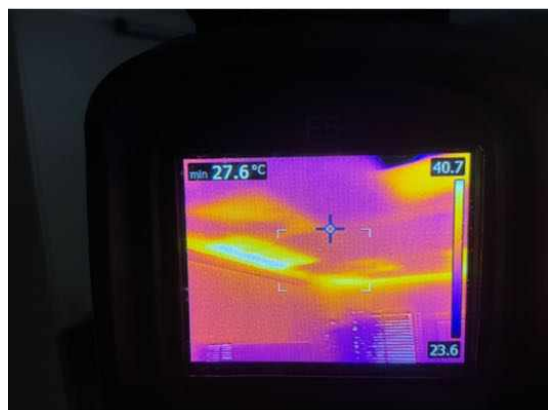
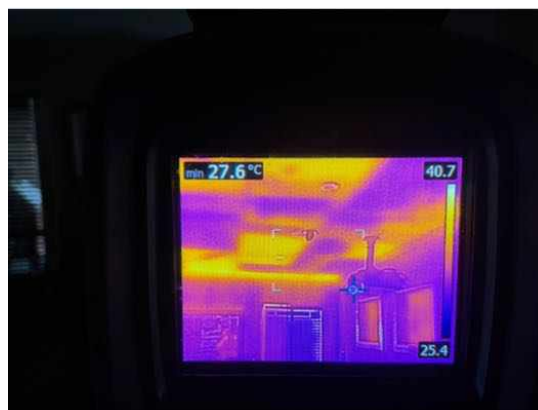
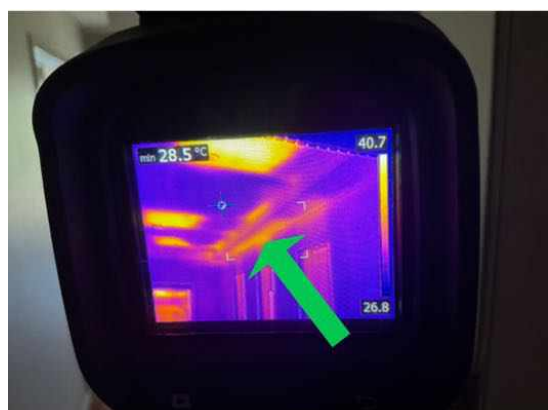
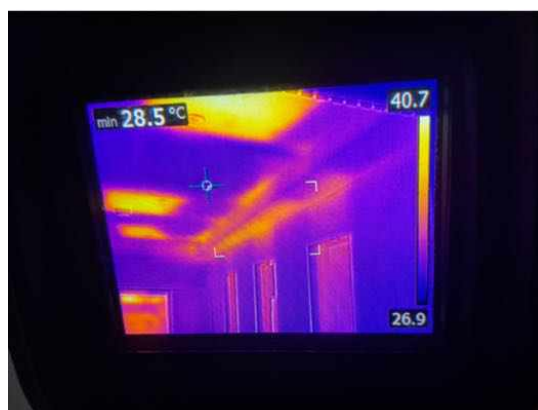
### Defects 3.11

Building:	Main Building
Location:	All Internal Areas
Finding:	Inconsistent Thermal Performance to Ceiling Areas – Suspected Insulation Deficiencies
Information:	Thermal imaging conducted to internal ceiling areas at the time of inspection identified inconsistent heat patterns, which are indicative of variations in thermal performance across the roof space. These patterns are commonly associated with areas of missing, displaced, or insufficient insulation above the ceiling linings.

Inadequate or uneven insulation coverage can reduce the energy efficiency of the dwelling, contribute to heat loss in cooler periods and heat gain in warmer conditions, and may result in reduced occupant comfort and increased heating and cooling costs. Due to the non-invasive nature of the inspection, the exact extent and condition of insulation could not be confirmed visually in all affected areas.

It is recommended that a qualified insulation contractor inspect the roof space, assess insulation coverage and condition, and top up or reinstate insulation where required to achieve consistent thermal performance throughout the property.

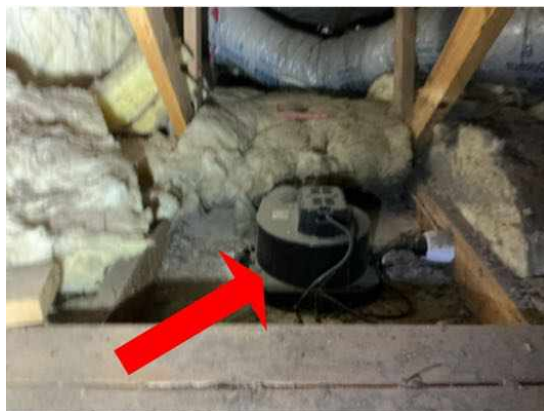
### Defects 3.12

Building:	Main Building
Location:	Roof Void
Finding:	Bathroom Exhaust Fans Not Ducted to External Atmosphere
Information:	The exhaust fans installed in the bathrooms were observed to be discharging directly into the roof cavity rather than being ducted to the external atmosphere. This configuration does not comply with best practice ventilation standards, as it allows moist air to accumulate within the roof space.

Prolonged moisture build-up in the roof cavity can lead to elevated humidity levels, which may contribute to mould growth, timber decay, and potential damage to insulation or other roof components over time.

It is recommended that a licensed ventilation specialist or electrician be engaged to install compliant ducting that vents the exhaust air to the outside of the building, in accordance with current building regulations and ventilation standards.

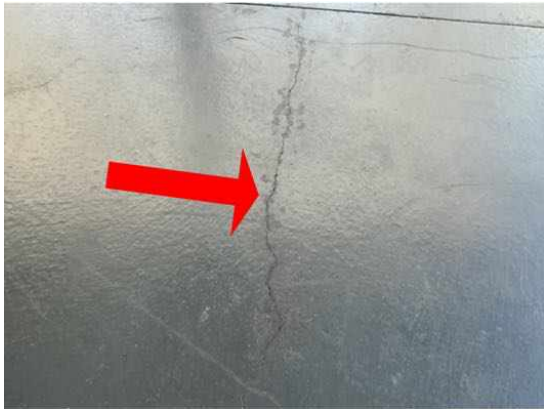
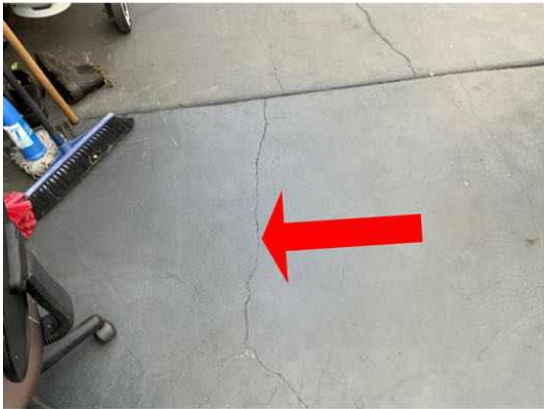
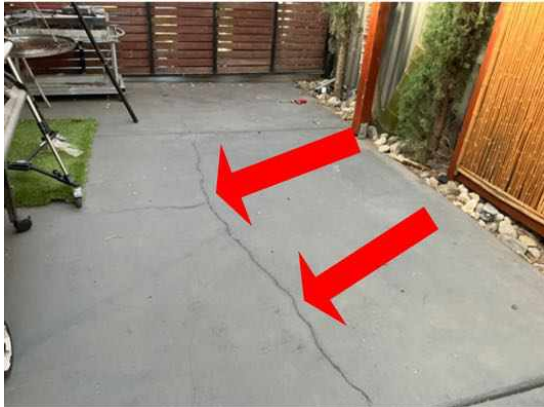
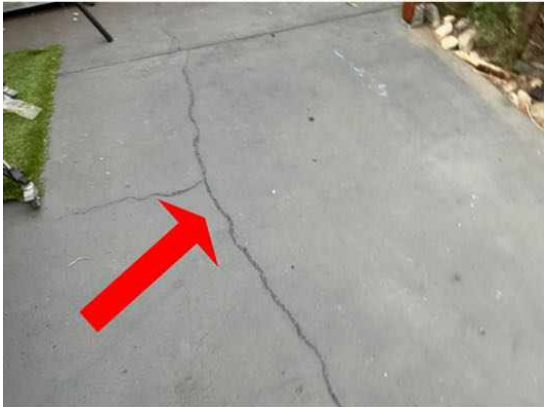
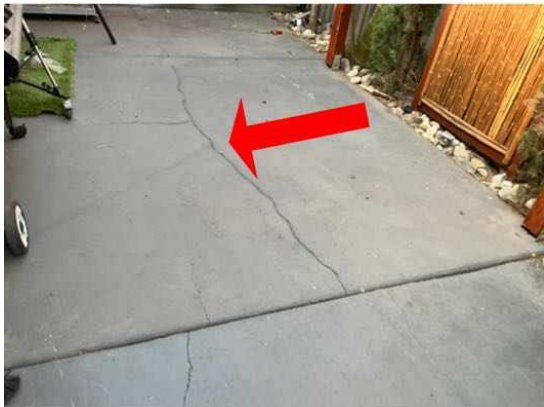
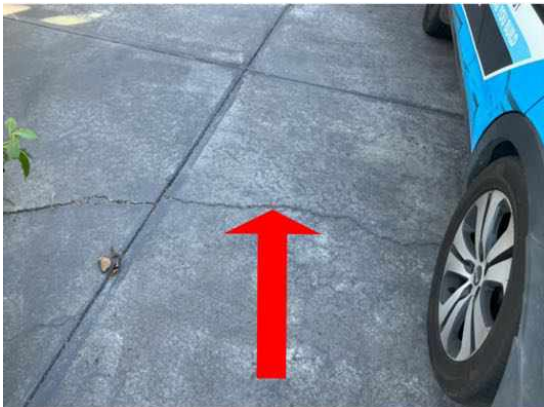
### Defects 3.13

Building:	Main Building
Location:	All External Areas
Finding:	Cracking - External Concrete Paving and Driveway Damage Category 2 - Distinct (less than 3mm)
Information:	Distinct cracks were identified in external concrete paving and driveway. Distinct cracks are generally found in older concrete paving, and may also present as a trip hazard as consequence of an uneven or curved surface.

General age and expected deterioration of the paved areas is a common cause of this type of cracking. However, expansion and contraction of the slab may also have occurred due to environmental factors. Such factors include variable moisture and weather conditions, the presence of trees and their roots having a settling or lifting affect on the soil, or the effect of load bearing, e.g. heavy vehicles over a sustained period of time.

Cracking to this degree may also be due to poor original installation of the concrete. Factors such as poor compaction of the sub surface and/or inadequate reinforcing of the slab may create cracking and other secondary defects.

Repairs are likely to be required to prevent further cracking and to reduce hazards associated with cracking, such as tripping. Monitoring of all cracking should be conducted frequently. Always contact a building inspector should cracks widen, lengthen, or become more numerous.

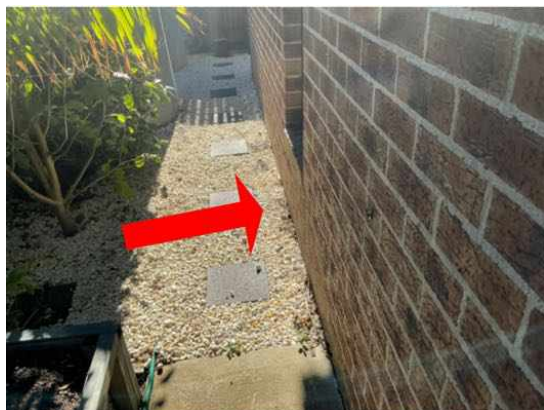
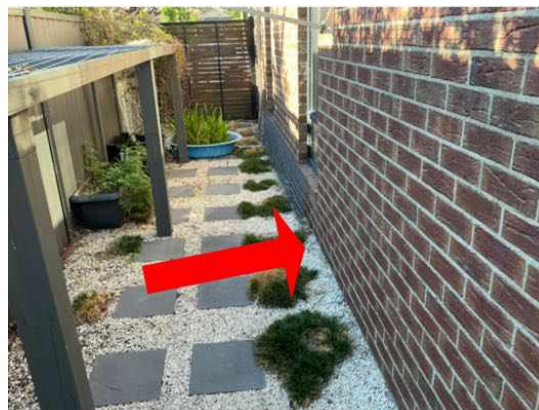
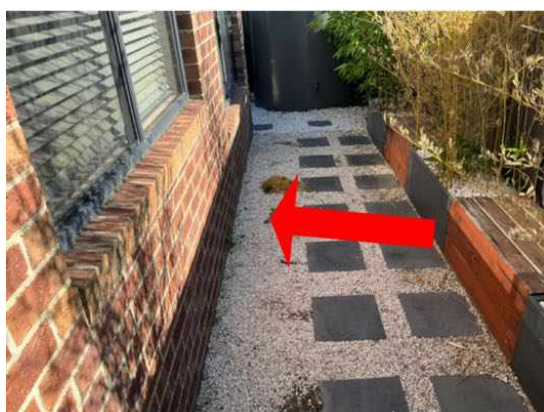
**Defects 3.14**

Building: Main Building  
Location: All External Areas  
Finding: Site drainage - Inadequate  
Information: The site drainage in the yards was found to be inadequate at the time of inspection, creating potential for subsequent water damage to associated building elements.

It is important that water does not lie against the base of walls; surrounding paths and ground levels should be sloped to drain water away from walls. Downpipes should not discharge stormwater onto lower walls or plinths. Stormwater should be carried away by large, regularly cleaned drains. Ground levels may need to be lowered to expose a buried DPC.

Where site drainage is inadequate, installation of an Agricultural (Aggie) Drain may be required. A qualified plumber should be appointed to further inspect the property and perform any remedial works as necessary. Water damage and secondary defects are likely to occur if left unmanaged.

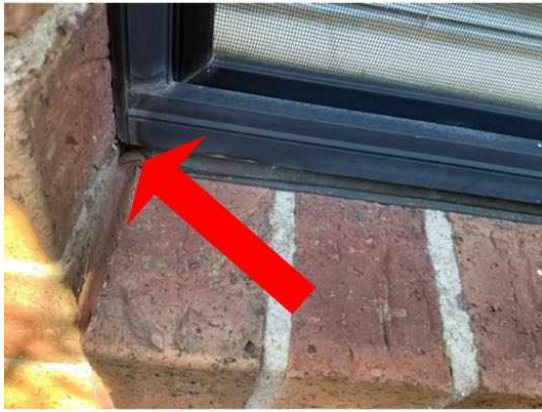
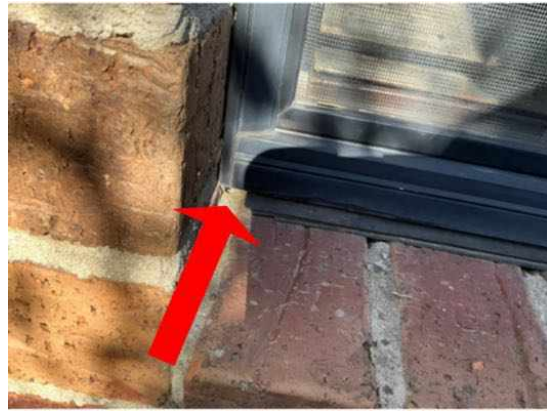
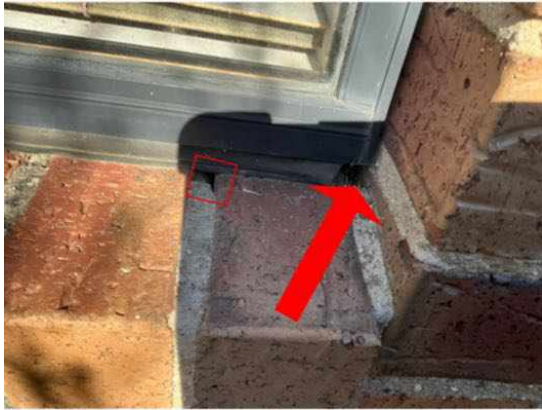
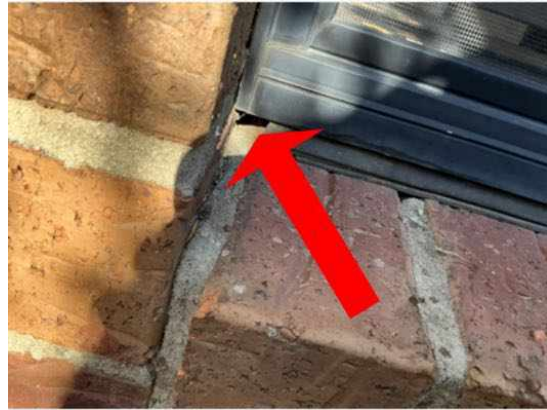
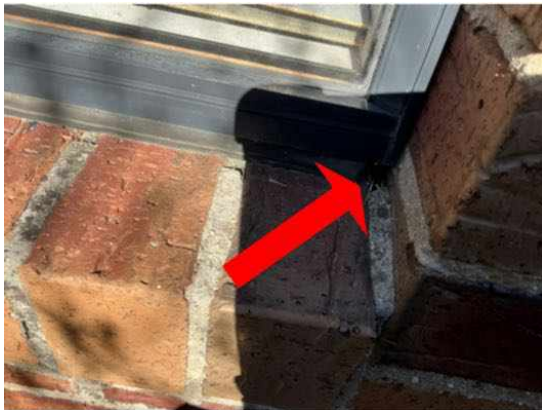
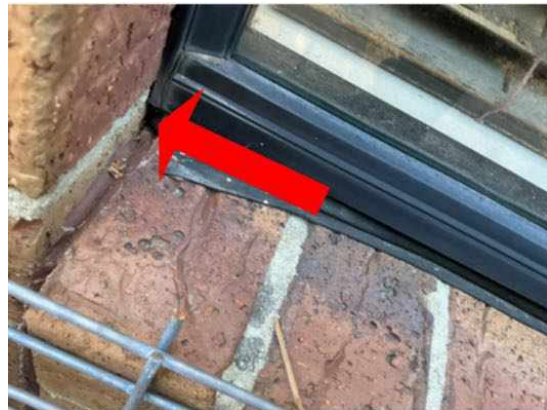
### Defects 3.15

Building:	Main Building
Location:	All External Areas
Finding:	Window seals - deteriorated
Information:	The window seals have deteriorated and are in a generally poor condition. Due to frequent exposure to weather conditions and subsequent moisture, deterioration of window seals is expected in a property of this condition and age.

Where window seals have deteriorated, the window is no longer weather-tight; rain penetration and subsequent water damage is therefore likely to ensue. Insulation of the area against external weather conditions will also be compromised.

It is recommended that all deteriorated window seals be replaced by a general handyman or sealant expert to prevent any further damage and to restore the window to a fully functional level.

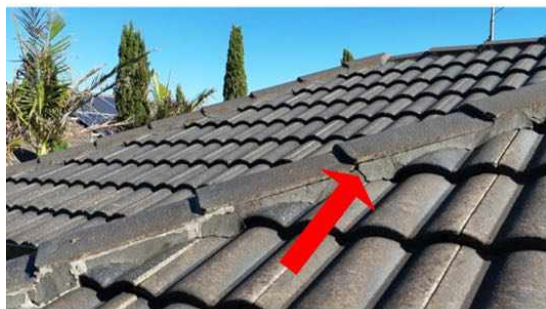
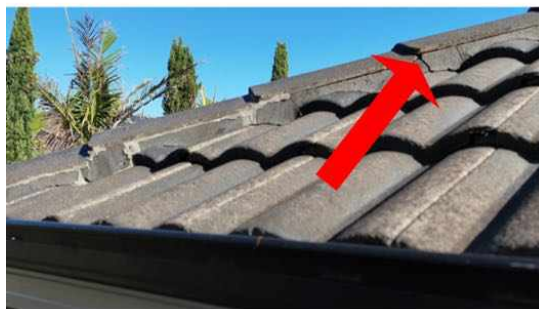
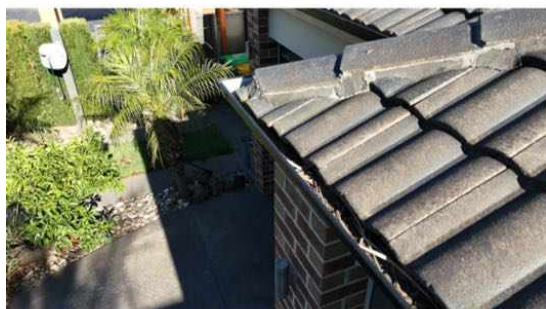
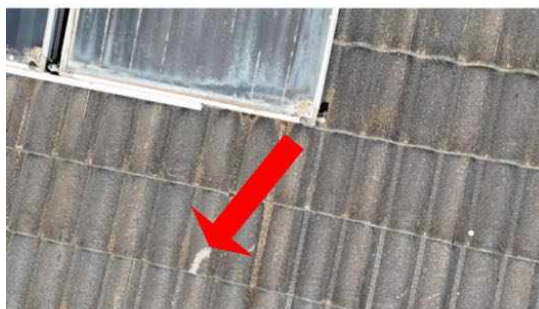
### Defects 3.16

Building: Main Building  
 Location: Roof Exterior  
 Finding: Roof Tiles – Localised Repointing Required and Cracked Tile  
 Information:

The external roof tiles were observed to be in generally fair condition at the time of inspection. However, localised areas of the ridge tiles were noted to have deteriorated mortar pointing, indicating that repointing works are required in selected sections. In addition, one roof tile was observed to be cracked and previously repaired using silicone sealant.

Deteriorated ridge pointing may allow moisture ingress and reduce the long-term

durability of the ridge system. Silicone repair to a cracked roof tile is not considered a permanent or appropriate repair method and may fail over time, increasing the risk of water penetration into the roof space.

It is recommended that a qualified roofing contractor undertake localised repointing of affected ridge tiles using a suitable flexible pointing compound. The cracked roof tile should be replaced with a matching tile to ensure proper weatherproofing and long-term performance of the roof covering.

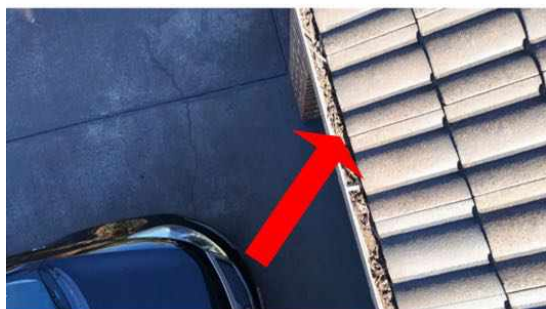
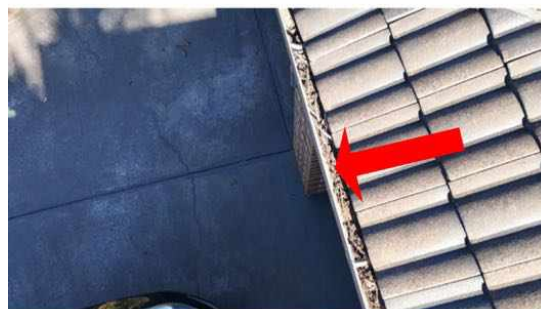
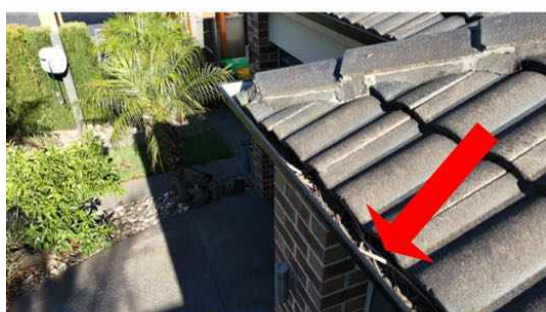
### Defects 3.17

Building:	Main Building
Location:	Roof Exterior
Finding:	Gutters - Partially Blocked
Information:	Sections of the external gutters were partially blocked with debris, soil and leaves. Roof plumbing structures, such as guttering and downpipes, should be free of all debris to prevent blockages. Blockages of the guttering and downpipes will lead to pooling and accumulated water overflows, which is likely to subsequently flood eaves and exterior walls.

Blocked gutters are likely to lead to high levels of moisture in the affected areas. Such

moisture will not only cause rust and decay of the associated building materials, but can also provide conditions that are conducive to termite and timber pest activity. Blockages in gutters should therefore be removed immediately to ensure dry conditions are maintained.

Consult a Licensed Plumber for further specific advice on remedial works that may be required. In the interim, it is highly advised that blocked gutters be removed by the homeowner or a general handyperson as a matter of urgency.

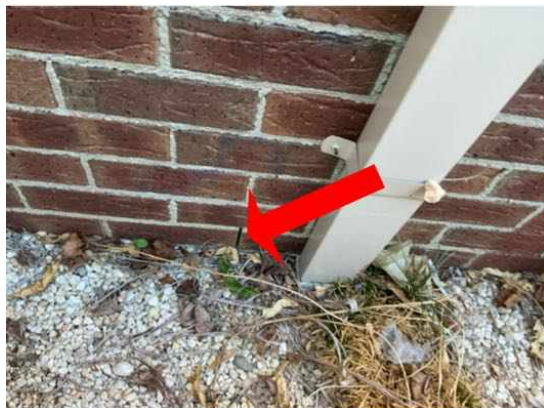
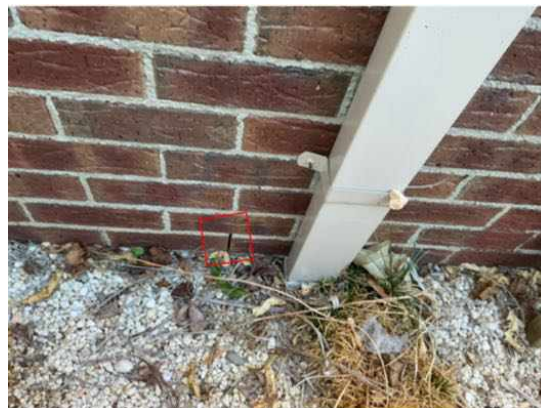
### Defects 3.18

Building:	Main Building
Location:	All External Areas
Finding:	Insufficient Clearance to External Weep Holes
Information:	Inspection revealed that the external weep holes around the base of the external walls have insufficient clearance, with landscaping materials such as soil or stones positioned directly beneath or against them. Weep holes are essential for allowing moisture within the wall cavity to escape and for enabling ventilation of the internal wall space.

When weep holes are obstructed or have inadequate clearance, their function is compromised. This can result in moisture being trapped within the wall cavity, leading to potential structural deterioration, rising damp, or even termite ingress—especially in

timber-framed dwellings.

It is recommended that the landscaping be adjusted to ensure a minimum vertical clearance of at least 75mm below the lowest part of the weephole. This will allow for proper drainage and ventilation and help protect the structural integrity of the property.

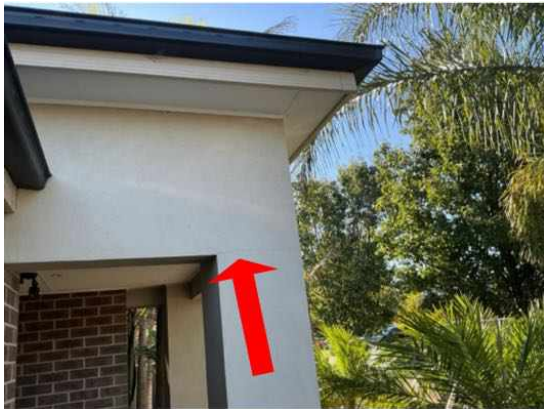
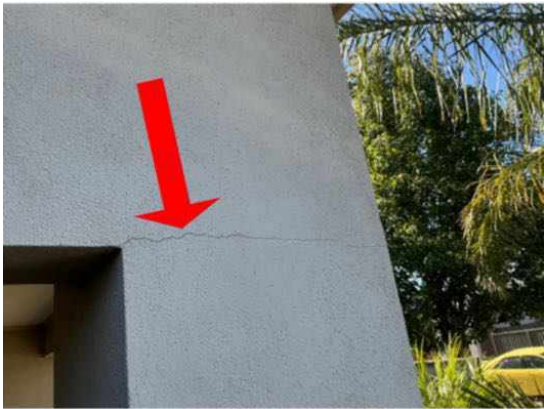
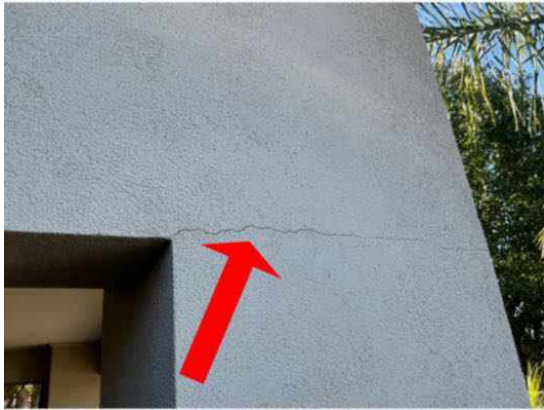
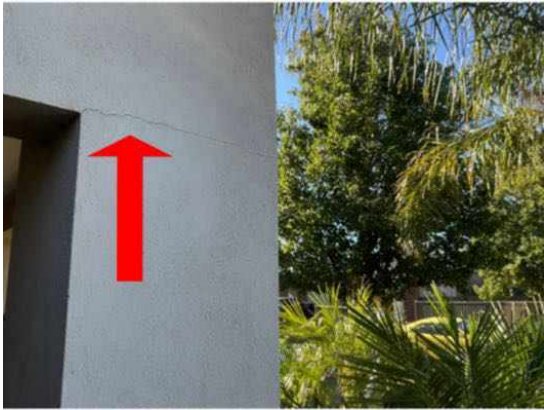
### Defects 3.19

Building:	Main Building
Location:	All External Areas
Finding:	Horizontal Cracking – Front Rendered External post
Information:	A horizontal crack was observed to the rendered finish of the front external post at the time of inspection. The cracking appears consistent with typical settlement and movement-related stress that commonly develops in rendered masonry surfaces over time.

Such cracking is generally associated with normal building movement, thermal expansion and contraction, and minor settlement. At the time of inspection, the crack does not appear structurally significant; however, cracks in render may allow moisture ingress if left unsealed, potentially leading to further deterioration of the finish.

If rectification is desired, a qualified renderer should be engaged to properly prepare the affected area, apply appropriate crack repair treatment, re-render as required, and repaint to achieve a uniform and weather-resistant finish. Ongoing monitoring is recommended to ensure the cracking does not progressively widen.

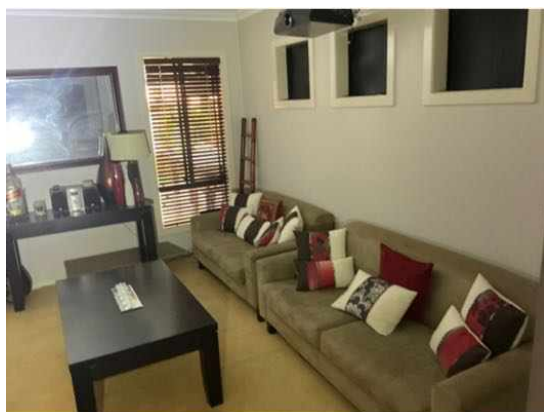
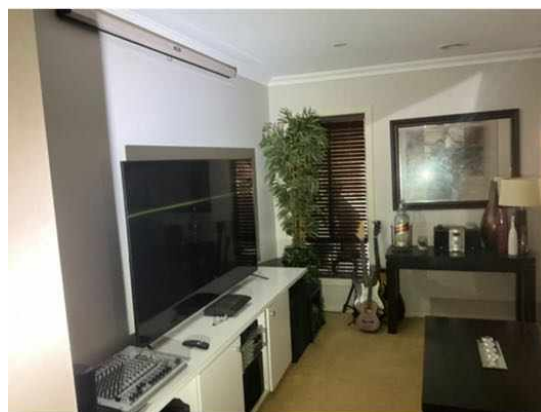
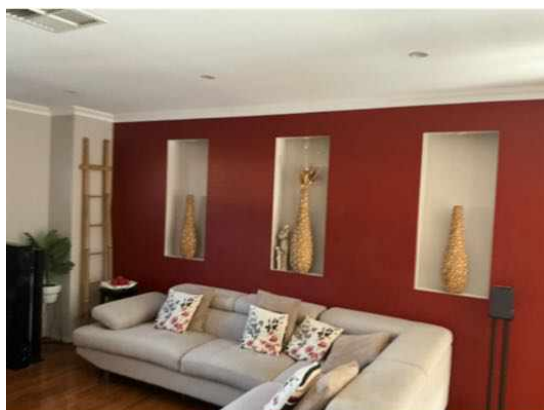
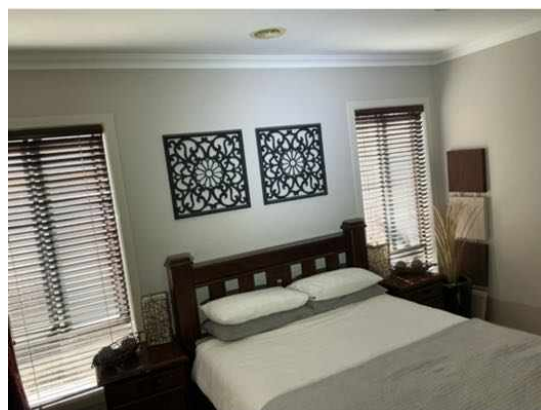
Building: Main Building  
 Location: All Areas  
 Finding: Obstructions and Limitations - Interior  
 Information: These photographs are an indication of the obstructions and limitations which impeded the inspection of the internal areas of the property at the time of inspection. These obstructions can hide an array of defects and should be removed to allow full inspection to be carried out. A re-inspection is recommended once the areas are made accessible.

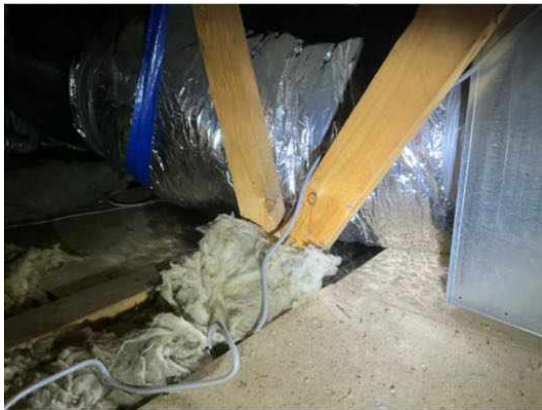
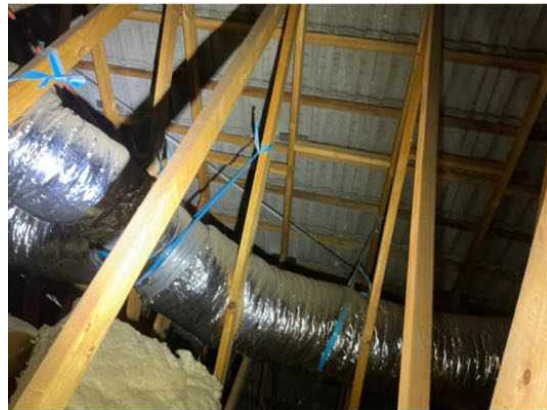
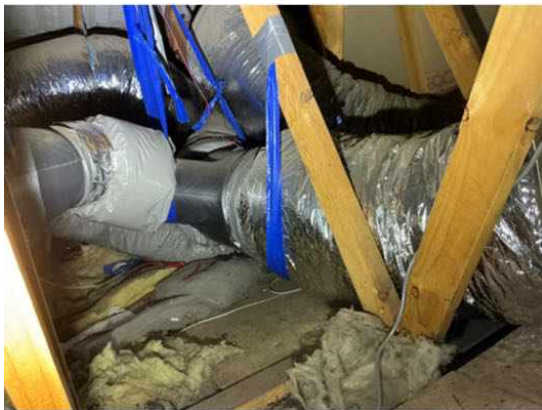
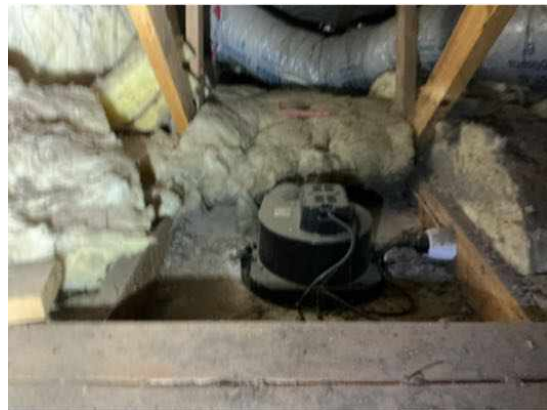
Building: Main Building  
 Location: Roof Void  
 Finding: Obstructions and Limitations - roof cavity  
 Information: These photographs are an indication of the obstructions and limitations which impeded the inspection of the roof cavity area of the property at the time of inspection.

These obstructions can hide an array of defects and should be removed to allow full inspection to be carried out. A re-inspection is recommended once the areas are made accessible.

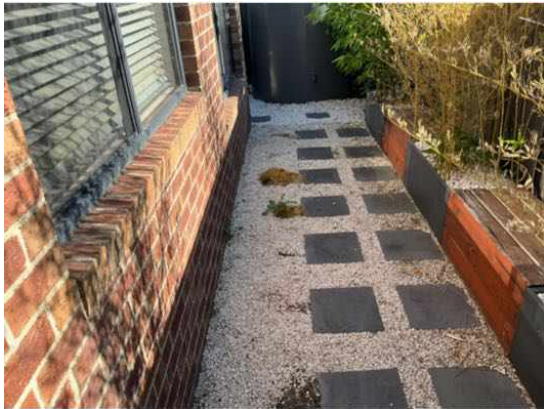
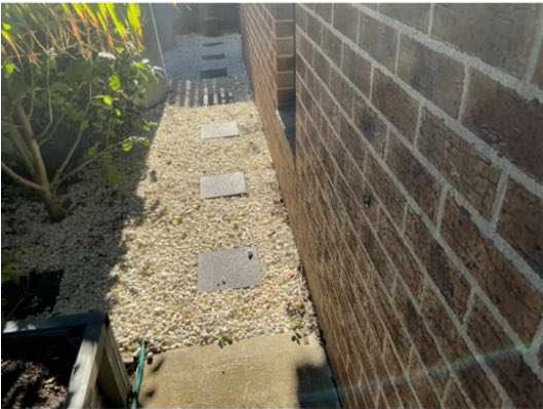
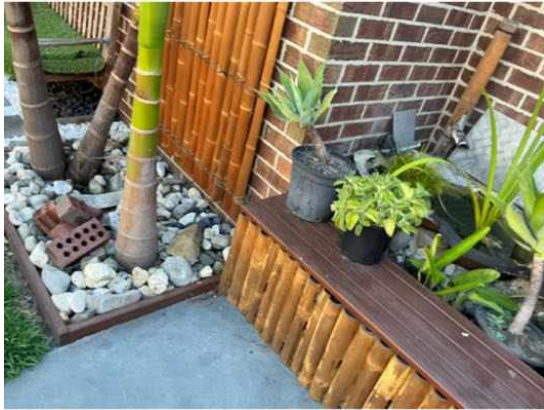
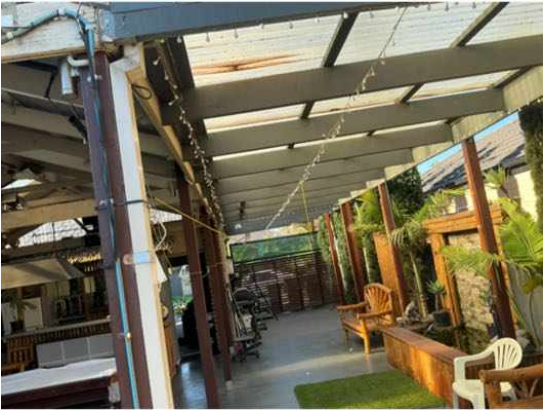
Building:	Main Building
Location:	All External Areas
Finding:	Obstructions and Limitations - Exterior
Information:	These photographs are an indication of the obstructions and limitations which impeded the inspection of the external areas of the property at the time of inspection. These obstructions can hide an array of defects and should be removed to allow full inspection to be carried out. A re-inspection is recommended once the areas are made accessible.
