Building and Timber Pest Inspection Report

Inspection Date: Mon, 30 Mar 2026

Property Address: 69 Southern View Dr, West Albury NSW
2640, Australia

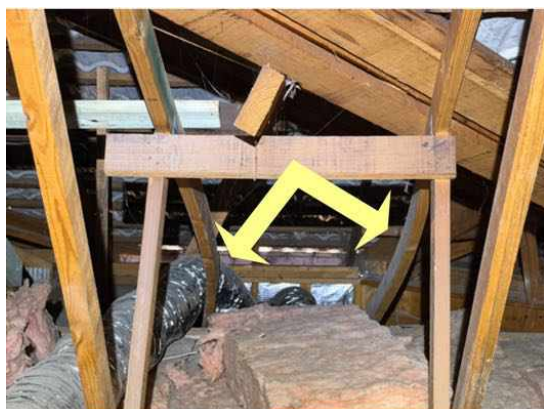
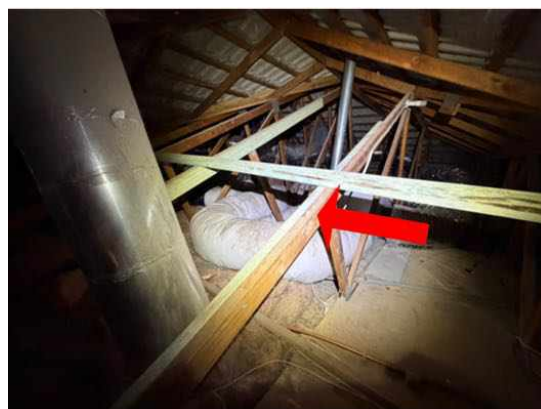
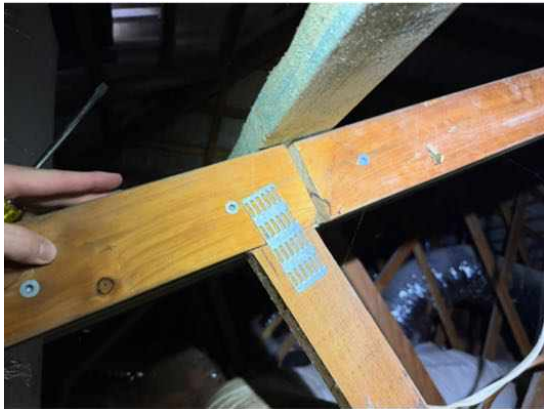
Finding 3.01

Building: Main Building

Location: Roof Void

Finding: Roof Framing - Deflection & Modifications

Information: It appears that areas of some roof trusses showed signs of deflection towards their ends, which may indicate additional stress on the roof framing. It appears some modification works have been conducted to the adjacent roof trusses.

It appears some areas of the roof trusses showed signs of deflection towards their ends, which can be an indication of strain on the roof framing. Recommend consulting with a registered builder in the short term, to provide further advice & remedial works where necessary, to avoid further deflection.

Recommend engaging a registered builder in the short term to provide further advice regarding previous modification works and provide remedial works to the roof trusses where necessary, to avoid further deflection.

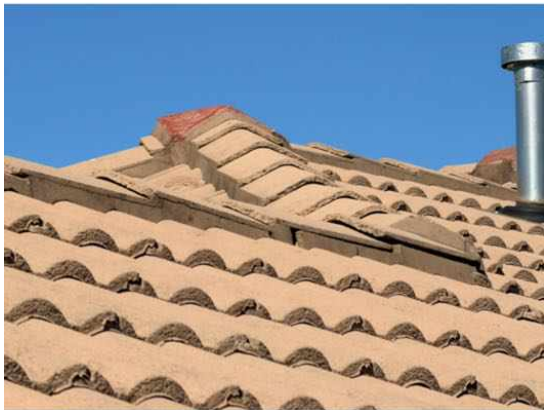
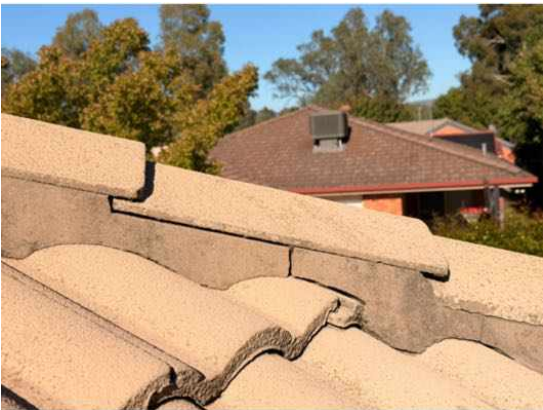
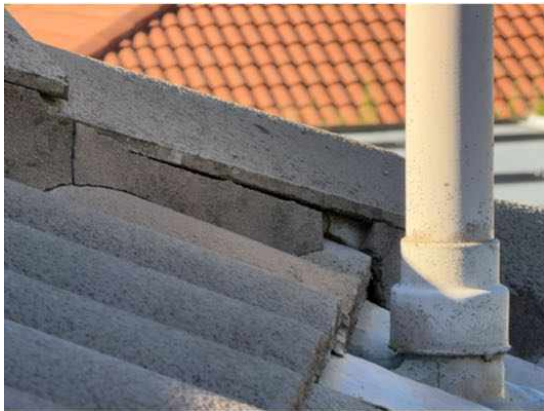
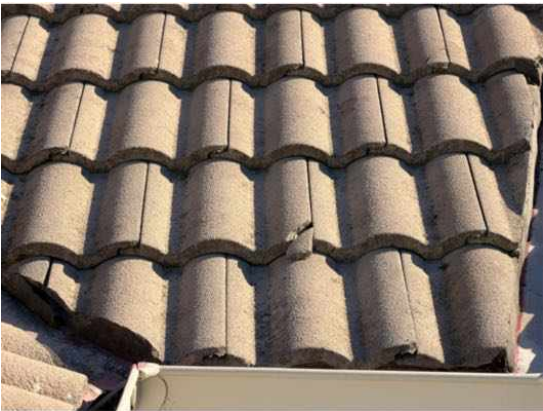
Finding 3.02

Building: Main Building
Location: Roof Exterior
Finding: Roof Exterior - Minor Cracking
Information: Areas of minor cracking were identified to the tile pointing and some roof tiles. While weathering of the roof tiles is consistent with the age of the property, maintenance works are advised. Recommend consulting with a licensed roofing contractor, at clients convenience, to provide further advice on future maintenance works required.

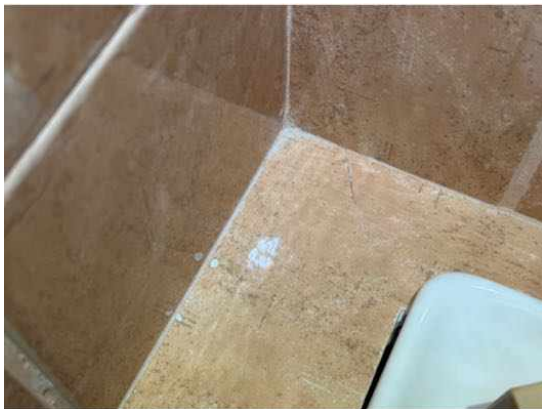
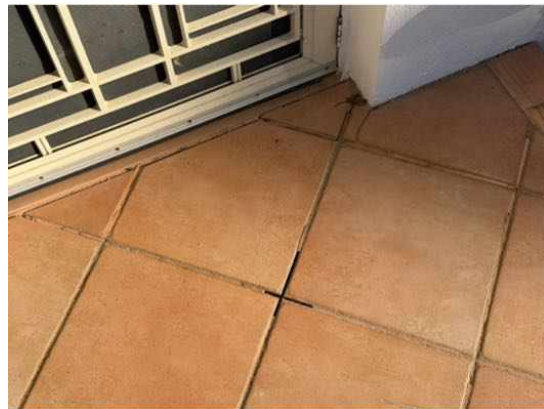
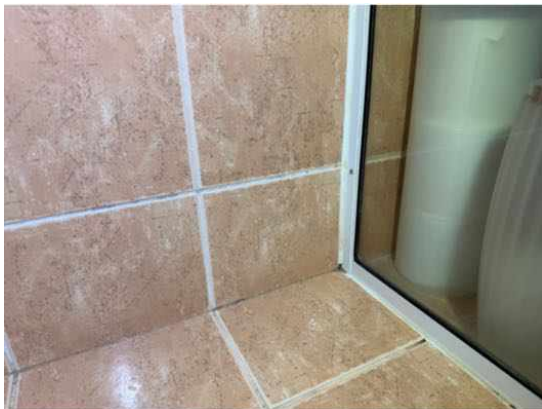
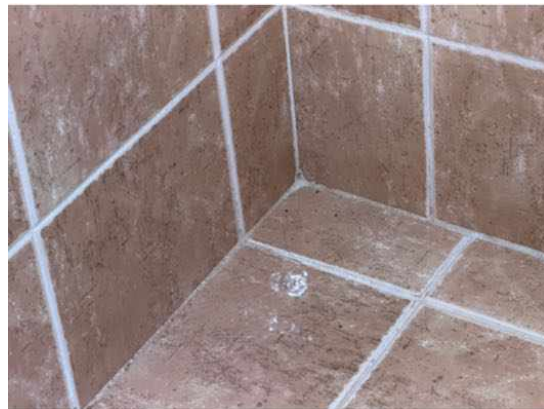
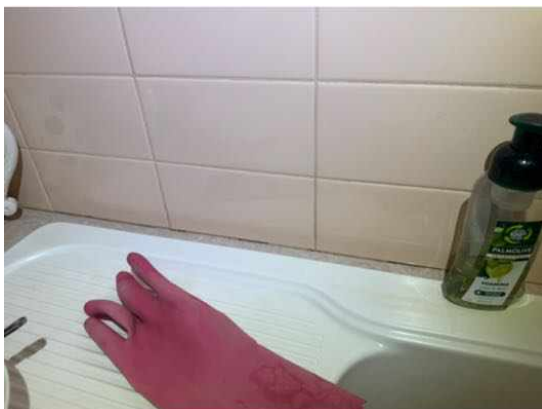
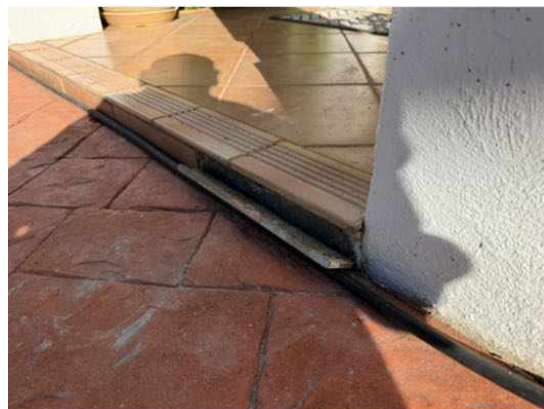
Finding 3.03

Building: Main Building
Location: Tiled Areas
Finding: Sealant / grouting - deteriorated or missing & Cracked Tiles
Information: It appears that the sealant and grout has deteriorated / weathered in some tiled areas, a common defect in buildings of a similar age. Areas of cracked / loose tiles to the entry porch were also noted.

Sealant and grouting in areas that come into regular contact with water should be maintained for the long term care of your property.

Recommend engaging a licensed tiling contractor, at clients convenience, to provide maintenance works where necessary.

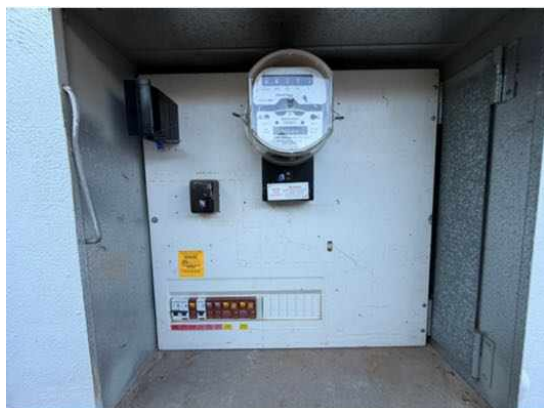
Finding 6.01

Building: Main Building
 Location: Switchboard
 Finding: Termite Management System - no evidence of a chemical installation
 Information: The application of a termite barrier is recommended, as it appears no termite management system has been installed, with no evidence or durable notice to suggest works taking place. Generally, a durable notice is placed in the meter box to indicate current termite barriers.

Such barriers are highly effective in preventing termite attack on the building and therefore should be installed.

Installation of a termite barrier is strongly recommended as there was no evidence of installation of a previous termite management system. 12 monthly termite inspections, conducted by a qualified termite inspector are also advised. Recommend engaging a licensed pest controller, to provide further advice.

Recommend seeking further advice from a licensed pest controller.

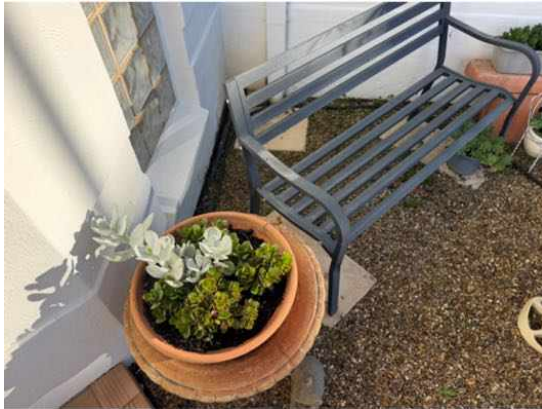
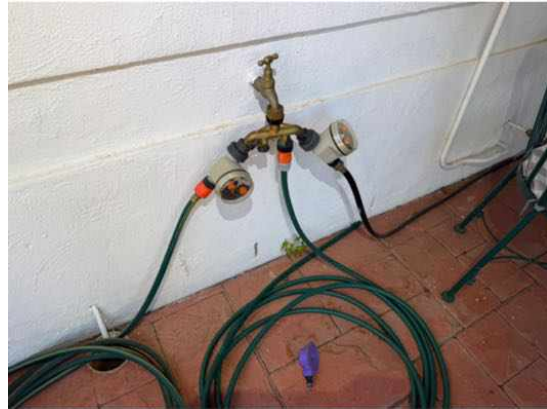
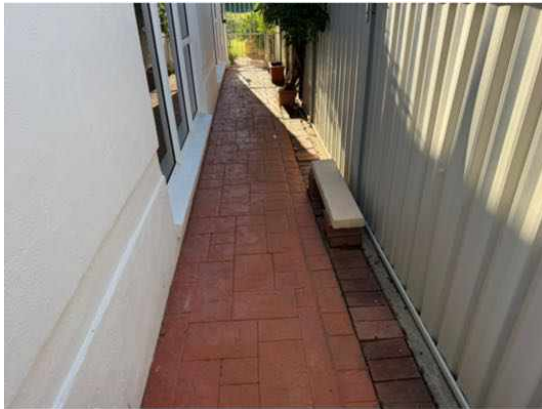
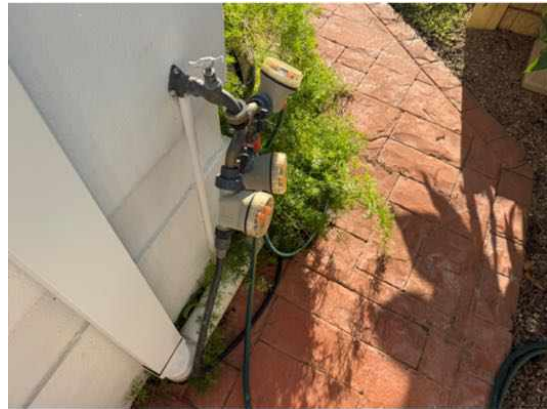
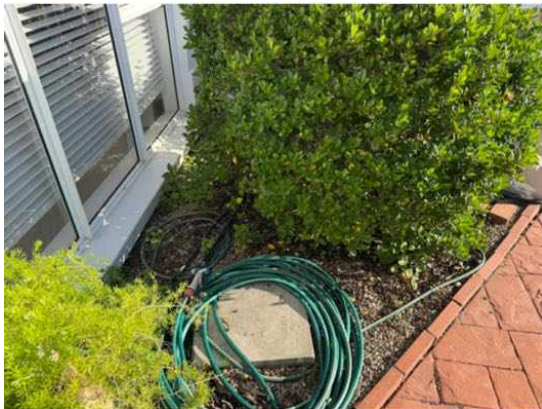
Finding 6.02

Building: Main Building
 Location: All external areas
 Finding: Potential Water pooling - against property
 Information: Potential areas of water pooling around the perimeter of the property were identified. Where insufficient drainage of taps, and garden beds against the house are present, water pooling is likely to occur, and can create areas conducive to timber pests.

Recommend consulting with a licensed plumber and/or landscaping contractor to provide further advice.

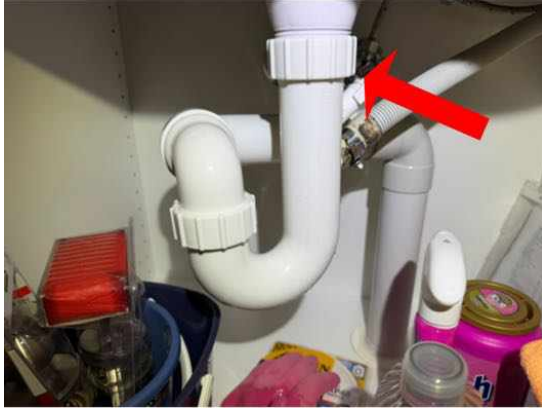
Finding 6.03

| Location: | Laundry sink |
| Finding: | Laundry Sink Plumbing - Dripping |
| Information: | It appears that the laundry sink plumbing was leaking/dripping at the time of inspection. Recommend client to engage a licensed plumber or general handyman to tighten the screw cap and install a seal if necessary to prevent further leaking. |

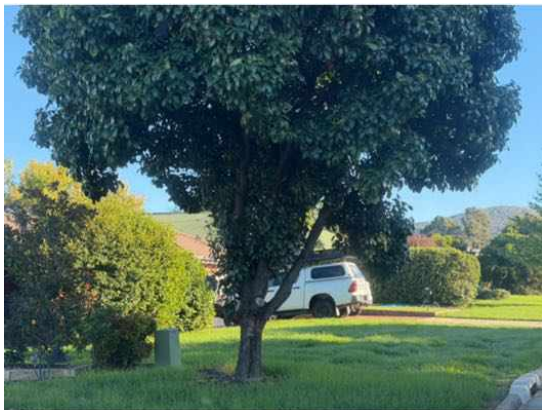
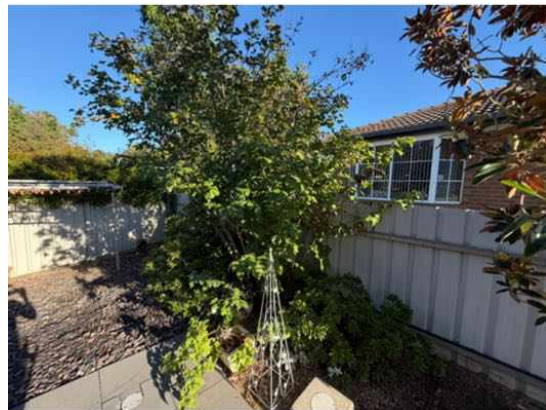
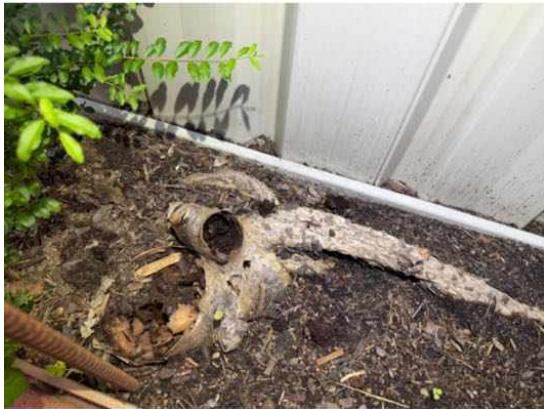
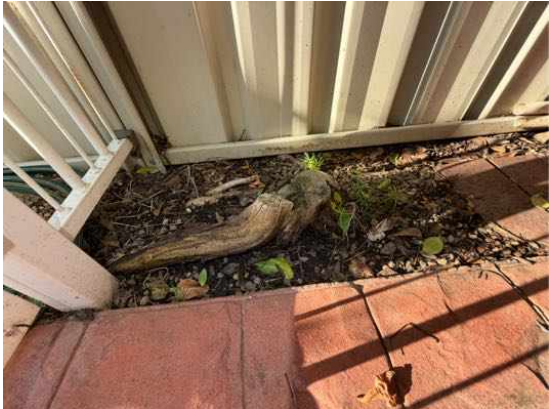
Finding 6.04

| Location: | All External Areas |
| Finding: | Timber in direct ground contact & trees - conducive to termites |
| Information: | Where timber materials are in direct contact with the ground and consequently moisture, they become conducive to termite activity. The tree stumps, and trees surrounding the building create an environment conducive to termite activity. |

Where feasible, any timbers in direct contact with the ground should be removed and any trees in close proximity to the building should be inspected at least annually to reduce the risk of termite infestation & detect any early signs of termite activity.

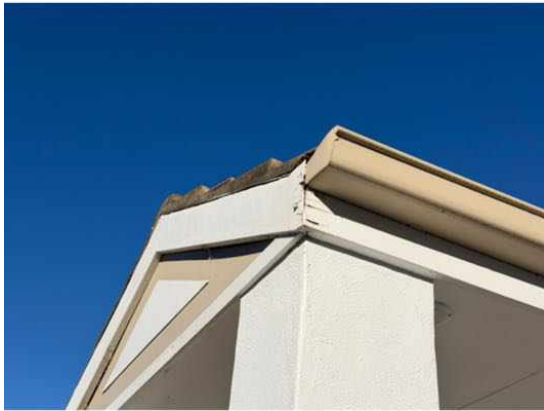
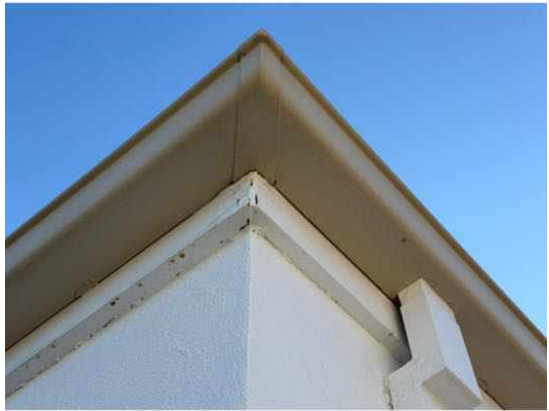
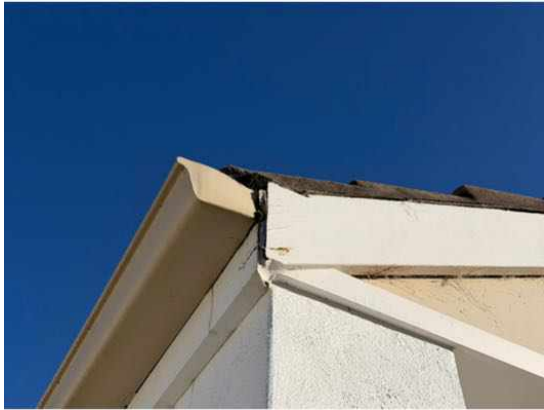
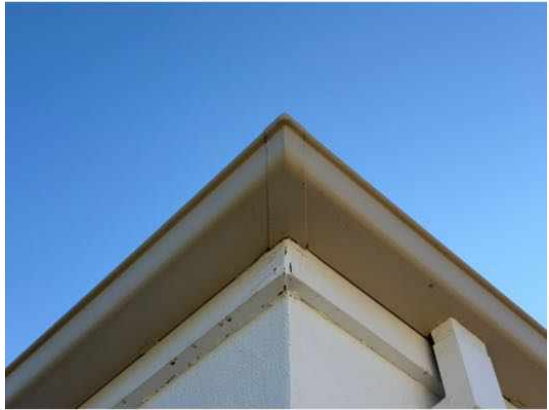
Finding 7.01

Building: Main Building
Location: Fascias
Finding: Fungal decay & weathering
Information: Areas of minor fungal decay (wood rot) were identified to the corners of the fascias. Recommend client to ensure general maintenance is kept to external timbers (i.e painting and application of protective coatings) to prevent further deterioration.

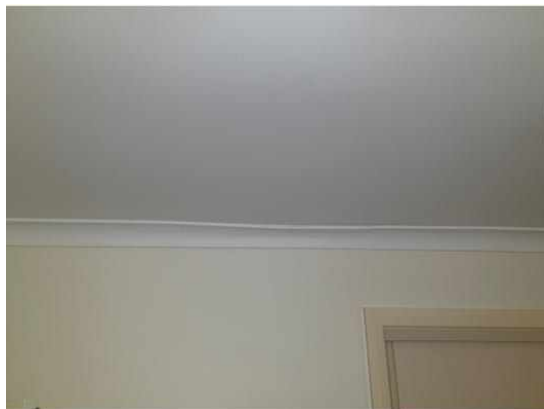
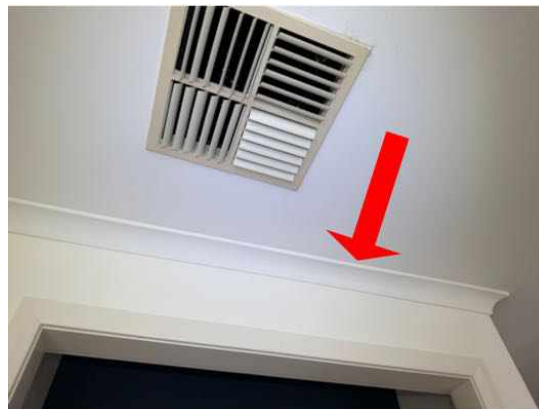
| Location: | Lounge room, bedroom |
| Finding: | Ceiling/Cornice - Sagging (minor) |
| Information: | Sections of the ceilings/cornices at but not limited to, bedroom & lounge room appear to be slightly sagging. Recommend that the client monitor the sagging. Should further sagging occur, a licensed plasterer can be engaged to provide maintenance works where necessary. |

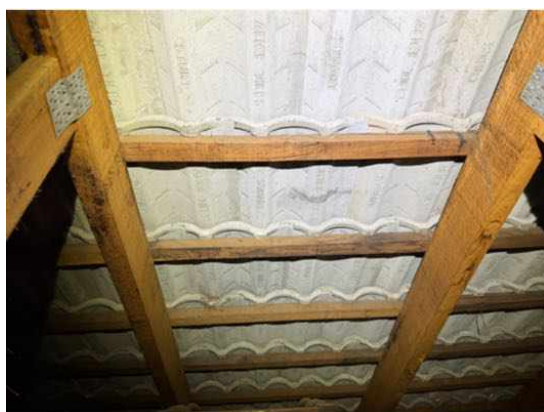
| Location: | Roof Void |
| Finding: | Sarking - Not Present |
| Information: | It is noted for your information that sarking has not been installed on the roof. Sarking is a laminated aluminium foil applied to the interior of the roof covering, assists in insulating the property and acting as a vapour-barrier to the roof void. |

The client can consult with a licensed roofing contractor at their discretion, to provide further advice.

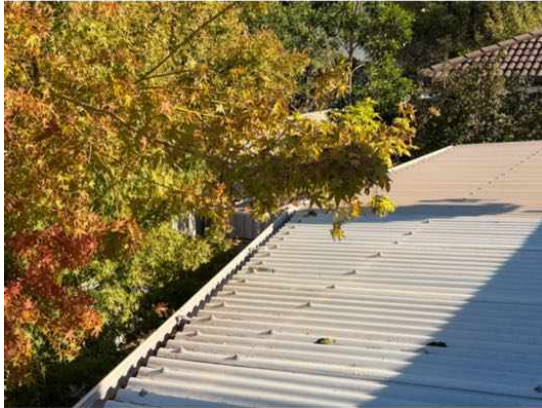
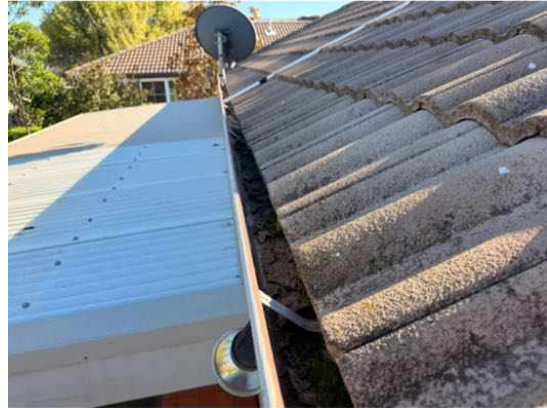
Location: Gutters

Finding: Debris in Gutters

Information: It appears that there is some debris in the gutters. Accumulation of debris can lead to blockages of the gutters, if neglected.

Recommend engaging a general handyman to remove debris from gutters to prevent further accumulation.
