Building and Timber Pest Inspection Report

Inspection Date: Tue, 24 Feb 2026

Property Address: 7 Moreton Dr, Jacobs Well QLD 4208,
Australia

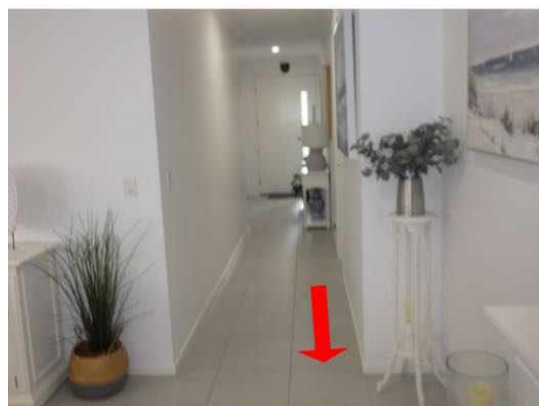
Building: Main Building
 Location: Living Room > Front
 Finding: Tile - Cracked
 Information: A cracked tile to the living room walkway area was identified at the time of inspection. Such defects are generally caused by impact. Cracked or broken tiled areas may also be a direct result of poor workmanship during the construction process.

A tiling contractor could be appointed to perform repair works at the clients discretion.

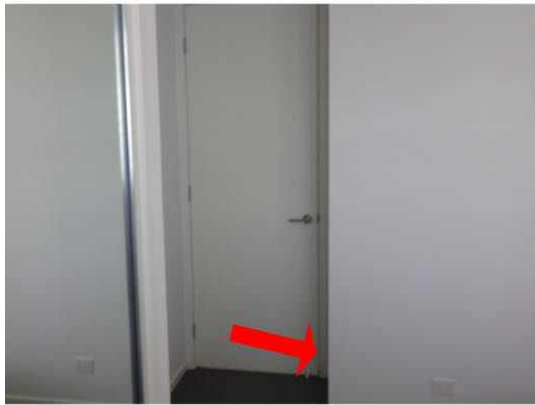
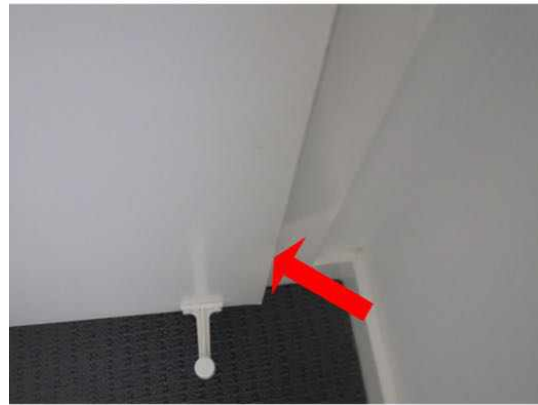
Finding 3.05

Building: Main Building
 Location: Bedroom 3 > Front
 Finding: Door - Binding/Jamming
 Information: Binding and/or jamming of the bedroom 3 door on the door frame was evident during standard operation. This defect inhibits the functionality of affected door as well as creating potential for secondary defects to associated building elements, such as damage to the door framing.

A door that binds to the associated door frame or sill may have several causes, such as poor installation of the door or deteriorated hinges.

A qualified carpenter or general handyperson could be appointed to perform minor rectification works at client discretion.

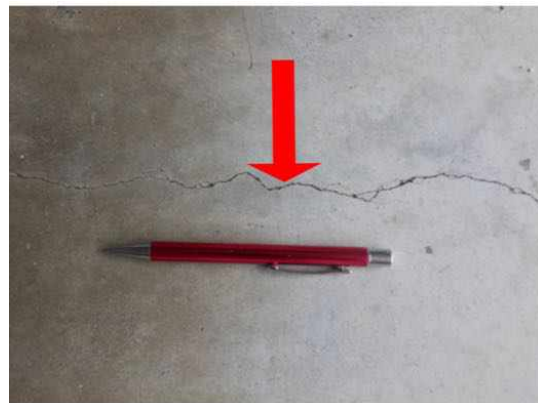
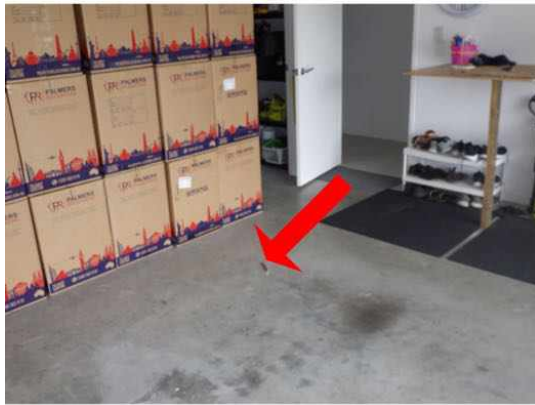
Finding 3.06

Building: Main Building
 Location: Garage > Existing
 Finding: Cracking in concrete slab - Category 1
 Information: Cracking coded as Category 1 was identified in the garage floor concrete slab (as per example photos). A Category 1 crack is described as a fine but noticeable crack, with the slab at an otherwise reasonable level.

To be considered Category 1, the approximate width of the crack is less than 1.0mm, or a less than 10mm change in offset when a 3m straight edge is placed over the defect.

Category 1 cracks should be monitored for a period of 12 months. At the end of the monitoring period, identified cracks that are rated greater than Category 2 are considered defects, and require rectification.

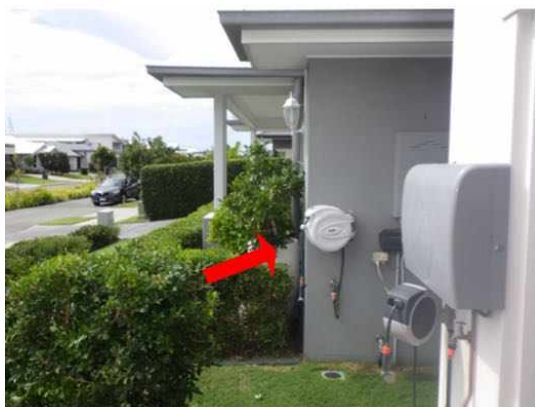
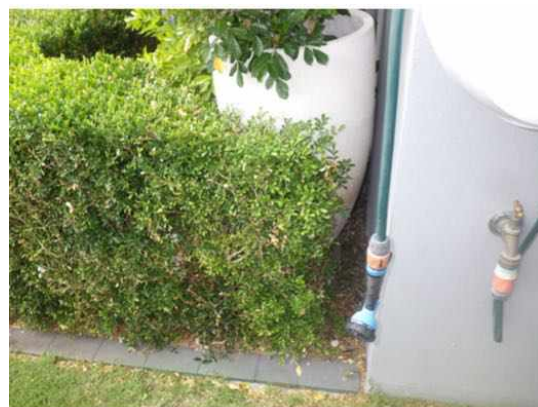
Building: Main Building
Location: Exterior walls - front > Front Right
Finding: Vegetation
Information: At the time of inspection there was vegetation growing over external wall areas.

The vegetation over growing wall areas should be trimmed back clear of the external surfaces. The grass and other vegetation heights should be maintained around the perimeter of the building to allow for an inspection zone around the building exterior.

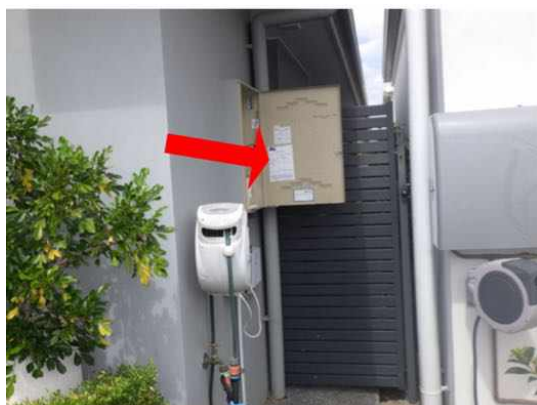
In this instance evidence of a previously installed physical barrier was observed, along with a durable notice inside the electrical meter box (dated 28/8/2020). This system requires regular annual inspections.

No evidence of regular or annual inspections was found.

Where a Termite Management System has been identified you should refer to the type of barrier date of installation warranty conditions and any documentation provided by the barrier installation company or past owner.
