## Building Inspection Report

Inspection Date: Mon, 16 Feb 2026

Property Address: 12 Verna Pl, Quakers Hill NSW 2763,  
Australia

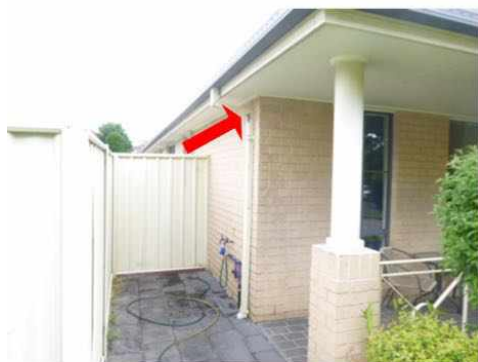
#### Defects 3.01

Building:	Main Building
Location:	Down pipe - Front
Finding:	Roof plumbing - Rusted or corroded
Information:	The roof plumbing has areas of evidence of water leak (rust and corrosion).

Rusted roof plumbing will generally develop holes and leaks that can affect other building elements with poor drainage of storm water. Poorly drained roof areas will also lead to damp conditions surrounding the base perimeter of the building which, if left unmanaged, can lead to a range of secondary building defects.

Repair and/or replacement of rusted roof plumbing is highly required in order to reinstate the roof drainage system to a fully operational level. To further maintain these areas, gutters should be cleaned frequently, allowing the avoidance of any partial blockages.

A licensed plumber or specialist roof restoration company should be appointed to undertake these works. It is advised that such works be completed as soon as possible to prevent any further damage and deterioration.

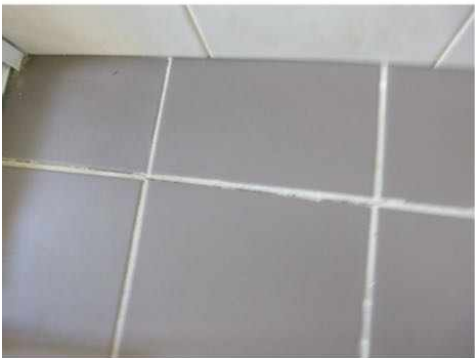
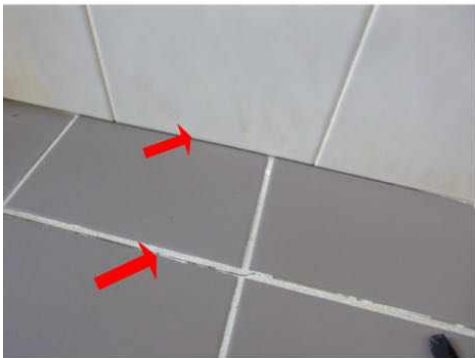
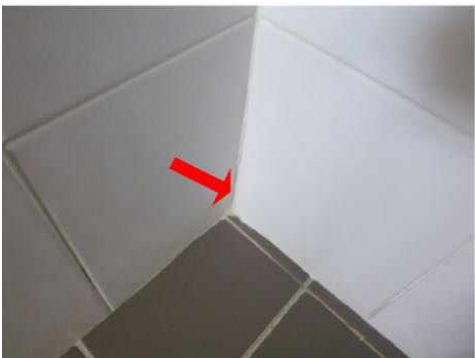
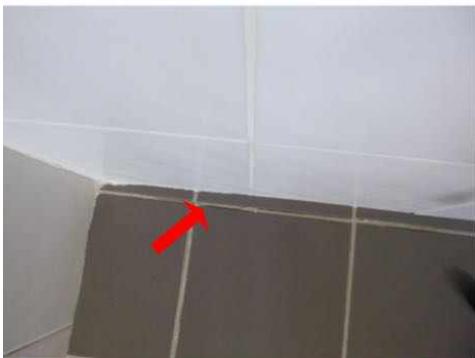
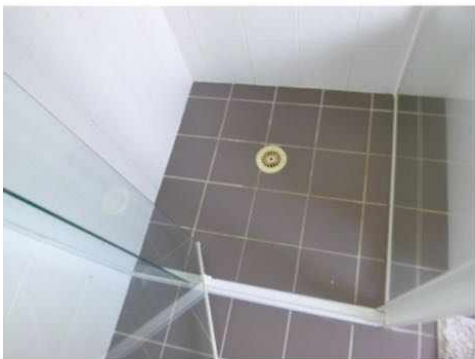
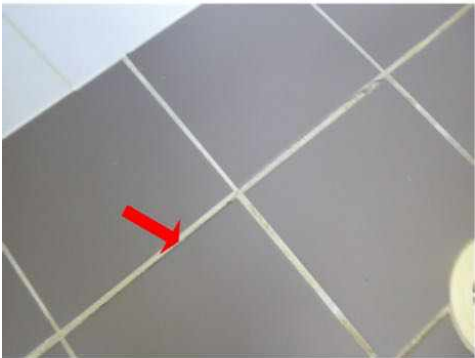
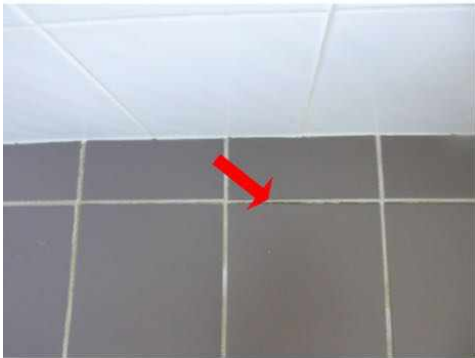
### Defects 3.04

Building: Main Building  
 Location: Shower area  
 Finding: Grout - Missing  
 Information: Grout is missing in this area. Grout is used to protect gaps and crevices in building materials to ensure that they are water-tight and prevent water penetration to the associated structures. While damage grout appears to be minor, this area is frequently exposed to water, allowing potential for water penetration into adjoining sections of walls or flooring.

Failure to do so is likely to lead to water damage to the surrounding area.

A tiling contractor should be appointed to ensure that no further water damage occurs. The re-application of silicone and grouting throughout remaining tile work is also advised, to further protect the area against water penetration.

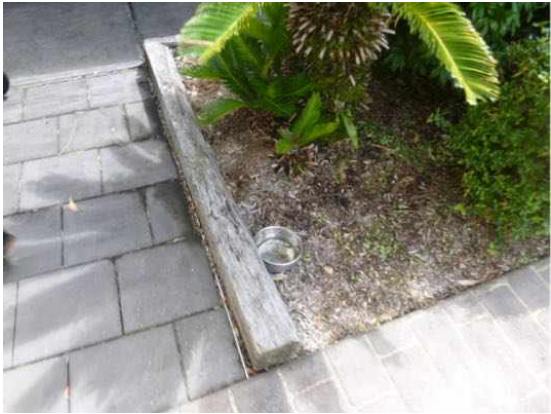
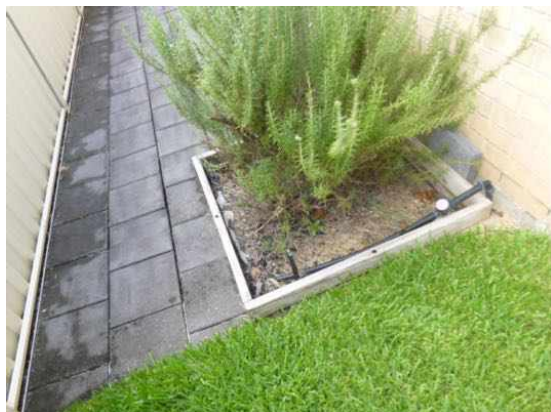
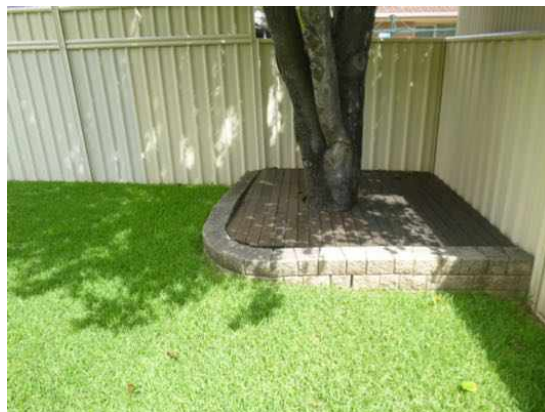
Building: Main Building  
 Location: All External Areas  
 Finding: Landscaping Timber  
 Information: Any timbers in direct ground contact provide opportunity for concealed termite entry and are likely to be subject to premature rot and decay as the soil retains moisture or damp conditions against the timbers. Remove untreated timber that is in direct contact with external grounds. If there is old tree stumps present frequent pest inspections are advised to readily identify any termite activity in these areas. Monitor treated landscape timbers within the garden area, as treated pine breaks down and rots over a period of time causing conducive conditions for termite activity.

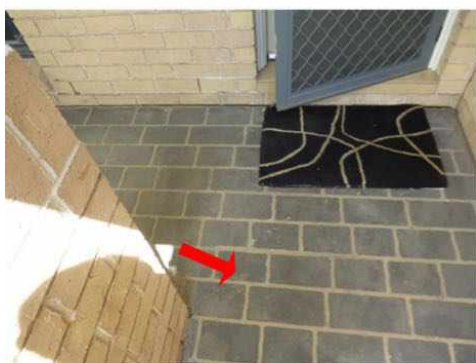
Building:	Main Building
Location:	Porch
Finding:	Cracking - External Concrete Paving Damage Category 0 - Hairline (less than 1mm)
Information:	Hairline cracks were identified in external concrete paving. Hairline cracks are very minor in nature and generally are only ever an appearance defect. To be classified as a Category 0 or hairline crack, the crack width would be less than 0.3mm. While such cracking may be noticeable in some cases, it is common and does not indicate any structural damage.

Generally the cause of a hairline crack in existing concrete paving such as driveways and pathways is indicative of the expansion and contraction of the concrete. Such causes are generally due to environmental factors, such as moisture levels, weather conditions, root systems of nearby trees or the soil types on which they are laid.

Hairline cracks may also be due to poor original installation of the concrete. Factors such as poor compaction of the sub surface and/or inadequate reinforcing of the slab may create cracking and other secondary defects.

Monitoring of all cracking should be conducted frequently. Always contact a building inspector should cracks widen, lengthen, or become more numerous.

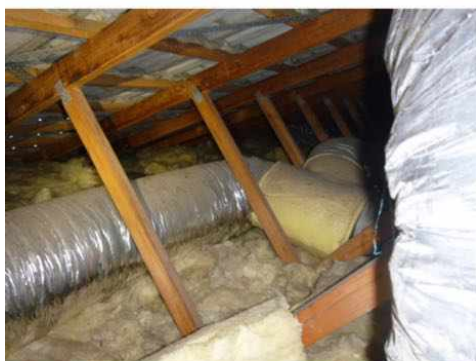
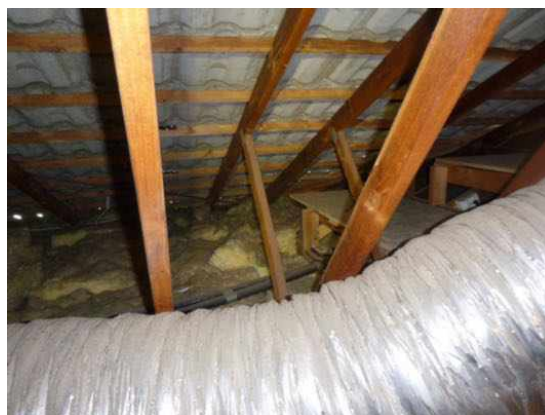
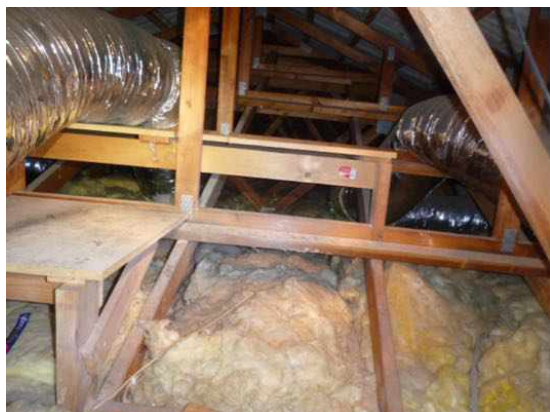
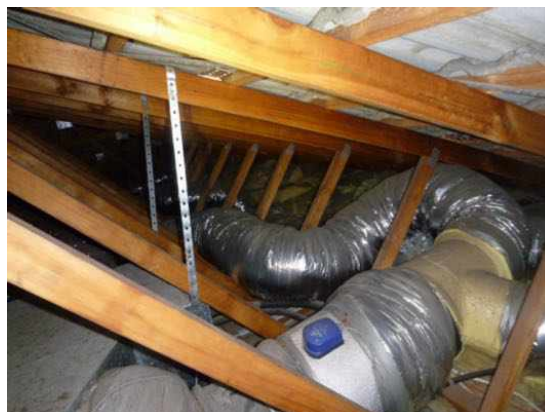
Building: Main Building  
 Location: Roof Void  
 Finding: Insulation - adequate  
 Information: Upon inspection of the roof void it was noted that there is adequate insulation. Insufficient insulation will result in a comparatively higher cost to heat and cool a property as there is adequate Insulation which works as a barrier to heat transfer. This helps to keep out unwanted heat in summer and preserves warmth inside your home in winter. It can also help soundproof your home from unwanted airborne noise transfer.

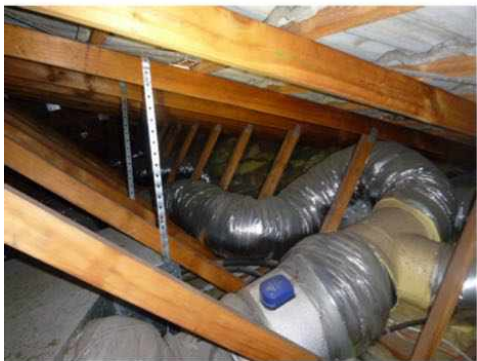
Building: Main Building  
 Location: Roof void  
 Finding: Air condition Unit- Good condition NO drain leaks  
 Information: There is NO drain leaks in air condition during the inspection. Leaking from an air-conditioning unit in roof space may be a result of several causes, including poor installation, blockages in internal drains, or a blockage to the drain hole. Heavy leaking from the air-conditioning unit is likely to produce damp conditions in the surrounding area conditions which are conducive to termite attack. If left unattended, such leaking can develop into water pooling below the unit, creating potential for subsequent water damage to associated building elements.

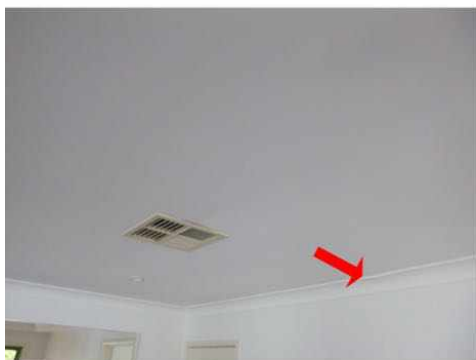
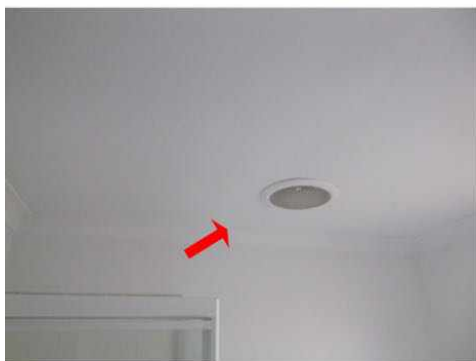
Building: Main Building  
Location: All Internal Areas  
Finding: Cracking - Damage Category 0 - Hairline (less than 1mm)  
Information: Hairline cracks are very minor in nature and generally are only ever an appearance defect. While such cracking may be noticeable in some cases, it is quite common and does not indicate any structural damage.

Cracking of this nature can generally be repaired with minor sanding, filling and/or repainting. Such works should be performed by a qualified painter or a general handyman.

Monitoring of all cracking should be conducted frequently. Always contact a building inspector should cracks widen, lengthen, or become more numerous.

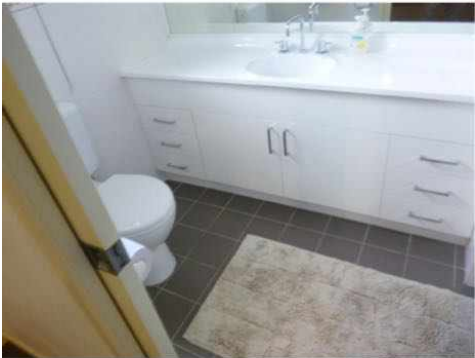
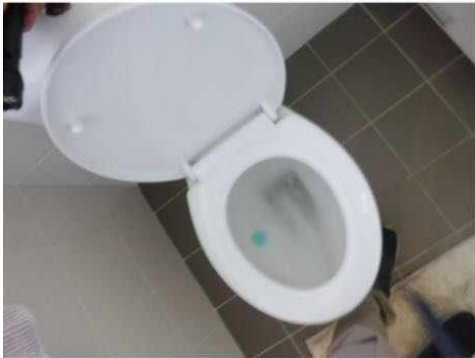
Building: Main Building  
 Location: Bathroom And other wet area  
 Finding: No evidence of excessive moisture- Bathroom  
 Information: All areas of the dwelling are checked with particular attention paid to wet areas which were closely assessed to check for excessive levels of moisture and temperature anomalies. There was NO evidence of excessive moisture present at the time of inspection in bathrooms.

Regular maintenance and replacement of damage or missing or damaged sealant and grout is highly recommended to the wet areas, as this is a regular wear and tear defect. Sealant and grouting in areas that come into regular contact with water should

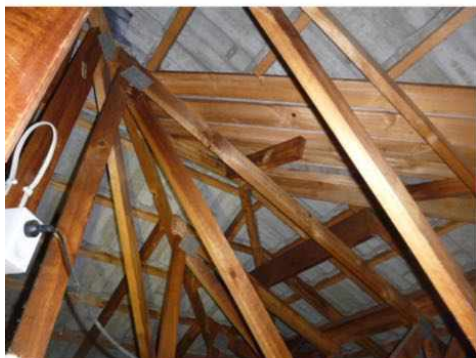
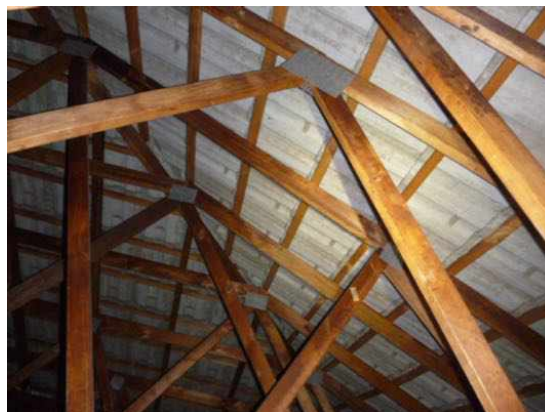
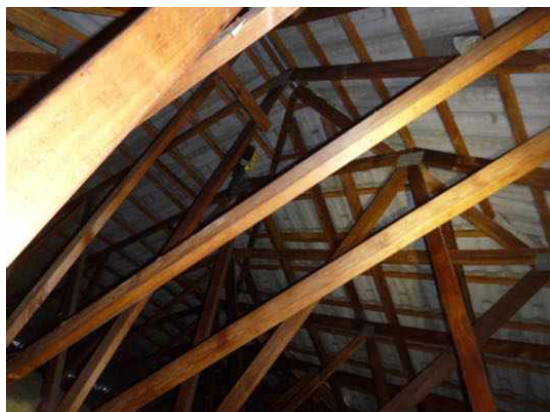
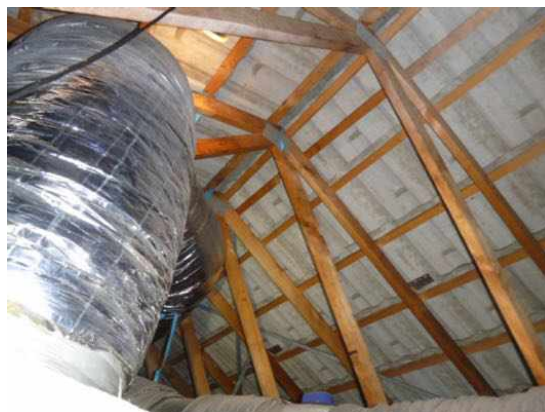
Building:	Main Building
Location:	Roof void
Finding:	Sarking - Missing
Information:	Sarking is missing under the roof sheeting. Sarking acts as an insulator that helps with noise reduction and protects against water penetration. Sarking plays a key role in the operation and function of the overall roofing structure and its performance.

Although it is a requirement at the time of construction, replacement of any missing building element is advisable (although this can be quite expensive to do after the time of construction). Where sarking is missing, regular inspections of the roof tiles for cracking and potential moisture penetration is required.

Sarking may be retrospectively fitted by a registered builder at the discretion of the client.

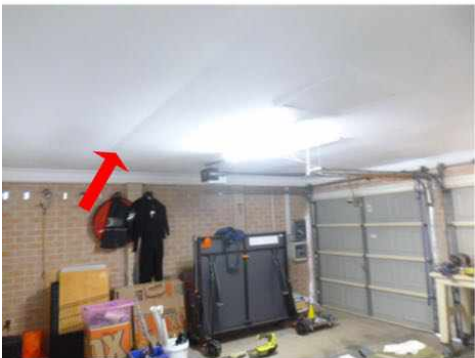
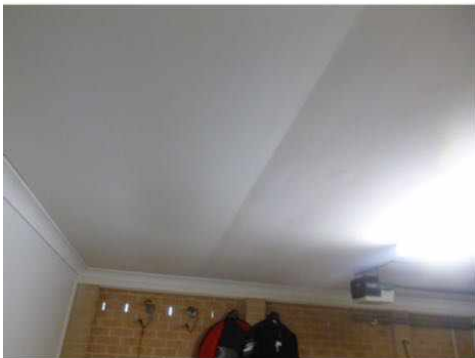
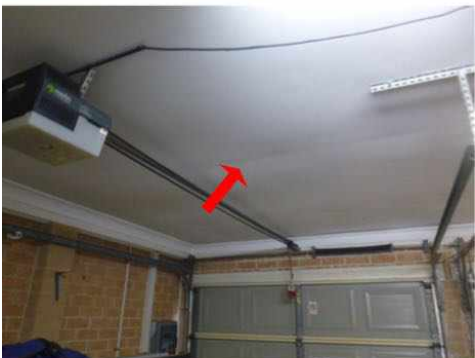
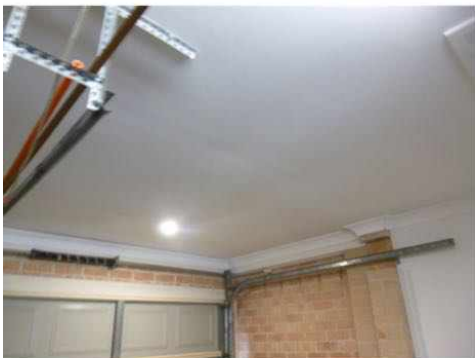
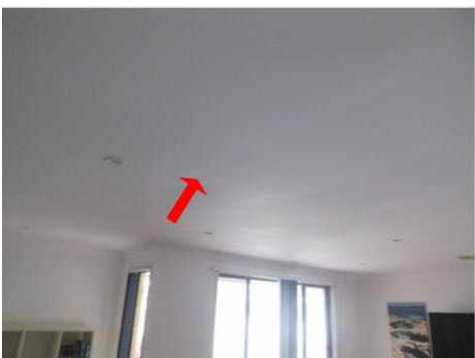
Building:	Main Building
Location:	Garage And other areas
Finding:	Ceiling - Sagging
Information:	Sections of the ceiling were found to be sagging at the time of inspection. Sagging to the fixed ceiling structure generally indicates that the building materials have swollen, due to contact with water, or that fixings (e.g. nails or glue) have become loose and require reattachment.

Where minor sagging is evident, comparatively minor works, such as re-gluing of ceiling sheets, may be required. Such works may be performed by relevant tradespeople, such as plasterers and painters. Where excessive moisture has caused the roofing structure to swell and sag, the source of the water leak should primarily be identified prior to any remedial works being performed.

The appropriate action should be taken by the client as soon as possible to ensure that any potential further damage is limited.

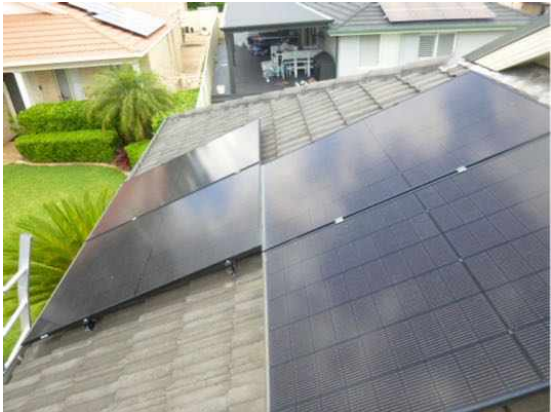
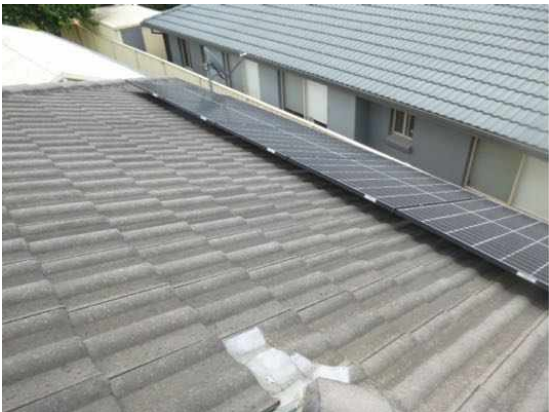
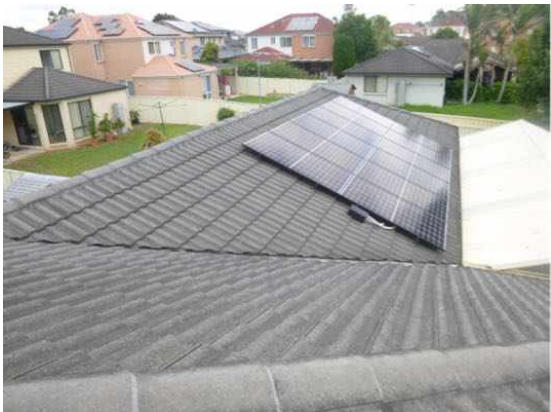
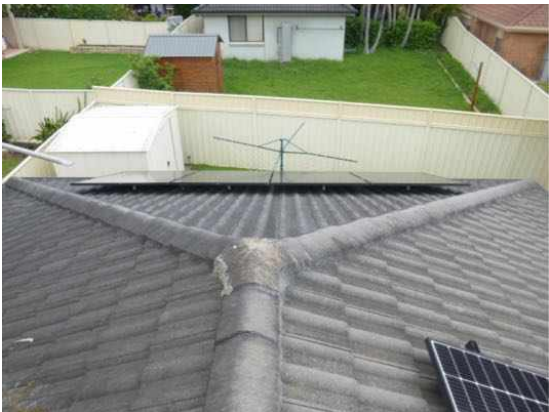
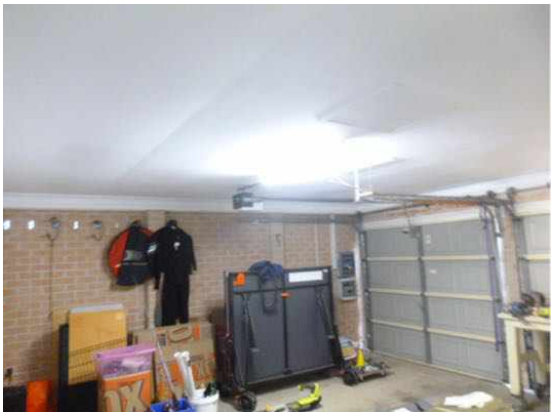
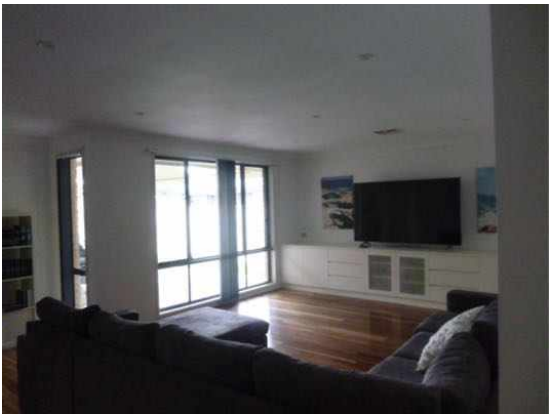
Building: Main Building  
Location: All Areas  
Finding: Additional Photos - Obstructions and Limitations  
Information: These photographs are an indication of the obstructions and limitations which impeded full inspection of the property at the time of inspection. These obstructions can hide an array of defects and should be removed to allow full inspection to be carried out.

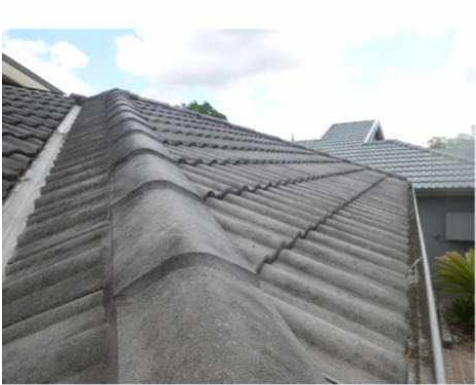
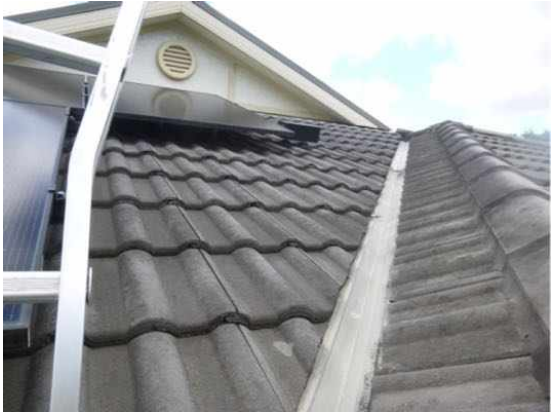
Building: Main Building  
Location: Roof Exterior  
Finding: Roof Tile - Good condition  
Information: Upon inspection of the exterior and interior roofing, the majority of rood tiles were considered to be in a good condition. Few crack tiles were noted during the inspection. It should be replace asap soon as possible to avoid further damage and leakages.
