Building and Timber Pest Inspection Report

Inspection Date: Tue, 10 Feb 2026

Property Address: 7 Downshire Parade, CHESTER HILL, NSW, 2162, Australia

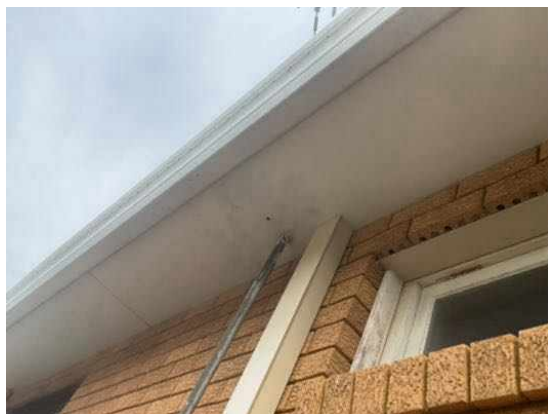
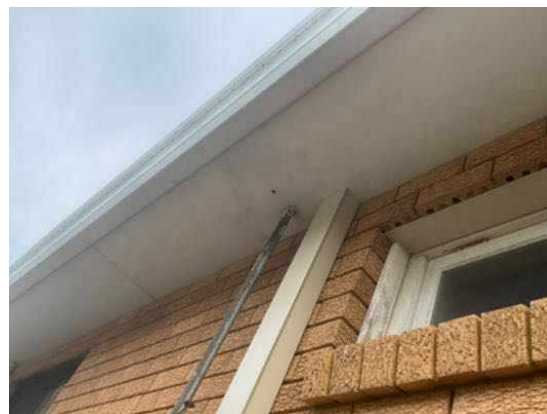
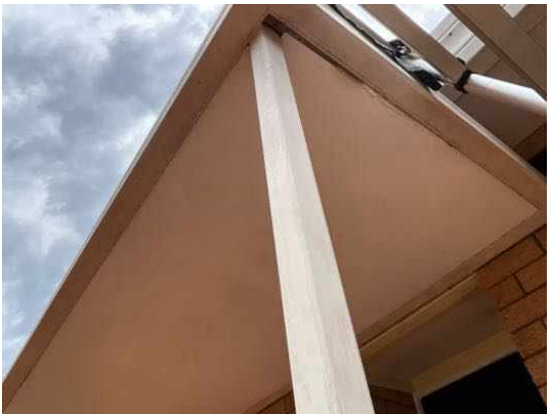
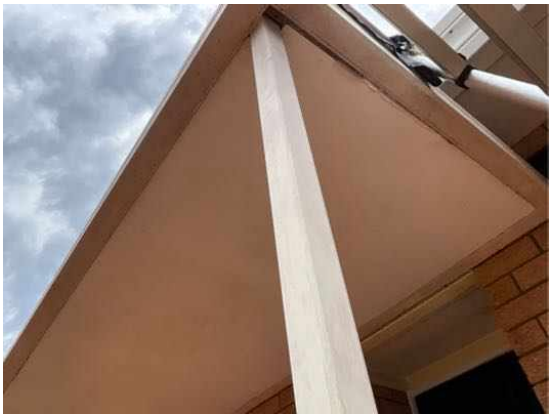
Building:	Main Building
Location:	All Areas
Finding:	Asbestos - Suspected ACM Identified on Site
Information:	Reporting on Asbestos is outside the Scope of this Report. This suspected defect is highlighted as a caution only. We suspect, based on our experience in the building industry, that there is a higher risk of the identified building element containing asbestos.

As Asbestos Reporting is outside the scope of this report, we advise that you consider a separate Asbestos Inspection and Condition Audit, which can include the taking of samples for definitive confirmation of the presence of Asbestos.

In the interim, the client is advised to act with caution, especially when considering any damage to building materials general wear and tear renovations extensions demolition and general maintenance activities due to the suspected presence of Asbestos.

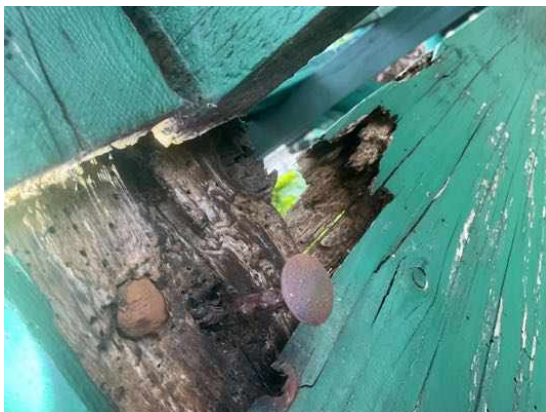
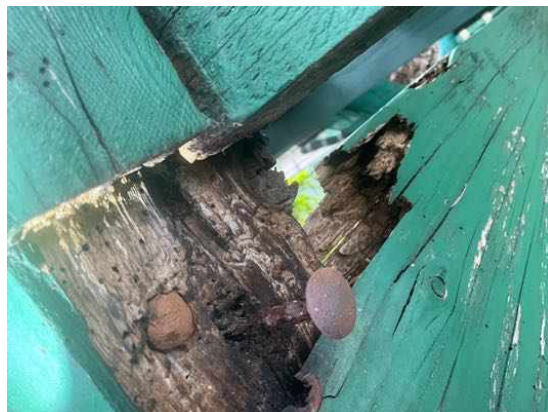
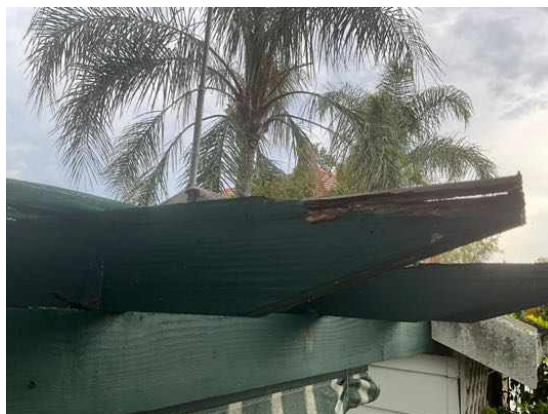
Finding 2.01

Building: Main Building
Location: Pergola
Finding: Rot weakening the timber structure
Information: Cracks and signs of wood rot have been observed, weakening the timber structure. The deterioration could be due to moisture exposure, aging, or insect infestation, compromising the structural integrity of the timber.

- ****Structural Instability:**** The cracks and wood rot can compromise the load-bearing capacity of the timber, potentially leading to structural failure or collapse, especially in load-bearing walls, beams, or frames.
- ****Safety Hazard:**** Weakening of the timber structure increases the risk of accidents, such as falling debris or collapse, posing a danger to occupants.
- ****Progressive Damage:**** If left unaddressed, wood rot can spread, further degrading the timber and accelerating the risk of structural failure.
- ****Pest Infestation:**** Wood rot can attract pests such as termites, which may cause additional damage.

A structural engineer or professional carpenter should be contacted to assess the extent of the damage. Depending on the severity, repairs may involve replacing the affected timber sections, treating the wood with preservatives, or reinforcing the structure. If there is extensive rot, a specialist in wood restoration or pest control may also be required to prevent further decay or infestation.

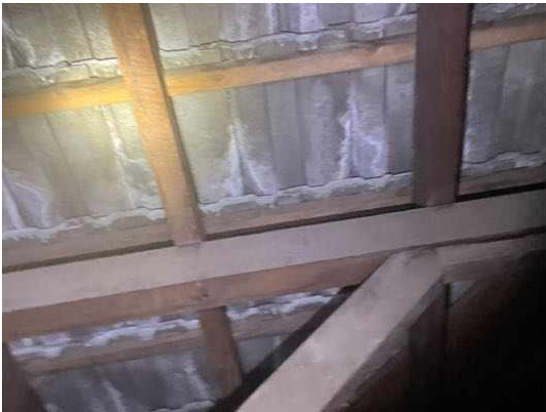
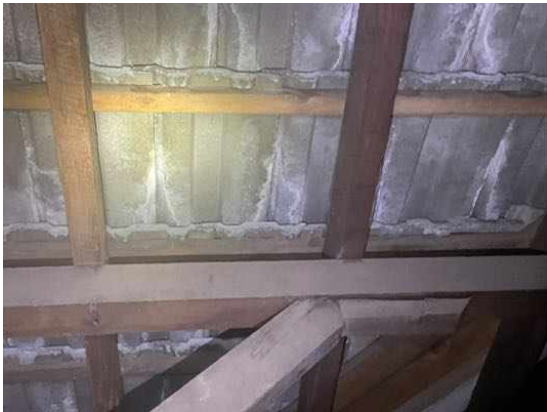
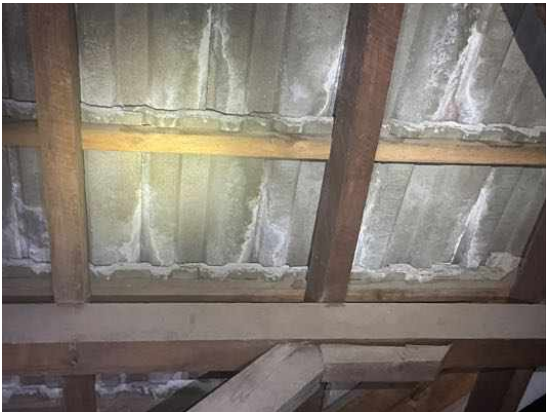
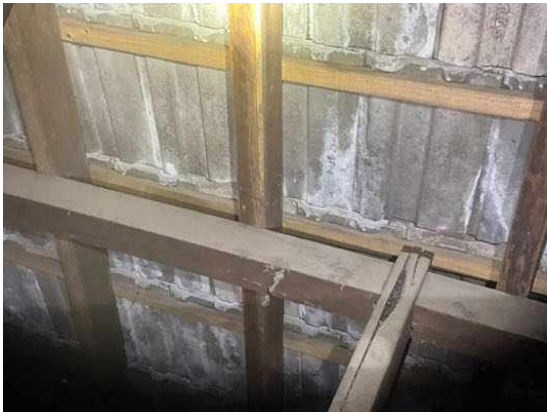
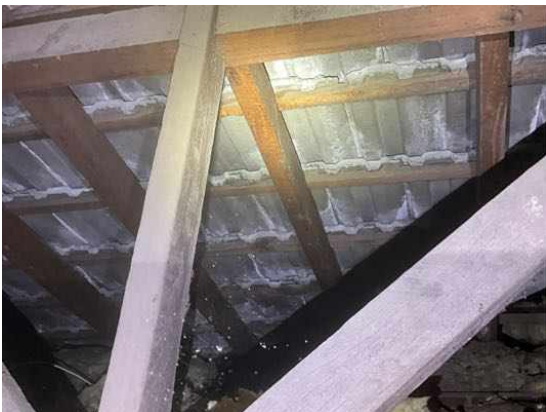
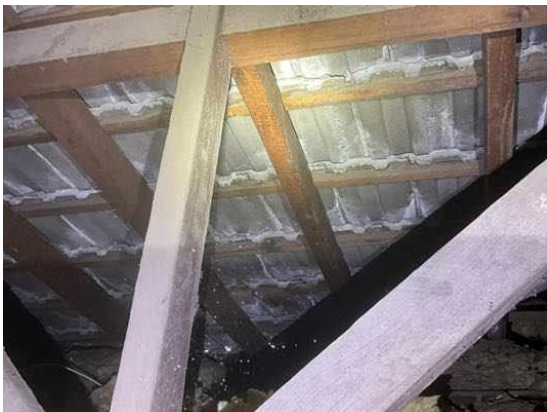
Finding 2.02

Building:	Main Building
Location:	Roof Void
Finding:	Roof void - Suspected water leak
Information:	Suspected water leak in the roof void, as evidenced by the presence of water stains, indicating potential gaps or holes.

- **Structural Damage:** Continuous water leakage can weaken the structural integrity of the roof and ceiling, leading to potential collapse.
- **Mold and Mildew:** Persistent moisture can promote the growth of mold and mildew, posing health risks such as respiratory problems and allergic reactions.
- **Electrical Hazard:** Water intrusion near electrical wiring can create a risk of short circuits, fires, or electrical shocks.
- **Insulation Damage:** Prolonged exposure to moisture can damage insulation, reducing its effectiveness and increasing energy costs.

A licensed roofing contractor should be contacted immediately to inspect, diagnose,

and repair the source of the leak to prevent further damage.

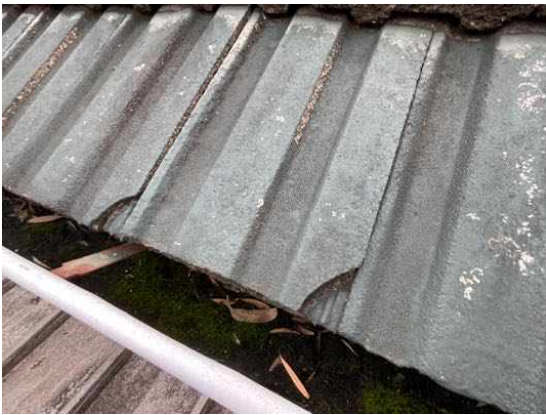
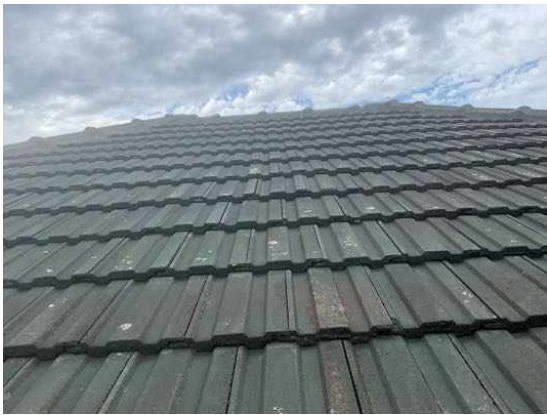
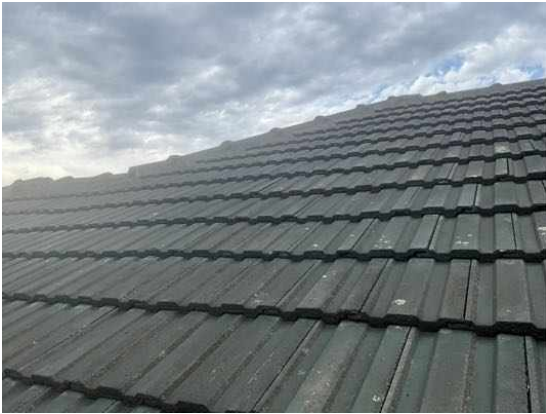
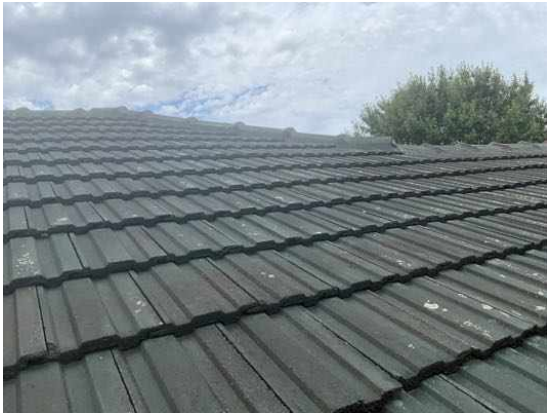
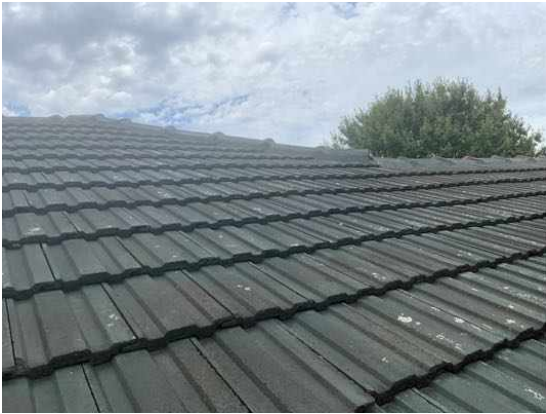
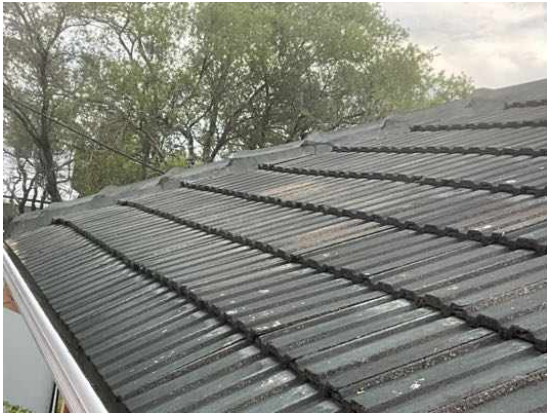
Finding 3.01

Building:	Main Building
Location:	All Areas
Finding:	Roof Weathered
Information:	Upon inspection of the exterior roofing, the majority of roof was not in a fair condition. While weathering of the roof is consistent with the age of the property, maintenance works are required.

Isolated areas of mortar have come loose in the valleys and minor cracking is also present. Re-pointing and re-sealing the may be considered as an interim solution by the client to help preserve and extend the life span of the tiles.

Where left unmanaged, deteriorating roof are likely to lead to a number of secondary defects, including minor water leaks and weather exposure to internal roofing structures.

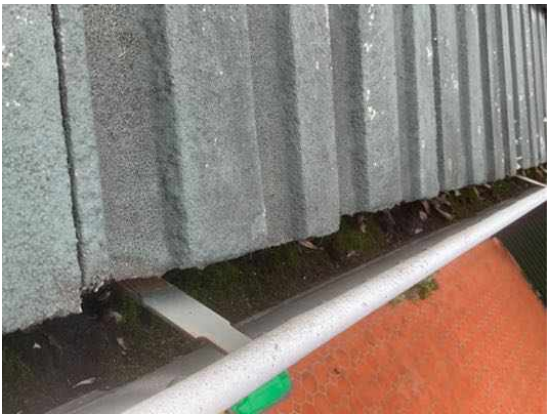
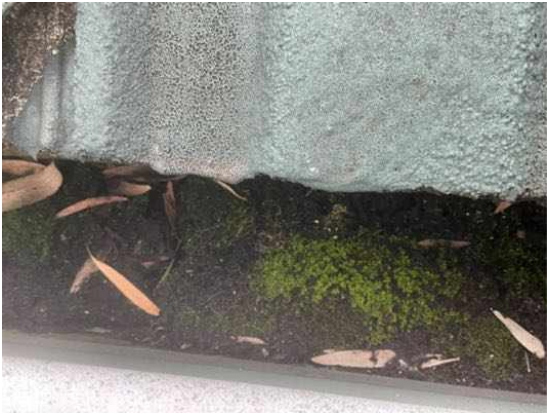
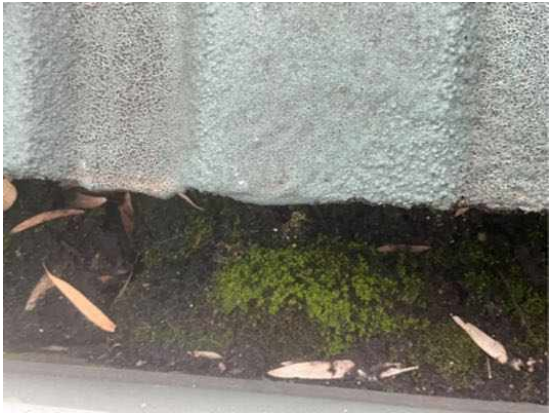
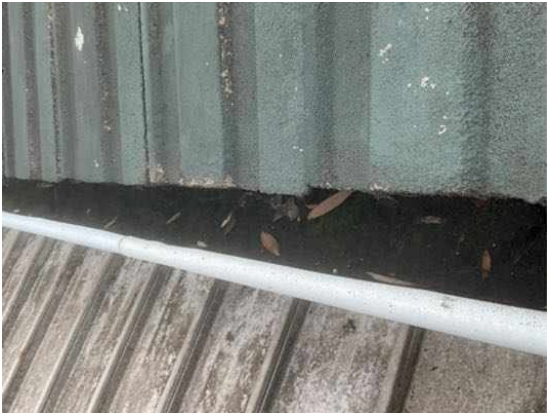
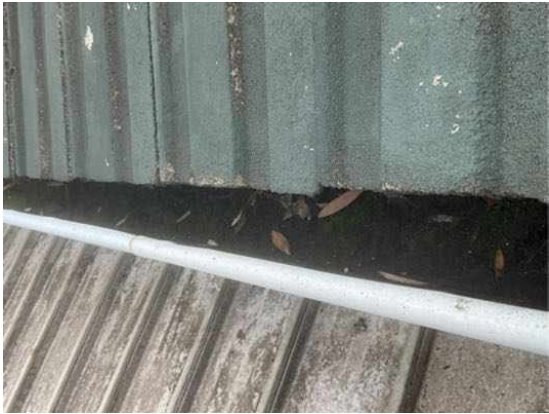
Finding 3.02

Building: Main Building
Location: All Areas
Finding: Blocked gutters - organic debris
Information: The roof gutter system was observed to be blocked with organic debris and moss growth, as evident in the provided images.

- Water ingress into the eaves or walls,
- Timber rot or deterioration of fascia and soffits,
- Accelerated moss and algae growth, promoting further blockages,
- Potential foundation issues if water pools near the base of the structure.

A licensed roofing contractor or qualified gutter cleaning service should be engaged to remove the debris and inspect the system for any further issues.

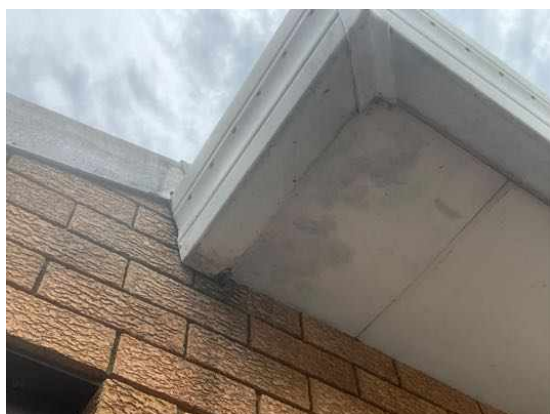
Finding 3.03

Building: Main Building
 Location: Exterior walls - left side
 Finding: Roofing Gutters - leak
 Information: Roofing gutters are experiencing leaks, compromising their ability to channel water effectively, posing a risk of water damage to the building structure and surroundings.

Risk: "The gutter leaks may result in water seepage into the foundation, potential interior damage, and deterioration of the building's exterior surfaces."

Resolution: "To address the issue, it is recommended to hire a licensed roofing plumber or gutter specialist to inspect, identify, and repair the leaks promptly."

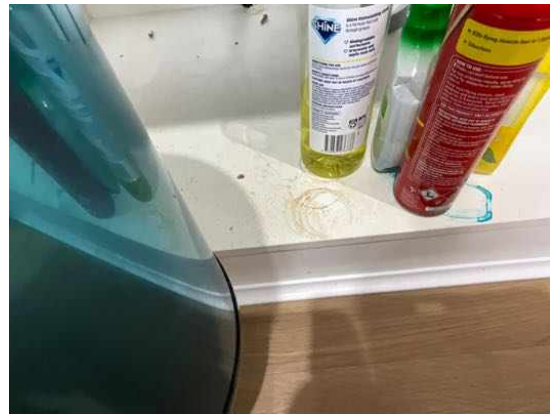
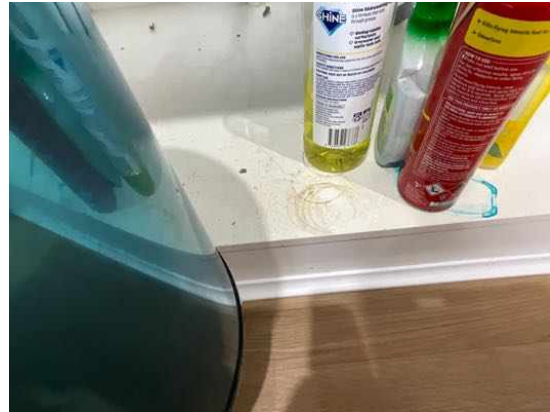
Building: Main Building
 Location: Kitchen
 Finding: Stains in Vanity

Information: Defect: General Stains in the Vanity

Description: The vanity surface exhibits general stains that may be due to water exposure, soap scum, cosmetics, or other substances. These stains are unsightly and may indicate ongoing maintenance issues.

- Hygiene Concerns: Stains can harbor bacteria and germs, potentially compromising hygiene in the bathroom.
- Aesthetic Impact: Stains reduce the visual appeal of the bathroom, making it look unkempt and less inviting.
- Potential for Hidden Damage: Stains caused by water exposure could indicate underlying water damage that, if left untreated, may lead to more serious structural issues.
- Decreased Resale Value: An unappealing vanity can negatively affect the overall aesthetic and perceived value of the property.

- Clean the vanity using appropriate cleaning agents to remove stains.
- Inspect for any underlying issues, such as leaks or surface damage, and address them accordingly.
- Consider refinishing or replacing the vanity if stains are persistent and cannot be removed.

- Homeowner or Cleaning Service: For minor stains, thorough cleaning can often be done by the homeowner or a professional cleaning service using suitable cleaning products.
- Handyman: For more stubborn stains or minor repairs, a handyman can clean, repair, or refinish the vanity surface.
- General Contractor: If the stains indicate more serious damage or if a replacement is needed, a general contractor with experience in bathroom renovations can perform the necessary repairs or replacement of the vanity.

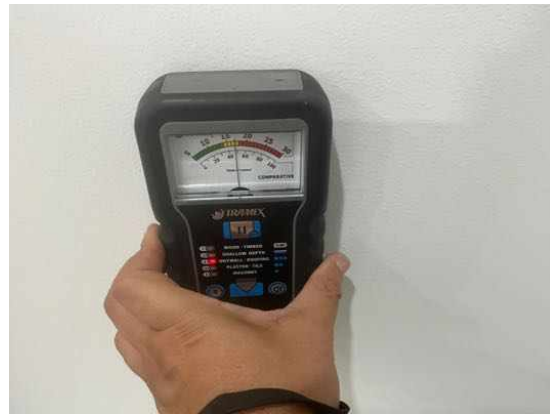
Finding 3.11

Building:	Main Building
Location:	Living Room
Finding:	Evidence of excessive moisture - Drywall
Information:	Excessive moisture is present at the time of , indicating a potential water leakage issue within the wall.

The prolonged presence of moisture can lead to mold growth, deteriorate the structure, and create an environment conducive to health hazards. Additionally, it may compromise the adhesive holding the tiles, leading to their detachment.

A licensed plumber or a qualified contractor specializing in water damage remediation should investigate the source of the moisture, fix any leaks, and address the damage. Additionally, replacing affected tiles and ensuring proper waterproofing are crucial to preventing future issues.

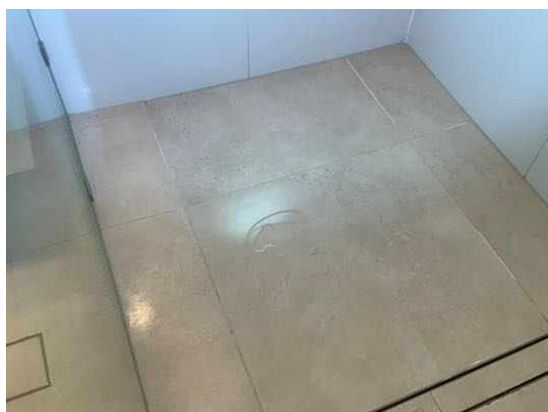
Finding 3.12

Building: Main Building
 Location: Bathroom
 Finding: Shower base - Water pooling
 Information: Evidence of water pooling around the floor waste in the shower recess was noticed at the time of inspection. It is suspected that this excessive moisture is attributed to insufficient fall in the shower floor tiles.

This pooling is minor overall but is still considered unsatisfactory, as standard tiling practices would not permit this situation to occur. Pooling water around floor wastes can create a slip hazard in extreme cases and create conditions that are conducive to mould growth over time. Where left unmanaged, the degradation of sealant and

grouting is also likely to occur, possibly necessitating further repair works.

Remedial works may involve some sections of tiling and flooring repair and replacement. A tiling contractor or bathroom specialist should be appointed to provide further advice on reparation options and to perform works as necessary.

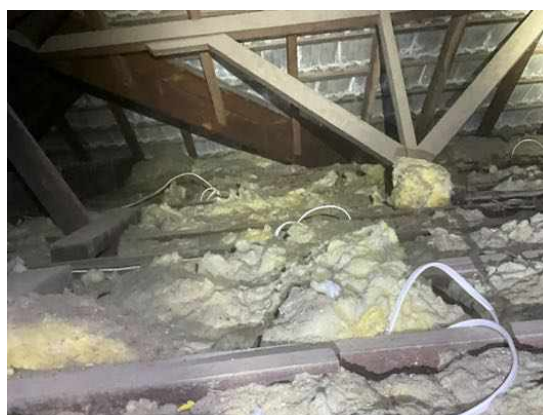
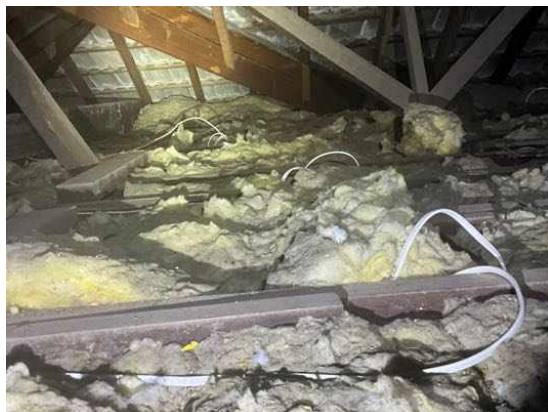
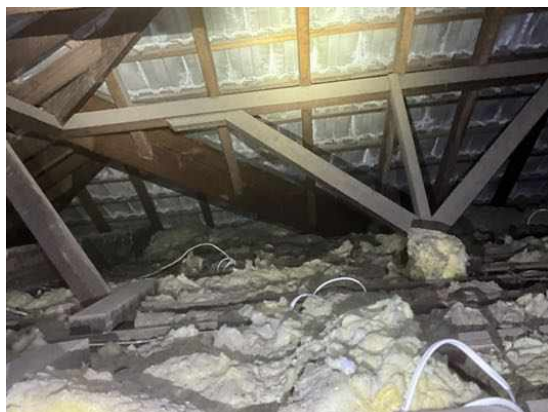
Building: Main Building
 Location: Roof Void
 Finding: Insulation - Covering downlights
 Information: Sections of insulation in the roof void have been poorly installed or moved from their original position and are covering down light fittings. While the down lights have been fitted with appropriate protective covers, the presence of this insulation creates a potential fire hazard.

Any insulation within the vicinity of down light fixtures should be moved and re-applied to more appropriate sections of the roof void, thus ensuring the area is fire-safe. An insulation contractor should be appointed as soon as possible to perform any necessary works as required.

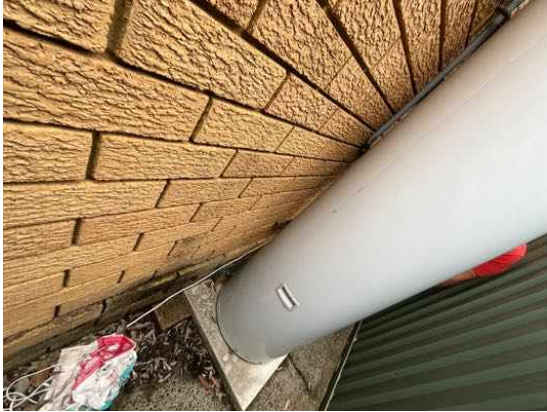
Where bridging has occurred full inspection is prevented and termites may enter a property in a concealed or undetected manner.

Recommended moving obstructions away from the external walls for further and future inspections.

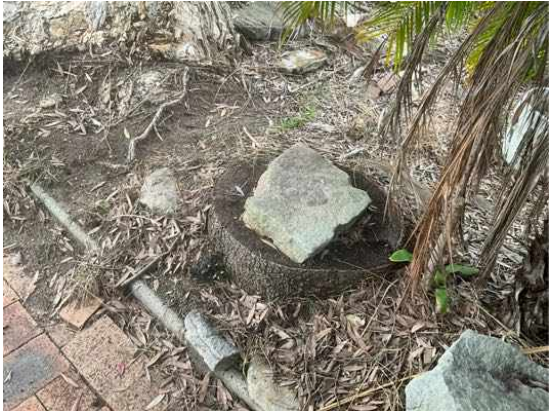
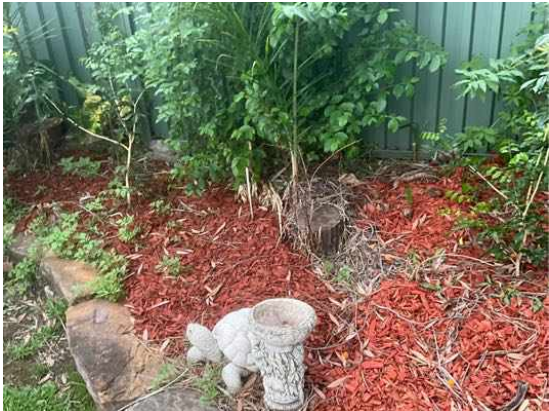
Building: Main Building
 Location: All Areas
 Finding: Cut and Exposed tree Stumps
 Information: The tree stump, which has been cut and exposed, poses a potential risk of termite infestation due to its increased vulnerability to termite attacks.

Please contact Licenced pest controller for further advice. Pictures attached for your reference.

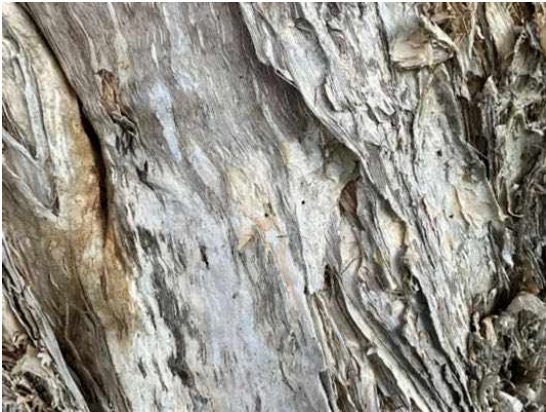
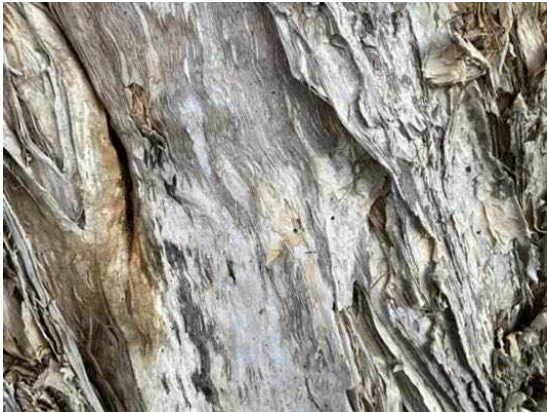
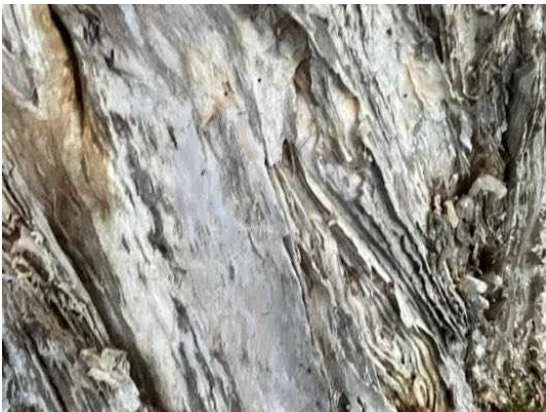
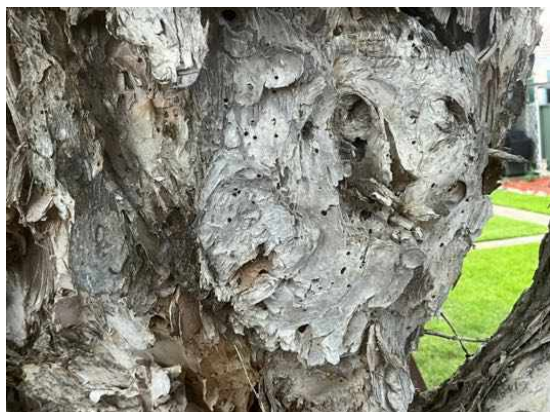
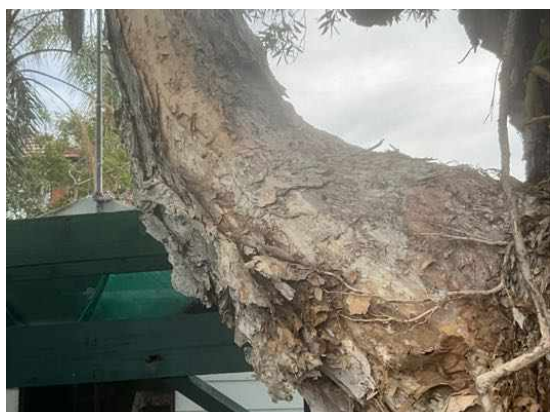
Finding 7.02

Building:	Main Building
Location:	Yard - Back
Finding:	Wood Borer Activity - Trees
Information:	Numerous small to medium-sized exit holes and surface tunnelling marks were noted along the trunk and branches of a dead standing tree. The pattern and shape of the damage are consistent with wood borer infestation. No live activity was observed at the time of inspection, though damage is clearly evident.

- Engage a qualified arborist to assess the structural integrity of the tree and arrange for safe removal if required.

- If the tree is within falling distance of a building, fence, or utility infrastructure, urgent removal is recommended.
- Regular site monitoring is advised for surrounding trees to detect any early signs of similar pest activity.

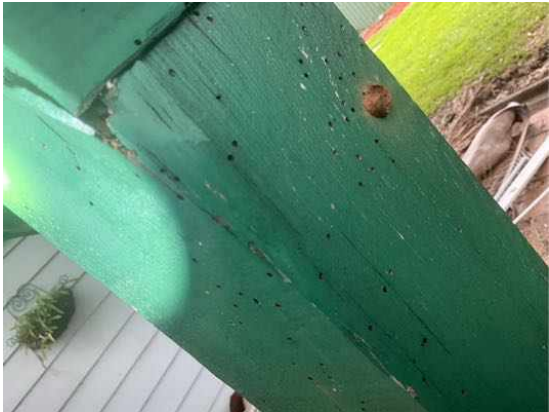
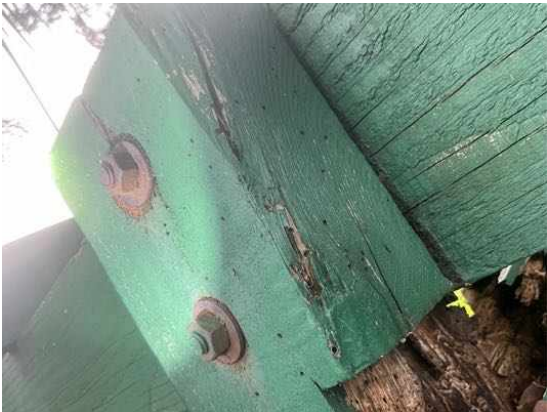
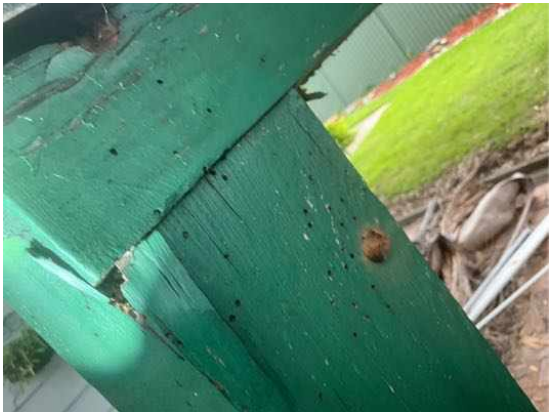
Finding 8.01

Building:	Main Building
Location:	Pergola
Finding:	Evidence of wood borer activity identified
Information:	Wood borers small beetles that colonise in exposed timber elements are a common timber pest that are regularly mistaken for termites. Although wood borer activity is generally not detrimental to the affected timber they may lead to serious damage and necessitate replacement of certain building elements if left unattended.

As no live wood borer activity was identified treatment is not required at this time. Replacement of affected timbers may be considered by the client for superficial reasons.

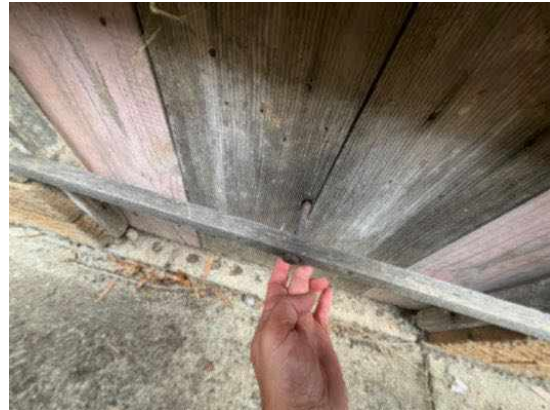
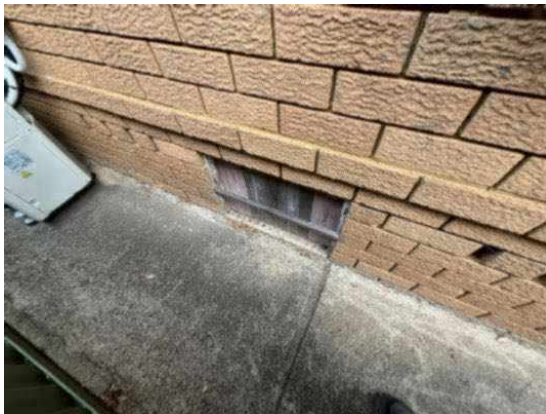
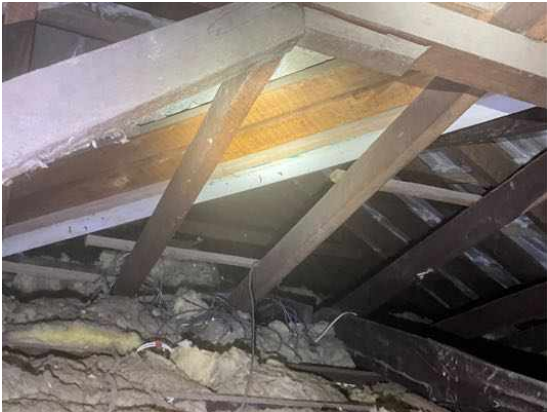
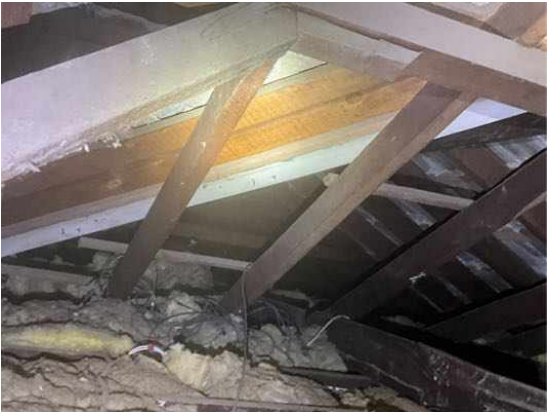
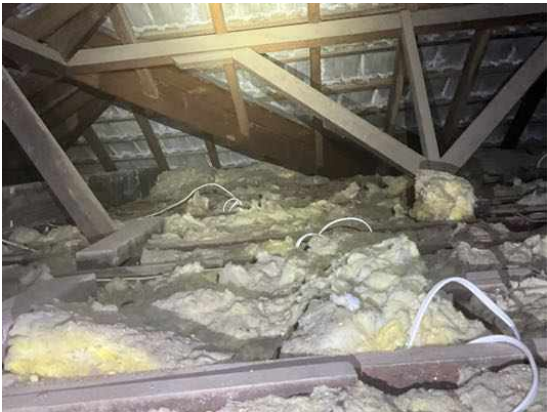
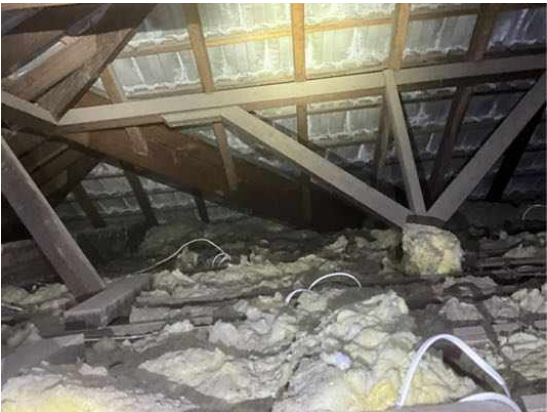
Building: Main Building
Location: All Areas
Finding: Additional Photos - Obstructions and Limitations
Information: These photographs are an indication of the obstructions and limitations which impeded full inspection of the property at the time of inspection. These obstructions can hide an array of defects and should be removed to allow full inspection to be carried out. A re-inspection is recommended once the areas are made accessible.
