# Building and Timber Pest Inspection Report VR

Inspection Date: Thu, 12 Mar 2026

Property Address: 63 Breimba St, Grafton NSW 2460,  
Australia

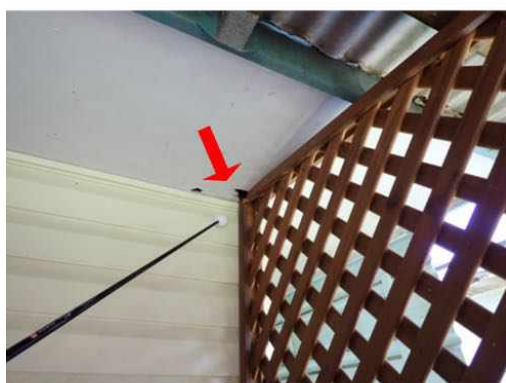
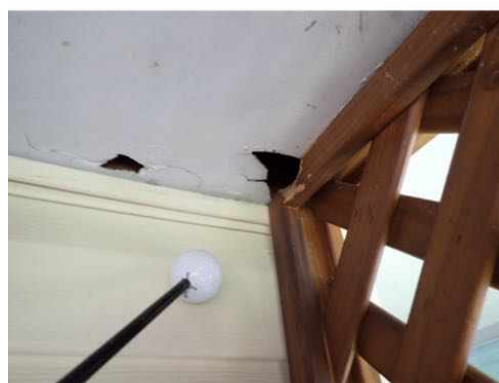
#### Finding 1.01

Building:	Main Building
Location:	Rear decked area roof
Finding:	Eaves – Damaged Eave Sheets
Information:	Damage was identified to the eave sheets above the rear decked area at the time of inspection. The eave sheets may contain asbestos due to the age of the building. In plain English, the sheeting under the roof overhang above the rear deck is damaged and may be made from asbestos-containing material, which was commonly used in properties of this age. Asbestos materials can present a health risk if disturbed or damaged, and appropriate safety precautions should be taken. An appropriately licensed asbestos contractor or suitably qualified tradesperson should assess and carry out repairs or replacement.

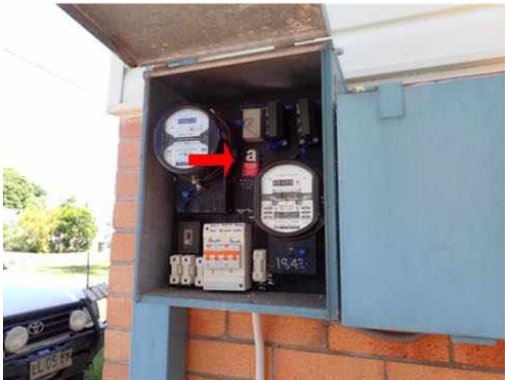
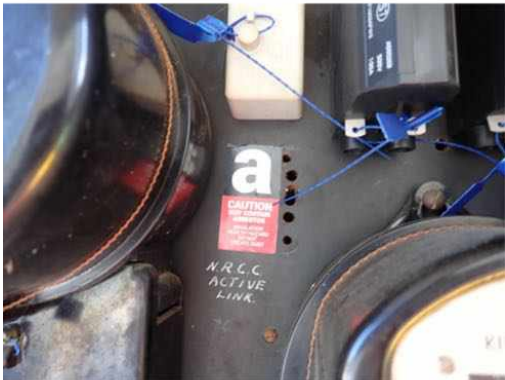
**Finding 1.03**

Building: Main Building  
 Location: Electrical meter box right hand side of building  
 Finding: Electrical Meter Box – Asbestos Warning Label  
 Information: An asbestos warning sticker was identified in the electrical meter box at the time of inspection. In plain English, the label indicates that materials associated with the meter box and potentially within the building may contain asbestos, which was commonly used in properties of this age. The label acts as a warning that asbestos-containing materials may be present within the building. Care should be taken if any works are carried out in this area. An appropriately licensed asbestos contractor should be consulted if disturbance or removal of materials is required.

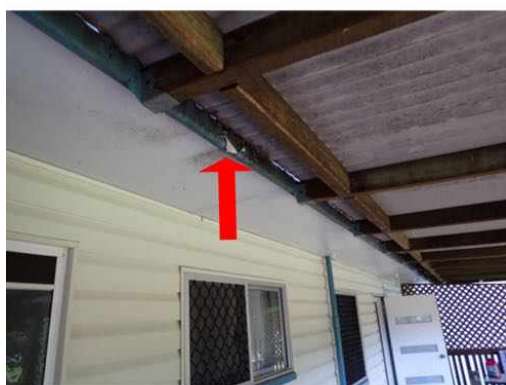
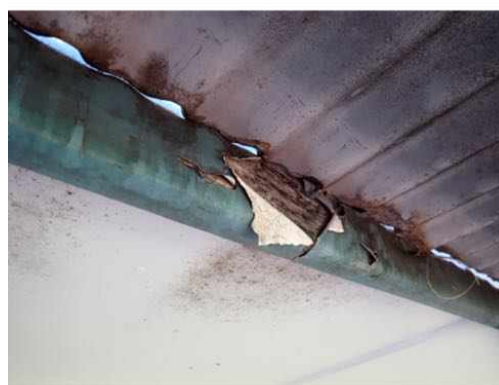
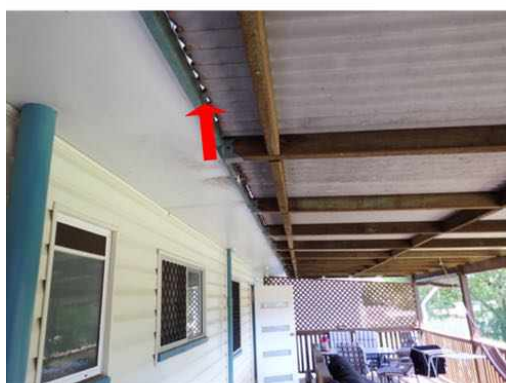
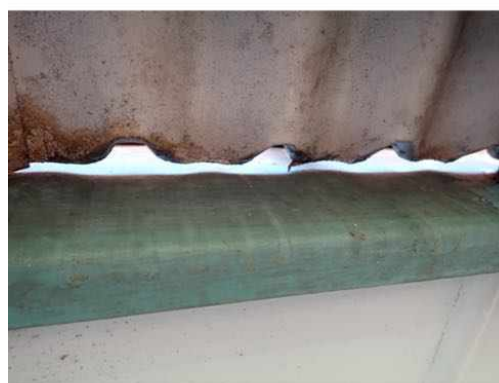
### Finding 2.01

Building:	Main Building
Location:	Rear decked area roof
Finding:	Back Deck Roof – Fascia Wood Rot and Rust
Information:	Minor wood rot was identified to the fascia boards to the back deck roof. Minor rust was also noted to the roof cladding in the same location, which may allow water ingress during periods of driving rain. In plain English, some timber along the edge of the roof has started to rot and the metal roof sheeting shows early rusting in the same area. This may allow water to enter during heavy wind-driven rain. The top of the roof could not be inspected due to the height of the structure. A licensed roofer or suitably qualified carpenter would be the appropriate trades to assess and carry out repairs required to prevent further damage.

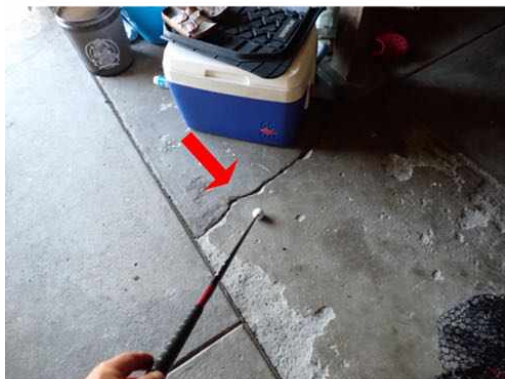
### Finding 2.02

Building:	Main Building
Location:	Garage
Finding:	Garage Concrete Slab – Large Cracks

Information: Large cracks were identified in the garage concrete slab at the time of inspection. In plain English, significant cracking was noted in the concrete floor which may be caused by ground movement or structural stress. This is a common defect with properties of this age and location. A suitably qualified concreter or builder should assess the slab and carry out rectification works as required. A structural engineer may also need to be consulted.

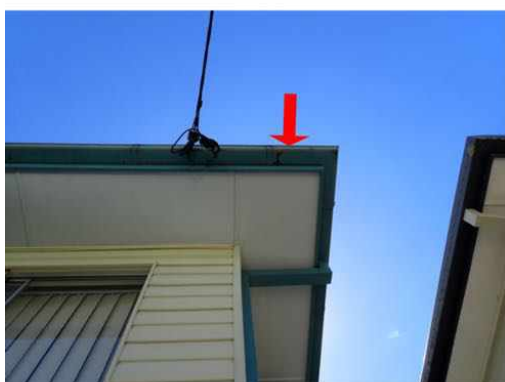
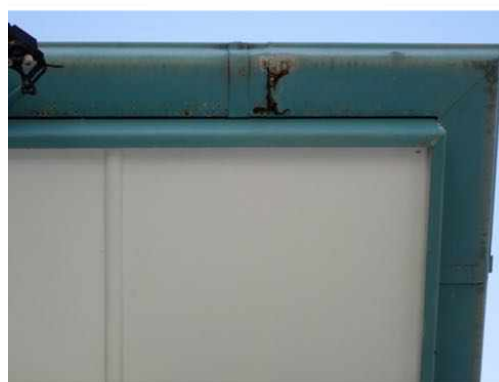
### Finding 2.03

Building: Main Building  
 Location: Gutters  
 Finding: Gutters – Rust and Limited Inspection  
 Information: Rust was identified to the gutters at several locations at the time of inspection. In plain English, the gutters show signs of corrosion which is common with metal gutters over time. The gutters and roof could not be thoroughly inspected due to the second storey height limiting safe access. A licensed roofer or suitably qualified tradesperson should assess the gutters and roof and carry out maintenance or repairs as required.

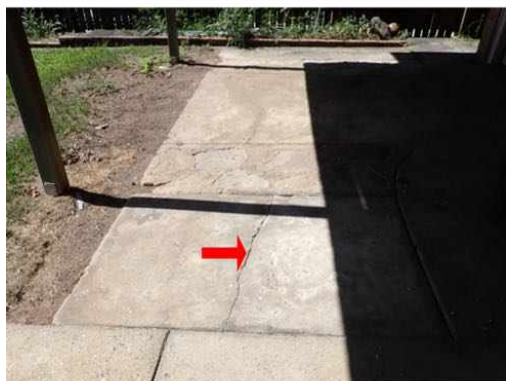
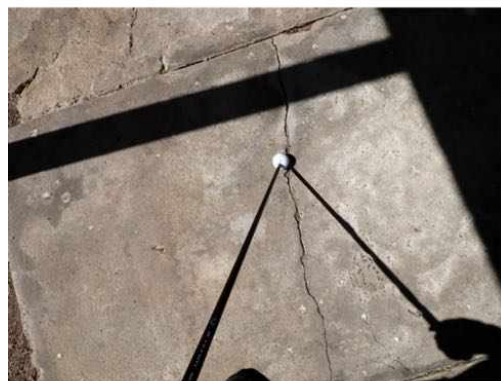
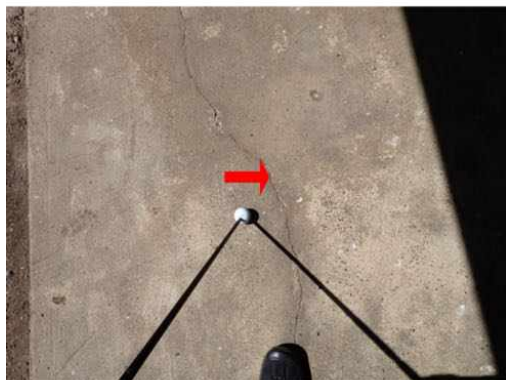
### Finding 2.04

Building: Main Building  
 Location: Rear of building  
 Finding: Rear Concrete Area – Major and Minor Cracks

Information: Major and minor cracks were identified to the rear patchy concreted area at the time of inspection. In plain English, several cracks of varying size were noted in the rear concrete surface. This can occur due to ground movement, age, poor installation, or general wear over time. A suitably qualified concreter or builder should assess the area and carry out rectification works as required.

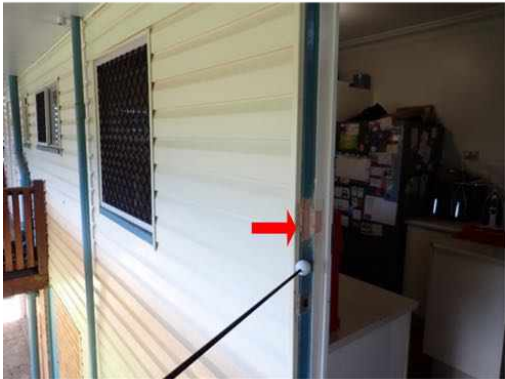
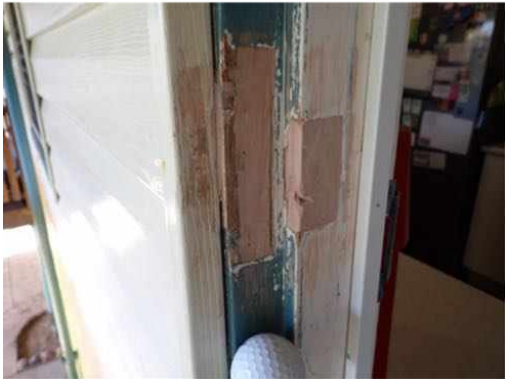
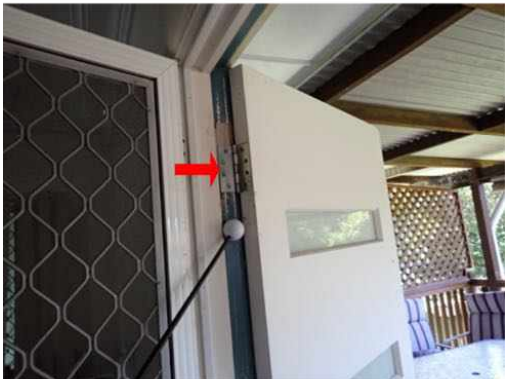
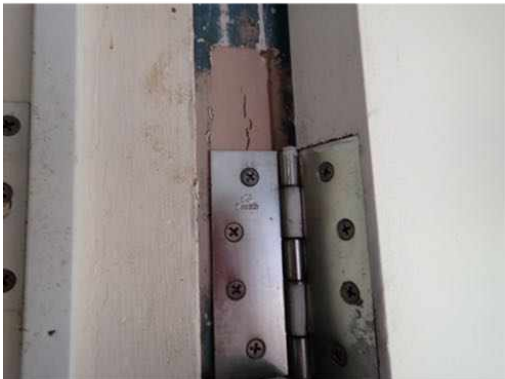
### Finding 3.01

Building: Main Building

Location: Front entry door

Finding: Front Door – Fair Condition

Information: The front door was in fair working order at the time of inspection; however, old patch repairs were noted to the door jambs from previous door hardware and would benefit from painting. In plain English, the door works, but the frame has been patched where old locks or fittings were installed and requires painting to improve the finish. This is a common condition with a property of this age. A painter or handyman would be the appropriate trade to carry out this work.

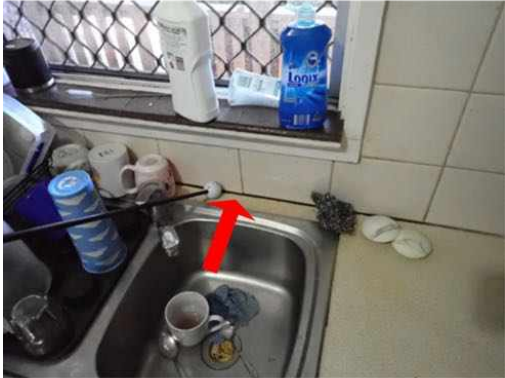
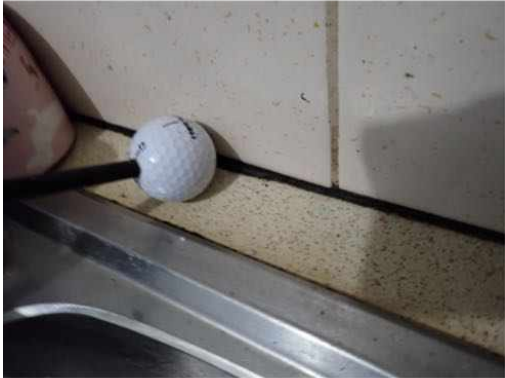
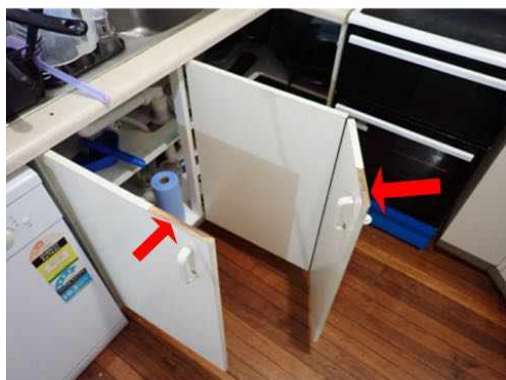
**Finding 3.02**

Building: Main Building  
Location: Kitchen  
Finding: Kitchen – Fair Condition

Information: The kitchen was found to be in fair condition at the time of inspection with age-related defects noted, including damaged edge tape to cabinetry and deteriorated silicone to junctions. In plain English, the kitchen appears functional but shows general wear and deterioration consistent with a property of this age. Maintenance or minor repairs may be carried out at the owner’s discretion. A cabinet maker or suitably experienced handyman would be the appropriate trade to carry out any repairs if required.

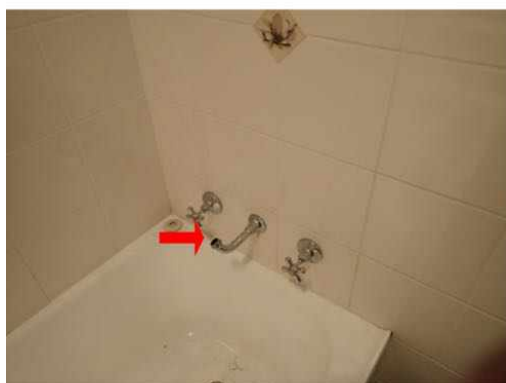
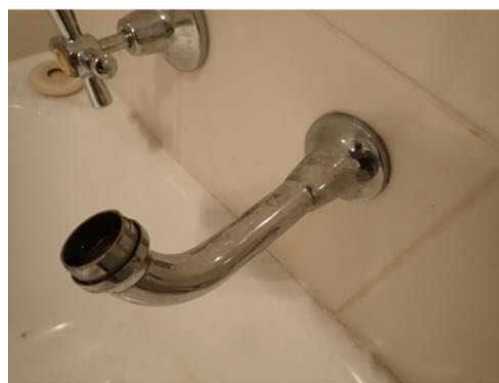
### Finding 3.03

Building:	Main Building
Location:	Bathroom
Finding:	Bath Spout Up side down.
Information:	The bath spout was observed to be turned upside down at the time of inspection and possible because of a minor drip. In plain English, the spout appears to have been turned upside down, possibly by the homeowner or renters to stop a minor drip. A licensed plumber may be engaged to assess the issue.

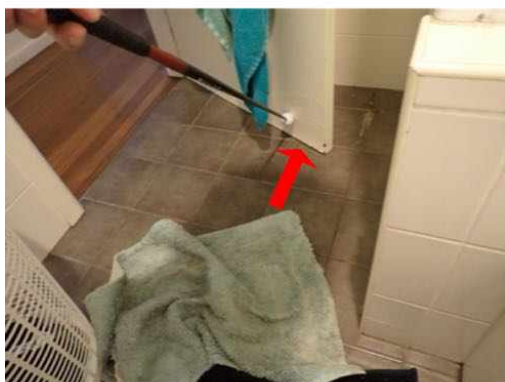
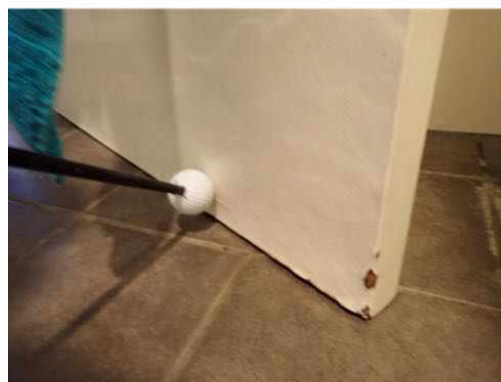
### Finding 3.04

Building:	Main Building
Location:	Bathroom
Finding:	Bathroom Door – Swelling
Information:	Swelling was noted to the bottom of the bathroom door at the time of inspection. In plain English, the bottom of the door has absorbed moisture and expanded, which is common in wet areas and properties of this age. A carpenter or suitably experienced handyman would be the appropriate trade to repair or replace the affected section of the door.

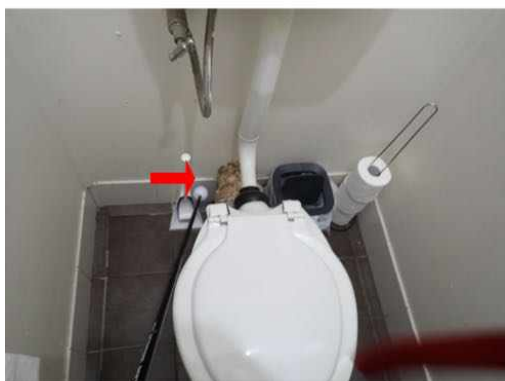
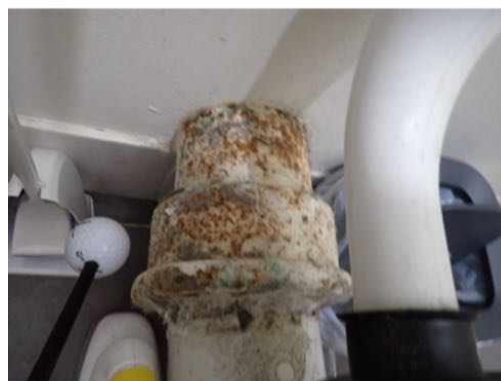
### Finding 3.05

Building:	Main Building
Location:	Toilet (WC)
Finding:	Toilet Plumbing – Surface Rust
Information:	Surface rust was noted to the toilet plumbing at the time of inspection. In plain English, the plumbing components show signs of corrosion; however, no visible leaks were observed during normal operation. This is a common defect with plumbing components over time. A licensed plumber would be the appropriate trade to assess and carry out maintenance or replacement if necessary.

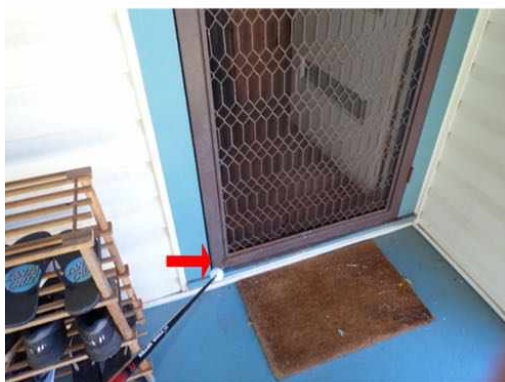
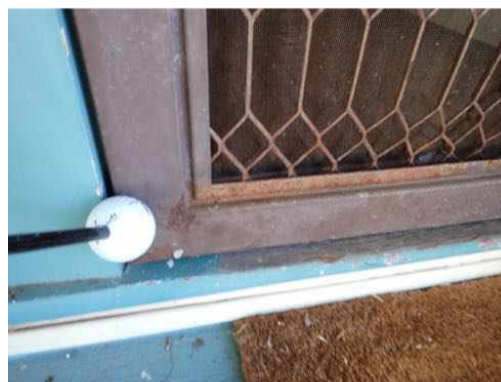
### Finding 3.06

Building:	Main Building
Location:	Front entry door
Finding:	Entry Screen Door – Surface Rust
Information:	Surface rust was noted to the entry screen door at the time of inspection. In plain English, the metal screen door shows early signs of corrosion, which is common with external metal components over time. Maintenance such as cleaning, rust treatment, and repainting is recommended. A painter or suitably experienced handyman would be the appropriate trade to carry out repairs.

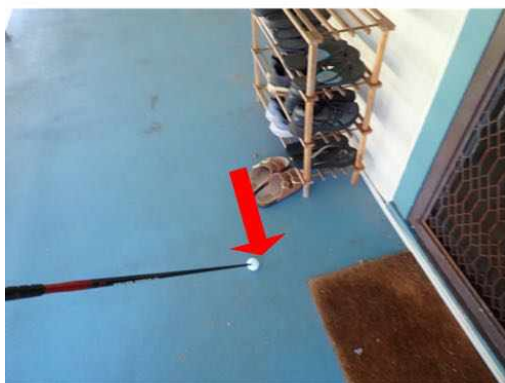
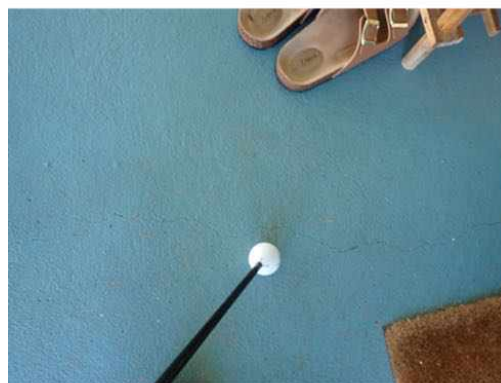
### Finding 3.07

Building: Main Building

Location: Front balcony

Finding: Front Concrete Balcony – Minor Crack

Information: A minor crack was identified in the front concrete balcony at the time of inspection. In plain English, a small crack was noted in the concrete, which can occur due to normal movement, shrinkage during curing, or the original laying of the concrete. This is a common defect in concrete structures. The crack should be monitored for any signs of further movement or deterioration. If the crack increases in size or changes over time, a suitably qualified concreter or builder should be contacted to assess the area and perform rectification works as required.

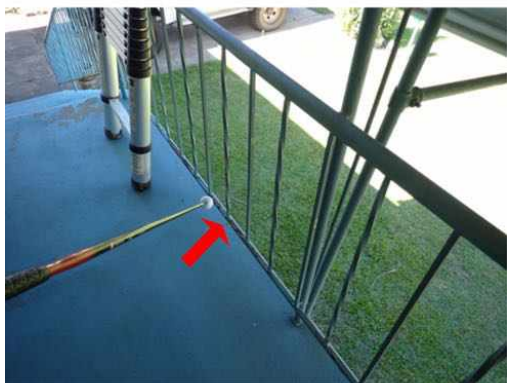
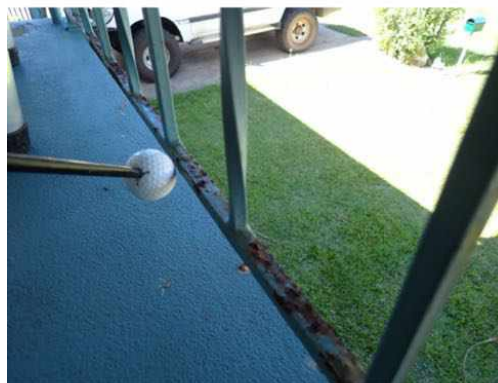
### Finding 3.08

Building: Main Building

Location: Front balcony

Finding: Front Balcony Balustrade – Rust

Information: Rust was identified to the steel front balcony balustrade at the time of inspection. In plain English, the metal railing shows signs of corrosion, which is common with exposed steel elements over time. Maintenance such as cleaning, rust treatment, and repainting is recommended. A painter, metal fabricator, or suitably experienced handyman would be the appropriate trade to carry out repairs.

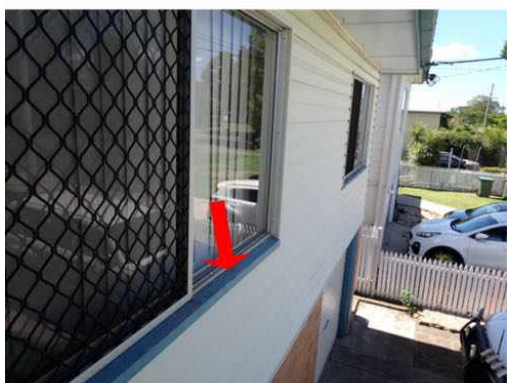
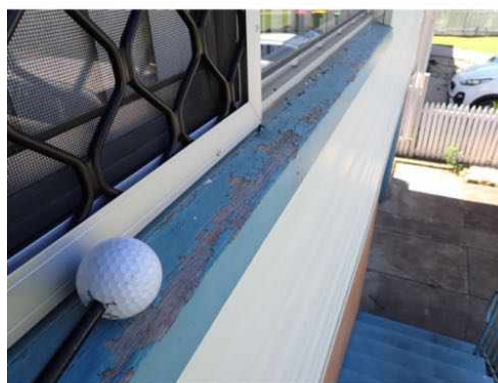
### Finding 3.09

Building:	Main Building
Location:	External windows
Finding:	External Timber Windows – General Maintenance
Information:	The external timber windows were found to be in need of general maintenance at the time of inspection. In plain English, the windows show signs of age and weathering, which is common with timber windows over time. Maintenance such as sanding, sealing, and repainting is recommended to prevent further deterioration. A painter, carpenter, or suitably experienced handyman would be the appropriate trade to carry out the maintenance works.

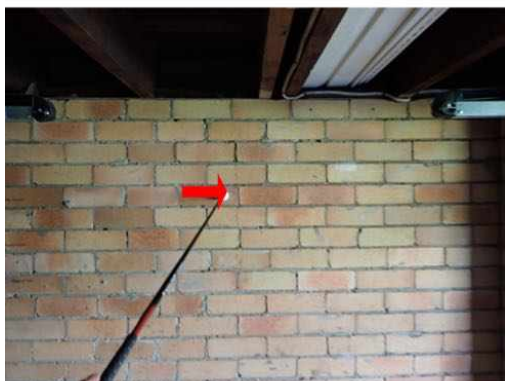
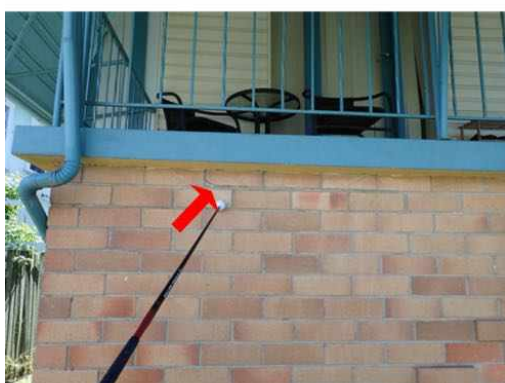
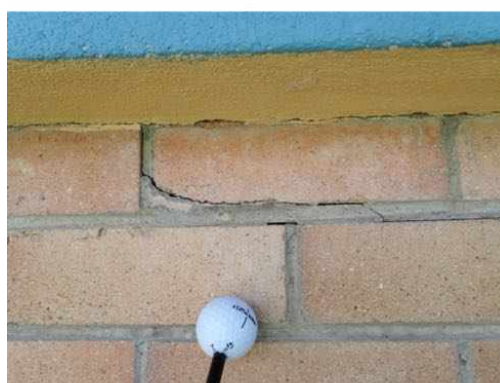
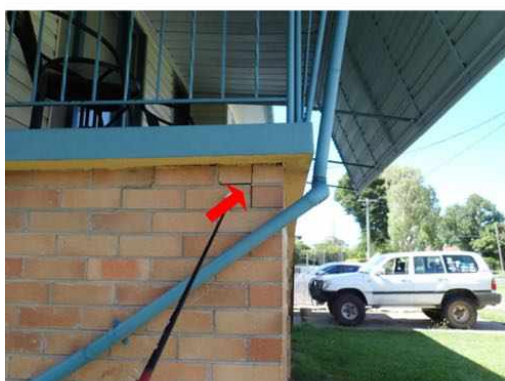
### Finding 3.10

Building:	Main Building
Location:	Below front concrete porch area.
Finding:	Brickwork Below Front Porch – Minor Cracks
Information:	Minor cracks were identified in the brickwork below the front concrete porch area at the time of inspection. In plain English, small cracks were noted in the brickwork which can occur due to normal movement and age of the structure. This is a common defect with properties of this age. The area should be monitored for any signs of further movement. If the cracks increase in size, a suitably qualified builder or bricklayer

should be contacted to assess and carry out repairs as required.

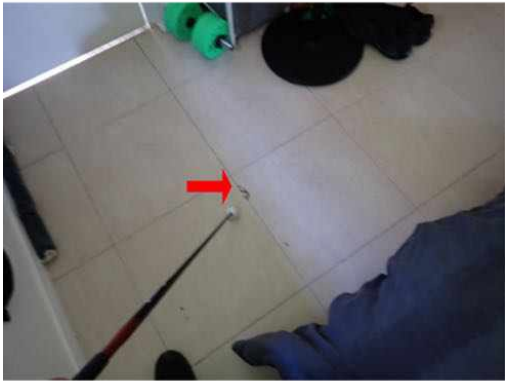
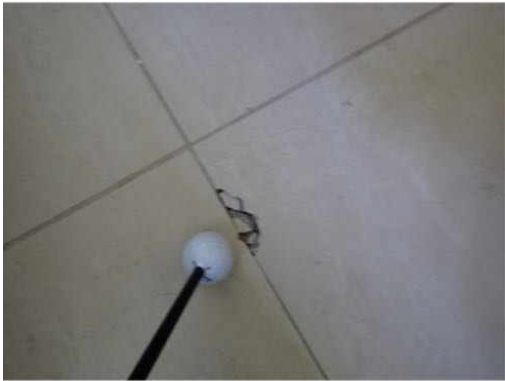
### Finding 3.11

Building:	Main Building
Location:	Ground floor bedroom
Finding:	Ground Floor Bedroom Floor – Damaged Tile
Information:	A damaged tile was identified to the ground floor bedroom floor at the time of inspection. In plain English, one of the floor tiles is broken, likely due to impact damage. A tiler or suitably experienced handyman should assess and replace the damaged tile as required.

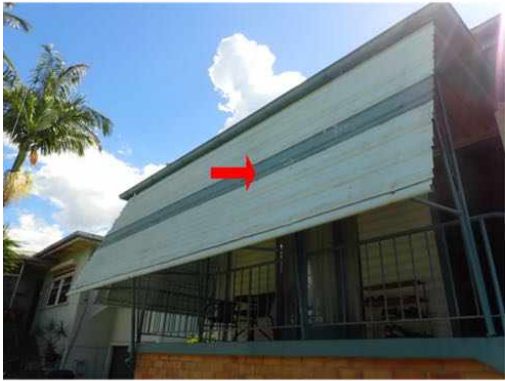
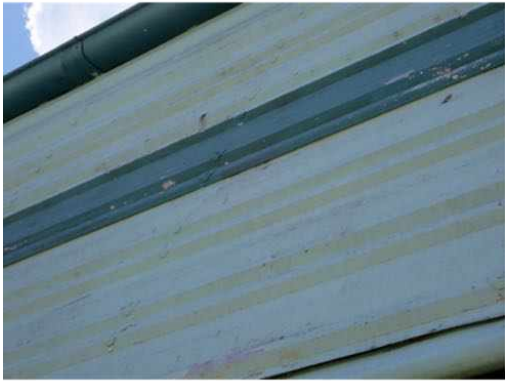
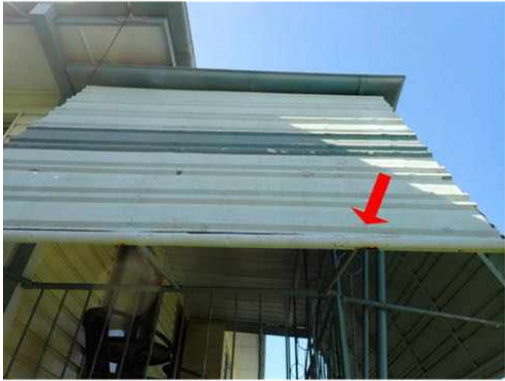
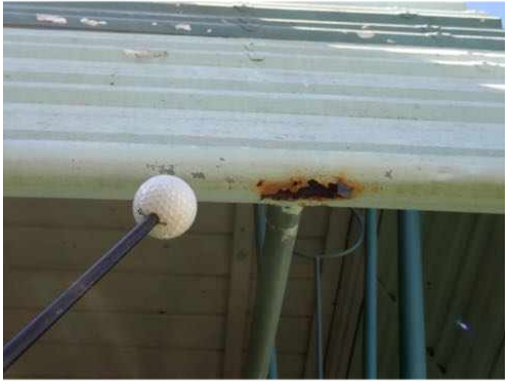
**Finding 3.12**

Building: Main Building  
 Location: Front and left hand side external  
 Finding: Balcony and Window Sun Screens – Poor Condition  
 Information: The balcony and window sun screens were found to be in poor condition with rust identified at the time of inspection. In plain English, the metal sun screens show corrosion and general deterioration from weather exposure over time. Maintenance or replacement may be required to prevent further deterioration. A metal fabricator, painter, or suitably experienced handyman would be the appropriate trade to carry out repairs or replacement.

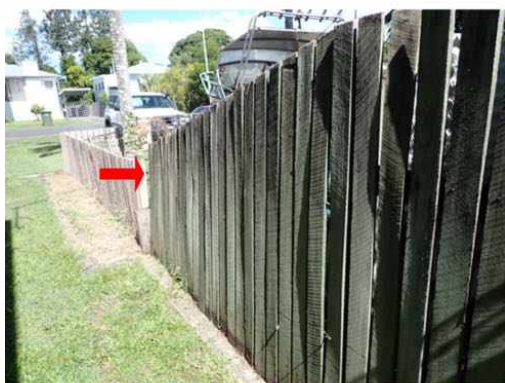
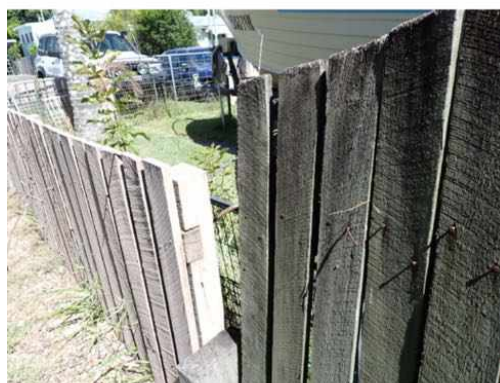
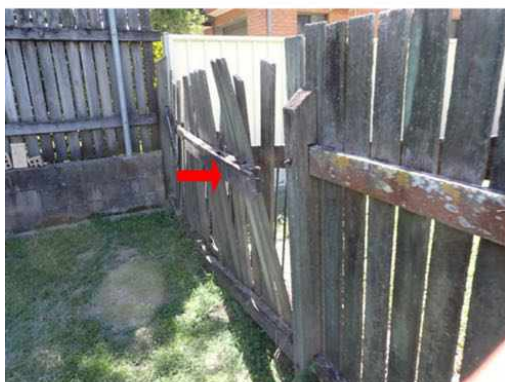
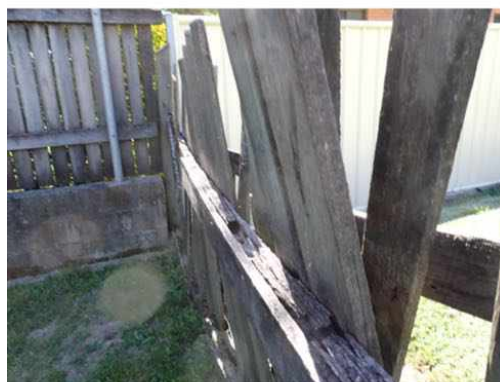
### Finding 3.13

Building:	Main Building
Location:	Boundary fences
Finding:	Timber Fencing – Poor Condition
Information:	Sections of the timber fencing were found to be in poor condition at the time of inspection. In plain English, parts of the fence show deterioration consistent with age and weather exposure. Repairs or replacement of the affected sections may be required to maintain the fence. A carpenter, fencing contractor, or suitably experienced handyman would be the appropriate trade to carry out the works.

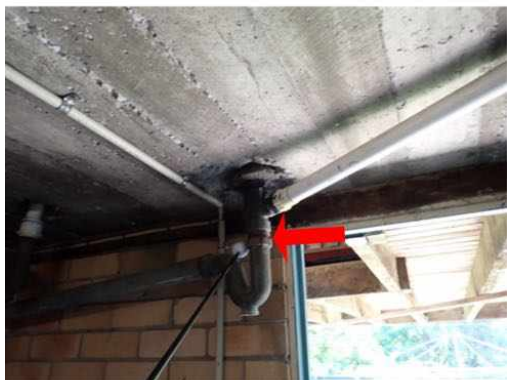
### Finding 3.14

Building:	Main Building
Location:	Laundry
Finding:	Bathroom Plumbing – Minor Leak
Information:	A minor leak was identified to the plumbing below the bathroom within the laundry area at the time of inspection. In plain English, a small amount of water was observed leaking from plumbing pipes servicing the bathroom. This is a common defect with plumbing of this age. A licensed plumber should assess the plumbing and carry out repairs to prevent further damage or deterioration.

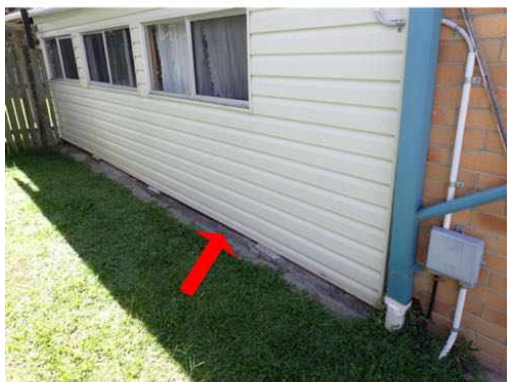
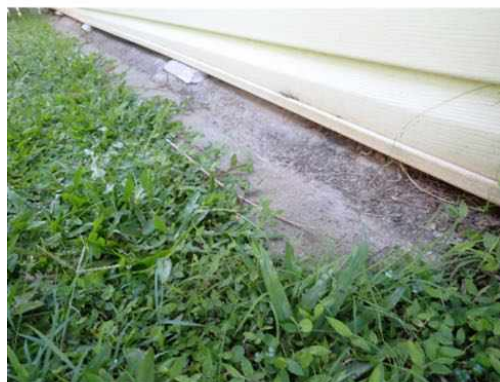
### Finding 6.01

Building:	Main Building
Location:	Perimeter of building
Finding:	Concrete Slab – Insufficient Inspection Zone
Information:	An insufficient slab edge inspection zone was identified at the time of inspection, which restricted the ability to carry out a complete termite inspection. In plain English, the edge of the concrete slab was not visible in some areas, limiting the ability to check for termite activity or entry points. This condition is conducive to concealed termite activity. Adequate slab edge exposure should be provided to allow proper inspection. A licensed pest control technician would be the appropriate professional to assess the area and implement a termite management plan if required.

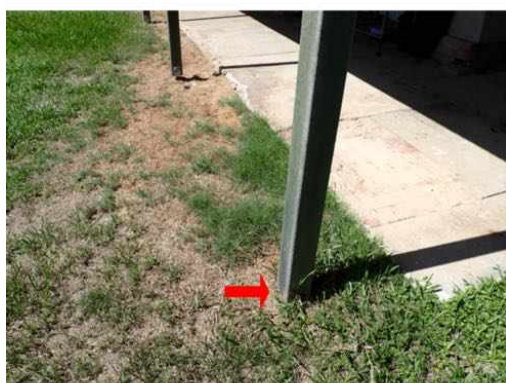
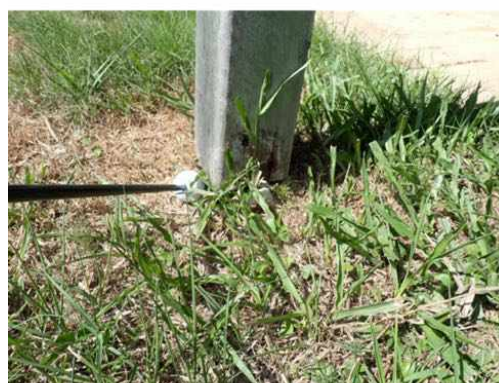
## Finding 6.02

Building:	Main Building
Location:	Rear of building
Finding:	Timber Posts in Contact with Ground – Conducive to Termite Attack
Information:	Timber posts were observed to be in contact with the ground at the time of inspection. In plain English, the timber posts are touching the soil, which can attract termites and allow concealed entry into the structure. This condition is conducive to termite attack and should be addressed to reduce the risk. A licensed pest control technician or suitably qualified builder should assess the area and carry out rectification works as required.

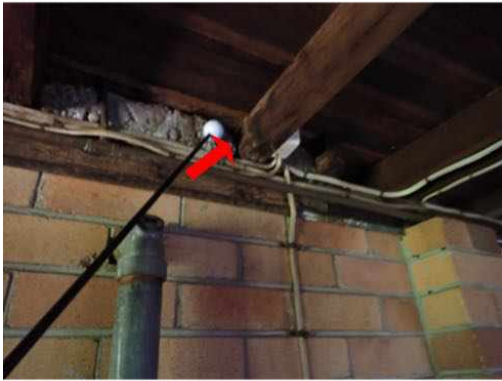
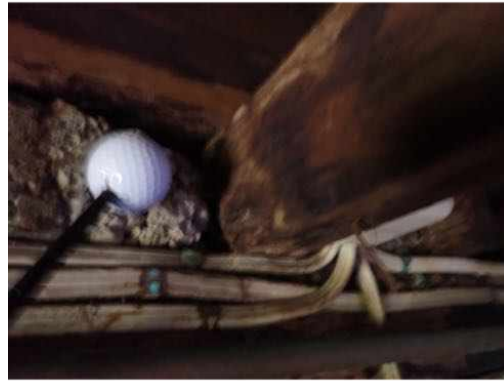
### Finding 7.01

Building:	Main Building
Location:	Garage near bathroom concrete floor
Finding:	Bathroom Floor Structure – Timber Wood Rot
Information:	Wood rot was identified to the timber beams leading into the bathroom concrete floor at the time of inspection. In plain English, sections of the timber supporting the floor near the bathroom show signs of decay, which can occur in wet areas where moisture is present. A suitably qualified carpenter or builder should assess the affected timbers and carry out rectification works as required.

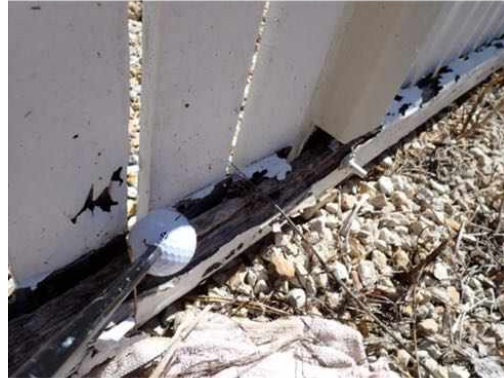
### Finding 7.02

Building:	Main Building
Location:	Right hand side fence
Finding:	Right Hand Side Fence – Wood Rot
Information:	Wood rot was identified to sections of the timber fence on the right-hand side of the property at the time of inspection. In plain English, parts of the fence timber have started to decay due to age and weather exposure. Wood rot is also conducive to termite attack. Repairs or replacement of the affected sections may be required. A fencing contractor, carpenter, or suitably experienced handyman would be the appropriate trade to carry out the works.

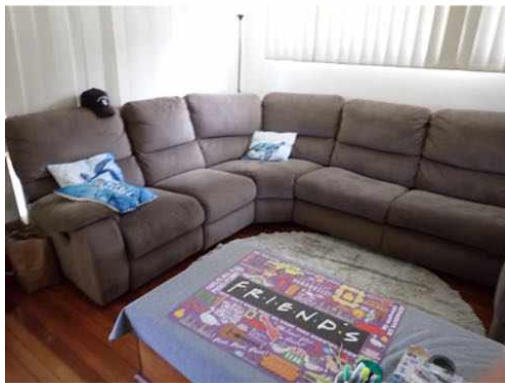
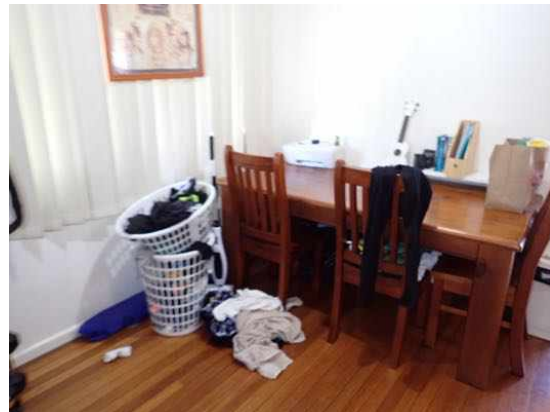
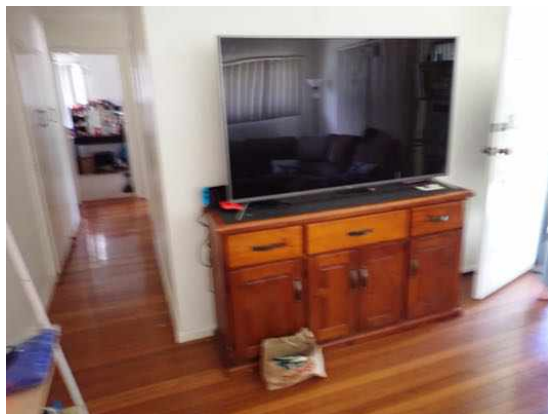
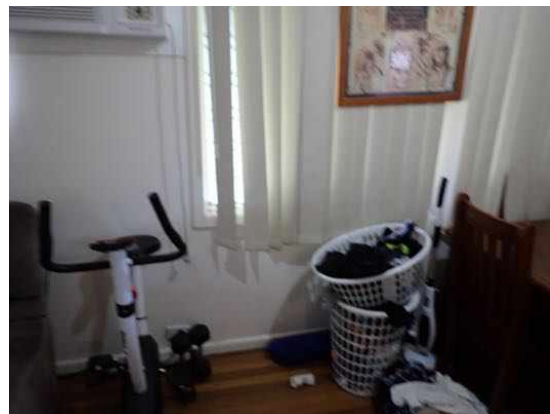
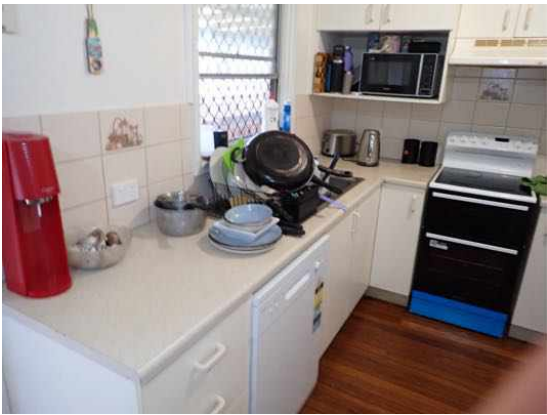
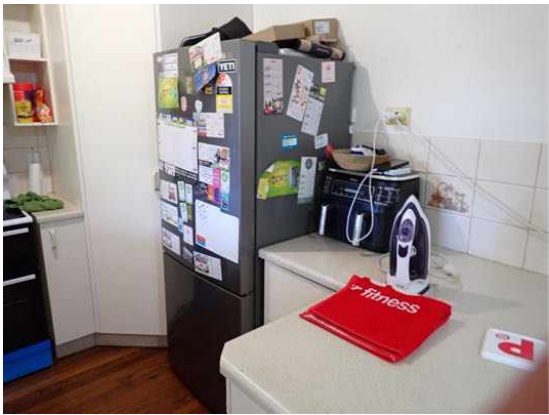
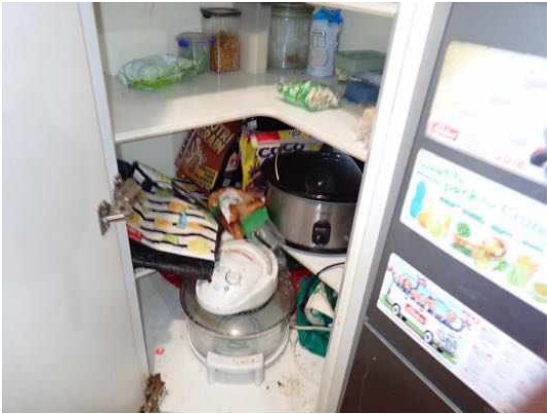
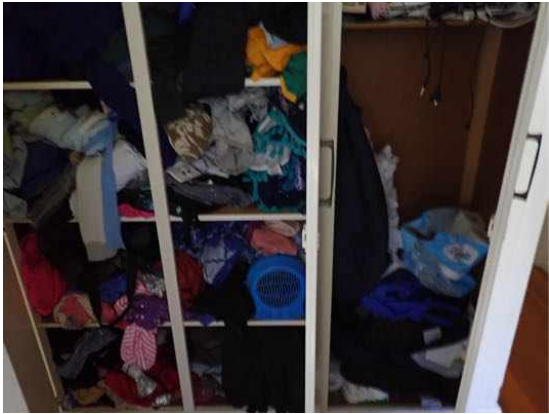
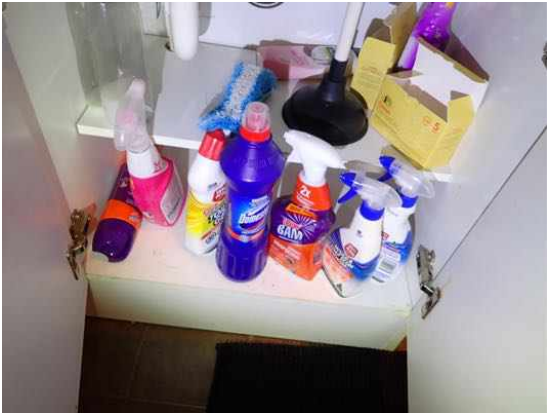
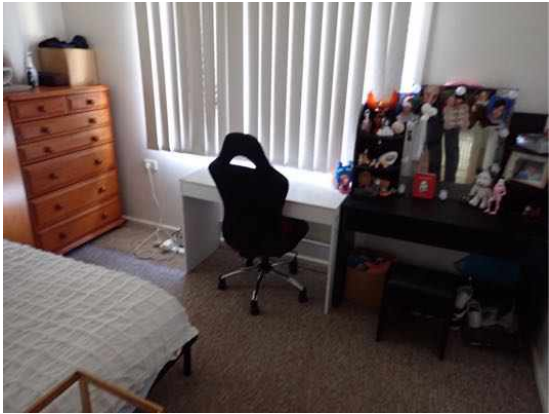
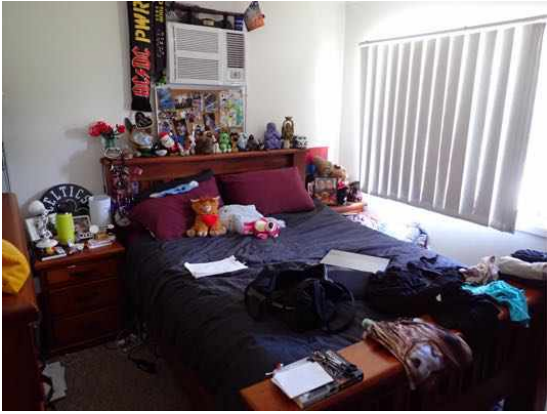
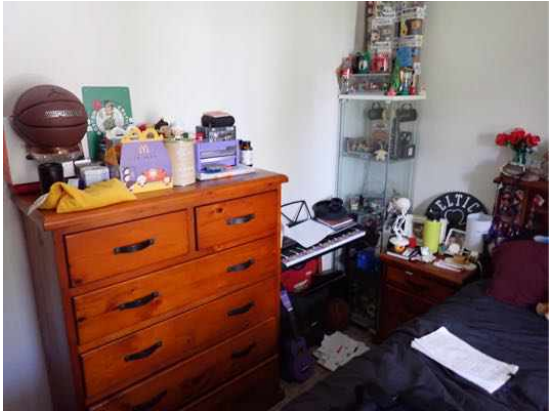
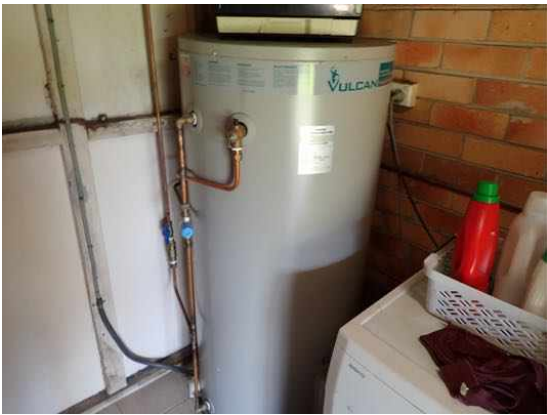
#### Noted Item

Building: Main Building  
Location: All Areas  
Finding: Additional Photos - Obstructions and Limitations  
Information: These photographs are an indication of the obstructions and limitations which impeded full inspection of the area at the time of inspection. These obstructions can hide an array of defects and should be removed to allow full inspection to be carried out. A re-inspection is recommended once the areas are made accessible.
