Building and Timber Pest Inspection Report

Inspection Date: Thu, 12 Mar 2026

Property Address: 66 Minnamurra St, Kiama NSW 2533, Australia

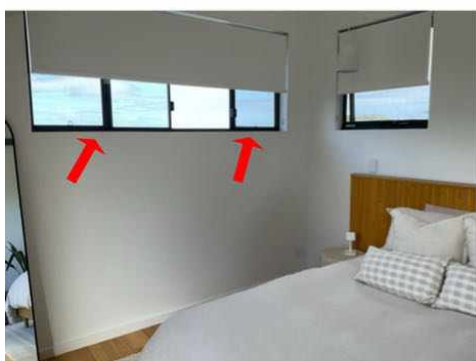
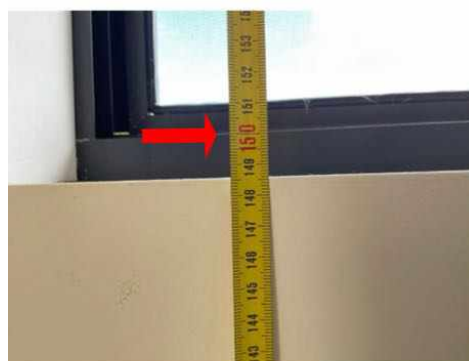
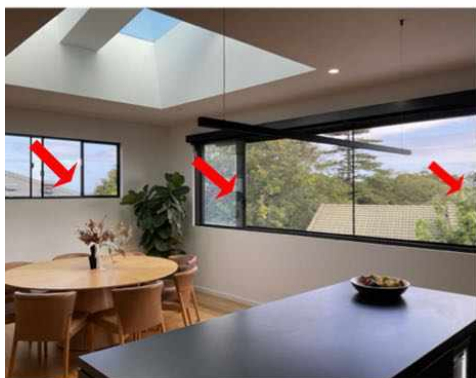
Finding 1.01

Building:	Building 1
Location:	Pictured upstairs windows
Finding:	Window opening restrictors missing.
Information:	The Building Code of Australia rules require all openable windows (where the internal floor is more than 2m above the ground outside) in residential rooms to be fitted with a suitable screen or restrictor. Windows located 1.7m above the floor level do not require protection.

Window restrictors are required where people who are vulnerable to the risk of falling have access to windows. This means all windows above ground level which do not have another fall prevention safety measure in place, such as a balcony or balustrade should have a restrictor. These are inexpensive easily fitted devices. The alternative to these devices is heavy duty security mesh installed.

These need to be added urgently for the safety of all persons.

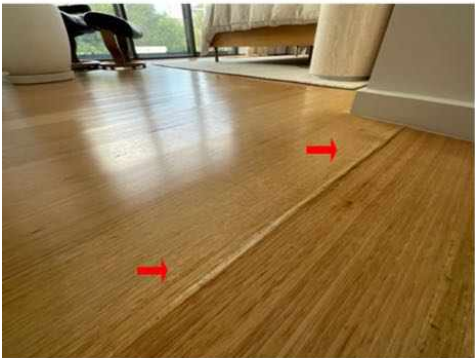
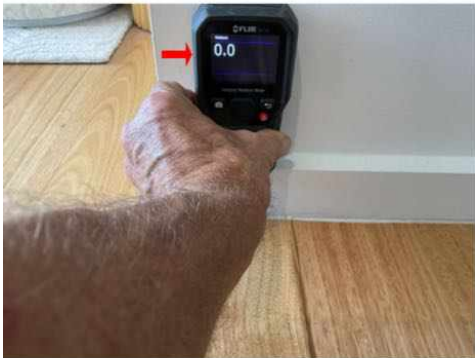
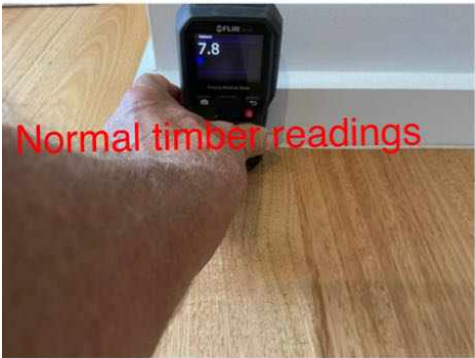
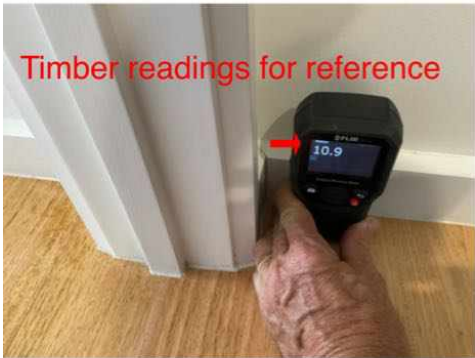
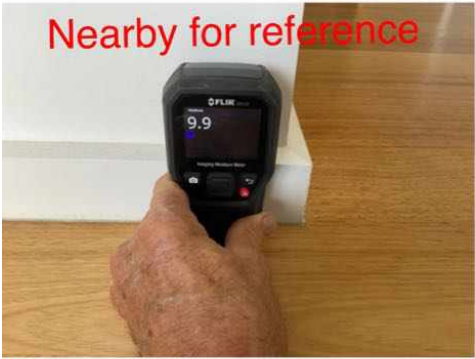
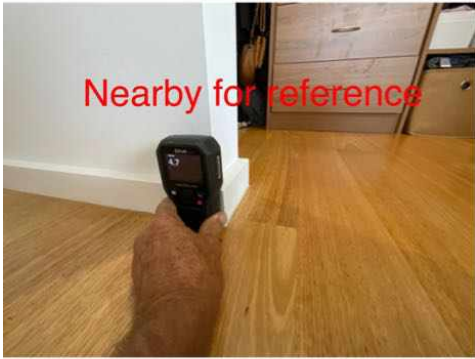
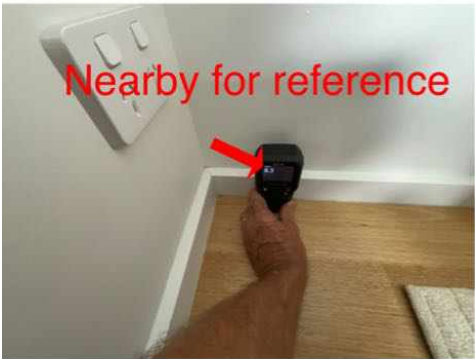
Finding 3.01

Building: Building 1
Location: Master bedroom
Finding: Floating floor fault
Information: A few areas of the floating floor has moved since installation. This sometimes occurs due to minor expansion when a small gap is not left between the flooring and the perimeter wall. The owner started at the time of the inspection this would be rectified with the damaged piece of flooring removed and cover strip installed in this area for expansion. Over 12 moisture readings were undertaken in this area with no excessive moisture found.

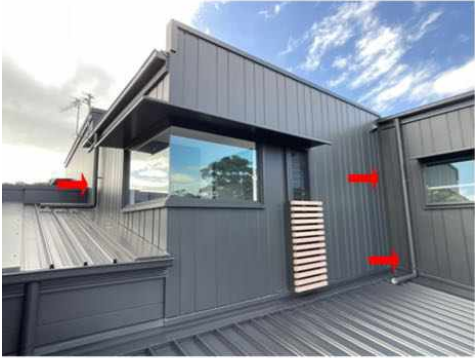
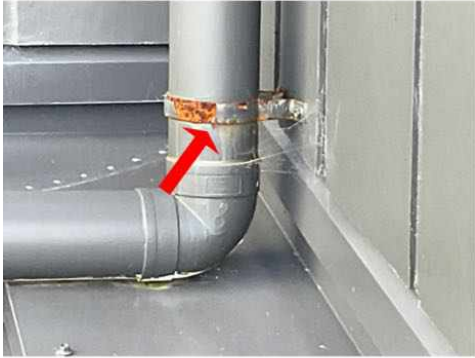
Finding 3.02

Building: Building 1
 Location: Pictured roof areas
 Finding: Roof plumbing brackets - Rusted or corroded
 Information: Three roof plumbing brackets have areas of rust and corrosion.

A licensed plumber or handyman should be appointed to undertake these works. It is advised that such works be completed as soon as possible to prevent any further damage and deterioration.

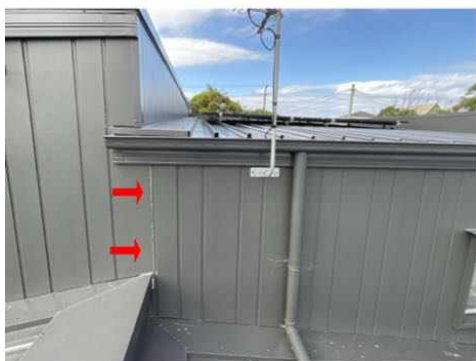
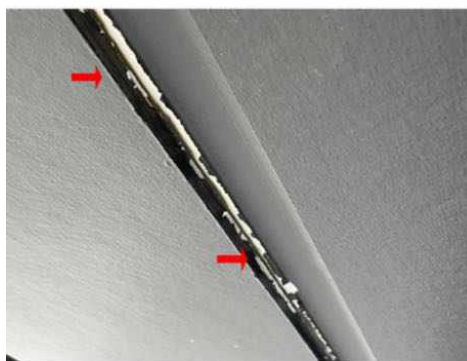
Finding 3.03

Building: Building 1
 Location: Exterior upper wall cladding joint
 Finding: Sealant (external) - missing
 Information: It was noted on inspection that one small area of external sealant was missing to this external wall.

Flexible sealants should be applied to these affected areas to prevent any subsequent water damage that is likely to occur.

A sealant specialist or skilled handy person should be appointed to complete these works as soon as possible

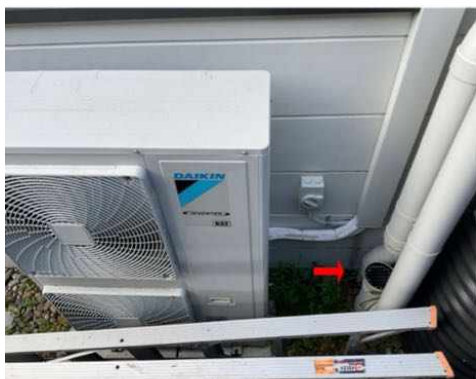
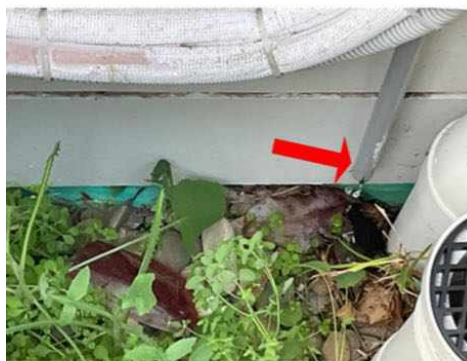
Finding 3.04

Building: Building 1
 Location: Left Wall and rear alfresco area
 Finding: Site drainage - Inadequate
 Information: The site drainage in this area was found to be inadequate at the time of inspection, creating potential for subsequent water damage to associated building elements.

The air conditioner overflow run against the left rear house wall. The rear deck grass is also soggy with no drainage evident.

It is important that water does not lie against the base of walls; surrounding paths and ground levels should be sloped to drain water away from walls. Downpipes should not discharge stormwater onto lower walls or plinths. Stormwater should be carried away by large, regularly cleaned drains. Ground levels may need to be lowered to expose a buried DPC.

Where site drainage is inadequate, installation of an Agricultural (Aggie) Drain may be required. A qualified plumber can further inspect the property and perform any remedial works as necessary. Damp areas can attract termite activity.

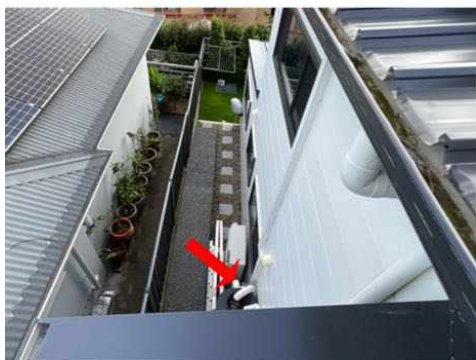
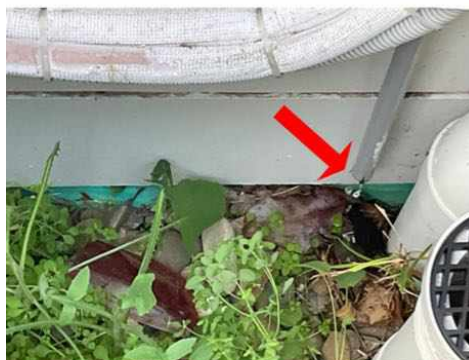
Finding 6.03

Building:	Building 1
Location:	Pictured external wall area
Finding:	Overflows - Not plumbed for drainage
Information:	The pictured overflow pipe is not plumbed or connected to suitable drainage, which has resulted in the surrounding area becoming excessively damp.

These damp conditions can lead to secondary defects such as rot, rust or corrosion of associated building elements and the formation of fungal decay. When coupled with poor site drainage, pooling of water may also attract termite activity to this area. It is highly recommended that a qualified plumber plumb this overflow to the adjacent drainage pipe.

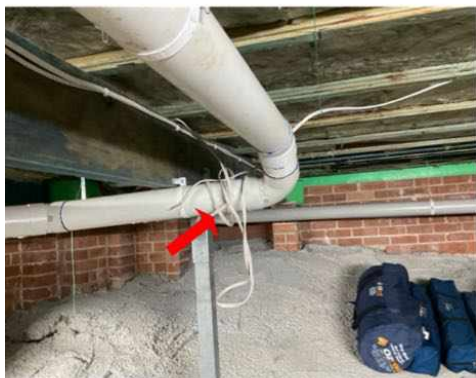
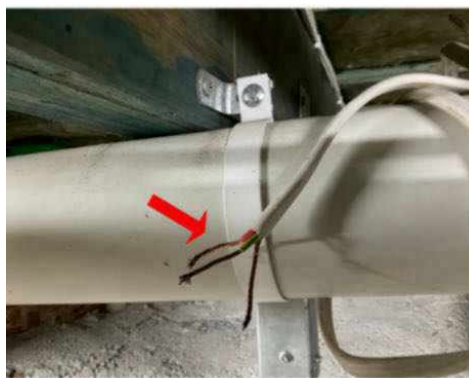
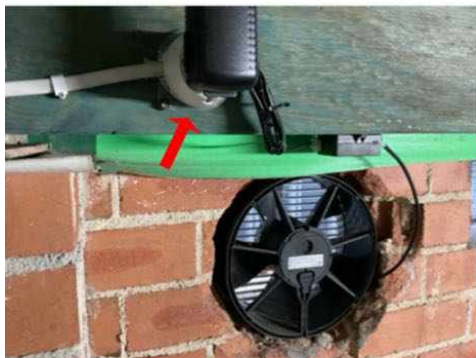
Building: Building 1
 Location: Subfloor
 Finding: Electrical cables - added junction box 5pm 12.03.26
 Information: The electrical fitting in this subfloor area had now added a safety junction box see photo 4 .

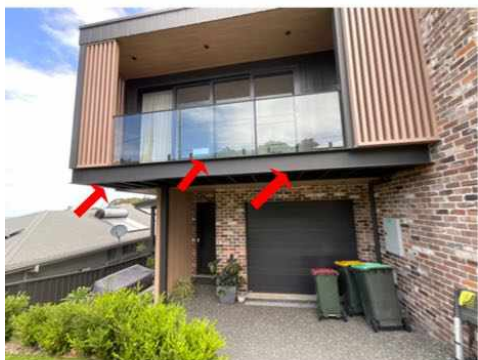
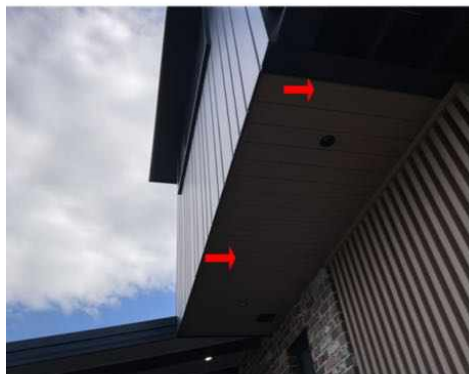
Building: Building 1
 Location: Front upper deck
 Finding: Elevated structure inspections
 Information: While this upper deck appears to be very well constructed, where any elevated Structure (deck, balcony, verandah etc) is present, and this elevated structure is designed to accommodate people, you **MUST** have this structure checked by an engineer or other suitably qualified person.
