Building and Timber Pest Inspection Report

Inspection Date: Wed, 8 Apr 2026

Property Address: 6 Harrower Place, Glenmore Park NSW
2745

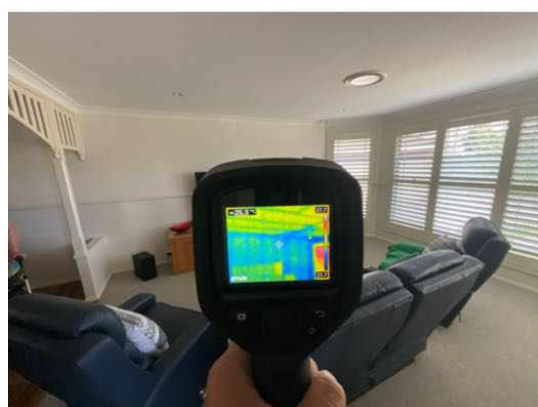
At the time of the inspection, no abnormalities indicating live termite activity were observed. However, it's important to note that various factors—such as obstructions, ambient temperature, and wall material/thickness—can impact the accuracy of thermal readings. In cases where surfaces are visually restricted or obstructed, a comprehensive thermal scan may not always be feasible.

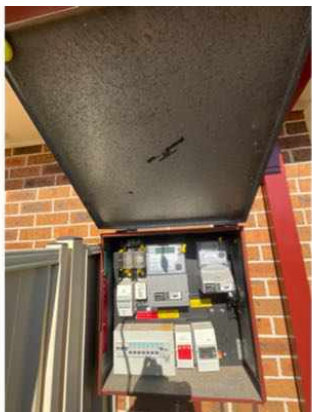
Building: Main Building
 Location: All Areas
 Finding: Termite Management System - Missing Durable Notice..

At the time of inspection, no durable notice or sticker was found within the switchboard unit or other accessible areas to indicate the presence or type of termite management system currently installed.

It is strongly recommended that a durable notice be affixed within the main electrical switchboard or another prominent location (e.g. meter box or inside garage) to clearly identify:

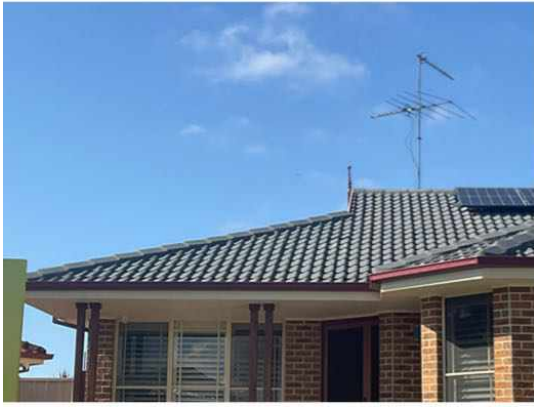
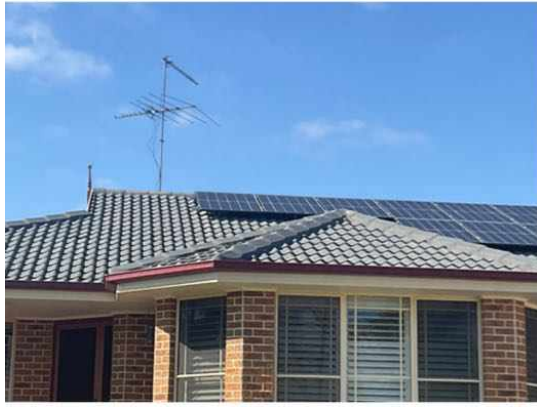
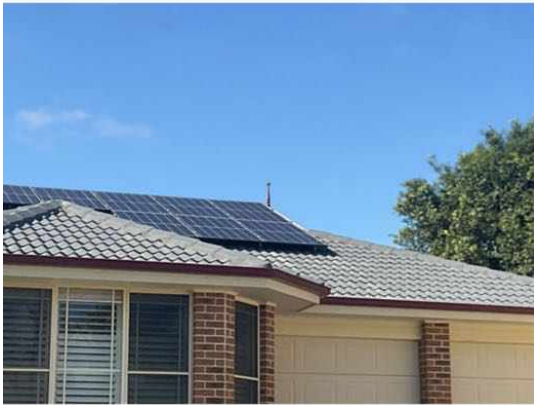
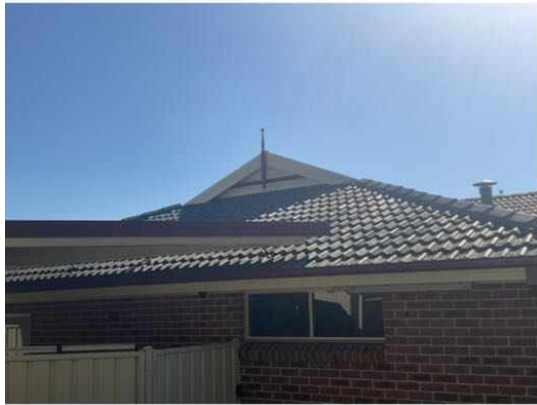
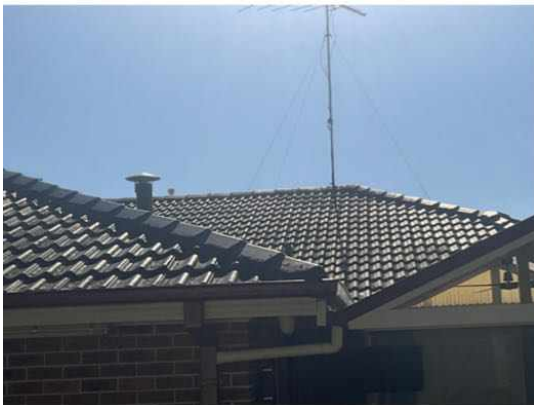
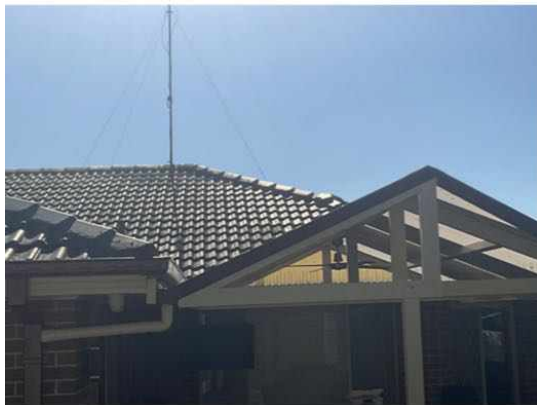
Building: Main Building
Location: Roof Exterior
Finding: Roof Tiles – External Inspection.
Information: Condition Overview:

Upon inspection of the exterior roofing, the majority of roof tiles were found to be in good condition. The mortar to the capping tiles appeared sound, with no significant signs of deterioration. General weathering of the roof tiles is consistent with the age and type of the property and does not raise immediate concern.

Some areas of the roof not safely accessible from a 3.6m ladder are excluded from this inspection due to access limitations. These areas could not be assessed in detail, and it is therefore recommended that a qualified roofing specialist be engaged to inspect these sections and confirm the overall condition of the roofing system.

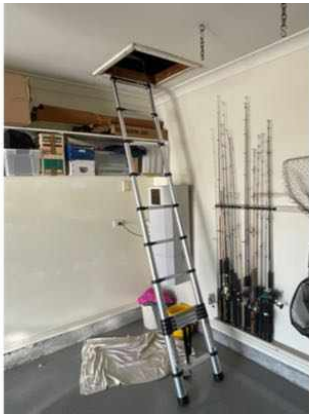
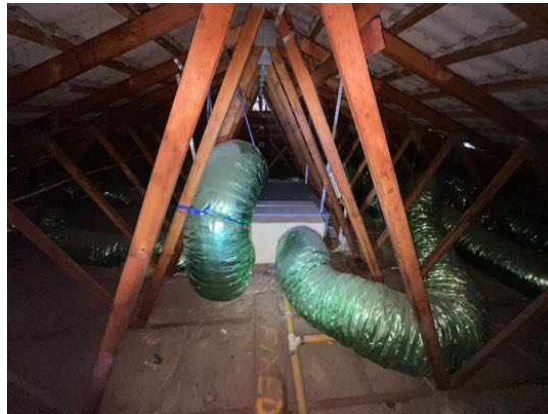
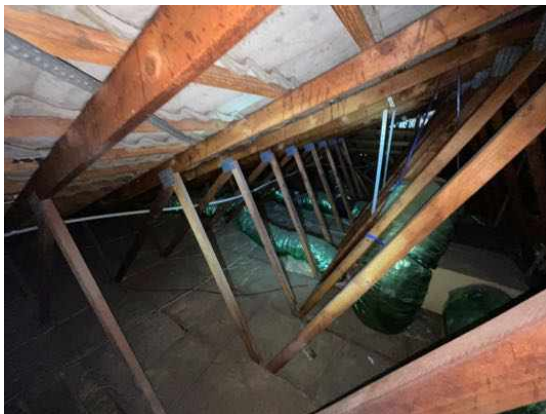
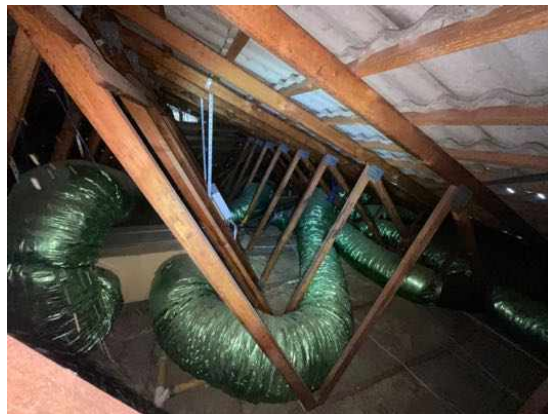
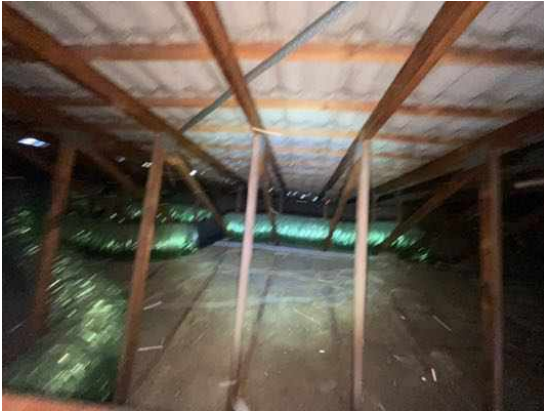
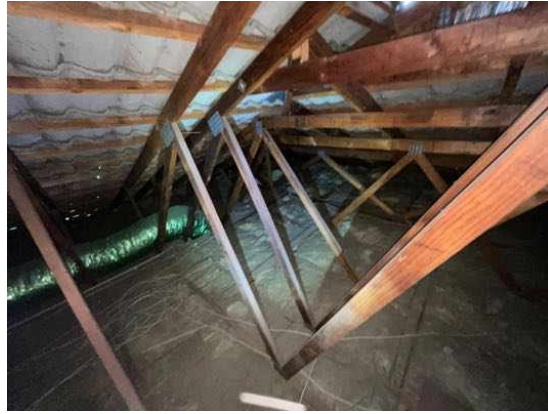
Building: Main Building
Location: Roof Void
Finding: Roof Void – Limited Accessibility..
Information: Observation:

A full inspection of the roof space is not achievable unless all obstructions—including insulation and restricted access points—are removed, and full, safe access is provided. Termite activity or timber pest damage may go undetected in concealed or inaccessible areas.

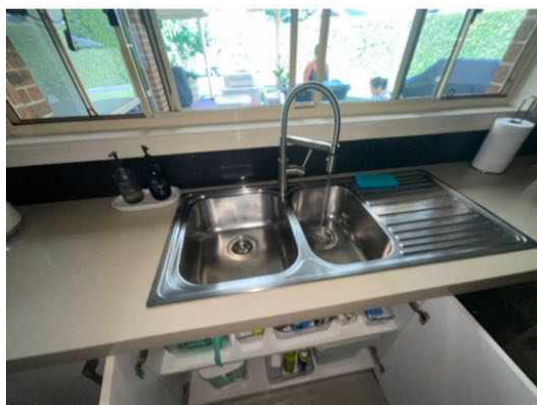
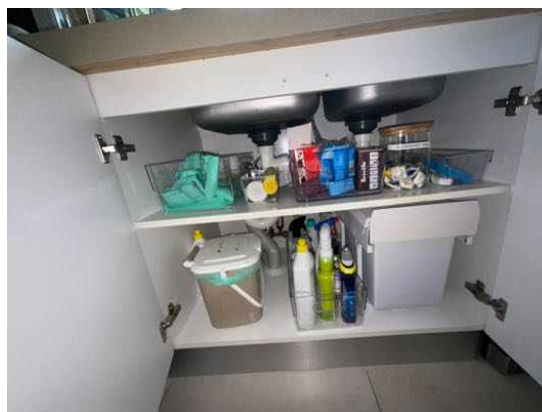
Building: Main Building
 Location: Kitchen
 Finding: Kitchen Sink – Overall Condition & Recommendations.
 Information: Observations:

- The kitchen sink tap(s) were water tested at the time of inspection, with no evidence of leaks or blockages observed in the visible plumbing or drainage.
- No significant water damage was observed to the cabinetry/unit
- Stored items under the sink obstructed access, limiting a full inspection of the

- Further monitoring and testing are recommended once the tap(s) are in constant use, to identify any drainage issues or signs of slow leaks not evident during the limited inspection.
- For long-term property care, it is advised that sealant and grouting in water-exposed areas be regularly inspected and maintained.
- It is recommended that the stored items beneath the sink be removed to allow for a full re-inspection of the plumbing and cabinetry, ensuring no concealed defects are present.

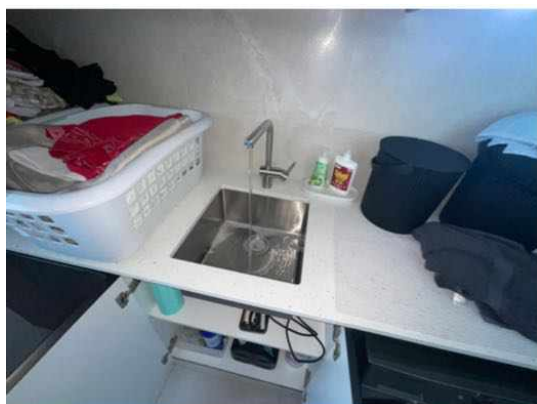
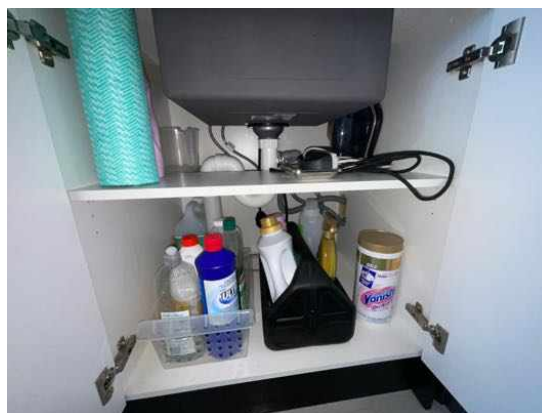
Building: Main Building
 Location: Laundry
 Finding: Laundry - Taps/Plumbing/Drainage.
 Information: Observation: Laundry Tub – Taps, Plumbing, and Cabinetry

- The taps to the laundry tub were water tested and inspected, with no evidence of plumbing or drainage leaks observed at the time of inspection.
- No visible signs of water damage, rust, or corrosion were noted to the cabinetry or surrounding unit during the inspection.

- Further monitoring or testing is recommended once the taps are placed into regular use, to ensure no leaks develop over time and that the drainage system continues to

- Sealant and grouting in wet areas should be maintained as part of the long-term care and upkeep of the property.

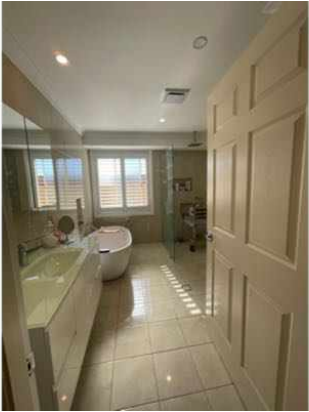
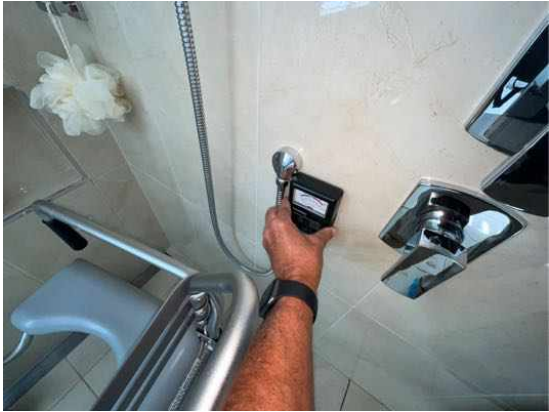
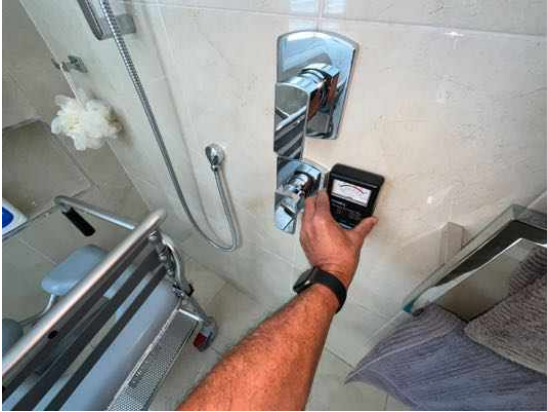
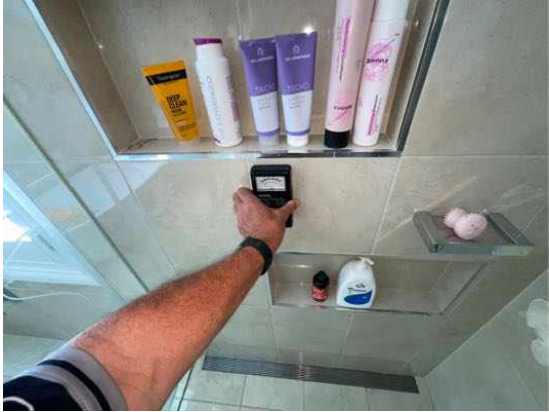
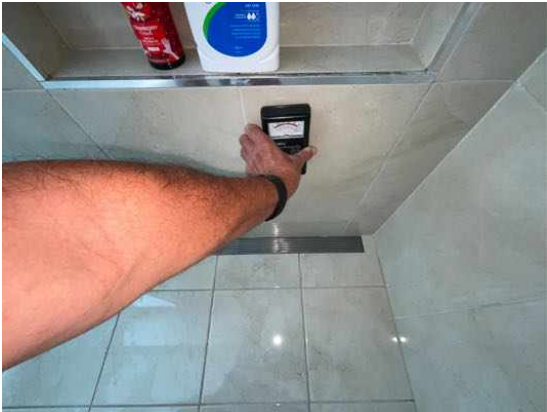
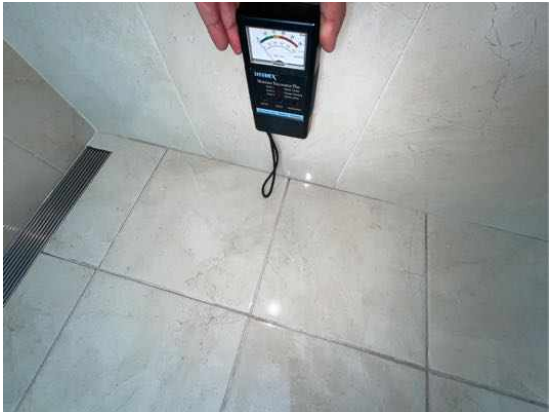
Building: Main Building
 Location: Bathroom
 Finding: Wet Areas - Bathroom(s) - Overall Condition & Recommendations.
 Information: Overall Condition & Recommendations

- Floor waste was found to be clear and free of blockages at the time of inspection. Further monitoring is advised after consistent use to identify any drainage issues or buildup requiring cleaning.

- No elevated moisture readings were detected around the tap fittings or behind the shower walls (as viewed from adjacent rooms), suggesting no active plumbing leaks at the time of inspection.

- Elevated moisture readings were found in the lower shower walls, which is a common occurrence with certain tile types that naturally absorb more moisture. This should be monitored over time.

- Flood testing of the shower recess is recommended. This may reveal inadequacies in the waterproofing or shower screens, which could lead to water damage in surrounding areas.

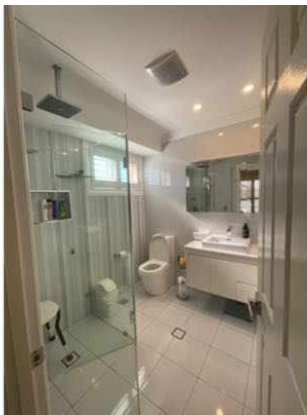
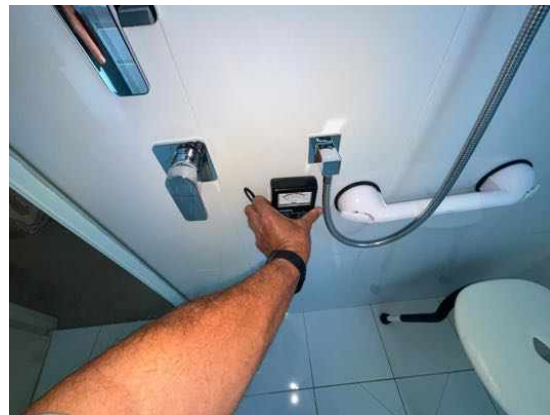
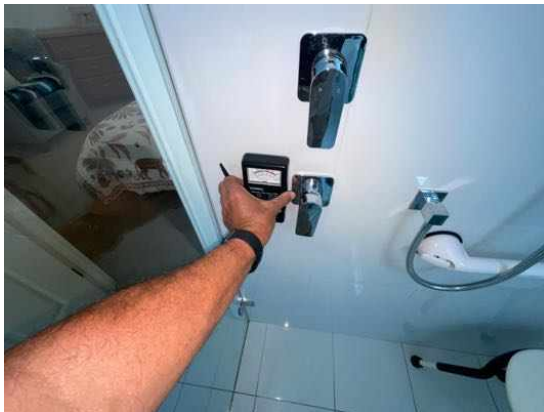
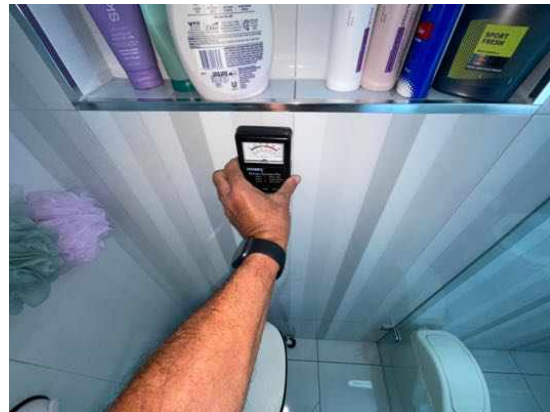
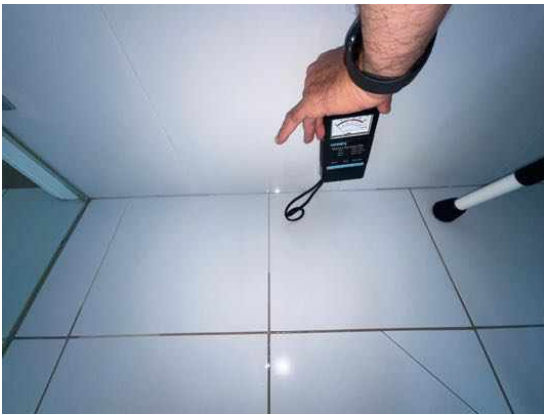
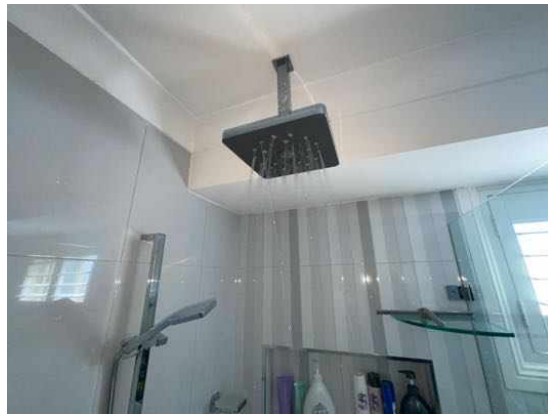
Building: Main Building
Location: Ensuite
Finding: Wet Areas - Bathroom(s) - Overall Condition & Recommendations.
Information: Overall Condition & Recommendations

- Floor waste was found to be clear and free of blockages at the time of inspection. Further monitoring is advised after consistent use to identify any drainage issues or buildup requiring cleaning.

- No elevated moisture readings were detected around the tap fittings or behind the shower walls (as viewed from adjacent rooms), suggesting no active plumbing leaks at the time of inspection.

- Elevated moisture readings were found in the lower shower walls, which is a common occurrence with certain tile types that naturally absorb more moisture. This should be monitored over time.

- Flood testing of the shower recess is recommended. This may reveal inadequacies in the waterproofing or shower screens, which could lead to water damage in surrounding areas.

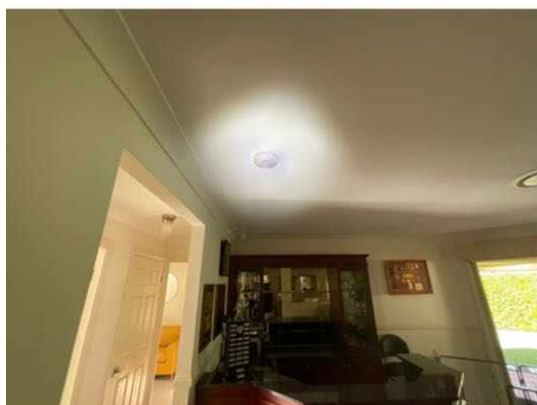
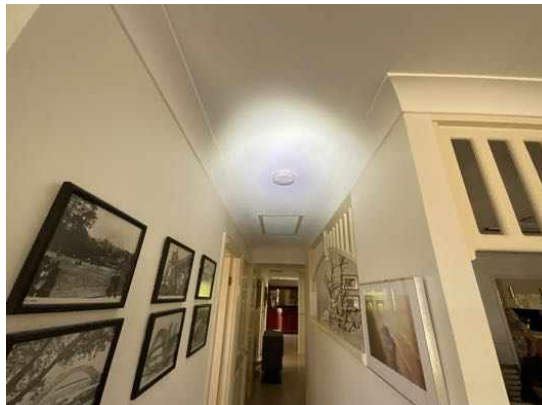
Building: Main Building
Location: All Areas
Finding: Smoke Detectors / Alarms.

- All smoke detectors be tested monthly by the homeowner.
- All systems comply with the requirements of AS 3786 and any applicable state-based legislation.
