Building and Timber Pest Inspection Report

Inspection Date: Wed, 8 Apr 2026

Property Address: 24 Hornseywood Ave, Penrith NSW 2750,
Australia

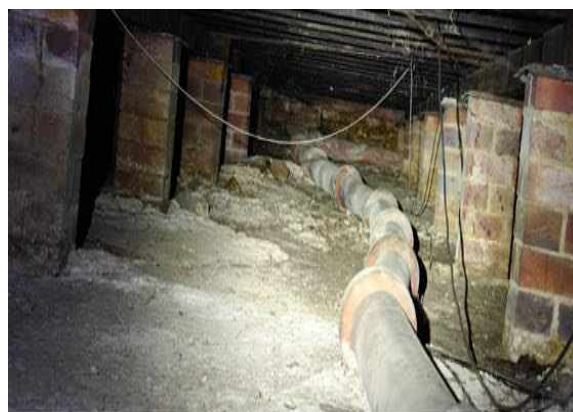
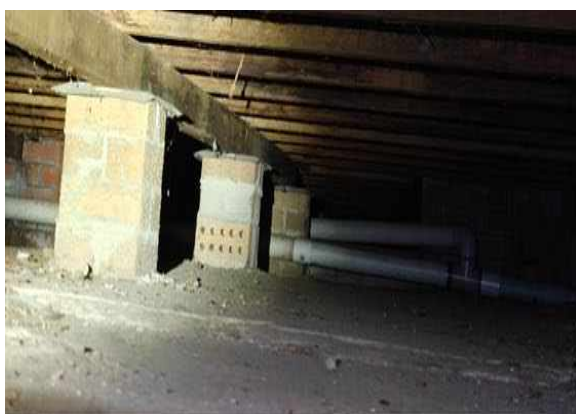
Building: Main Building
 Location: Subfloor
 Finding: Mould - Present
 Information: Mold growth is present throughout the property, primarily due to inadequate ventilation. Poor airflow and moisture accumulation within the house have created ideal conditions for mold to thrive.

- ****Health Hazards****: Mold growth can pose serious health risks to occupants, particularly those with allergies, asthma, or other respiratory conditions. Prolonged

exposure to mold spores can cause respiratory issues, skin irritation, and other allergic reactions.

- ****Structural Damage****: Mold can degrade building materials over time, leading to rot and weakening of the structural components such as timber, drywall, and insulation, which can result in costly repairs.

- ****Decreased Property Value****: The presence of mold can significantly reduce the value of the property, as it indicates underlying moisture and ventilation issues that need addressing.

A licensed mold remediation specialist should be engaged to remove the mold and treat affected areas. In addition, a ventilation expert or builder should assess and improve the house's ventilation system, possibly installing exhaust fans, vents, or mechanical ventilation systems to ensure adequate airflow and prevent future mold growth.

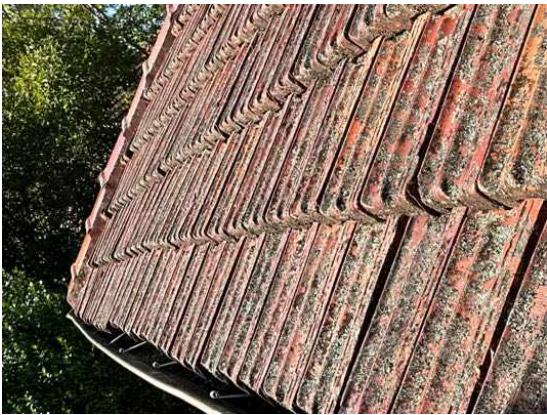
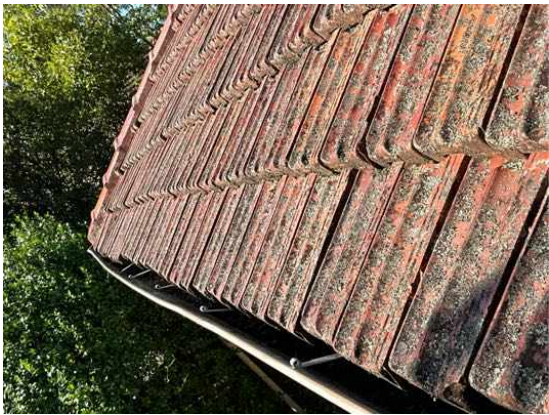
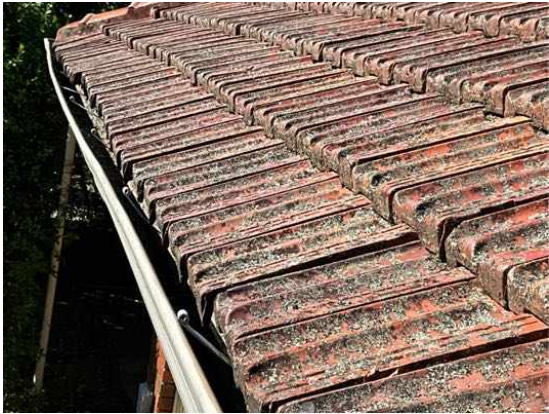
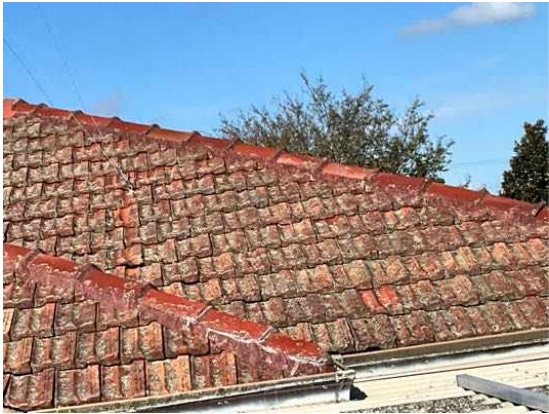
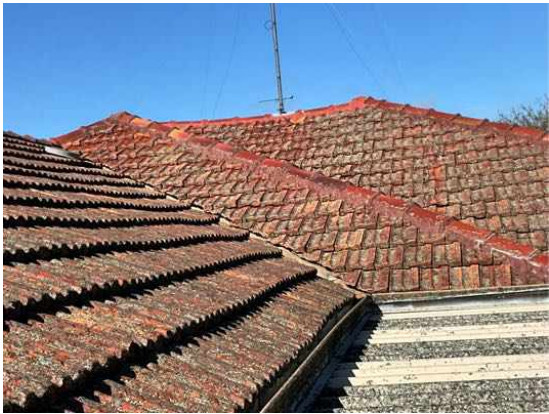
Building:	Main Building
Location:	All Areas
Finding:	Roof Weathered
Information:	Upon inspection of the exterior roofing, the majority of roof was not in a fair condition. While weathering of the roof is consistent with the age of the property, maintenance works are required.

Isolated areas of mortar have come loose in the valleys and minor cracking is also

Where left unmanaged, deteriorating roof are likely to lead to a number of secondary defects, including minor water leaks and weather exposure to internal roofing structures.

Consultation with a roofing contractor is highly advised to gain advice on cost of remedial works that may be required in the short to medium term. Remedial works are likely to increase the longevity of the exterior roofing structure.

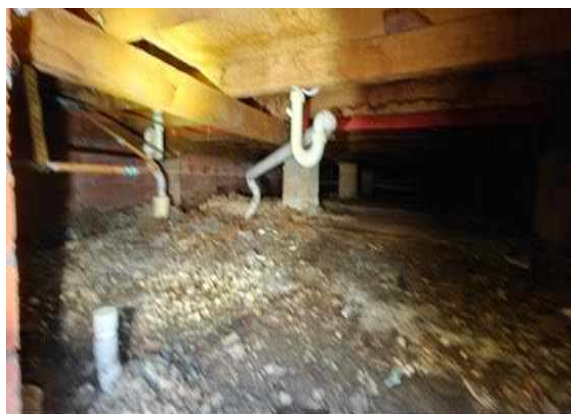
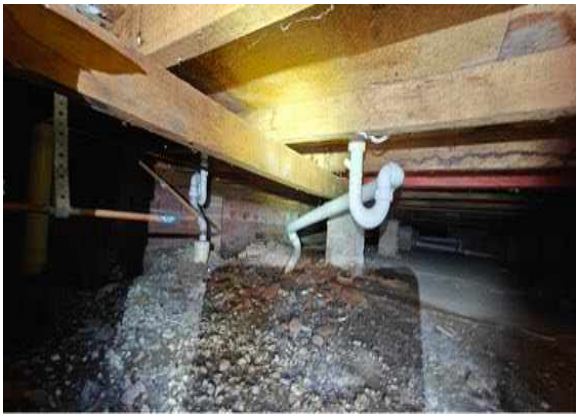
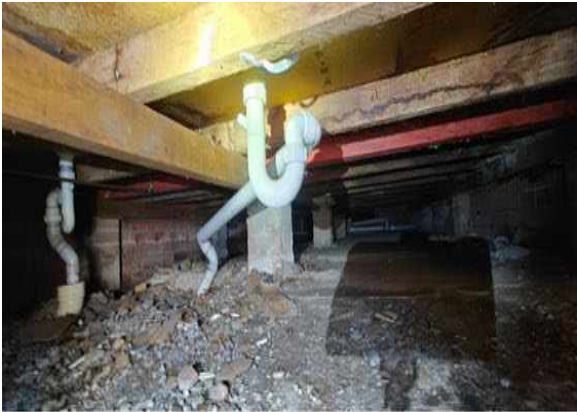
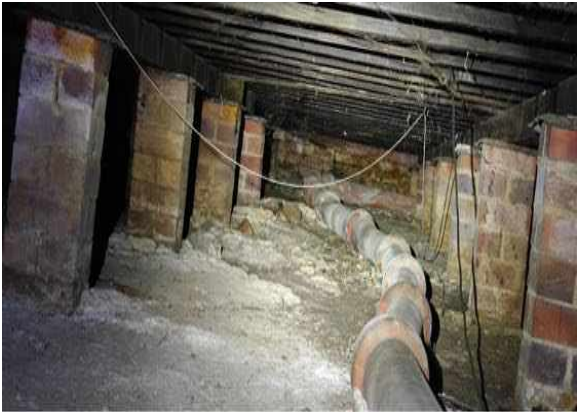
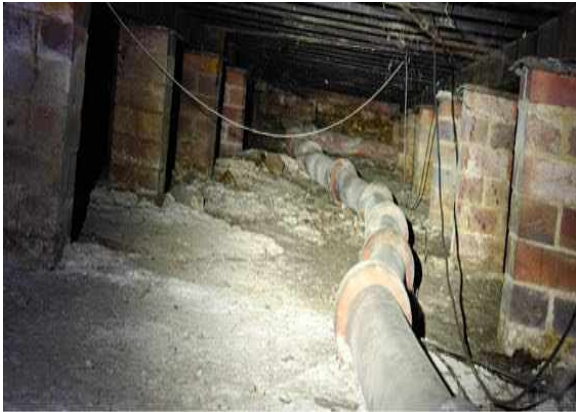
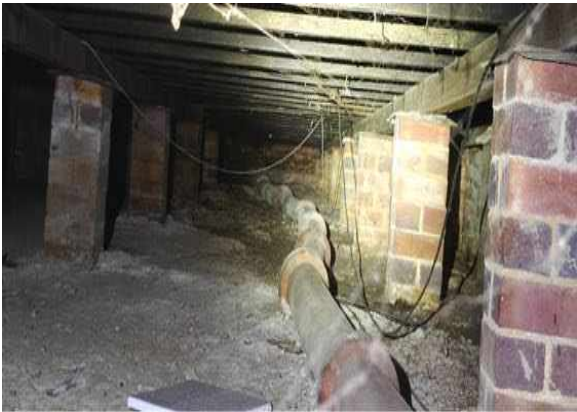
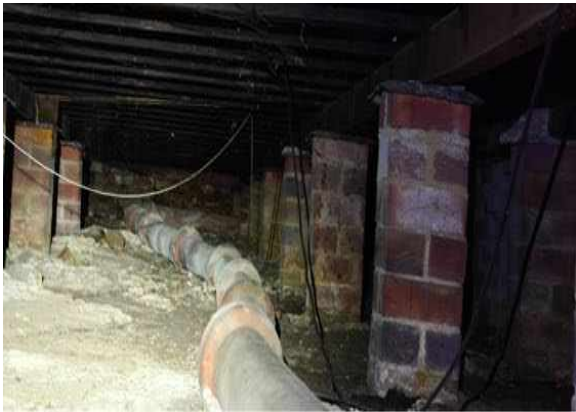
Finding 2.03

Building: Main Building
Location: Subfloor
Finding: Subfloor - Site drainage - Inadequate
Information: The site exhibits poor drainage under the subfloor, leading to several critical issues. Water accumulates and does not properly drain away from the subfloor area, creating a hazardous condition.

1. Frequent water pooling and stagnation under the subfloor.
2. Risk of subfloor structural damage due to prolonged moisture exposure.
3. Potential for mold and mildew growth, compromising indoor air quality and a potential of Termite attack.
4. Safety hazard for occupants due to slippery surfaces and potential electrical hazards.

The poor site drainage under the subfloor poses a significant safety risk to the occupants, as it can lead to structural damage and health hazards.

This issue requires immediate attention and rectification. A licensed and experienced plumber or licensed builder specialising in drainage and foundation work should be engaged to assess the problem and implement necessary drainage solutions, such as improved grading, installation of drainage systems, and moisture barrier enhancements. Regular maintenance and inspections should also be scheduled to prevent future occurrences. Water damage and secondary defects are likely to occur if left unmanaged.

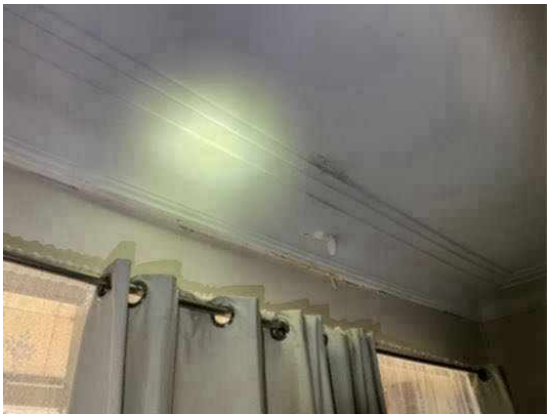
Finding 2.04

Finding: Roof Leaks

Information: The roof has developed leaks, allowing water to penetrate the building envelope. These leaks may be due to damaged or missing shingles/tiles, deteriorated flashing, clogged gutters, or other roof system failures.

1. Structural Damage: Continuous water ingress can weaken the structural integrity of the roof and supporting structures, leading to potential collapse or costly repairs.

2. Mold and Mildew Growth: Persistent moisture promotes mold and mildew growth, which can cause health issues for occupants, including respiratory problems and allergic reactions.
3. Electrical Hazards: Water infiltration can come into contact with electrical wiring and fixtures, increasing the risk of short circuits, electrical fires, or electrocution.
4. Insulation Damage: Wet insulation loses its effectiveness, leading to reduced energy efficiency and higher heating and cooling costs.
5. Interior Damage: Leaks can cause staining, peeling paint, and damage to interior ceilings, walls, and personal property.
6. Pest Infestation: Moist environments can attract pests such as termites, ants, and rodents, which can further damage the property.

A licensed roofing contractor or qualified roofer should be contacted to inspect and repair the roof leaks. They will:

- Identify the source of the leaks and assess the extent of the damage.
- Repair or replace damaged shingles, tiles, flashing, or other roofing materials.
- Ensure proper sealing around roof penetrations, such as vents, chimneys, and skylights.
- Clean and maintain gutters and downspouts to ensure proper drainage.
- Provide recommendations for any additional necessary repairs or preventive measures to avoid future leaks.

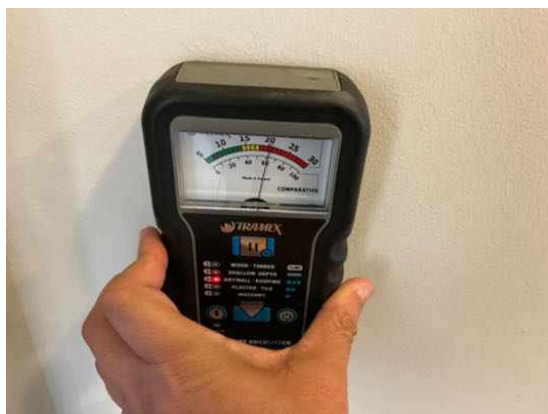
Finding 2.05

Building:	Main Building
Location:	Bathroom
Finding:	Evidence of excessive moisture was present at the time of inspection
Information:	Excessive moisture is present behind the bathroom tiles, indicating a potential water leakage issue within the wall.

The prolonged presence of moisture can lead to mold growth, deteriorate the structure, and create an environment conducive to health hazards. Additionally, it may compromise the adhesive holding the tiles, leading to their detachment.

A licensed plumber or a qualified contractor specializing in water damage remediation should investigate the source of the moisture, fix any leaks, and address the damage. Additionally, replacing affected tiles and ensuring proper waterproofing are crucial to preventing future issues.

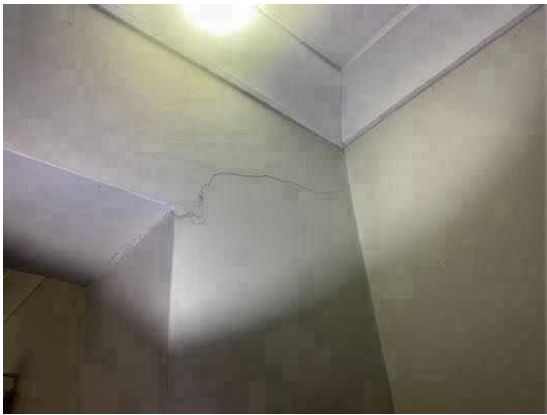
Finding 2.06

Building: Main Building
 Location: Bedroom 3 & en-suite
 Finding: Cracking - internal walls
 Information: Cracking was observed on the internal walls. These cracks may be indicative of differential movement within the structure, such as foundation settlement or structural stress at junctions.

If left unaddressed, the cracking may worsen, potentially affecting structural integrity, leading to misalignment of doors/windows or water ingress.

- Engage a structural engineer to investigate the extent and cause of the cracking across the building.
- If deemed non-structural, repairs can be carried out by a licensed plasterer or builder.

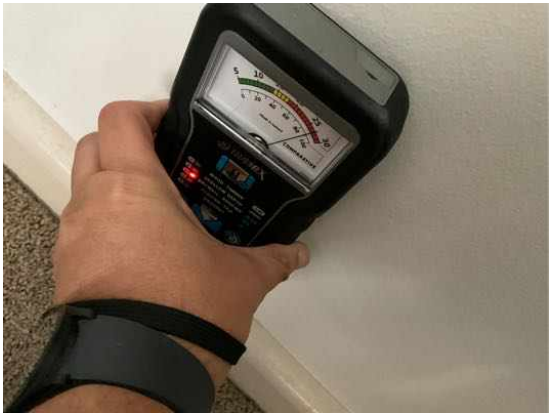
Rising damp is generally managed by the installation of a damp proof course during construction. A Damp Proof Course (DPC) is an impermeable barrier at the base of the wall above ground level. However, many 19th Century buildings have no damp course installed, or the materials have failed. The DPC may have been omitted as a consequence of poor workmanship, or it may have been bridged where materials built up against the side of the house allow moisture ingress above the DPC level.

The first step in addressing rising damp is to diagnose the cause. The identified cause should be addressed first before addressing the appearance and other defects which have resulted from the rising damp. If the original cause is not resolved, further cases of damp are likely to ensue, resulting in secondary defects.

Consultation with a qualified plumber is advised immediately to identify the cause of the damp and perform remedial works as required.

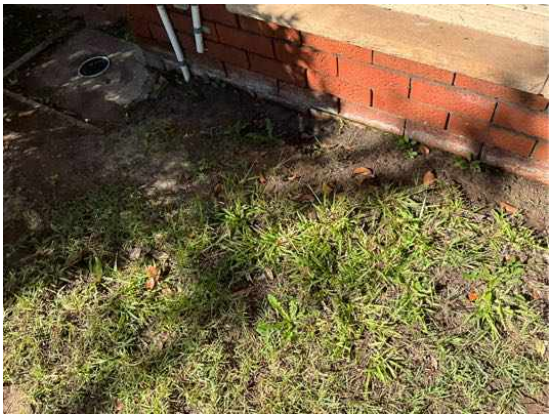
Building: Main Building
 Location: All Areas
 Finding: Perimeter - Insufficient Fall
 Information: The perimeter ground levels were found to have an inadequate slope away from the adjoining building structure, creating potential for water pooling in this area.

Perimeter is required to fall from the building by a minimum of 25mm in the first metre and bare ground should fall away from the house by 50mm in the first meter. This standard ensures that excessive moisture does not pool around the base of building structures, which creates potential for water and structural damage, as well as making the area susceptible to termite and timber pest activity.

Where ground levels do not have adequate fall, a licensed paving contractor should be appointed to install or remove and re-level pavement.

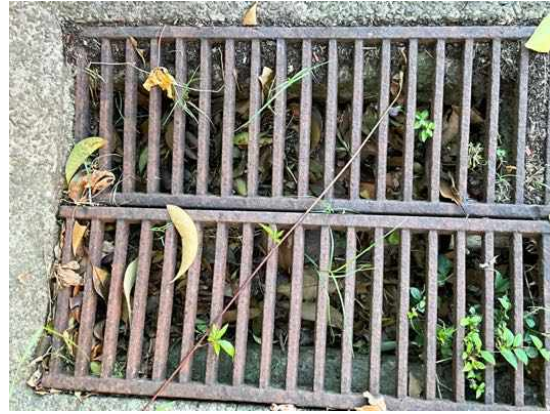
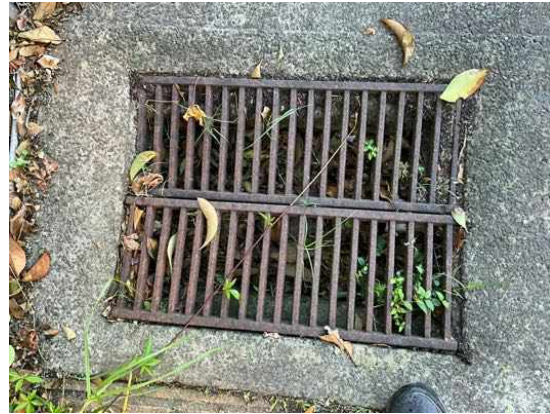
Finding 3.04

Building: Main Building
Location: All Areas
Finding: Vegetation inside Drain
Information: Vegetation, such as roots or foliage, is obstructing the drainage system, impeding water flow and potentially leading to blockages and water damage.

Risk:
The presence of vegetation in the drain poses a risk of water backup, flooding, and structural damage to the property, including foundation issues and mold growth.

Who Can Fix It:
A qualified plumber or drainage specialist should clear the vegetation from the drain, ensuring proper water flow and preventing potential drainage problems and associated damages. Regular maintenance may also be required to prevent future vegetation intrusion.

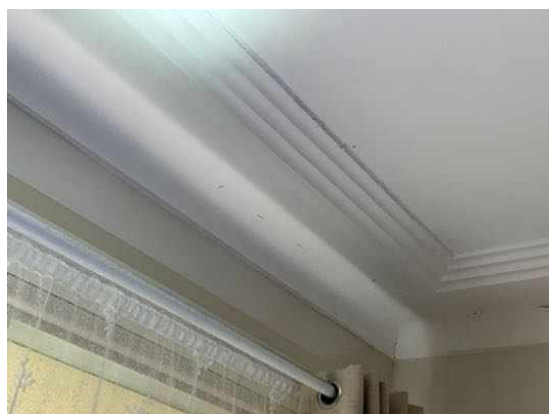
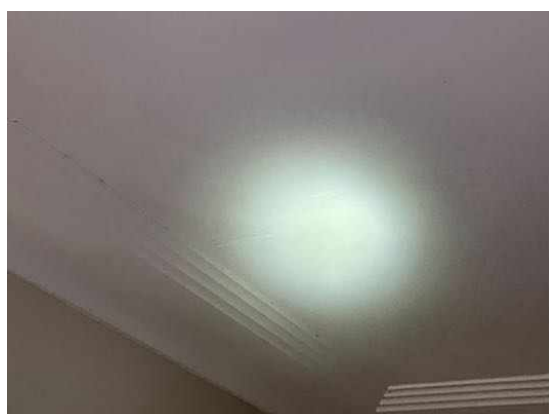
Finding 3.10

Building:	Main Building
Location:	All Areas
Finding:	Flaky Paint
Information:	Sections of the paint in this area was found to have deteriorated. Paint deteriorating is generally an indication of excessive moisture in the area that is currently hidden by the painted surface.

The presence of excessive moisture can have major implications on associated building elements if left unattended. While only seemingly minor at this stage, the damage cannot be determined due to the paint, obstructing any further inspection of the damage.

It is highly advised that the affected paint to be cleaned to allow a further, more invasive inspection by a licensed builder/painter. Failure to act on this defect may necessitate major works in the future.

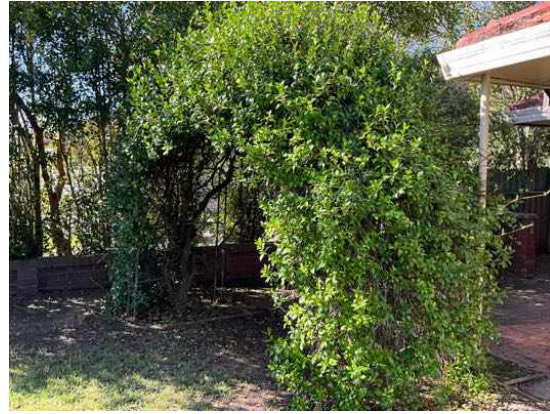
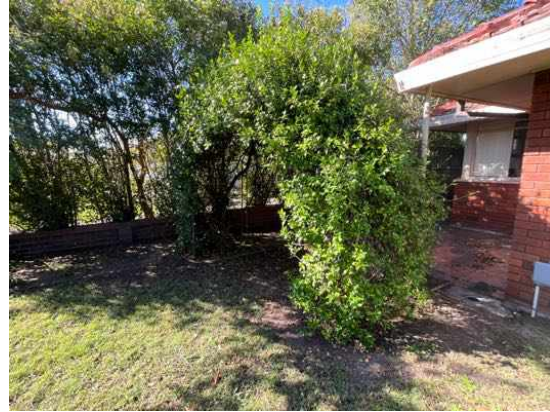
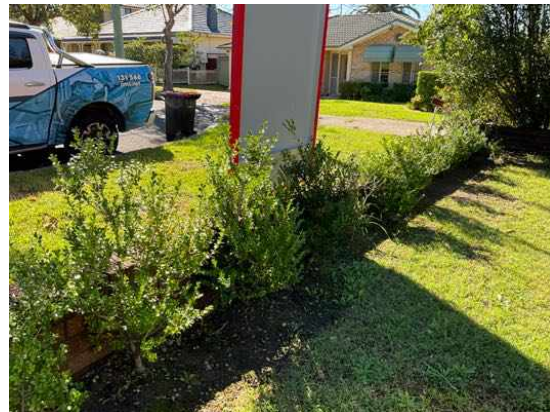
Finding 6.02

Building:	Main Building
Location:	All Areas
Finding:	Dense vegetation around a property can increase the risk of termite infestation
Information:	The presence of dense vegetation around a property can increase the risk of termite infestation, as it provides a conducive environment for them. To address this, consider maintaining a clear space between the vegetation and your home. If you suspect a termite issue, it's advisable to consult with a licensed pest control professional for inspection and treatment.

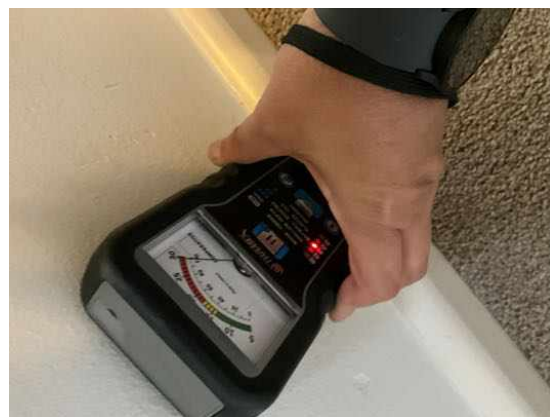
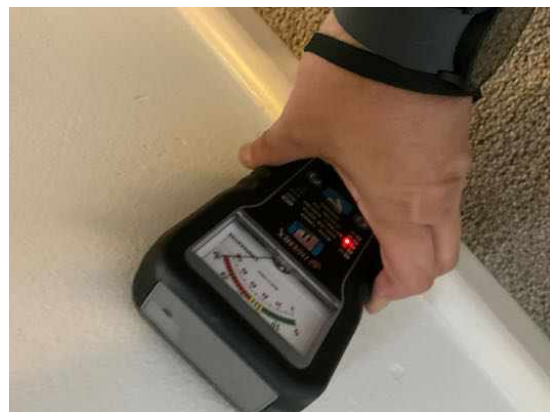
If mould growth has been found there may be environmental biological or health issues involved. In these cases an appropriately qualified inspector should also be contacted.

Prior to any remedial works being performed a qualified plumber should be appointed to further inspect the property and to identify the cause of the excessive moisture. Works to remove affected building elements may then be necessary and should be performed by an appropriate tradesperson.
