Building and Timber Pest Inspection Report

Inspection Date: Tue, 24 Mar 2026

Property Address: 9/3 Hampstead Rd, Homebush West NSW
2140, Australia

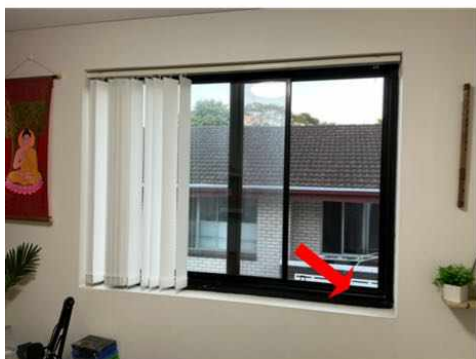
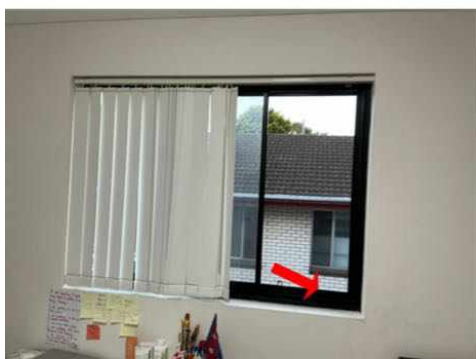
Building: Main Building
 Location: All Areas
 Finding: Window Restrictors - Recommended
 Information: Upstairs windows did not have window restrictors installed. Although not a requirement at the time of construction, it is advisable to install window opening restrictors on all second storey windows with sill heights below 1.7 meter and potential fall of 2 meters or more.

If you live in a strata scheme, window safety devices must be installed on all applicable windows by 13 March 2018. Residents with safety devices installed can still fully open their windows but it's recommended that devices be engaged whenever children are present, to prevent falls.

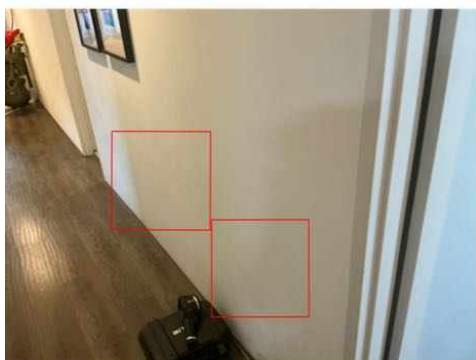
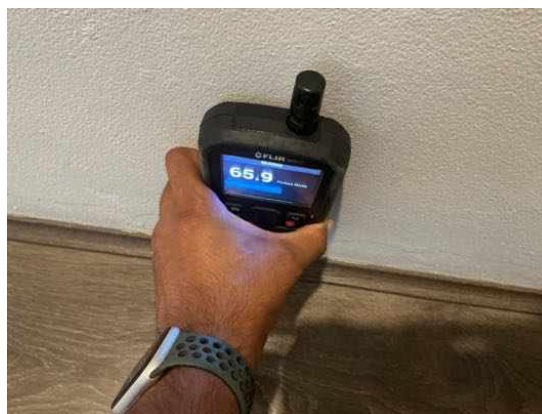
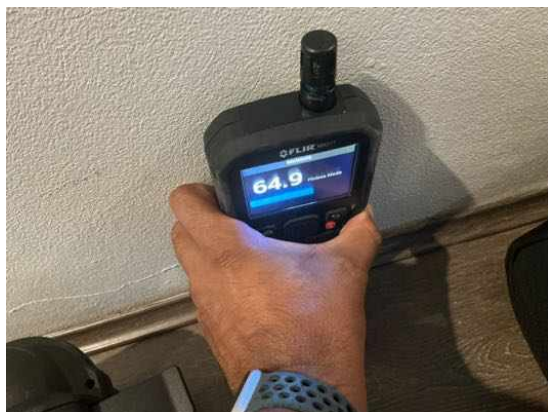
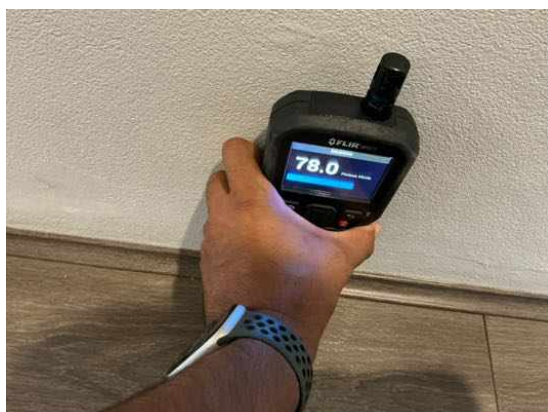
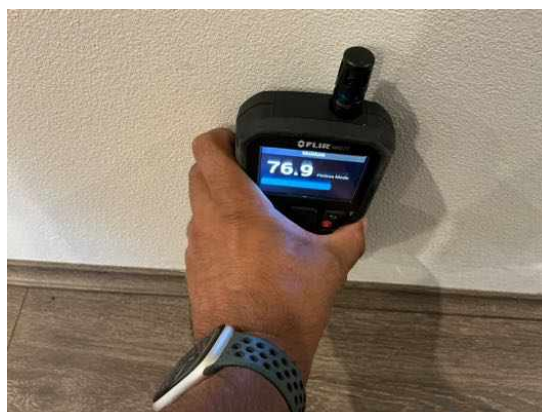
Building:	Main Building
Location:	Hallway opposite both bathrooms
Finding:	Shower Damp - Adjacent Bathroom (Monitoring)
Information:	At the time of inspection, elevated moisture levels were detected on the wall adjacent to the shower area. While no visible water damage or deterioration was noted, the presence of moisture suggests possible seepage or condensation associated with regular shower use.

At this stage, no immediate action is required. However, the area should be monitored over the next 12 months for any signs of deterioration such as staining, bubbling paint, or mould growth. It should be noted that moisture ingress of this nature does not generally resolve without intervention, and at some point remedial works are likely to be required. Should conditions worsen, the client is advised to engage services of a licensed plumber or waterproofing specialist to rectify the issue of moisture before this minor defect turns into major defect.

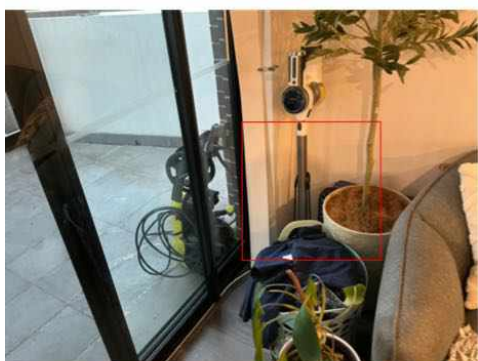
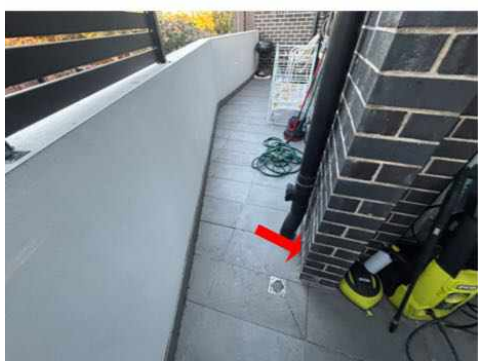
Finding 3.02

Building:	Main Building
Location:	Living Room
Finding:	Rising Damp / Moisture Ingress
Information:	At the time of inspection, signs consistent with rising damp and moisture ingress were noted to the wall in the living room. The condition appears to be associated with the adjoining balcony area, where deteriorated sealant and loose/delaminating tiles were observed compromising the waterproofing allowing moisture to penetrate through to the internal wall.

This condition is indicative of water ingress from the external balcony area rather than an internal plumbing issue, and if left unaddressed, may lead to further deterioration of

internal finishes, paint damage, and potential mould growth over time.

The client is advised to engage the services of a qualified tiler to repair and resurface the affected balcony tiling. The internal affected area should be monitored over a 12-month period, and if signs of progression such as bubbling paint, staining, or surface deterioration are observed, further assessment by a suitably qualified waterproofing tradesperson is recommended.

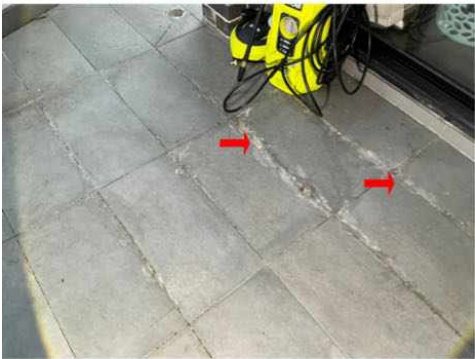
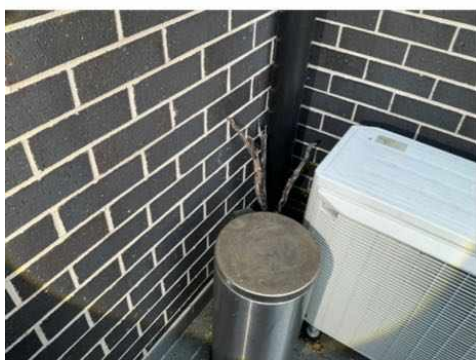
Finding 3.03

Building:	Main Building
Location:	Balcony
Finding:	Deteriorated Sealant and Waterproofing to Balcony Tiling
Information:	At the time of inspection, deterioration of sealant and grout joints was noted across the balcony tiled areas. There is visible white powdery residue (efflorescence) present, which is typically caused by moisture movement through the substrate bringing dissolved salts to the surface. In addition, plant/vegetation growth was observed within tile joints and edges, indicating prolonged moisture retention and lack of adequate sealing.

These conditions suggest that the waterproofing system beneath the tiles is deteriorating, allowing moisture ingress over time. If left unaddressed, this can lead to further deterioration of the substrate, internal moisture penetration, and damage to

This is considered a maintenance-related defect with potential to develop into a major defect if not rectified.

The client is advised to engage the services of a qualified tiling and waterproofing specialist to remove affected tiles where required, reinstate proper waterproofing, reseal joints, and ensure adequate falls and drainage. Addressing these exposed areas promptly will help prevent long-term damage and ongoing moisture-related issues.

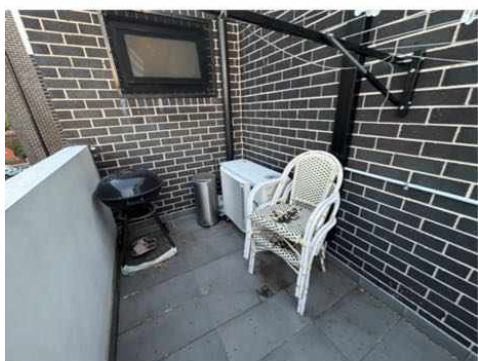
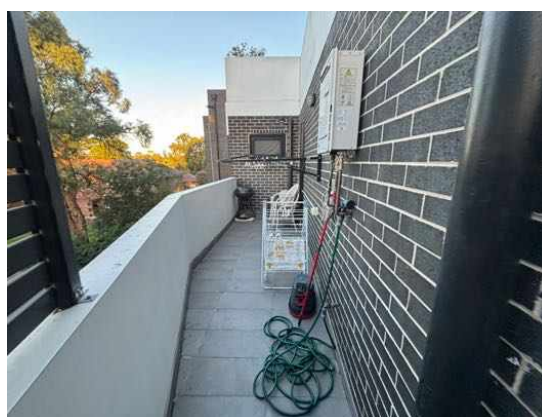
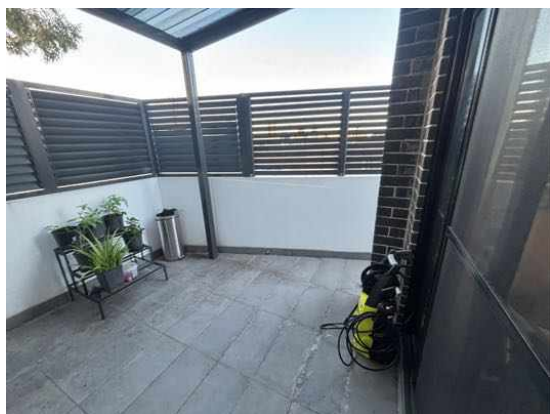
Building: Main Building
Location: All External Areas
Finding: Obstructions and Limitations - External Areas
Information: The attached photographs provide a visual representation of the obstructions and limitations that impeded a full inspection of the external areas of the property at the time of assessment. These obstructions, which may include vegetation, stored items, debris, or other physical barriers, can obscure potential defects and prevent a thorough evaluation of the property's condition. Obstructions of this nature can conceal a wide range of issues, such as structural damage, water ingress, pest infestations, or deteriorating building materials, which may not be visible during the initial inspection.

It is essential that these obstructions be cleared to allow for a comprehensive inspection of the external areas. Removing these barriers will enable a more accurate assessment of the property's condition and allow any hidden defects to be identified and addressed promptly. Failure to do so could result in undetected issues worsening over time, potentially leading to more costly repairs in the future.

Therefore, it is strongly recommended that the obstructions be removed and a re-inspection be scheduled once the affected areas are made fully accessible. This will ensure a complete evaluation of the property's exterior and provide the client with a clear understanding of any potential issues that may have been concealed during the initial inspection.

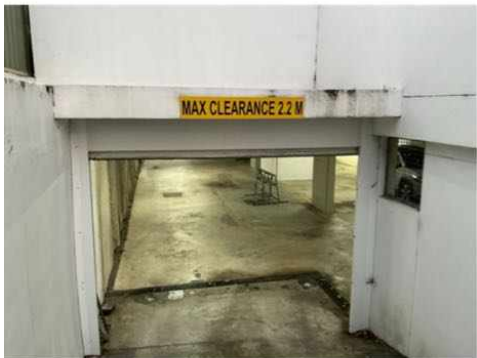
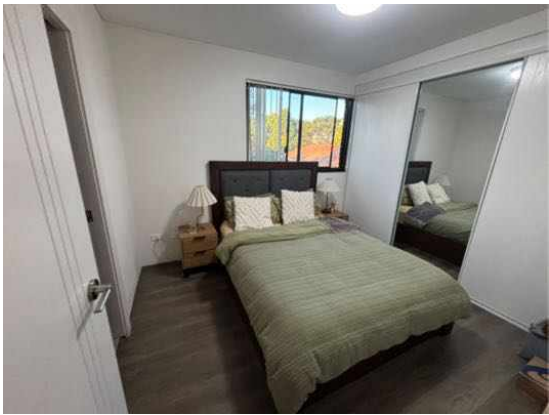
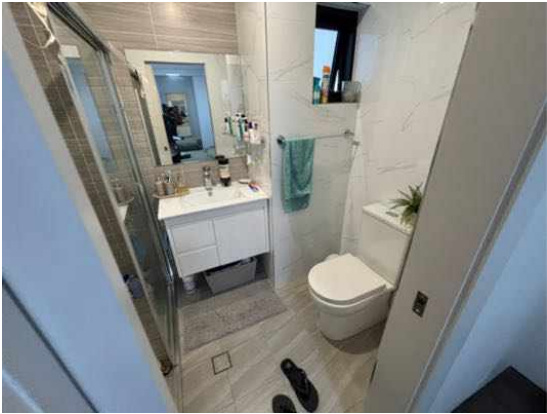
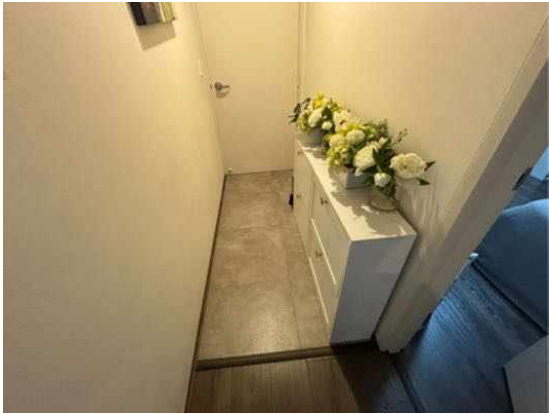
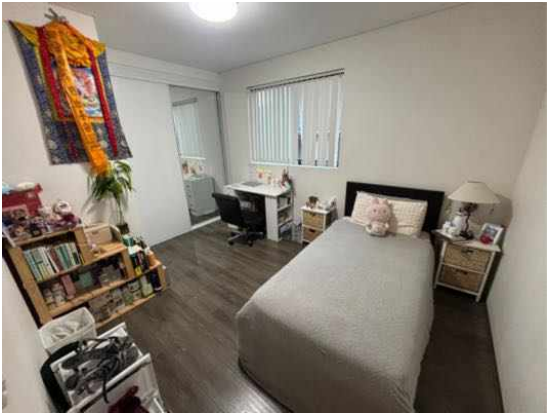
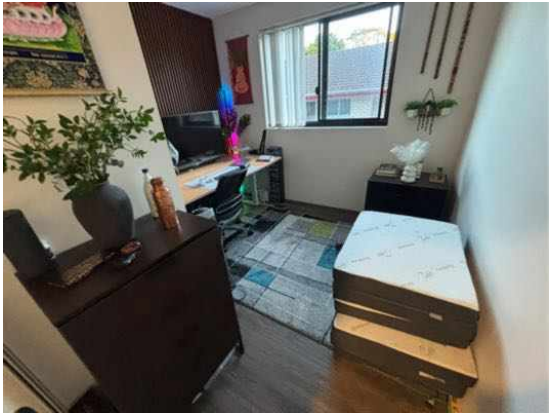
Building:	Main Building
Location:	All Internal Areas
Finding:	Obstructions and Limitations - Internal Areas
Information:	The accompanying photographs provide clear evidence of the obstructions and limitations that restricted a comprehensive inspection of the internal areas of the property at the time of assessment. These obstructions, which may include furniture, personal belongings, stored items, or structural elements such as wall coverings and built-ins, significantly hindered the ability to thoroughly evaluate these areas. It is important to note that such obstructions can potentially conceal a wide array of defects, ranging from hidden structural damage, water leaks, pest infestations, or electrical issues, to deteriorating materials that may not be visible during the initial inspection.

The presence of these impediments means that critical areas of the property were not accessible, and therefore, any underlying defects that may affect the integrity and safety of the property could remain undetected. These hidden defects, if left unaddressed, could worsen over time and may result in costly repairs or pose potential safety hazards to the occupants.

It is highly recommended that all obstructions be cleared to facilitate a complete and thorough inspection of the internal areas. Once the obstructions have been removed and full access is available, a re-inspection should be carried out to ensure that any previously concealed issues can be properly identified and rectified. This follow-up inspection will provide a more accurate assessment of the property's internal condition and help the client make informed decisions about any necessary repairs or maintenance.

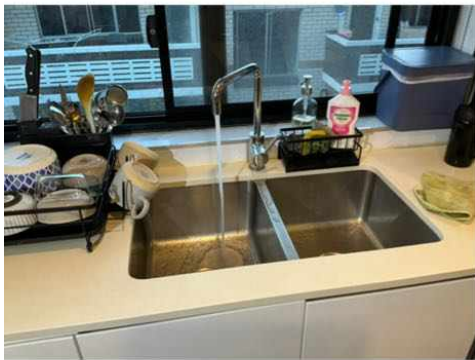
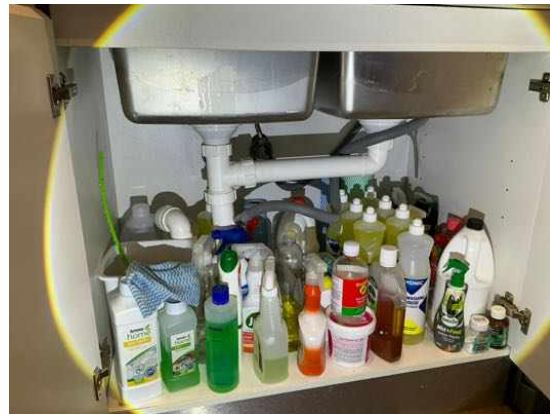
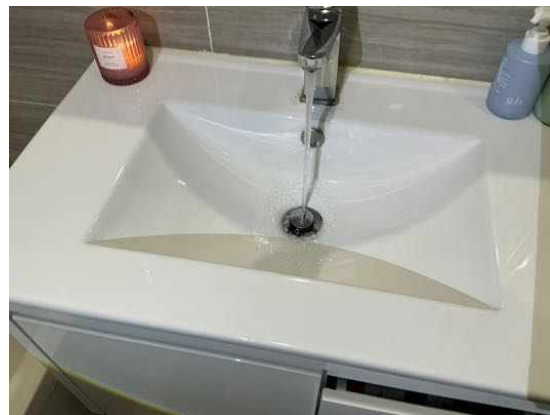
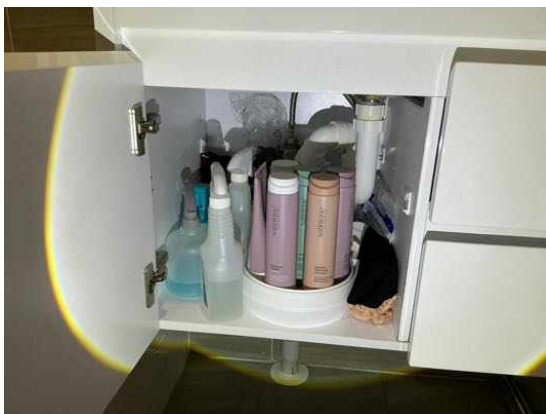
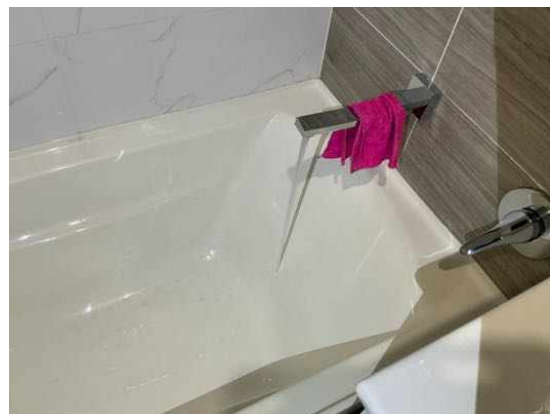
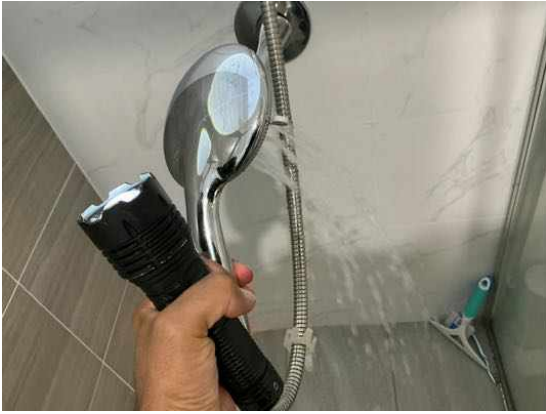
Building: Main Building
Location: All Areas
Finding: FYI - Taps, Drainage & Toilets Tested and Cabinetry Obstructions
Information: During the inspection, all accessible taps, drainage systems, and toilets were tested for water flow and drainage efficiency, and checked for any visible signs of leakage. At the time of the inspection, no issues were noted in these areas. Unless highlighted in a separate defect statement, no immediate remedial work appears necessary. Supporting images may be found in the additional photos section for reference.

beneath sinks and vanities was undertaken, stored personal items and fixtures presented obstructions that limited full visibility of the internal areas. As per standard inspection practices, inspectors are not permitted to move or disturb personal belongings during the inspection process. Therefore, only visible and accessible sections were inspected, and concealed water damage or plumbing defects may not have been detected.

Given this, a re-inspection is recommended after all obstructions have been cleared to allow for a comprehensive assessment of these areas. Regular maintenance and monitoring of plumbing and drainage systems is also advised to ensure ongoing functionality and early detection of potential issues.
