# Building and Timber Pest Inspection Report

Inspection Date: Fri, 27 Feb 2026

Property Address: 5 Summit Mews, Hillside VIC 3037, Australia

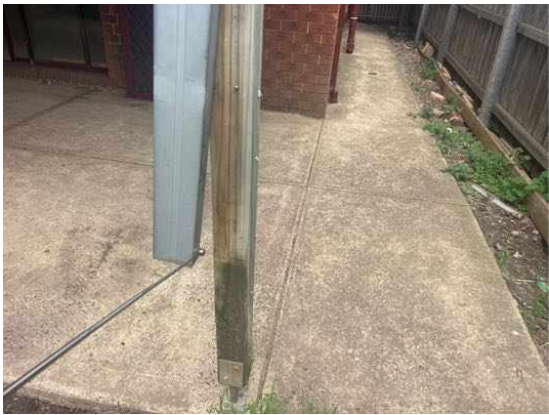
Building:	Main Building
Location:	Pergola > All Areas
Finding:	Installation - substandard or incomplete
Information:	The installation of this building element appears to have been completed to a substandard level of workmanship or is incomplete. Generally substandard repairs or installation are related to poor workmanship, the use of inappropriate materials, or a failure to complete installation to a suitable standard.

Where installation is substandard and/or incomplete, the client should contact the responsible trade to undertake rectification. Unfinished and substandard building works are likely to degrade more quickly and may create potential for secondary defects to associated building elements.

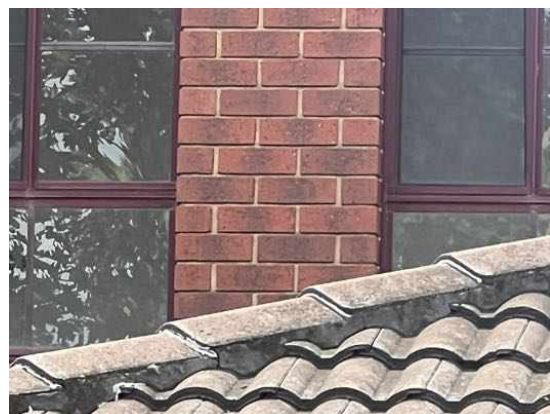
### Finding 3.08

Where left unmanaged, deteriorating roof tiles are likely to lead to a number of secondary defects, including minor water leaks and weather exposure to internal roofing structures.

Consultation with a roofing contractor is highly advised to gain advice on cost of remedial works that may be required in the short to medium term. Remedial works are likely to increase the longevity of the exterior roofing structure.

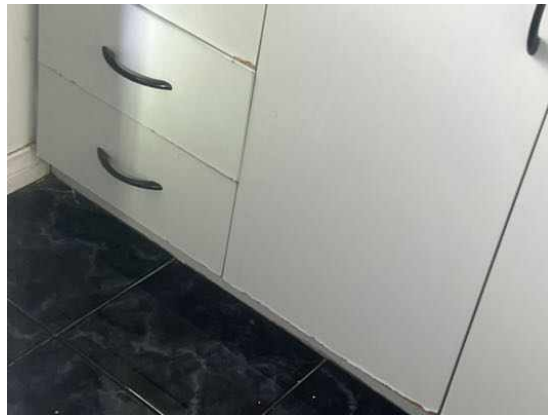
The structural integrity of swollen building elements can not be guaranteed, and further damage is likely to develop if left unmanaged. Excessive moisture is likely to lead to the development of secondary damage to any associated building elements, which may necessitate major reparation works if prolonged.

Rectification of the cause of the water leak should be addressed prior to any remedial works to the swollen building elements. A licensed plumber should be appointed immediately to identify the cause of the leak and provide advice on remedial works as necessary. Repair and/or replacement of swollen building elements should be conducted as a matter of urgency by a registered builder or qualified carpenter.

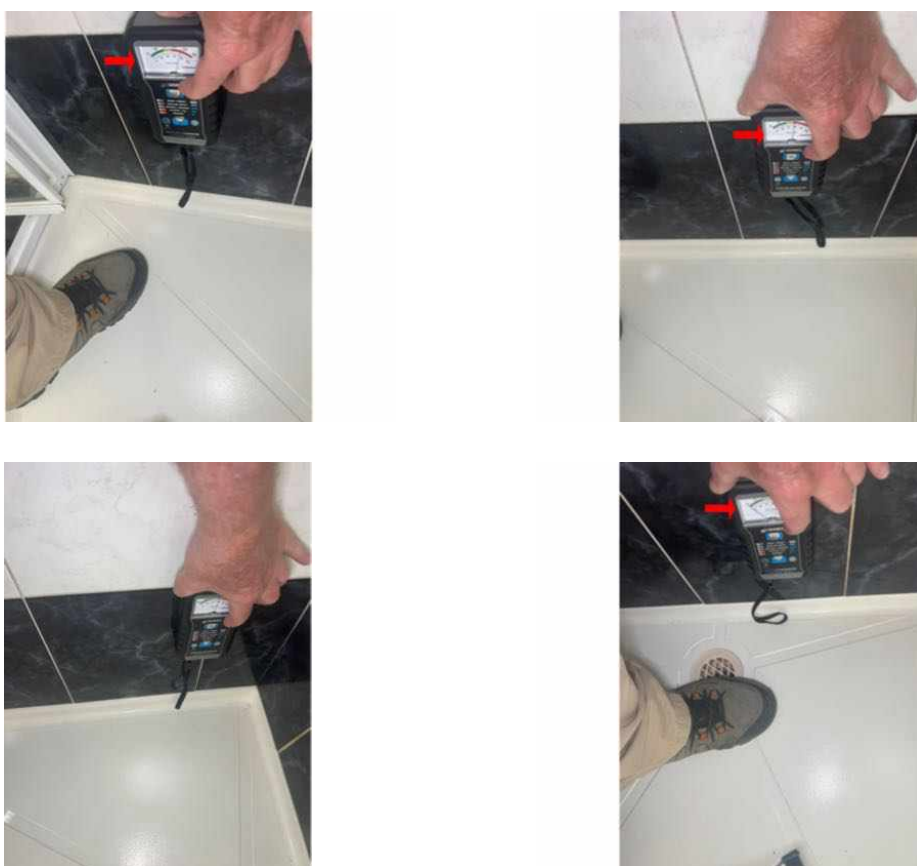
Building:	Main Building
Location:	Ensuite - Other > Front Right
Finding:	Building element - Swollen-no moisture detected
Information:	Swollen building elements generally indicate that the building materials have been affected by excessive moisture over a prolonged period of time, and have swollen as a result. The formation and development of mould/fungi or mildew is also a likely consequence of excessive moisture, which may pose major respiratory issues for occupants, particularly the elderly, the very young and those with existing illnesses and could be potential health safety hazards. In these cases an appropriately qualified inspector/tester should also be contacted for advice and/or technical assistance.

Consultation with a qualified plumber or bathroom specialist is advised immediately to identify the cause of damp and to perform remedial works as required. Where excessive mould growth is present, further inspection by a specialist environmental health inspector should also be considered.

Always ensure that sealant and grout is in good condition to prevent any moisture issues occurring in the future.

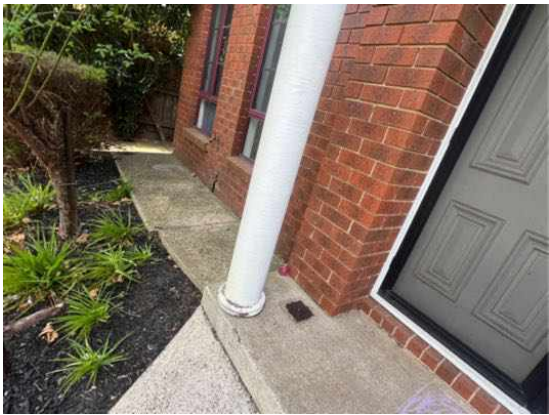
When met with excessive moisture timber begins to decay and develop wood rot. Any timbers that are in direct contact with external grounds especially if left untreated or non-durable also provide ingress for subterranean termites into that particular element.

The removal of any such materials that may be conducive to termite activity should be removed as soon as possible to minimise the risk of termite attack.

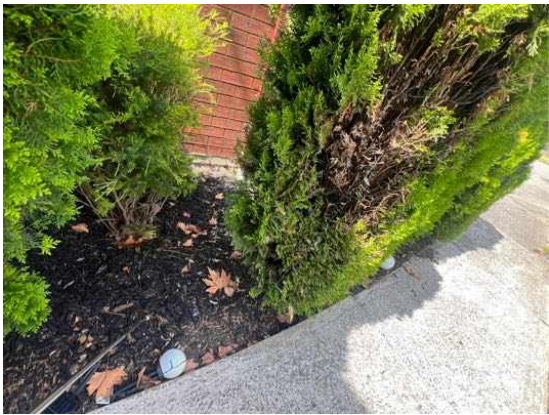
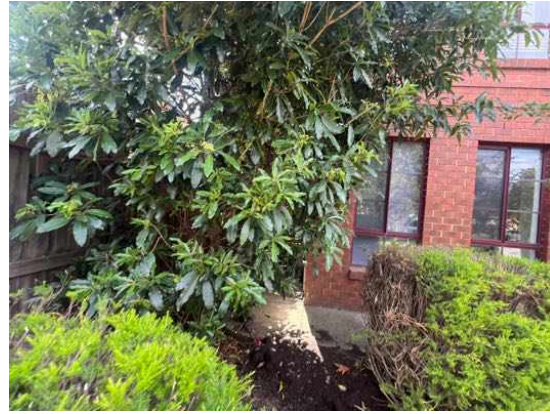
Finding 6.02

Building: Main Building  
Location: Front Elevation > Front Left  
Finding: Garden Beds - Conditions Conducive to Termites  
Information: Garden beds were found to be evident in the garden area. These garden beds can include untreated timber, and with a combination of moisture from watering hosing can make conditions conducive to termite activity and termite ingress.

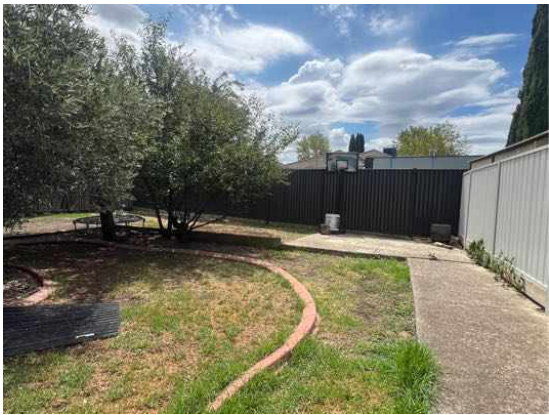
### Finding 6.07

Building:	Yard
Location:	Yard - Back > All Areas
Finding:	Building materials in direct ground contact - conducive to termites
Information:	Where timber elements are in direct contact with the ground and consequently moisture or dampness they become conducive to termite activity. Whether timber is used as a building element part of a fencing structure or stored as an unused item they can provide an environment that is attractive to termite infestation.

When met with excessive moisture timber begins to decay and develop wood rot. Any timbers that are in direct contact with external grounds especially if left untreated or non-durable also provide ingress for subterranean termites into that particular element.

The removal of any such materials that may be conducive to termite activity should be removed as soon as possible to minimise the risk of termite attack.
