Building and Timber Pest Inspection Report

Inspection Date: Tue, 3 Feb 2026

Property Address: 20 Aberfeldy Cres, St Andrews NSW 2566, Australia

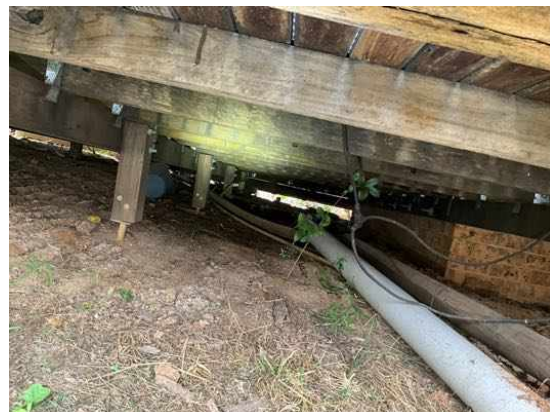
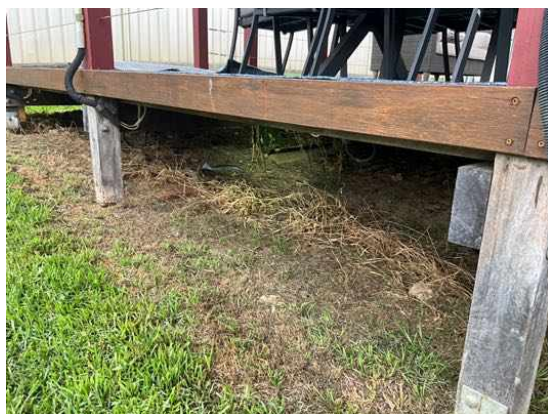
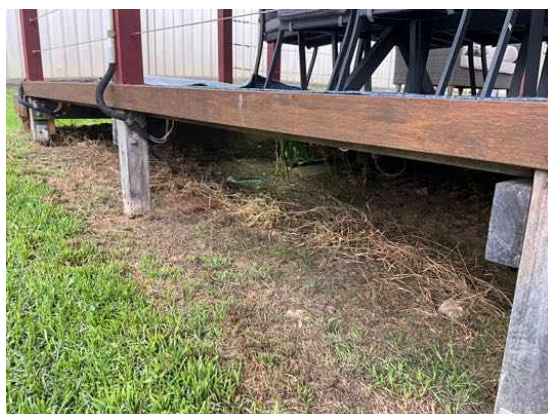
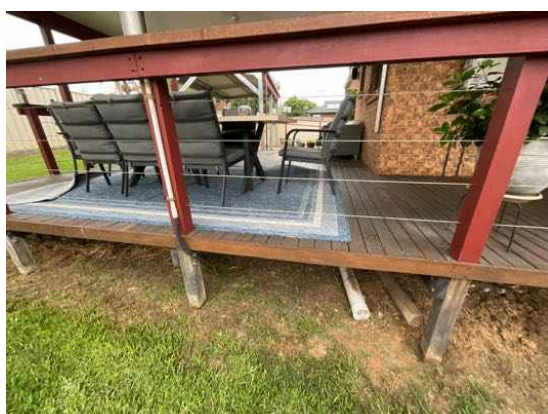
External timber structures are also constantly exposed to weather deteriorates in an exhilarate manner, ongoing assessments are required.

It is highly recommended that a structural engineer further, assess the external timber balcony or a deck to inform the client of its load capacity.

Regular maintenance inspections by competent practitioners is needed.

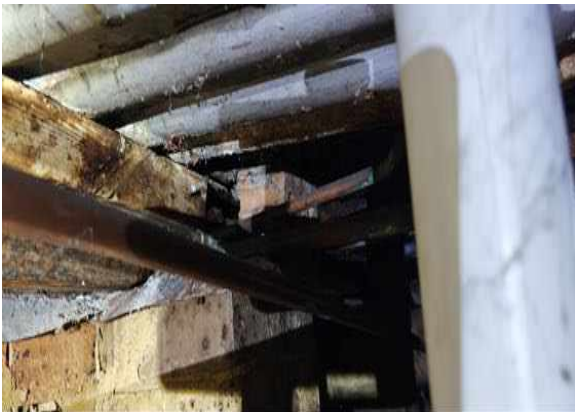
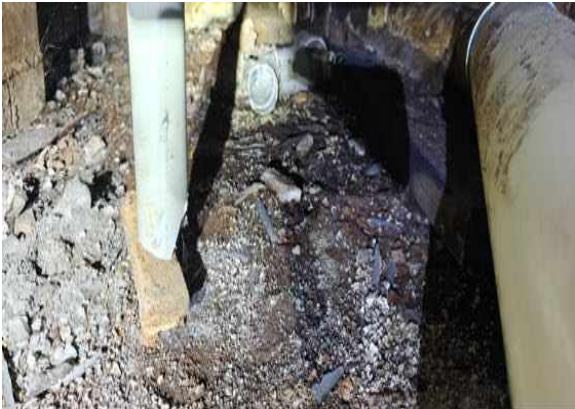
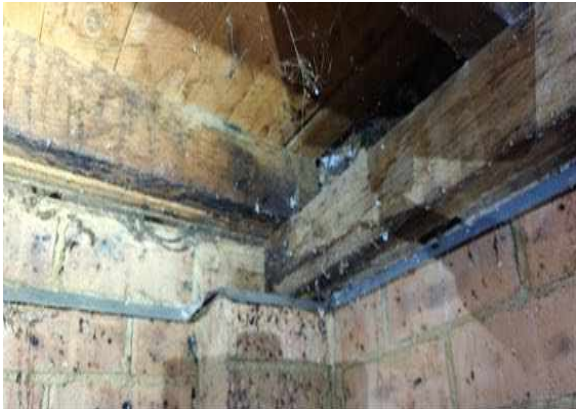
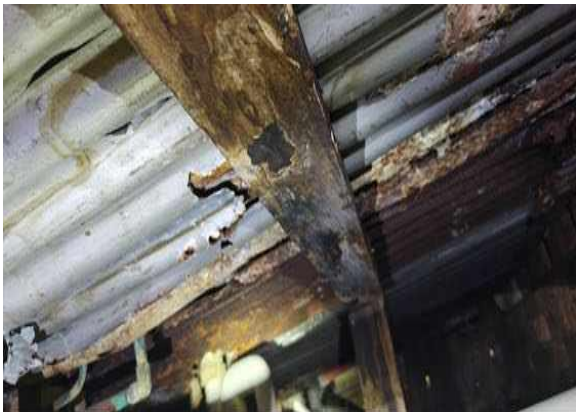
Building: Main Building
Location: Subfloor
Finding: Subfloor- leaking plumbing fittings
Information: Evidence of leaking plumbing fittings was observed within the subfloor area. Moisture staining and timber deterioration suggest prolonged water exposure from faulty pipe joints or fixtures.

- Structural damage to timber framing and flooring due to continuous moisture exposure.
- Mould growth and decay, posing potential health risks and further degradation of building materials.
- Pest attraction, as damp environments are conducive to termites and other pests.
- Non-compliance with plumbing standards and risk of escalation if not addressed promptly.

- A licensed plumber should be engaged to identify the exact source of leakage, repair or replace faulty fittings, and confirm watertight integrity. A builder may also be required to assess and rectify any structural damage.

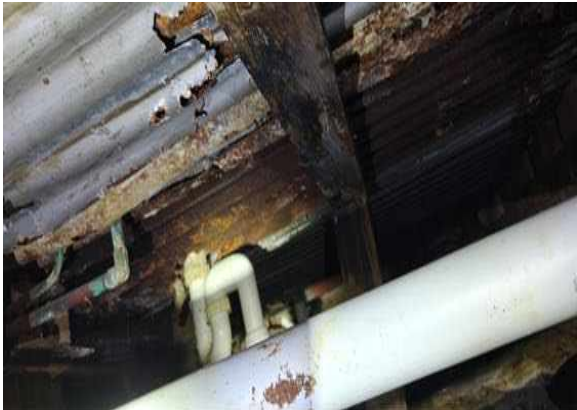
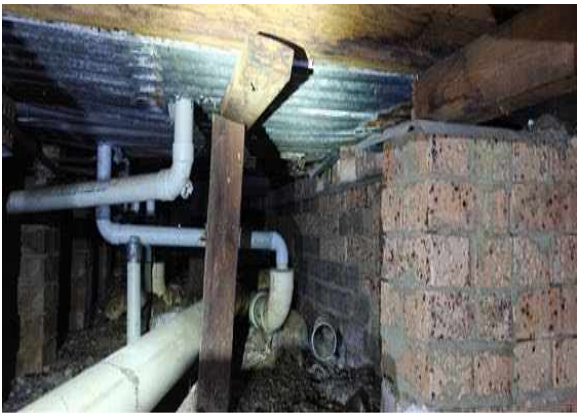
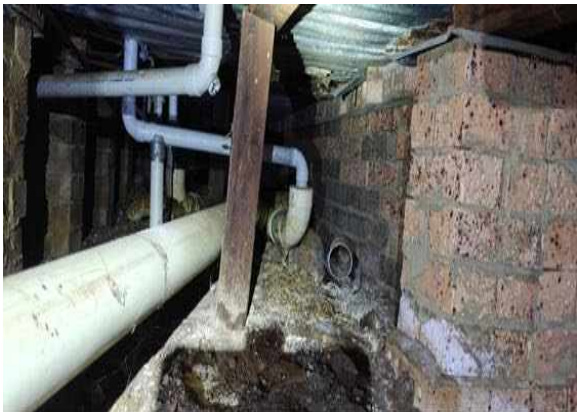
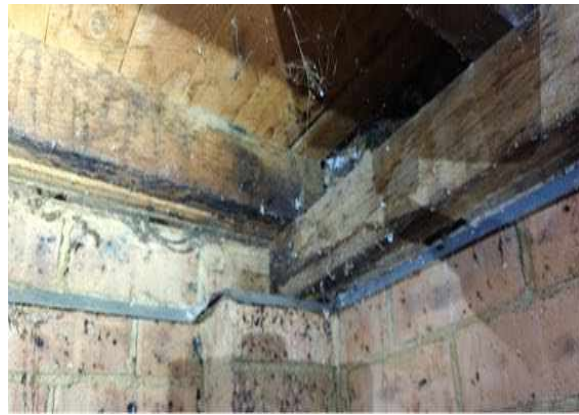
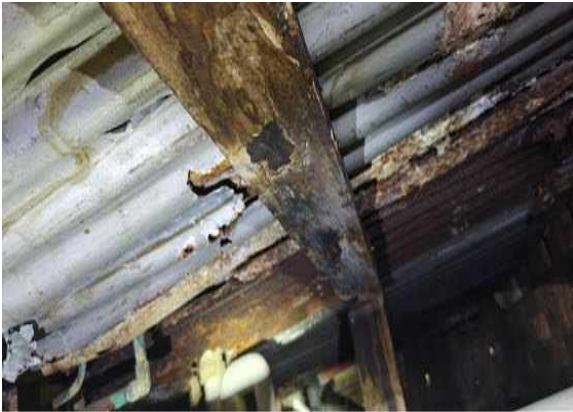
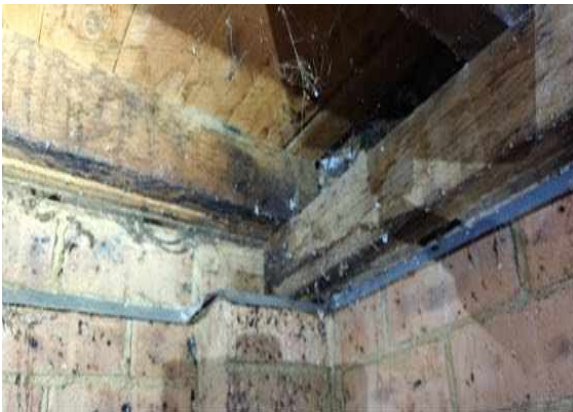
Building:	Main Building
Location:	Subfloor
Finding:	Subfloor- Wood Rot in Bearer and Joist
Information:	The bearer and joist in the subfloor show significant wood rot, which has compromised the structural integrity of the timber. Wood rot typically occurs due to prolonged exposure to moisture, and in this case, it has led to severe decay, weakening the timber and reducing its load-bearing capacity. This deterioration poses a critical risk to the overall stability of the floor structure.

- **Structural Risk:** High risk of structural failure in the affected area due to compromised load-bearing capacity. If left unaddressed, this could lead to sagging, uneven floors, or even collapse in extreme cases.
- **Safety Risk:** Elevated safety risk for occupants, as a weakened subfloor could fail under load, posing a potential hazard.
- **Moisture and Decay Propagation Risk:** The presence of rot in the timber can spread if the source of moisture is not addressed, potentially affecting adjacent timbers and leading to widespread damage.

This defect should be classified as a major defect due to the severe impact on

structural integrity and safety. Immediate action is required to rectify the issue and maintain the building's stability.

- **Engage a Licensed Carpenter or Structural Engineer:** A qualified carpenter or structural engineer should assess the extent of the damage and replace the affected bearer and joist. They will ensure the replacement timbers are adequately treated and installed to meet structural standards.
- **Address Moisture Source:** It is critical to identify and eliminate the moisture source contributing to the wood rot. Improving subfloor ventilation, repairing leaks, or installing a moisture barrier may be necessary to prevent future decay.

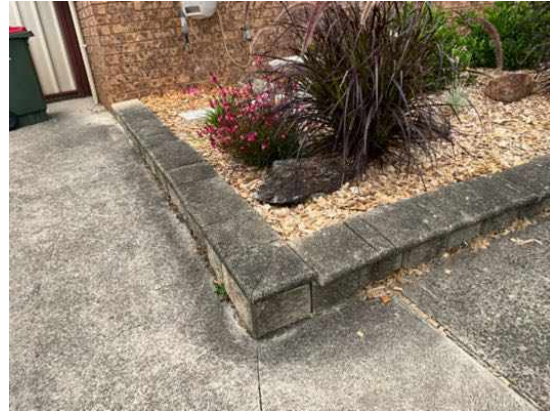
Finding 3.01

Building:	Main Building
Location:	All Areas
Finding:	Retaining wall Brickwork - Cracking [Repair required]
Information:	An approximate 10mm crack has been observed in the brick retaining wall, raising concerns about its stability and long-term durability. Immediate attention and repair are required to address this structural issue."

To fix this, you should consider consulting with a professional mason or a construction contractor experienced in brickwork and retaining walls. They can assess the extent of the damage and provide the necessary repairs or recommendations for the best course of action.

A qualified bricklayer should be contacted immediately to estimate and perform repair and restoration works. Consultation with a structural engineer may be required where structural instability is found to be the underlying cause of the cracking.

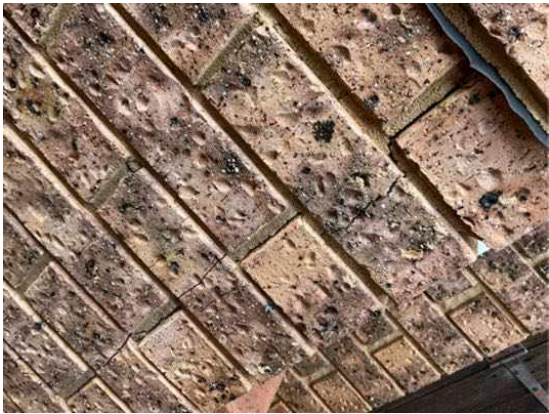
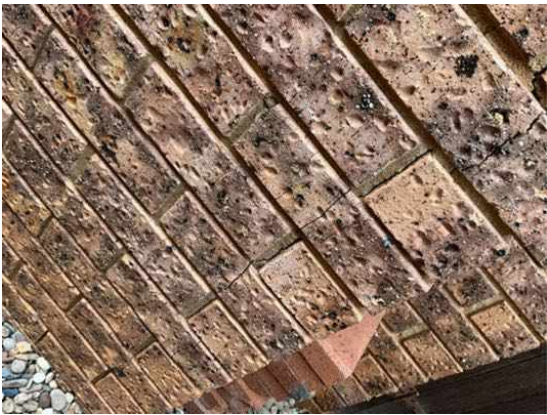
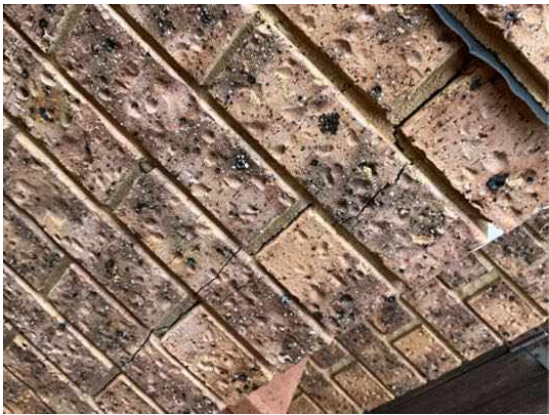
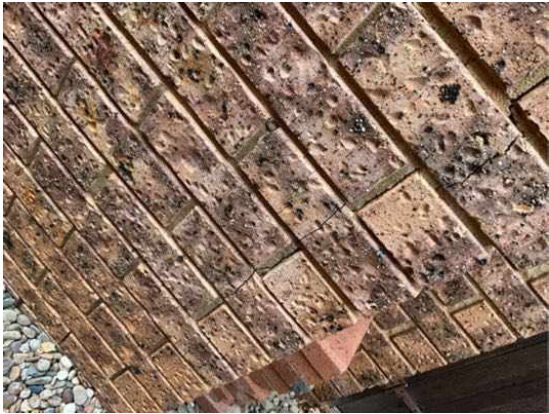
Finding 3.02

Finding: Brickwork - Cracking [Fine]

Information: Although fine cracks are quite noticeable, they are often only considered to be an appearance defect and usually do not indicate any structural damage. Generally, the cause of a fine crack is indicative of a separation between brickwork and mortar throughout the structure, but single bricks may also show cracks of this nature.

Cracking of this nature can generally be repaired with minor filling and should be conducted by a qualified bricklayer.

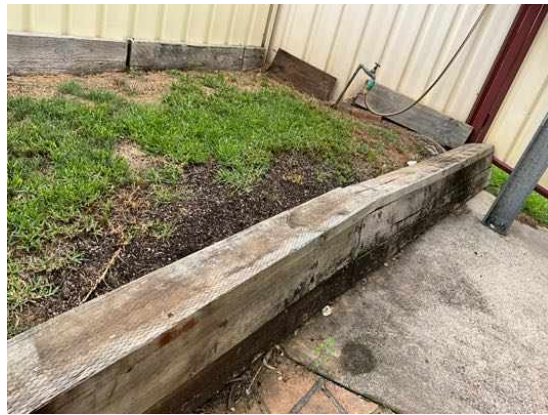
This is classified as a major structural defect under AS 4349.1-2007, as it affects the stability and load-bearing capacity of the retaining wall. There is a risk of collapse, posing a hazard to nearby structures, occupants, and vegetation. Failure of the wall may also result in soil displacement and drainage issues.

- **Inspection:** A qualified structural engineer should conduct a detailed assessment to determine the cause and extent of movement.
- **Repair:** Rectification work should be performed by a licensed builder or landscaper with experience in retaining structures, following engineering specifications.
- **Prevention:** Ensure proper drainage, footing depth, and wall anchorage in the rebuild to prevent recurrence.

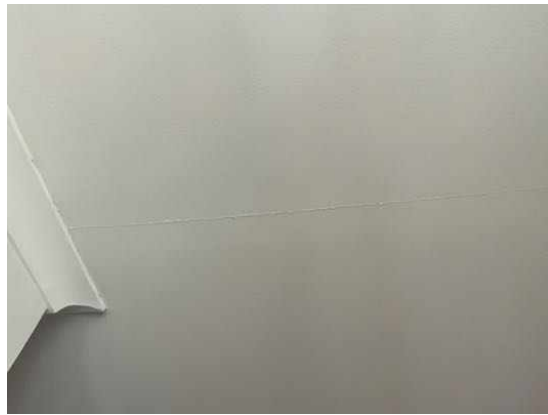
Finding 3.05

Building:	Main Building
Location:	Living Room
Finding:	Ceilings - Crack (Fine)
Information:	Fine cracks are observed in the ceiling, suggesting potential structural issues or settling.

The presence of fine cracks in the ceiling poses a risk of further structural damage, compromising the integrity of the building. Additionally, it may indicate underlying issues such as foundation problems or insufficient support.

A structural engineer or a qualified contractor should be consulted to assess the cause of the cracks and recommend appropriate repairs. Addressing the underlying issues is crucial to prevent further damage and maintain the safety and stability of the structure.

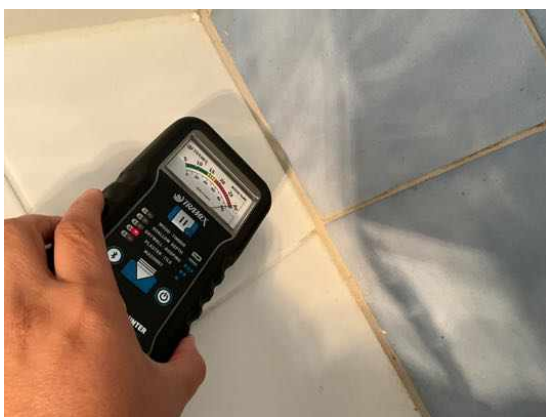
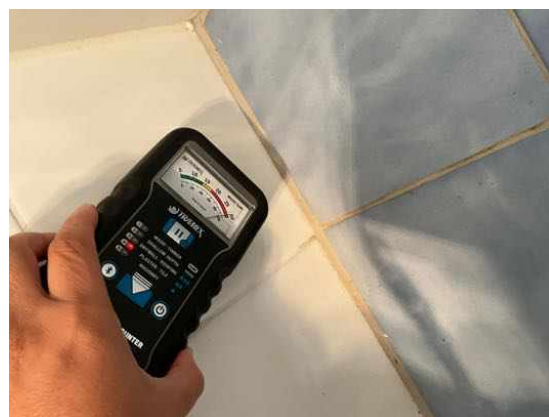
Damp is evident to the lower 300mm of wall to the shower alcove. This defect is quite common, and is suspected to have been caused by moisture permeating through the grouting in this area, which shows evidence of deterioration. Leaking pipes within the adjoining wall is also a possible cause.

Unmanaged damp in the shower recess is likely to facilitate the formation and development of mould and fungi growth, decaying associated building materials and compromising their structural integrity. It is important to address damp conditions, as the World Health Organisation notes that excess moisture leads - on almost all indoor materials - to growth of microbes such as moulds, fungi and bacteria, which subsequently emit spores and other matter into the indoor air. Exposure to these contaminants is associated with a wide range of respiratory and other health-related problems.

Consultation with a qualified plumber or bathroom specialist is advised immediately to identify the cause of damp and to perform remedial works as required. Where excessive mould growth is present, further inspection by a specialist environmental health inspector should also be considered.

Always ensure that sealant and grout is in good condition to prevent any moisture issues occurring in the future.

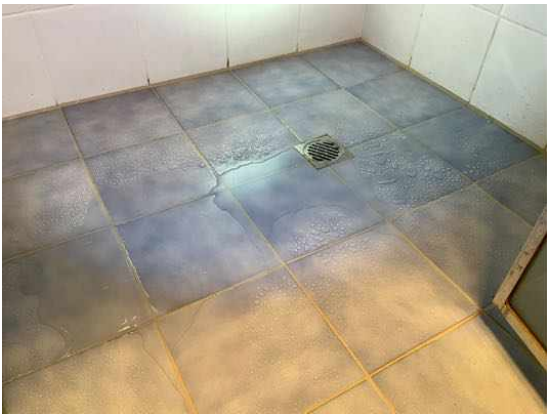
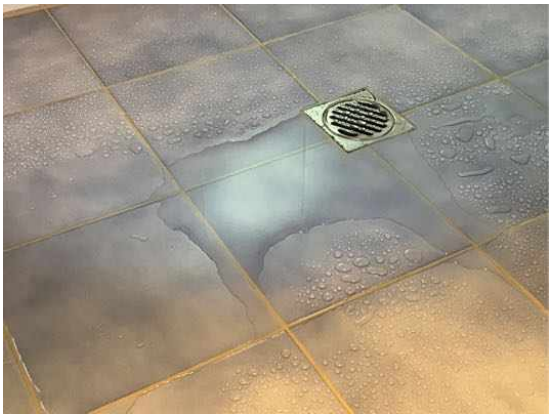
Finding 3.08

Building:	Main Building
Location:	Bathroom
Finding:	Shower base - Water pooling
Information:	Evidence of water pooling around the floor waste in the shower recess was noticed at the time of inspection. It is suspected that this excessive moisture is attributed to insufficient fall in the shower floor tiles.

This pooling is minor overall but is still considered unsatisfactory, as standard tiling practices would not permit this situation to occur. Pooling water around floor wastes can create a slip hazard in extreme cases and create conditions that are conducive to mould growth over time. Where left unmanaged, the degradation of sealant and grouting is also likely to occur, possibly necessitating further repair works.

Remedial works may involve some sections of tiling and flooring repair and replacement. A tiling contractor or bathroom specialist should be appointed to provide further advice on reparation options and to perform works as necessary.

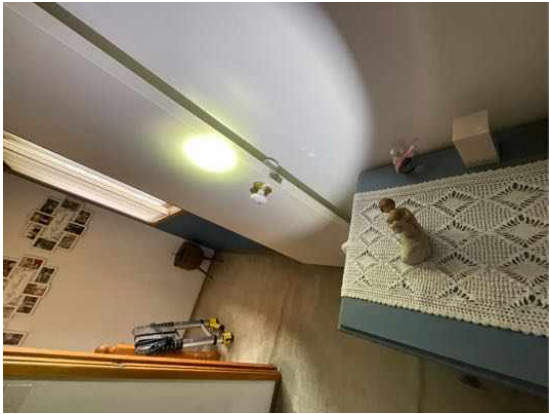
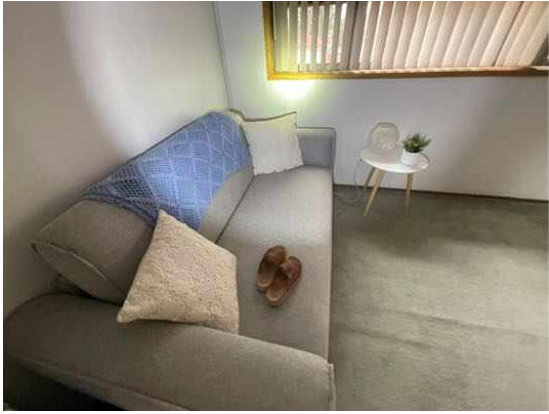
Finding 3.09

Building: Main Building
Location: All Areas
Finding: carpet exhibits visible signs of aging
Information: Carpets are exhibiting visible signs of aging, including fraying edges, faded colors, and flattened fibers, diminishing their aesthetic appeal and functional quality.

The risk associated with aging carpets includes diminished appearance, decreased comfort, potential tripping hazards due to frayed edges, and a negative impact on indoor air quality if fibers begin to degrade and release particles into the air.

Professional carpet cleaning and restoration services can address issues such as deep cleaning to rejuvenate colors, repairing frayed edges, and restoring fibers. Additionally, replacing the carpets entirely may be necessary in severe cases of aging or damage beyond repair.

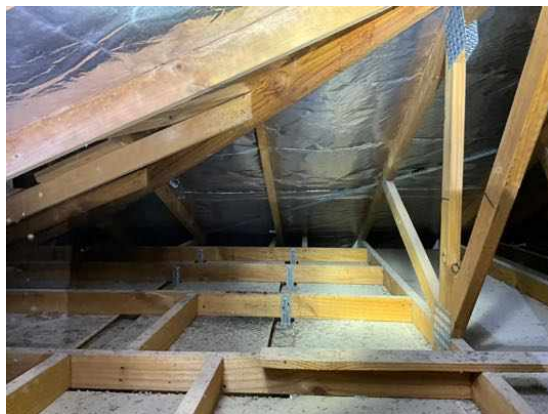
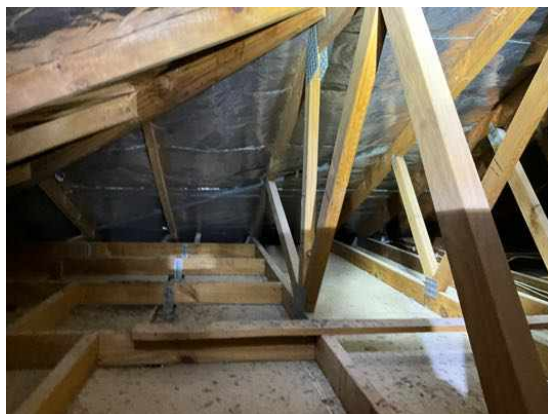
Building: Main Building
 Location: Roof Void
 Finding: Insulation - Missing
 Information: Upon inspection of the roof void it was noted that insulation is not present.

Where insulation is absent, the area does not meet current Australian Standards. Installation of adequate insulation is required and should be conducted as soon as possible.

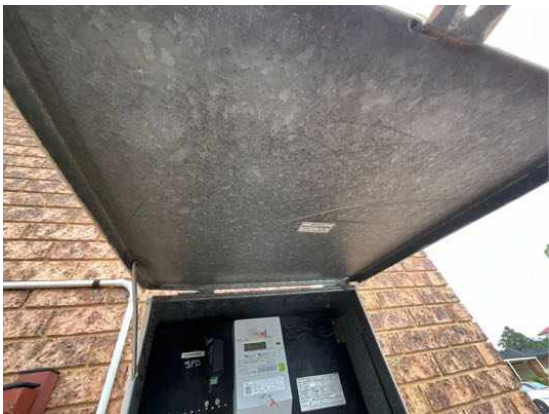
Building: Main Building
Location: Exterior walls - left side
Finding: No Evidence of Termite Management System - Durable notice / Legible Sticker
Information: The application of a pre & post-construction chemical termite barrier is highly recommended for all properties. Such barriers are highly effective in preventing termite attack on any timber building elements throughout the property.

Client must seek further information from the vendor or real estate agent if the

conditions of termite management systems were maintained.

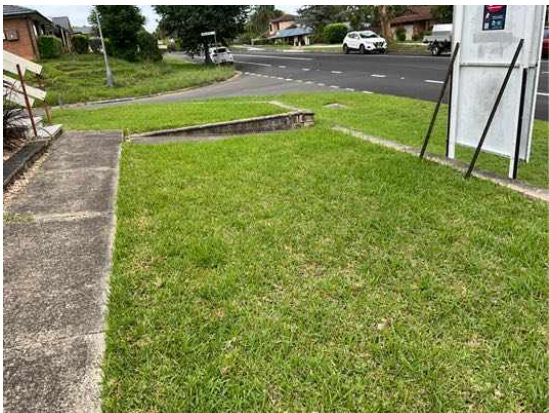
Finding 6.02

Building: Main Building
Location: All Areas
Finding: Dense vegetation around a property can increase the risk of termite infestation
Information: The presence of dense vegetation around a property can increase the risk of termite infestation, as it provides a conducive environment for them. To address this, consider maintaining a clear space between the vegetation and your home. If you suspect a termite issue, it's advisable to consult with a licensed pest control professional for inspection and treatment.

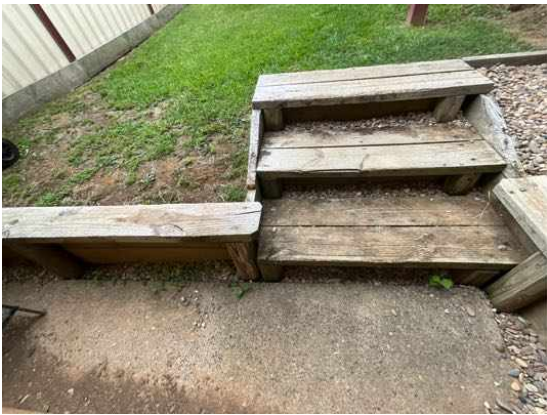
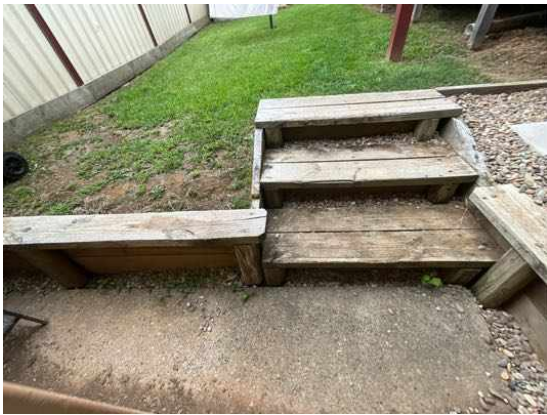
Finding 6.03

Building: Main Building
Location: All Areas
Finding: Timber on ground / conducive conditions to termite damage
Information: Timber on the ground is indeed conducive to termite damage. Termites are known to thrive in moist environments, and wood in contact with soil or moisture is more susceptible to infestation.

To prevent this, it's important to keep timber elevated and away from direct ground contact. Regular inspections and proper termite control measures are also essential to protect your wooden structures from termite damage.

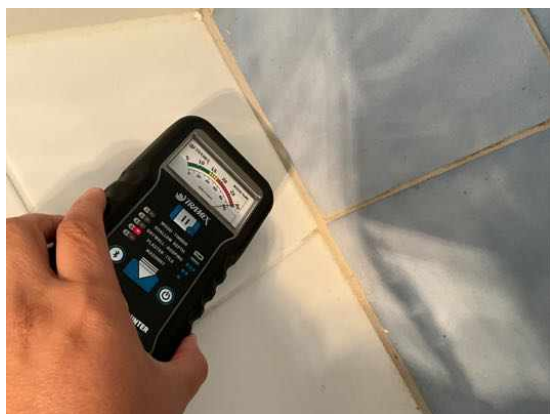
Building:	Main Building
Location:	Toilet (WC)
Finding:	Excessive moisture - Conducive to Timber pest
Information:	Excessive moisture can attract termites and produce conditions that promote fungal growth and wood decay.

Excessive moisture is generally caused by deteriorated inadequate or missing roof drainage leaking plumbing pipes or fixtures poorly plumbed HWS overflows or condenser units and poor site drainage.

Prior to any remedial works being performed a qualified plumber should be appointed to further inspect the property and to identify the cause of the excessive moisture.

Works to remove affected building elements may then be necessary and should be performed by an appropriate tradesperson.

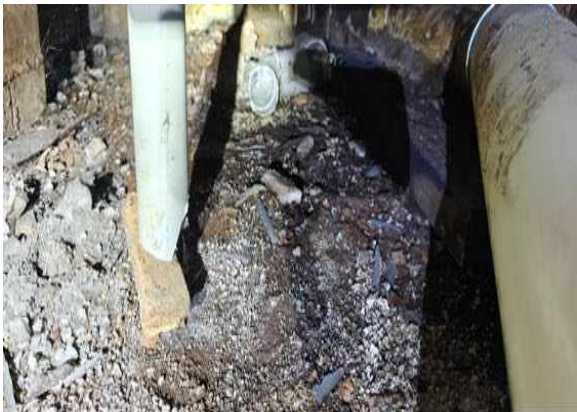
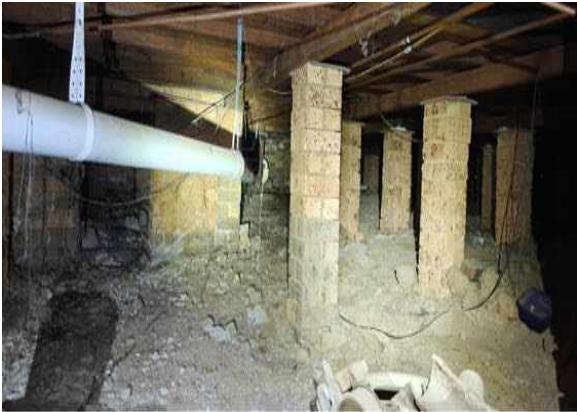
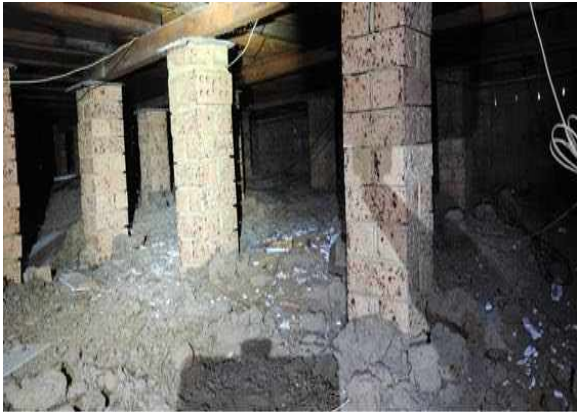
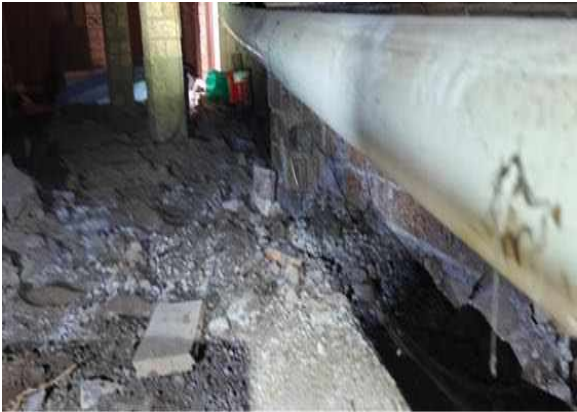
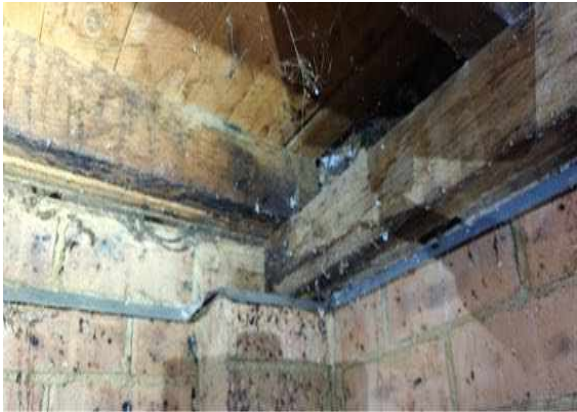
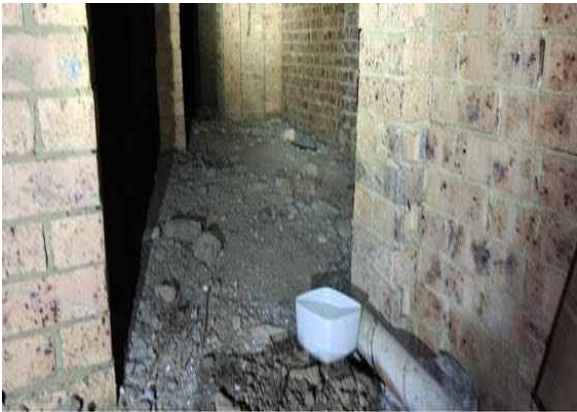
Finding 6.06

Building:	Main Building
Location:	Subfloor
Finding:	Subfloor - poor ventilation, inadequate site drainage, water stains
Information:	The subfloor lacks adequate ventilation, suffers from inadequate site drainage, exhibits water stains, creating conducive conditions for timber pests such as termites.

Risk: The combination of poor ventilation, inadequate drainage, water stains significantly increases the risk of timber pest infestations. Termites are attracted to moist environments and can thrive in subfloors with high humidity levels and water damage. The lack of proper ventilation and drainage exacerbates moisture retention, providing an ideal habitat for timber pests to establish colonies and cause extensive damage to the subfloor structure. Additionally, water stains indicate previous or ongoing moisture issues, which further attract timber pests and contribute to the deterioration of timber materials.

A licensed pest control professional specializing in timber pest management should be consulted to assess the extent of the infestation and develop a comprehensive treatment plan. They can implement strategies to eliminate existing timber pests, such as termites and prevent future infestations by addressing underlying moisture issues. Additionally, a qualified plumber or builder may be needed to improve subfloor ventilation, enhance site drainage, repair water-damaged areas. Regular inspections and maintenance are essential to ensure ongoing protection against timber pests and maintain the structural integrity of the subfloor.

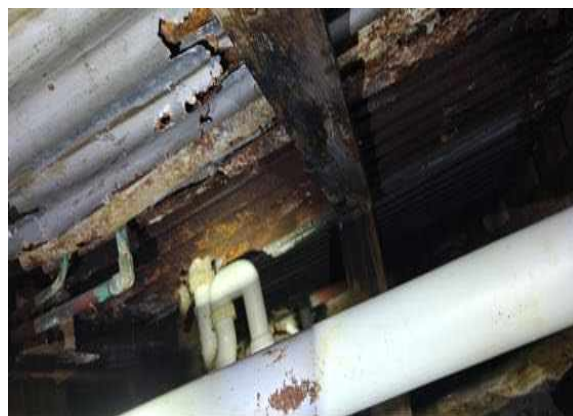
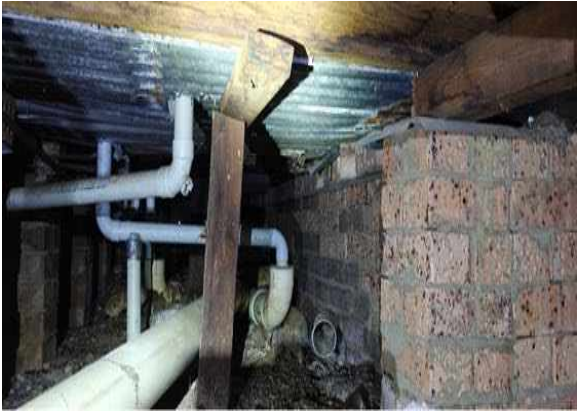
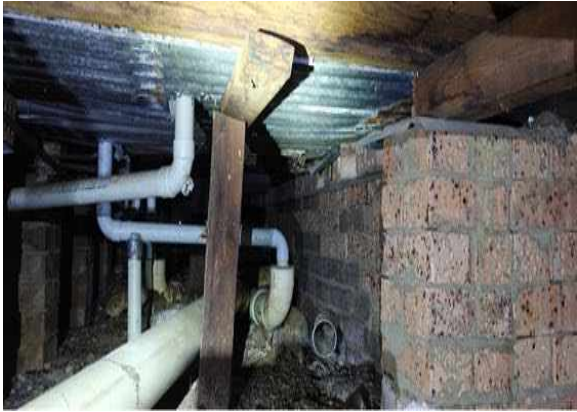
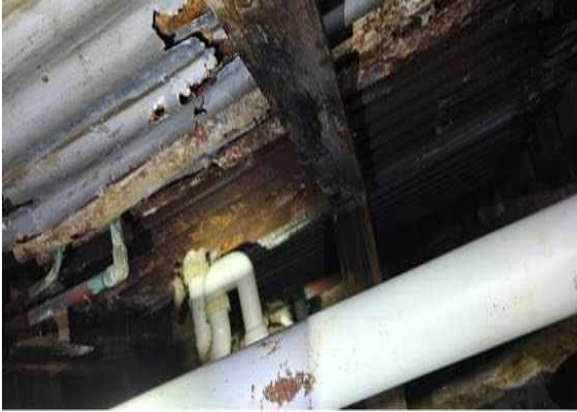
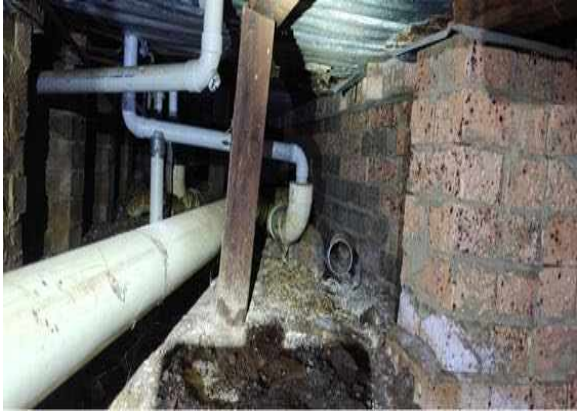
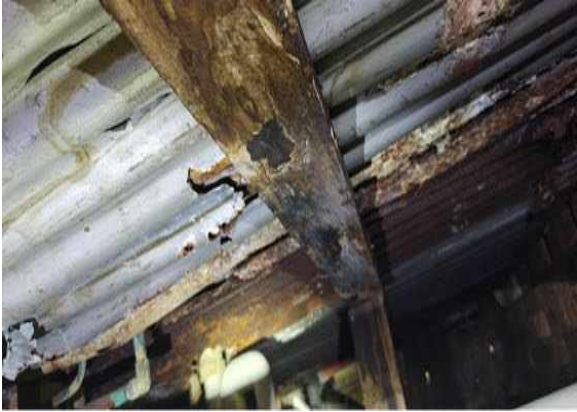
Finding 7.01

Building:	Main Building
Location:	Subfloor
Finding:	Wood rot
Information:	This building element shows evidence of wood rot. Wood rot, also known as Fungal Decay, occurs when timbers and other cellulose building materials are exposed to damp conditions on an ongoing basis. This could be the result of exposure to weathering over a prolonged period of time, or the attraction of excessive moisture from other abutting building materials. Contributing factors also include poor air ventilation in the area.

Wood rot is often associated with general damp problems and is evidenced by a 'musty' smell or mould and mildew occurring on surfaces. If left unmanaged, damp conditions can lead to further health problems and the decay of timbers will continue.

Early intervention and regular maintenance, particularly of exterior timbers, will prolong the useful life of these building elements. Prior to any works being performed, the cause of the moisture that has created the visible wood rot should be identified and addressed in a suitable manner. Replacement of affected timbers may then be a necessary step in protecting surrounding building elements from such deterioration.

A qualified plumber may be appointed to assess the cause of excessive moisture and to provide advice on any remedial works as required. A qualified carpenter or registered builder may also be required to replace affected building materials.
