Building Inspection Report

Inspection Date: Tue, 10 Mar 2026

Property Address: 1/8 Hunter Ct, Ringwood East VIC 3135,
Australia

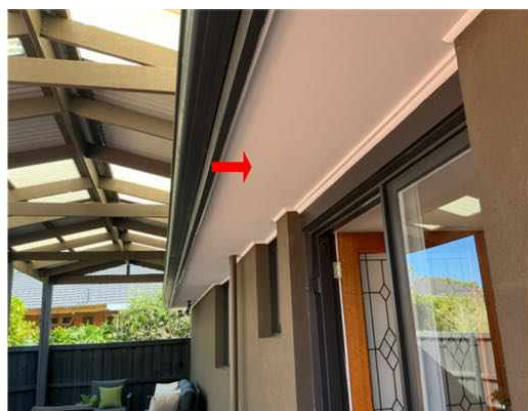
Defects 1.01

Building:	Main Building
Location:	Eaves
Finding:	Asbestos - Suspected ACM Identified on Site
Information:	Reporting on Asbestos is outside the Scope of this Report. This suspected defect is highlighted as a caution only. We suspect, based on our experience in the building industry, that there is a higher risk of the identified building element containing asbestos.

As Asbestos Reporting is outside the scope of this report, we advise that you consider a separate Asbestos Inspection and Condition Audit, which can include the taking of samples for definitive confirmation of the presence of Asbestos.

In the interim, the client is advised to act with caution, especially when considering any damage to building materials general wear and tear renovations extensions demolition and general maintenance activities due to the suspected presence of Asbestos.

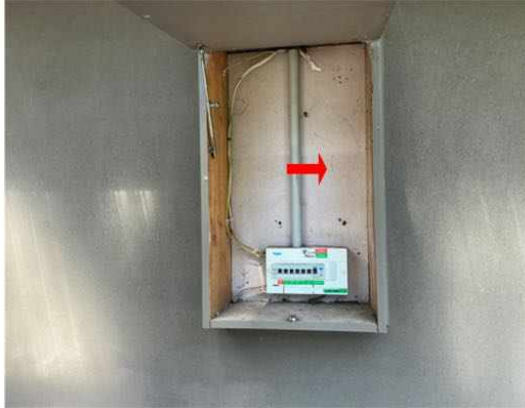
Defects 1.02

Building:	Main Building
Location:	Electrical Switchboard
Finding:	Asbestos - Suspected ACM Identified on Site
Information:	Reporting on Asbestos is outside the Scope of this Report. This suspected defect is highlighted as a caution only. We suspect, based on our experience in the building industry, that there is a higher risk of the identified building element containing asbestos.

As Asbestos Reporting is outside the scope of this report, we advise that you consider a separate Asbestos Inspection and Condition Audit, which can include the taking of

samples for definitive confirmation of the presence of Asbestos.

In the interim, the client is advised to act with caution, especially when considering any damage to building materials general wear and tear renovations extensions demolition and general maintenance activities due to the suspected presence of Asbestos.

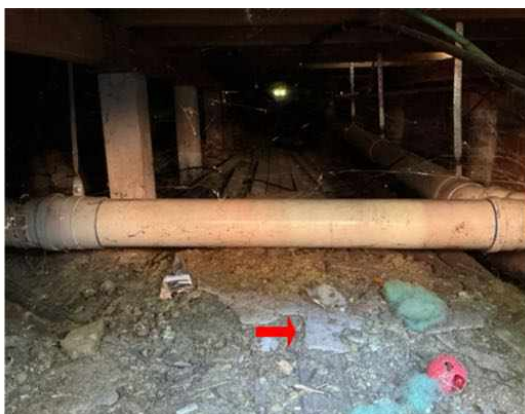
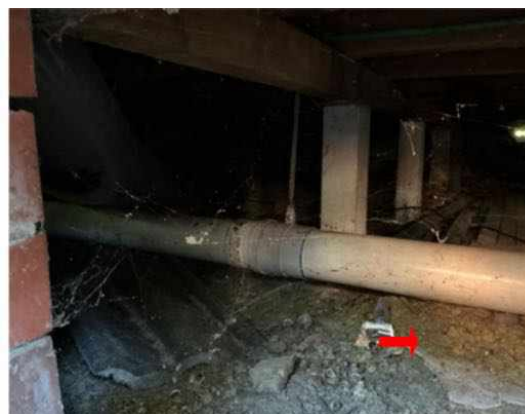
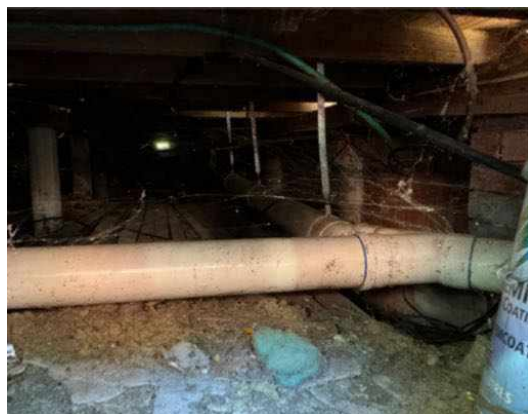
Defects 1.03

Building:	Main Building
Location:	Subfloor
Finding:	Asbestos - Suspected ACM Identified on Site
Information:	Reporting on Asbestos is outside the Scope of this Report. This suspected defect is highlighted as a caution only. We suspect, based on our experience in the building industry, that there is a higher risk of the identified building element containing asbestos.

As Asbestos Reporting is outside the scope of this report, we advise that you consider a separate Asbestos Inspection and Condition Audit, which can include the taking of samples for definitive confirmation of the presence of Asbestos.

In the interim, the client is advised to act with caution, especially when considering any damage to building materials general wear and tear renovations extensions demolition and general maintenance activities due to the suspected presence of Asbestos.

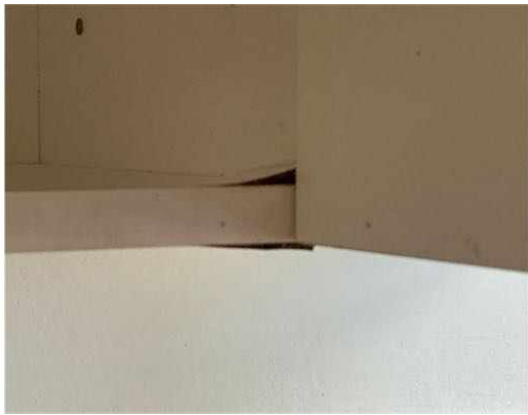
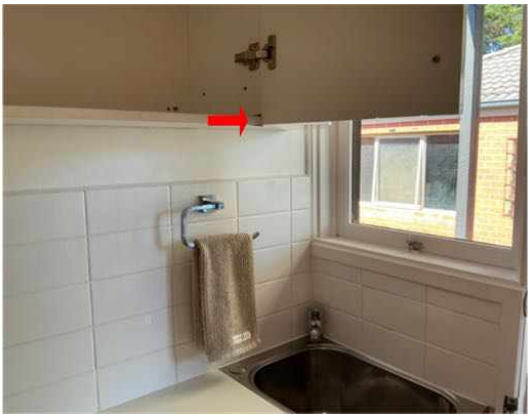
Defects 3.01

Building:	Main Building
Location:	Laundry
Finding:	Building element - Swollen
Information:	Swollen building elements generally indicate that the building materials have been affected by excessive moisture over a prolonged period of time, and have swollen as a result. The formation and development of mould/fungi or mildew is also a likely consequence of excessive moisture, which may pose major respiratory issues for occupants, particularly the elderly, the very young and those with existing illnesses and could be potential health safety hazards. In these cases an appropriately qualified inspector/tester should also be contacted for advice and/or technical assistance.

The structural integrity of swollen building elements can not be guaranteed, and further damage is likely to develop if left unmanaged. Excessive moisture is likely to lead to the development of secondary damage to any associated building elements, which may necessitate major repair works if prolonged.

Rectification of the cause of the water leak should be addressed prior to any remedial works to the swollen building elements. A licensed plumber should be appointed immediately to identify the cause of the leak and provide advice on remedial works as necessary. Repair and/or replacement of swollen building elements should be conducted as a matter of urgency by a registered builder or qualified carpenter.

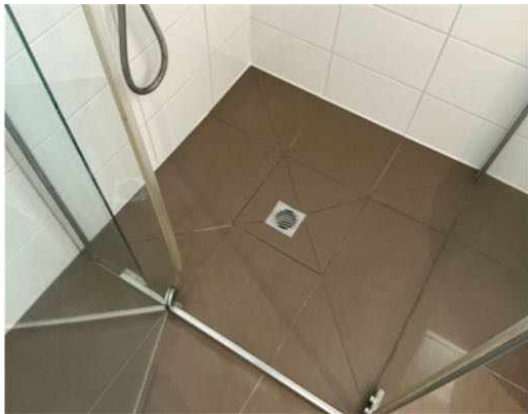
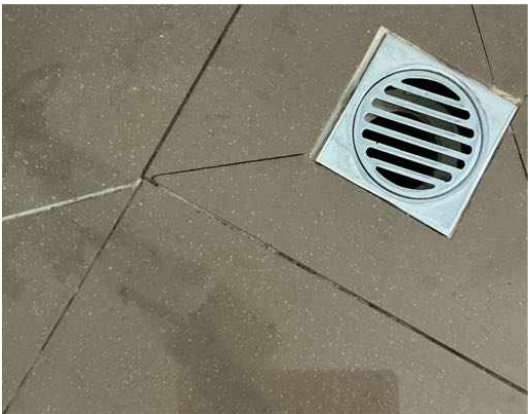
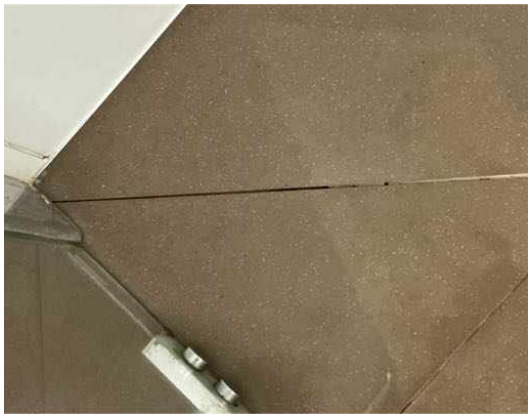
Defects 3.02

Building: Main Building
Location: Bathroom
Finding: Grout - Missing
Information: Grout is missing in this area. Grout is used to protect gaps and crevices in building materials to ensure that they are water-tight and prevent water penetration to the associated structures.

Where grout is missing, a tiling contractor should be appointed immediately to apply grout and re-apply any silicone where necessary. Failure to do so is likely to lead to water damage to the surrounding area.

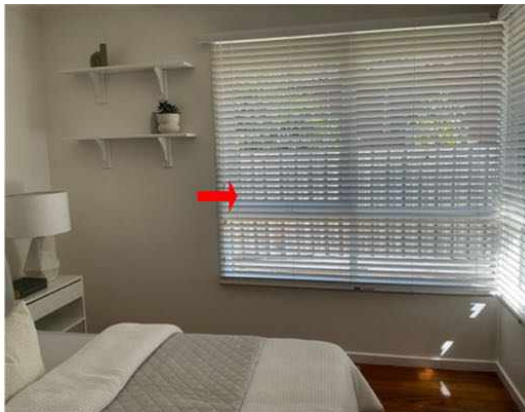
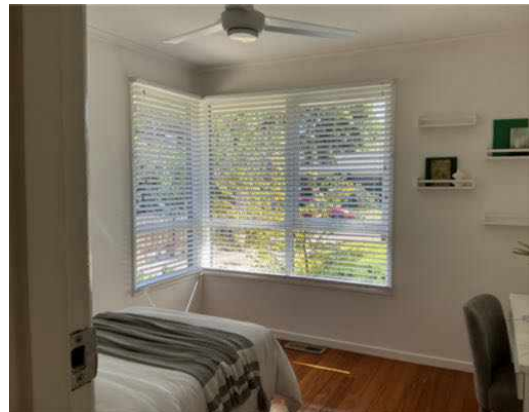
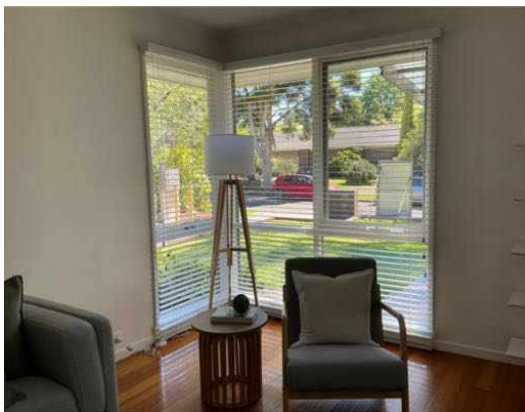
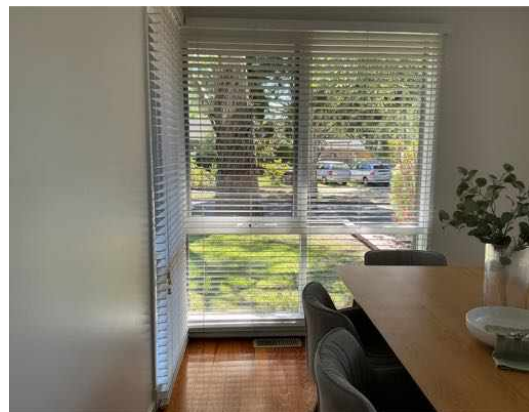
Defects 3.03

Building:	Main Building
Location:	Windows
Finding:	Sticking or jamming
Information:	Some windows were found to be sticking at the time of inspection and some windows were locked, therefore functionality could not be tested .

Building elements which are sticking or jamming are difficult to operate and don't function as intended. There are a variety of causes for sticking and jamming.

The most usual causes are swelling of timbers due to moisture, bulging or bowing of metal frames, or general material deterioration. Generally, sticking and jamming building elements indicate that their frames are uneven or out of level, generally as result of movement to surrounding walls and floors.

Easement will be required, which usually depends on the building materials used. This may involve some sanding and/or application of a lubricant. It will almost always include ensuring the areas are cleaned and free of any debris that may be detrimental to their operational state.

Appointment of a carpenter or general handyman is recommended to rectify any sticking/jamming building elements.

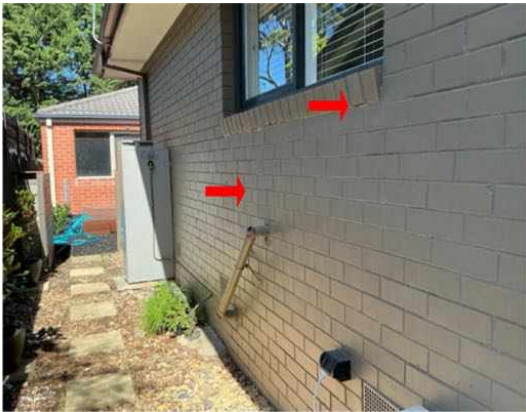
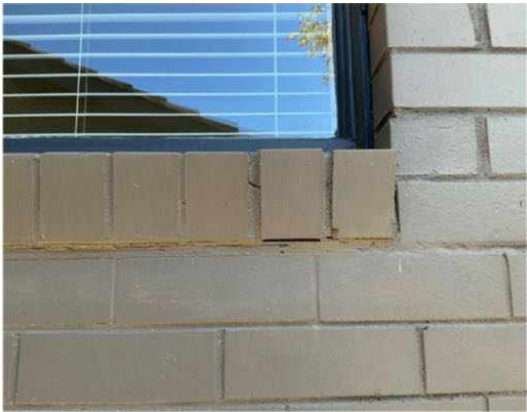
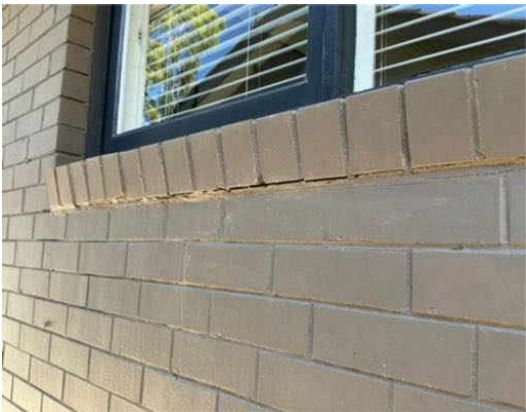
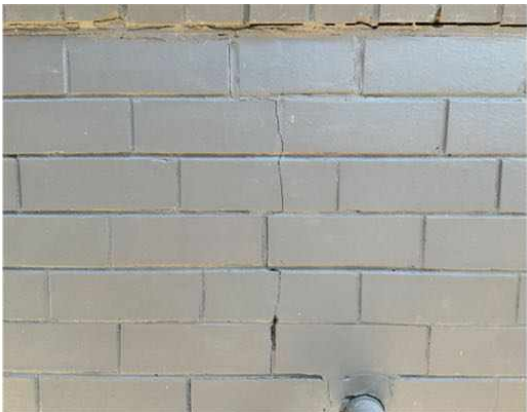
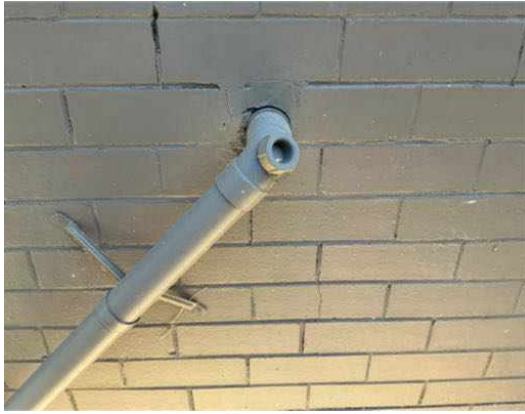
Defects 3.04

Building: Main Building
Location: Exterior walls - left side
Finding: Brickwork - Cracking [Fine]
Information: Although fine cracks are quite noticeable, they are often only considered to be an appearance defect and usually do not indicate any structural damage. Generally, the cause of a fine crack is indicative of a separation between brickwork and mortar throughout the structure, but single bricks may also show cracks of this nature.

Cracking of this nature can generally be repaired with minor filling and should be conducted by a qualified bricklayer.

Always contact a building inspector should cracks widen lengthen or become more numerous.

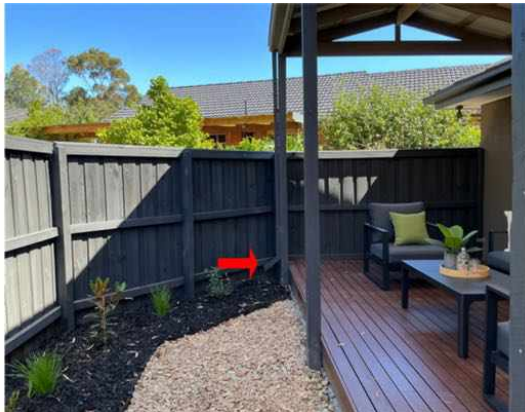
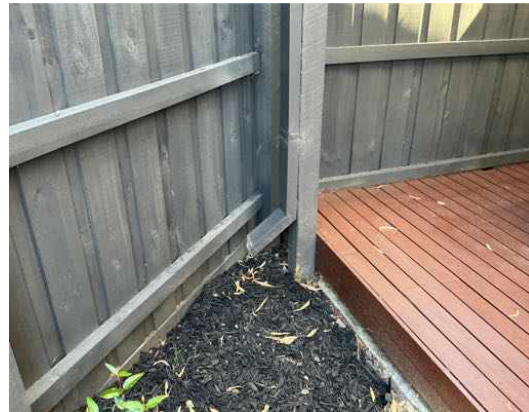
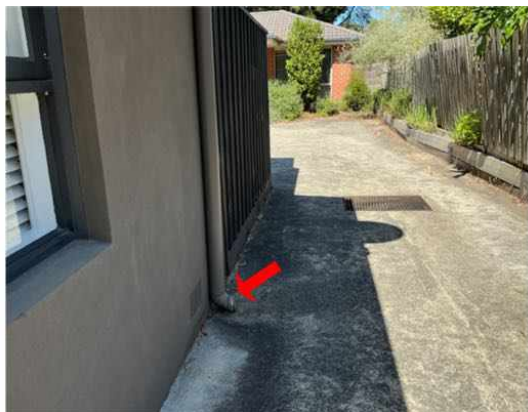
Defects 3.05

Building:	Main Building
Location:	Rear and side Elevation
Finding:	Stormwater drain - Not connected
Information:	The roof plumbing is not adequately connected to stormwater drainage on the site. This disconnection negatively impacts the functional capacity of the roof plumbing.

Where roof plumbing doesn't drain adequately, the area at the base perimeter can become excessively damp, potentially creating an environment that is susceptible to rust and corrosion of surrounding building elements, as well as attracting termites and other pests.

It is highly recommended that a plumber be appointed to further inspect the area and to install adequate drainage equipment where necessary.

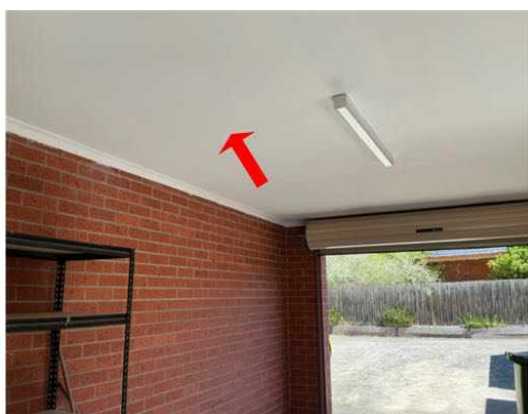
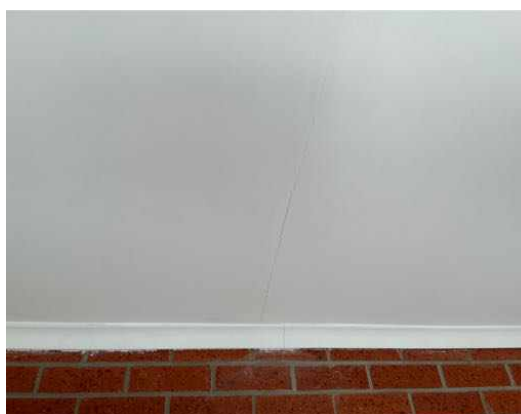
Defects 3.06

Building:	Garage
Location:	Garage
Finding:	Cracking - Damage Category 1 - Fine (up to 1mm)
Information:	Although fine cracks are quite noticeable, they are often only considered to be an appearance defect, and usually do not indicate any structural damage. Generally, the cause of a fine crack is indicative of a separation between building materials and finishes (e.g. paint, plaster, etc.) along joints.

Cracking of this nature can generally be repaired with minor sanding, filling and/or repainting. Such works should be performed by a qualified painter or a general handyman.

Monitoring of all cracking should be conducted frequently. Always contact a building inspector should cracks widen, lengthen, or become more numerous.

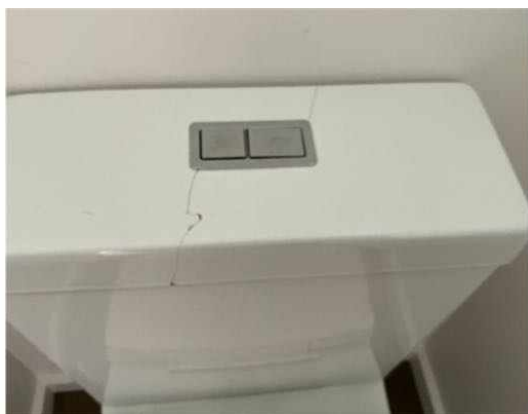
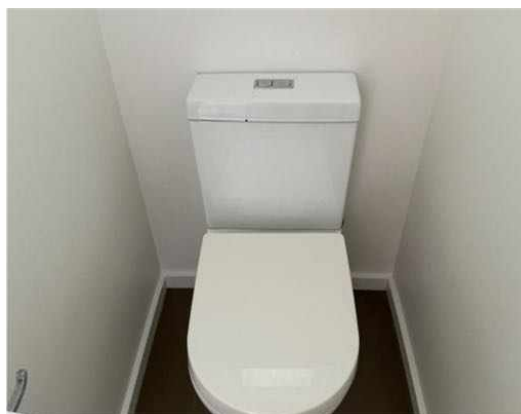
Defects 3.07

Building:	Main Building
Location:	Toilet (WC)
Finding:	Toilet- Cracked
Information:	Cracking was evident to the toilet at the time of inspection, which is suspected to have

been by minor impact damage and age. While the cracking appears to be minor, this will continue to deteriorate and may begin to leak if not replaced.

As the cracking provides potential for water leaks, secondary water damage may occur to associated cabinetry, walls or flooring, if the cracking is left unmanaged.

Consultation with a plumber regarding replacement is required. Remedial works may be required to protect against any further damage.

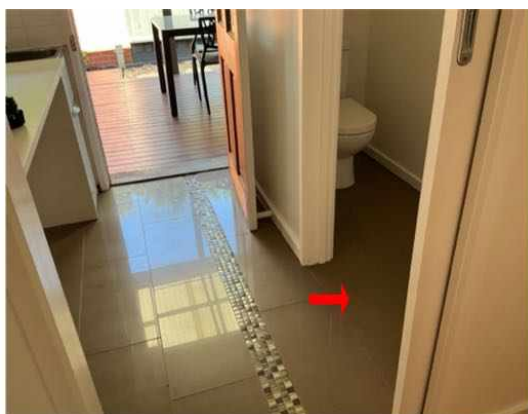
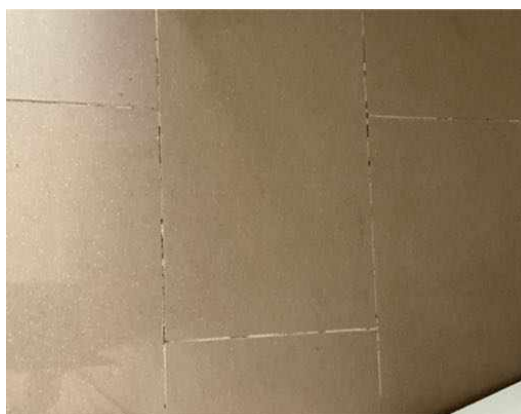
Defects 3.08

Building:	Main Building
Location:	Toilet (WC)
Finding:	Grout - Missing
Information:	Grout is missing in this area. Grout is used to protect gaps and crevices in building materials to ensure that they are water-tight and prevent water penetration to the associated structures.

Where grout is missing, a tiling contractor should be appointed immediately to apply grout and re-apply any silicone where necessary. Failure to do so is likely to lead to water damage to the surrounding area.

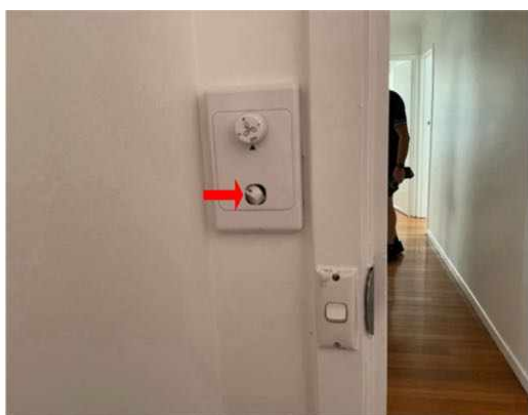
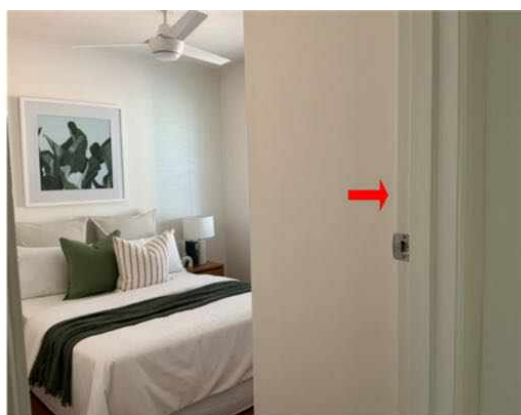
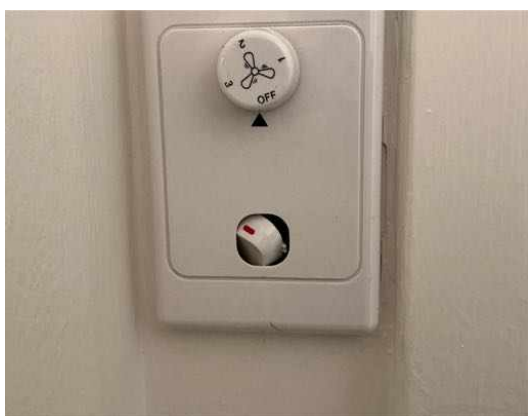
Defects 3.09

Building: Main Building
 Location: Bedroom
 Finding: Building element - Damaged
 Information: Breakage occurs generally when the building materials have either aged and decayed, or as a result of damage (accidental or deliberate).

Repair and/or replacement of broken elements is advised to ensure that additional secondary defects do not arise as a consequence. Such works are necessary, as all building elements play a key role in the operation and function of the overall structure and its performance.

A relevant tradesperson should be appointed to repair or replace the affected building element prior to any subsequent damage being caused.

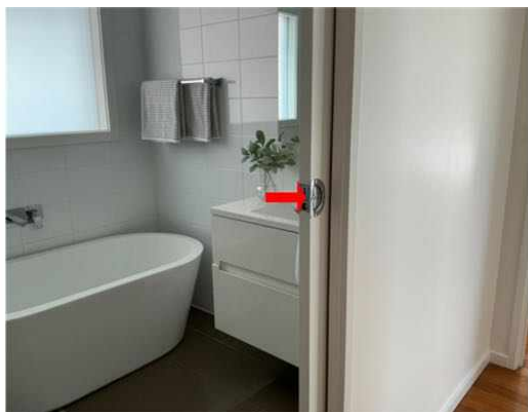
Defects 3.10

Building: Main Building
 Location: Bathroom
 Finding: Door - stiff to slide
 Information: The door to this area was difficult to operate at the time of inspection. This is likely due to damaged wheels which help the door to operate in a smooth fashion.

operational level to ensure user comfort and safety. Restricted function of the door may also pose as a potential safety hazard if required for emergency egress from the building.

Generally, factors such as general age of the building element and a lack of maintenance are the usual causes for this type of defect.

Replacement of door running hardware may be required, as well as minor repairs and cleaning. A registered builder or general handy person will be required to repair the sliding door.

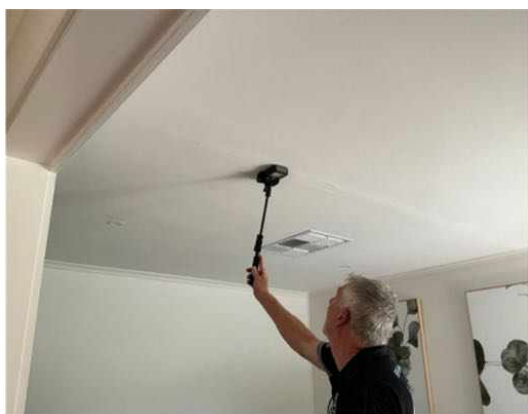
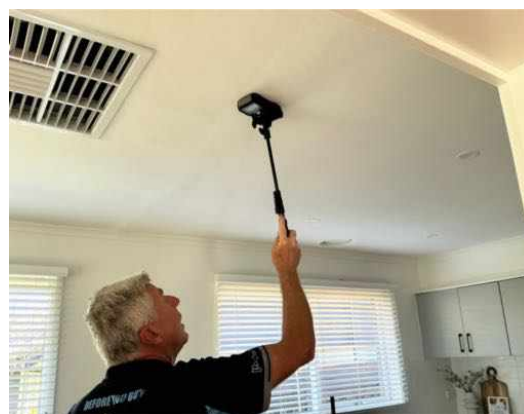
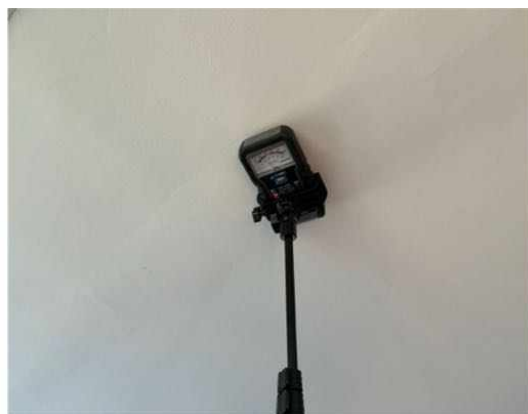
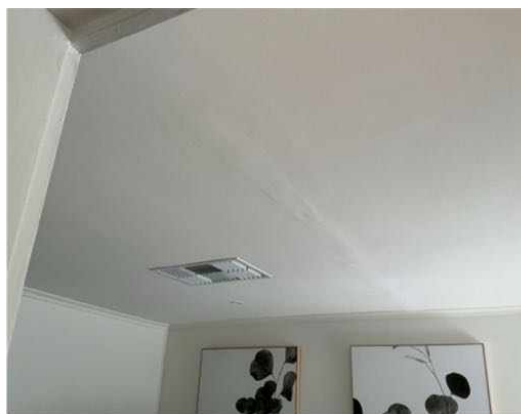
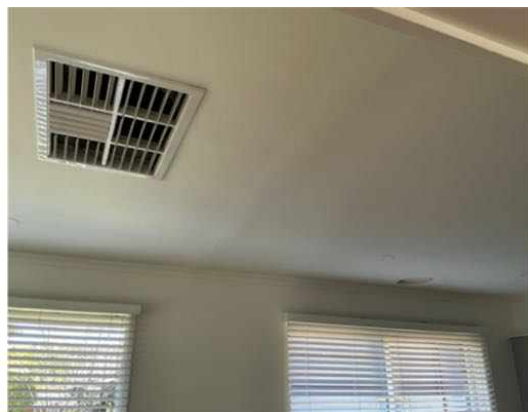
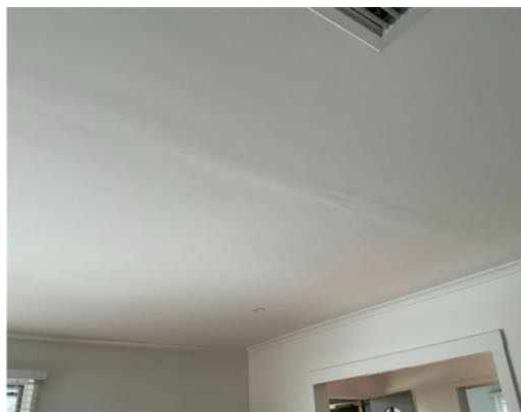
Defects 3.11

Building:	Main Building
Location:	Lounge Room and kitchen
Finding:	Plasterboard finish - defective
Information:	The finish of the plaster in the identified area is defective as it falls below Level 4 category finish as defined in AS 2589.1 Section 6.6 Levels of Finishes for Plasterboard Surfaces. The key features of a Level 4 finish include: joints and fasteners adequately concealed joints and interior angles to have tape embedded in joint compound and at least 2 coats of joint compound to each joint angle fasteners accessories. A level 4 finish should be smooth and free of tool marks or ridges.

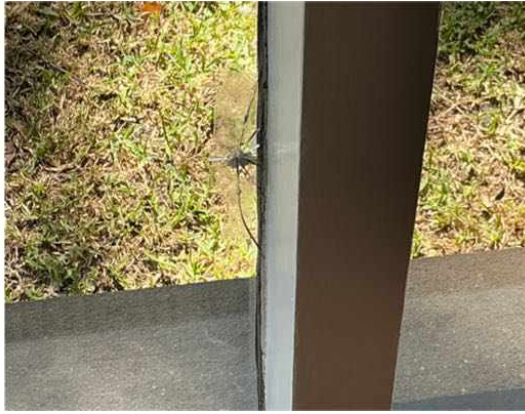
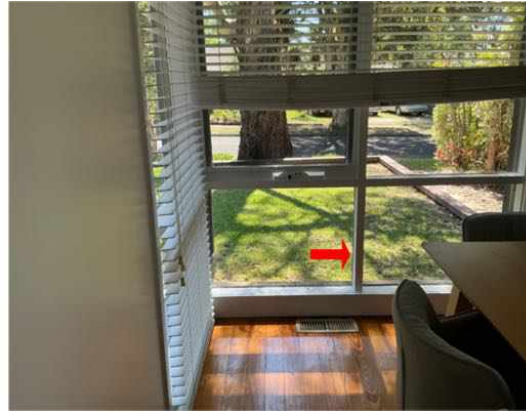
Defects 3.12

Building:	Main Building
Location:	Dining Room
Finding:	Window - Cracked
Information:	Cracks were identified in the window in this area. Cracking in windows is generally the result of impact damage, and is likely to develop further when left unmanaged.

The likelihood of this windowpane further cracking and shattering is increased exponentially, providing a safety hazard in the area. The cracked window also impairs the weather tightness of the building, creating potential for minor water leaks.

A qualified glazier is required to repair the window as soon as possible. Depending on the extent of the cracking, replacement of the window may be required. Please be advised that any persons coming into contact with the cracked window should do so with due caution to avoid any personal injury that may ensue.

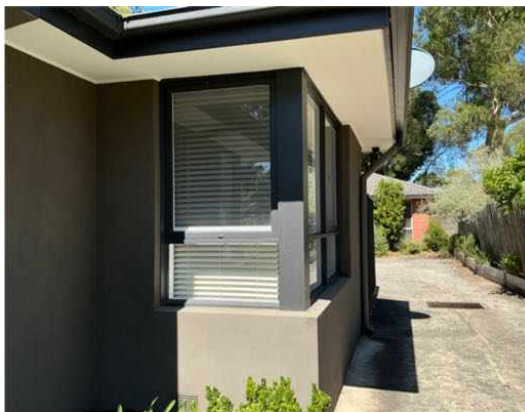
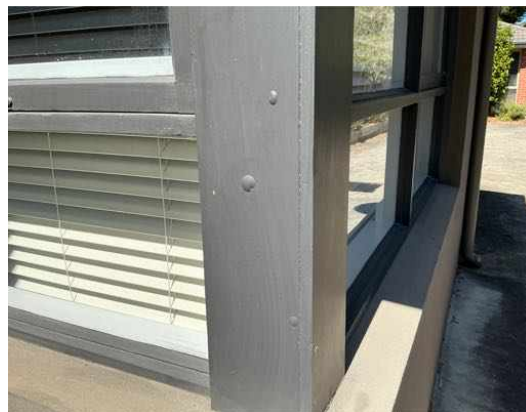
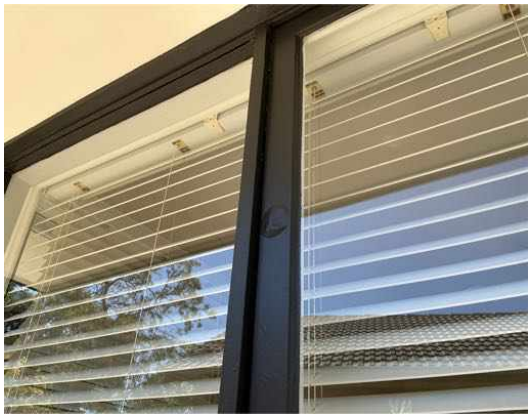
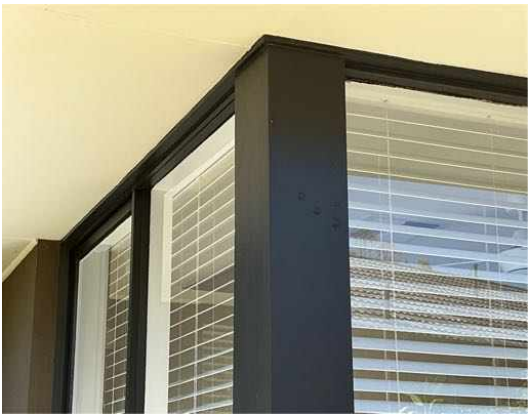
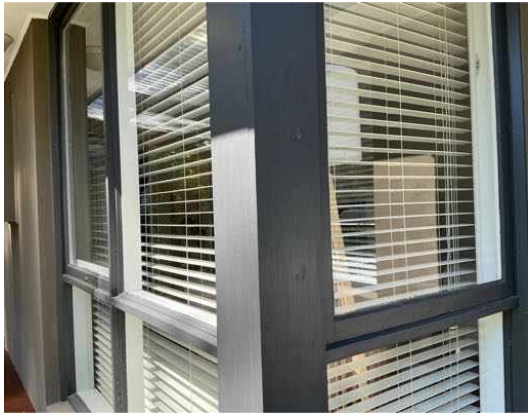
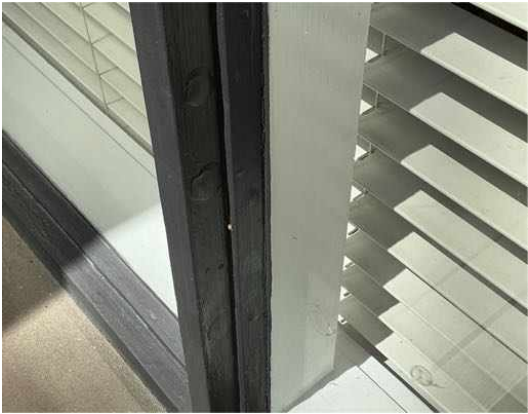
Defects 3.13

Building:	Main Building
Location:	All Areas
Finding:	Painted surface - Bubbling
Information:	Sections of paint in this area was found to have bubbled and deteriorated. Paint bubbling is generally an indication of excessive moisture in the area, that is currently hidden by the painted surface.

The presence of excessive moisture can have major implications on associated building elements if left unattended. While only seemingly minor at this stage, the damage cannot be determined due to the paint obstructing any further inspection of the damage.

It is highly advised that the affected paint be cleaned to allow a further, more invasive inspection by a licensed plumber. Failure to act on this defect may necessitate major works in the future.

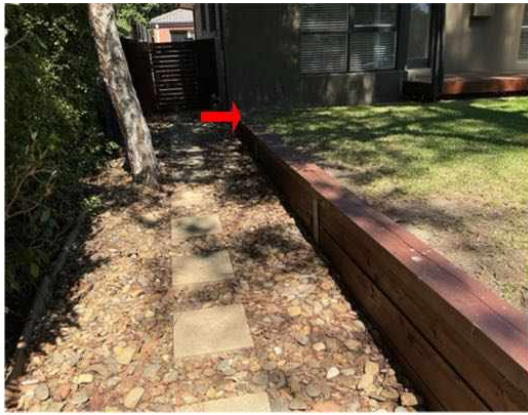
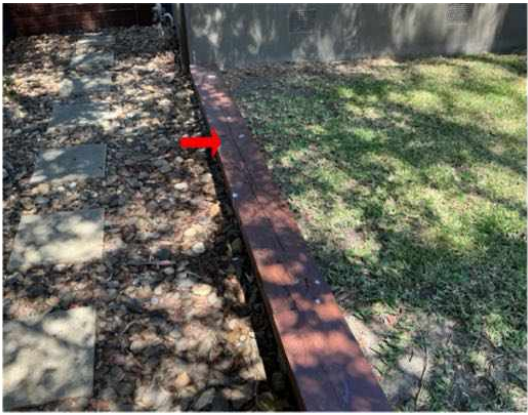
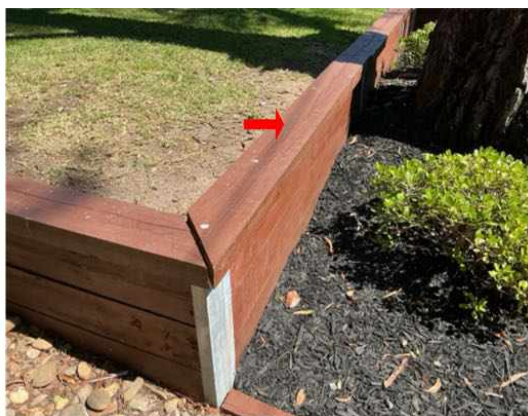
Defects 3.14

Building: Main Building
 Location: Retaining wall capping
 Finding: Timber capping to retaining wall - Loose
 Information: The fitting in this area is loose and requires adjustment to tighten.

If left unmanaged, the fitting may further deteriorate, causing potential for the development of other minor secondary defects.

A relevant tradesperson should be appointed to perform these rectification works at discretion of the client.

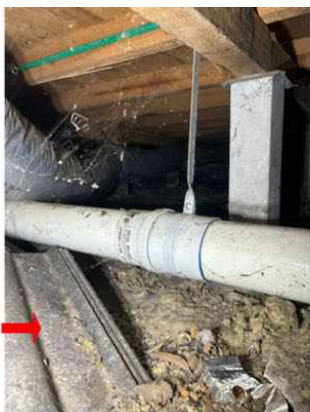
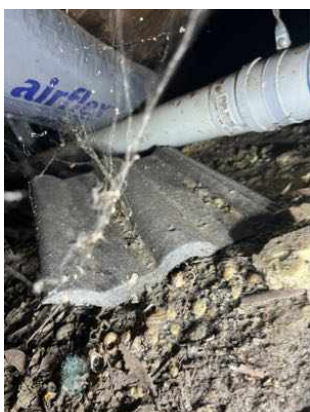
Defects 3.16

Building:	Main Building
Location:	All Areas
Finding:	Subfloor - Debris
Information:	An array of debris was found in the subfloor area at the time of inspection. Debris in this area restricts subfloor ventilation and creates potential for concealed pest entry. Stored timbers and other materials may also make the area susceptible to termite

activity and wood rot.

A clear and empty subfloor will be better ventilated and easier to maintain in a dry condition. The removal of any timber debris is vital in minimising the risk of termite or wood borer activity.

Debris in the subfloor should be removed as soon as possible. Depending on the location and amount of debris and stored items, the homeowner may elect to undertake this task. Alternatively there are a large number of rubbish removal subcontractors that could undertake these works.

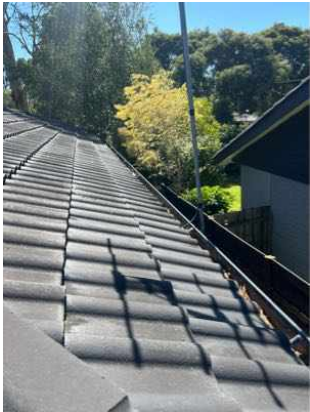
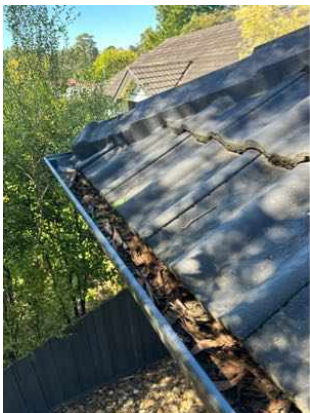
Defects 3.17

Building:	Main Building
Location:	All Areas
Finding:	Gutters - Blocked
Information:	Roof plumbing structures, such as guttering and downpipes, should be free of all debris to prevent blockages. Blockages of the guttering and downpipes will lead to pooling and accumulated water overflows, which is likely to subsequently flood eaves and exterior walls.

Blocked gutters are likely to lead to high levels of moisture in the affected areas. Such moisture will not only cause rust and decay of the associated building materials, but can also provide conditions that are conducive to termite and timber pest activity. Blockages in gutters should therefore be removed immediately to ensure dry conditions are maintained.

Consult a Licensed Plumber for further specific advice on remedial works that may be required. In the interim, it is highly advised that blocked gutters be removed by the homeowner or a general handyperson as a matter of urgency.

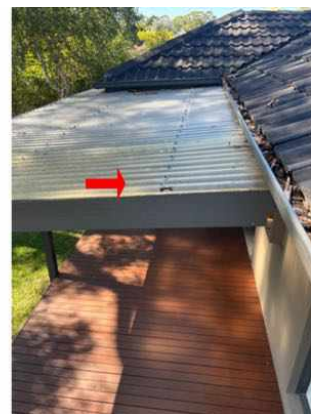
Defects 3.18

Building:	Main Building
Location:	Porch
Finding:	Polycarbonate sheeting - Damaged
Information:	The polycarbonate sheeting has deteriorated as a result of exposure to weather conditions over a prolonged period of time. Exposure to elements, such as heavy rain and hailstorms, is likely to damage polycarbonate sheeting, which is not as strong as other roof coverings.

Further deterioration of the polycarbonate sheeting is likely to occur if left unmanaged. Such deterioration creates potential for water penetration and secondary damage to the internal roofing structure, accelerating deterioration of all associated building elements.

Repair and replacement of several sections of the sheeting is required. Appointment of a roofing restorer is required to perform these works as soon as possible to prevent any further damage being sustained.

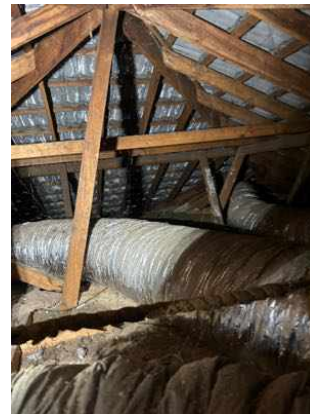
Defects 3.19

Building:	Main Building
Location:	All Areas

Information: Insul-fluff is common in many older homes and is a loose form of insulation that is 'blown' into roof voids. While this type of insulation was considered effective at the time of installation, modern materials have surpassed it as the preferred insulator.

It is highly advised that this insulation be removed and replaced with a more appropriate material. This will ensure that the property is adequately insulated and will promote an increase in energy efficiency within the property. An insulation contractor should be appointed to provide further advice on replacement options and to perform works as necessary.

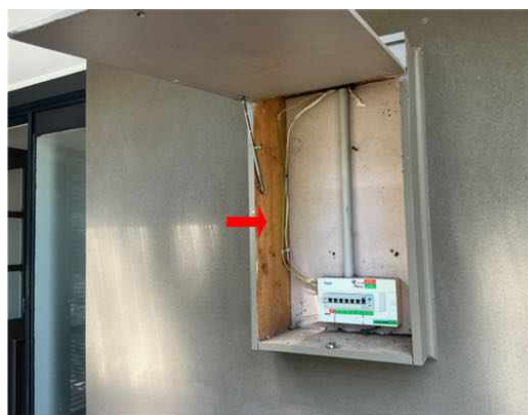
Building: Main Building
 Location: Electrical Switchboard
 Finding: Termite Management System - no evidence of a chemical installation
 Information: The application of a post-construction chemical termite barrier is highly recommended for all properties, particularly if live termite activity has been found on the site previously. Such barriers are highly effective in preventing termite attack on any timber building elements throughout the property.

The client may consider gaining further advice from a pest controller as to the costs and procedures involved with this application. It is recommended that obtaining such advice be a short-term priority.

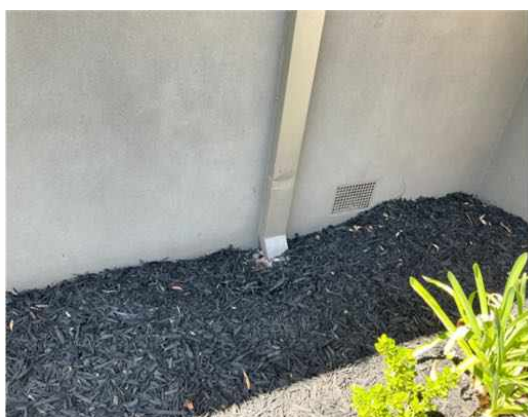
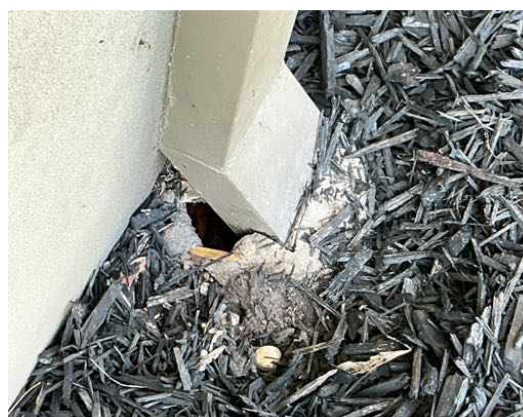
Location:	All Areas
Finding:	Terracotta pipes
Information:	<p>Terracotta drainage pipes (sometimes referred to as clay or vitrified clay pipes) have been used for many many years. The use of clay drainage pipes dates back to the Romans, who used the clay pipe system as it was easy to manufacture, straightforward to lay and, for the most part, reliable. However, due to the rigid and brittle nature of clay or terracotta pipes problems can begin to occur over time. Even if they're functioning fine now, clay pipes will need replacing eventually.</p> <p>The average lifespan of a clay pipe sewer system is 60 years — which means an upgrade is decades overdue for many homes. For your peace of mind you may wish to have your sewer pipes inspected and replaced before a major problem occurs</p>

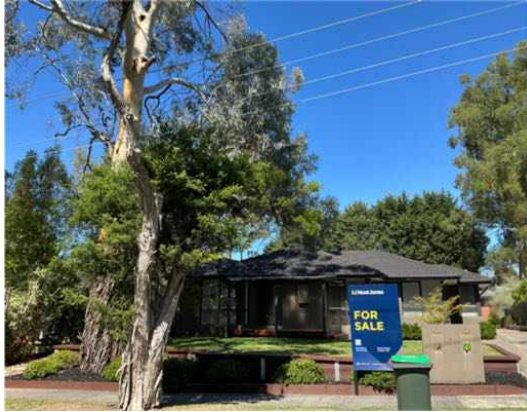
Building:	Main Building
Location:	Roof Exterior
Finding:	Trees - Overhanging and filling gutters
Information:	Overhanging trees often result in excessive amounts of leaf debris accumulating in gutters.

Gutters are a critical part of the building's management of storm water and rain. It is therefore important that they be kept clear to prevent secondary damage to associated building elements, including exterior and interior walls, ceiling linings and any adjoining building elements. Where gutters are blocked, pooling of rainwater is likely to occur, fast-tracking rust and corrosion of the roof plumbing elements.

It is highly advised that all overhanging tree branches be removed as soon as possible to prevent any further damage. Repair and/or replacement of sections of damaged guttering may also be required where the extent of the damage necessitates.

Such works should be performed by the homeowner; however, appointment of a landscape contractor or an arborist may be required. Consultation with a licensed roof plumber is required where guttering has been damaged.
