## Building Inspection Report VR

Inspection Date: Thu, 15 Jan 2026

Property Address: 50 Jocelyn Dr, Eumundi QLD 4562,  
Australia

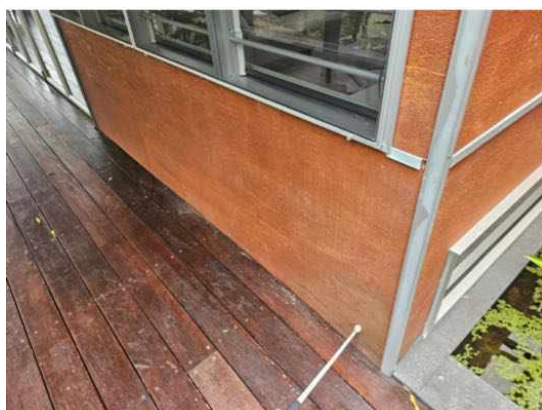
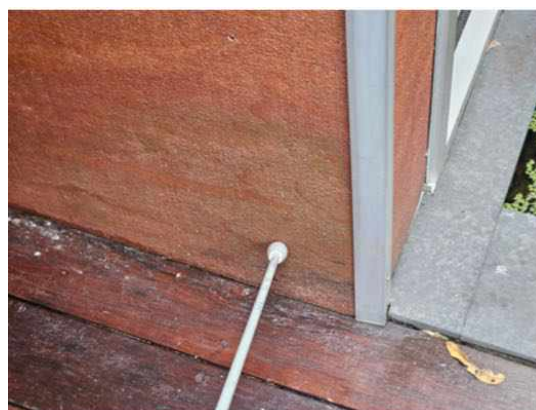
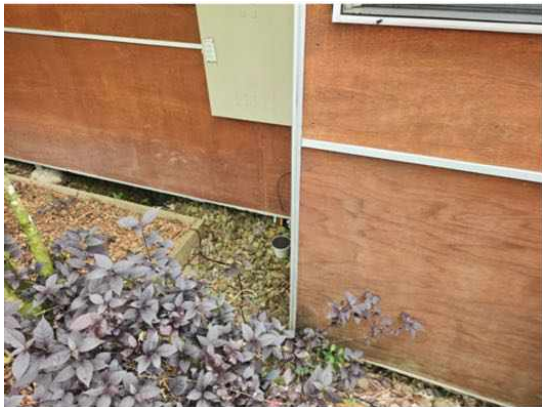
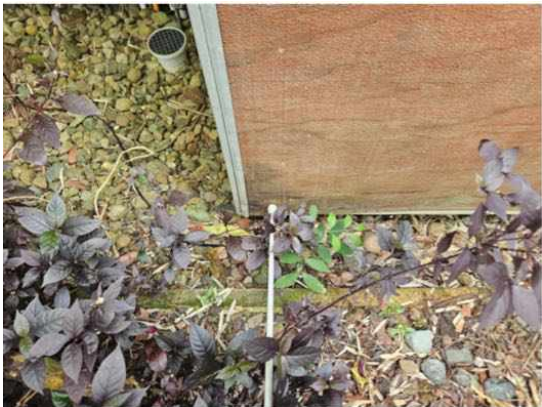
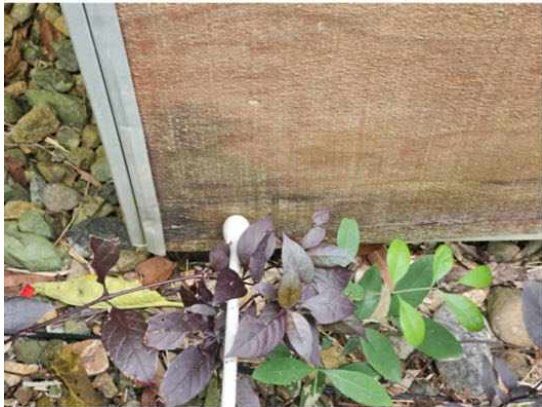
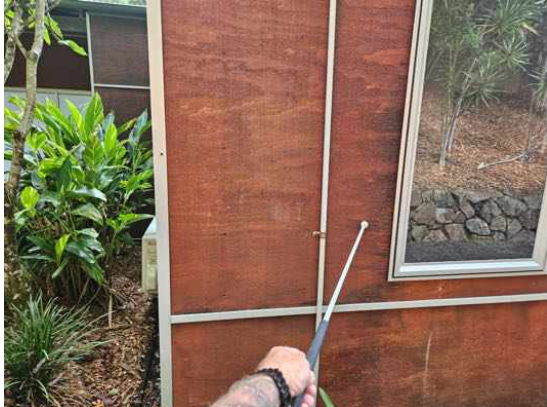
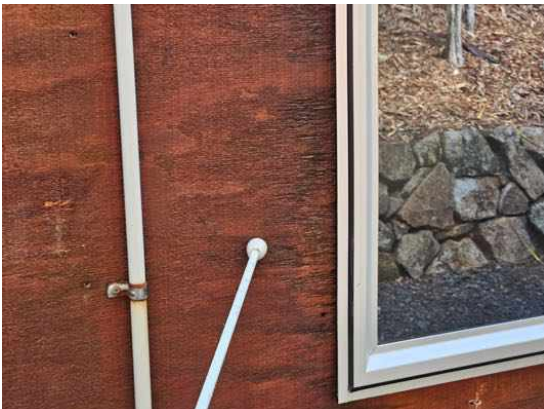
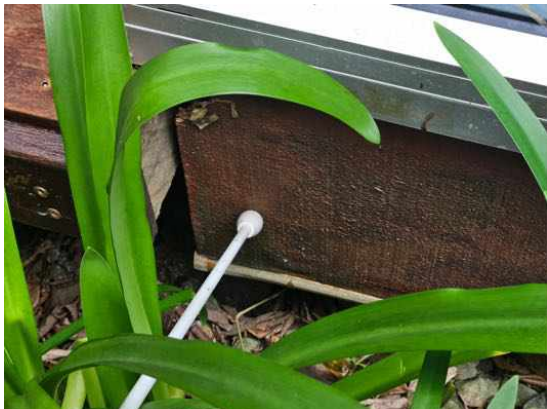
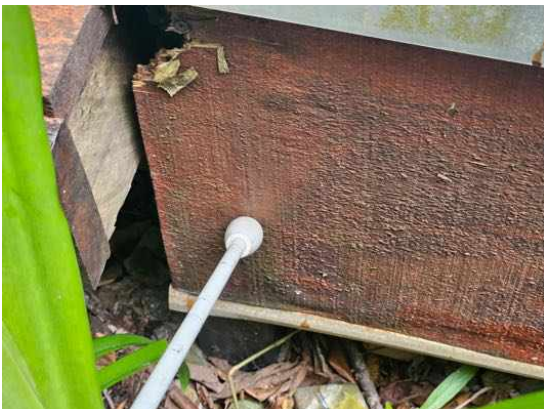
#### Defects 3.01

Building:	Main Building
Location:	Cladding as shown
Finding:	Wood rot / fungal decay
Information:	The timber plywood cladding shows evidence of wood rot developing in sections of the timber.

Wood rot, also known as Fungal Decay, occurs when timbers and other cellulose building materials are exposed to damp conditions on an ongoing basis. This could be the result of exposure to weathering over a prolonged period of time, or the attraction of excessive moisture from other abutting building materials.

Early intervention and regular maintenance, particularly of exterior timbers, will prolong the useful life of these building elements. Prior to any works being performed, the cause of the moisture that has created the visible wood rot should be identified and addressed in a suitable manner. Replacement of affected timbers may then be a necessary step in protecting surrounding building elements from such deterioration.

A licensed carpenter or licensed builder should be consulted to advise on a solution for the affected building materials.

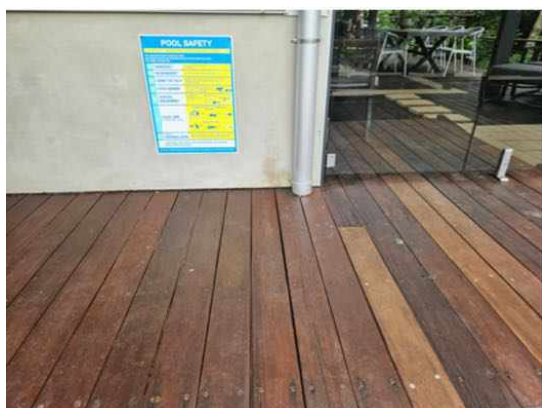
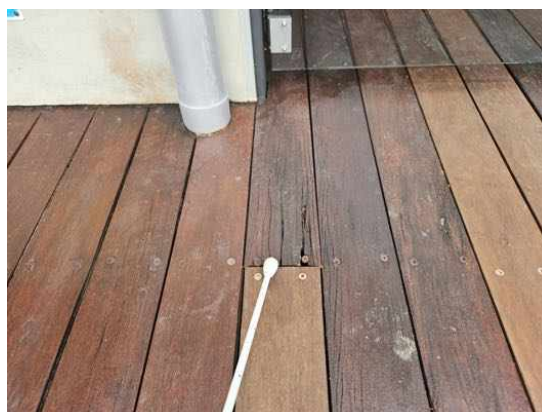
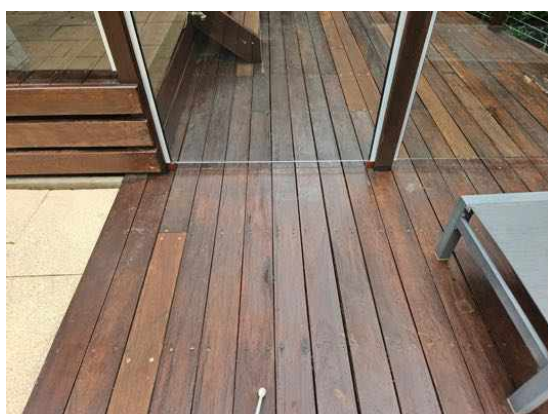
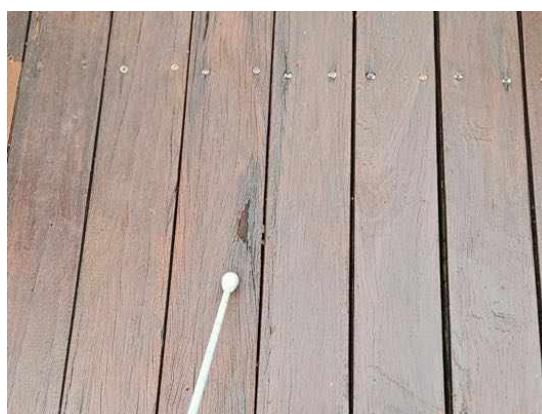
Defects 3.02

Building:	Main Building
Location:	Deck
Finding:	Wood rot / fungal decay. Decking boards
Information:	The timber decking boards of the rear deck shown have visible evidence of wood rot beginning in various sections of the timber.

Wood rot, also known as Fungal Decay, occurs when timbers and other cellulose building materials are exposed to damp conditions on an ongoing basis. This could be the result of exposure to weathering over a prolonged period of time, or the attraction of excessive moisture from other abutting building materials.

Early intervention and regular maintenance, particularly of exterior timbers, will prolong the useful life of these building elements. Prior to any works being performed, the cause of the moisture that has created the visible wood rot should be identified and addressed in a suitable manner. Replacement of affected timbers may then be a necessary step in protecting surrounding building elements from such deterioration.

A licensed carpenter or licensed builder should be consulted to advise on a solution for the affected building materials.

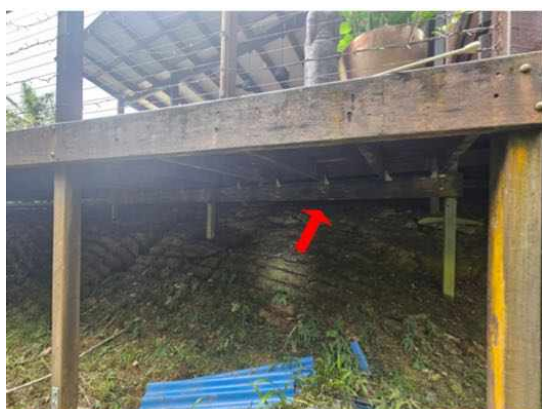
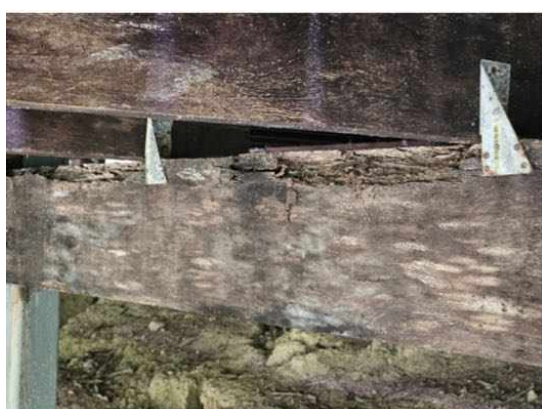
### Defects 3.03

Location:	Deck bearers
Finding:	Wood rot / fungal decay
Information:	The timber deck bearer seen in the photos show evidence of established wood rot in the top section of the timber. This is considered a minor defect at this time due to the percentage of unaffected timber; however, this has the potential to become a major defect if left unattended.

Wood rot, also known as Fungal Decay, occurs when timbers and other cellulose building materials are exposed to damp conditions on an ongoing basis. This could be the result of exposure to weathering over a prolonged period of time, or the attraction of excessive moisture from other abutting building materials.

Early intervention and regular maintenance, particularly of exterior timbers, will prolong the useful life of these building elements. Prior to any works being performed, the cause of the moisture that has created the visible wood rot should be identified and addressed in a suitable manner. Replacement of affected timbers may then be a necessary step in protecting surrounding building elements from such deterioration.

A licensed carpenter or licensed builder should be consulted to advise on a solution for the affected building materials.

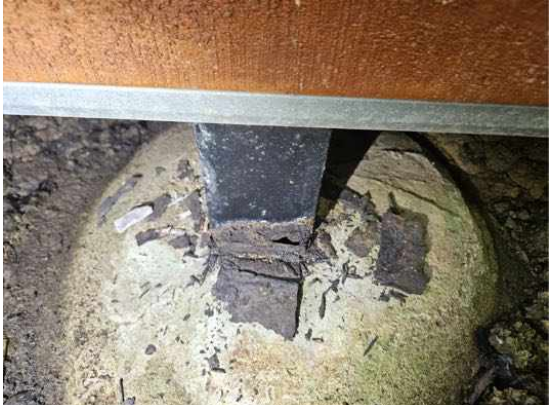
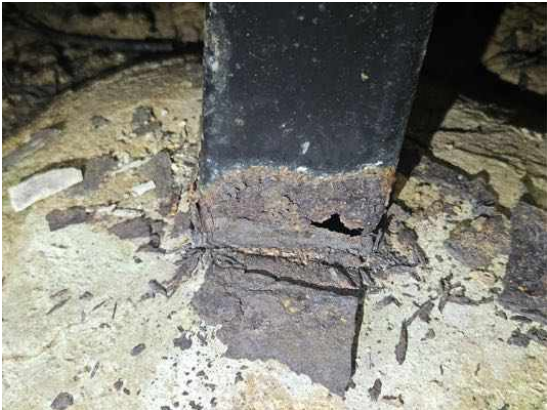
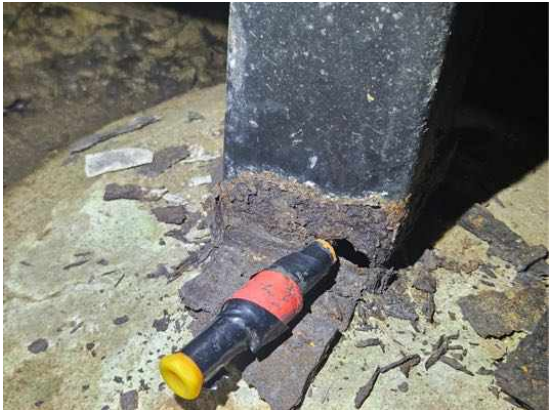
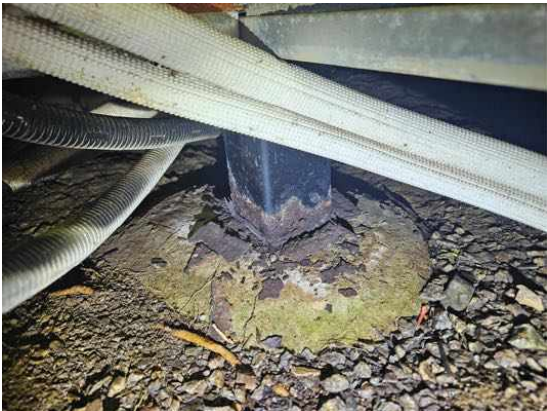
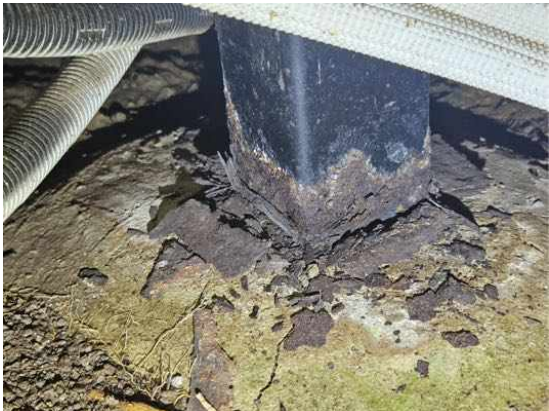
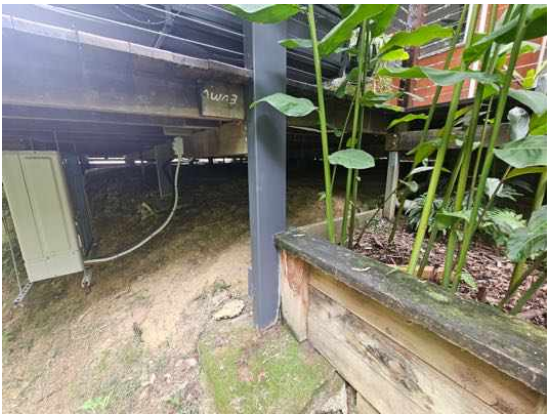
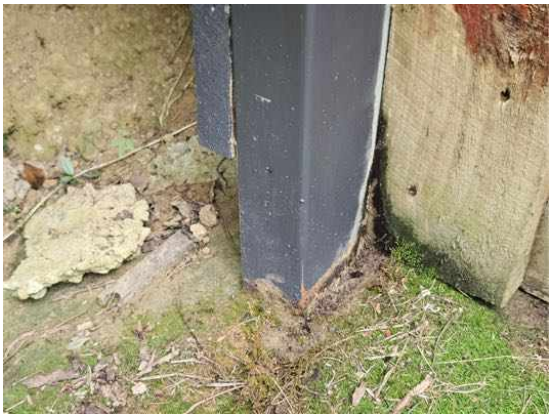
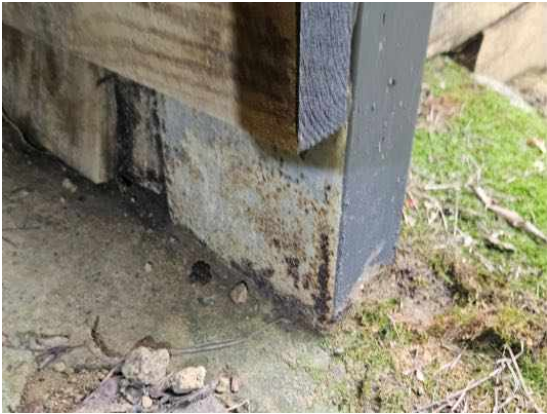
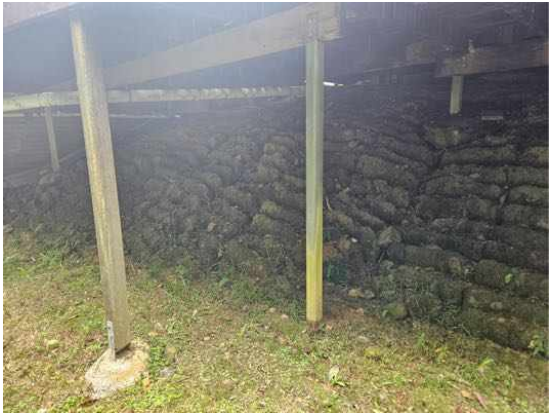
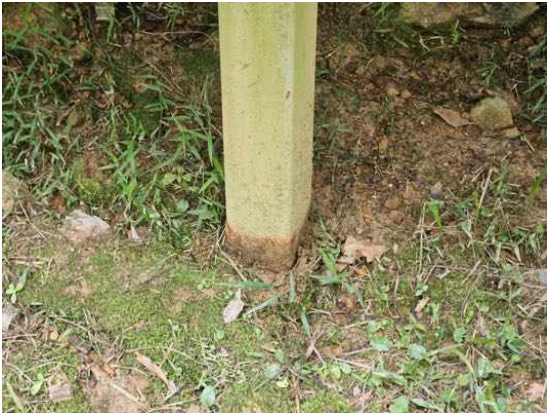
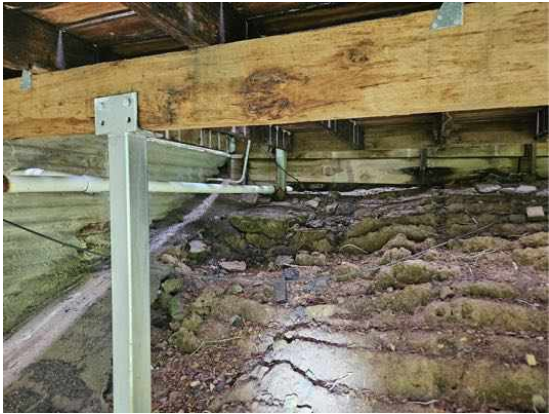
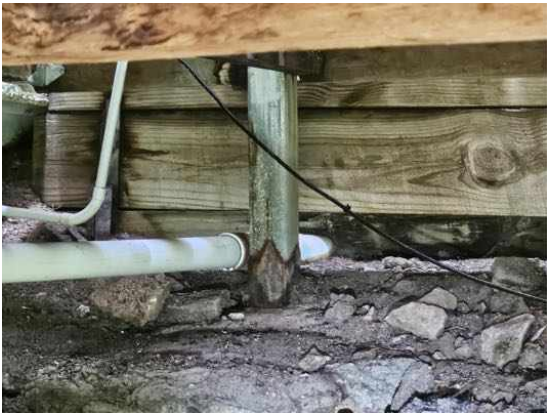
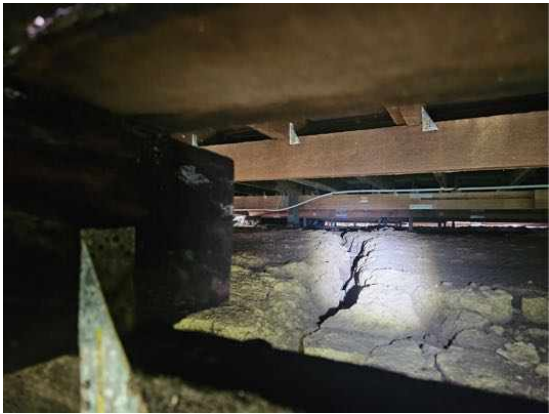
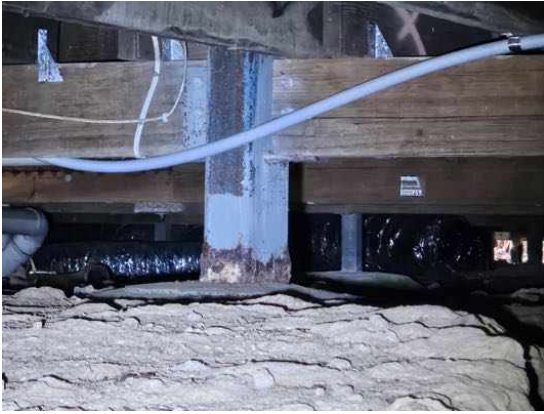
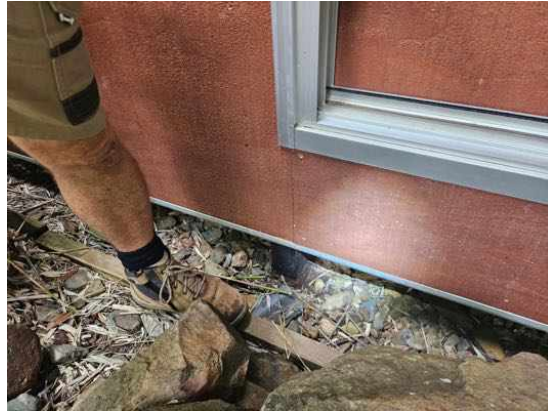
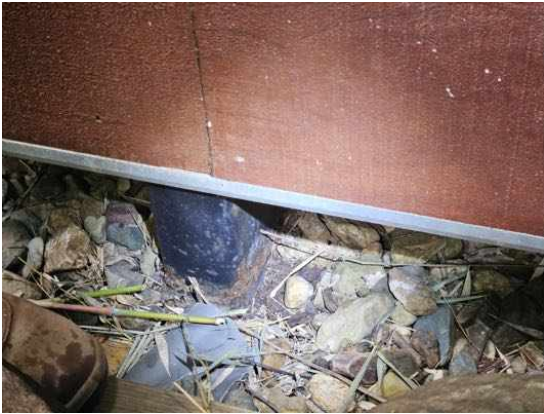
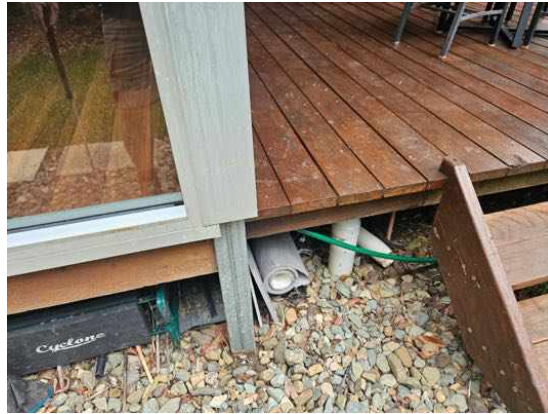
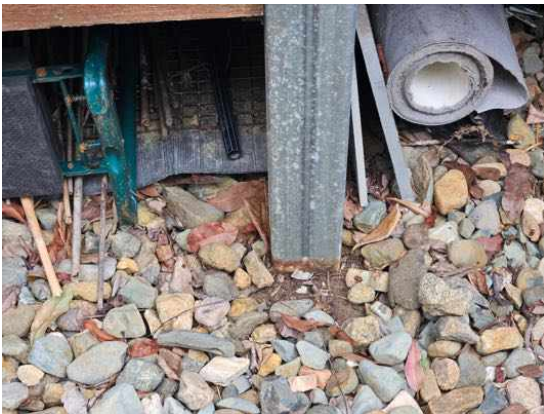
### Defects 3.04

Location: As shown.

Finding: Post base - rusting.

Information: It was noted at the time of inspection that established rust and surface rust is in the bases of the house subfloor stumps. The severely rusted stumps may require replacement and should be assessed by a licensed builder. The stumps affected by surface rust should be treated and coated to prevent possible further deterioration.

A licensed builder and a licensed painter could be engaged to carry out the required task.

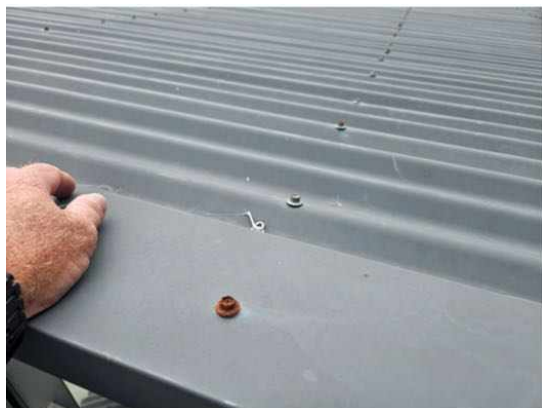
### Defects 3.05

Building:	Main Building
Location:	Random positions
Finding:	Roof screws - rusting
Information:	It was noted during inspection, that throughout the roof surface a small percentage of roof screws are showing signs of rust at varying degrees ranging from minor to moderate.

The roof condition is noted as a minor defect. The screws noted are a low percentage of the roof area and are spaced randomly across the roof surface.

This should be monitored over time, and should the condition worsen, consider replacement of the screws. As roof screws deteriorate they can have an effect on the adjoining roof materials.

A roofing plumber could be appointed at the clients discretion to replace the screws in question.

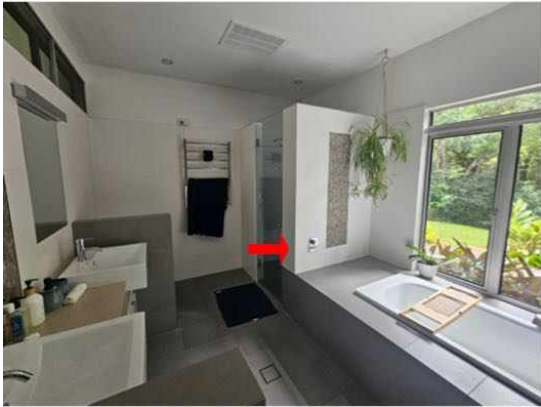
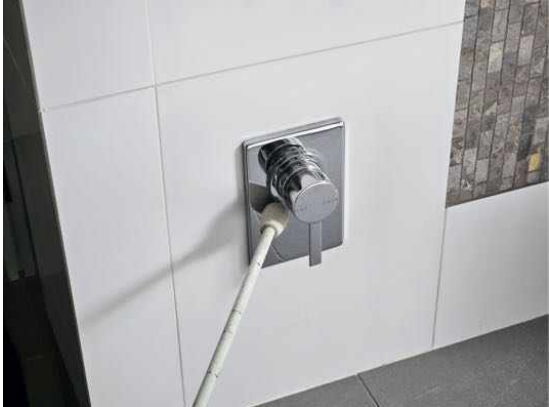
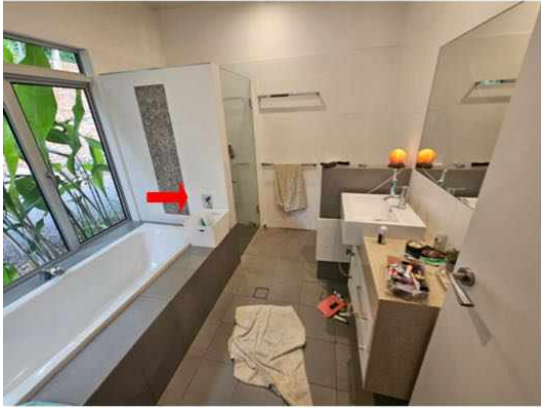
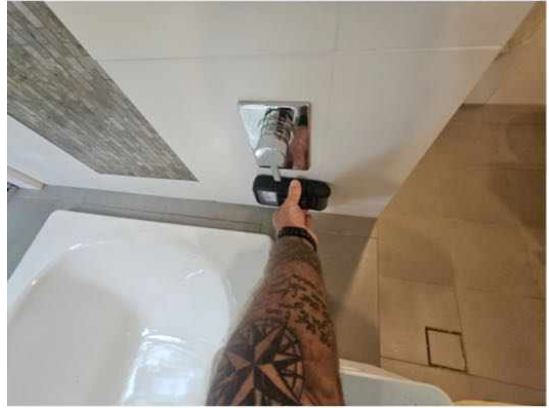
### Defects 3.06

Building:	Main Building
Location:	Bathroom, ensuite
Finding:	Water Hammer
Information:	Evidence of water hammer has been noted to be present in the bath mixers. Water hammer is generally caused by factors that create high water pressure in the affected plumbing system usually evidenced by a banging or vibrating noise during operation of a tap or appliance.

Although water hammer is generally considered to be a minor defect, increased stress by hydraulic shock within the water pipes can cause weaknesses to develop and in worst cases for a pipe to burst. Water hammer can also accentuate the movement of poorly fixed water pipes which can lead to fatigue cracks or friction holes developing.

Securely fixing loose water pipes and installing shock absorbing devices designed to lessen the effect of water hammer, can be a solution for affected water reticulation systems.

A licensed plumber should be appointed to advise on any remedial works as necessary.

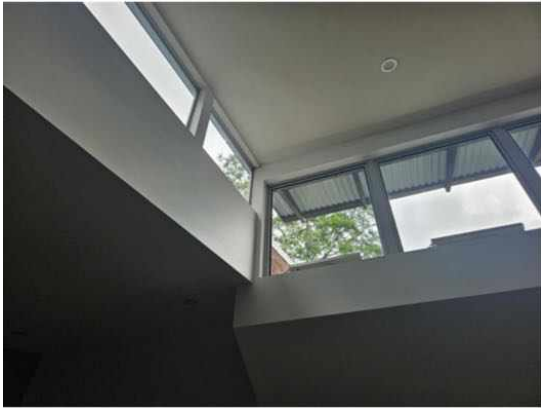
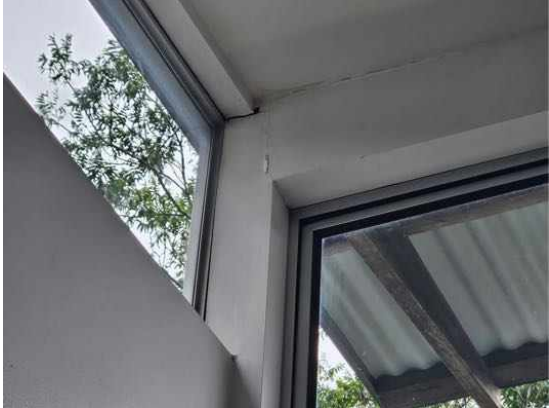
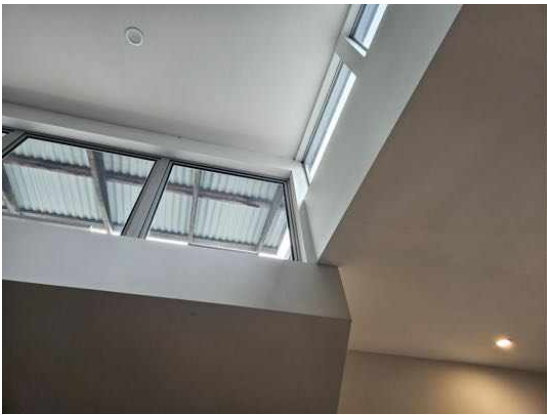
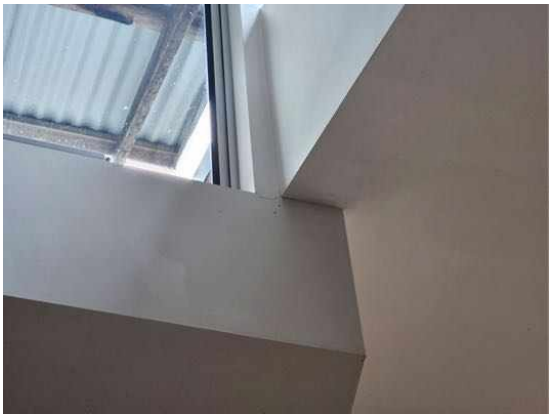
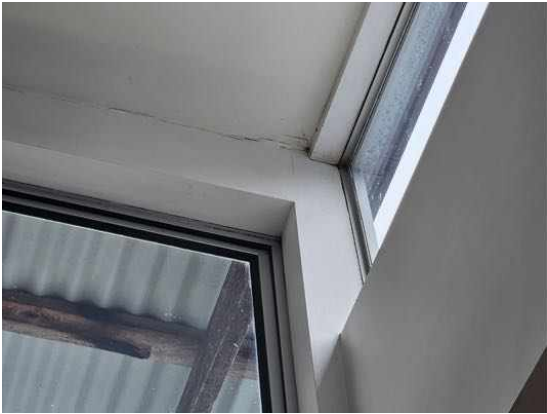
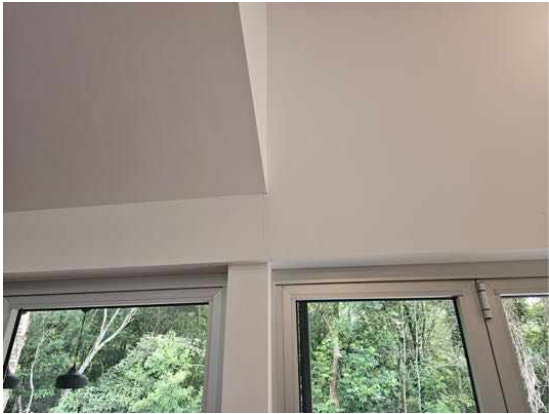
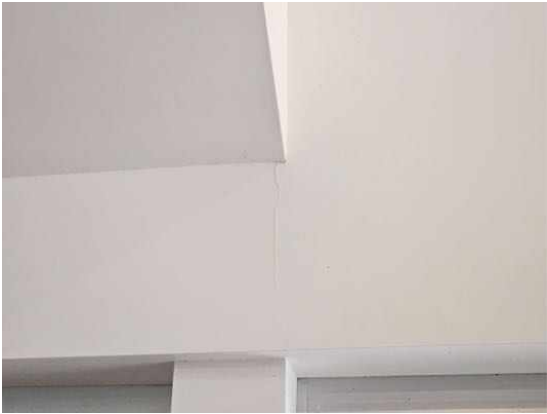
**Defects 3.07**

Building: Main Building  
 Location: As shown  
 Finding: Minor settlement cracking  
 Information: Minor settlement cracking to wall and ceiling linings was observed in the areas photographed at the time of the inspection. Cracking of this nature is expected in this type of building.

These fine but visible cracks can be patched and painted over by an experienced painter or handyman at the clients discretion.

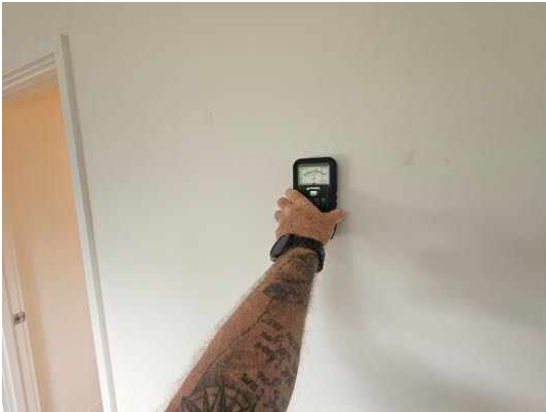
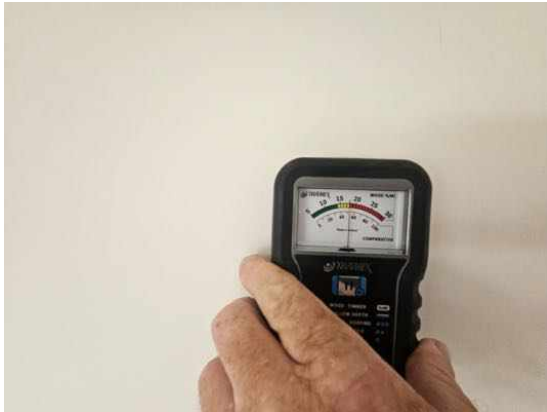
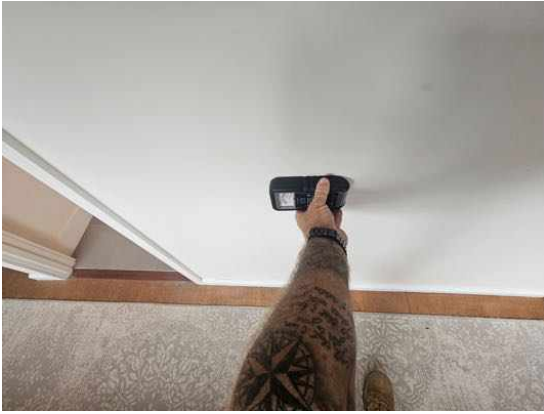
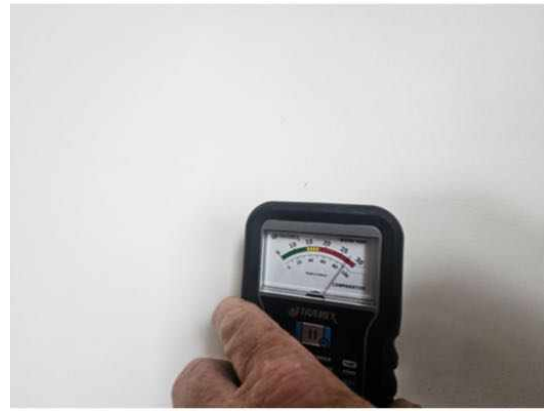
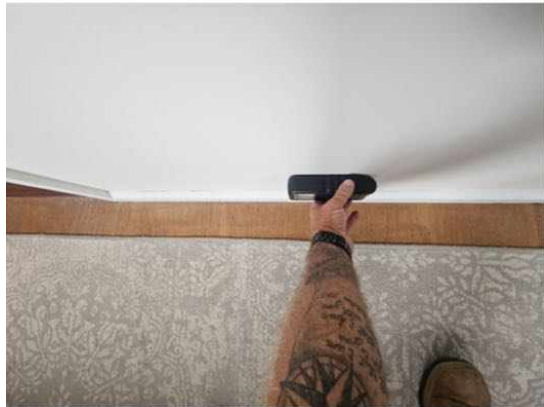
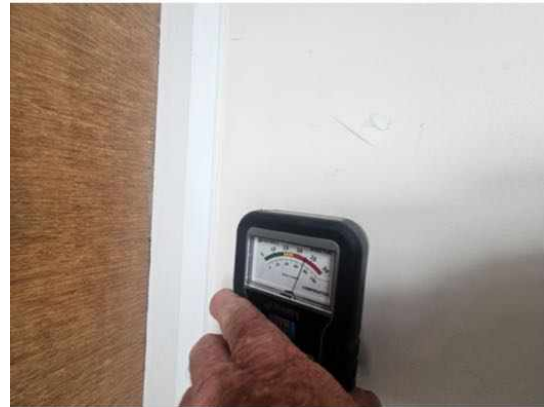
Moisture readings were taken in the showers of the house and secondary dwelling. As these have been recently renovated the readings are not indicative of the true nature of the surface. A period of drying must be allowed for all membranes and adhesives to fully cure before true readings can be used. Some residual moisture was noted in the hallway / bathroom wall of the secondary dwelling.

Building: Out Building  
Location: Bathroom  
Finding: Residual moisture present  
Information: During the inspection of the bathroom of the secondary unit, residual moisture was noted on the hallway side of the bathroom shower wall. This shower has been recently renovated and it is believed that the moisture measured is residual from the previous moisture issues. This should be monitored over time to gauge effective drying.

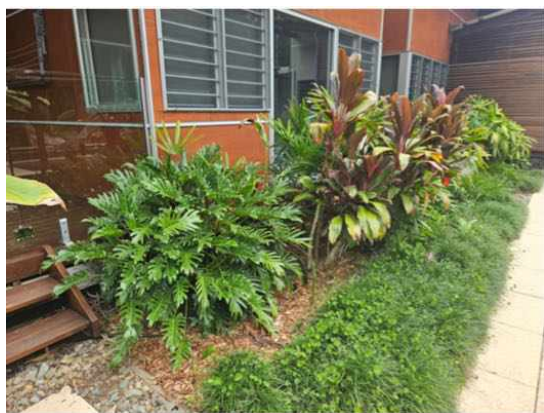
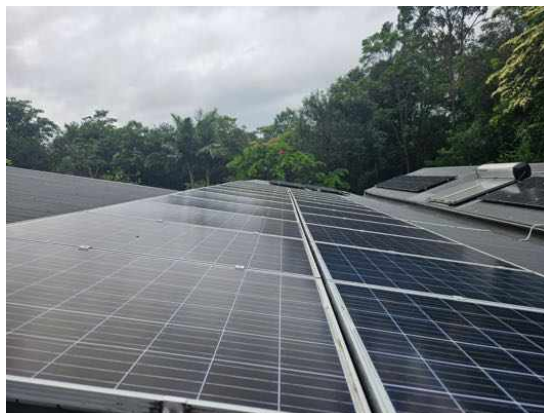
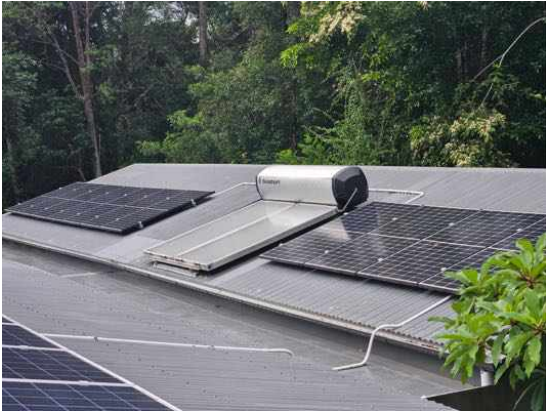
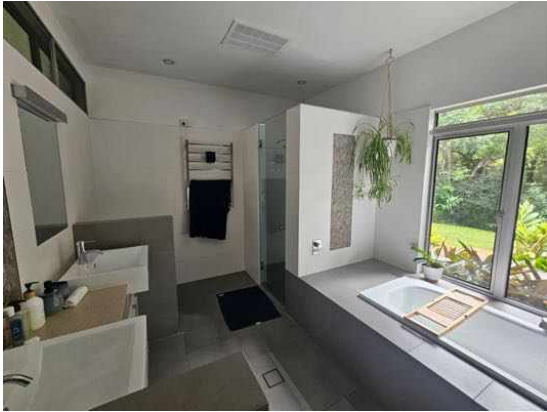
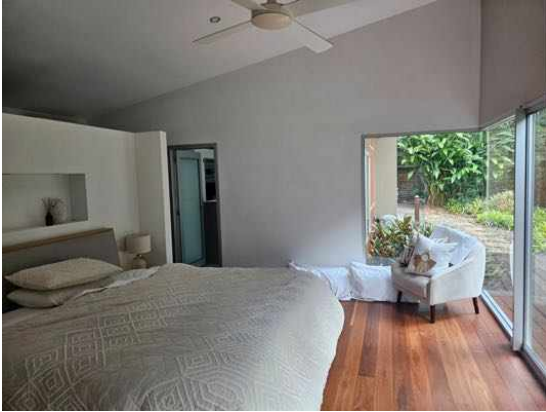
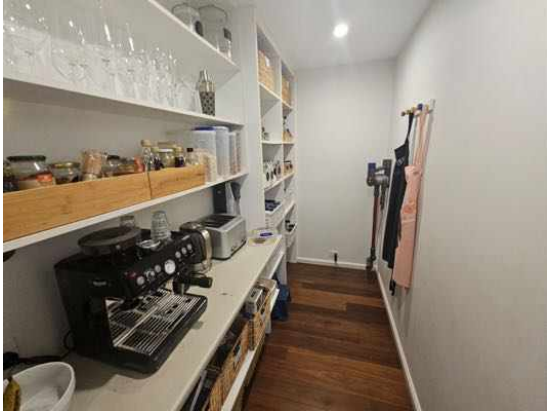
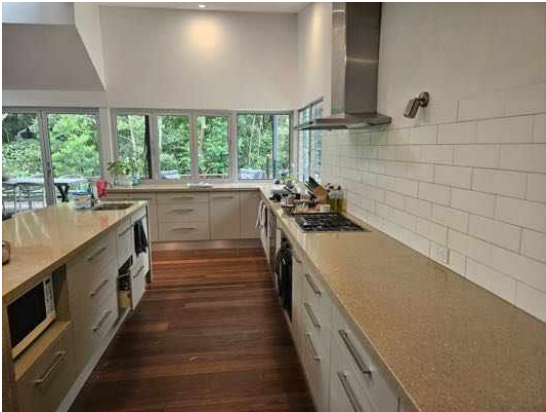
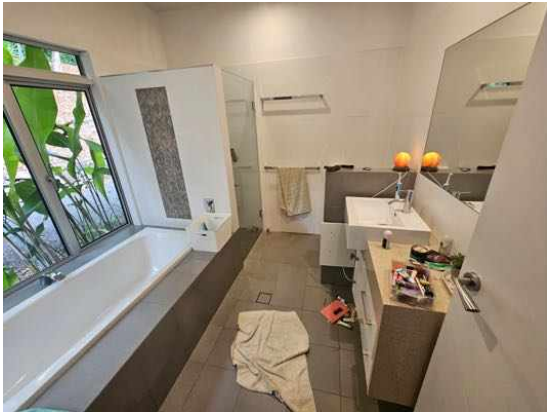
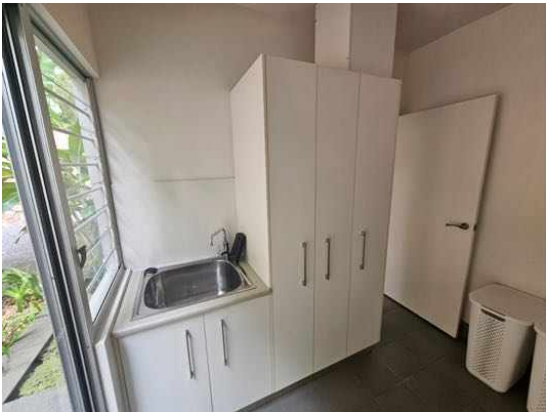
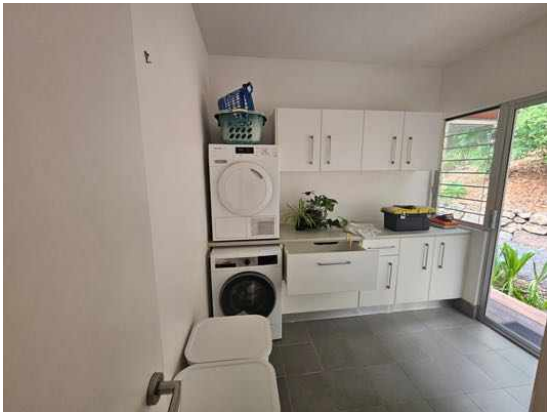
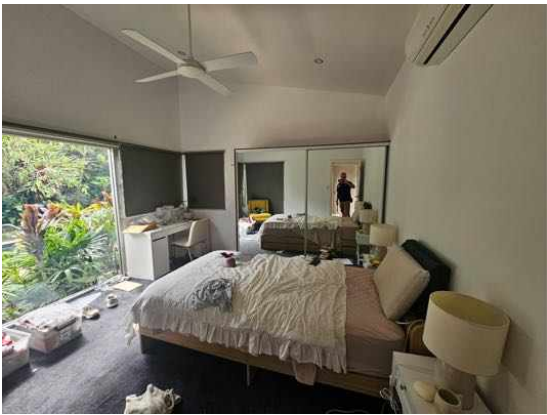
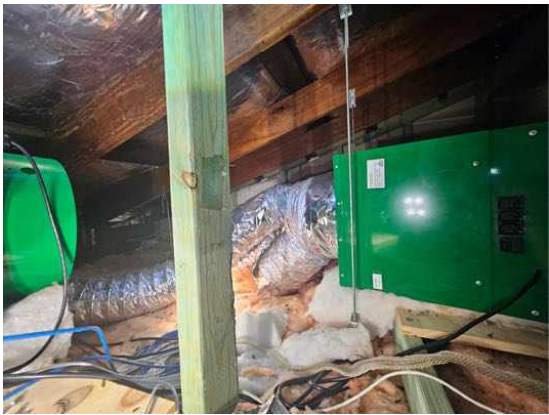
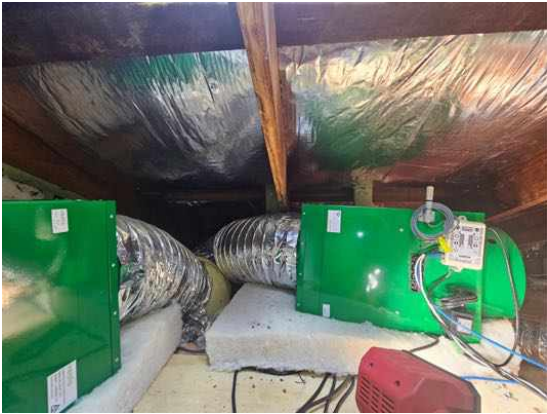
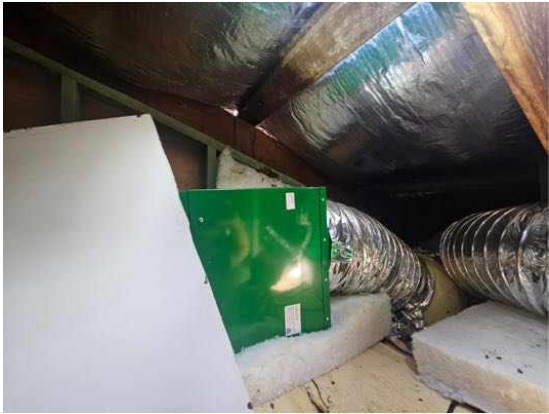
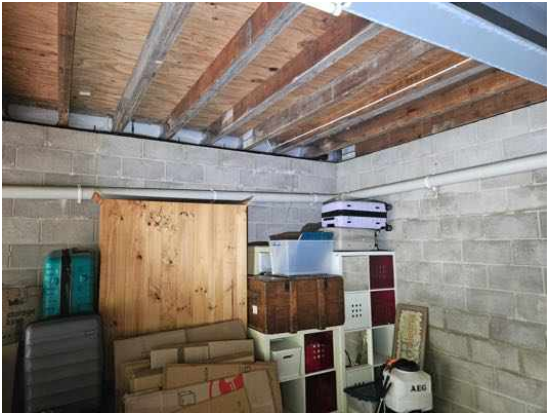
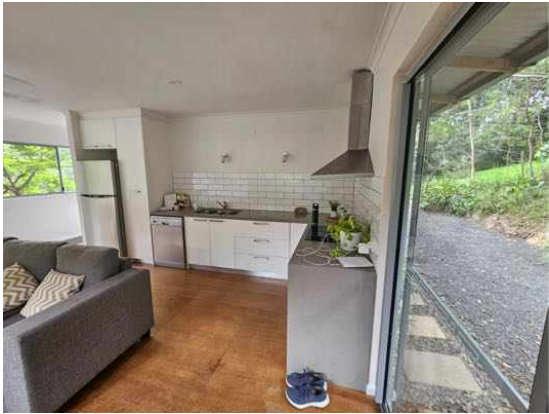
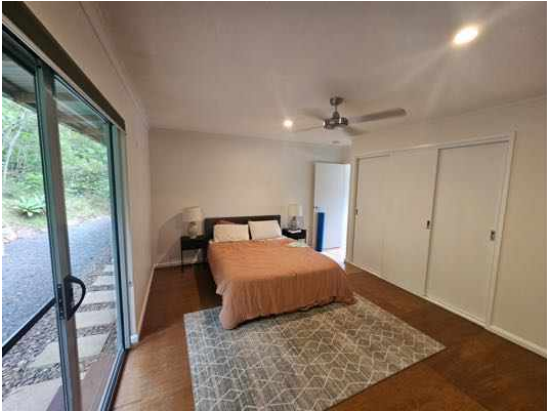
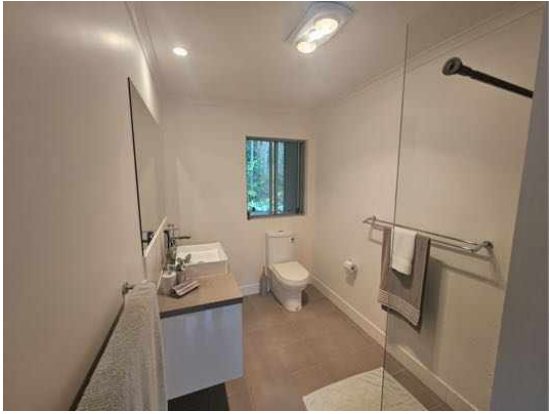
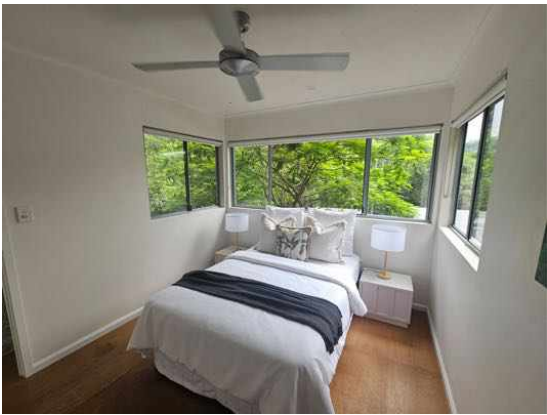
Building: Main Building  
 Location: All Areas  
 Finding: Additional Photos - Obstructions and Limitations  
 Information: These photographs are an indication of the obstructions and limitations which impeded full inspection of the property at the time of inspection. These obstructions can hide an array of defects and should be removed to allow full inspection to be carried out. A re-inspection is recommended once the areas are made accessible.
