# Building and Timber Pest Inspection Report

Inspection Date: Tue, 03 Feb 2026

Property Address: 163 Charles Ave, Minnamurra NSW,  
Australia

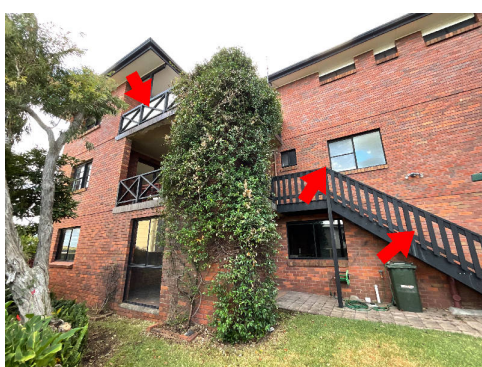
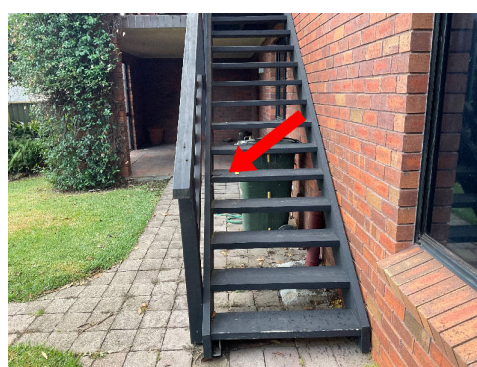
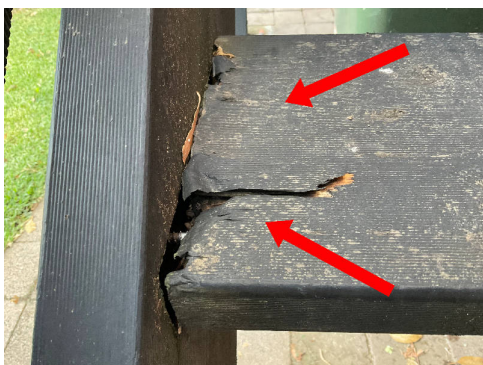
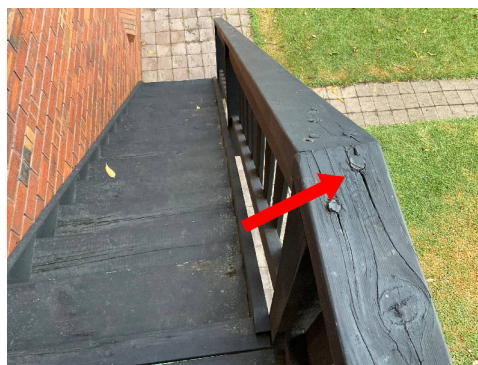
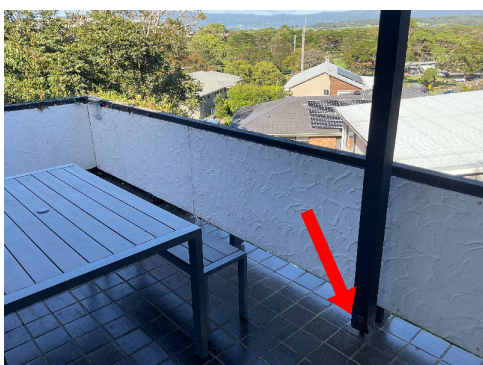
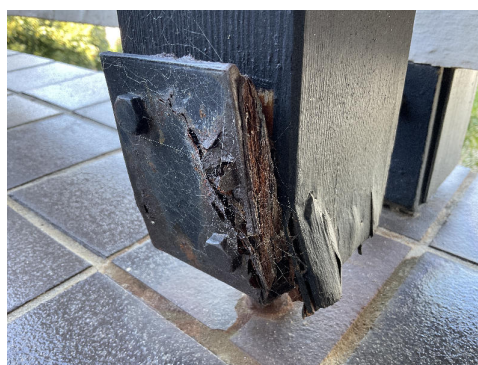
Building:	Building 1
Location:	Rear balcony Rear
Finding:	Stairs, balcony & other areas - Wood rot
Information:	Wood rot was found to be affecting external rear verandah and other small areas. The rear stair tread, railing and post areas are a safety defect requiring repair.

The other areas of the gate and window are minor defects.

Wood rot, also known as Fungal Decay, occurs when timbers and other cellulose building materials are exposed to damp conditions on an ongoing basis.

It is likely that this wood rot has developed as a result of frequent exposure to rain and other weather conditions. Early intervention and regular maintenance will prolong the useful life of these building elements.

Repair and/or replacement of affected stair treads and areas of damaged railings is a necessary step in protecting surrounding building elements from such deterioration and for the safety of users. Remedial works should be performed by a qualified carpenter or registered builder as soon as possible to prevent any further damage.

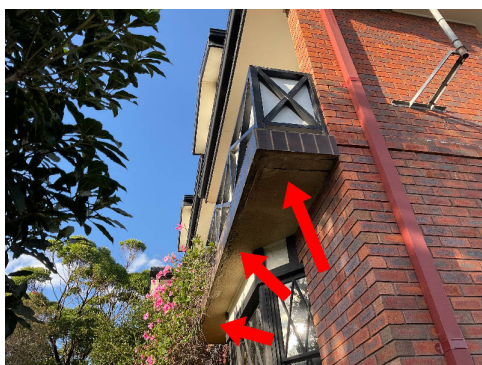
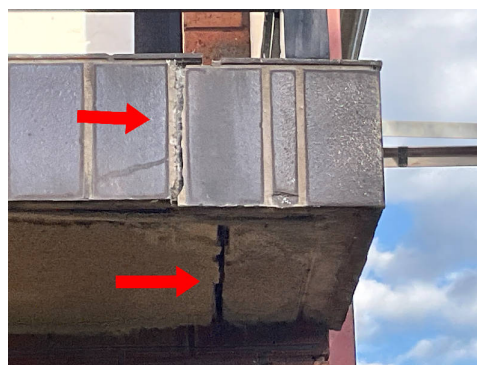
**Finding 1.02**

Building: Building 1  
Location: Front right verandah  
Finding: Concrete - Cancer

Information: Concrete cancer and other damage was found in this front right verandah. This is the common term used to describe a number of factors which cause concrete construction to deteriorate. Generally, water penetration causes the concrete reinforcement to rust and expand, creating stresses on the surrounding concrete and in turn causing it to spall (or break away). Alternatively, if the cement component is too alkaline, reactions with the general atmosphere occurs and star-shaped cracks appear which allow rainwater to penetrate. Concrete cancer may also originate from poor original water proofing.

In some instances, repairs are possible; however, repair works will generally involve extensive works, including removal of affected concrete and the treatment or replacement of any exposed steel. Some injection of resins or special mortars may also be possible, however this depends on the size and extent of consequent damage.

Ultimately, the cause of the concrete cancer (e.g. poor water proofing) must also be addressed, otherwise the problem is likely to recur. Treatment of concrete cancer can be expensive and, left unmanaged, the problem is likely to worsen over time, potentially leading to the development of major structural defects or safety hazards.

The client is advised to exercise caution and to prepare for the potential cost of remedial and / or replacement works. A structural engineer should be appointed to provide estimates on the required works.

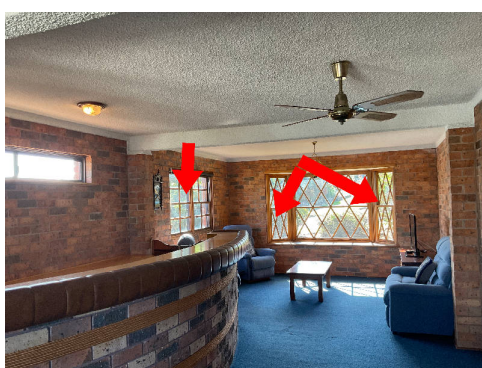
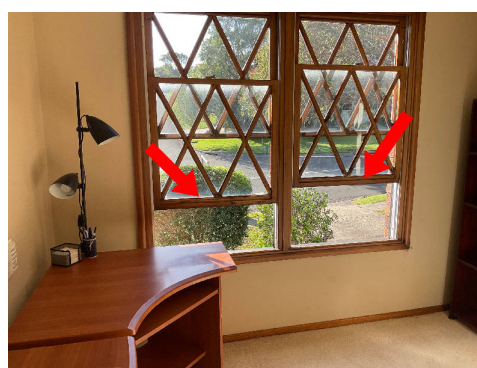
### Finding 1.03

Building: Building 1  
 Location: Many upstairs windows  
 Finding: Window opening restrictors missing.

Window restrictors are required where people who are vulnerable to the risk of falling have access to windows. This means all windows above ground level which do not have another fall prevention safety measure in place, such as a balcony or balustrade should have a restrictor.

These need to be added urgently for the safety of all persons.

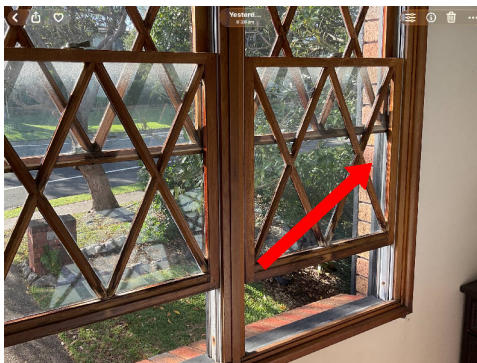
#### Finding 1.04

Finding: Windows - Cracked

Information: Cracks were identified in three windows. Cracking in windows is generally the result of impact damage, and is likely to develop further when left unmanaged.

The likelihood of these windowpanes further cracking and shattering is increased exponentially, providing a safety hazard in the area. The cracked window also impairs the weather tightness of the building, creating potential for minor water leaks.

A qualified glazier is required to repair the windows. Depending on the extent of the cracking, replacement of the window may be required. Please be advised that any persons coming into contact with the cracked windows should do so with due caution to avoid any personal injury that may ensue.

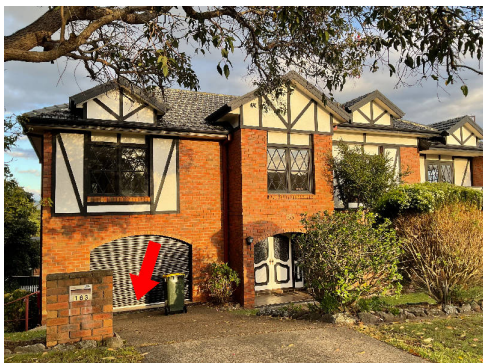
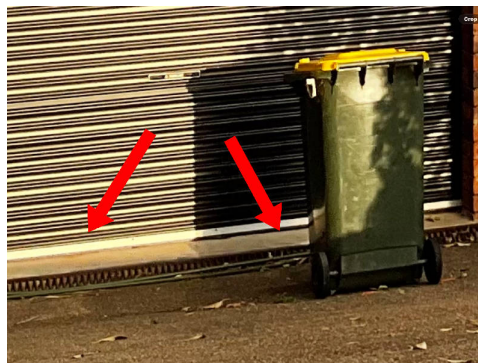
### Finding 2.01

Information: There is a height difference of 80mm between the lower driveway and the top of the garage slab. There is a 30mm crack under the garage slab. It is suspected there has been subsidence in this area causing this crack. The lower room moisture could originate in this area and causing be the rising damp found in the lower rooms.

General subsidence is usually initiated by changes in soil moisture content. The most critical factor is identifying the specific causes, and identifying if this is an ongoing problem.

It is recommended to consult a structural engineer for advice on this subsidence.

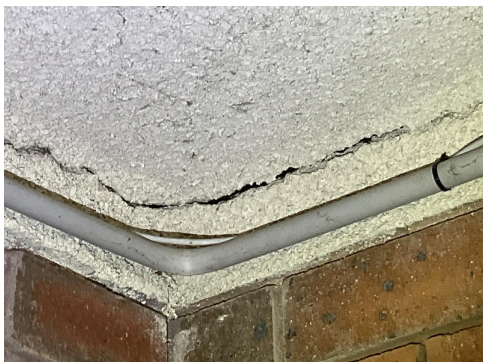
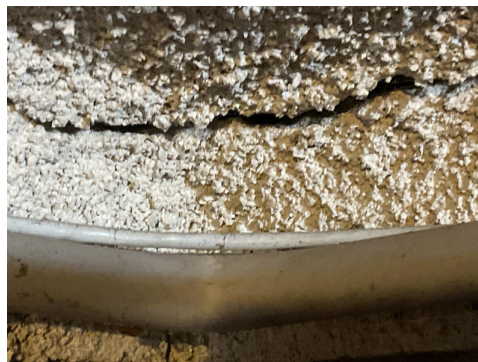
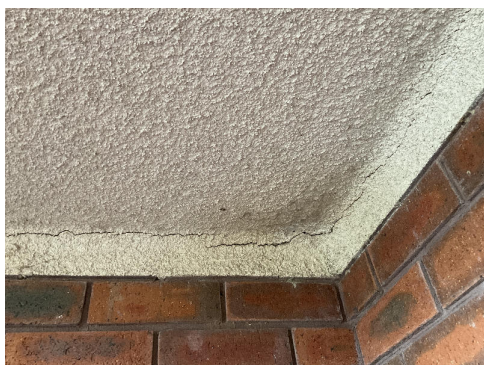
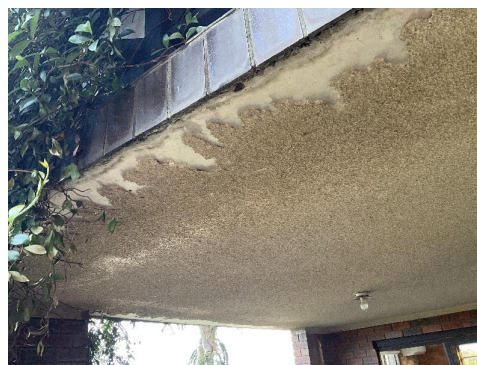
### Finding 3.01

Finding: Ceiling coatings cracked and damaged

Information: It has been observed that minor external and internal damage to some external ceiling coatings have occurred not affecting the adjoining suspended slabs.

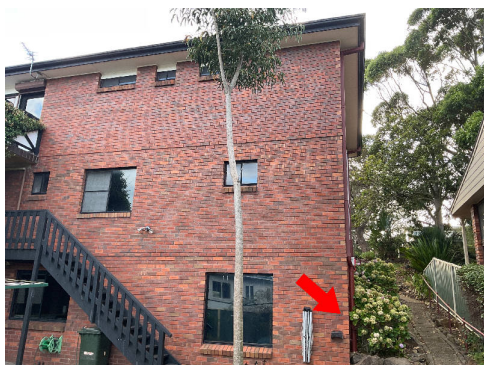
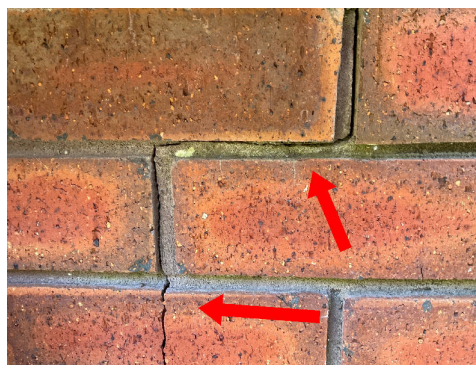
### Finding 3.02

Building:	Building 1
Location:	Exterior walls - left side Rear
Finding:	Brickwork - Step cracking (minor)
Information:	Step cracking was identified to the brickwork in this area at the time of inspection. Step cracking, which is similar to other forms of cracking, has a variety of possible causes. However, the most common is the subsidence of adjacent footings.

Step cracking is a relatively common defect, and is most likely to occur adjacent to windows, doors and other openings. Mortar failure in the gaps between affected bricks indicates the stresses and tensions affecting the wall.

Where step cracking is extensive or severe, the client is advised to consult a structural engineer. This minor step cracking can be used as a warning sign to address factors causing stress to the wall, which can include the effect of surrounding trees, water leaks, soil erosion, or even the presence of reactive soils in the surrounding area.

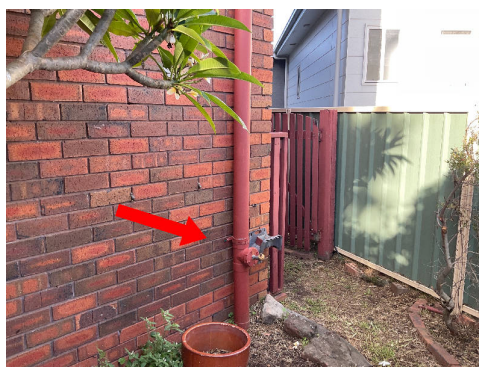
### Finding 3.03

Building:	Building 1
Location:	Exterior walls - right side Rear
Finding:	Additional fixings to downpipe
Information:	Evidence of insufficient fixings were evident to this down pipe. This downpipe need additional fixings to affix to the adjoining wall ensure its longevity. A carpenter, plumber or handy person should add additional fixings to this area as soon as possible to limit potential damage.

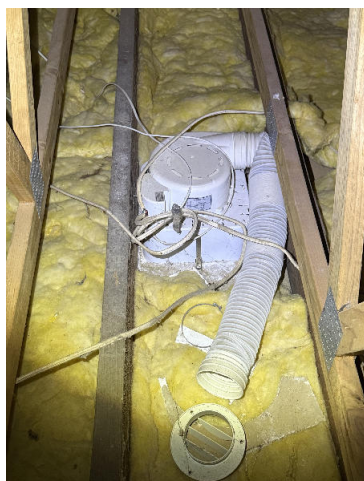
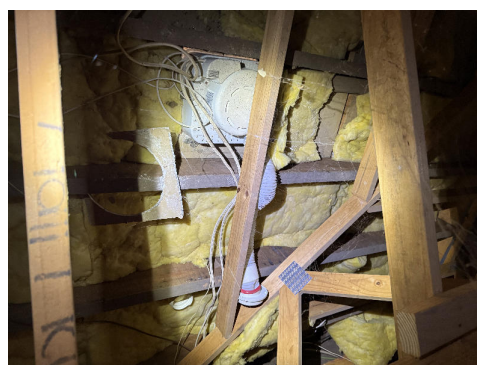
### Finding 3.05

Finding: Exhaust fans and sarking on roof

Information: On inspection of the roof void, it was observed that the exhaust fans to the bathroom and ensuite do not exhaust directly to the outside of the building, if sarking has been fitted, as it has in this home. This is not ideal and a quote should be sought to vent these fans outside the building.

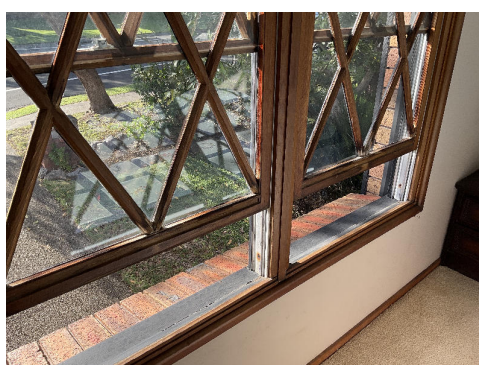
### Finding 3.06

Building: Building 1  
 Location: some rooms Upstairs  
 Finding: Minor mould - Present

Information: Where evidence of mould growth was noted, there may be environmental, biological or health issues associated with the report. A specialist inspection by a suitably qualified environmental health inspector is warranted, where mould is extensive or where any queries regarding air quality spores or other related issues apply.

Generally, the client is advised to ensure that the general environment is free of moisture and humidity to aid in the prevention of mould formation and development. Any mould found during the inspection should be cleaned immediately by a cleaning contractor or the homeowner.

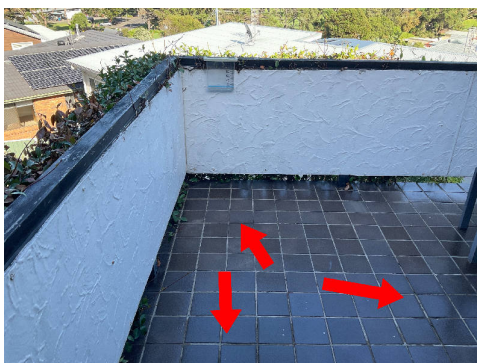
### Finding 3.07

Building:	Building 1
Location:	Bathrooms & Verandah Upstairs
Finding:	Sealant and grouting - Missing or damaged
Information:	It was noted on inspection that sealant or grout is degraded to the tiled shower alcove and or other areas of the bathroom.

Different materials and floor areas move at different rates, generally causing cracking to grout or sealant at this point. A flexible sealant is required to allow for expected expansion and contraction, while keeping the joint water tight and protective of all associated building materials.

There appears to be excessive mould to the sealant and grout which will likely require scraping out and replacement.

Flexible and mould resistant materials should be applied to affected areas to prevent any subsequent water damage that is likely to occur. Regular maintenance and replacement of damage or missing or damaged sealant and grout is highly recommended to the wet areas, as this is a regular wear and tear defect. Sealant and grouting in areas that come into regular contact with water should be maintained for the long term care of your property.

A sealant specialist or tiling contractor should be appointed to complete these works as soon as possible

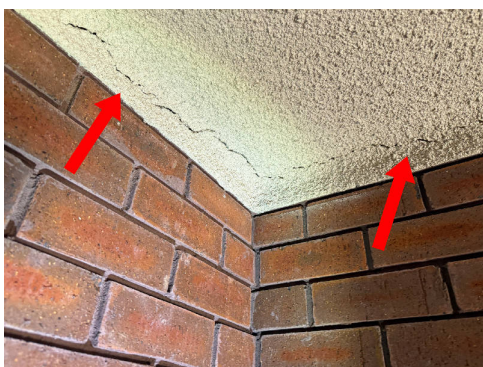
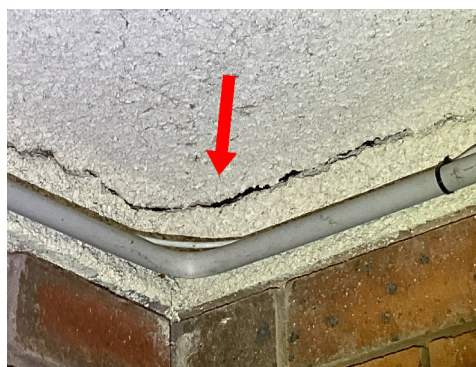
### Finding 3.08

Building:	Building 1
Location:	Many ceiling areas
Finding:	Cracking - Damage Category 2 - Noticeable (up to 5mm)

Information: Noticeable cracks of varying widths were found in many ceiling areas. Such causes may include age, general wear and tear, expected building movement and general expansion/contraction of building materials in different weather conditions.

Monitoring of all cracking should be conducted frequently. Always contact a building inspector should cracks widen, lengthen, or become more numerous. Additionally, your building inspector should also be contacted if associated building elements such as doors and windows become more difficult to operate over time.

Relevant tradespeople should be appointed to perform remedial works, as deemed necessary.

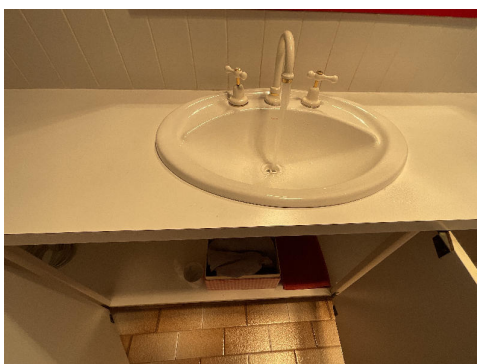
### Finding 3.09

Building: Building 1  
Location: Ensuite Upstairs  
Finding: Tap - Water hammer

Information: This tap shows evidence of water hammer being present. Water hammer, a pressure surge resulting when a fluid is forced to suddenly change direction, is a common defect in plumbing fittings, particularly those that are aged and not frequently maintained. Water hammer is generally caused by factors that create high water pressure in the affected plumbing fixture, usually evidenced by a faint banging noise during operation of the affected tap.

Although water hammer is generally considered to be a minor defect, subsequent damage such as erosion of tap hardware and/or water damage to associated building elements is likely to occur if left unmanaged.

A licensed plumber should be appointed as soon as possible to replace any affected tap hardware and perform any remedial works as necessary. Please be advised that the appointment of a cabinet maker or qualified carpenter may be necessary if water damage to associated building elements has occurred.

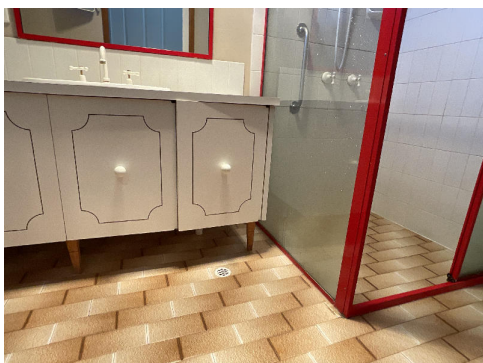
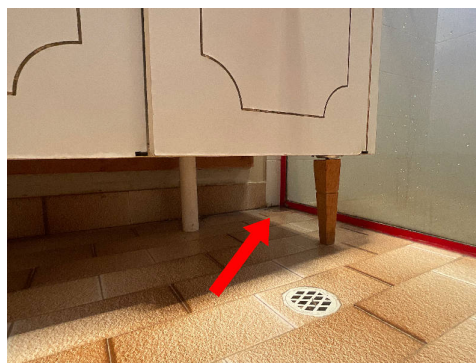
### Finding 3.10

Building: Building 1  
 Location: Ensuite Upstairs  
 Finding: Shower screen - Leaking

Information: Leaking was evident to the shower screening at the time of inspection. It is suspected that the leaking has occurred as a result missing sealant. Leaking from the shower , where left unattended, is likely to lead to water damage to adjoining flooring and walls. Such damage can lead to water damage and necessitate extensive remedial works being required. Active water leaks may also create an environment that is susceptible to the formation and development of mould.

Appointment of a sealant expert is required to repair or replace this missing sealant. Such works should be performed as soon as possible to ensure that no further damage occurs.

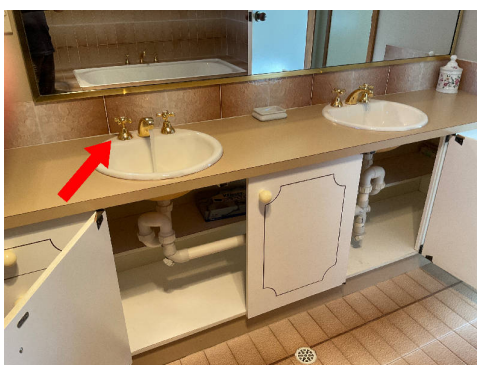
### Finding 3.11

Building:	Building 1
Location:	Ensuite Upstairs
Finding:	Building elements damaged
Information:	<p>Evidence of minor missing or damaged areas was identified in the bathroom at the time of the inspection. These include -</p> <ol style="list-style-type: none"> <li>1. The left vanity drain is partially blocked.</li> <li>2. The vanity cupboard shelves show some swelling.</li> </ol> <p>A licensed plumber would be the trade responsible for rectification of these areas when convenient.</p>

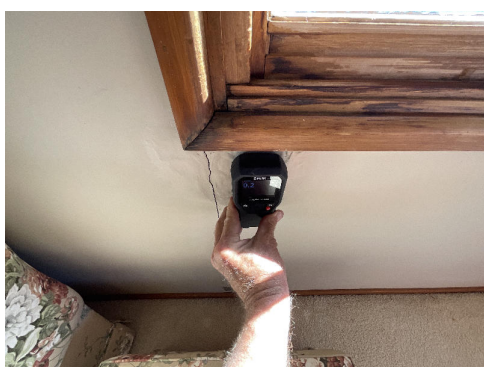
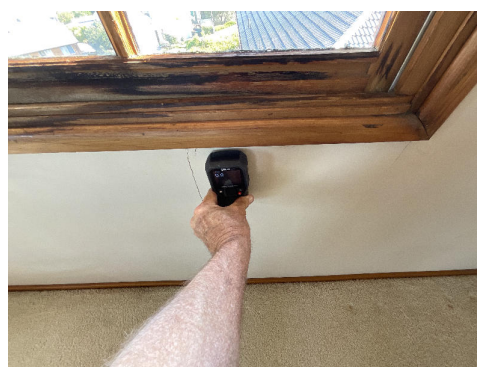
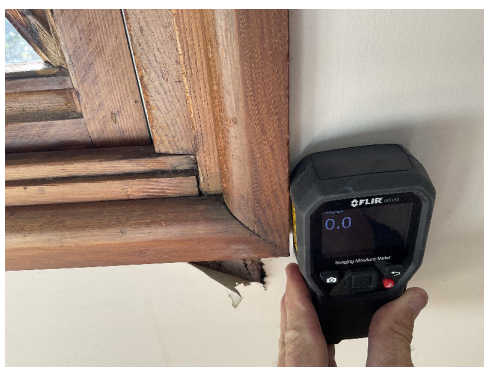
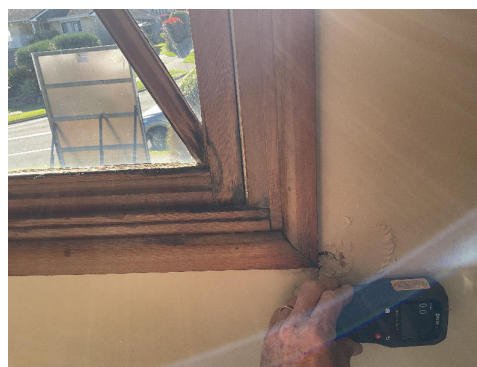
### Finding 3.14

Building: Building 1  
 Location: Walls Upstairs  
 Finding: Moisture damaged wall elements  
 Information: Moisture damaged walls were found in some north rooms with no signs of excessive moisture evident.

Moisture can compromise the structural integrity of the wall as well as lead to the formation of mould and be attractive to termite activity.  
 In these areas and despite 24+ hours of rain, no moisture was found.

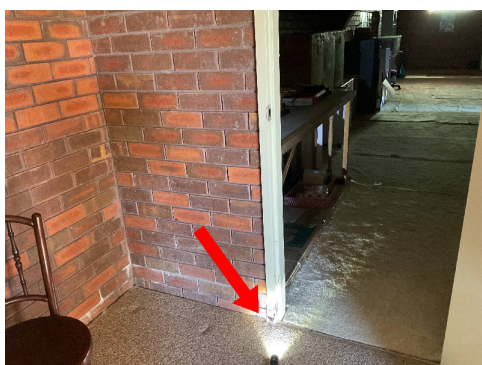
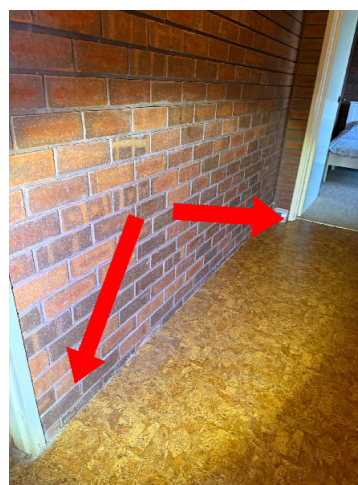
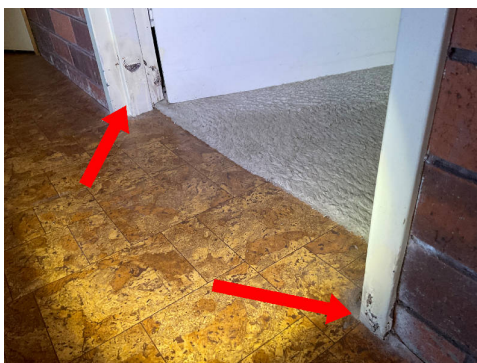
### Finding 3.15

Building: Building 1  
 Location: many rooms Upstairs  
 Finding: Damp - Rising leading to rust and efflorescence

Rising damp leading to rust of some door frames was found. This describes the upward movement of water in low sections of building elements (e.g. walls) by capillary action - the movement of water through porous materials such as bricks, sandstone or mortar.

Left unmanaged, rising damp can lead to health problems resulting from mould growth and can have major implications on affected building elements, including these rusted areas.

Efflorescence was also found. This typically occurs when excess salts within the concrete or cement mortar is leached to the surface due to water transfer.

It is typically seen as white salt deposits on the surfaces of concrete pavement or mortar between bricks or tiles. While detracting from the overall appearance of the affected area, efflorescence is not likely to develop into secondary damage if left unmanaged.

The first step in addressing rising damp is to diagnose the cause. The identified cause should be addressed first before addressing the appearance and other defects which have resulted from the rising damp. If the original cause is not resolved, further cases of damp are likely to ensue, resulting in secondary defects.

Consultation with a qualified plumber is advised immediately to identify the cause of the damp and perform remedial works as required.

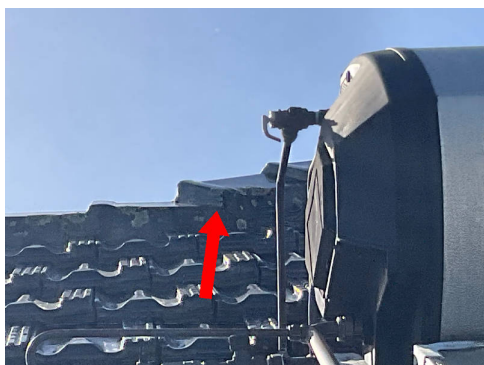
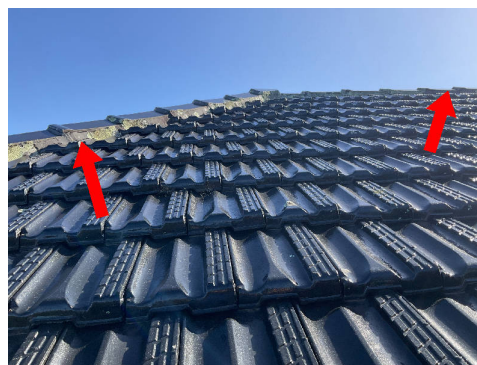
### Finding 3.16

Information: Upon inspection of the exterior roofing, the majority of roof tiles were considered to be in a fair condition. While weathering of the tiles is consistent with the age of the property, maintenance works are required.

Isolated areas of mortar have come loose in the valleys and minor cracking is also present. Re-pointing and re-sealing the may be considered as an interim solution by the client to help preserve and extend the life span of the tiles.

Where left unmanaged, deteriorating roof tiles are likely to lead to a number of secondary defects, including minor water leaks and weather exposure to internal roofing structures.

Consultation with a roofing contractor is highly advised to gain advice on cost of remedial works that may be required in the short to medium term. Remedial works are likely to increase the longevity of the exterior roofing structure.
