Building and Timber Pest Inspection Report

Inspection Date: Mon, 23 Mar 2026

Property Address: 11 Oxford Dr, Thurgoona NSW 2640,
Australia

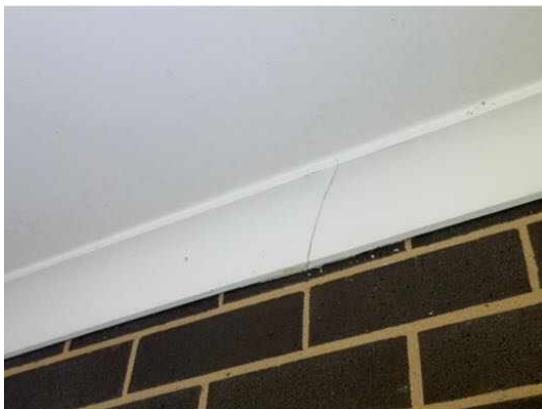
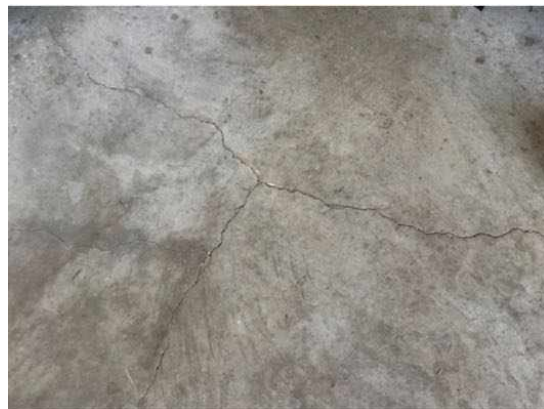
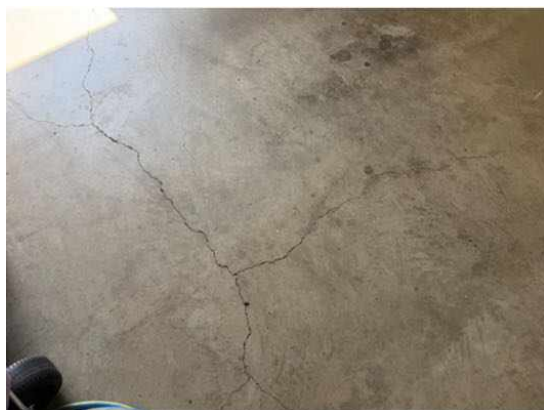
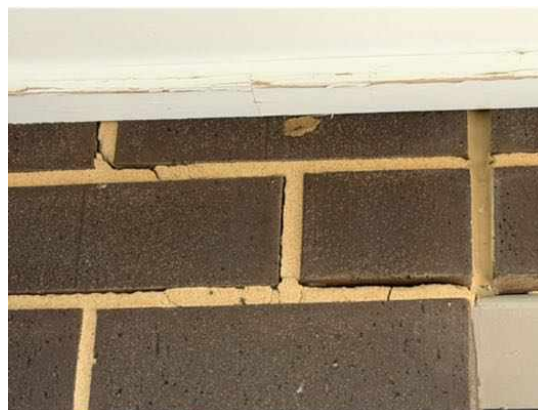
Finding 3.01

Building:	Main Building
Location:	Brickwork, Garage Slab, Internal Areas
Finding:	Cracking - External & Internal
Information:	Cracking was identified to some areas of the brickwork, garage slab and cornice at the time of inspection. Cracking has a variety of possible causes, however, the most common is “settling” of the building after construction, and/or expansion / contraction of building materials.

Cracking is a relatively common defect, and is most likely to occur adjacent to windows, doors and other openings. The client should monitor the cracking. Should the cracking lengthen, widen or become more numerous, the client should consult with a structural engineer to provide further advice.

All areas of internal and external cracking should be monitored to identify any further movement. Should cracking lengthen, widen, or become more numerous, a structural engineer should be engaged for further evaluation.

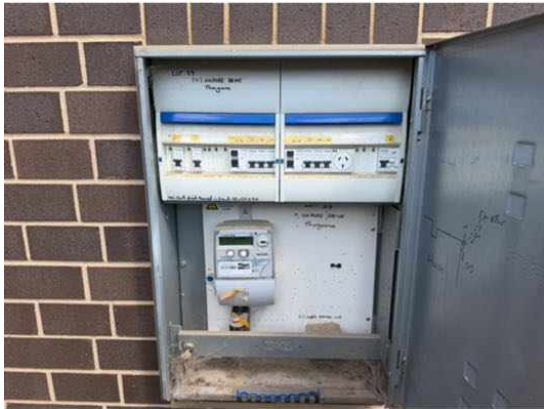
Finding 6.01

Building: Main Building
 Location: Switchboard
 Finding: Termite Management System - no evidence of a chemical installation
 Information: The application of a termite barrier is recommended, as it appears no termite management system has been installed, with no evidence or durable notice to suggest works taking place. Generally, a durable notice is placed in the meter box to indicate current termite barriers.

Such barriers are highly effective in preventing termite attack on the building and therefore should be installed.

Recommend seeking further advice from a licensed pest controller.

Installation of a termite barrier is recommended as there was no evidence of installation of a previous termite management system. 12 monthly termite inspections, conducted by a qualified termite inspector are also advised. Recommend engaging a licensed pest controller, to provide further advice.

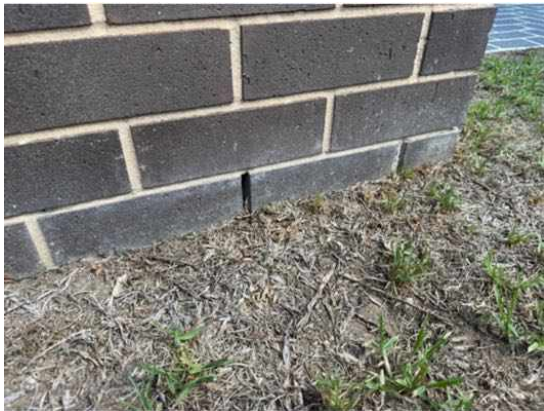
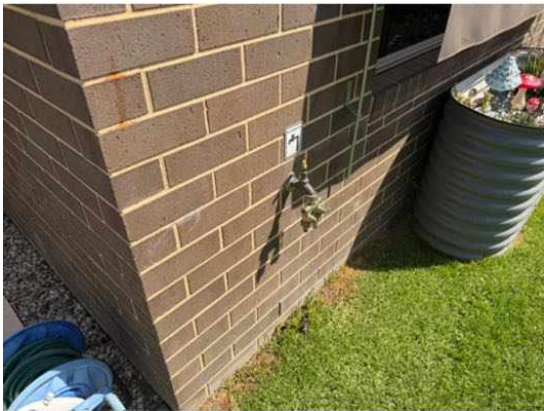
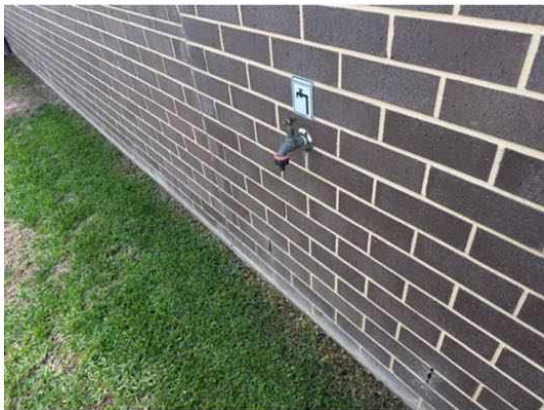
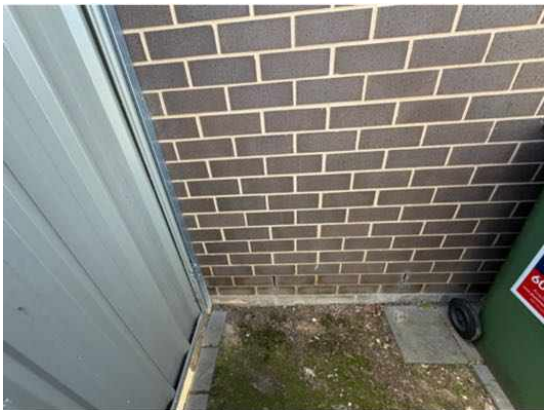
Finding 6.02

Building: Main Building
Location: All external areas
Finding: Potential Water pooling - against property
Information: Potential areas of water pooling around the perimeter of the property were identified. Where insufficient drainage of taps and garden beds against the house are present, water pooling is likely to occur, and can create areas conducive to timber pests.

Recommend consulting with a licensed plumber and/or landscaping contractor to provide further advice.

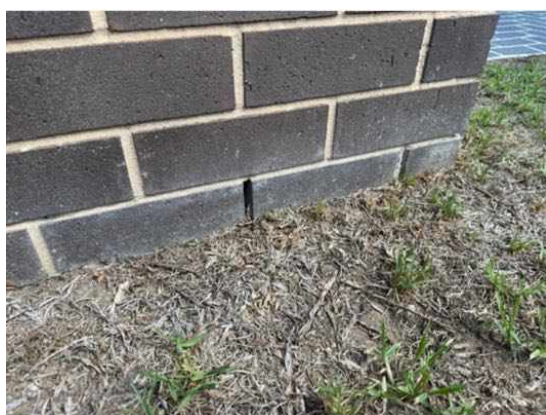
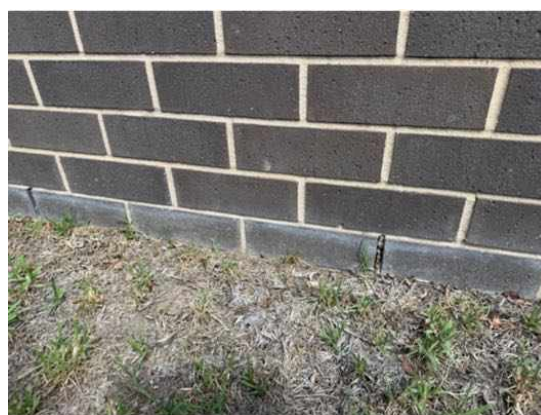
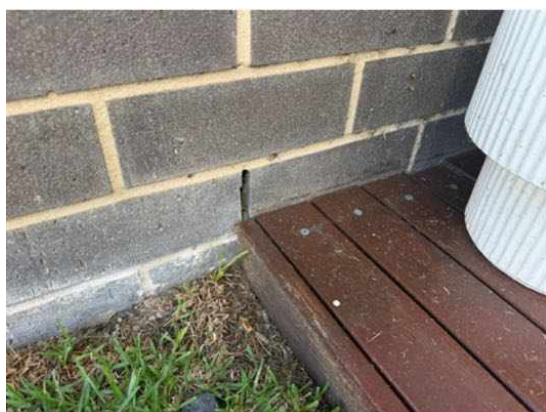
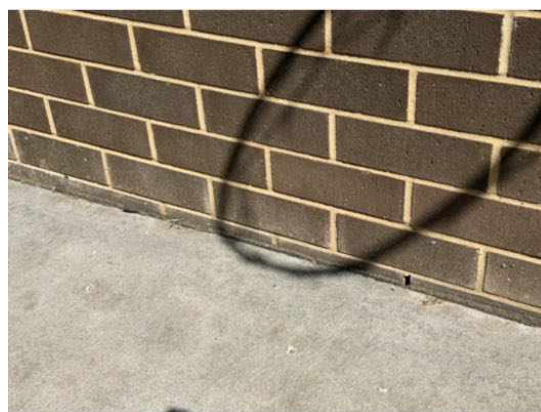
Finding 6.03

Building:	Main Building
Location:	Brickwork
Finding:	Weep holes - Blocked
Information:	It appears some weep holes of the brickwork are blocked by the external finished ground level. This can restrict moisture escape and can create conducive conditions to termite activity. This also allows for termites to bypass any termite barriers & allows for concealed entry into the building.

Recommend engaging a licensed landscaping contractor in the short term to lower external ground levels where feasible and restore adequate weep hole drainage and inspection zones.

Areas of the external ground level were found to be higher than the base of the weep holes. Where feasible, it is advised the external ground level be lowered to allow for sufficient inspection zone and drainage. These areas should be inspected frequently, by a qualified termite inspector.

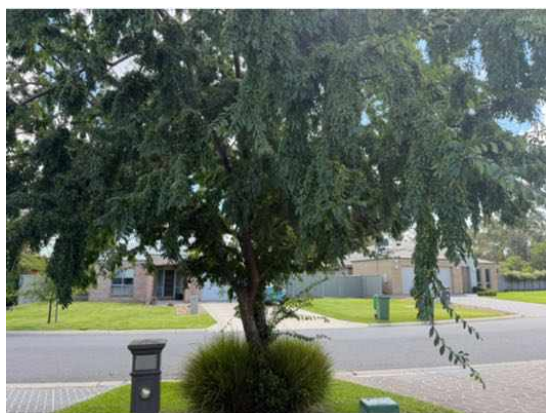
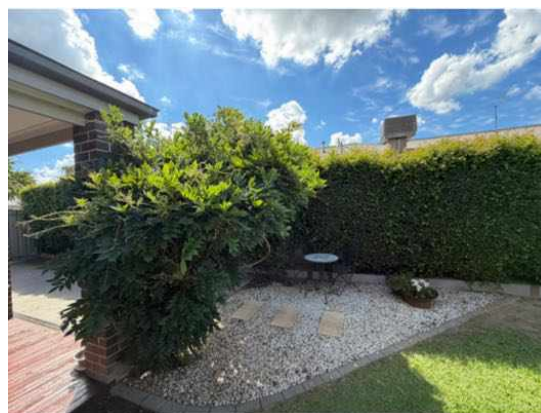
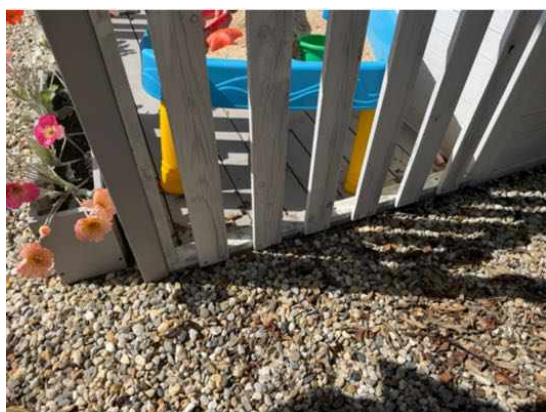
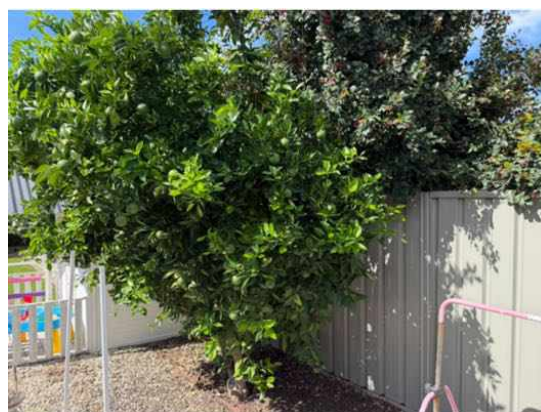
Finding 6.04

Building:	Main Building
Location:	All External Areas
Finding:	Timber in direct ground contact & trees - conducive to termites
Information:	Where timber materials are in direct contact with the ground and consequently moisture, they become conducive to termite activity. The kids play house timbers, and trees surrounding the building create an environment conducive to termite activity.

Where feasible, any timbers in direct contact with the ground should be removed and any trees in close proximity to the building should be removed or test drilled (inspected) at least annually to reduce the risk of termite infestation & detect any early signs of termite activity.

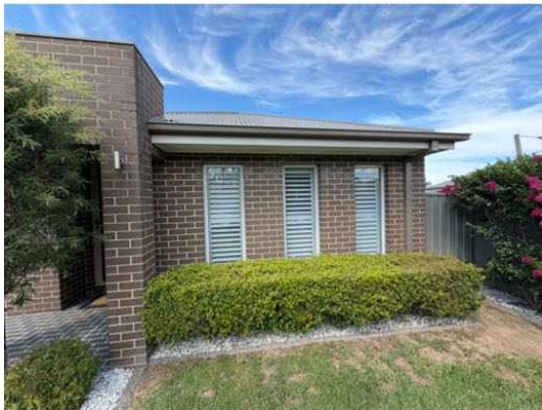
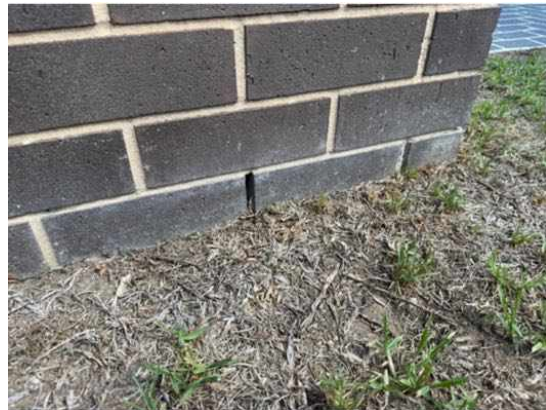
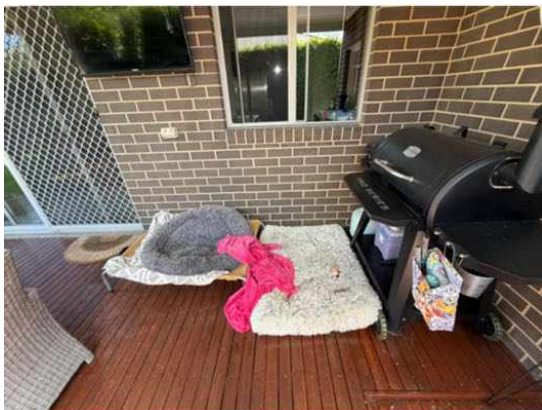
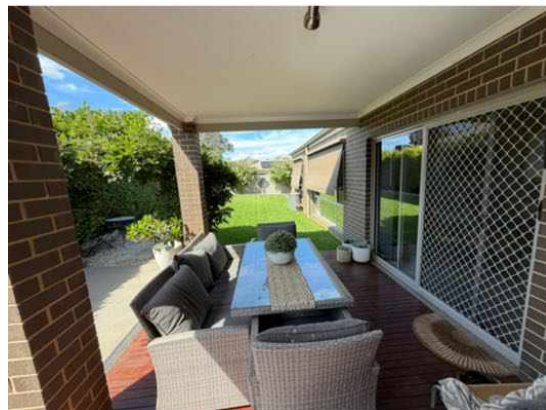
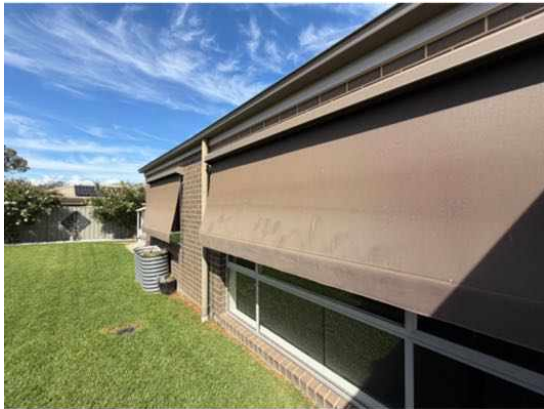
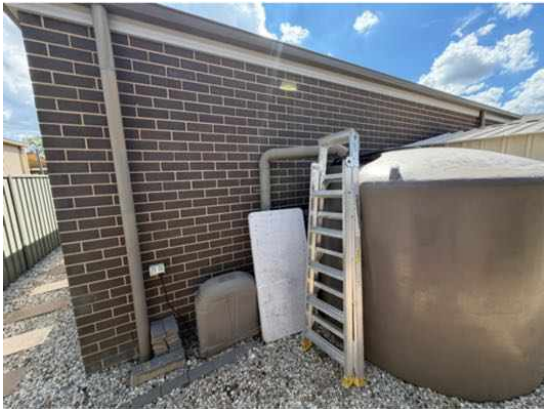
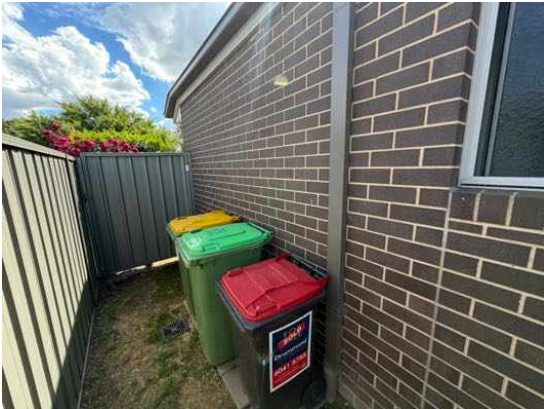
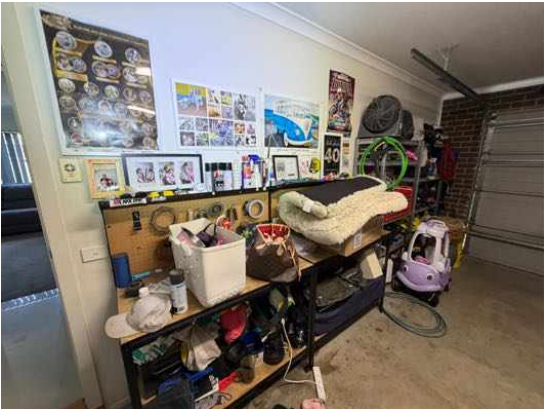
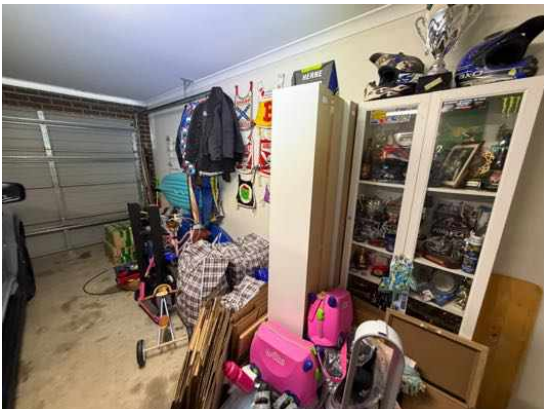
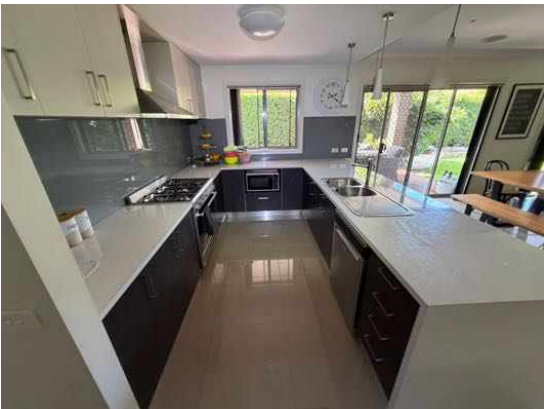
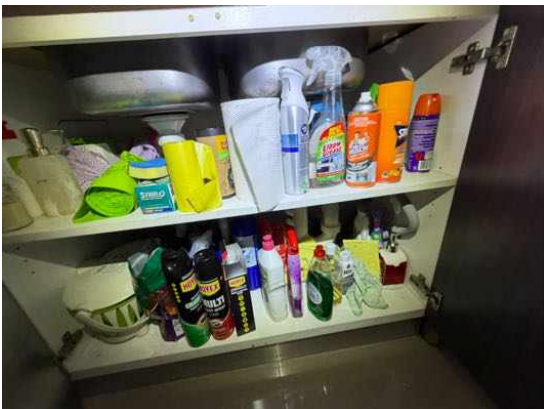
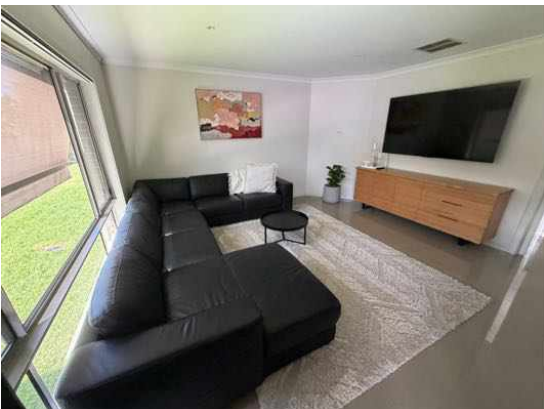
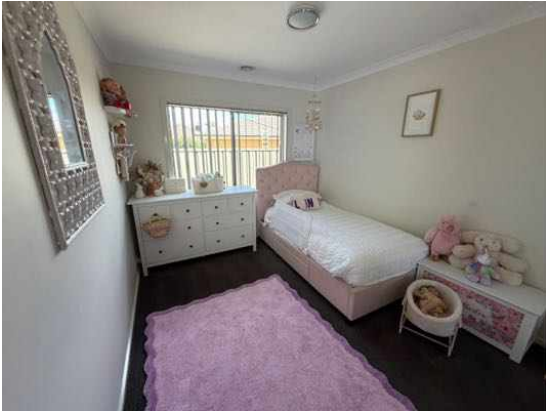
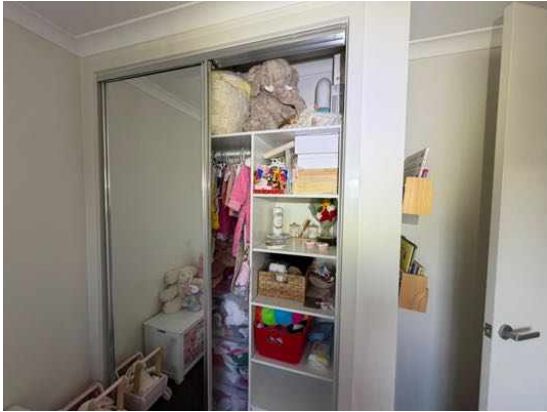
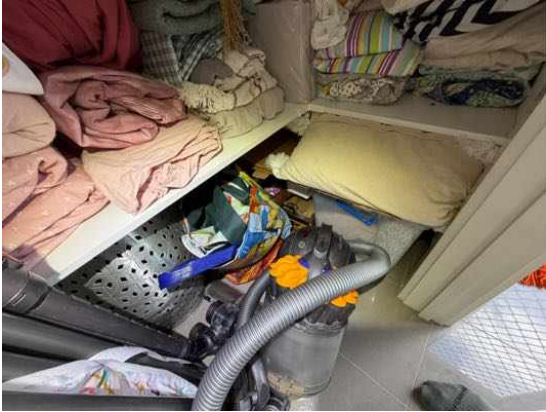
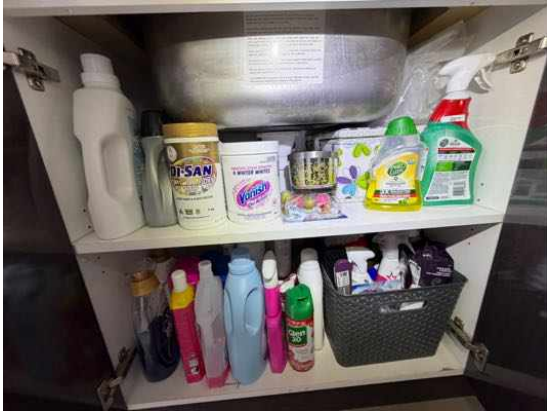
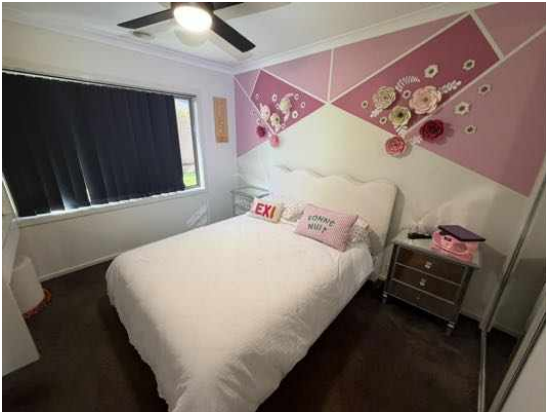
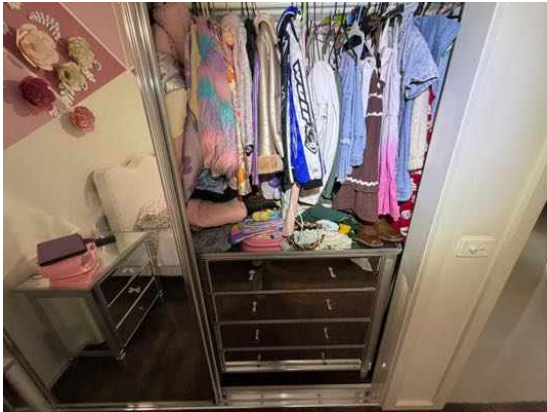
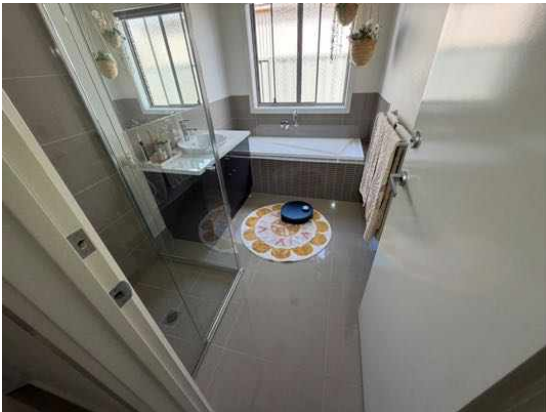
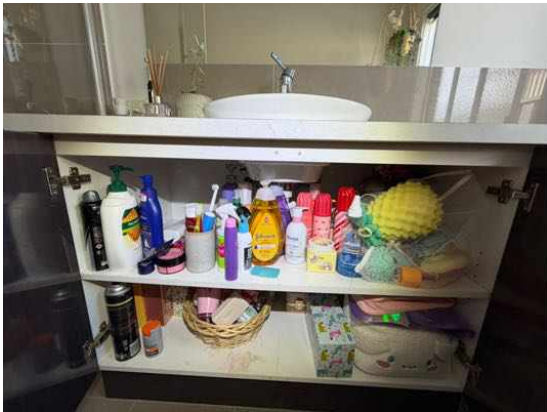
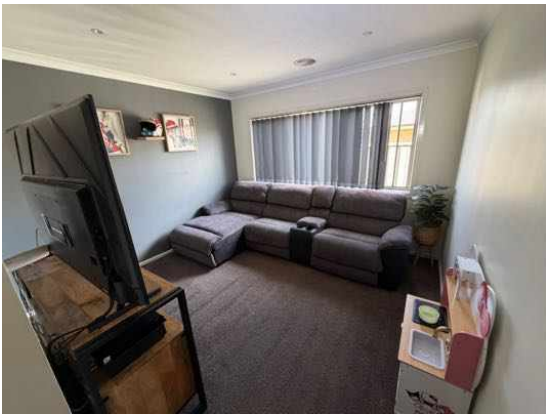
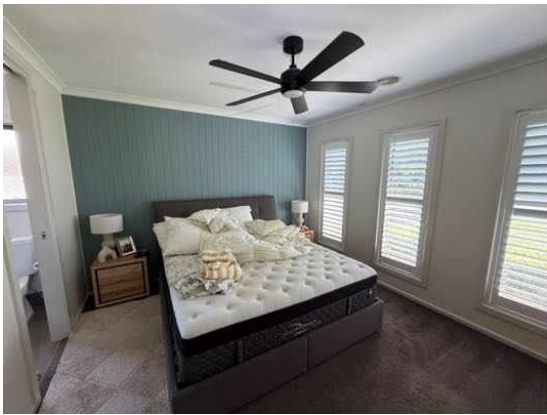
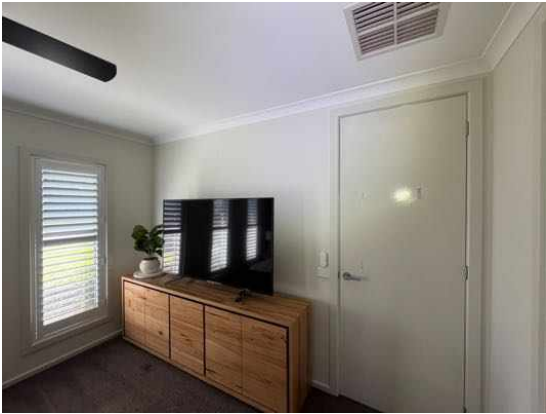
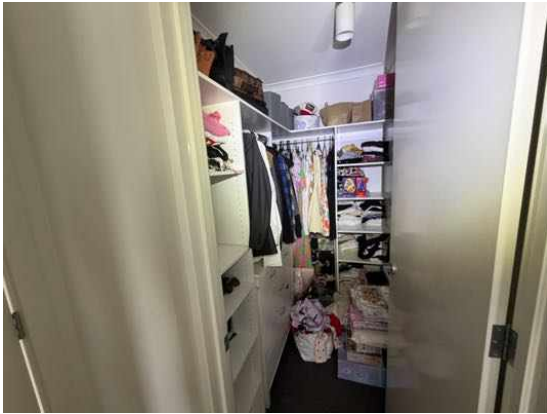
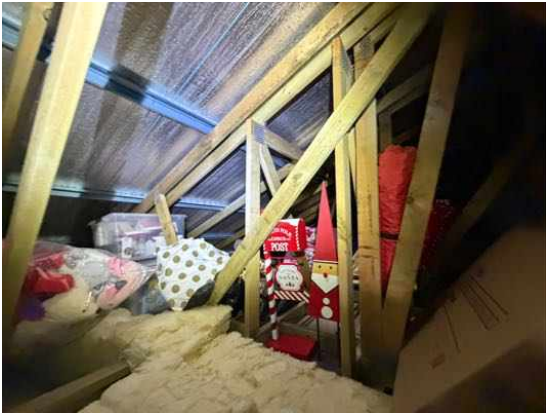
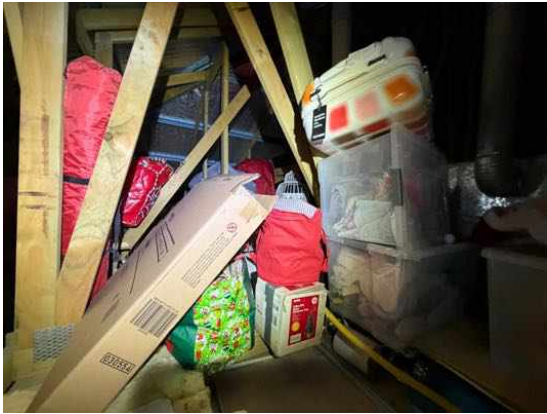
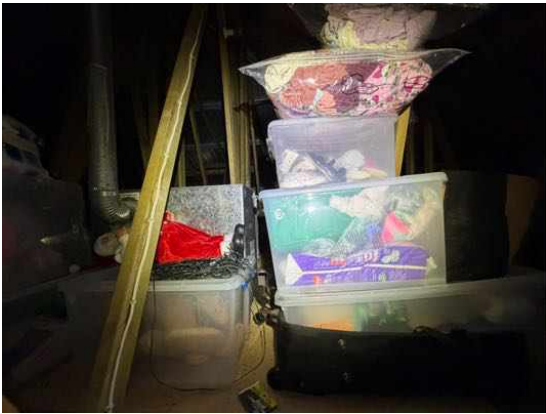
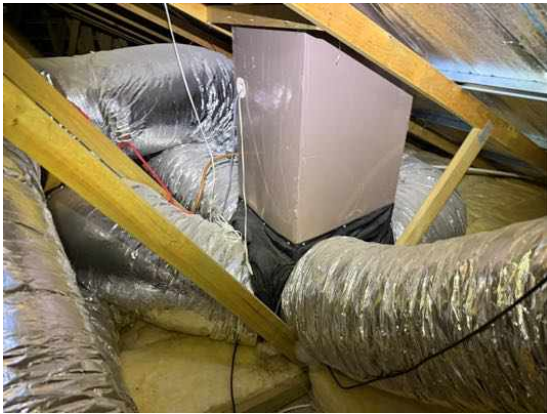
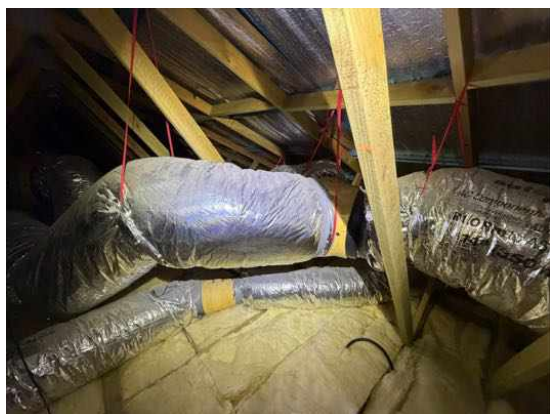
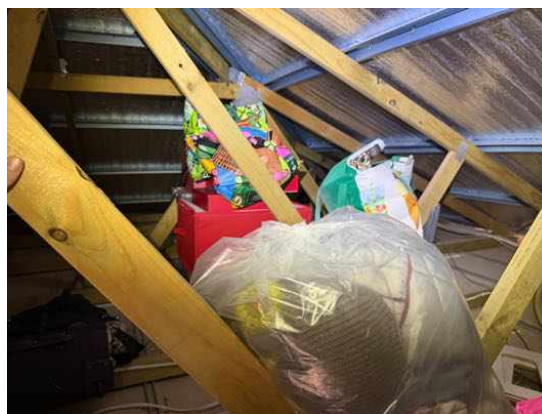
Building: Main Building
Location: All Areas
Finding: Additional Photos - Obstructions and Limitations
Information: These photographs are an indication of the obstructions and limitations which impeded full inspection of the property at the time of inspection. These obstructions can hide an array of defects and should be removed to allow full inspection to be carried out. A re-inspection is recommended once the areas are made accessible.

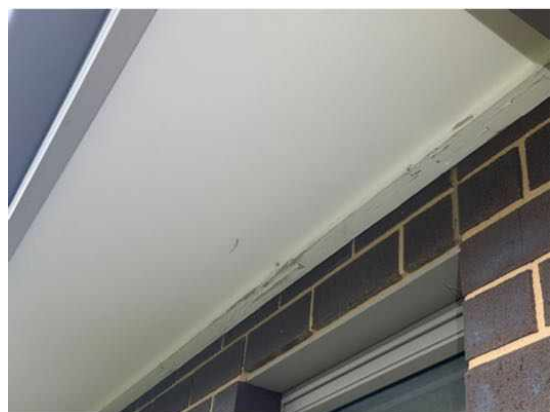
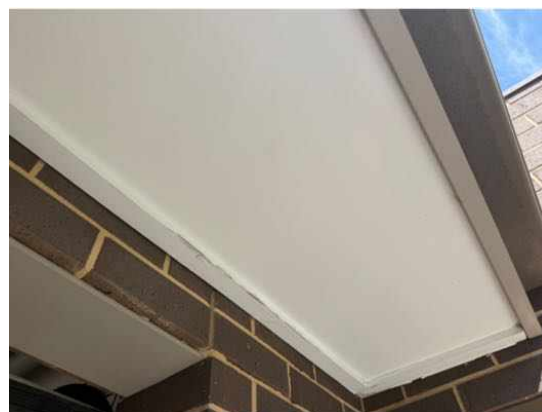
Building: Main Building
 Location: Trims
 Finding: External Timbers - General Weathering
 Information: Some external trims had areas of general weathering. The client can engage a painting contractor at their discretion to provide maintenance works where necessary.

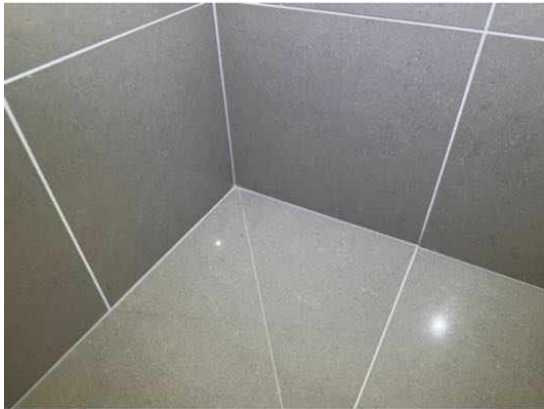
Building: Main Building
 Location: Tiled Areas
 Finding: Sealant and grouting - Monitor & General Maintenance
 Information: Although the sealant and grouting to the tiled areas appeared to be in good condition, it is noted for the clients information that all sealant and grouting should be monitored & maintained for the long term care of your property.

Should the sealant and grouting begin deteriorating, a tiling contractor should be appointed to provide maintenance works where necessary.

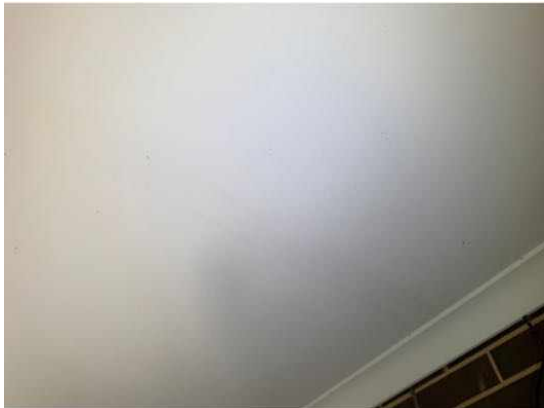
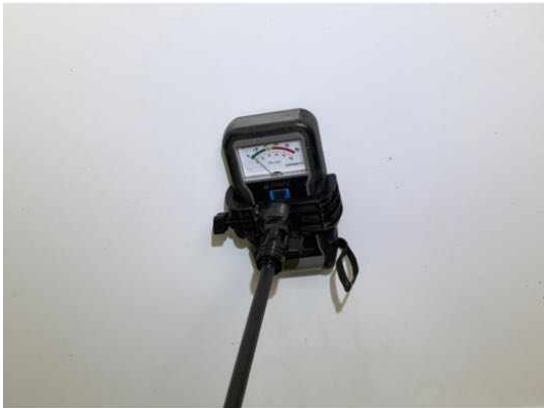
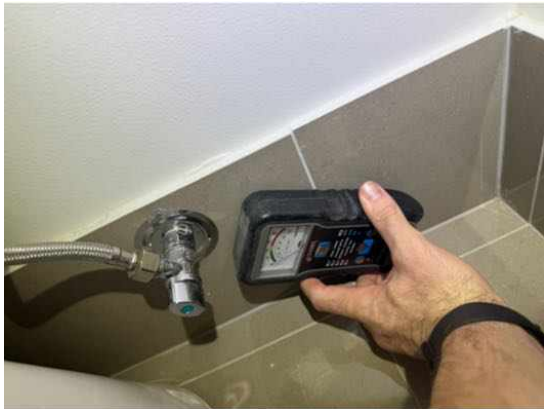
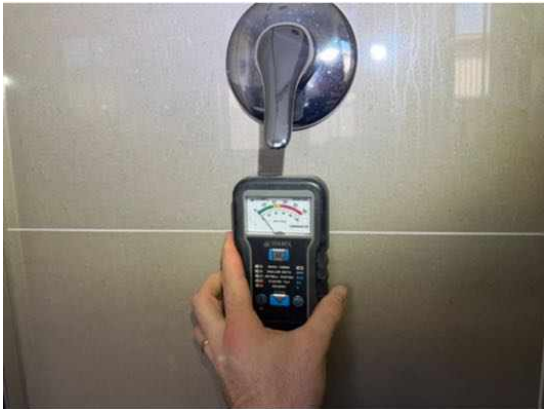
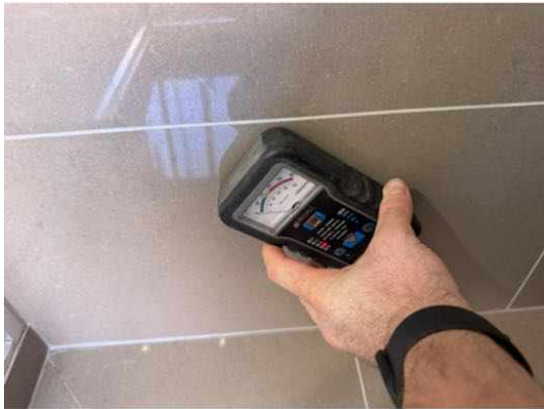
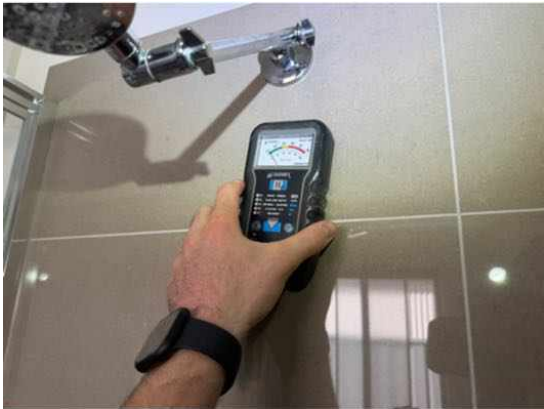
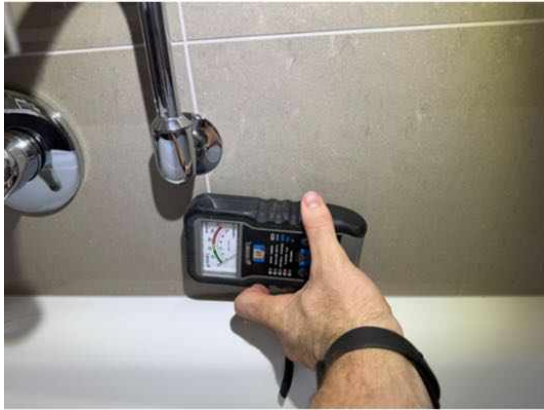
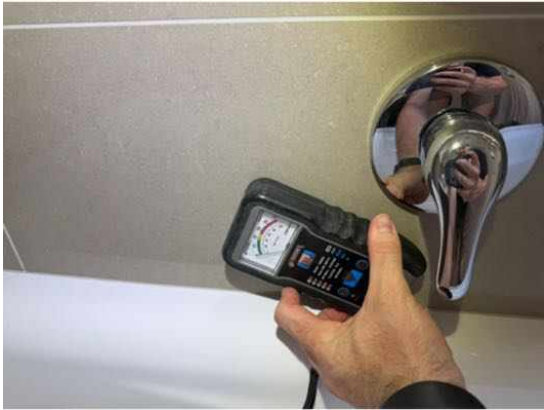
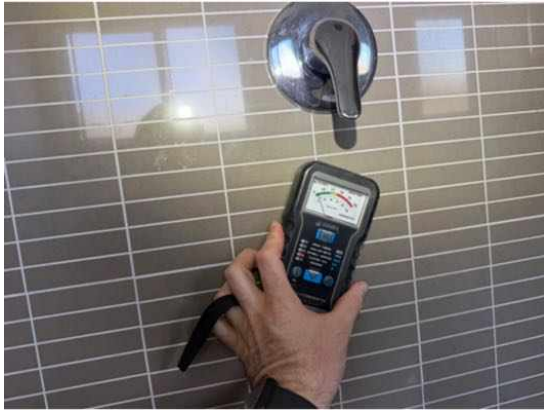
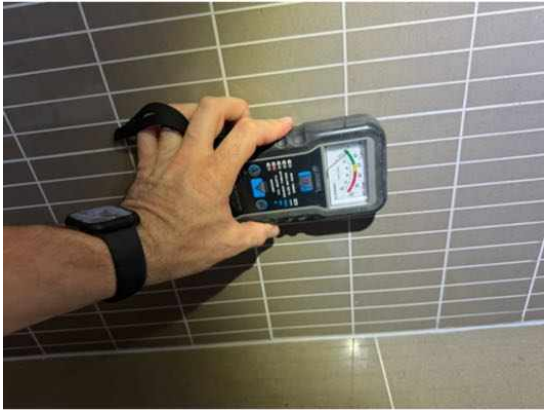
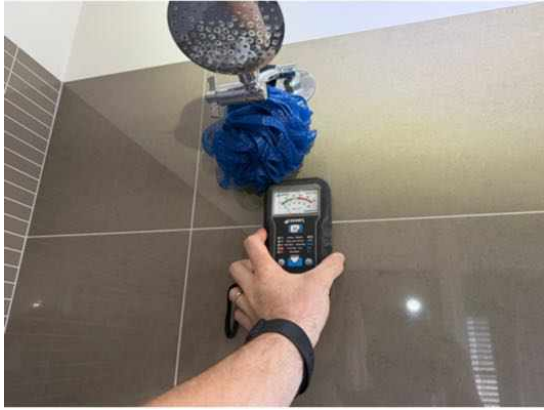
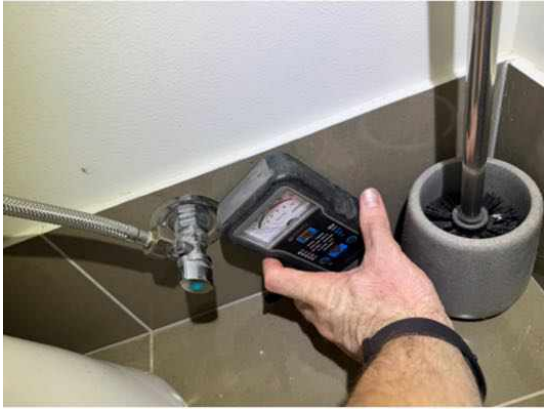
Building: Main Building
Location: All Areas
Finding: FYI Moisture Readings
Information: These photos are the moisture readings taken near plumbing fixtures and fittings for your information.

No moisture was evident in these areas at the time of inspection.
