Building and Timber Pest Inspection Report

Inspection Date: Thu, 19 Mar 2026

Property Address: 8 Maple St, Echuca VIC 3564, Australia

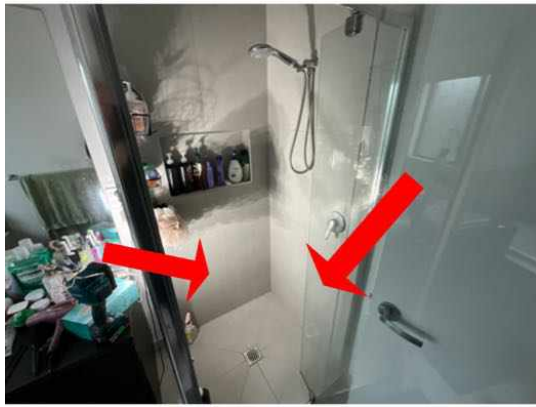
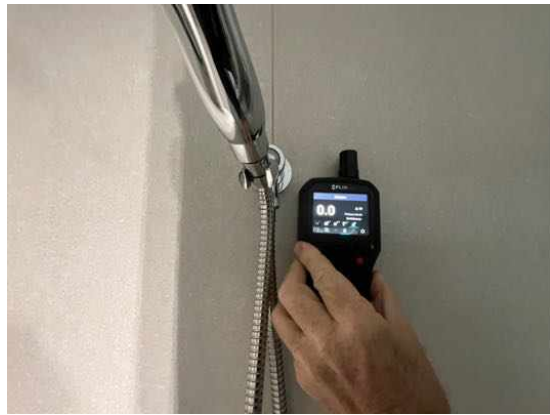
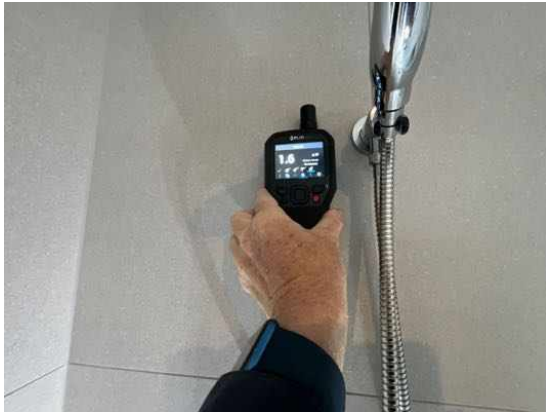
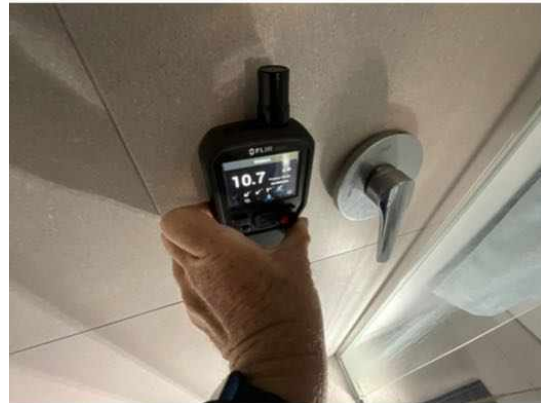
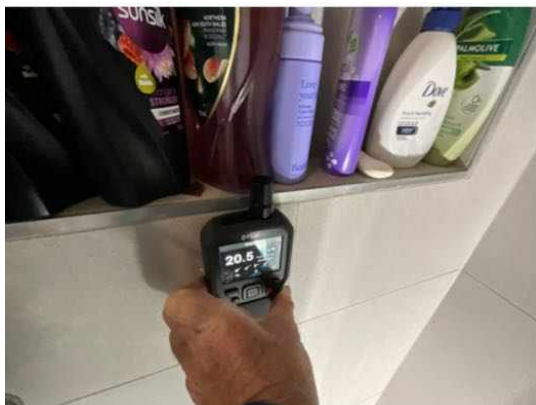
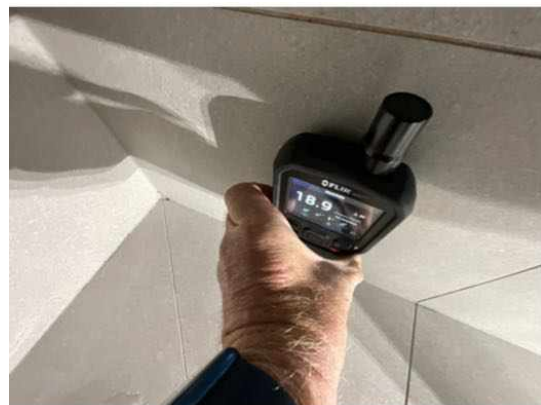
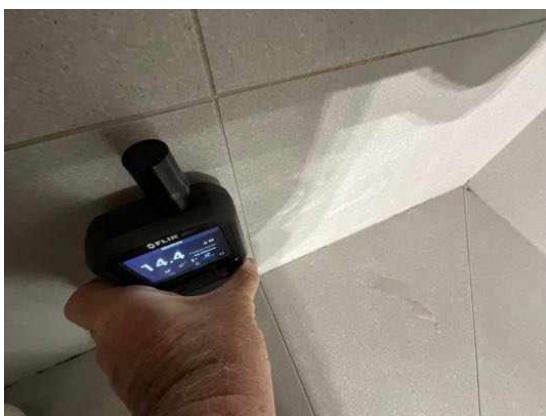
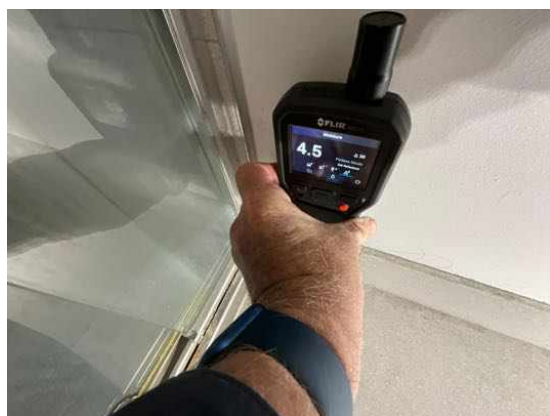
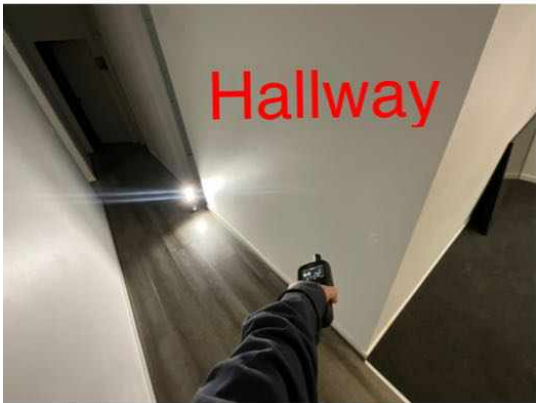
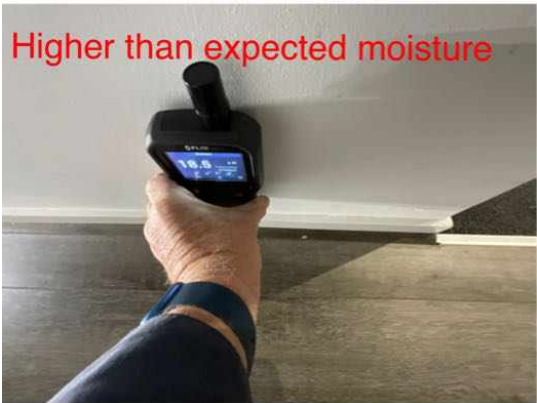
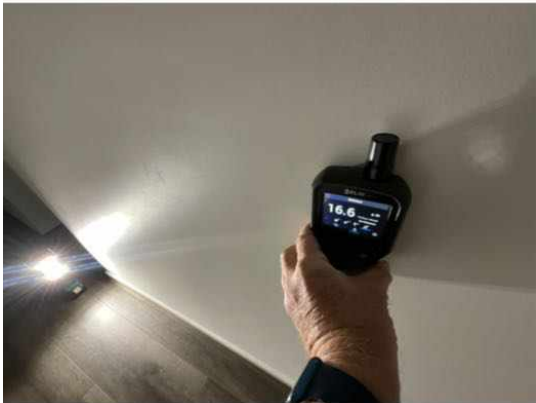
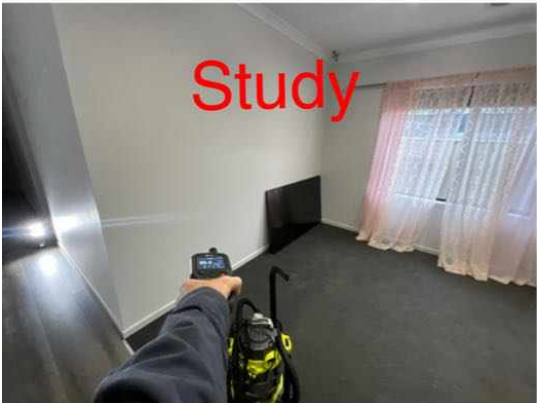
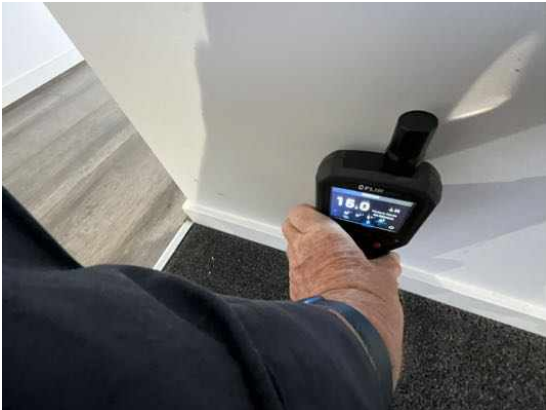
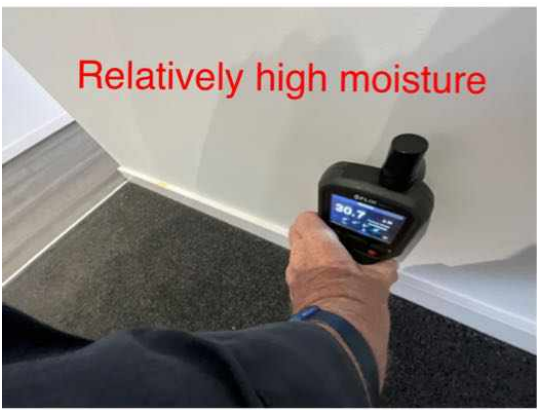
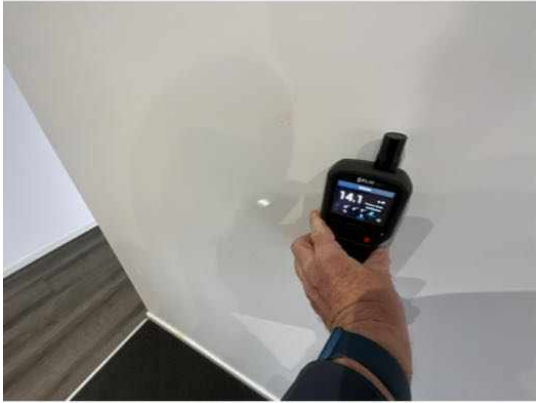
Finding 3.01

Building:	Building 1
Location:	Bathroom
Finding:	Shower damp- Monitor
Information:	Damp is evident to the lower 400mm of wall to the shower alcove.

This defect is quite common, and is suspected to have been caused by moisture permeating or leaching through the grouting and perhaps gaps in the sealant prior to repair.

Damp (or structural damp) refers to the presence of unwanted moisture in the structure of a building, either as the result of intrusion from outside, or condensation from within the structure. In the shower area, internal water leaks or other sources of excessive moisture are generally the cause of damp.

Monitoring the area is advised and if any visual signs of excessive moisture appear (peeling paint, mould) then consultation with a qualified plumber or bathroom specialist would be advised to identify the cause of damp and to perform remedial works as required.

Always ensure that sealant and grout is in good condition to prevent any moisture issues occurring in the future.

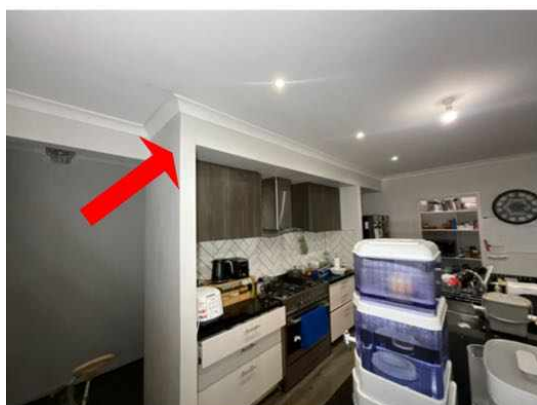
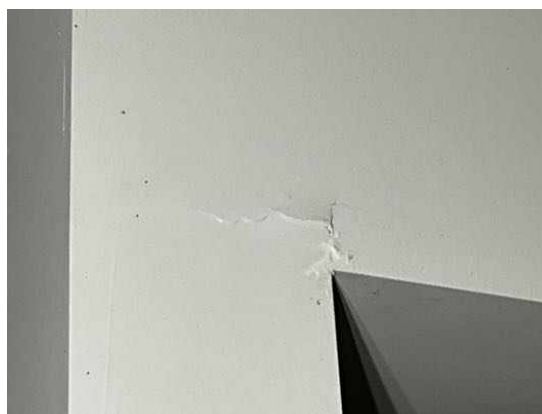
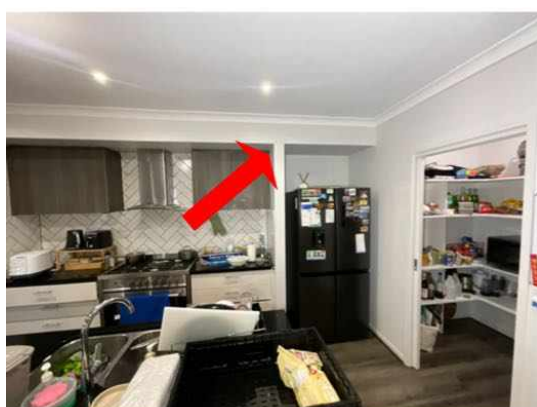
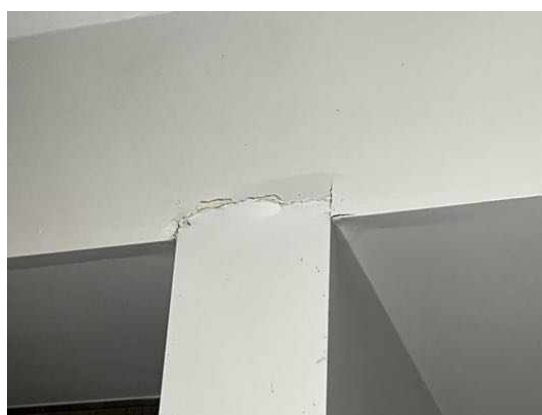
Finding 3.02

Building: Building 1
Location: Kitchen
Finding: Cracking - Damage Category 2 - Noticeable (up to 5mm)
Information: Noticeable cracks are a common occurrence as a result of many primary defects. Such causes may include age, general wear and tear, expected building movement, general expansion/contraction of building materials in different weather conditions, and/or minor failings in the installation or application of building materials.

Noticeable cracks may result in minor sticking or jamming of associated doors and windows, which require easement. However, noticeable cracks are easily filled and repaired. A plasterer can be consulted to install an expansion joint at this point to allow for this movement during different weather conditions.

Monitoring of all cracking should be conducted frequently. Always contact a building inspector should cracks widen, lengthen, or become more numerous. Additionally, your building inspector should also be contacted if associated building elements such as doors and windows become more difficult to operate over time.

Relevant tradespeople, such as carpenters, painters and plasterers, should be appointed to perform remedial works, as deemed necessary.

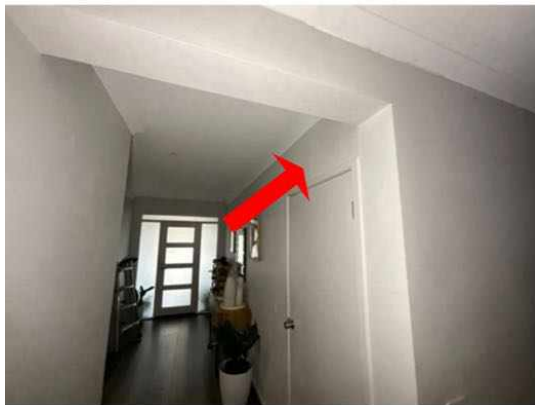
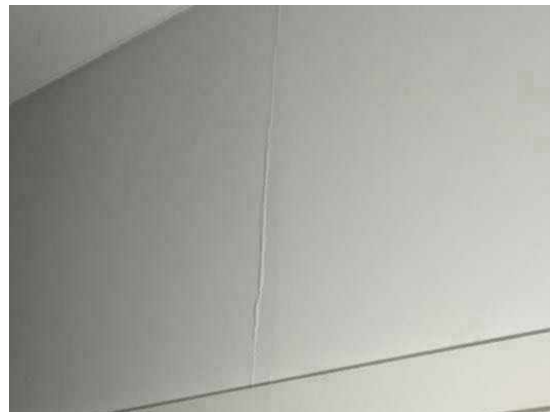
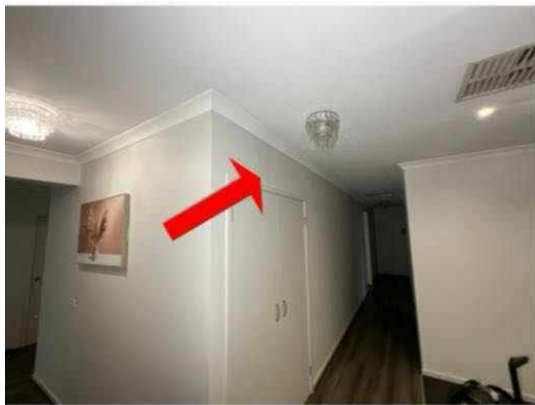
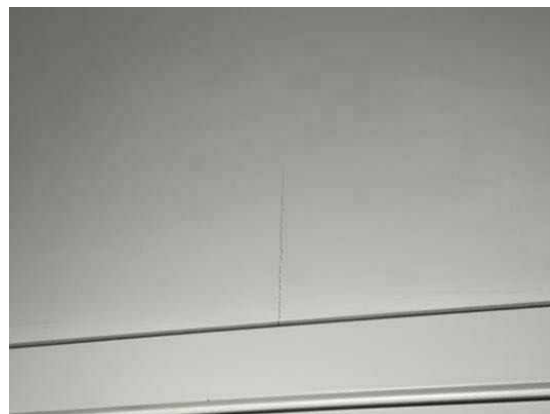
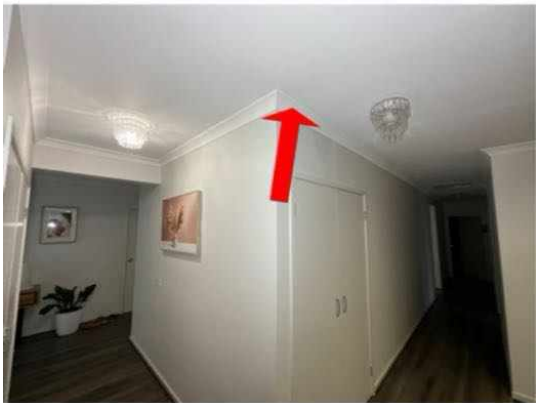
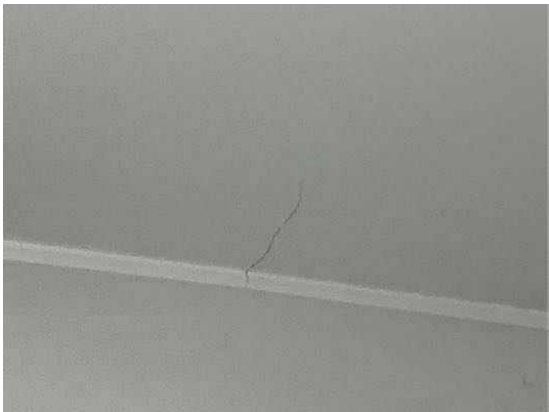
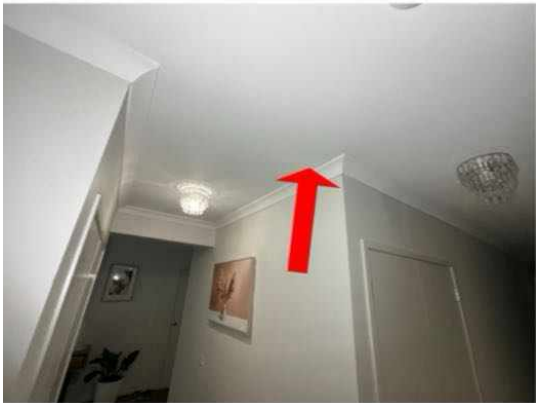
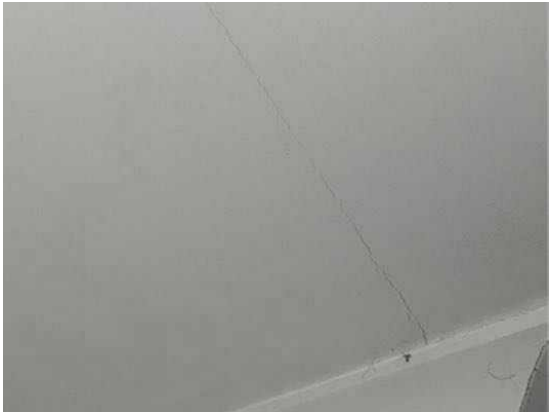
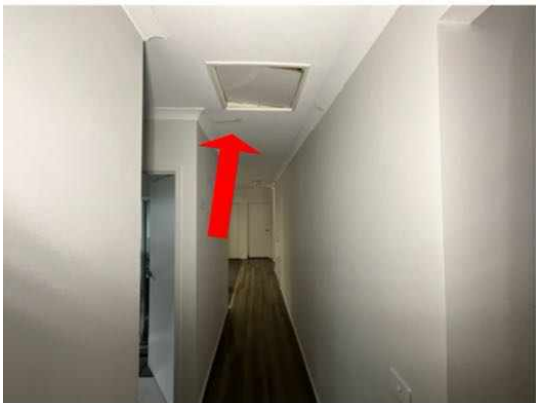
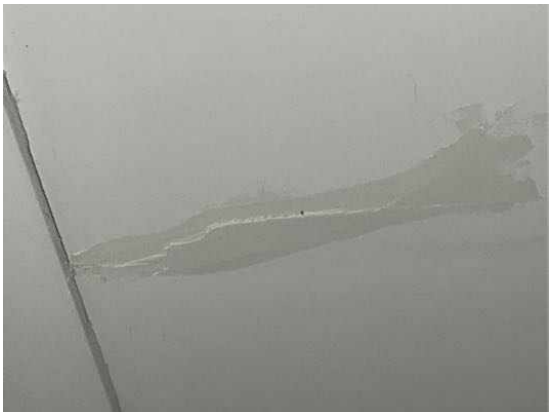
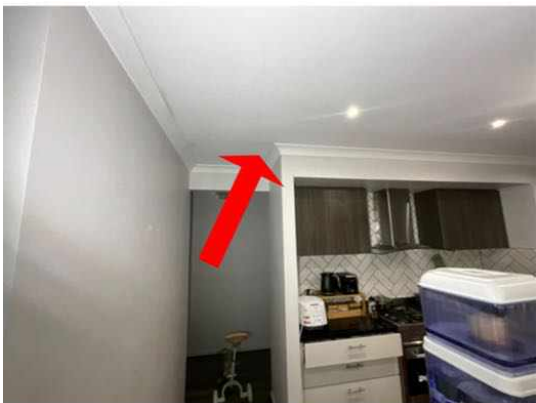
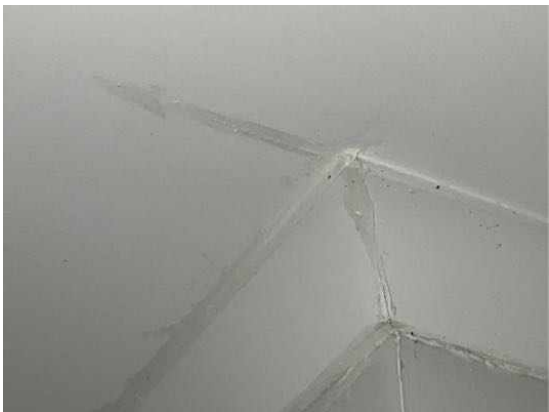
Finding 3.03

Building: Building 1
Location: Hall, hallway, kitchen
Finding: Cracking - Damage Category 1 - Fine (up to 1mm)
Information: Although fine cracks are quite noticeable, they are often only considered to be an appearance defect, and usually do not indicate any structural damage. Generally, the cause of a fine crack is indicative of a separation between building materials and finishes (e.g. paint, plaster, etc.) along joins.

Cracking of this nature can generally be repaired with minor sanding, filling and/or repainting. Such works should be performed by a qualified painter or a general handyman.

Monitoring of all cracking should be conducted frequently. Always contact a building inspector should cracks widen, lengthen, or become more numerous.

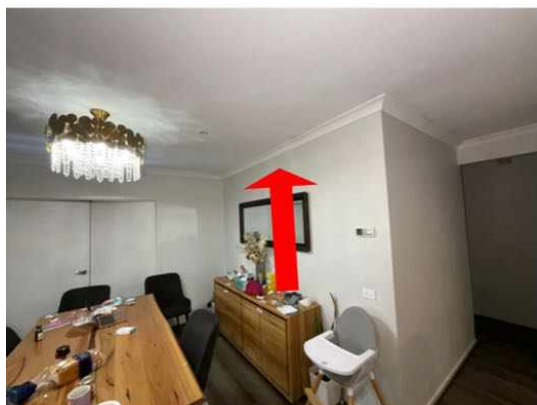
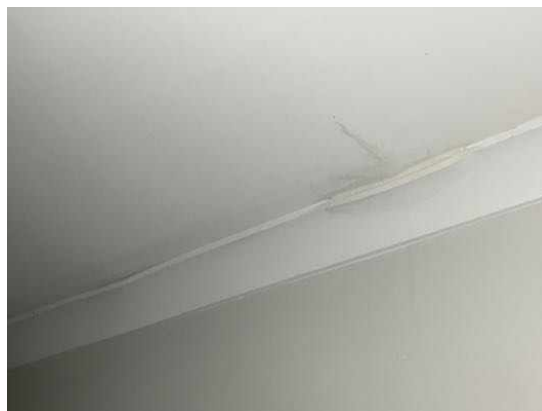
Finding 3.04

Building: Building 1
 Location: Dining Room
 Finding: Cornice- sagging
 Information: The cornice in this area is sagging. This may be due to age or poor initial installation.

A plasterer or handyman should be contacted soon to restore the area and prevent further deterioration.

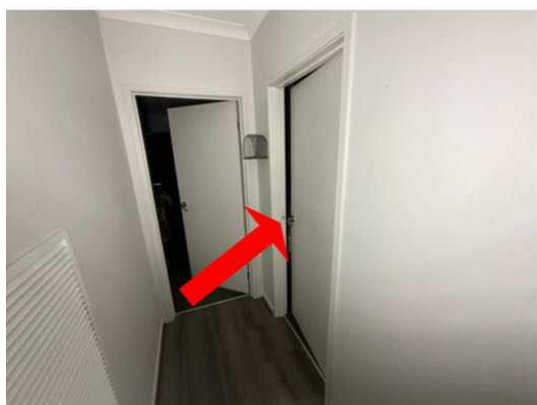
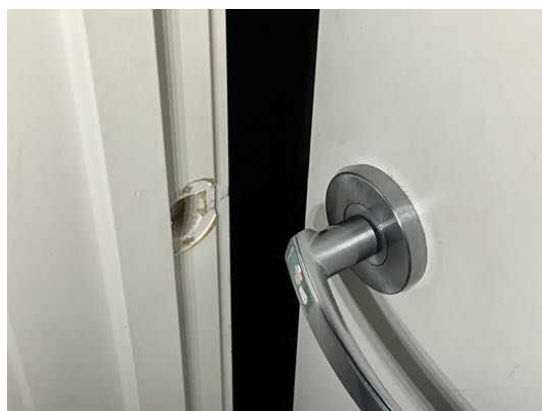
Finding 3.05

Building: Building 1
 Location: Bedroom 3
 Finding: Door - Striker plate misaligned
 Information: The striker plate to this door appears to have become misaligned and has consequently resulted in the door's operation being compromised.

This is a common defect and is expected in a property of this age, whether being due to substandard installation or general deterioration of the door hardware.

Readjustment of the striker plate is recommended at client discretion. Works such as these can be completed by a general handyman or qualified carpenter.

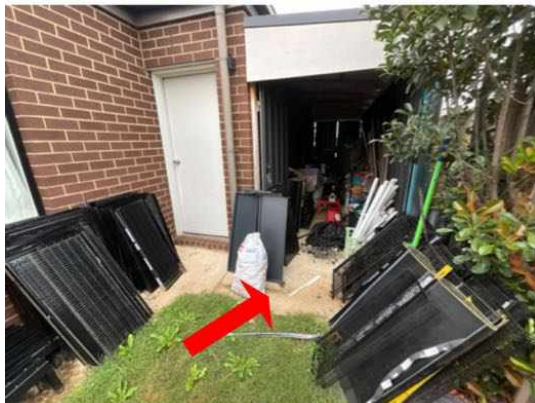
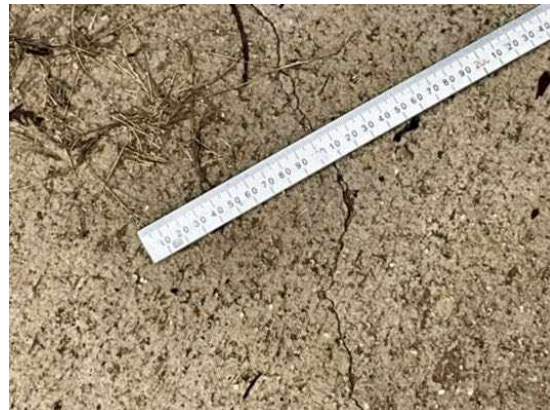
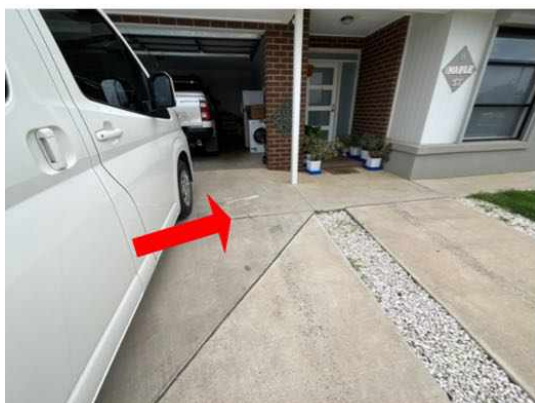
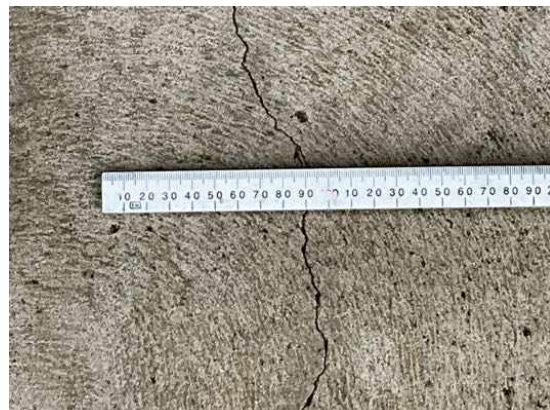
Finding 3.06

Building:	Building 1
Location:	Storage, driveway
Finding:	Cracking - External Concrete Paving Damage Category 1 - Fine (less than 2mm)
Information:	Fine cracks were identified in external concrete paving. Although fine cracks are quite noticeable, they are often only considered to be an appearance defect, and usually do not indicate any structural damage. To be considered a Category 1 or fine crack, the crack is found to be less than 2mm in width.

Generally the cause of a hairline crack in existing concrete paving such as driveways and pathways is indicative of the expansion and contraction of the concrete. Such causes are generally due to environmental factors, such as moisture levels, weather conditions, root systems of nearby trees or the soil types on which they are laid.

Fine cracks may also be due to poor original installation of the concrete. Factors such as poor compaction of the sub surface and/or inadequate reinforcing of the slab may create cracking and other secondary defects.

Monitoring of all cracking should be conducted frequently. Always contact a building inspector should cracks widen, lengthen, or become more numerous.

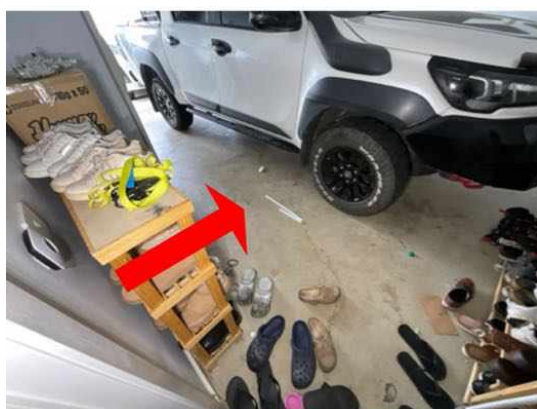
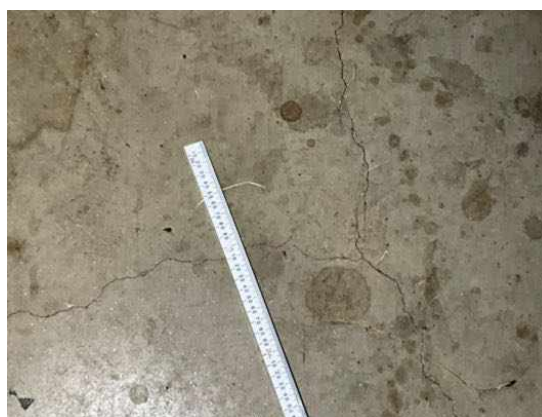
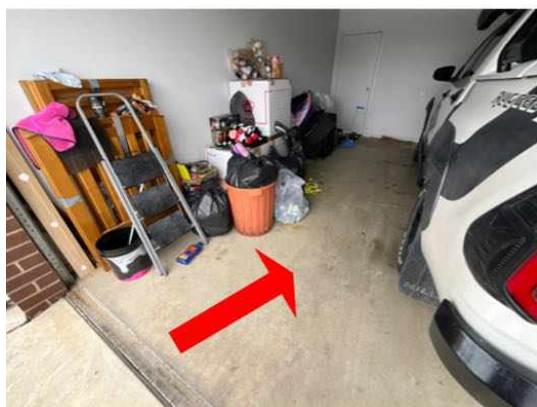
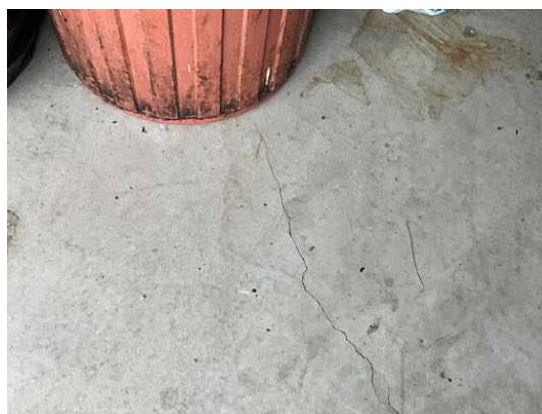
Finding 3.07

Building:	Building 1
-----------	------------

Location: Garage
Finding: Crack in concrete slab - Category 1
Information: A crack coded as Category 1 was identified in the slab. A Category 1 crack is described as a fine but noticeable crack, with the slab at an otherwise reasonable level.

To be considered Category 1, the approximate width of the crack is less than 1.0mm, or a less than 10mm change in offset when a 3m straight edge is placed over the defect.

Category 1 cracks should be monitored for a period of 12 months. At the end of the monitoring period, identified cracks that are rated greater than Category 2 are considered defects, and require rectification.

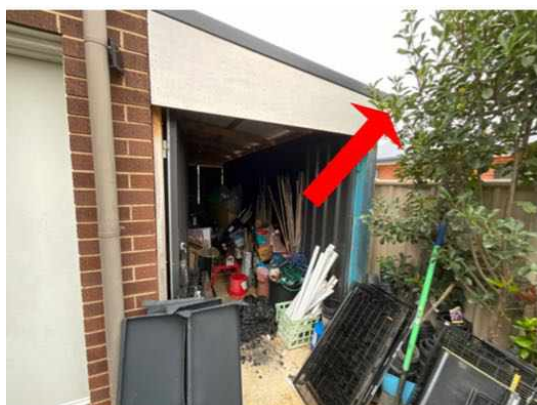
Finding 6.01

Building:	Building 1
Location:	Storage
Finding:	Stormwater drain - Not connected
Information:	The roof plumbing is not adequately connected to stormwater drainage on the site. This disconnection negatively impacts the functional capacity of the roof plumbing.

Where roof plumbing doesn't drain adequately, the area at the base perimeter can become excessively damp, potentially creating an environment that is susceptible to rust and corrosion of surrounding building elements, as well as attracting termites and other pests.

It is highly recommended that a plumber be appointed to further inspect the area and to install adequate drainage equipment where necessary.

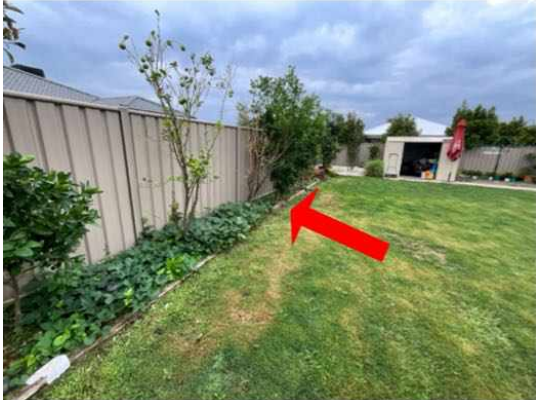
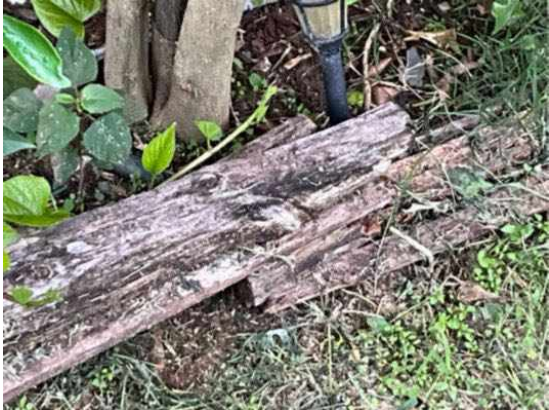
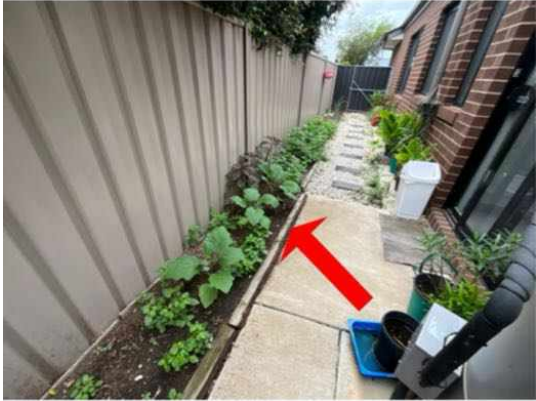
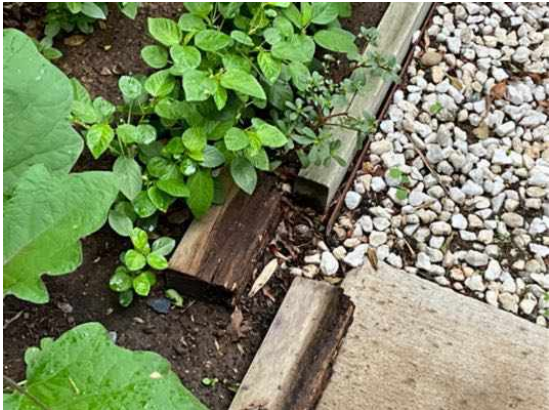
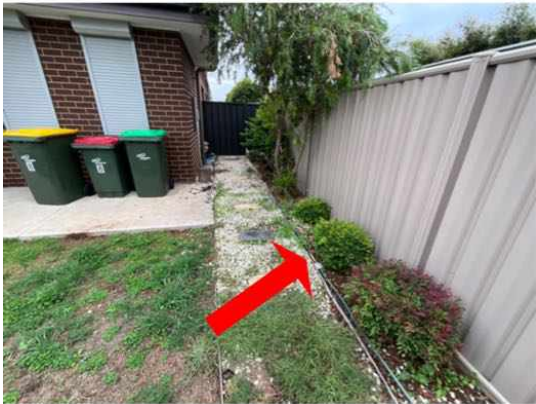
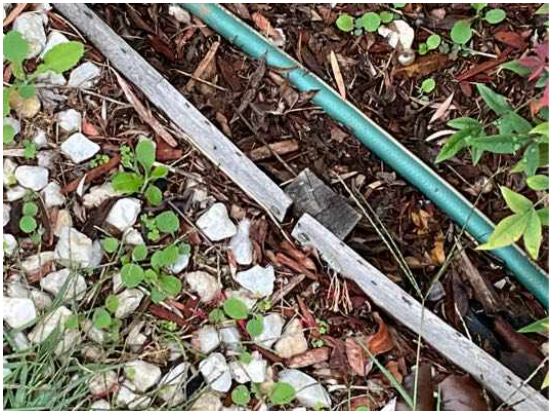
Finding 6.02

Building:	Building 1
Location:	Yard - Back, side, front
Finding:	Untreated or non-durable timbers in a hazardous environment
Information:	To reduce the risk of timber pest attack it is essential that timber used in a hazardous environment (e.g. in direct contact with the ground or frequently exposed to damp conditions) is of sufficient durability and/or is adequately preservative treated.

Untreated timbers in direct contact with the ground are likely to develop severe wood rot and/or fungal decay if left unattended creating attraction for subterranean termites to infest the timbers from surrounding areas.

If untreated or non-durable timbers are found to be in a hazardous environment it is highly advised that replacement of these building elements be performed as soon as possible to aid the protection of the property against termite / timber pest attack.

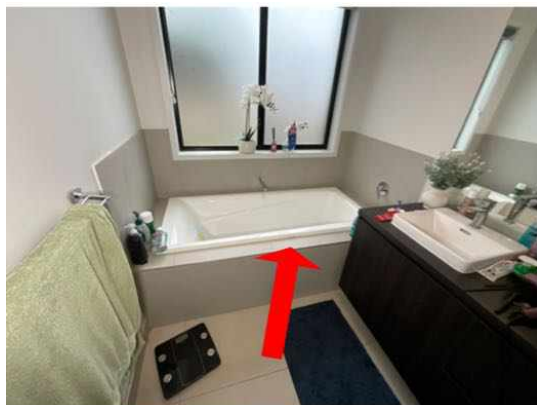
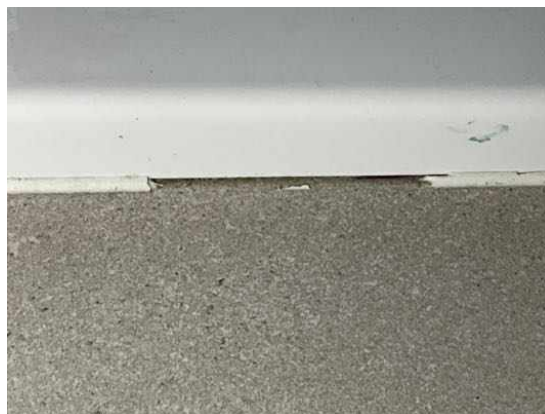
Finding 6.03

Building: Building 1
 Location: Bathroom
 Finding: Inadequate sealant or Grout
 Information: This area has a lack of effective Sealant or Grout. This is allowing the ingress of water to the structure inside the wall.

The presence of water encourages Termite attack, Mould and Fungal Decay.

A Tiler or General Handy person must be contacted as soon as possible to effect

repairs and prevent further deterioration.

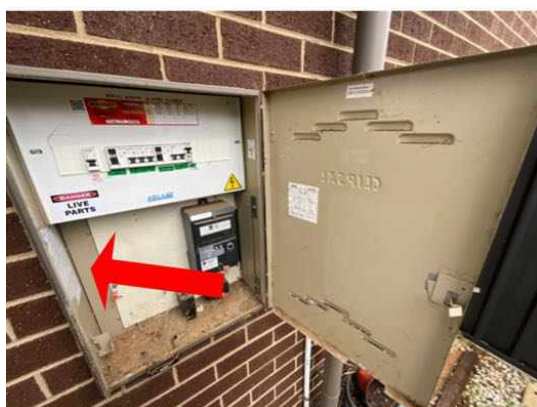
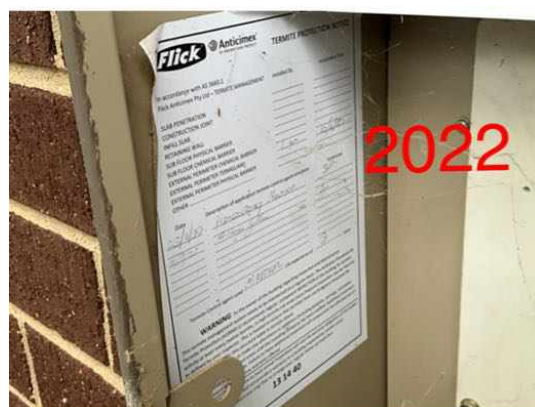
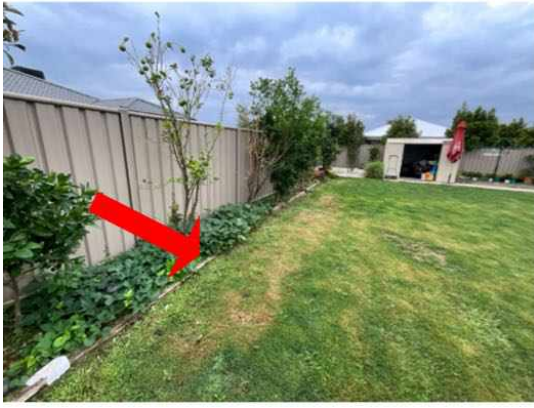
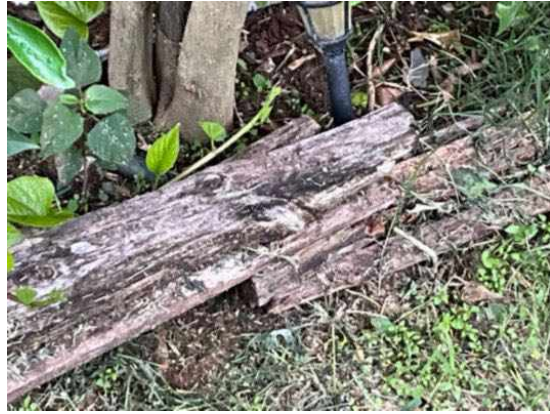
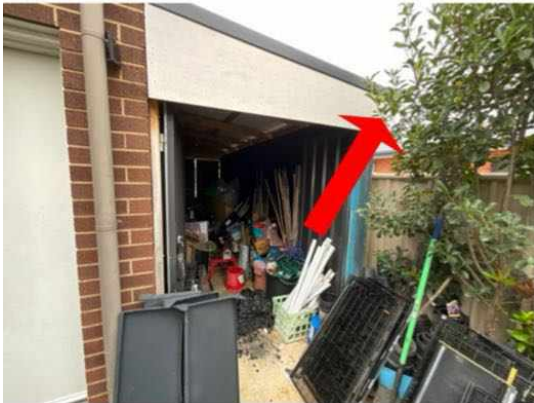
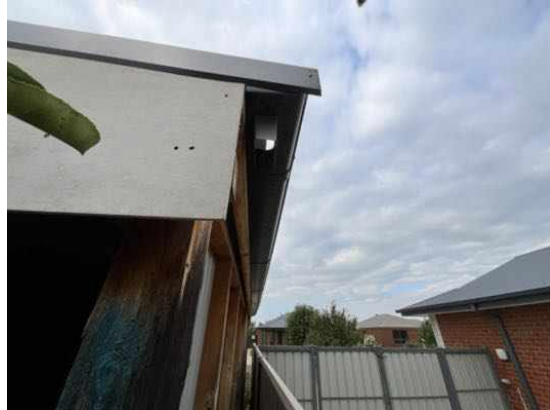
Finding 6.04

Building: Building 1
 Location: All External Areas
 Finding: Termite Management System- evidence of a chemical installation
 Information: The application of a post-construction chemical termite barrier is highly recommended for all properties, particularly if live termite activity has been found on the site previously. Such barriers are highly effective in preventing termite attack on any timber building elements throughout the property.

A durable notice has been placed in the switchboard unit to indicate current termite barriers. At the time of inspection, it appeared as though a termite management system has been installed. The recency of any treatment cannot be determined.

The client may consider gaining further advice from a pest controller as to the costs and procedures involved with this application. It is recommended that obtaining such advice be a short-term priority.

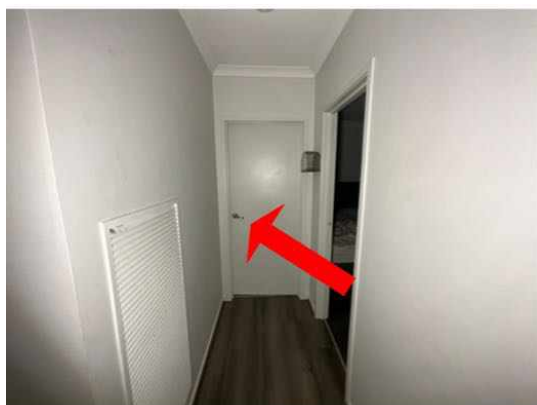
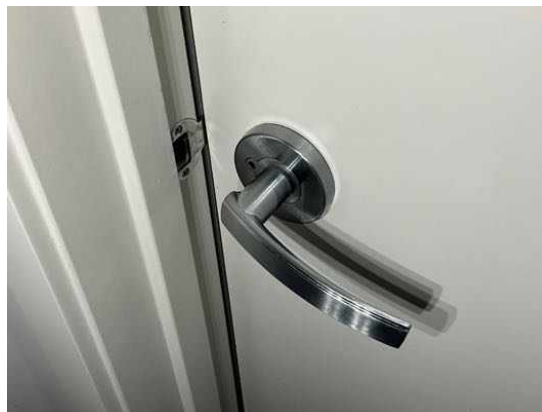
Building: Building 1
 Location: Bedroom - Master
 Finding: Door handle- Poor operation
 Information: The door handle/ catch in this area was found to be faulty during the visual inspection. This is most probably because of a lack of maintenance or wear and tear over time.

A general Handy person or lock specialist should be contacted to make needed repairs at the discretion of the owner and restore full function.

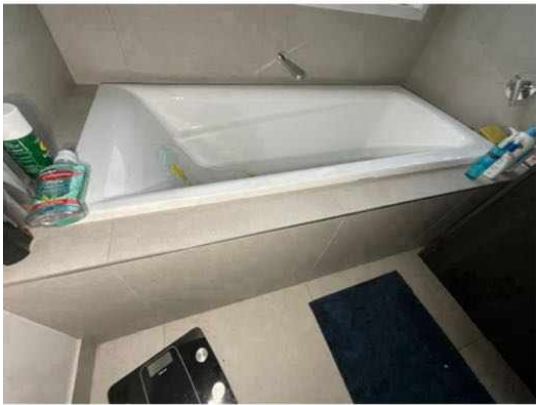
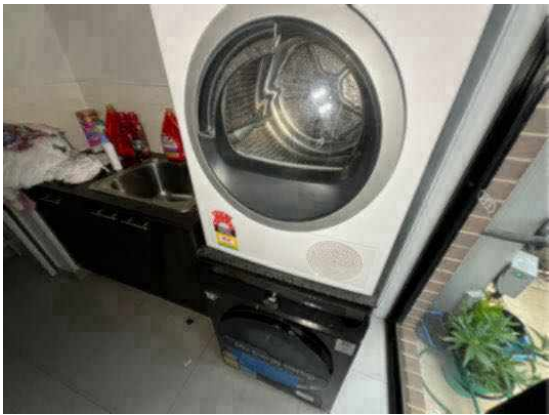
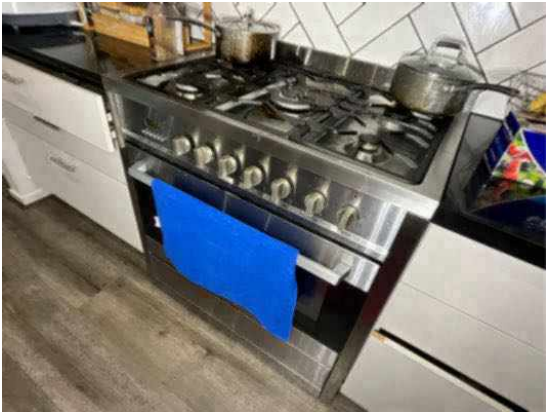
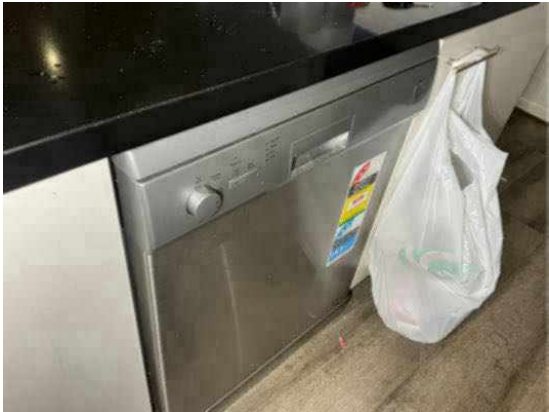
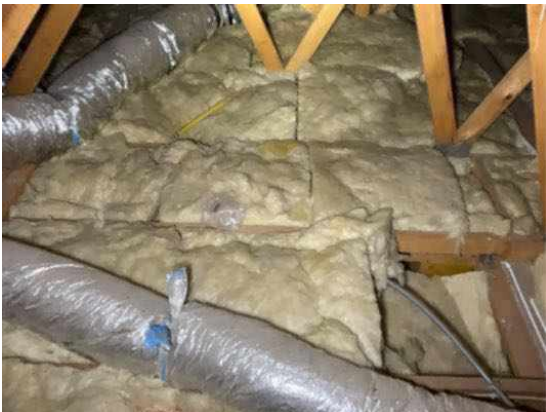
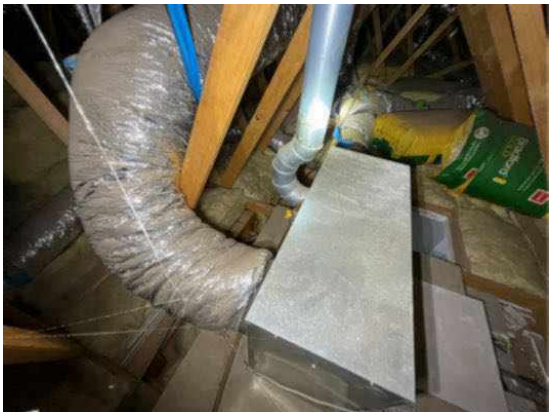
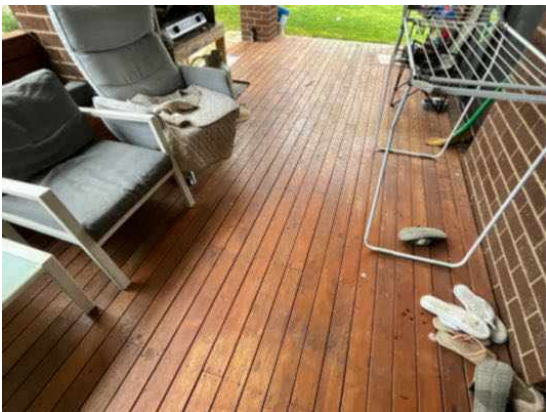
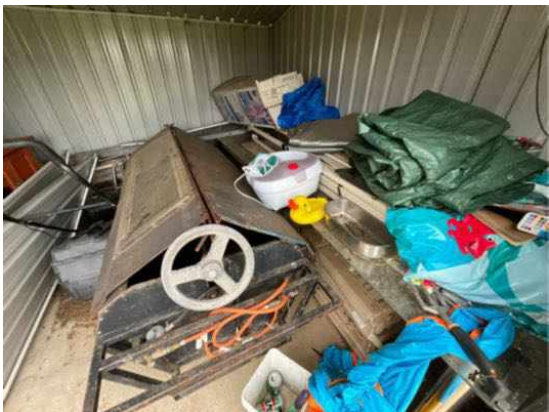
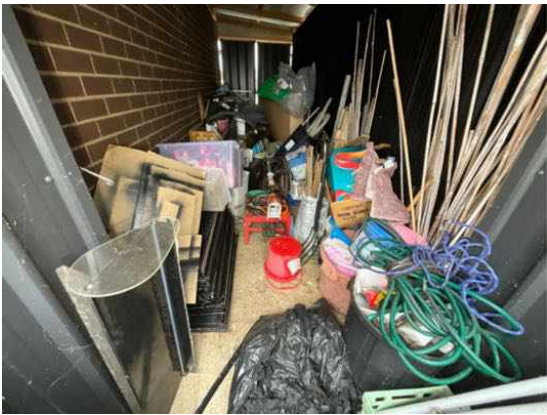
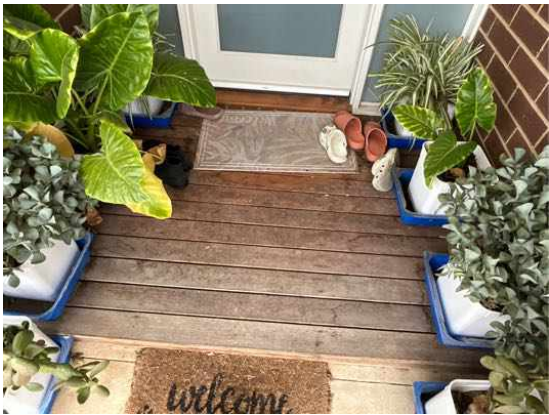
Building: Building 1
 Location: All Areas
 Finding: Additional Photos - Obstructions and Limitations
 Information: These photographs are an indication of the obstructions and limitations which impeded full inspection of the property at the time of inspection. These obstructions can hide an array of defects and should be removed to allow full inspection to be carried out. A re-inspection is recommended once the areas are made accessible.
