Building Inspection Report

Inspection Date: Tue, 20 Jan 2026

Property Address: 6 Crane St, Berwick VIC 3806, Australia

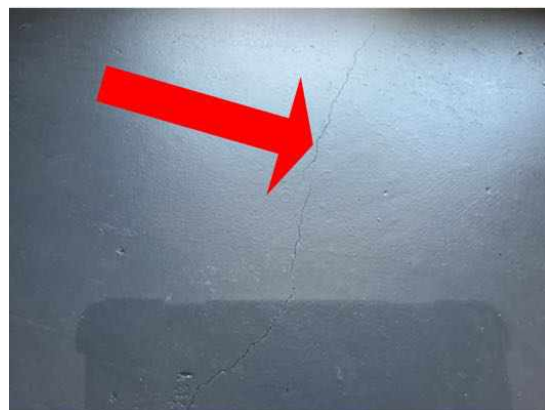
Defects 3.01

Building:	Main Building
Location:	Garage
Finding:	Noticeable cracks in concrete slab of the the garage floor
Information:	During the inspection, multiple noticeable cracks were identified in the concrete slab of the garage floor. These cracks vary in size and location, which may indicate underlying movement or stress within the slab. While they do not currently appear to significantly impact the structural integrity, their presence suggests potential early-stage deterioration.

It is recommended that the cracks be monitored closely over the next 12 months. If any of the cracks widen or worsen during this period, it is critical to engage a structural engineer immediately to assess the situation and recommend appropriate rectification measures to prevent further damage and ensure the long-term stability of the structure.

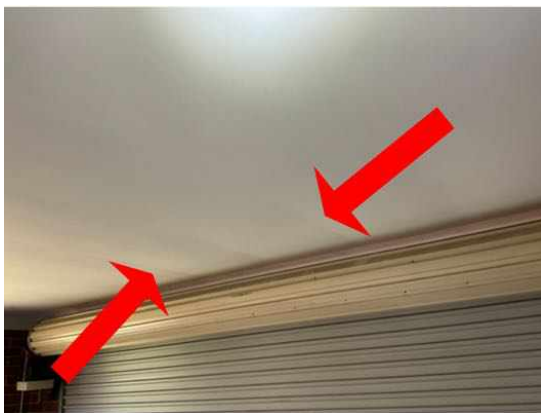
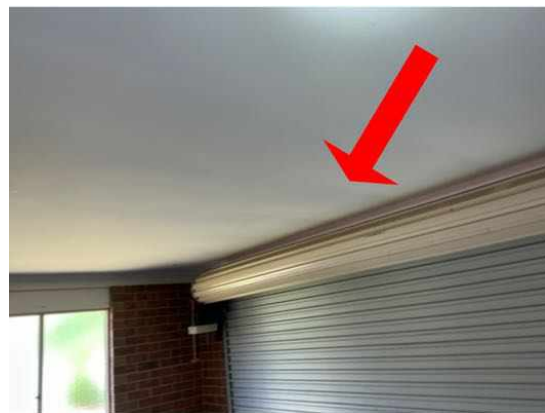
Defects 3.02

Building:	Main Building
Location:	Garage
Finding:	Minor sagging in the ceiling - garage

Information: Sections of the ceiling were found to be sagging slightly at the time of inspection. Sagging in the fixed ceiling structure generally indicates that the building materials have swollen due to contact with water or that fixings (e.g., nails or glue) have become loose and require reattachment. This is a very common defect in garages due to their lack of insulation and susceptibility to moisture. Condensation builds up in the roof and rests on the plasterboard, softening it somewhat, which makes it more likely to sag and release from its fixing points.

While damage is minimal at this stage, a licensed plasterboard contractor should be appointed to repair the ceiling. Insulating the area could be considered by the client once repaired.

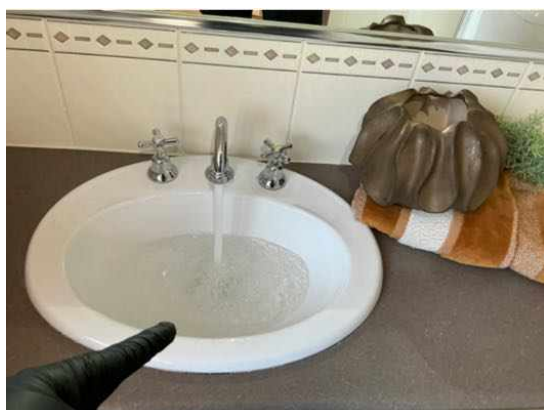
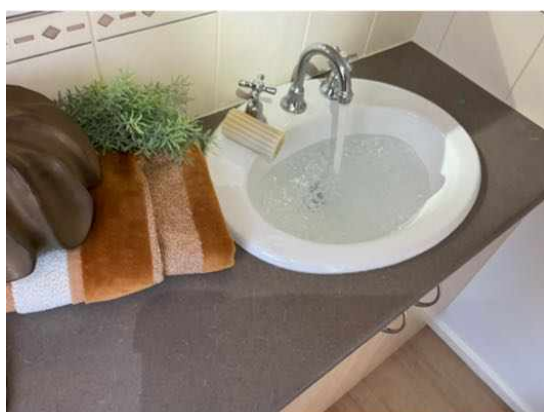
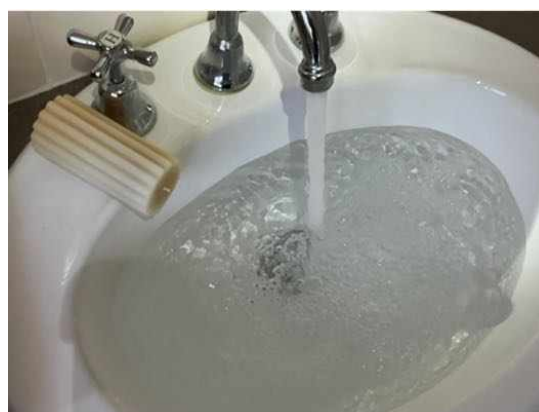
Defects 3.03

Building: Main Building
 Location: Ensuite - Master
 Finding: Slow Drainage in En-Suite Vanity Sinks
 Information: Upon inspection, the en-suite vanity sinks were found to have very slow drainage, resulting in water pooling within the basin during use. This issue is typically associated with a partial blockage within the sink drain, or excessive water flow which may lead to further plumbing complications if left unaddressed. Additionally, prolonged pooling of water can contribute to bacterial growth and potentially cause damage to surrounding cabinetry or surfaces due to excess moisture.

It is recommended that a licensed plumber be engaged to inspect and clear any obstructions within the drainage system as soon as possible to restore proper functionality and prevent further issues. Regular maintenance of sink drains is also advised to ensure efficient water flow.

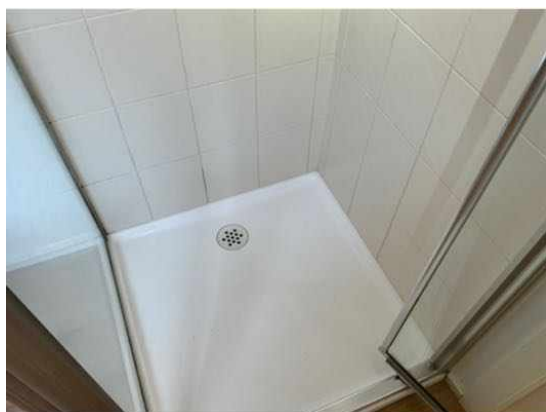
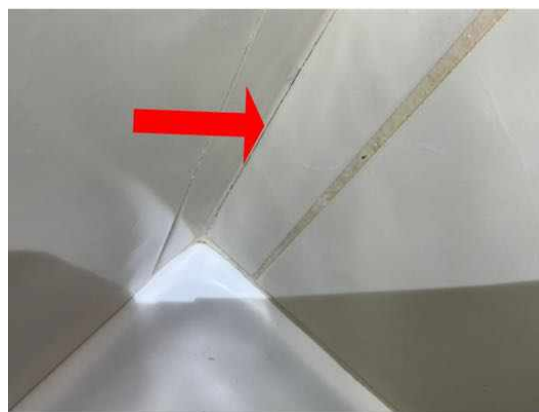
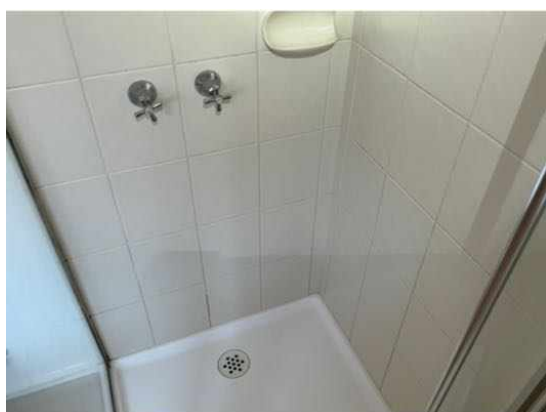
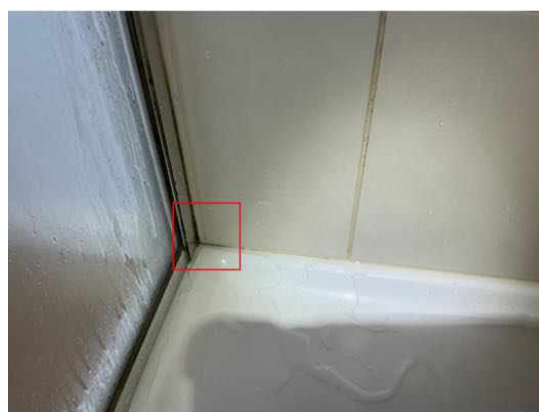
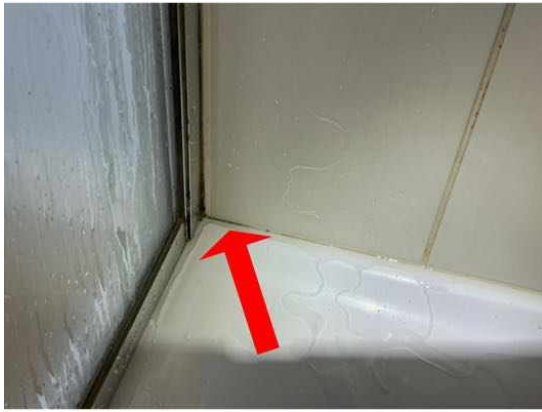
Defects 3.04

Building: Main Building
 Location: Ensuite - Master
 Finding: Degraded Sealant and Grout to Shower and Bathroom Areas
 Information:

It was noted during the inspection that sealant and/or grout to the tiled shower alcove and other areas of the bathroom are degraded in places. This condition is common in wet areas due to regular exposure to moisture and the natural movement that occurs between different building materials and floor finishes.

Different materials expand and contract at different rates, which commonly results in cracking or separation of rigid grout at junctions. Flexible sealant is required at these locations to accommodate movement while maintaining a water-tight seal and protecting adjoining building materials from moisture ingress.

It is recommended that flexible, mould-resistant sealant be applied to the affected areas and that any deteriorated grout be repaired as required. Sealant and grout in wet areas are considered ongoing maintenance items and should be regularly inspected, maintained, and replaced as part of normal property upkeep. A sealant specialist or qualified tiling contractor should be engaged to complete these works as soon as practical. Minor areas may only require topping up; however, all affected joints should be thoroughly checked.

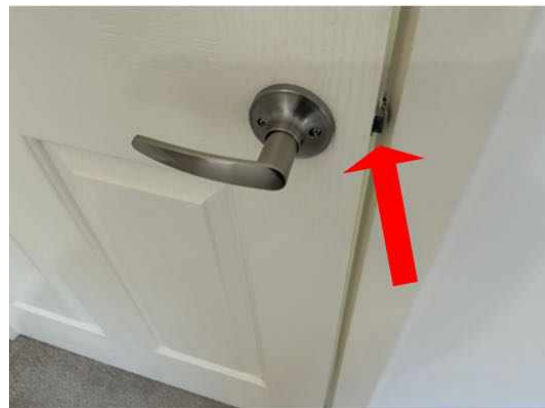
Defects 3.05

Building:	Main Building
Location:	Bedroom - Master
Finding:	Door handle - Not latching
Information:	It was noted that the door the master bedroom was not latching during operation at the time of inspection. Whilst detracting from the functionality of this building element, this minor defect may also be a security risk, and may therefore have serious implications if left unattended.

It is suspected that this defect has occurred due to minor issues with the associated hinges. Such damage is identified as general wear and tear, which is expected for building elements of this age.

A qualified carpenter or general handyperson may be appointed to perform rectification works as necessary, at client discretion. If left unattended, further functional impairment is likely to occur.

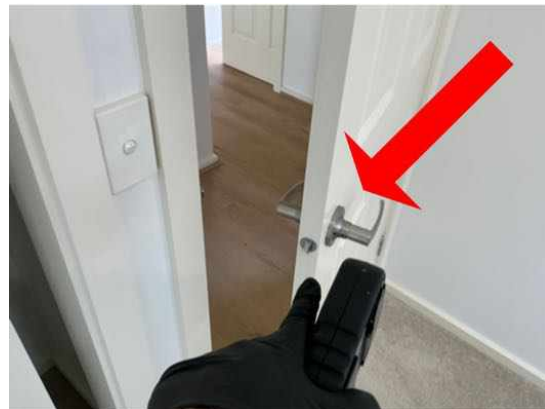
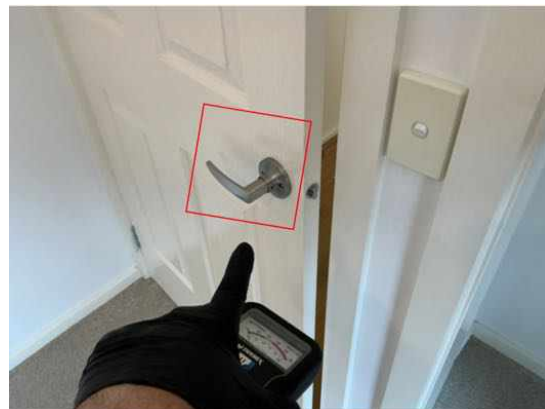
Defects 3.06

Building:	Main Building
Location:	Bedrooms 3 & 4
Finding:	Door handles - Not latching

Information: It was noted that the doors to both bedroom 3 and 4 were not latching during operation at the time of inspection. Whilst detracting from the functionality of this building element, this minor defect may also be a security risk, and may therefore have serious implications if left unattended.

It is suspected that this defect has occurred due to minor issues with the associated hinges. Such damage is identified as general wear and tear, which is expected for building elements of this age.

A qualified carpenter or general handyperson may be appointed to perform rectification works as necessary, at client discretion. If left unattended, further functional impairment is likely to occur.

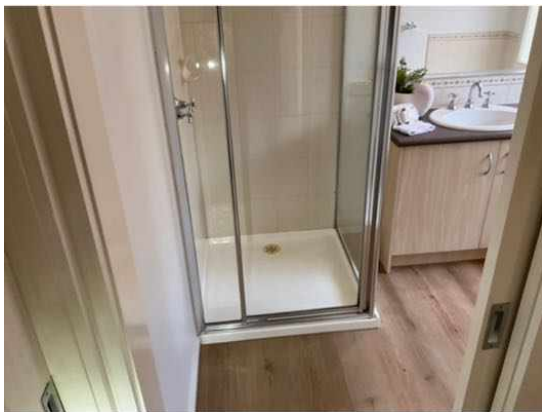
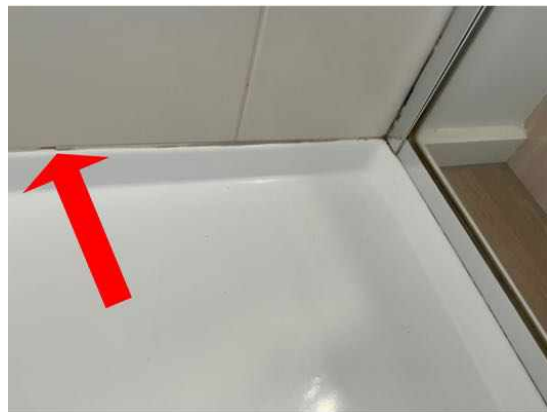
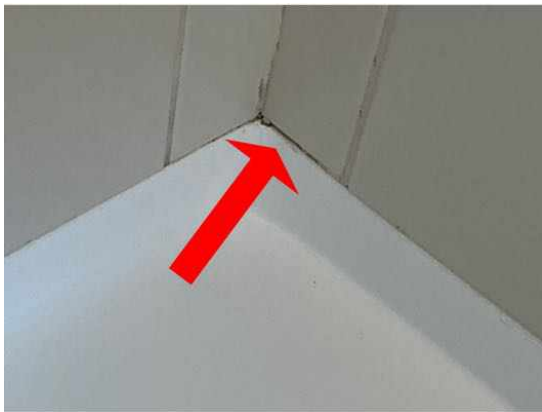
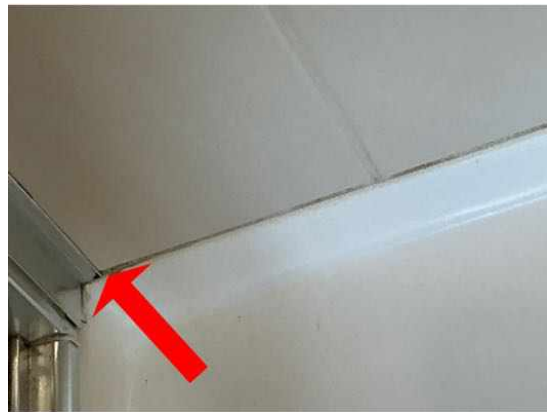
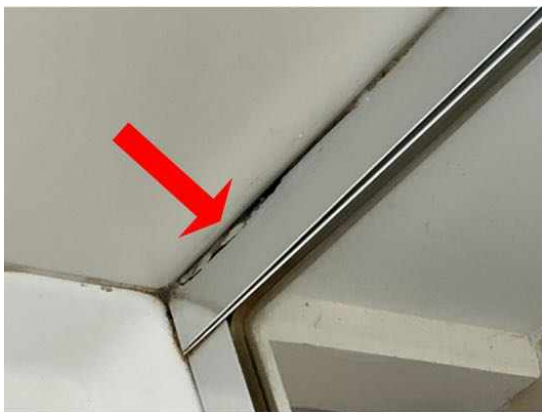
Defects 3.07

Building: Main Building
 Location: Bathroom 2
 Finding: Sealant and grouting - Deteriorated
 Information: It was noted on inspection that sealant or grout is degraded to the tiled shower alcove and or other areas of the bathroom.

Different materials and floor areas move at different rates, generally causing cracking to grout or sealant at this point. A flexible sealant is required to allow for expected

Flexible and mould resistant materials should be applied to affected areas to prevent any subsequent water damage that is likely to occur. Regular maintenance and replacement of damage or missing or damaged sealant and grout is highly recommended to the wet areas, as this is a regular wear and tear defect. Sealant and grouting in areas that come into regular contact with water should be maintained for the long term care of your property.

A sealant specialist or tiling contractor should be appointed to complete these works as soon as possible

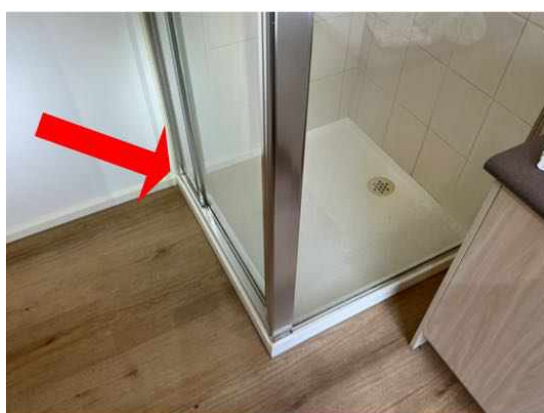
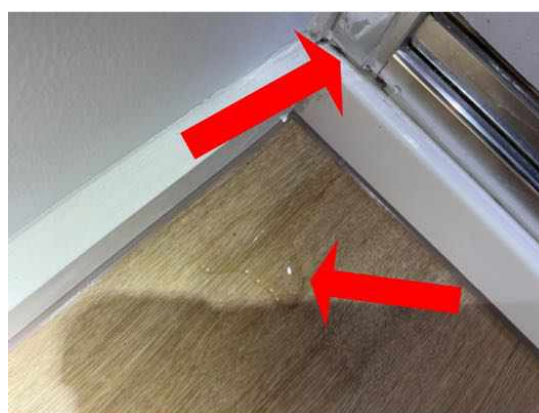
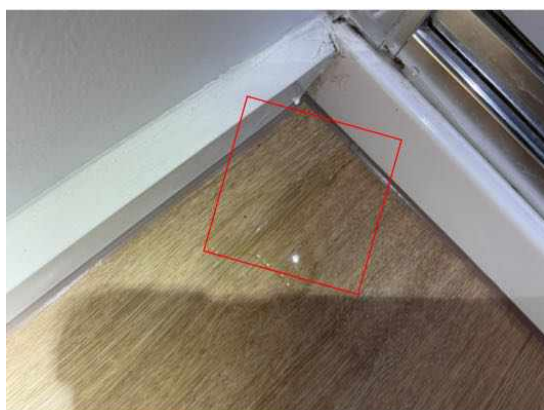
Defects 3.09

Finding: Shower screen - Leaking

Information: Leaking was evident to the 2nd bathroom's shower screen at the time of inspection. It is suspected that the leaking has occurred as a result of deteriorated or missing caulking to the shower or general ageing of the building elements.

Leaking from the shower where left unattended, is likely to lead to water damage to adjoining flooring and walls. Such damage can lead to water damage and necessitate extensive remedial works being required. Active water leaks may also create an environment that is susceptible to the formation and development of mould.

Appointment of a caulking contractor is required to repair or replace the caulking to the shower area. Such works should be performed as soon as possible to ensure that no further damage occurs.

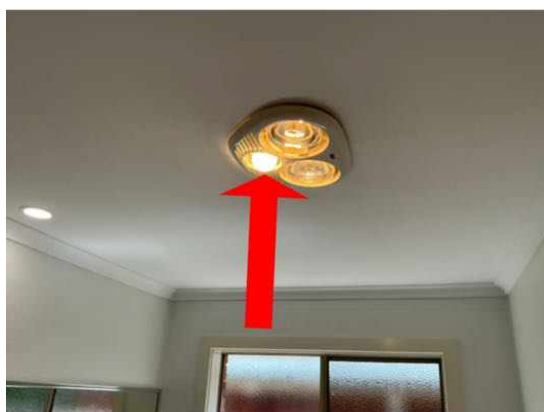
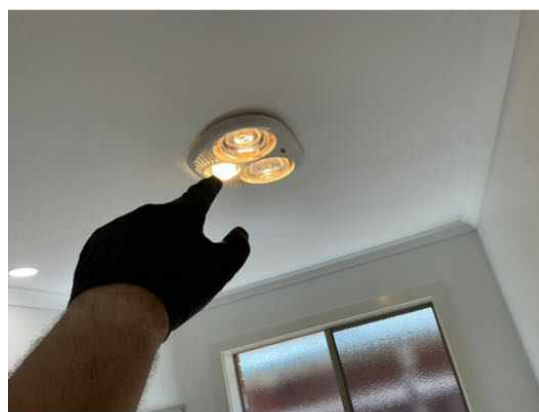
Defects 3.10

This issue may reduce the efficiency of the exhaust fan, leading to inadequate ventilation in the en-suite, which could contribute to moisture buildup and potential issues such as mold or mildew growth. A noisy fan is also generally less effective at expelling humid air, which could affect the overall air quality and comfort of the space.

It is recommended that a qualified technician inspect and service the exhaust fan to determine the cause of the noise. If necessary, the fan should be repaired or replaced to restore proper ventilation and ensure the en-suite remains well-ventilated and free of excess moisture.

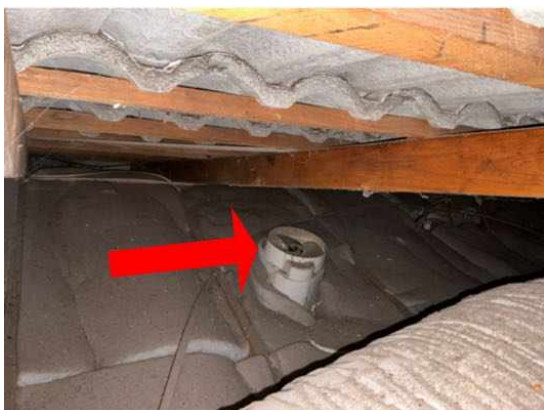
Defects 3.11

Building:	Main Building
Location:	Roof Void
Finding:	Bathroom Exhaust Fans Not Ducted to External Atmosphere
Information:	The exhaust fans installed in the bathrooms were observed to be discharging directly into the roof cavity rather than being ducted to the external atmosphere. This configuration does not comply with best practice ventilation standards, as it allows moist air to accumulate within the roof space.

Prolonged moisture build-up in the roof cavity can lead to elevated humidity levels, which may contribute to mould growth, timber decay, and potential damage to insulation or other roof components over time.

It is recommended that a licensed ventilation specialist or electrician be engaged to install compliant ducting that vents the exhaust air to the outside of the building, in accordance with current building regulations and ventilation standards.

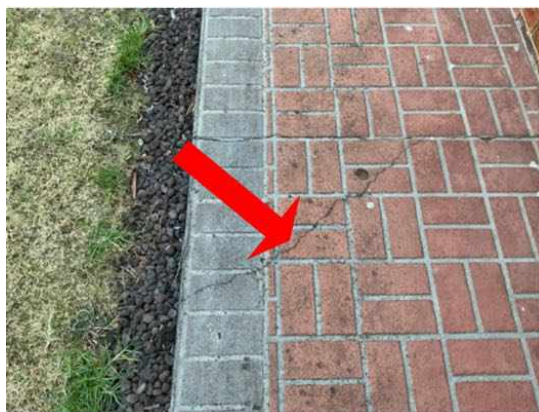
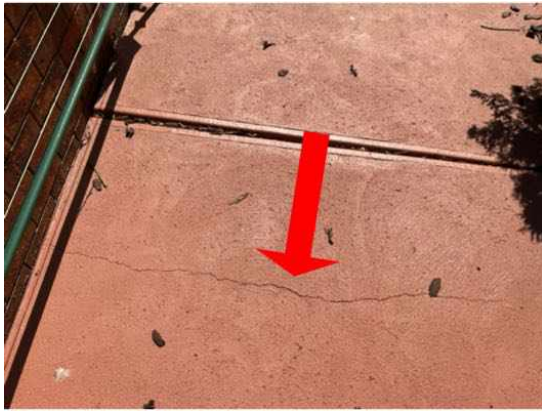
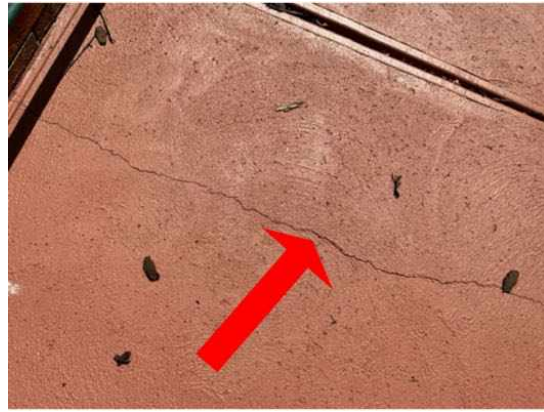
Defects 3.12

Building: Main Building
 Location: All External Areas
 Finding: Cracking - Damage Category 2 - Noticeable (up to 5mm)
 Information: Noticeable cracks are a common occurrence as a result of many primary defects. Such causes may include age, general wear and tear, expected building movement, general expansion/contraction of building materials in different weather conditions, and/or minor failings in the installation or application of building materials.

Noticeable cracks may result in minor sticking or jamming of associated doors and windows, which require easement. However, noticeable cracks are easily filled and repaired. A plasterer can be consulted to install an expansion joint at this point to allow for this movement during different weather conditions.

Monitoring of all cracking should be conducted frequently. Always contact a building inspector should cracks widen, lengthen, or become more numerous. Additionally, your building inspector should also be contacted if associated building elements such as doors and windows become more difficult to operate over time.

Relevant tradespeople, such as carpenters, painters and plasterers, should be appointed to perform remedial works, as deemed necessary.

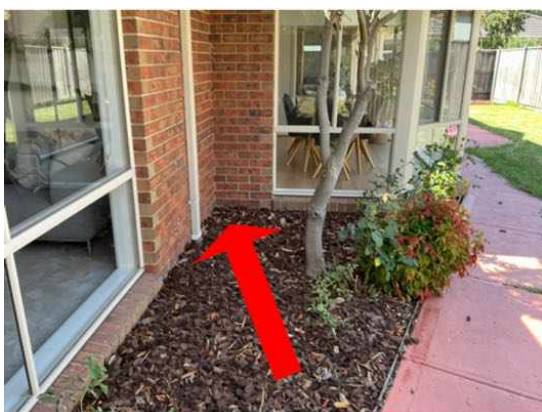
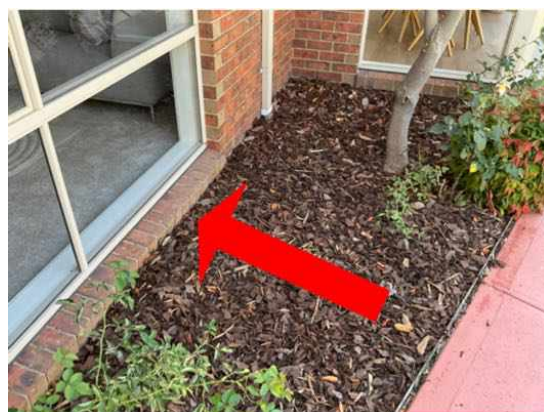
Defects 3.13

Building:	Main Building
Location:	Front Elevation
Finding:	Site drainage - Inadequate
Information:	The site drainage in sections of the front elevation was found to be inadequate at the time of inspection, creating potential for subsequent water damage to associated building elements.

It is important that water does not lie against the base of walls; surrounding paths and ground levels should be sloped to drain water away from walls. Downpipes should not discharge stormwater onto lower walls or plinths. Stormwater should be carried away by large, regularly cleaned drains. Ground levels may need to be lowered to expose a buried DPC.

Where site drainage is inadequate, installation of an Agricultural (Aggie) Drain may be required. A qualified plumber should be appointed to further inspect the property and perform any remedial works as necessary. Water damage and secondary defects are likely to occur if left unmanaged.

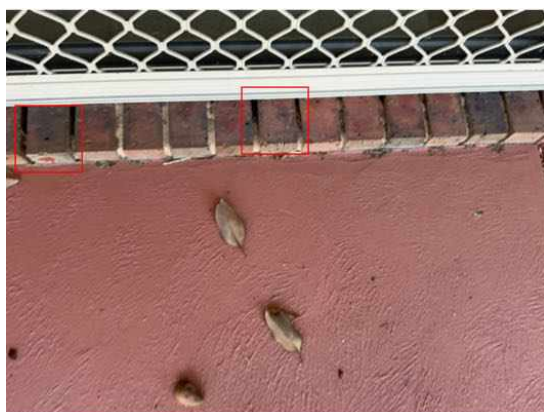
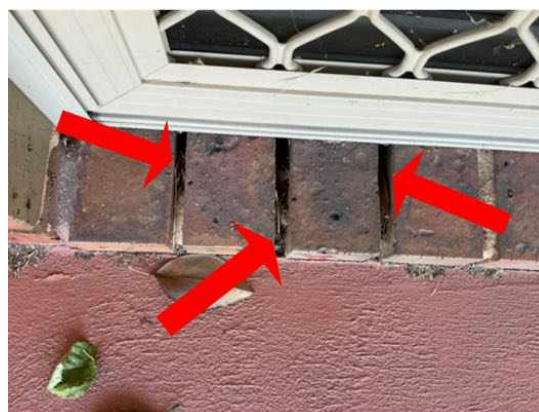
Defects 3.14

Finding: Brickwork - Deteriorated mortar

Information: Sections of the exterior mortar to the brickwork was deteriorated at the time of inspection. Mortar, or 'bedding', is the material which fills joints and intersections between bricks in masonry walls and structures. Sections of mortar in this brickwork were identified as having deteriorated, which is generally expected for a property of this age and condition.

Mortar may deteriorate as a result of age of building materials, minor movement of bricks, or frequent exposure to weathering. Mortar should be replaced to ensure that bricks remain in their intended location and to prevent gaps, which would allow water or moisture ingress and secondary damage as a result.

Mortar deterioration can be addressed by a bricklayer where areas of deterioration are localised and easily accessible. Alternatively, appointment of a registered builder is advised, to repoint large areas of decaying mortar. Where secondary structural defects have become evident, consultation with a structural engineer may be required.

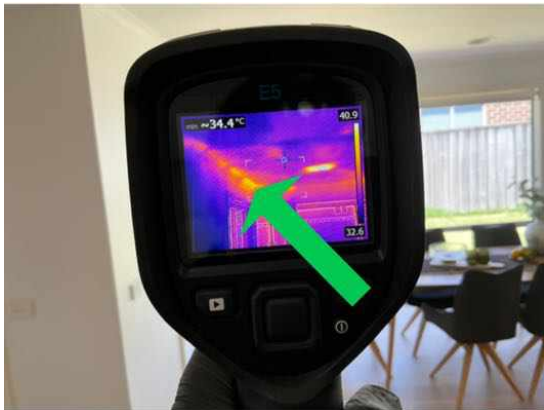
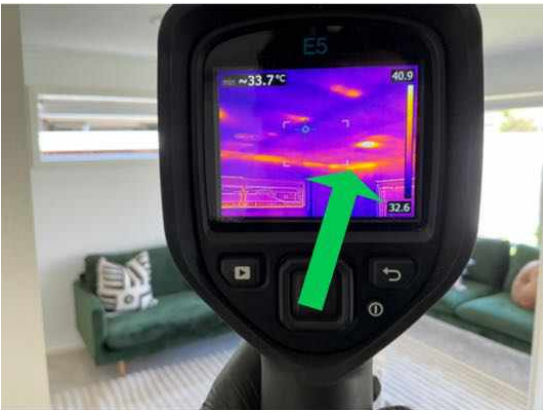
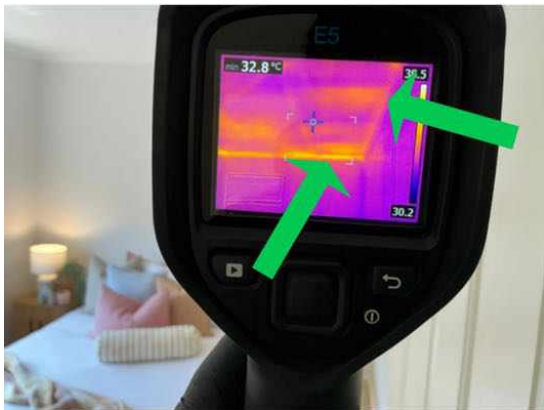
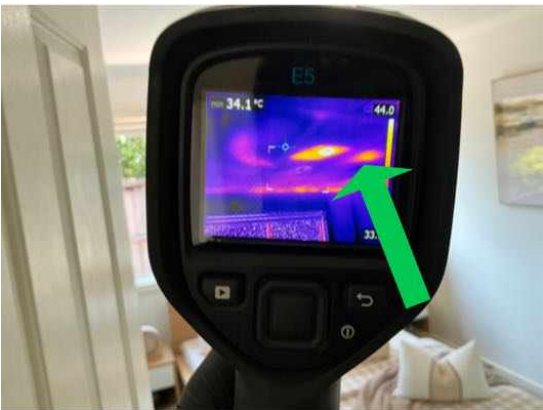
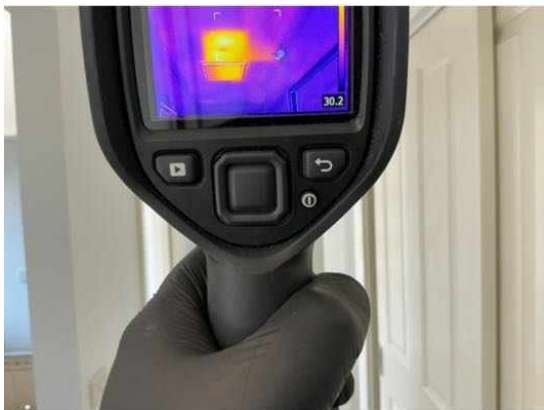
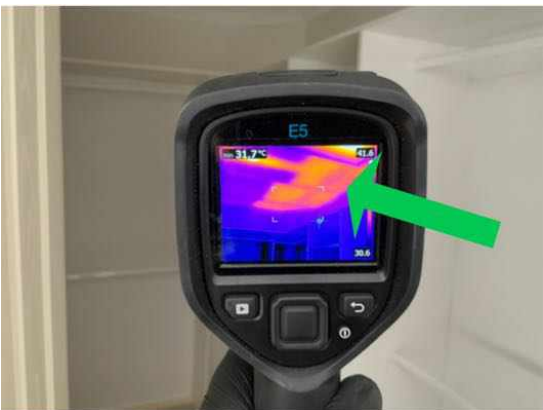
Defects 3.15

Finding: Inconsistent Thermal Performance to Ceiling Areas – Suspected Insulation Deficiencies

Information: Thermal imaging conducted to internal ceiling areas at the time of inspection identified inconsistent heat patterns, which are indicative of variations in thermal performance across the roof space. These patterns are commonly associated with areas of missing, displaced, or insufficient insulation above the ceiling linings.

Inadequate or uneven insulation coverage can reduce the energy efficiency of the dwelling, contribute to heat loss in cooler periods and heat gain in warmer conditions, and may result in reduced occupant comfort and increased heating and cooling costs. Due to the non-invasive nature of the inspection, the exact extent and condition of insulation could not be confirmed visually in all affected areas.

It is recommended that a qualified insulation contractor inspect the roof space, assess insulation coverage and condition, and top up or reinstate insulation where required to achieve consistent thermal performance throughout the property.

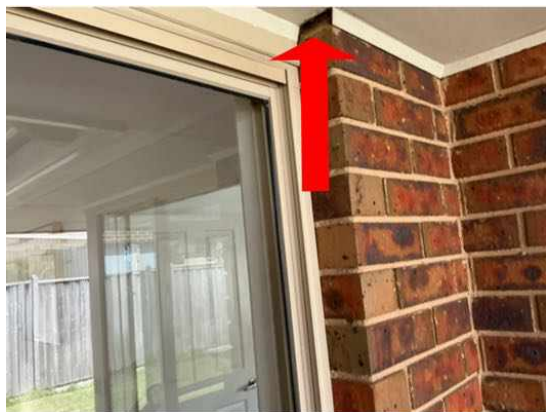
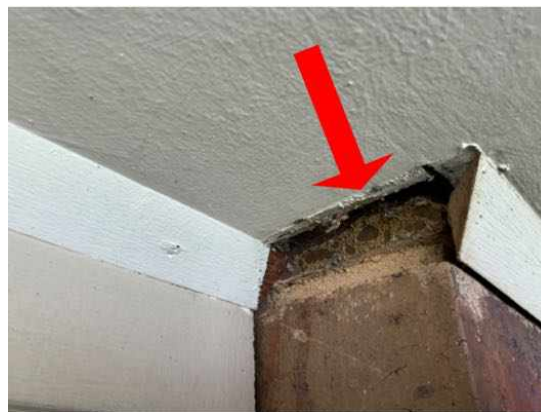
Defects 3.16

Building: Main Building
Location: Pergola
Finding: Detached Eaves Trim Near Pergola
Information:

One of the eaves trims adjacent to the pergola area was found to be detached at the time of inspection. This appears to be a minor maintenance issue and is likely due to

fixings loosening over time or minor movement.

While this is not considered a major defect, the trim should be re-secured or replaced to ensure the eaves remain neatly finished and protected from weather exposure and pest entry. It is recommended that a suitably qualified handyman or carpenter attend to this item as part of routine maintenance.

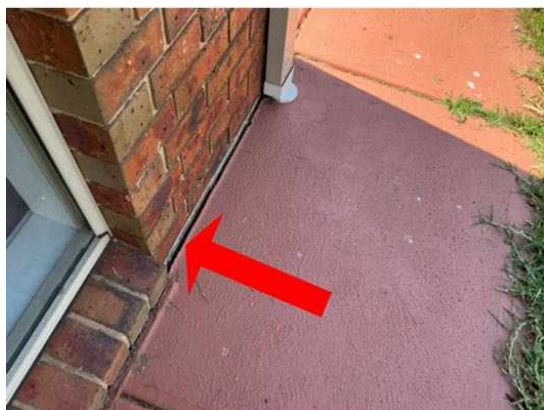
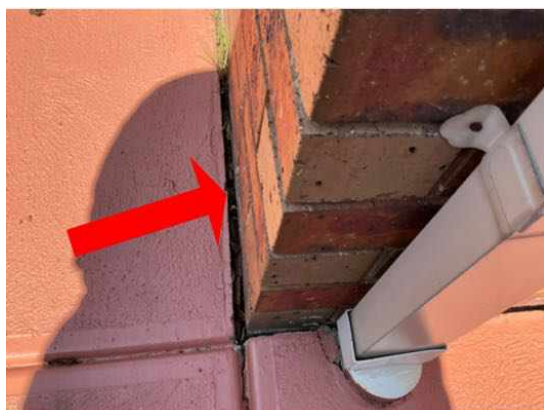
Defects 3.17

Building:	Main Building
Location:	All External Areas
Finding:	Gaps Between External Concrete Pathways and Exterior Walls
Information:	Noticeable gaps were observed between the external concrete pathways surrounding the house and the exterior walls. These openings present a potential pathway for water ingress during rainfall.

If rainwater penetrates through these gaps, it may lead to moisture accumulation beneath the slab and within the subfloor area, increasing the risk of structural damage and potential termite infestation.

It is recommended that a qualified caulking specialist be engaged to fill these gaps with a flexible, weatherproof sealant to prevent water ingress and help maintain the integrity of the building envelope. Timely remediation of these gaps will reduce the likelihood of associated structural and pest-related issues.

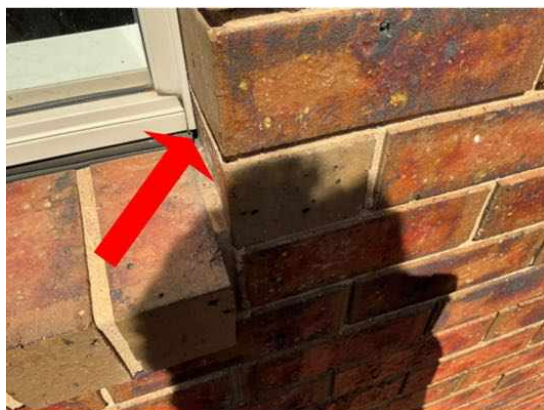
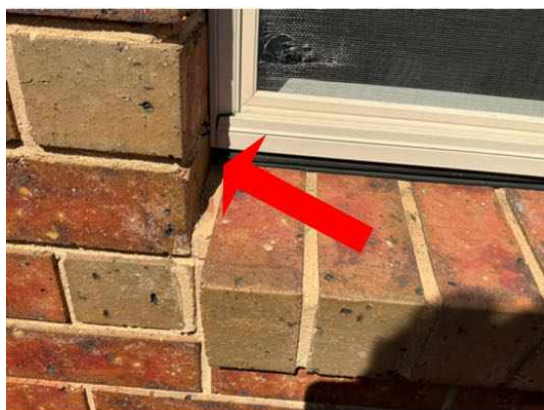
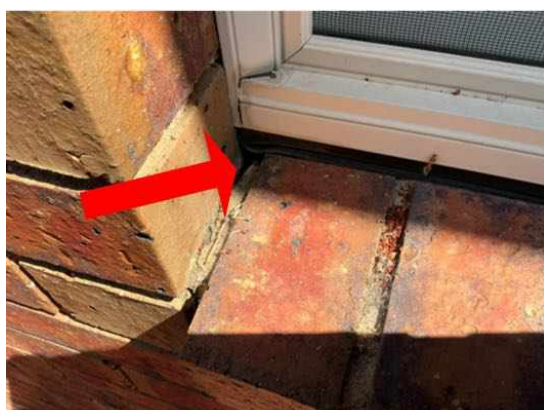
Defects 3.18

Building:	Main Building
Location:	All external areas
Finding:	Gaps Around External Window Frames
Information:	Multiple gaps were identified between the external window frames and the adjoining brickwork across several elevations. These gaps appear to be the result of either poor or inconsistent sealant application during installation, or deterioration of the original sealant over time.

Unsealed or poorly sealed gaps can allow moisture ingress, wind-driven rain, draughts, and provide potential entry points for pests. Ongoing exposure to moisture may also contribute to internal dampness and premature deterioration of surrounding building elements.

A qualified handyman or registered builder should apply a consistent, waterproof, flexible exterior-grade sealant around all affected windows to ensure adequate weatherproofing and protection against moisture and pest entry.

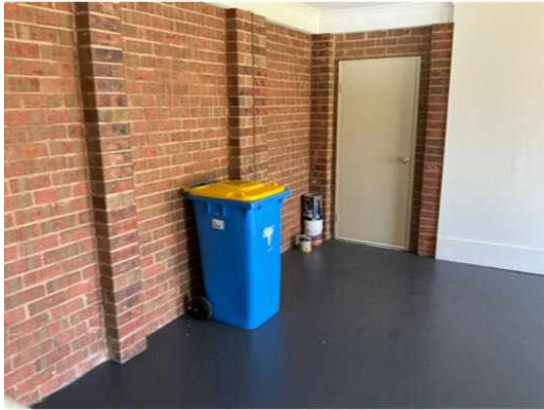
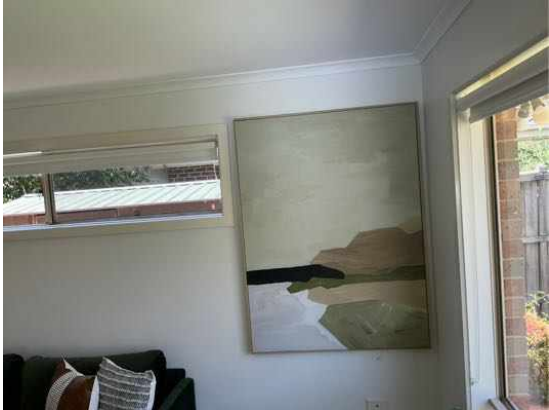
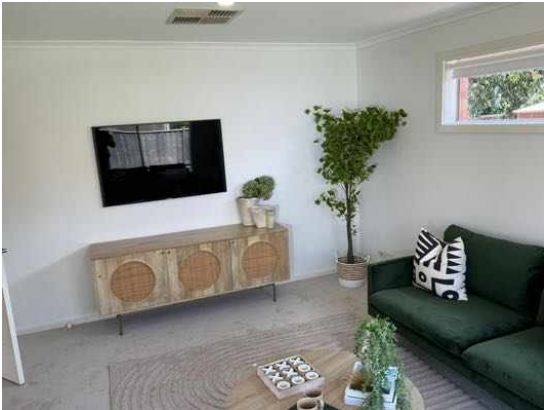
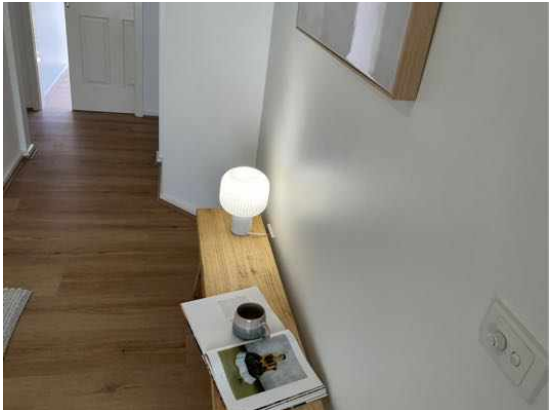
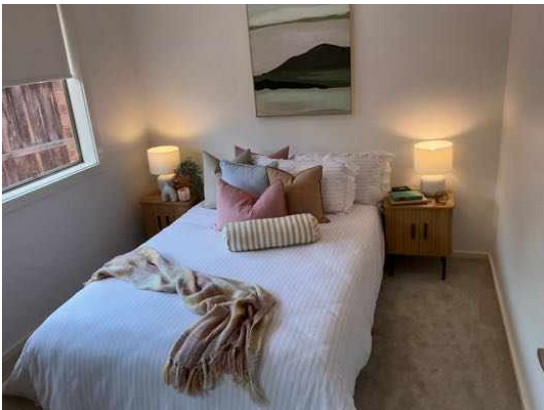
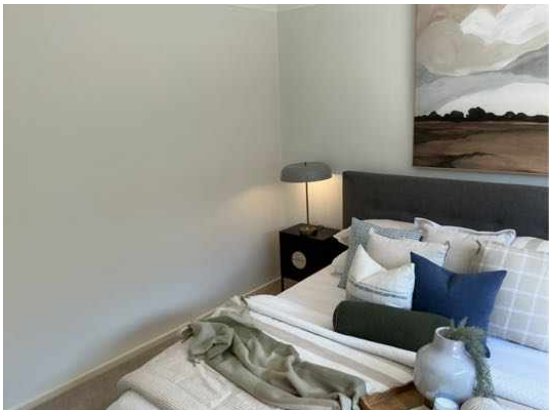
Building: Main Building
Location: All Areas
Finding: Additional Photos - Obstructions and Limitations
Information: These photographs are an indication of the obstructions and limitations which impeded full inspection of the property at the time of inspection. These obstructions can hide an array of defects and should be removed to allow full inspection to be carried out. A re-inspection is recommended once the areas are made accessible.

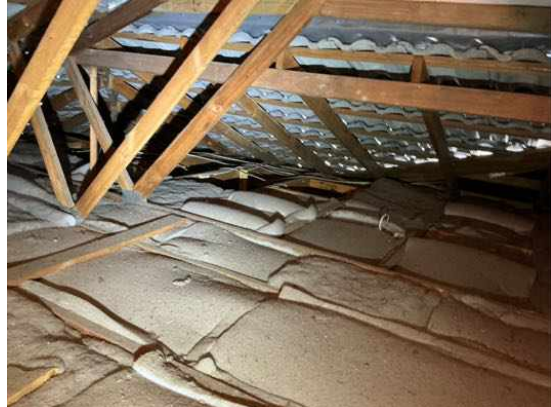
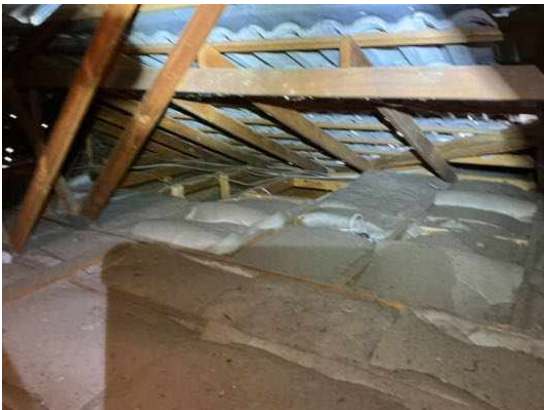
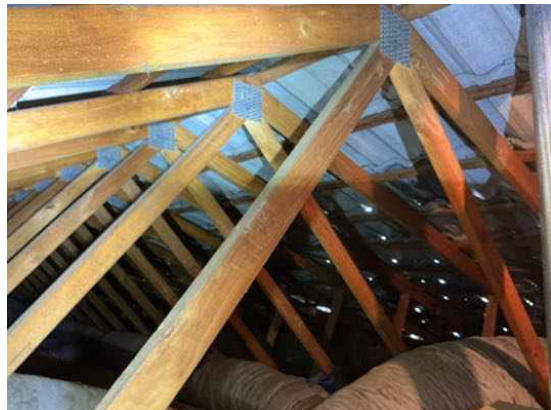
Finding: Obstructions and Limitations - roof cavity

Information: These photographs are an indication of the obstructions and limitations which impeded the inspection of the roof cavity area of the property at the time of inspection. These obstructions can hide an array of defects and should be removed to allow full inspection to be carried out. A re-inspection is recommended once the areas are made accessible.
