Building and Timber Pest Inspection Report

Inspection Date: Thu, 22 Jan 2026

Property Address: 18/38 Stanley Rd, Epping NSW 2121,
Australia

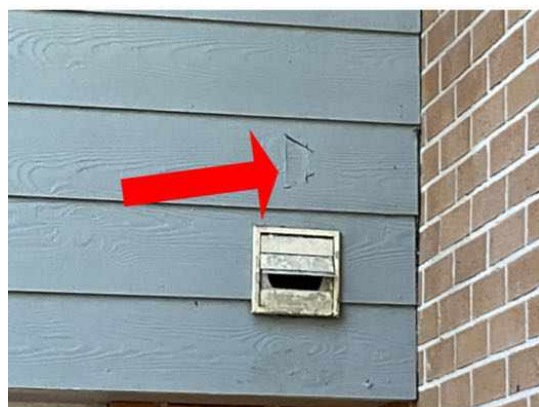
Finding 3.01

Building:	Main Building
Location:	Exterior walls - rear
Finding:	External Cladding - Damaged
Information:	At the time of inspection, the external cladding at the front elevation was found to be damaged. Further inspection by Licensed Building or Qualified Carpenter is highly recommended to ensure its safety and structural integrity of the area. If left unmanaged, the area is likely to deteriorate further, potentially creating not weather tight.

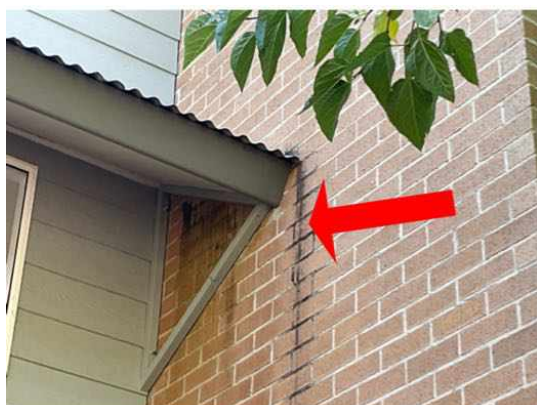
Finding 3.02

Building:	Main Building
Location:	Exterior walls - rear
Finding:	Excessive moisture - identified
Information:	Excessive moisture can attract termites and produce conditions that promote fungal growth and wood decay.

Excessive moisture is generally caused by deteriorated, inadequate or missing roof drainage, leaking plumbing pipes or fixtures, poorly plumbed HWS overflows or condenser units and poor site drainage.

Prior to any remedial works being performed a qualified plumber should be appointed to further inspect the property and to identify the cause of the excessive moisture. Works to remove affected building elements may then be necessary and should be performed by an appropriate tradesperson.

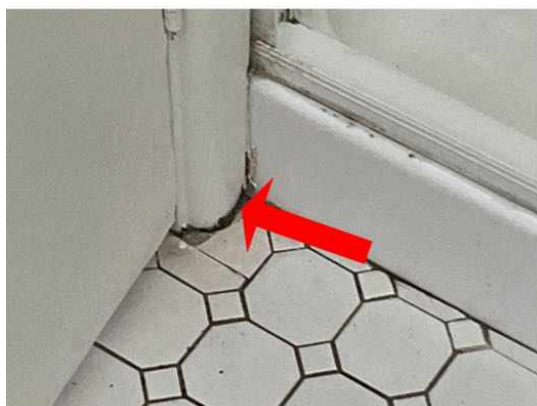
Building:	Main Building
Location:	Ensuite
Finding:	Signs of Past Water Damage to Timber Skirting Near Bathroom
Information:	Visible swelling and surface damage were noted to the skirting board and door frame near the recently renovated bathroom. The appearance is consistent with historical water ingress, likely from shower leaks or previous moisture intrusion into the wall/floor junction. No active leak was observed at the time of inspection, but the affected timber and paintwork suggest prolonged prior exposure to moisture.

No urgent repair required if the bathroom waterproofing has been properly upgraded during the renovation. However, the damaged skirting/trim should be monitored and replaced or repaired if deterioration continues. A moisture assessment with a meter is recommended to confirm no ongoing leak.

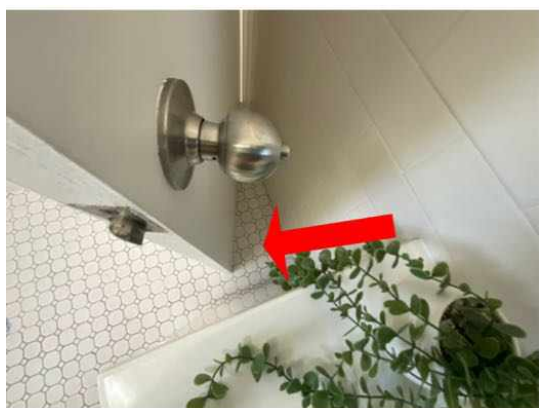
Building:	Main Building
Location:	All Internal Areas
Finding:	Door stop - Missing
Information:	The door stop is missing or is inadequate to stop the door handle from damaging the wall. Although some building elements may seem irrelevant or unnecessary, all building elements play a key role in the operation and function of the overall structure

Re-installation or replacement of the door stop is advised as soon as possible to prevent any subsequent damage to the door or associated structures. A general handyman may be appointed to perform these works at client discretion.

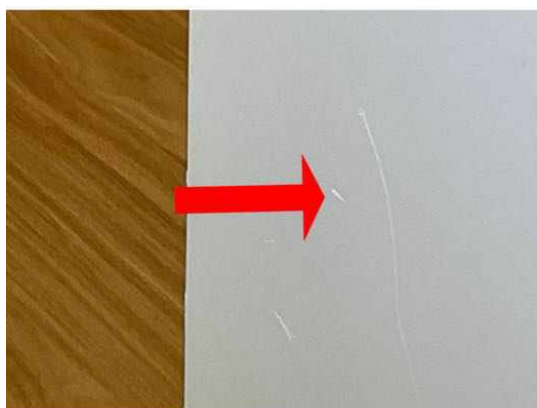
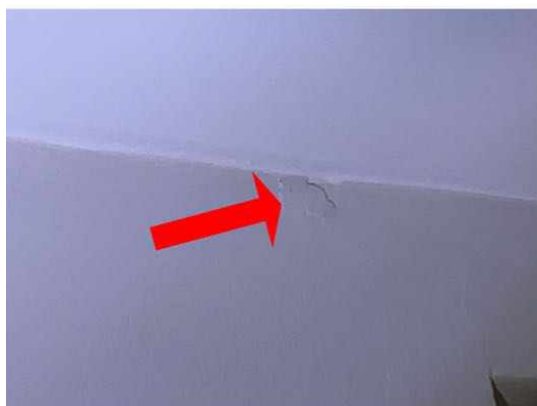
Finding 3.15

Information: The paint finish in this area was found to have been completed to a substandard level. Substandard painting is generally classified as an appearance defect. However, the substandard appearance may also be indicative of poor surface preparation and substandard workmanship.

If this applies, further areas of poor and incomplete finishes could develop over time. Furthermore, substandard paint finishes in areas exposed to moisture, e.g. external areas or wet areas, could lead to deterioration of underlying building materials.

Substandard paint finishes should be sanded back, filled, leveled and repainted, as applicable. Where inadequate paint protection has led to the deterioration of the associated building element, repair and/or replacement of this building element may be required.

A painting contractor should be appointed as soon as possible to perform necessary works to aid the appearance of the affected area and to ensure that the area is protected against further deterioration. Alternatively, the homeowner following manufacturer instructions may be able to provide this service.

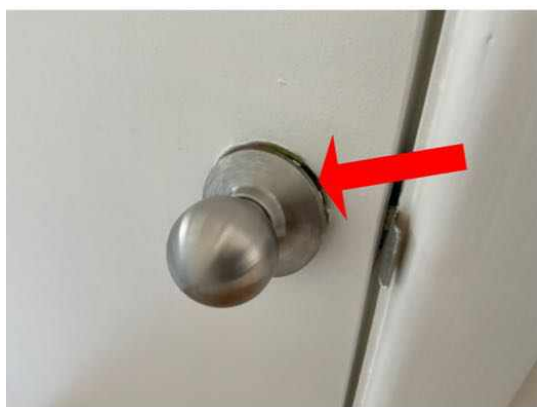
Finding 3.16

Building:	Main Building
Location:	Linen Cupboard
Finding:	Fitting (door handle) - Loose
Information:	The fitting in this area is loose and requires adjustment to tighten.

If left unmanaged, the fitting may further deteriorate, causing potential for the development of other minor secondary defects.

A relevant tradesperson should be appointed to perform these rectification works at discretion of the client.

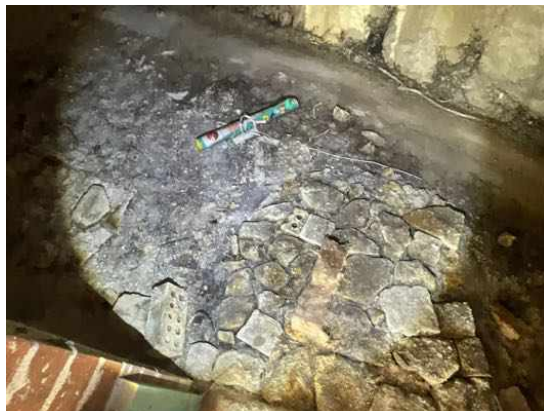
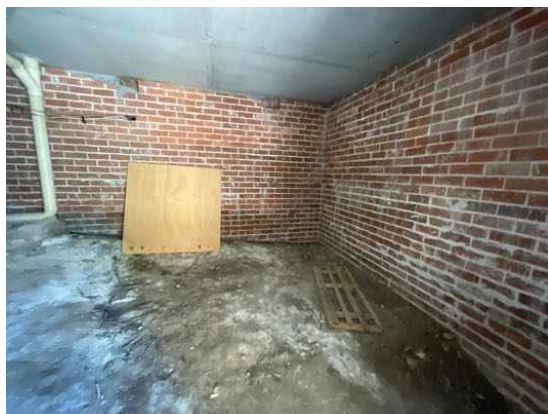
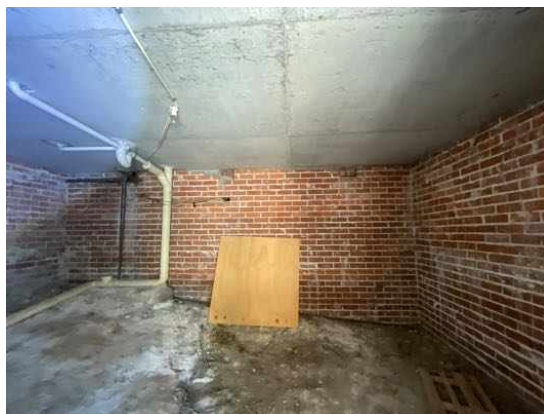
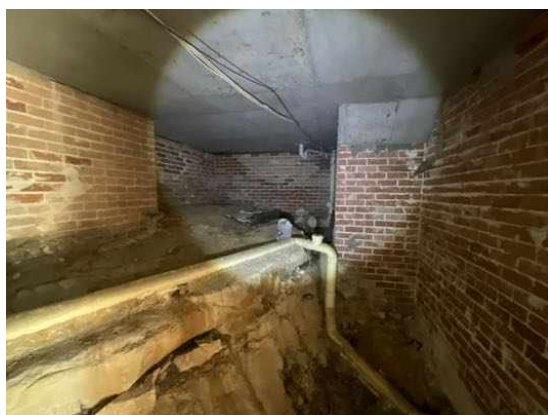
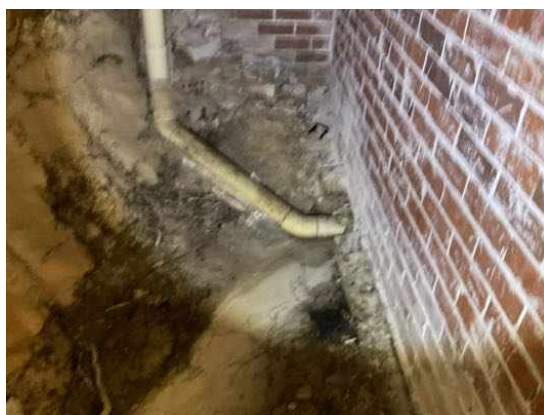
Finding 3.17

Building:	Main Building
Location:	Subfloor
Finding:	Subfloor - Lack of ventilation
Information:	It was noted at the time of inspection that the subfloor area lacks adequate ventilation. Ventilation can be restricted by a variety of minor defects, including obstructions in the subfloor space, a lack of vents or a low clearance.

A well ventilated subfloor aids in maintaining dry conditions, preventing secondary damage such as wood rot and pest activity, as well as preventing the development of

mould and mildew (which can lead to respiratory safety hazards for occupants).

The initial step in improving ventilation is to ensure that the subfloor area is free of any debris or stored items. Where ventilation is still inadequate, it is advised to ensure that all vents are clear of blockages, and additional vents may be installed.

The client may also consider mechanical ventilation (powered fans) to improve subfloor airflow. Remedial works should be conducted as a matter of urgency to protect against the development of potentially harmful subfloor conditions.

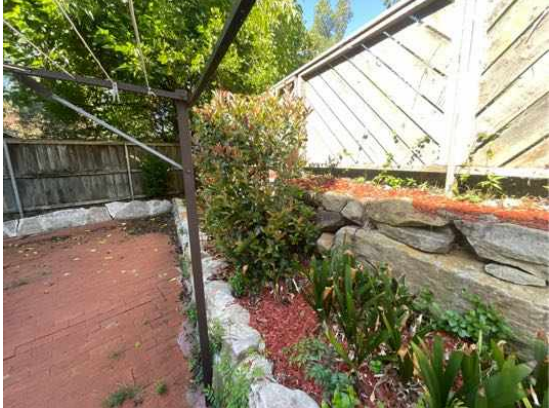
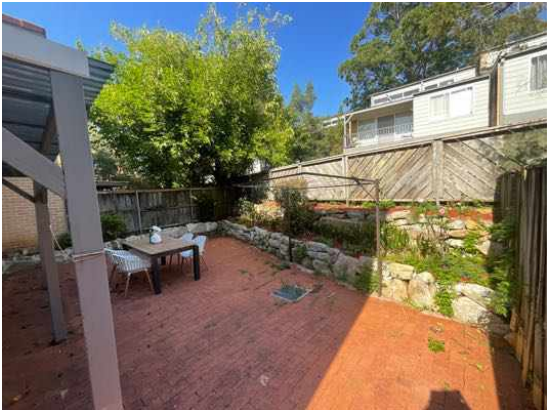
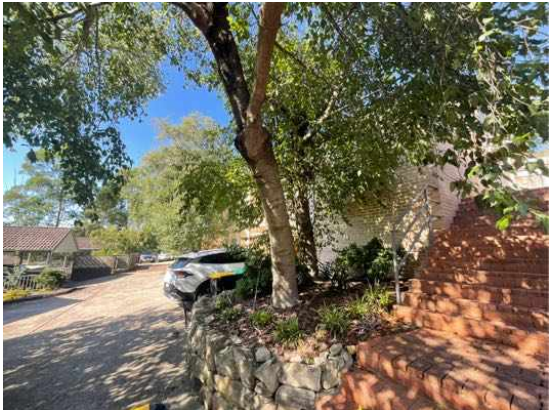
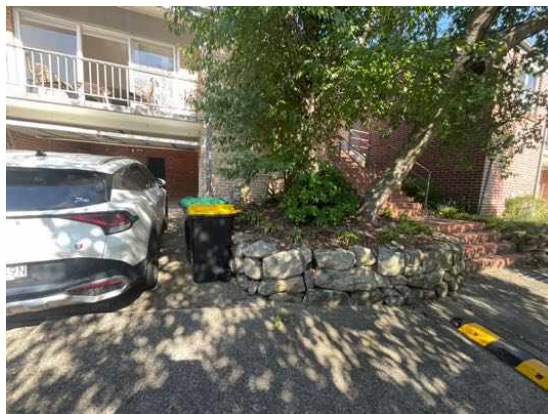
Finding 6.01

Building: Main Building
Location: All Areas
Finding: Garden Beds - Conditions Conducive to Termites
Information: Garden beds were found to be evident in the garden area. These garden beds can include untreated timber, and with a combination of moisture from watering hosing can make conditions conducive to termite activity and termite ingress.

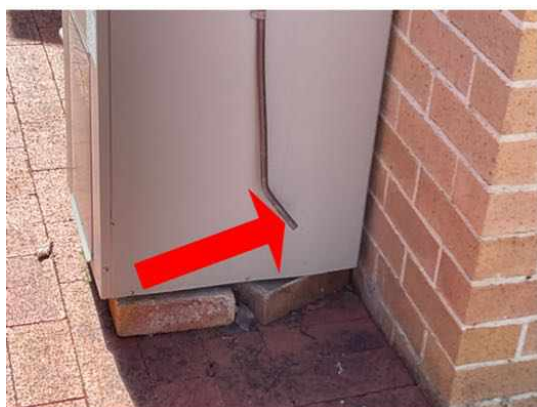
Finding 6.02

Building:	Main Building
Location:	All Areas
Finding:	Gravity-Fed HWS - Disconnected
Information:	It was noted at the time of inspection that a disconnected gravity-fed hot water system (HWS) remains in this area.

Despite this plumbing structure being unused, it is likely to be storing residual water, and is therefore susceptible to rust and corrosion. If allowed to continue, rust and corrosion is likely to lead to damage to adjoining building elements, and may also make the area susceptible to termite or timber pest activity.

While it is a costly exercise to remove the disused gravity-fed HWS, it is advisable in the short-term future to prevent any further damage to the area. Further consultation with a licensed plumber is required to gain further advice on removal of the structure.

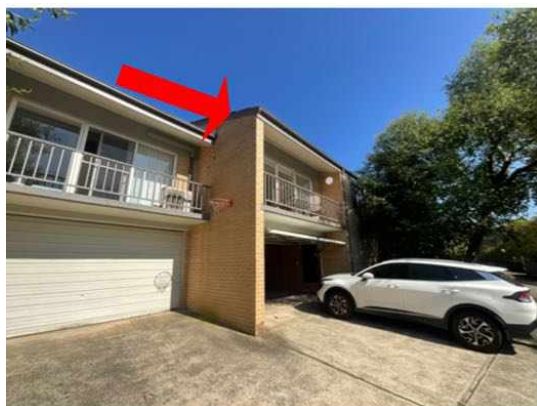
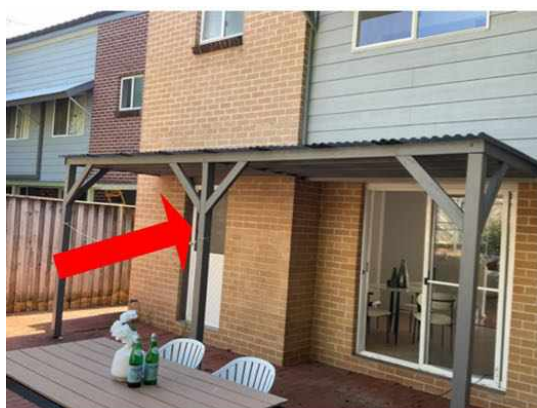
Finding 6.03

Building:	Main Building
Location:	All Areas
Finding:	Timber - exposed to weather
Information:	External timbers that are frequently exposed to harsh weather conditions require

adequate protection in order to maintain their condition. Where timbers have not been painted or treated adequately, general deterioration is likely to occur at an accelerated rate.

If left unattended, replacement of these timbers is likely to be necessary in the short-term future. Adequate treatment of these timbers is required as soon as possible by a painting contractor or general handyman.

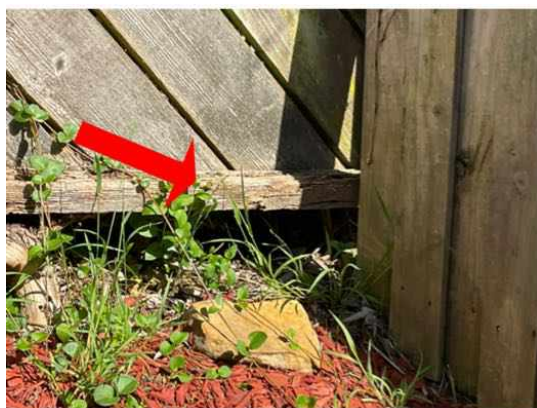
Building:	Main Building
Location:	All Areas
Finding:	Wood rot
Information:	This building element shows evidence of wood rot. Wood rot, also known as Fungal Decay, occurs when timbers and other cellulose building materials are exposed to damp conditions on an ongoing basis. This could be the result of exposure to weathering over a prolonged period of time, or the attraction of excessive moisture from other abutting building materials. Contributing factors also include poor air ventilation in the area.

Wood rot is often associated with general damp problems and is evidenced by a 'musty' smell or mould and mildew occurring on surfaces. If left unmanaged, damp conditions can lead to further health problems and the decay of timbers will continue.

Early intervention and regular maintenance, particularly of exterior timbers, will prolong the useful life of these building elements. Prior to any works being performed, the cause of the moisture that has created the visible wood rot should be identified and addressed in a suitable manner. Replacement of affected timbers may then be a necessary step in protecting surrounding building elements from such deterioration.

A qualified plumber may be appointed to assess the cause of excessive moisture and to provide advice on any remedial works as required. A qualified carpenter or registered builder may also be required to replace affected building materials.
