Building and Timber Pest Inspection Report

Inspection Date: Fri, 13 Feb 2026

Property Address: 5 Gibson Blvd, Tangambalanga VIC 3691,
Australia

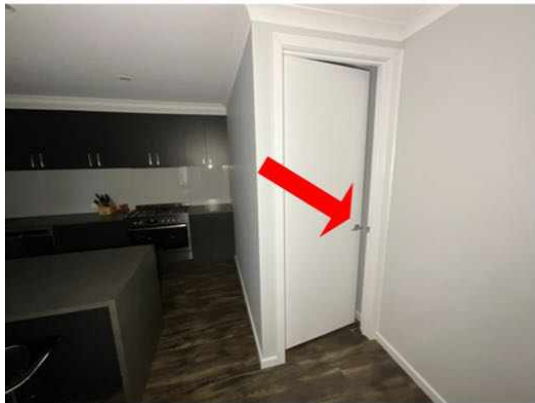
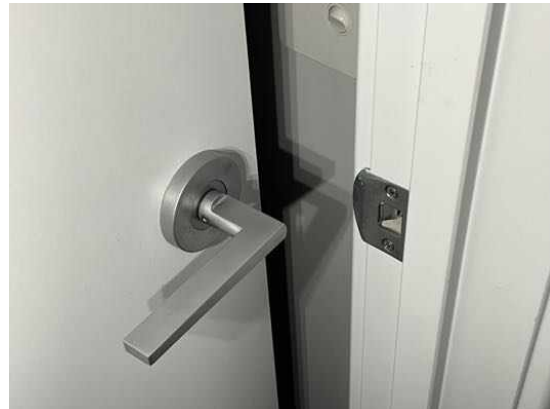
Finding 3.01

Building: Building 1
 Location: Hall
 Finding: Door - Striker plate misaligned
 Information: The striker plate to this door appears to have become misaligned and has consequently resulted in the door's operation being compromised.

This is a common defect and is expected in a property of this age, whether being due to substandard installation or general deterioration of the door hardware.

Readjustment of the striker plate is recommended at client discretion. Works such as these can be completed by a general handyman or qualified carpenter.

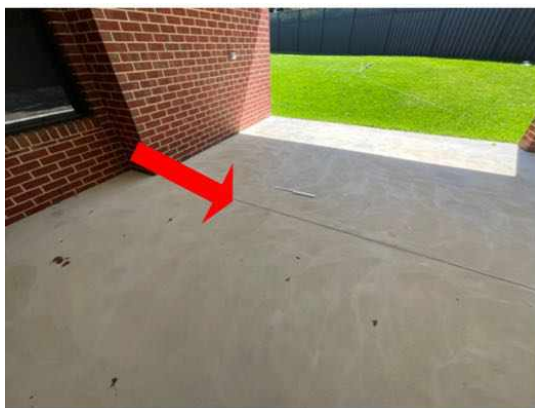
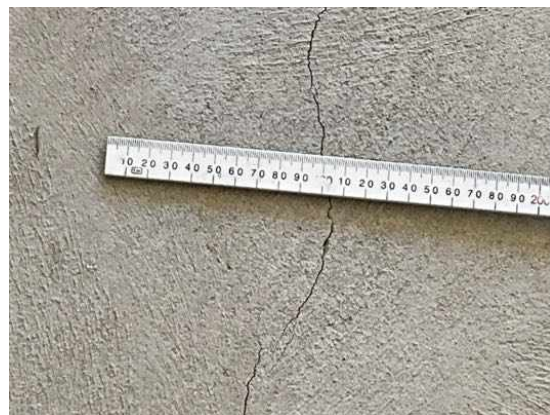
Finding 3.02

Building: Building 1
 Location: Alfresco
 Finding: Cracking - External Concrete Paving Damage Category 1 - Fine (less than 2mm)
 Information: Fine cracks were identified in external concrete paving. Although fine cracks are quite noticeable, they are often only considered to be an appearance defect, and usually do not indicate any structural damage. To be considered a Category 1 or fine crack, the

crack is found to be less than 2mm in width.

Generally the cause of a hairline crack in existing concrete paving such as driveways and pathways is indicative of the expansion and contraction of the concrete. Such causes are generally due to environmental factors, such as moisture levels, weather conditions, root systems of nearby trees or the soil types on which they are laid.

Fine cracks may also be due to poor original installation of the concrete. Factors such as poor compaction of the sub surface and/or inadequate reinforcing of the slab may create cracking and other secondary defects.

Monitoring of all cracking should be conducted frequently. Always contact a building inspector should cracks widen, lengthen, or become more numerous.

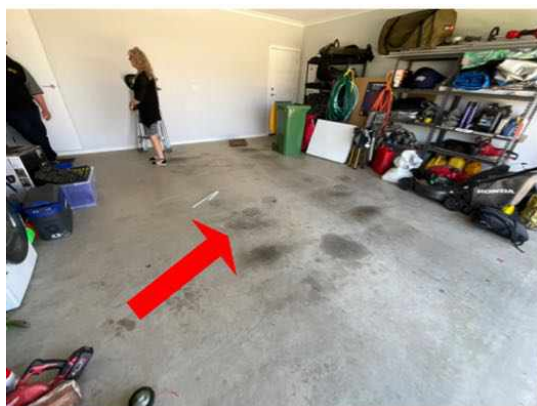
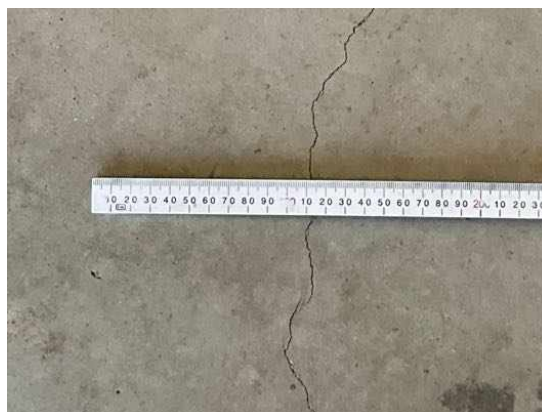
Finding 3.03

Building:	Building 1
Location:	Garage
Finding:	Crack in concrete slab - Category 1
Information:	A crack coded as Category 1 was identified in the slab. A Category 1 crack is described as a fine but noticeable crack, with the slab at an otherwise reasonable level.

To be considered Category 1, the approximate width of the crack is less than 1.0mm, or a less than 10mm change in offset when a 3m straight edge is placed over the defect.

Category 1 cracks should be monitored for a period of 12 months. At the end of the monitoring period, identified cracks that are rated greater than Category 2 are considered defects, and require rectification.

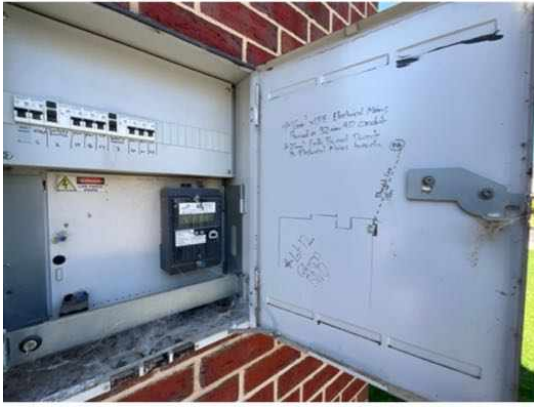
Finding 6.01

Building:	Building 1
Location:	All External Areas
Finding:	Termite Management System - no evidence of a chemical installation
Information:	The application of a post-construction chemical termite barrier is highly recommended for all properties, particularly if live termite activity has been found on the site previously. Such barriers are highly effective in preventing termite attack on any timber building elements throughout the property.

A durable notice should be placed in the switchboard unit to indicate current termite barriers. At the time of inspection, it appeared as though no termite management system has been installed, with no evidence to suggest preventative works taking place.

The client may consider gaining further advice from a pest controller as to the costs and procedures involved with this application. It is recommended that obtaining such advice be a short-term priority.

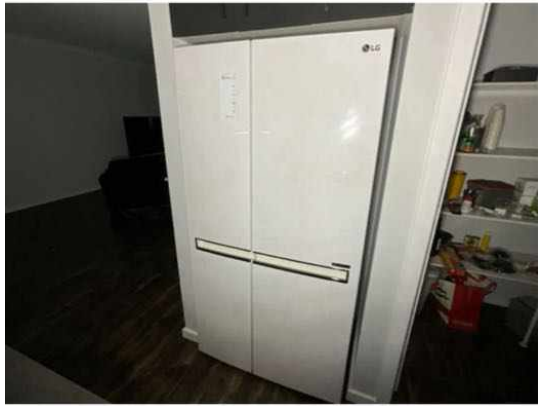
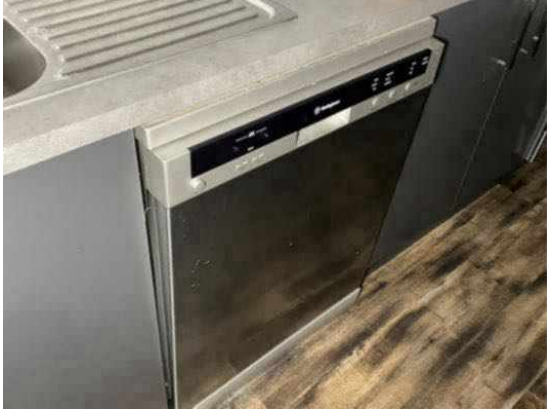
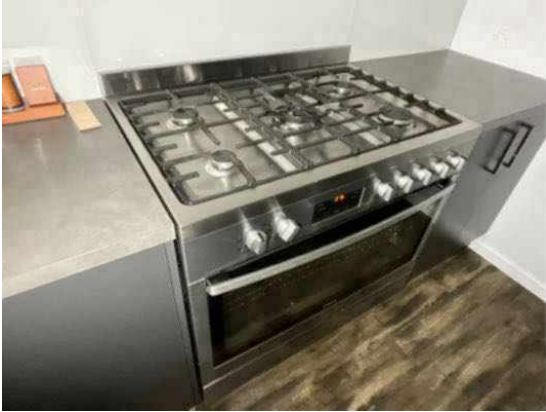
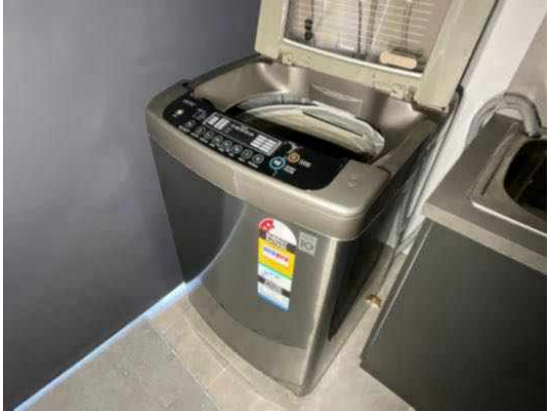
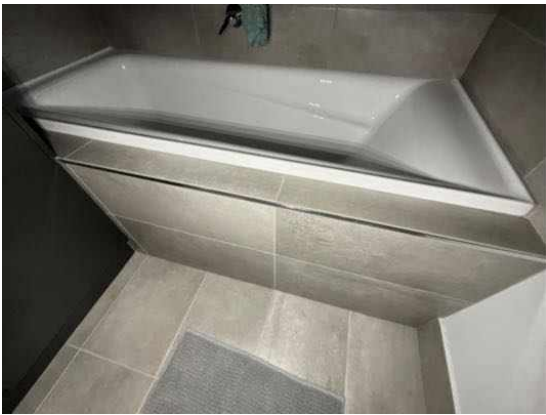
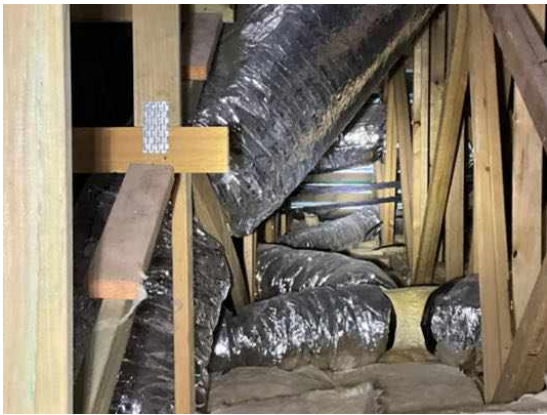
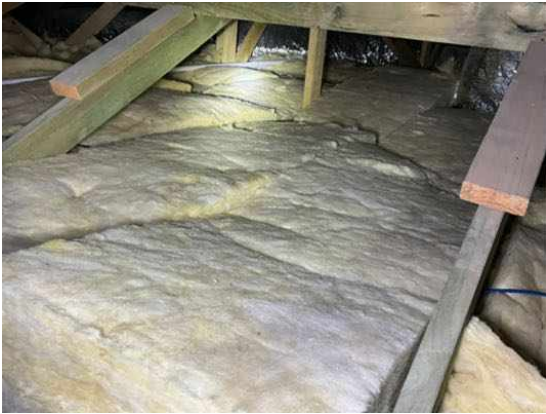
Noted Item

Building: Building 1
Location: All Areas
Finding: Additional Photos - Obstructions and Limitations
Information: These photographs are an indication of the obstructions and limitations which impeded full inspection of the property at the time of inspection. These obstructions can hide an array of defects and should be removed to allow full inspection to be carried out. A re-inspection is recommended once the areas are made accessible.
