# Building and Timber Pest Inspection Report VR

Inspection Date: Mon, 23 Mar 2026

Property Address: 13 Betula Grove, Bundanoon NSW 2578,  
Australia

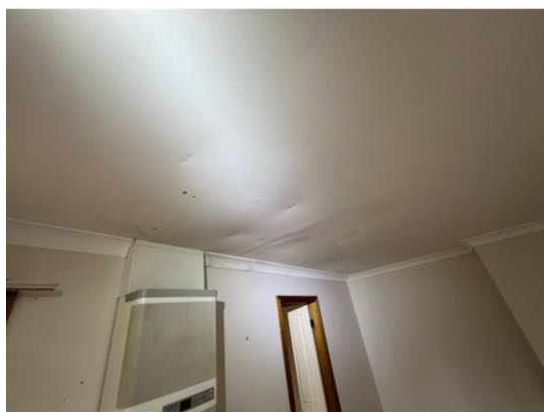
Building: Main Building  
Location: Family Room  
Finding: Ceiling - Water damaged  
Information: Water damage to the ceiling lining is generally an indication of excessive moisture being present in the roof void, usually via a leak to the roof covering.

Where water damage is evident to the ceiling, the primary requirement is to identify and rectify the source of the leak. A roofing plumber should be appointed as soon as possible to identify the leak and perform rectification works as necessary, ensuring the water damage is restricted.

Once the leak is repaired, consultation with relevant tradespeople, including plasterers and painters, is advised. Rectification works may include replacement of ceiling lining or minor repainting, depending on the extent of the damage.

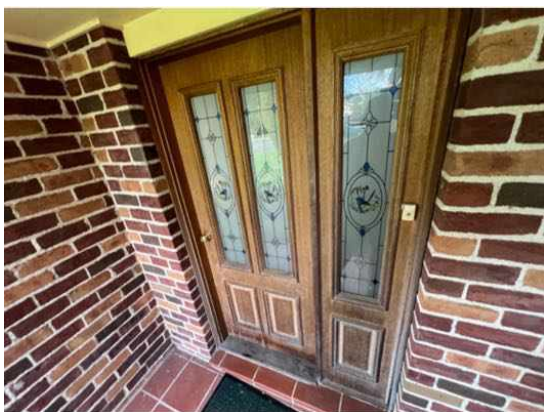
Building:	Main Building
Location:	Porch
Finding:	Timber door - exposed to weather
Information:	External timber doors that are frequently exposed to harsh weather conditions require adequate protection in order to maintain their condition. Where timbers have not been painted or treated adequately, general deterioration is likely to occur at an accelerated rate.

If left unattended, replacement of these timber doors is likely to be necessary in the short-term future by a licensed carpenter. Adequate treatment of these timber door/jamb is required as soon as possible by a painting contractor or general handyman.

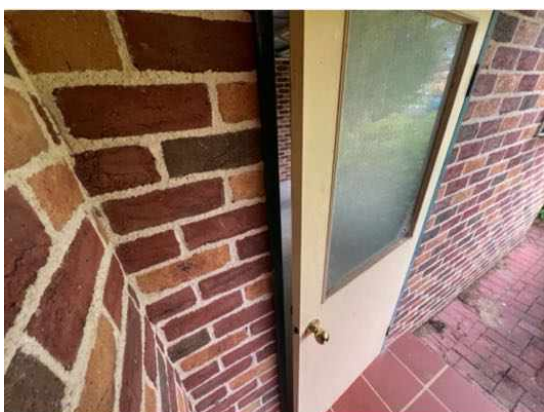
### Finding 3.03

Building:	Main Building
Location:	Garage
Finding:	Door - Binding/jamming
Information:	Binding and/or jamming of this door is evident during standard operation. This defect inhibits the functionality of the affected door as well as creating potential for secondary defects to associated building elements, such as damage to the floor covering.

A door that binds to flooring or to the associated door frame may have several causes, ranging from minor defects, such as poor installation of the door or deteriorated hinges, through to major structural issues, such as damage to subfloor structures.

For minor causes, a qualified carpenter or general handyperson should be appointed to perform minor rectification works at client discretion.

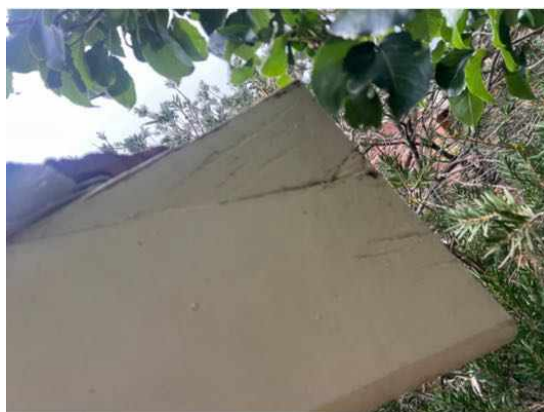
### Finding 3.04

Location: Garage  
Finding: Barge - Wood rot  
Information: Wood rot was found to be affecting fascias and barges in this area, evidenced by the presence of mould on the surface in some areas. Wood rot, also known as Fungal Decay, occurs when timbers and other cellulose building materials are exposed to damp conditions on an ongoing basis.

It is likely that this wood rot has developed as a result of faults in the roof plumbing, creating excessive moisture in this areas. Frequent exposure to rain and other weather conditions also make fascias and barges susceptible to accelerated deterioration.

Early intervention and regular maintenance will prolong the useful life of these building elements. Prior to any works being performed, the cause of the moisture that has created the visible wood rot should be identified and addressed in a suitable manner.

It is advised that a roof plumber be appointed to inspect all roof plumbing and subsequently identify the cause of the wood rot. Replacement of affected fascias and barges may then be a necessary step in protecting surrounding building elements from such deterioration.

A qualified plumber may be appointed to assess the cause of excessive moisture and to provide advice on any remedial works as required. A qualified carpenter or registered builder may also be required to replace affected building materials.

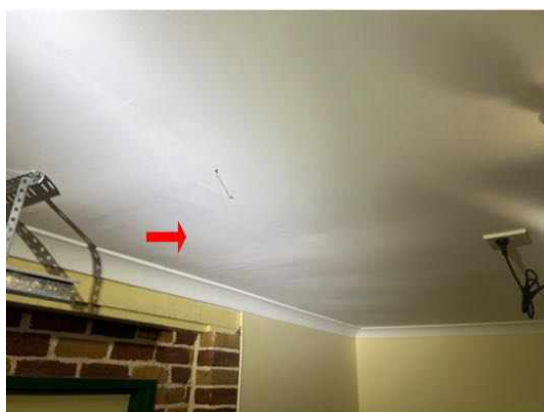
### Finding 3.05

Building:	Main Building
Location:	Garage
Finding:	Ceiling - Incomplete or substandard works
Information:	The works to this area appear to be incomplete or have been completed to a substandard level.

Works that have not been completed to a satisfactory level create potential for the development of building defects and may impede on the safety and integrity of the overall structure.

It is highly recommended that a licensed plasterboard contractor and or painter should be appointed to repair the ceiling. To ensure the safety of the area and the longevity of all associated building elements.

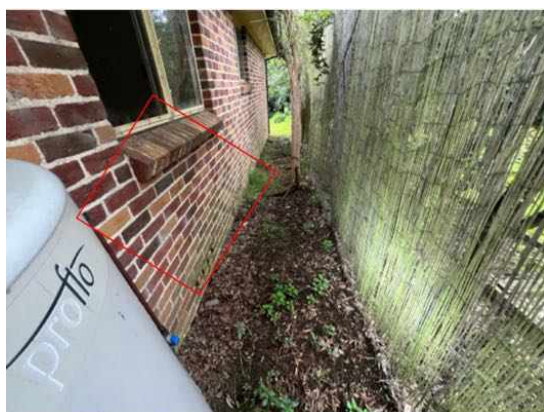
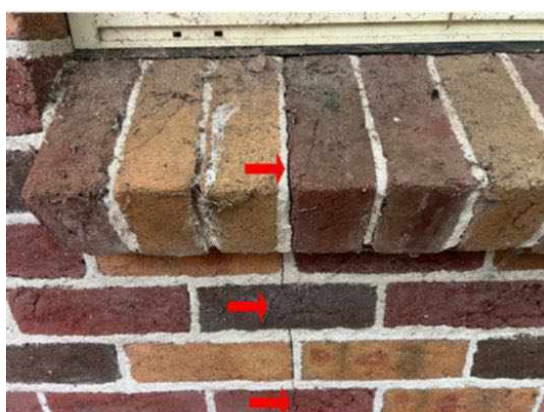
Building: Main Building  
 Location: Exterior walls - right side  
 Finding: Brickwork - Cracking noticeable  
 Information: There were several cracks and or crack repairs evident to external brickwork.

Noticeable cracks are a common occurrence in external brickwork and are a likely result of age expected building movement, general expansion, and/or contraction of building materials in different weather conditions. Noticeable cracks in brickwork may develop if left unattended, with potential for necessitating major remedial works or

replacement of the brickwork.

It is highly advised that a qualified bricklayer be appointed to provide necessary works to cracked brickwork to prevent any further damage. Such works should be conducted as soon as possible.

Always monitor these cracks and contact a building inspector should cracks widen, lengthen, or become more numerous.

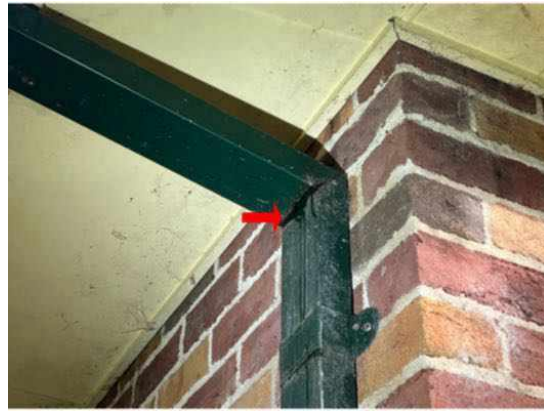
Building: Main Building  
Location: All External Areas  
Finding: Water leak - External - Gutters  
Information: Water leaks were found to be present to exterior plumbing work. Leaks are generally caused by deterioration of the plumbing elements over time, due to exposure to weather conditions, but may have also been caused by minor impact damage.

Such leaking creates damp conditions in the affected area, causing potential for water pooling and subsequent water damage if left unattended. These conditions may also attract termite attack, particularly if the area is subject to minimal levels of sun throughout daylight hours.

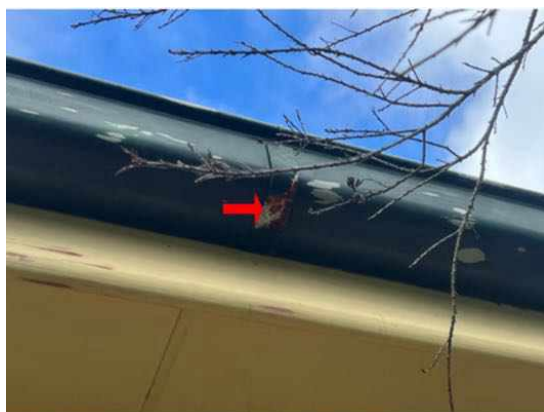
### Finding 3.11

Building:	Main Building
Location:	All External Areas
Finding:	Gutter brackets - Rusted or corroded
Information:	This building element shows evidence of rusting and corrosion, which is likely to have developed as a result of excessive exposure to moisture and or inadequate coatings.

Rusting and corrosion should be managed by ideally removing or limiting the affected surface from exposure to moisture. A registered builder may be appointed to replace any building elements that have been severely affected by rust or water damage.

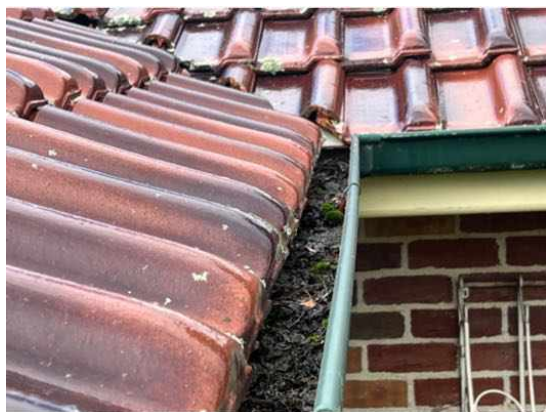
### Finding 3.17

Building:	Main Building
Location:	Roof Exterior
Finding:	Gutters - Blocked
Information:	Roof plumbing structures, such as guttering and downpipes, should be free of all debris to prevent blockages. Blockages of the guttering and downpipes will lead to pooling and accumulated water overflows, which is likely to subsequently flood eaves and exterior walls.

Consult a Licensed Plumber for further specific advice on remedial works that may be required. In the interim, it is highly advised that blocked gutters be removed by the homeowner or a general handyperson as a matter of urgency.

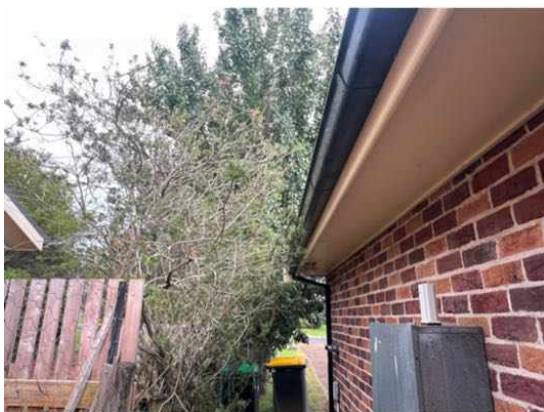
### Finding 3.18

Building:	Main Building
Location:	Roof Exterior
Finding:	Trees - Overhanging and filling gutters
Information:	Overhanging trees often result in excessive amounts of leaf debris accumulating in gutters.

Such works should be performed by the homeowner; however, appointment of a landscape contractor or an arborist may be required. Consultation with a licensed roof plumber is required where guttering has been damaged.

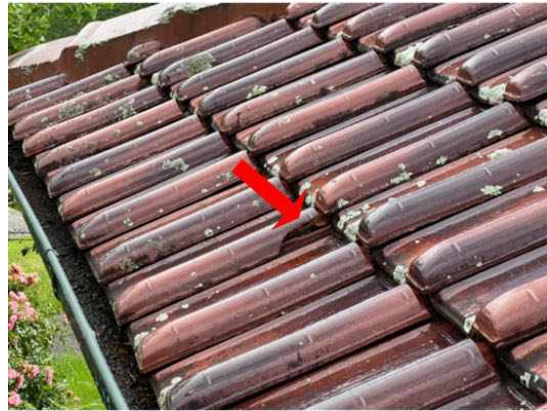
### Finding 3.19

Building:	Main Building
Location:	Roof Exterior
Finding:	Roof tiles - Broken
Information:	Upon inspection of the exterior roof covering, broken roofing tiles were identified. Broken and friable roof tiles are generally the result of ageing and weathering of what is essentially a porous material.

Replacement of broken tiles is required and should be performed by a roofing contractor as soon as possible.
