Building and Timber Pest Inspection Report

Inspection Date: Mon, 23 Feb 2026

Property Address: 5 Lochinvar Rd, Revesby NSW 2212,
Australia

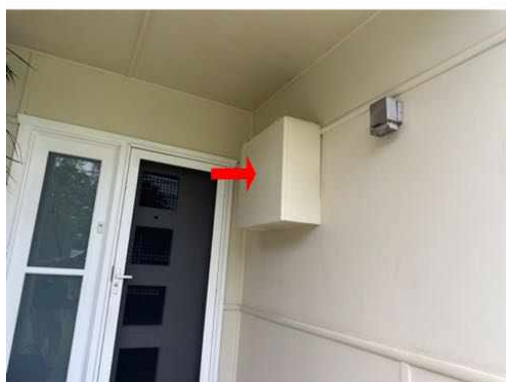
Building: Main Building
 Location: Entry > Centre
 Finding: Termite Management System - no evidence of a chemical installation
 Information: The application of a post-construction chemical termite barrier is highly recommended for all properties, particularly if live termite activity has been found on the site previously. Such barriers are highly effective in preventing termite attack on any timber building elements throughout the property.

A durable notice should be placed in the switchboard unit to indicate current termite barriers. At the time of inspection, it appeared as though no termite management system has been installed, with no evidence to suggest preventative works taking place.

The client may consider gaining further advice from a pest controller as to the costs and procedures involved with this application. It is recommended that obtaining such advice be a short-term priority.

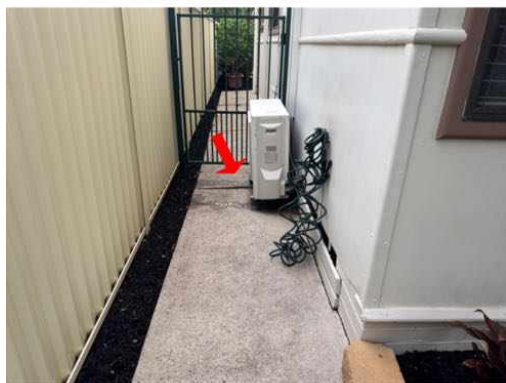
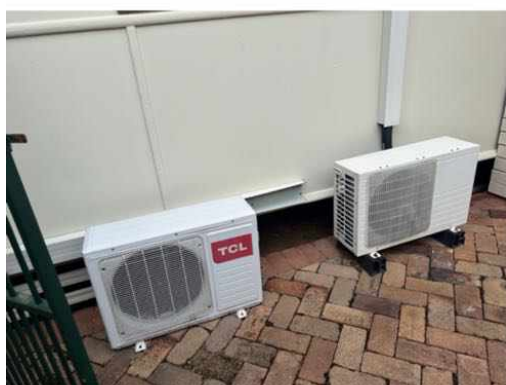
Finding 6.02

Building: Main Building
 Location: All Areas > All Areas
 Finding: Air conditioner - Disconnected overflow
 Information: The Air Conditioner (A/C) overflow was found to be disconnected from storm water drainage and is creating excessive moisture in the surrounding area.

Such leaking creates an environment which is conducive to an array of defects, including water damage to associated building elements and the attraction of termite or timber pest infestation.

It is highly recommended that a licensed plumber be appointed to connect the A/C overflow in order to prevent such an environment from being created. These minor works should be carried out as soon as possible.

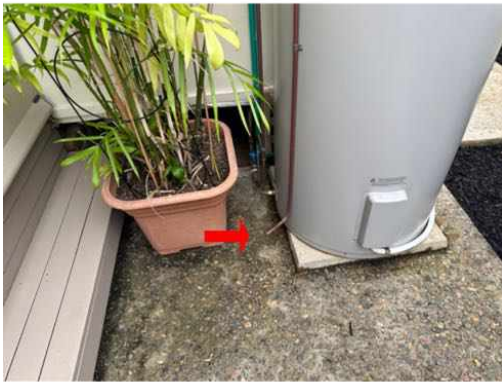
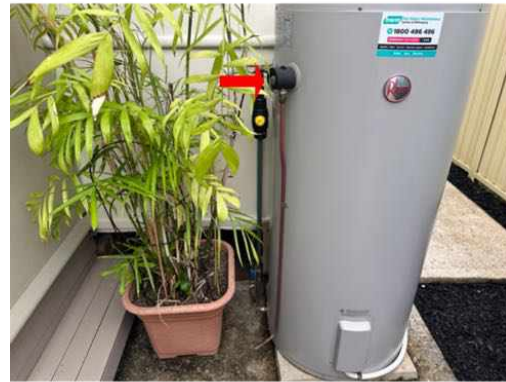
Finding 6.03

| Information: | The Hot Water System (HWS) overflow was found to be disconnected from storm water drainage and is creating excessive moisture in the surrounding area. |

These damp conditions can lead to secondary defects such as rot, rust or corrosion of associated building elements, the formation of fungal decay, or even the creation of potential slip hazards. When coupled with poor site drainage, pooling of water may also attract termite activity to this area.

It is highly recommended that a licensed plumber be appointed to connect the HWS overflow in order to prevent such an environment from being created. These minor

works should be carried out as soon as possible.

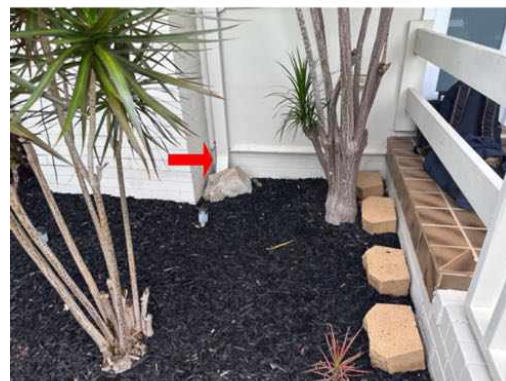
Finding 6.04

| Finding: | Roof plumbing - Missing |
| Information: | Some sections of the roof are not adequately drained via gutters and downpipes. Gutters and downpipes that are not installed adequately are likely to result in excessively damp conditions against the exterior surfaces and around the base perimeter of the building. |

Excessive moisture creates an environment which accelerates the deterioration of building elements in the area, as well as being conducive to termite and pest infestation. Such an environment is likely to necessitate repair and/or replacement of building elements, which are prone to sustaining wood rot, rust or corrosion.

A roofing plumber should be appointed as soon as possible to install relevant roof plumbing materials. Depending on the extent of the damage, repair and/or replacement of damaged building elements may be required.

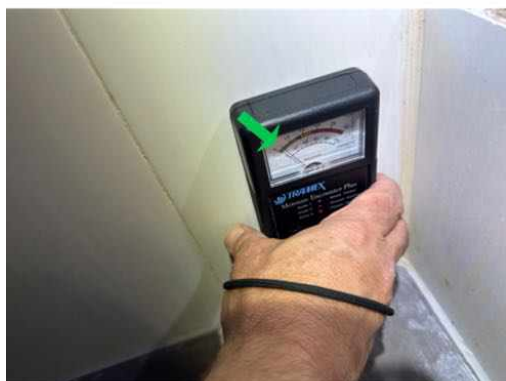
Finding 6.05

Building: Main Building
Location: Bathroom > Centre Right
Finding: Moisture meter: used in Shower area.
Information: A moisture meter was used during the inspection and isolated spots of excessive moisture was detected to accessible walls inside the property at the time of inspection.

It was noted on inspection that sealant or grout is in fair condition to most of the tiled shower alcove, with some areas requiring maintenance.

Different materials and floor areas move at different rates, generally causing cracking to grout or sealant at this point. A flexible sealant is required to allow for expected expansion and contraction, while keeping the joint water tight and protective of all associated building materials.

Flexible and mould resistant materials should be applied to affected areas to prevent any subsequent water damage that is likely to occur. Regular maintenance and replacement of damage or missing or damaged sealant and grout is highly recommended to the wet areas, as this is a regular wear and tear defect. Sealant and grouting in areas that come into regular contact with water should be maintained for the long term care of your property.

Monitoring the area is advised and if any visual signs of excessive moisture appear (peeling paint, mould) then consultation with a qualified plumber or bathroom specialist would be advised to identify the cause of damp and to perform remedial works as required.

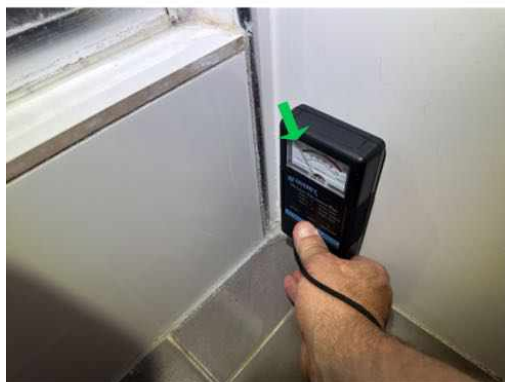
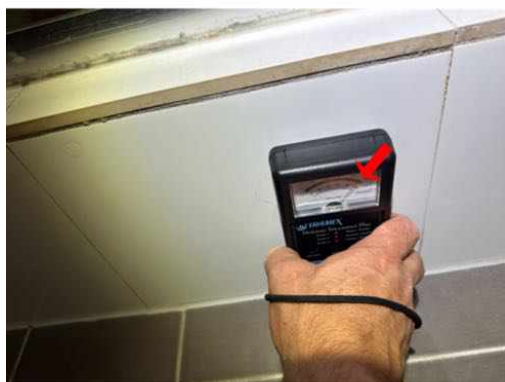
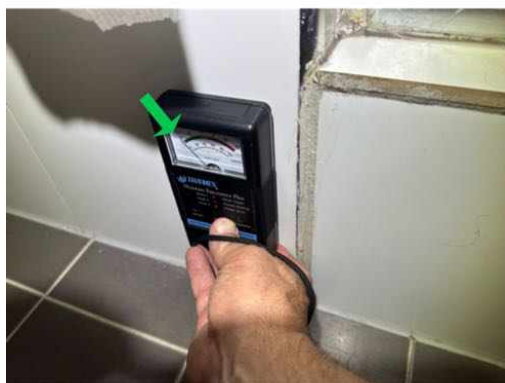
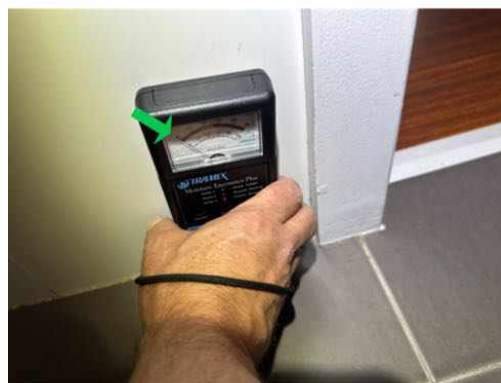
| Finding: | Moisture Meter used: minor spot of Moisture Detected outside of shower recess. |
| Information: | Moisture meter was used during the inspection and minor spot of excessive moisture was detected to accessible walls to the exterior of the shower recess in the property at the time of inspection. The grout appeared to be in fair condition. |

Unmanaged damp facilitates the formation and development of mould, fungi growth and wood rot, decaying associated building materials and compromising their structural integrity.

The first step in addressing moisture is to diagnose the cause. The identified cause should be addressed first prior to repairing the appearance and other defects which have resulted from the moisture penetration. If the original cause is not resolved, further cases of moisture penetration are likely to ensue, resulting in secondary defects.

Consultation with a qualified tiller is advised immediately to identify the cause of moisture penetration and perform remedial works as required. Where excessive mould growth is present, further inspection by a specialist environmental health inspector should also be considered.

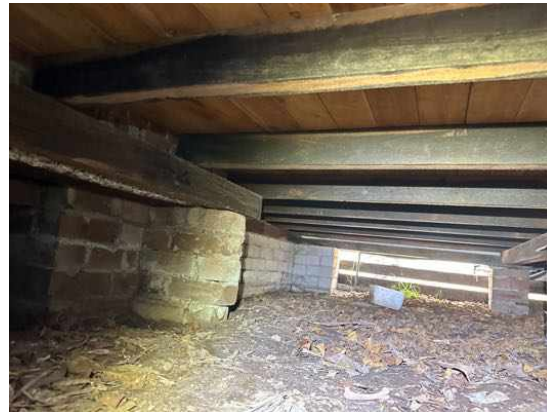
Finding 6.07

Building: Main Building
 Location: All Areas > All Areas
 Finding: Subfloor: Damp.
 Information:

At the time of inspection there appeared to be sections of the subfloor area with excessive moisture which can lead to secondary defect of other building materials. A well drained sub floor can aid in preventing secondary damage such as wood rot and pest activity, as well as preventing the development of mould and mildew (which can lead to respiratory safety hazards for occupants). This should be investigated as soon as possible by a plumber for leaking pipes or to improve site drainage.

Ventilation can be restricted by a variety of minor defects, including obstructions in the subfloor space, a lack of vents or a low clearance.

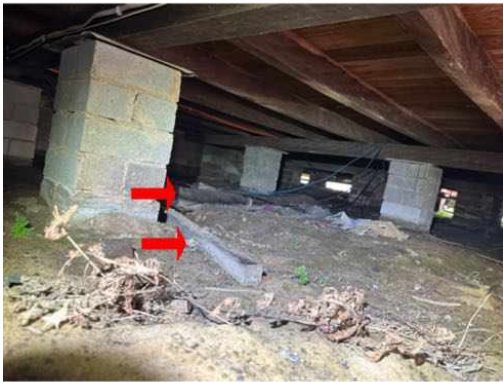
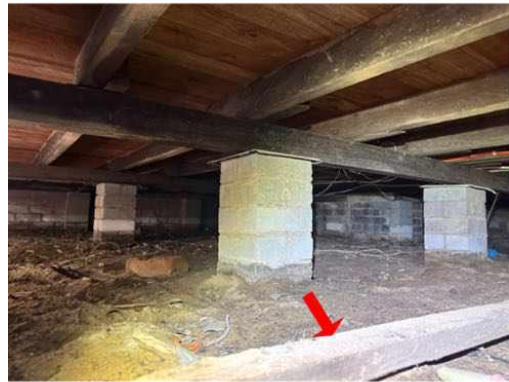
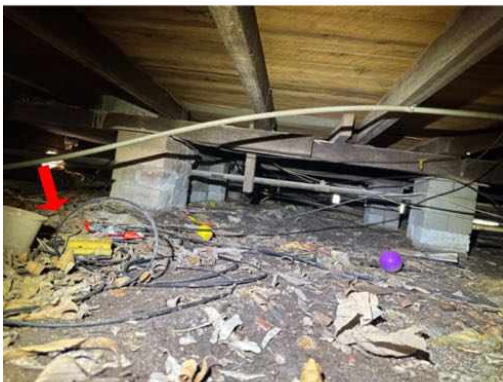
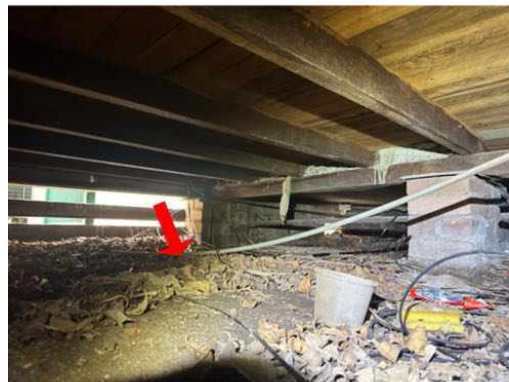
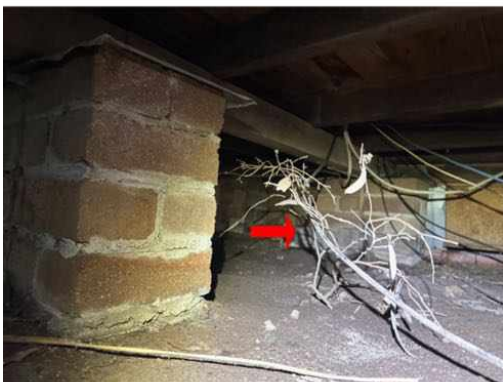
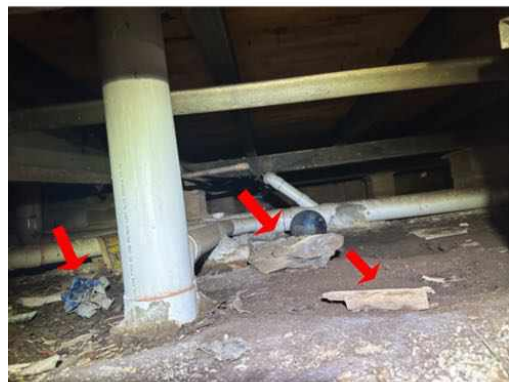
Finding 6.08

| Information: | An array of debris was found in the subfloor area at the time of inspection. Debris in this area restricts subfloor ventilation and creates potential for concealed pest entry. |

Stored timbers and other materials may also make the area susceptible to termite activity and wood rot.

A clear and empty subfloor will be better ventilated and easier to maintain in a dry condition. The removal of any timber debris is vital in minimising the risk of termite or wood borer activity.

Debris in the subfloor should be removed as soon as possible. Depending on the location and amount of debris and stored items, the homeowner may elect to undertake this task. Alternatively there are a large number of rubbish removal subcontractors that could undertake these works.

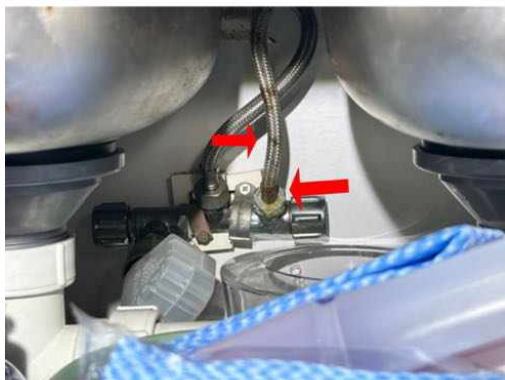
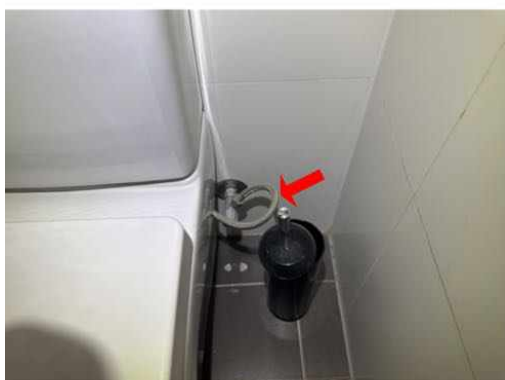
| Information: | Braided Stainless Steel Flexi connector hose are popular in modern home fit outs because they can be bent into shape. They started to be installed in the early two thousands and their use is now extremely widespread in contemporary construction and renovations. |

Flexible braided hoses accounted for more than one in five water damage claims lodged by Australian households according to research released by general insurer IAG.

It is recommended that the Flexi pipes to be replaced at the owners discretion to avoid an "escape water incident" which may lead to water damage to other building elements in the home.

This work can be undertaken by a licensed plumber, general handy person at the owners discretion.

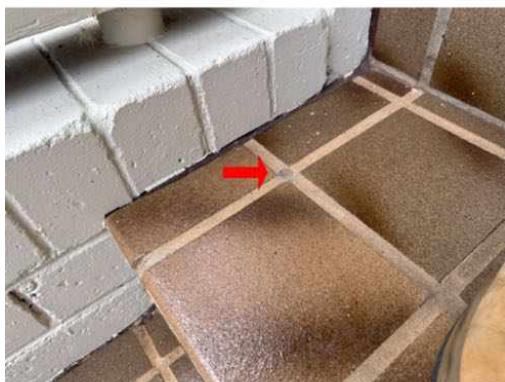
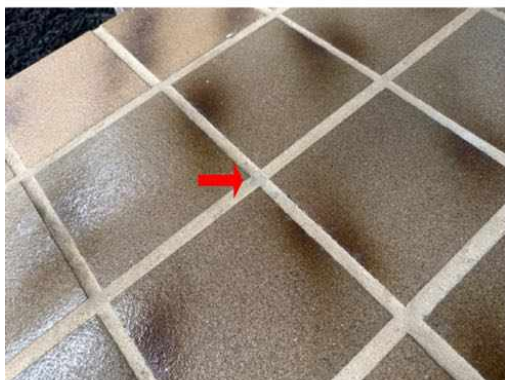
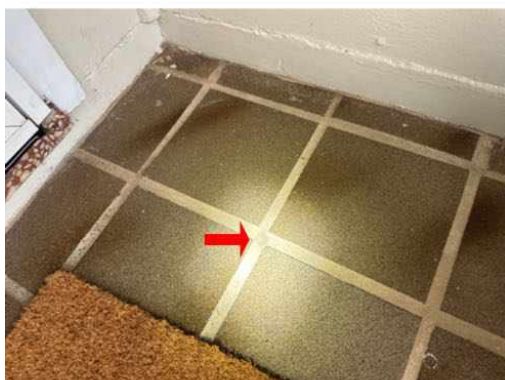
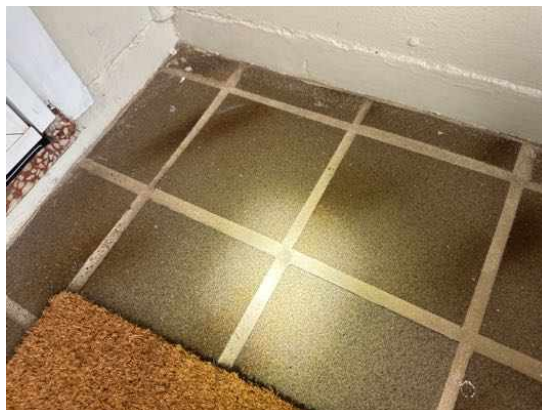
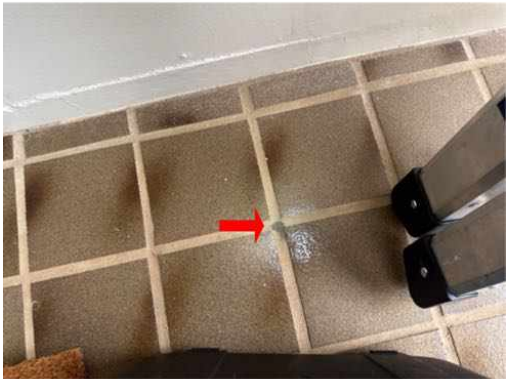
| Information: | During inspection of the property, it was noted that works to install a chemical treated zone barrier had previously been completed. A chemical treated zone barrier is likely to ensure effective protection against termites. |

However, we strongly recommend annual inspections of the barrier and surrounding areas as there are several factors that can lead to deterioration of the barrier and decrease its effectiveness.

Where a Termite Management System has been identified, the client should identify to the type of barrier, date of installation, warranty conditions and any documentation provided by a builder or past owner. Consult the company who installed the barrier to confirm whether the system is still under warranty.
