Building Inspection Report

Inspection Date: Wed, 8 Apr 2026

Property Address: 8/55 Warby St, Campbelltown NSW 2560,
Australia

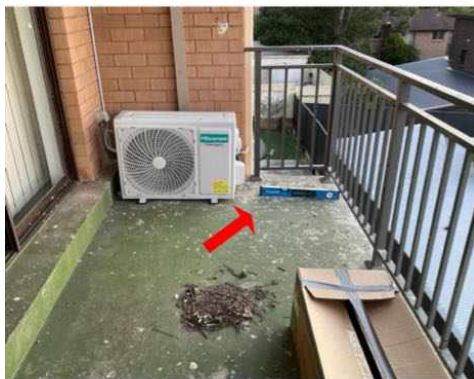
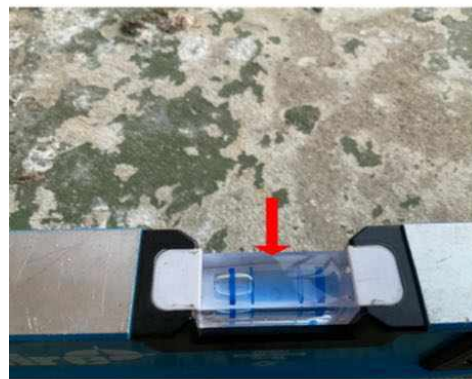
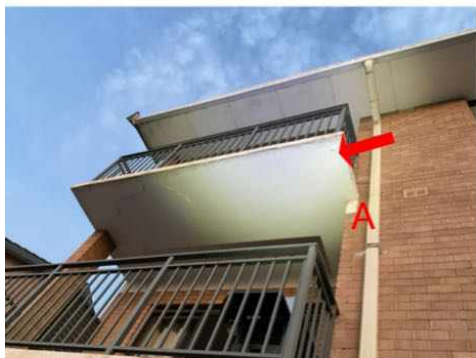
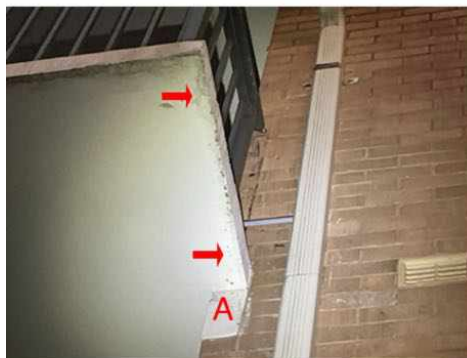
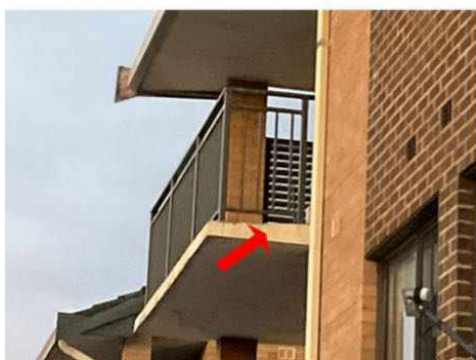
Defects 1.01

Building:	Main Building
Location:	Verandah
Finding:	Front upper balcony dropped
Information:	The front balcony slopes downward toward its outer rear edge. When stepping out from the sliding door onto the balcony, this downward lean creates a risk of losing balance or increasing walking speed unintentionally, presenting a potential slip or fall hazard. The slope suggests possible movement or settlement of the structure. The load-bearing capacity of the external balcony/deck could not be confirmed at the time of inspection. Some previous repairs may have been undertaken in area marked A.

External structures are continuously exposed to weather and environmental conditions, which can lead to accelerated deterioration over time. As such, their condition may change between inspections and requires ongoing monitoring.

For safety reasons, it is strongly recommended that a suitably qualified Structural Engineer conduct a detailed assessment of the external balcony/deck to determine its structural integrity and load capacity. Until this assessment is completed, caution should be exercised when using the balcony. Regular maintenance inspections by appropriately qualified practitioners are required.

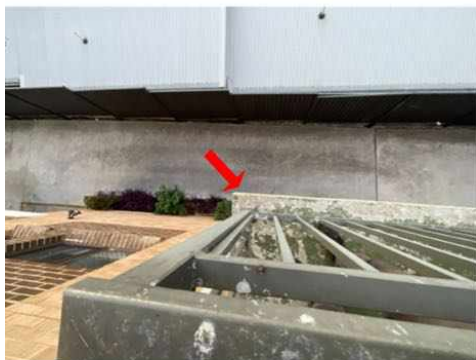
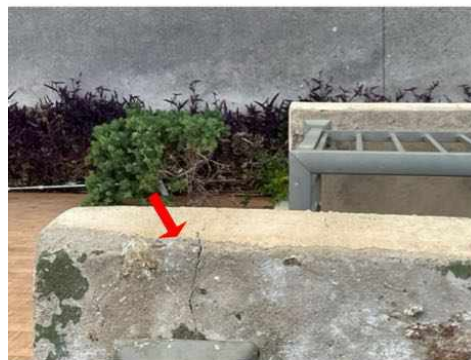
Defects 3.01

Building:	Main Building
Location:	Rear verandah corner
Finding:	Crack in concrete slab - Category 1
Information:	A crack coded as Category 1 was identified in the slab. A Category 1 crack is described as a fine but noticeable crack. To be considered Category 1, the approximate width of the crack is less than 1.0mm.

Due to the location of this crack, this should be added to the scope of works for assessment by a structural engineer to determine if it requires rectification.

This assessment should be done prior to purchase. If repairs are required, considerable costs will be incurred due to the height of this balcony. Note - if other balconies also need repair, costs may be borne by all residents as part of strata fees. See also page 24 of other balcony damage.

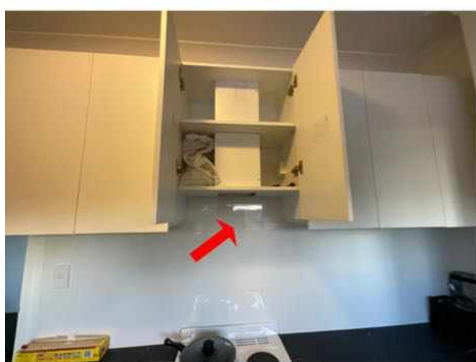
Defects 3.02

Building:	Main Building
Location:	Kitchen
Finding:	Rangehood missing
Information:	No rangehood was installed in the kitchen. This is likely to lead to a build-up of grease and grime in the surrounding area, which can pose as a fire hazard.

Without re-direction of heat from the cooktop to the exterior of the building, the missing Rangehood is deemed a minor safety hazard. It is therefore preferable that a range hood be installed to vent into the external environment. A licensed plumber should be appointed as soon as possible to provide further consultation on the scope of these works and to provide quotations for any necessary works.

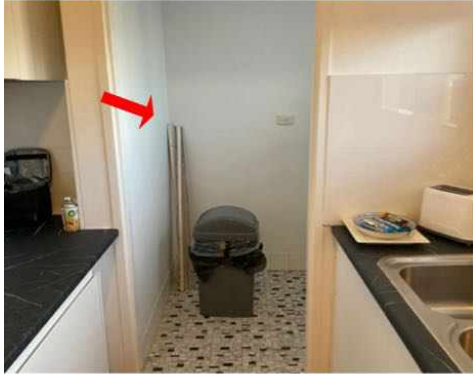
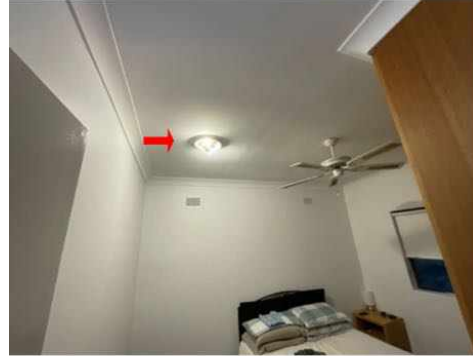
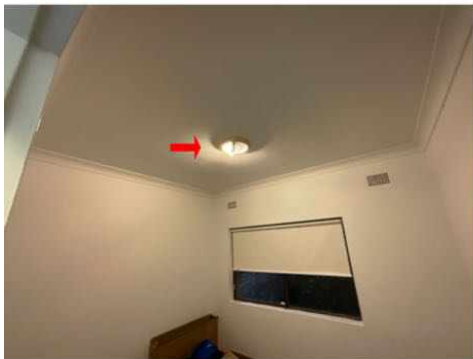
Defects 3.03

Building:	Building 1
Location:	Pictured internal Areas
Finding:	Building elements - Missing or Damaged
Information:	Evidence of missing building elements was identified to the following areas -

1. The laundry door is missing .
2. Two bedroom light covers are missing.

A carpenter or skilled handyperson is required to replace these items and bring them back to full function.

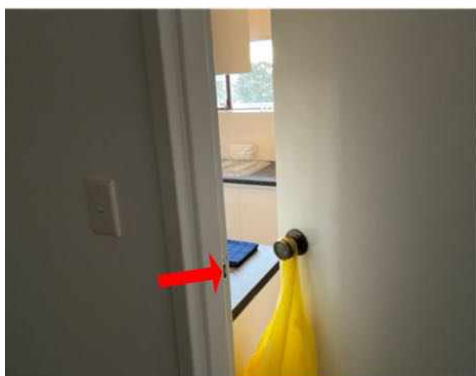
Defects 3.04

Building:	Main Building
Location:	Kitchen
Finding:	Door - Binding/jamming
Information:	Binding and/or jamming of this door is evident during standard operation. This defect inhibits the functionality of the affected door as well as creating potential for secondary defects to associated building elements, such as damage to the floor covering.

A door that binds to flooring or to the associated door frame may have several causes. For this minor cause, a qualified carpenter or general handyperson should be appointed to perform minor rectification works at client discretion.

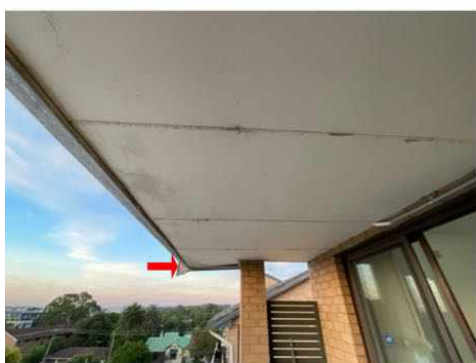
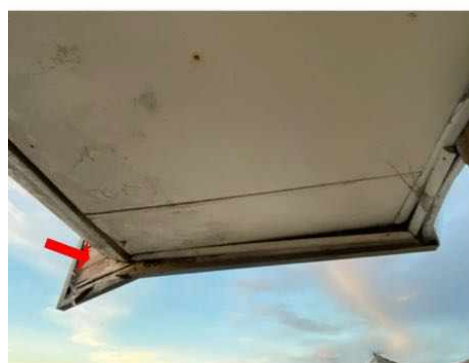
Defects 3.05

Building:	Main Building
Location:	Roof areas
Finding:	Fascias - Wood rot
Information:	Wood rot was found to be affecting the roof barges in this area. This has now been partially covered by metal fascia which should stop some wood rot occurring but may be attractive to termite activity. All exposed timber in roof areas should be protected by high quality external paint applied by a painting contractor in the next 6 months to stop further deterioration.

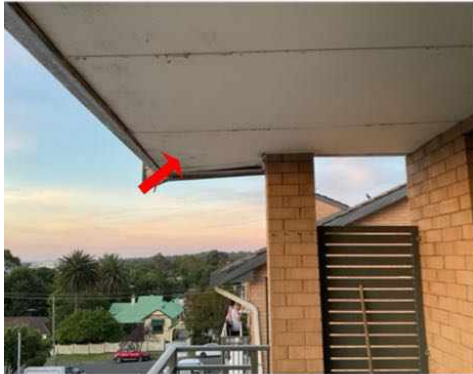
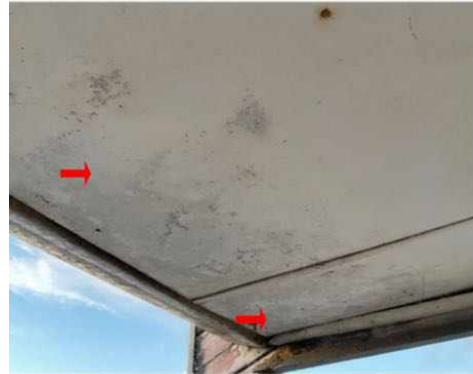
Defects 3.06

Building:	Main Building
Location:	Verandah
Finding:	Mould - Present
Information:	Where evidence of mould growth was noted, the cause of the mould should be addressed. A roof inspection is advised by a roofing contractor to check for any roof or gutter faults and ensure the gutters remain clear of leak debris which may be the cause of this mould. Any mould found during the inspection should be cleaned immediately by a cleaning contractor.

The above roof areas were not visible from anywhere on the property.

Please note that severely affected building elements or any roof faults may require

repair or replacement by a registered roofing contractor.

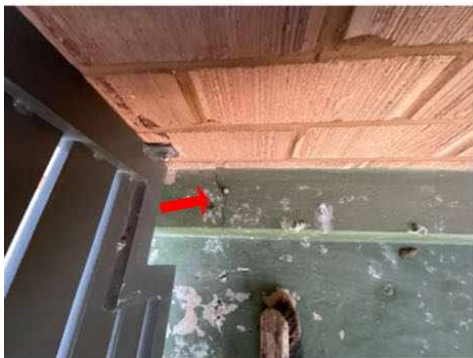
Defects 3.07

Building: Main Building

Location: Verandah

Finding: Render (external) cracking.

Information: It has been observed that minor cracking has occurred to some external rendered surfaces. The degree of damage is described as "slight" noticeable cracks which are easily filled. Cracking of this size is generally less than 5mm in width.

Always contact your building inspector should cracks widen, lengthen, or become more numerous.

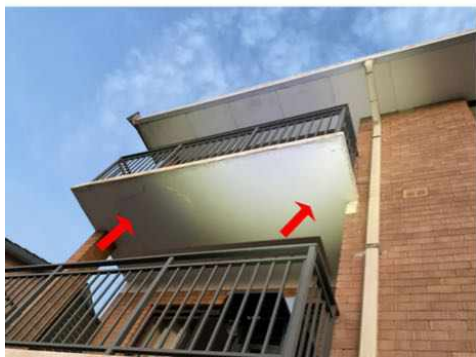
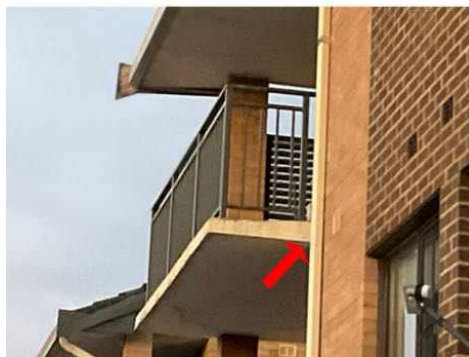
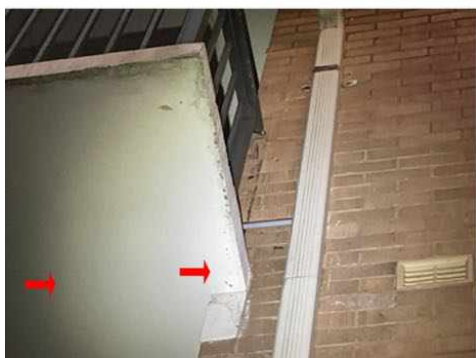
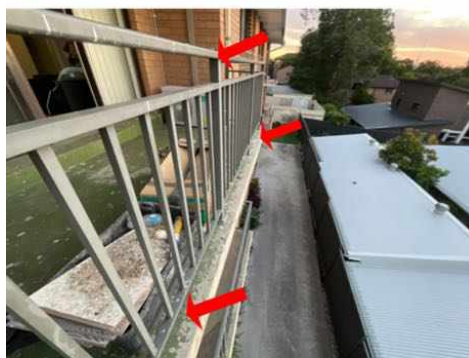
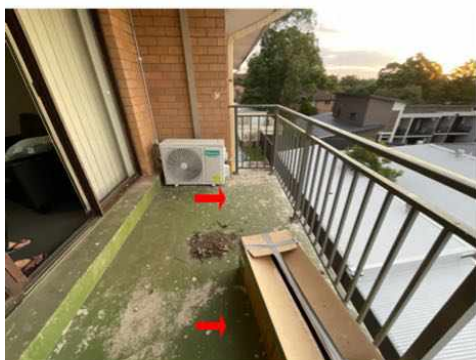
Noted Item

Building: Building 1
Location: Verandah
Finding: Elevated structure inspections.
Information: This front verandah appears to have moved and dropped after construction. It also has hairline cracks evident. Where any elevated verandahs are present, these structures MUST be checked by an engineer or other suitably qualified person.

Nothing contained in this report should be taken as an indicator that an assessment has been made, on any elevated structure, as suitable for any specific number of people or purpose. This can only be done by a qualified engineer. For the purpose of this report, the Structure includes the pictured verandah which appears to be unsafe due to its slope at the rear.

You should also arrange annual inspections of the structure by an engineer or other suitably qualified person to ensure any maintenance, that may become necessary, is identified. Care must be taken not to overload the structure.

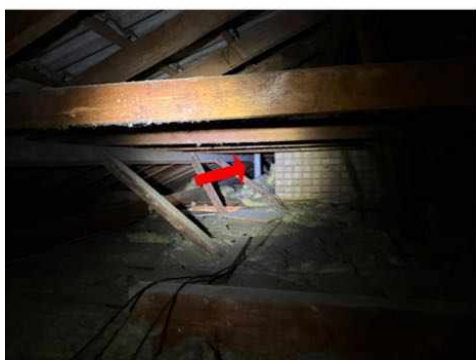
Noted Item

Building:	Building 1
Location:	Roof Void
Finding:	Firewall missing
Information:	This dividing wall between the units does not appear to comply with the current National Construction Code for fire walls in Class 1 Buildings.

There is no dividing wall in the roof void. This is likely not to have been a requirement at the time of construction of this unit.

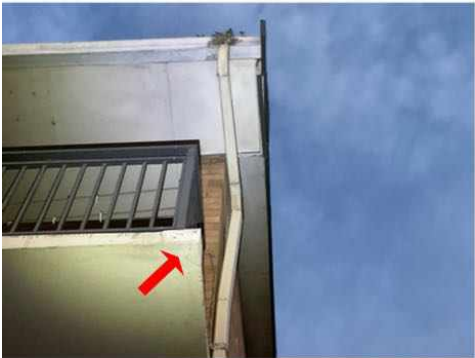
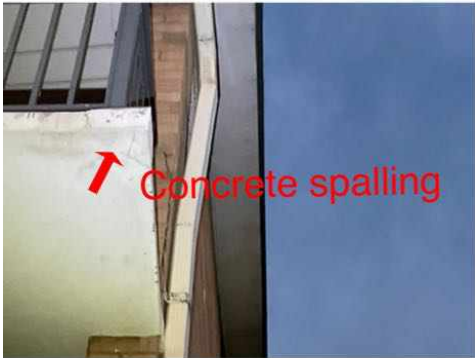
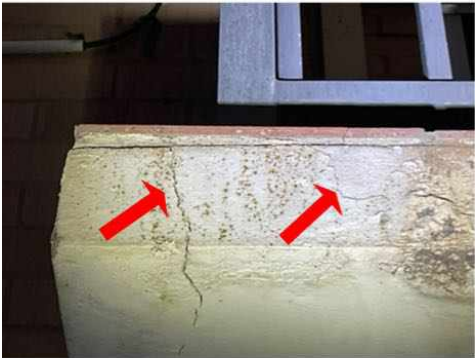
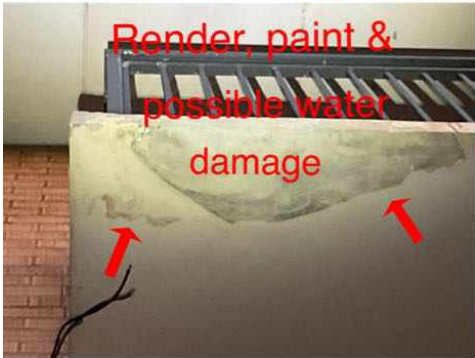
Noted Item

Building: Main Building
Location: Other Unit Balcony Areas in same block
Finding: Pictures of other balcony faults
Information:
