Building and Timber Pest Inspection Report

Inspection Date: Wed, 4 Mar 2026

Property Address: 1304/192 Stacey St, Bankstown NSW 2200,
Australia

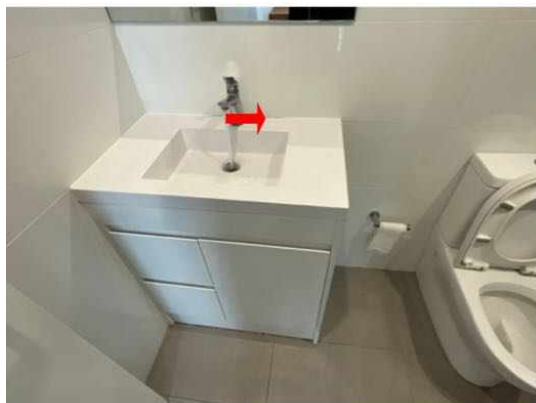
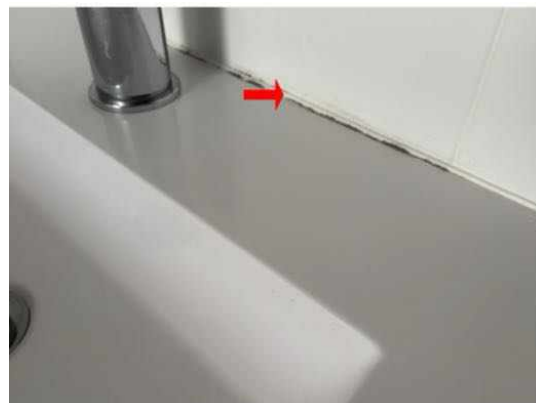
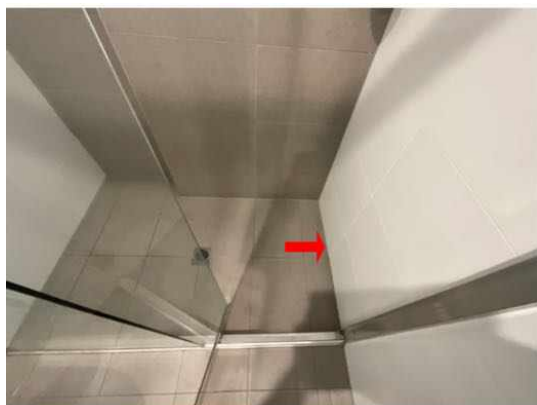
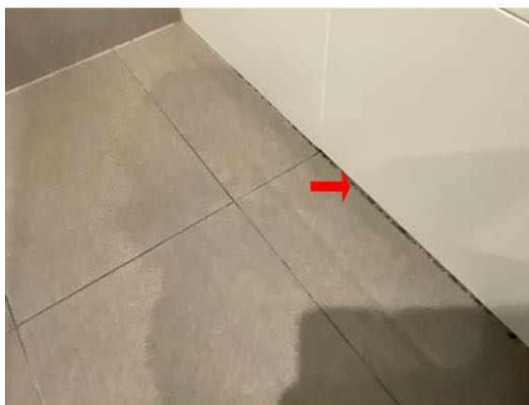
Finding 3.01

Building: Main Building
Location: Bathroom
Finding: Sealant and grouting - Missing or damaged
Information:

It was noted on inspection that sealant or grout is degraded to this area.

Different materials and floor areas move at different rates, generally causing cracking to grout or sealant at this point. A flexible sealant is required to allow for expected expansion and contraction, while keeping the joint water tight and protective of all associated building materials.

Flexible and mould resistant materials should be applied to affected areas to prevent any subsequent water damage that is likely to occur. Regular maintenance and replacement of damage or missing or damaged sealant and grout is highly recommended to the wet areas, as this is a regular wear and tear defect. Sealant and grouting in areas that come into regular contact with water should be maintained for the long term care of your property.

A sealant specialist should be appointed to complete these works as soon as possible.

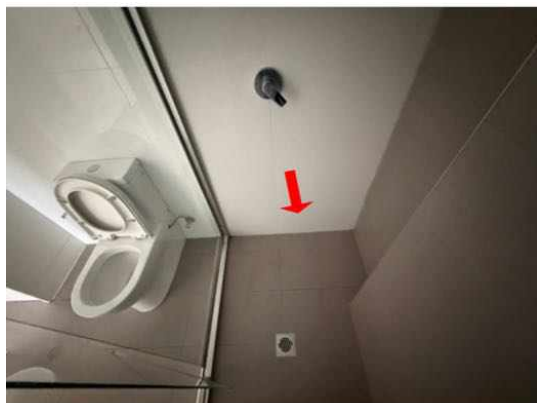
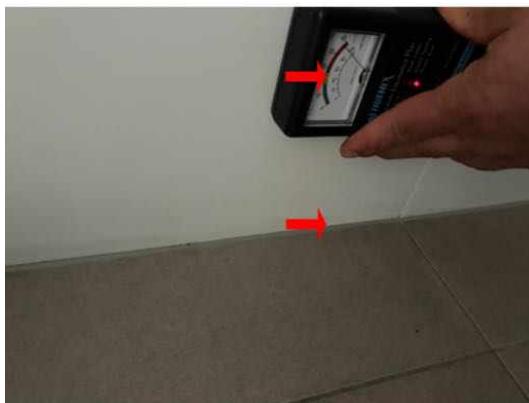
Finding 3.02

| Finding: | Shower damp - Monitor |
| Information: | Damp is evident to the lower 400mm of wall to the shower alcove. There is no high reading around the taps nor are there high readings transferring to the other side of the wall. Sealant appears to have been repaired recently and both sealant and grout appear in acceptable condition at present. |

This defect is quite common, and is suspected to have been caused by moisture permeating or leaching through the grouting and perhaps gaps in the sealant prior to repair.

Monitoring the area is advised and if any visual signs of excessive moisture appear (peeling paint, mould) then consultation with a qualified plumber or bathroom specialist would be advised to identify the cause of damp and to perform remedial works as required.

Always ensure that sealant and grout is in good condition to prevent any moisture issues occurring in the future.

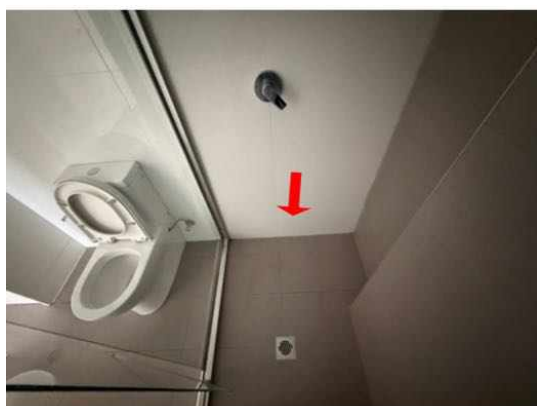
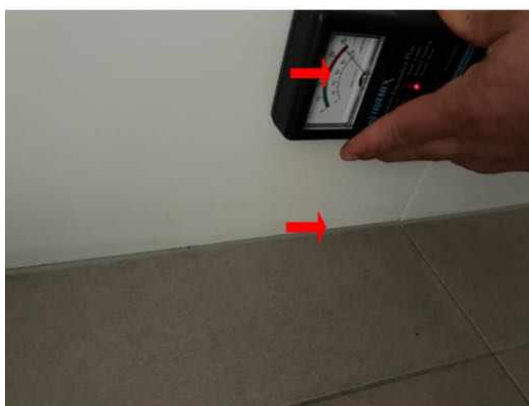
Finding 6.01

| Finding: | Shower damp - Monitor |
| Information: | Damp is evident to the lower 400mm of wall to the shower alcove. There is no high reading around the taps nor are there high readings transferring to the other side of the wall. Sealant appears to have been repaired recently and both sealant and grout appear in acceptable condition at present. |

This defect is quite common, and is suspected to have been caused by moisture permeating or leaching through the grouting and perhaps gaps in the sealant prior to repair.

Monitoring the area is advised and if any visual signs of excessive moisture appear (peeling paint, mould) then consultation with a qualified plumber or bathroom specialist would be advised to identify the cause of damp and to perform remedial works as required.

Always ensure that sealant and grout is in good condition to prevent any moisture issues occurring in the future.

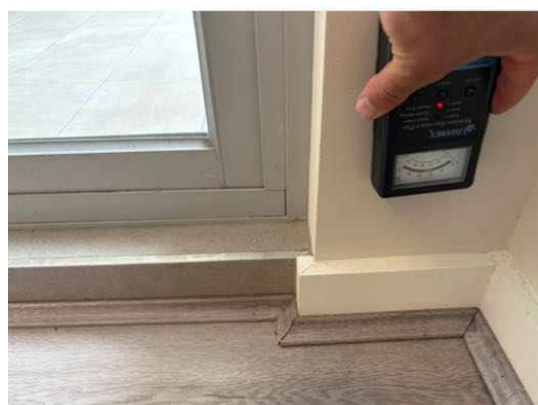
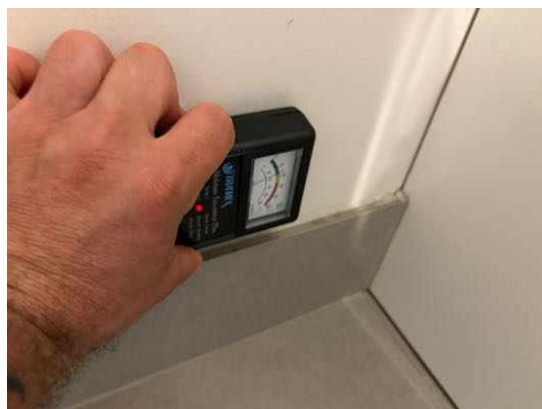
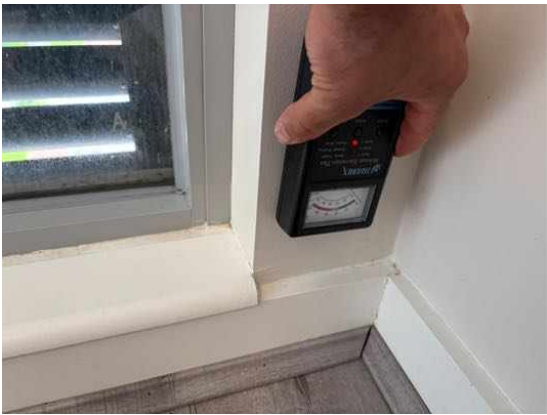
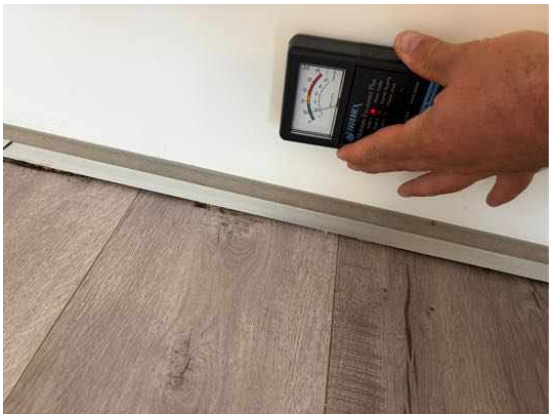
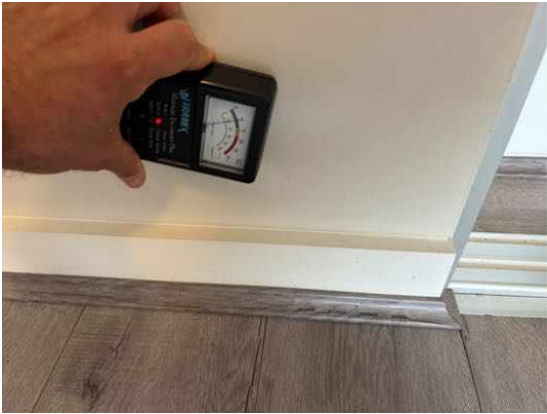
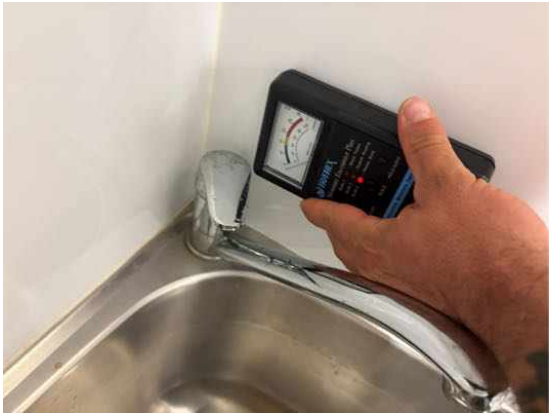
Building: Main Building
 Location: All Areas
 Finding: Moisture metre
 Information: During the inspection the property was checked for moisture using a moisture metre.

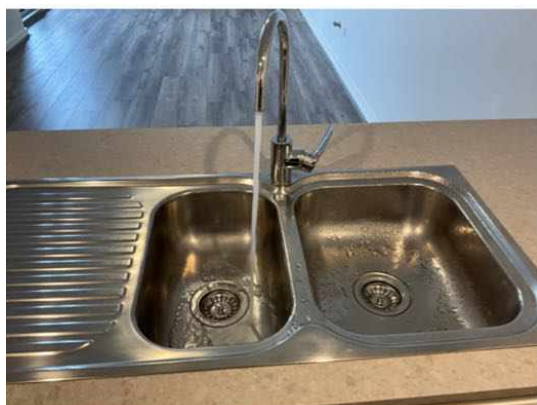
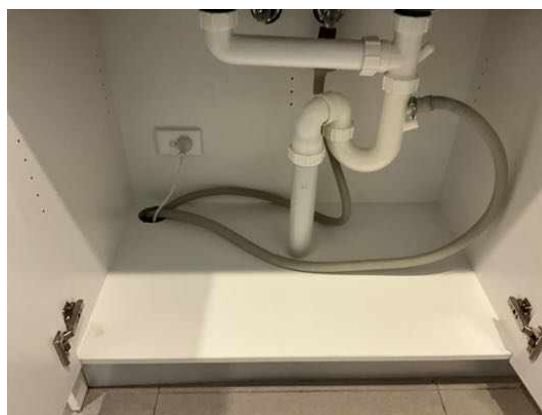
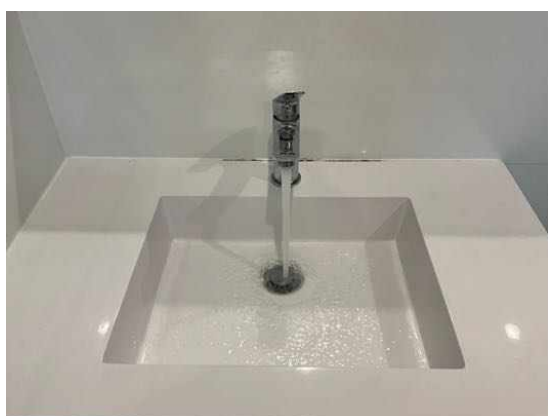
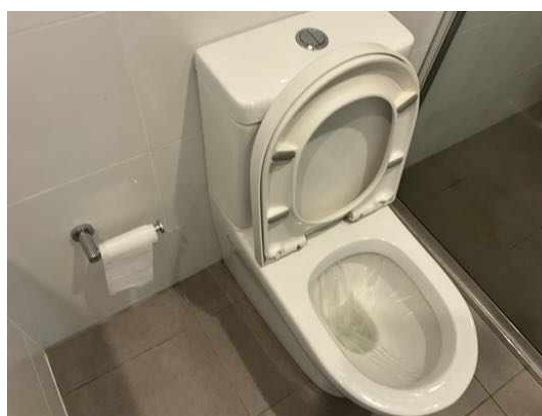
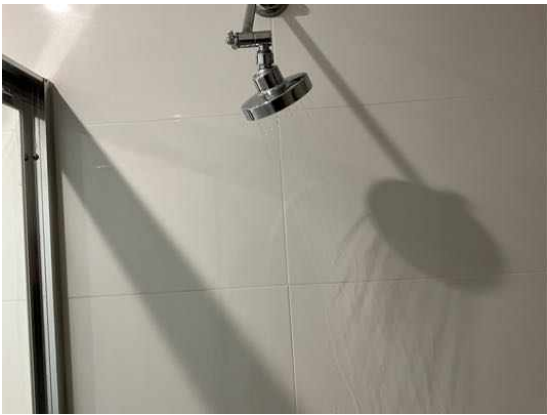
Building: Main Building
Location: All Wet Areas
Finding: Waterproofing
Information:

All taps, mixers and toilets were tested for operation, except for those obstructed. The waterproofing to the shower recess was assessed by checking the walls in and around the shower recess for varying moisture content. There were no significant variations across the tested areas. No sign of recent water damage was evident upon a visual inspection of the surrounding walls, where the visual nature of the inspection was possible.

Consequently, there is no conclusive evidence of any current shower recess leakage other than those which may have already been mentioned earlier in this report. It is reasonable to assume the shower waterproofing is sound. Note that if the shower is not used, or has not been used for some time, moisture readings would not vary significantly and this can lead to erroneous results. It is not possible under the visual inspection criteria (under which a prepurchase inspection is carried out) to categorically determine if there are leaks. If a more accurate assessment is required, a special purpose inspection should be requested. Alternatively, the assumption should be made that the shower may leak.

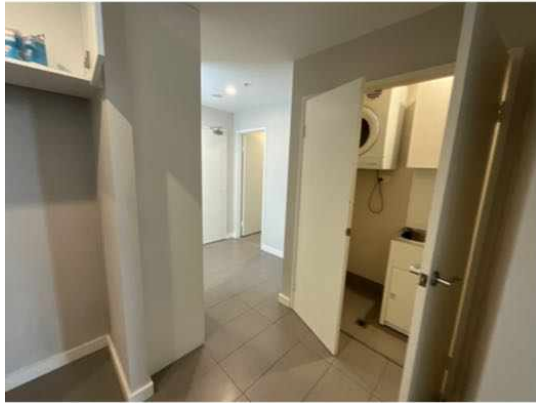
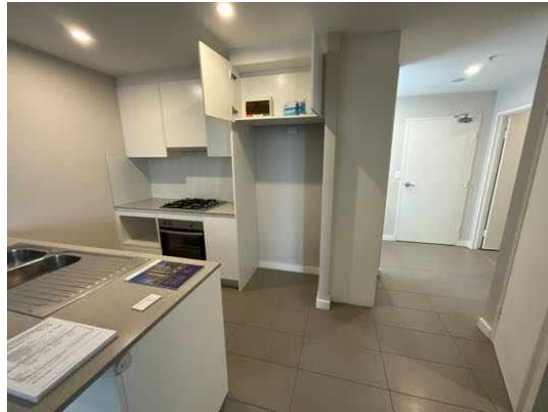
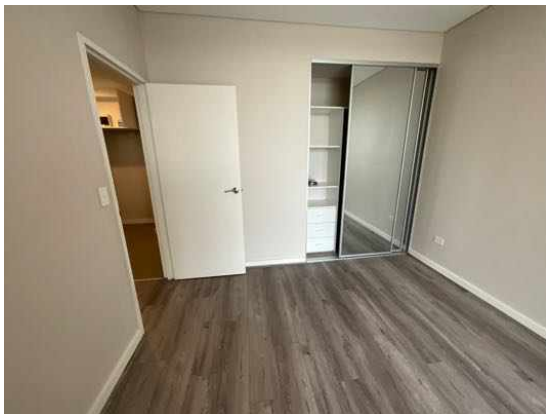
Finding: Additional Photos - Obstructions and Limitations

Information: These photographs are an indication of the obstructions and limitations which impeded full inspection of the property at the time of inspection. These obstructions can hide an array of defects and should be removed to allow full inspection to be carried out. A re-inspection is recommended once the areas are made accessible.
