Building and Timber Pest Inspection Report

Inspection Date: Thu, 19 Mar 2026

Property Address: 13/21 Edgeworth David Ave, Hornsby NSW
2077, Australia

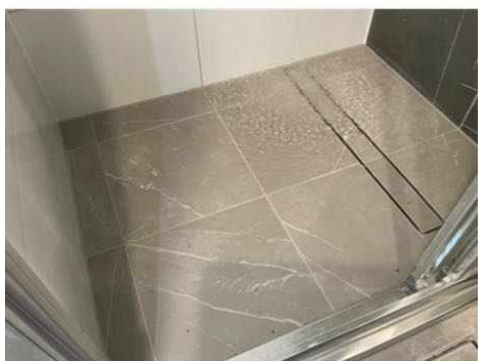
Building:	Main Building
Location:	Bathroom
Finding:	Shower Linear Drain – Restricted Discharge Due to Excess Adhesive
Information:	At the time of inspection, the linear drain within the shower was tested. It was observed that the connection between the linear drain insert and the drainage pipe appears to have been excessively glued. Visible adhesive residue was noted within the pipe, reducing the effective internal diameter of the outlet. This condition is restricting the free flow of water, resulting in a noticeably slower discharge rate. While no significant ponding was observed at the time, water was seen to build up across the shower floor before gradually draining.

The application of adhesive at the connection point is considered excessive and indicative of poor installation practices. Proper installation requires controlled use of adhesive to ensure a secure bond without obstructing the flow path. The current condition reflects a lack of care in workmanship, leading to a functional deficiency in the drainage system.

- Increased risk of water ingress beyond the shower area if drainage capacity is exceeded.
- Ongoing moisture exposure to finishes, which may contribute to deterioration, mould growth, or damage to surrounding materials over time.
- Possible long-term blockage risk if debris accumulates against the adhesive build-up.

Recommendations:

- Engage a licensed plumber to further investigate the drain connection.
- Remove the linear drain insert and rectify the connection to ensure that no excess adhesive obstructs the pipework.
- Clean or replace the affected section of pipe as required to restore full internal diameter and proper flow.
- Reinstall the linear drain in accordance with acceptable plumbing practices, ensuring a clear and unobstructed discharge path.
- Upon completion, retest the drainage to confirm adequate flow and performance under normal operating conditions.

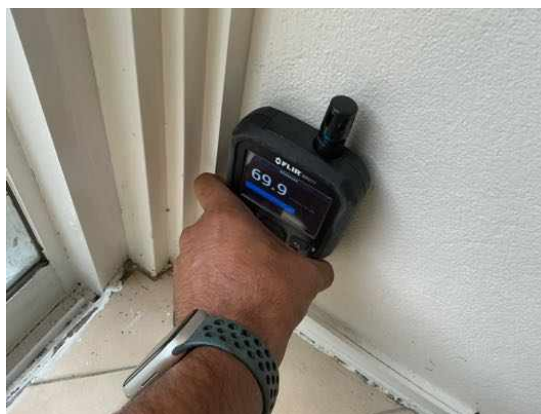
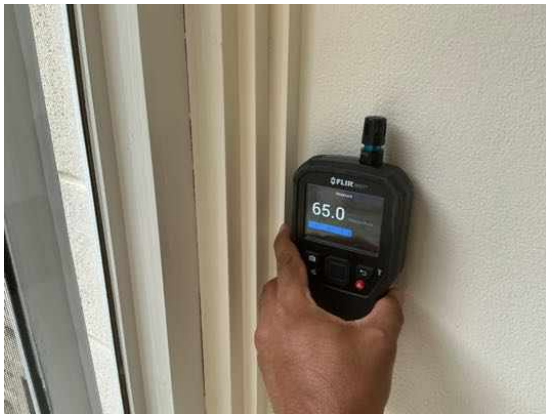
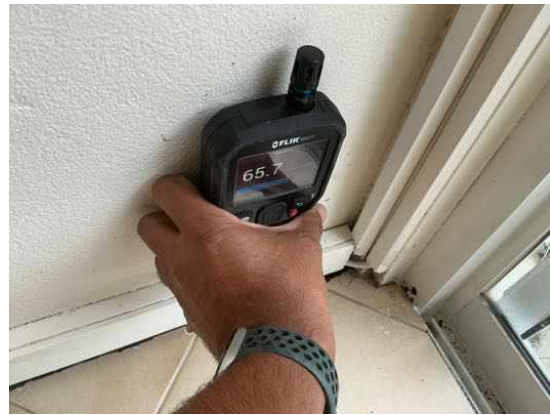
Finding 3.02

Information: At the time of inspection, rising damp was identified within the property. This condition results from the upward movement of moisture through porous building materials, such as bricks, sandstone, or mortar, via capillary action. A damp-proof course (DPC), an impermeable barrier installed at the base of walls above ground level during construction, is typically used to prevent rising damp. However, the absence, deterioration, or bridging of the DPC can compromise its effectiveness, specially in older buildings, leading to moisture ingress. Inadequate site drainage, which allows water to accumulate around the foundation, is a common contributing factor to this issue.

If left unaddressed, rising damp can pose significant health risks due to mould growth and cause extensive damage to building elements, including wall finishes such as paint and plasterwork. The current condition should be monitored over a 12-month period to assess its progression.

It is strongly recommended that the client engage a qualified damp-proofing specialist for remedial actions. Additionally, consulting a qualified plumber or drainage specialist to assess and improve site drainage is advised to mitigate further risks. Monitoring the condition for 12 months is essential to evaluate its status and prevent potential recurrence or further damage.

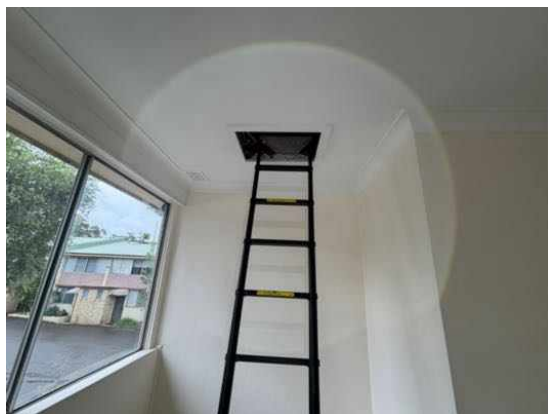
Building:	Main Building
Location:	All Areas
Finding:	Sarking - Damaged
Information:	Sarking, a laminated aluminium foil applied to the interior of the roof covering, assists in insulating the property and acting as a vapour-barrier to the roof void and, subsequently, to the household.

Where sarking is damaged, both insulation and moisture protection of the property are inhibited. This creates a loss of energy and thus negatively impacts the energy efficiency of the property, allowing potential for moisture ingress from condensation or leaking roof tiles.

It is important to repair any holes or damaged sections of sarking to ensure that the building material is fully functional. A registered roofer should be consulted to provide further advice on this defect and to perform rectification works at client discretion.

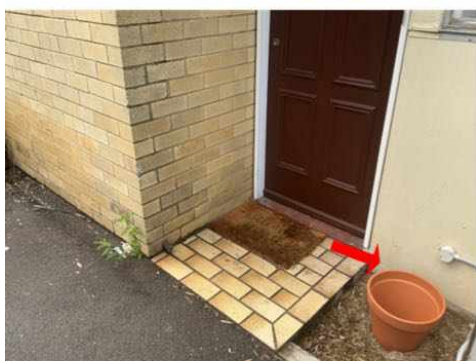
If the slab edge is not properly exposed there is a high risk of termite attack. Sometimes, in order to determine the type of slab, a suitably qualified person such as an architect or builder may be required to consult the construction plans.

Where the slab edge cannot be properly inspected, it is highly recommended that termite or timber pest inspections be carried out every 6-12 months to aid protection of the property against infestation.

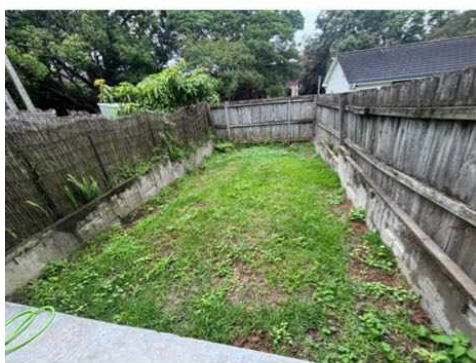
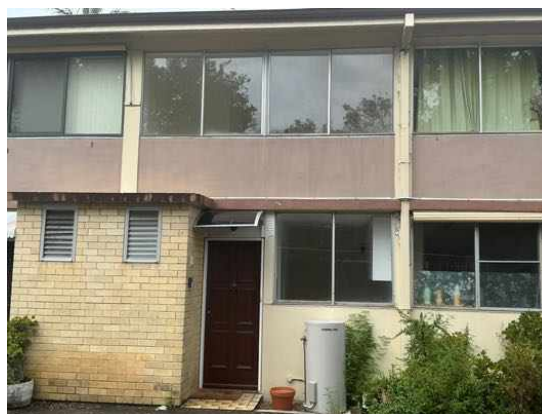
It is essential that these obstructions be cleared to allow for a comprehensive inspection of the external areas. Removing these barriers will enable a more accurate assessment of the property's condition and allow any hidden defects to be identified and addressed promptly. Failure to do so could result in undetected issues worsening over time, potentially leading to more costly repairs in the future.

Therefore, it is strongly recommended that the obstructions be removed and a re-inspection be scheduled once the affected areas are made fully accessible. This will ensure a complete evaluation of the property's exterior and provide the client with a clear understanding of any potential issues that may have been concealed during the initial inspection.

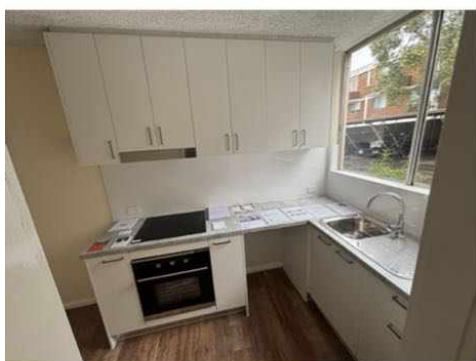
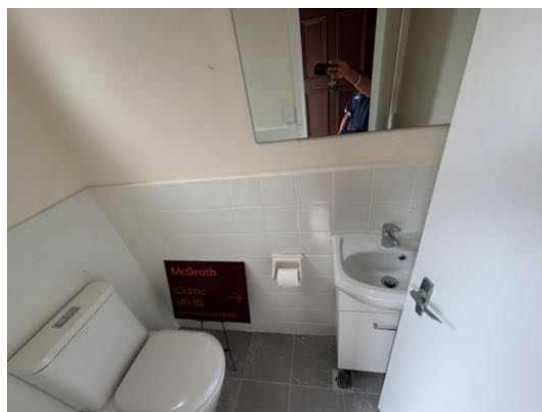
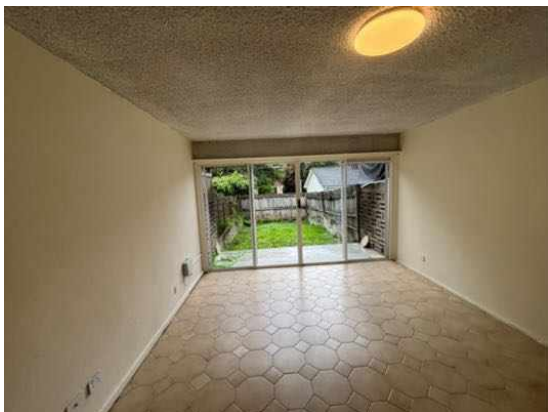
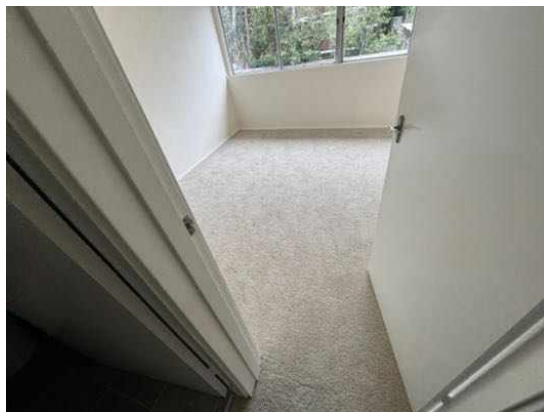
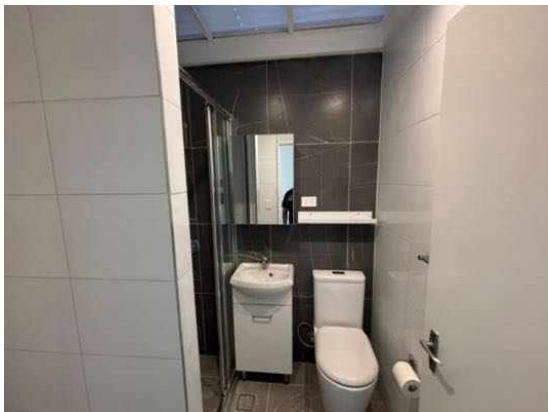
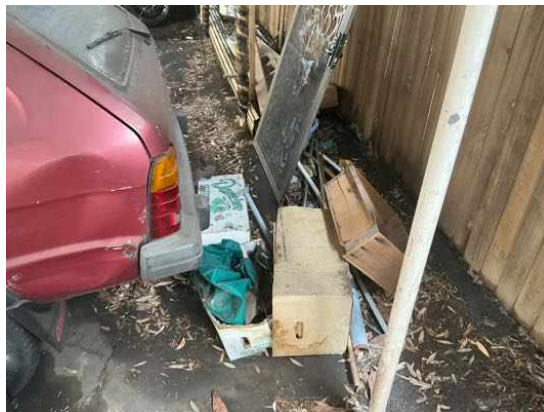
Noted Item

Building: Main Building
 Location: All Internal Areas

In summary, the limitations encountered during the inspection highlight the importance of ensuring full access to all areas of the property to accurately assess its overall condition. A re-inspection is strongly advised once these areas are made accessible.

It is highly recommended that all obstructions be cleared to facilitate a complete and thorough inspection of the internal areas. Once the obstructions have been removed and full access is available, a re-inspection should be carried out to ensure that any previously concealed issues can be properly identified and rectified. This follow-up inspection will provide a more accurate assessment of the property's internal condition and help the client make informed decisions about any necessary repairs or maintenance.

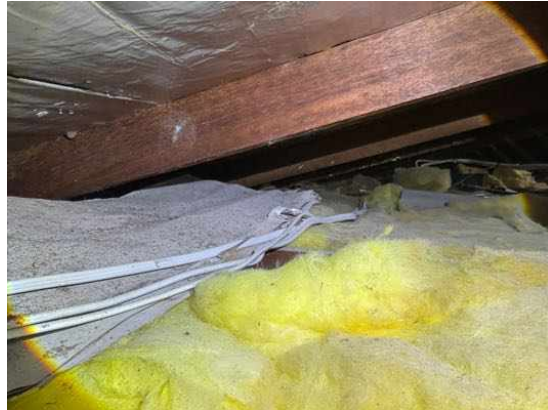
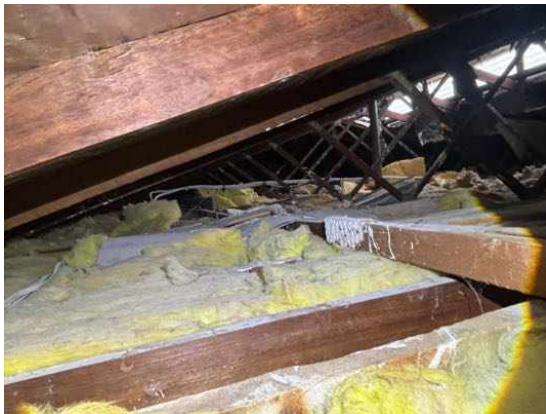
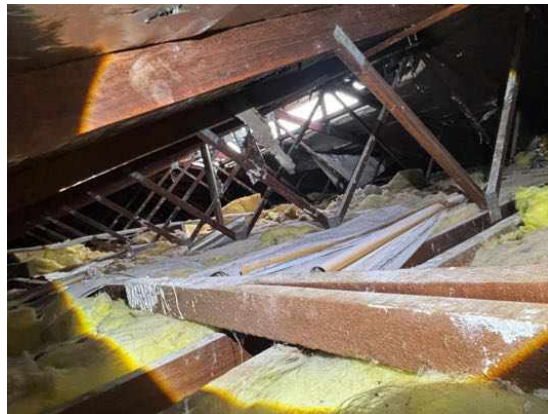
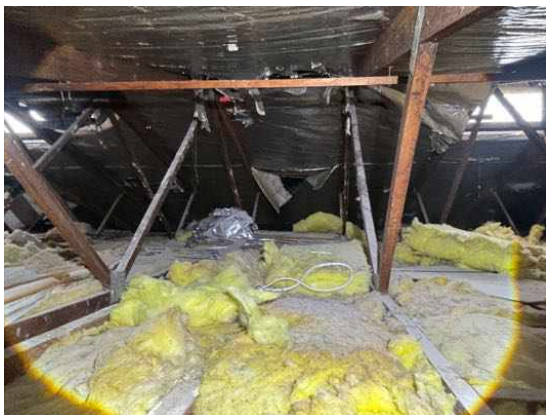
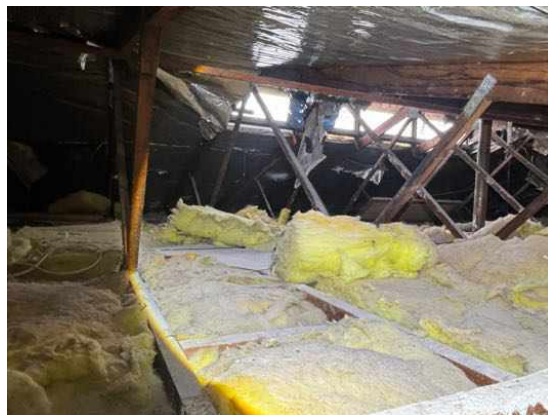
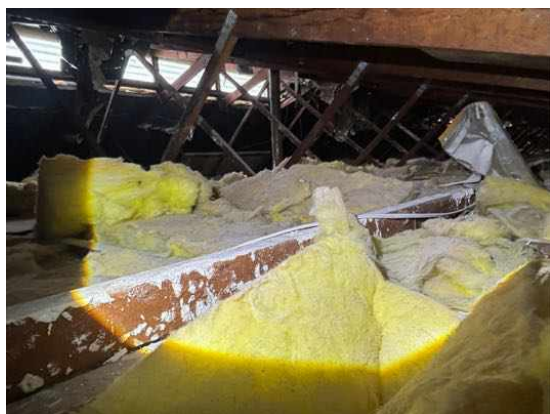
Noted Item

Building: Main Building
 Location: Roof Void
 Finding: Obstructions, Limitations, and General Roof Space Condition
 Information: The photographs provided document both the general condition and the obstructions and limitations that were present in the roof cavity of the main building at the time of inspection. These obstructions—such as insulation materials, stored items, structural elements, or electrical wiring—restricted safe and adequate access to key areas within the roof space. As a result, a comprehensive inspection of all components could not be completed.

damaged framing, compromised insulation, evidence of moisture ingress, pest activity, or electrical hazards. While no major issues were observed in the visible areas, the presence of these limitations means that some defects may remain undetected.

It is recommended that these barriers be removed or repositioned to facilitate full and safe access to the roof space. Once clear, a follow-up inspection should be conducted to allow for a thorough assessment of all concealed areas. This will help ensure that the condition of the roof cavity is accurately evaluated and any hidden issues are appropriately identified and addressed.

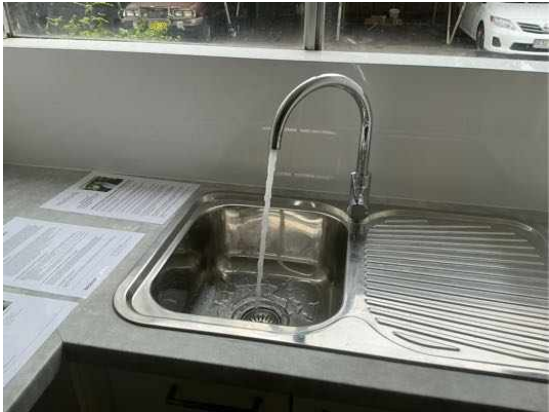
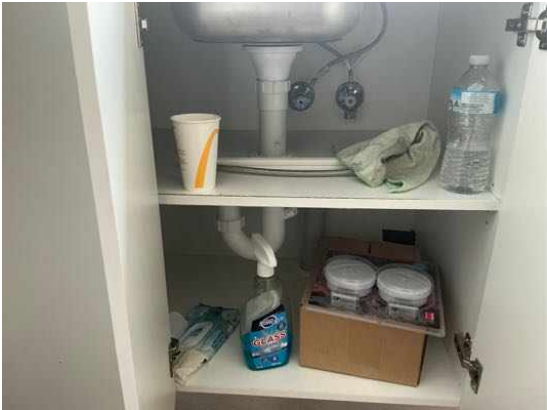
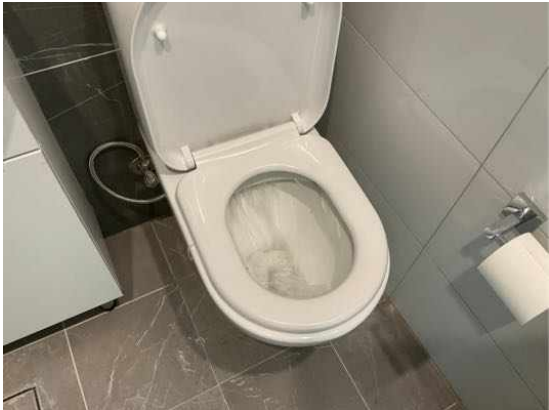
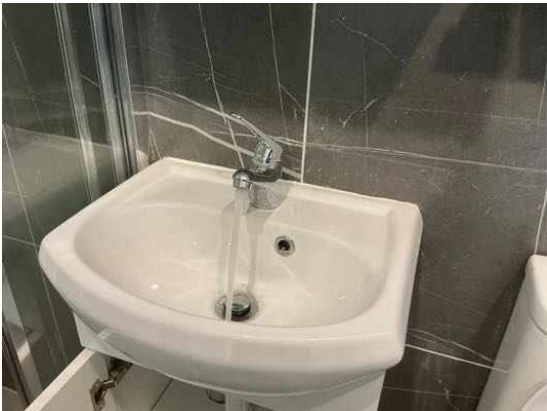
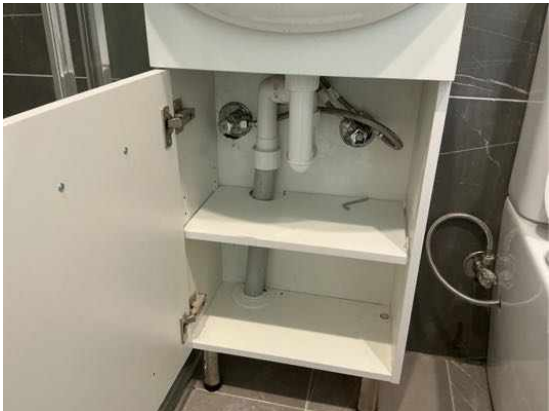
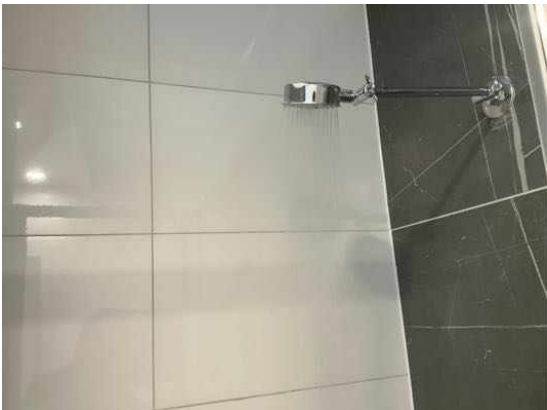
Noted Item

It is important to note that while a visual inspection of cupboards and cabinetry beneath sinks and vanities was undertaken, stored personal items and fixtures presented obstructions that limited full visibility of the internal areas. As per standard inspection practices, inspectors are not permitted to move or disturb personal belongings during the inspection process. Therefore, only visible and accessible sections were inspected, and concealed water damage or plumbing defects may not have been detected.

Given this, a re-inspection is recommended after all obstructions have been cleared to allow for a comprehensive assessment of these areas. Regular maintenance and monitoring of plumbing and drainage systems is also advised to ensure ongoing functionality and early detection of potential issues.

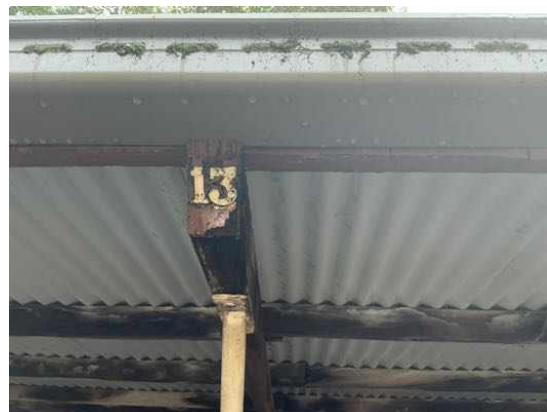
Finding: Allocated Car Spaces

Information: The accompanying photos are provided for your general reference, showcasing the current condition of the car parking spots and storage rooms as observed at the time of inspection. It is important to note that these images are meant to serve as a visual snapshot of the property's features at the time of the assessment. However, the client is strongly advised to confirm all allocations, such as car parking spots, storage rooms, and any associated rights or access, within the terms of the contract. Verifying these allocations through the contract ensures clarity and avoids potential disputes regarding ownership or usage. The photos included are intended to give an overview of the designated areas, but the final details should always be cross-referenced with the contractual agreements for accuracy and completeness.
