# Building and Timber Pest Inspection Report

Inspection Date: Wed, 14 Jan 2026

Property Address: 27 Chesterfield Parade, Bronte NSW 2024, Australia

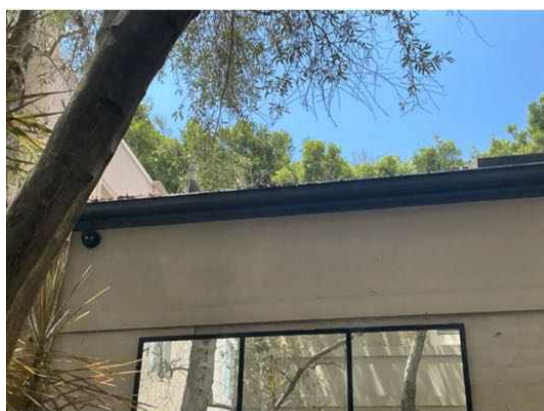
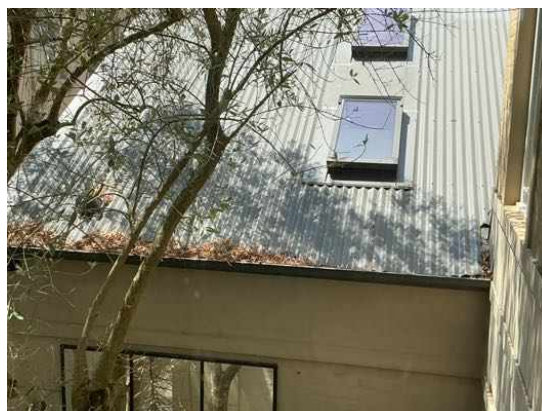
#### Finding 3.01

Blocked gutters are likely to lead to high levels of moisture in the affected areas. Such moisture will not only cause rust and decay of the associated building materials, but can also provide conditions that are conducive to termite and timber pest activity. Blockages in gutters should therefore be removed immediately to ensure dry conditions are maintained.

It is highly advised that blocked gutters be removed by the homeowner or a general handyperson.

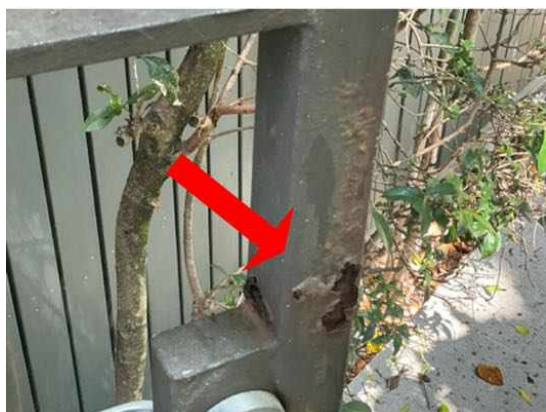
#### Finding 3.02

Building: Main Building  
 Location: Yard - Front

Finding: Rusted or corroded  
 Information: The gate shows evidence of rusting and corrosion, which is likely to have developed as a result of excessive exposure to moisture and or inadequate coatings.

Where possible, the use of galvanized (treated) metals or aluminium coated metals aid in rust prevention, as does regular general maintenance. Rust formation can be controlled with coatings, such as paint, that isolate the iron from the environment.

Rusting and corrosion should be managed by ideally removing or limiting the affected surface from exposure to moisture. A registered builder may be appointed to replace any building elements that have been severely affected by rust.

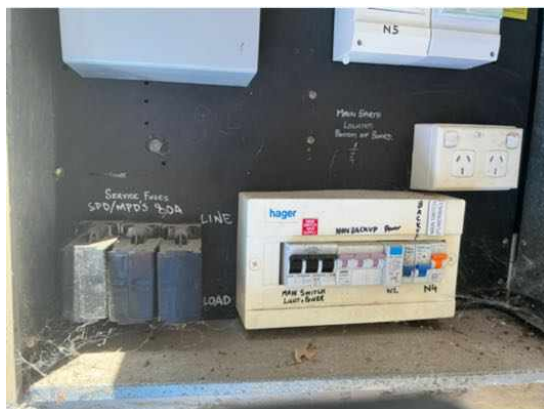
### Finding 6.01

Building: Main Building  
 Location: Electrical circuit box  
 Finding: Termite Management System No Evidence of Installation  
 Information: The application of a post-construction termite barrier is highly recommended for all properties. Such barriers are highly effective in preventing termite attack on any timber building elements throughout the property.

system has been installed, with no evidence to suggest preventative works taking place.

The client may consider gaining further advice from a pest controller as to the costs and procedures involved with this application. It is recommended that obtaining such advice be a short-term priority.

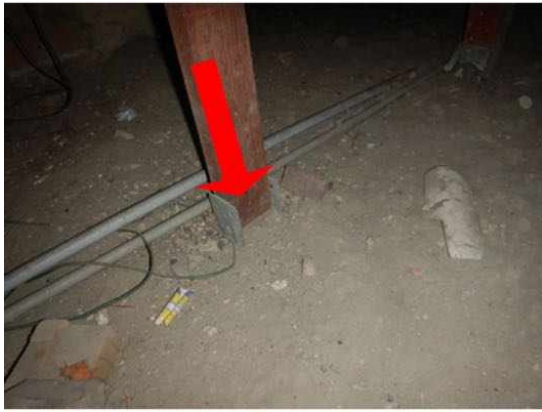
## Finding 6.02

Building:	Main Building
Location:	Subfloor
Finding:	Building materials in direct ground contact
Information:	Building timbers were observed to be in direct contact with the ground. This condition is conducive to timber pest activity, particularly subterranean termites, as it provides direct and concealed access between the soil and the structure without the need for visual detection.

Timbers in contact with the ground are at an increased risk of decay and infestation. This configuration bypasses typical termite management systems and may lead to undetected termite entry or timber rot due to moisture retention.

It is recommended that all structural and non-structural timbers in ground contact be modified to maintain a minimum clearance from soil levels in accordance with AS 3660.2 and good building practice. A licensed builder or carpenter should be consulted to carry out the necessary alterations. Ongoing termite inspections should also be conducted at regular intervals.

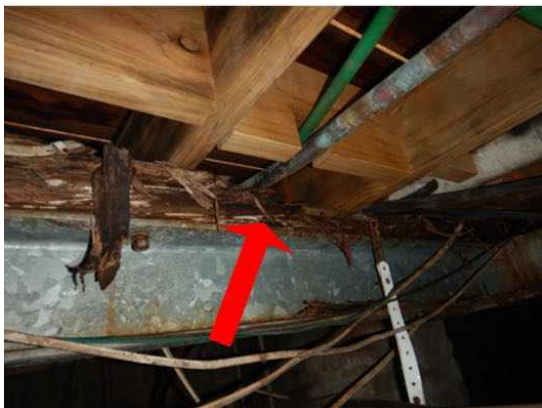
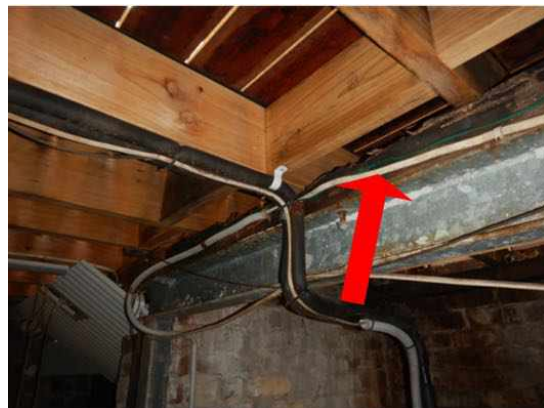
### Finding 7.01

Building:	Main Building
Location:	Deck
Finding:	Timber bearer with wood rot
Information:	A timber bearer supporting the deck structure was identified as being affected by significant wood rot. The deterioration is advanced and has reduced the structural capacity of the bearer. The affected bearer is located directly on top of a steel beam.

Wood rot of this nature is typically caused by prolonged moisture exposure and the timber that is affected being unsuitable for outdoor use.

It is recommended in the short term that a builder or carpenter be engaged to replace the affected bearer and inspect surrounding structural elements.

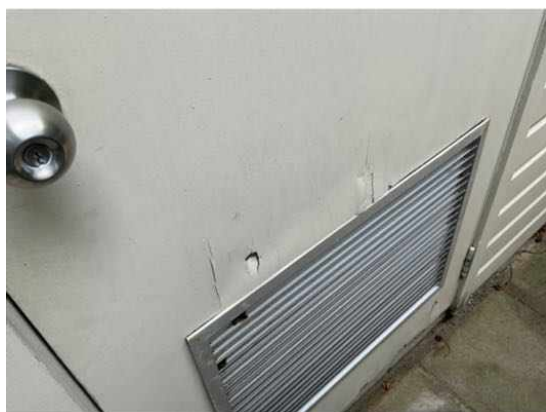
### Finding 7.02

Building:	Shed
Location:	Shed
Finding:	Door - Wood rot

**Information:** Wood rot was found to be affecting the door. Wood rot, also known as Fungal Decay, occurs when timbers and other cellulose building materials are exposed to damp conditions on an ongoing basis.

It is likely that this wood rot has developed as a result of frequent exposure to rain and other weather conditions. It is suspected that failure to maintain the timbers over a prolonged period has resulted in them deteriorating at an accelerated rate, increasing their susceptibility to the development of wood rot.

Early intervention and regular maintenance will prolong the useful life of these building elements.

Repair and/or replacement of affected timbers may be a necessary step in protecting surrounding building elements from such deterioration.

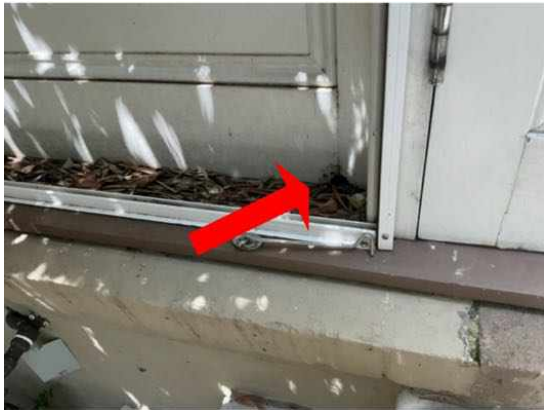
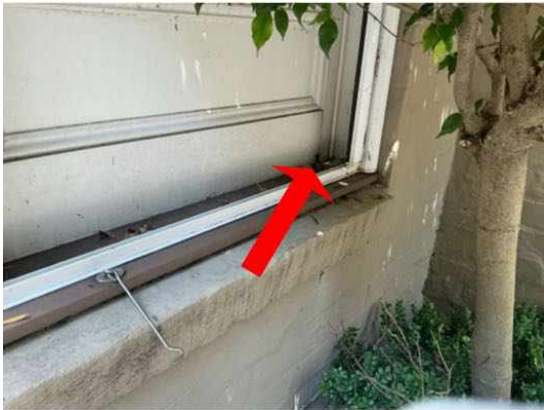
### Finding 7.03

**Building:** Main Building  
**Location:** Exterior walls - right side  
**Finding:** Windows & Doors - Wood rot  
**Information:** Wood rot was found to be affecting the windows & doors. Wood rot, also known as Fungal Decay, occurs when timbers and other cellulose building materials are exposed to damp conditions on an ongoing basis.

It is likely that this wood rot has developed as a result of frequent exposure to rain and other weather conditions. It is suspected that failure to maintain the timbers over a prolonged period has resulted in them deteriorating at an accelerated rate, increasing their susceptibility to the development of wood rot.

Repair and/or replacement of affected areas may be a necessary step in protecting surrounding building elements from such deterioration. Remedial works should be performed by a qualified carpenter or registered builder as soon as possible to prevent

any further damage.

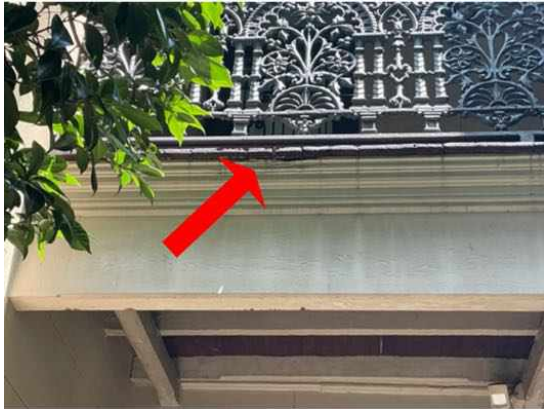
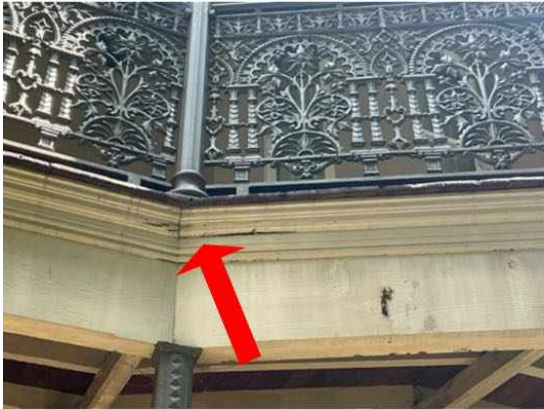
**Finding 7.04**

Building: Main Building  
Location: Balcony  
Finding: Wood Rot to Front Balcony Decorative Trims  
Information: Wood rot was identified to the decorative timber trims on the front balcony at the time of inspection. The deterioration appears consistent with prolonged exposure to moisture and weathering.

While the affected timbers are decorative in nature and do not appear to be structural at this stage, ongoing deterioration may lead to further decay and potential detachment if left unaddressed. This may also impact the overall appearance of the balcony.

It is recommended in the short to medium term that a carpenter be engaged to repair or replace the affected decorative trims. Any sources of moisture contributing to the wood rot should also be addressed to reduce the risk of recurrence.

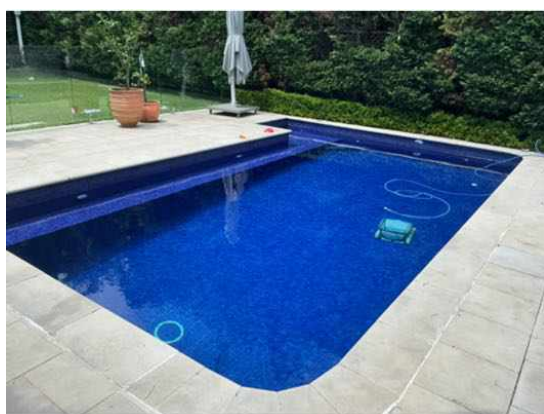
Building:	Main Building
Location:	Yard - Back
Finding:	Pool on property.
Information:	This property has a pool. Pools are not in the scope of inspection on building inspections as cannot be inspected sufficiently. Further Inspection by a pool specialist always recommended to determine the condition of the pool is advised to gain further insight.

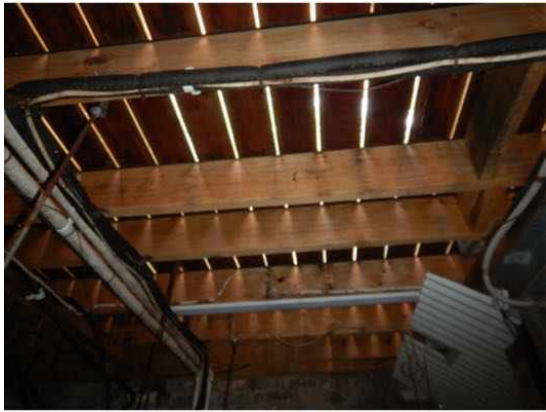
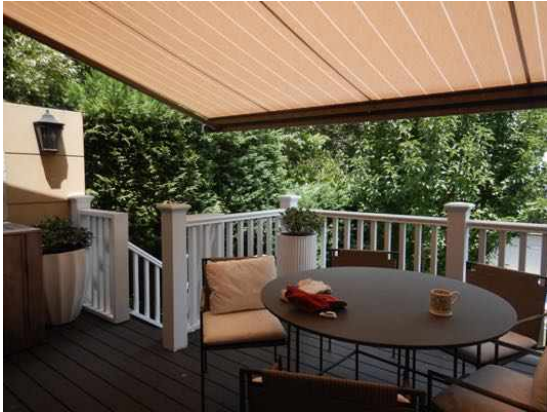
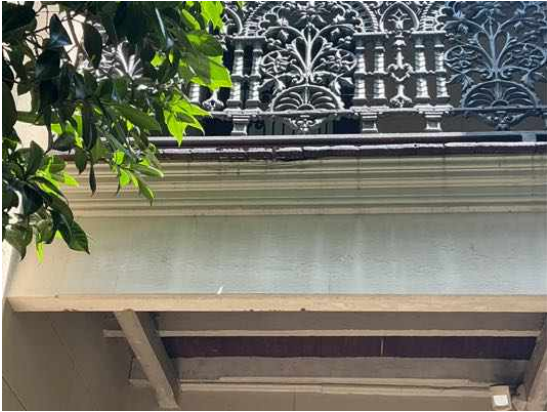
Building: Main Building  
 Location: Balconies & Decks  
 Finding: Note on Timber Balconies and Suspended Timber Structures  
 Information: The load capacity of timber balconies and other suspended external timber structures has not been verified as part of this inspection.

It is recommended that any suspended timber external structure be assessed and certified by a structural engineer to ensure it is not overloaded and remains safe for use.
