Building and Timber Pest Inspection Report

Inspection Date: Thu, 5 Mar 2026

Property Address: 155 Eglinton St, Kew VIC 3101, Australia

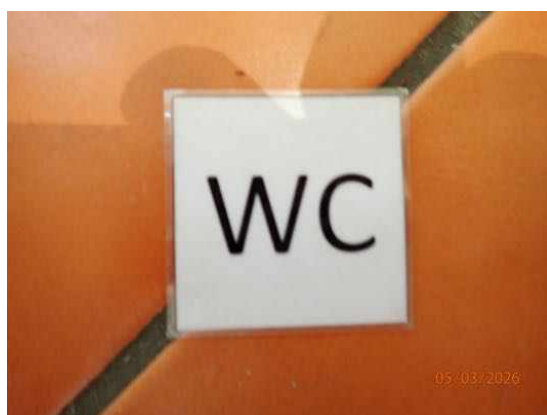
Building: Main Building
 Location: Bathroom & WC > Centre Left
 Finding: Toilet Seat - Loose
 Information: The toilet seat was found to be loose and relatively unstable at the time of inspection. It is suspected that this defect has developed due to general ageing of the toilet pan and associated materials. However, the loose fixing may also be a result of impact damage.

If left unmanaged, the toilet seat could deteriorate further, leading to greater

destabilisation and the potential for injury to people.

It is recommended the toilet seat be refixed by a licensed plumbing or qualified handyman immediately.

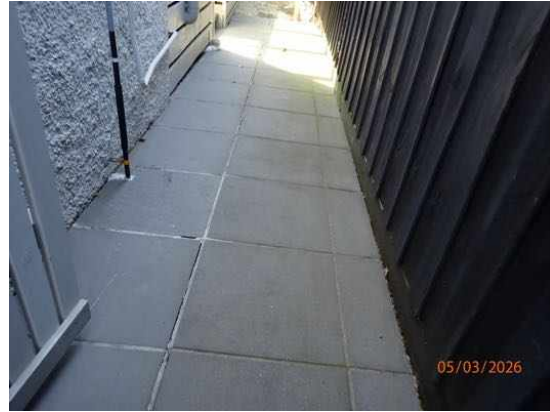
Where paving creates a trip hazard, personal injury may ensue if due caution is not taken by all persons within this area.

Re-paving of the area is required as soon as possible to remedy this situation. Further consultation with a specialist paving contractor is advised.

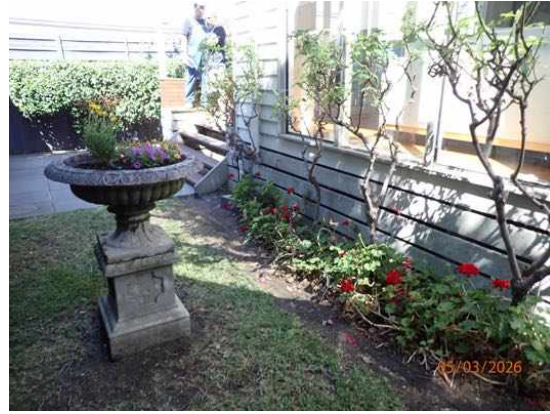
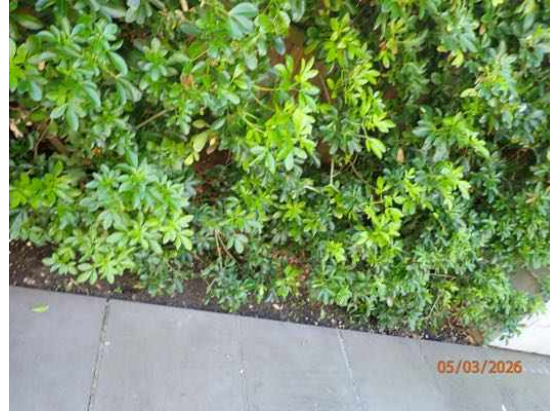
Building: Main Building
 Location: All External Areas
 Finding: Garden Beds - Conditions Conducive to Termites
 Information: Garden beds were found to be evident in the garden area. These garden beds can include untreated timber, and with a combination of moisture from watering hosing can make conditions conducive to termite activity and termite ingress.

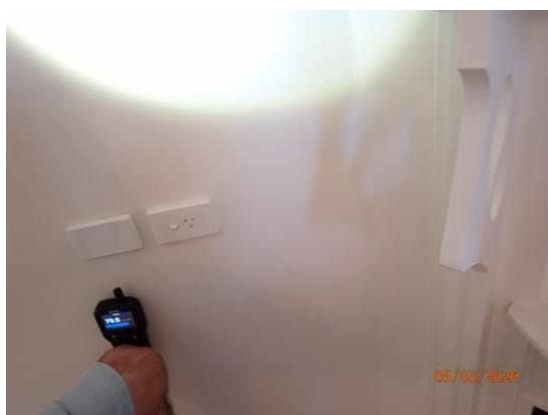
Finding 6.02

Building: Main Building
Location: Bedroom 4 > Centre Left
Finding: Excessive Moisture - Identified
Information: Excessive moisture can attract termites and produce conditions that promote fungal growth and wood decay.

Excessive moisture is generally caused by deteriorated or leaking plumbing pipes or excessive subfloor moisture to the subfloor where a qualified plumber or a mechanical ventilation specialist should be engaged to further inspect the property to identify the cause of the excessive moisture and carry out any necessary repairs.

This is advised to be carried out as soon as possible.

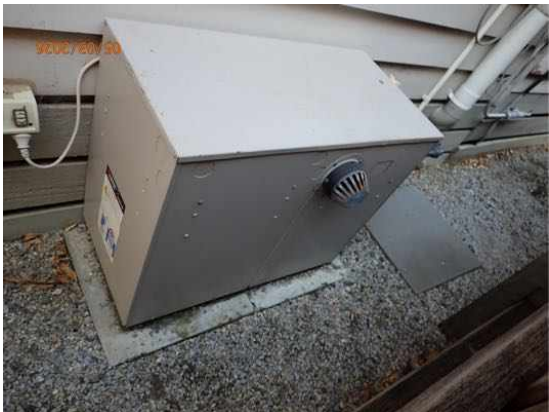
Finding 6.08

Building: Main Building
 Location: All External Areas
 Finding: Bridging or Obstruction - Air Conditioner, Hot Water & Storage
 Information: Bridging of termite barriers occurs when termites bridge (usually by building a mud

Where bridging has occurred full inspection is prevented and termites may enter a property in a concealed or undetectable manner.

Recommend moving obstructions away from the external walls for further and future inspections.
