Building and Timber Pest Inspection Report

Inspection Date: Tue, 24 Mar 2026

Property Address: 180 Lloyd St, Strathdale VIC 3550,
Australia

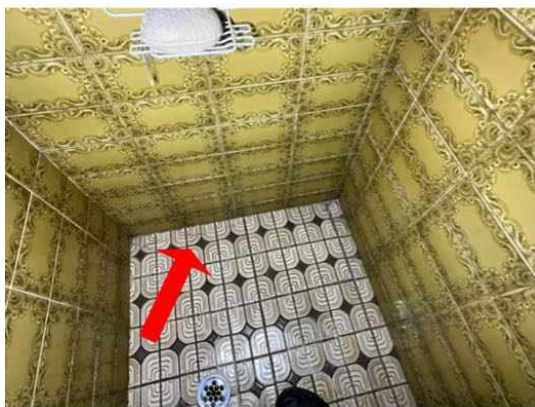
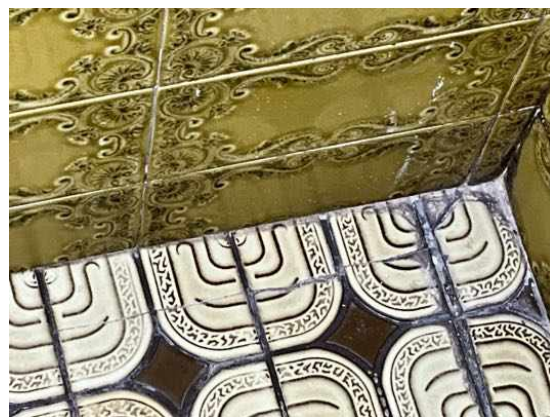
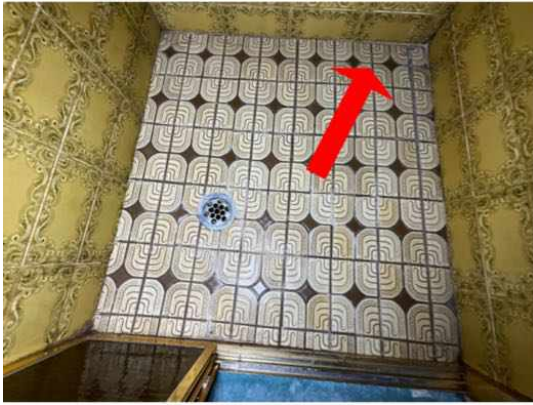
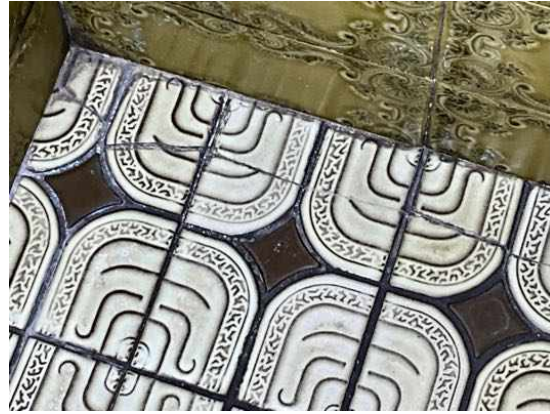
Finding 3.01

Finding: Cracked floor tiles

Information: Cracking in the floor tiles was evident in this area at the time of inspection. It is suspected that this cracking has occurred as a result of minor settlement or impact damage.

Cracked tiles throughout the household detract from the overall appearance of the affected areas however it is unlikely to create or lead to any secondary defects.

While not considered a matter of urgency, replacement of cracked floor tiles is recommended at the clients discretion. A tiling contractor may be appointed to perform these works. Where cracks become more numerous, contact a licensed building inspector for further investigation.

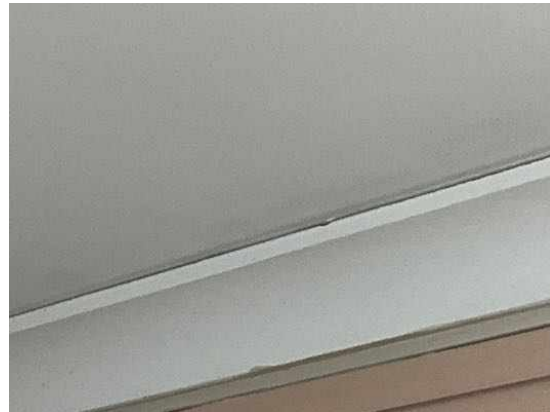
Finding 3.02

Building: Building 1
 Location: Bedroom - Master
 Finding: Cornice- sagging
 Information: The cornice in this area is sagging. This may be due to age or poor initial installation.

A plasterer or handyman should be contacted soon to restore the area and prevent further deterioration.

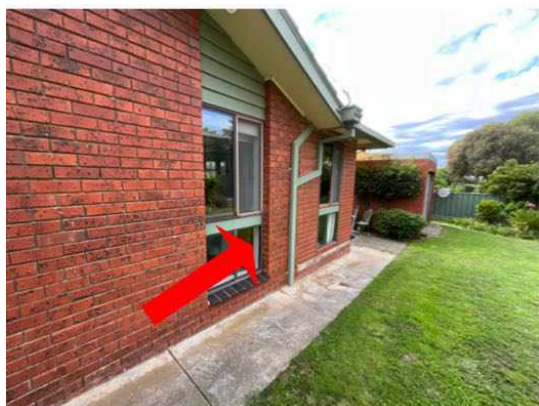
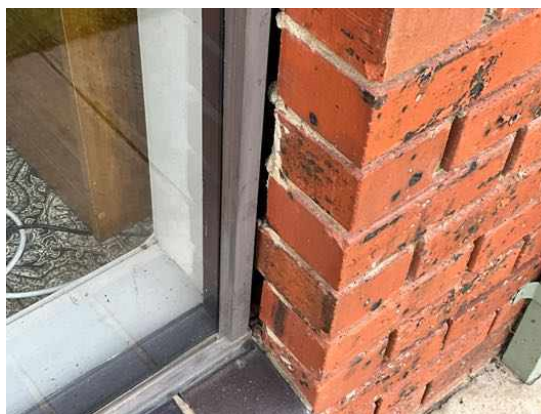
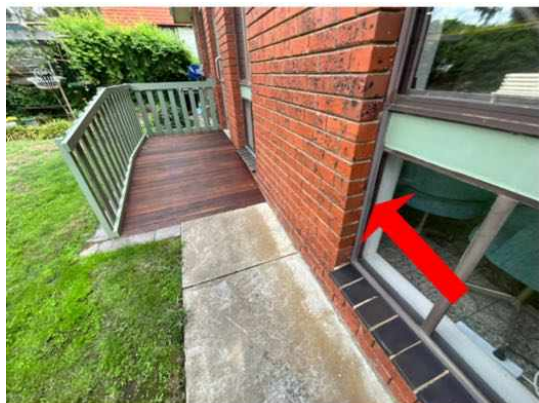
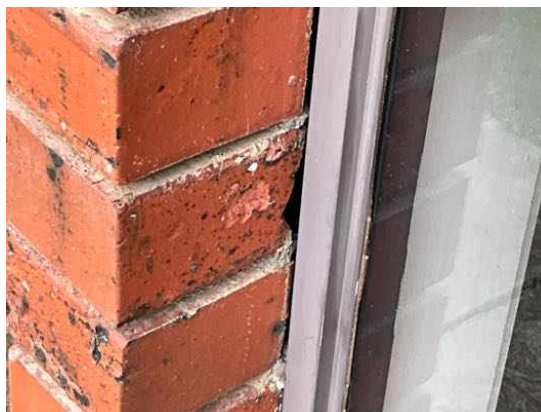
Finding 3.03

Building: Building 1
 Location: Living Room
 Finding: Inadequate sealant/caulking
 Information: This area has a lack of effective Sealant or Grout. This may be allowing the ingress of water to the structure.

The presence of water encourages Termite attack, Mould and Fungal Decay.

A Caulker or General Handy person must be contacted soon to effect repairs and prevent possible deterioration.

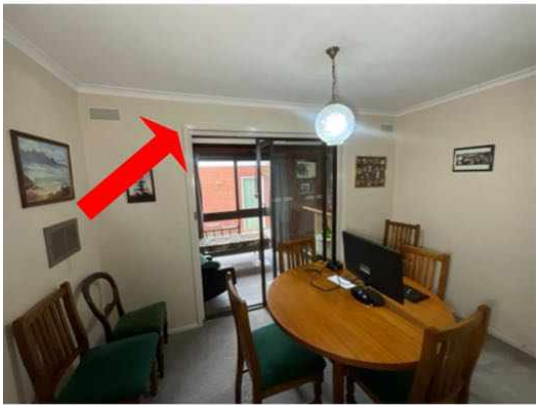
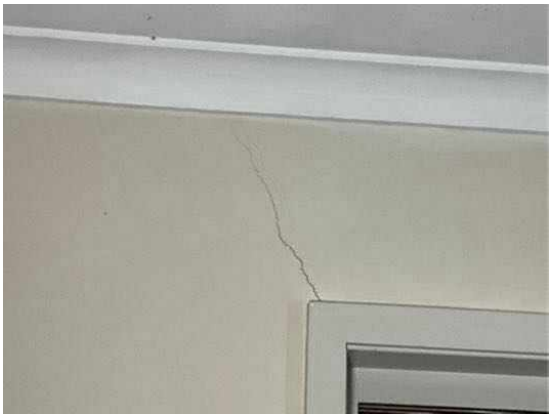
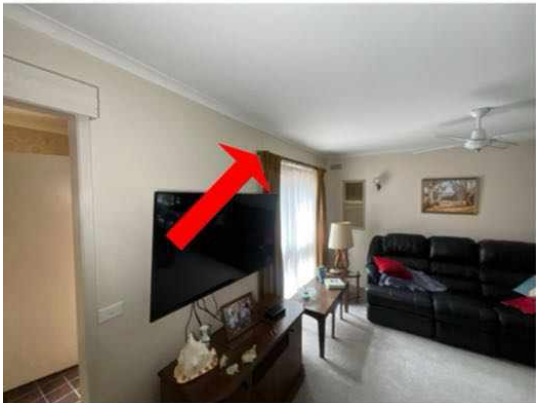
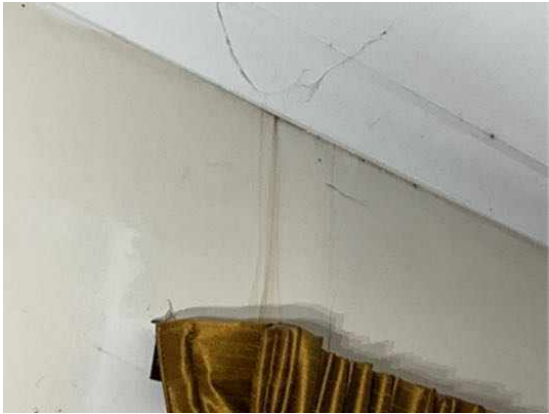
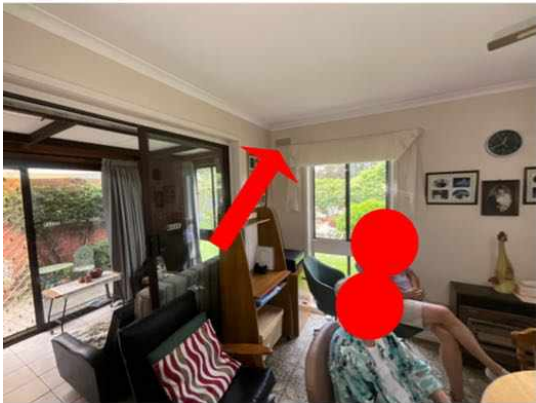
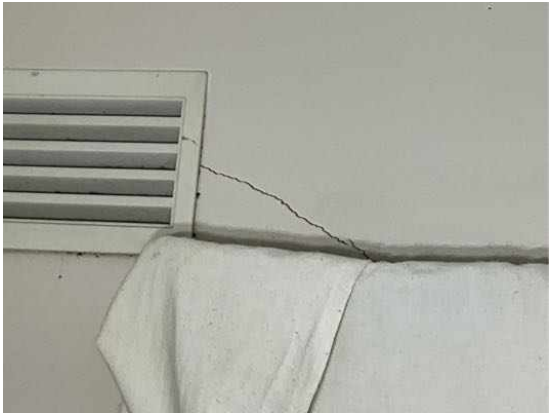
Finding 3.04

Building:	Building 1
Location:	Dining Room, lounge,
Finding:	Cracking - Damage Category 1 - Fine (up to 1mm)
Information:	Although fine cracks are quite noticeable, they are often only considered to be an appearance defect, and usually do not indicate any structural damage. Generally, the cause of a fine crack is indicative of a separation between building materials and finishes (e.g. paint, plaster, etc.) along joints.

Cracking of this nature can generally be repaired with minor sanding, filling and/or repainting. Such works should be performed by a qualified painter or a general handyman.

Monitoring of all cracking should be conducted frequently. Always contact a building inspector should cracks widen, lengthen, or become more numerous.

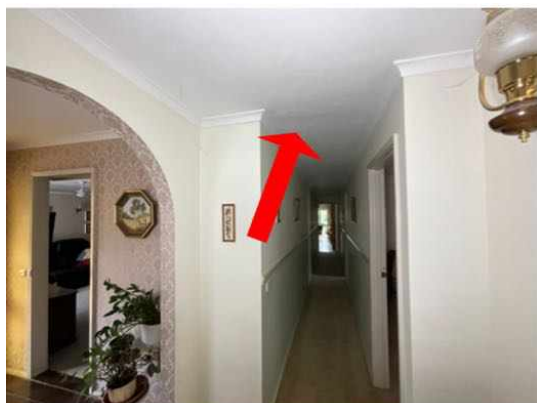
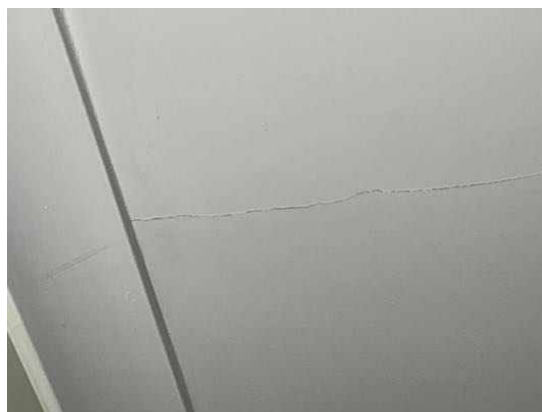
Finding 3.05

Building:	Building 1
Location:	Hall
Finding:	Cracking - Damage Category 1 - Fine (up to 1mm)
Information:	Although fine cracks are quite noticeable, they are often only considered to be an appearance defect, and usually do not indicate any structural damage. Generally, the cause of a fine crack is indicative of a separation between building materials and finishes (e.g. paint, plaster, etc.) along joins.

Cracking of this nature can generally be repaired with minor sanding, filling and/or repainting. Such works should be performed by a qualified painter or a general handyman.

Monitoring of all cracking should be conducted frequently. Always contact a building inspector should cracks widen, lengthen, or become more numerous.

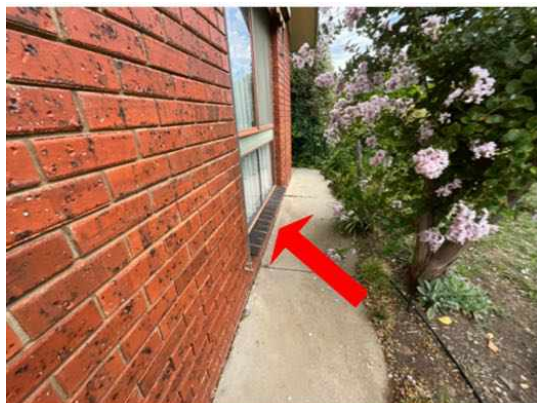
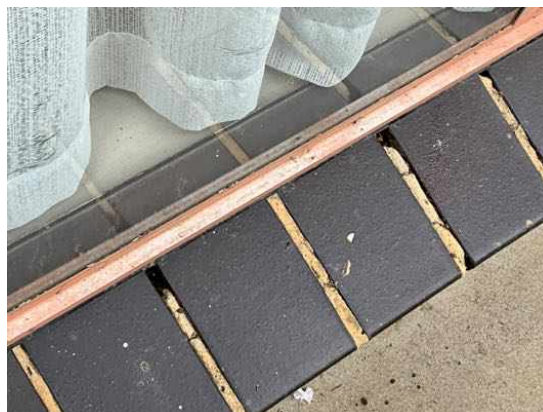
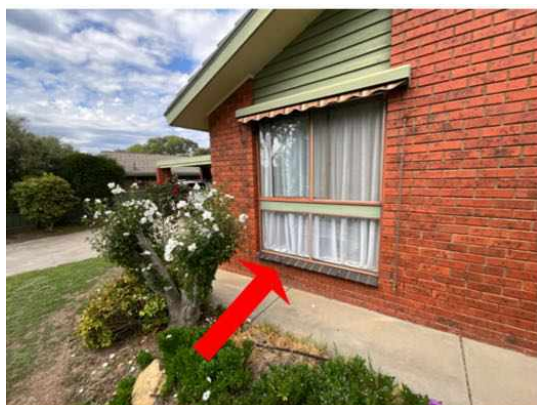
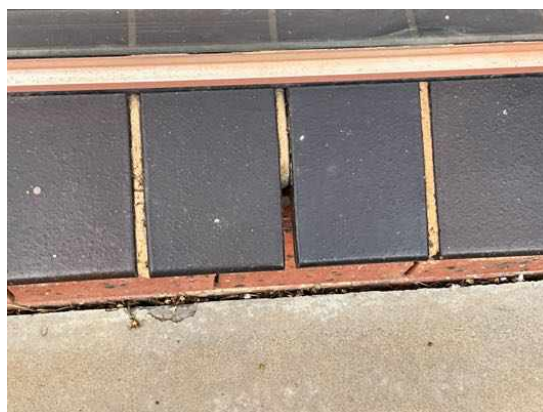
Finding 3.06

Building:	Building 1
Location:	Front windows
Finding:	Brickwork - Deteriorated mortar
Information:	Mortar, or 'bedding', is the material which fills joins and intersections between bricks in masonry walls and structures. Sections of mortar in this brickwork were identified as having deteriorated, which is generally expected for a property of this age and condition.

Mortar may deteriorate as a result of age of building materials, minor movement of bricks, or frequent exposure to weathering. Mortar should be replaced to ensure that bricks remain in their intended location and to prevent gaps, which would allow water or moisture ingress and secondary damage as a result.

Mortar deterioration can be addressed by a bricklayer where areas of deterioration are localised and easily accessible. Alternatively, appointment of a registered builder is advised, to repoint large areas of decaying mortar. Where secondary structural defects have become evident, consultation with a structural engineer may be required.

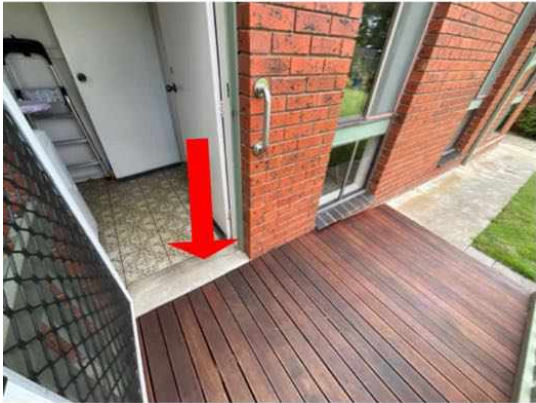
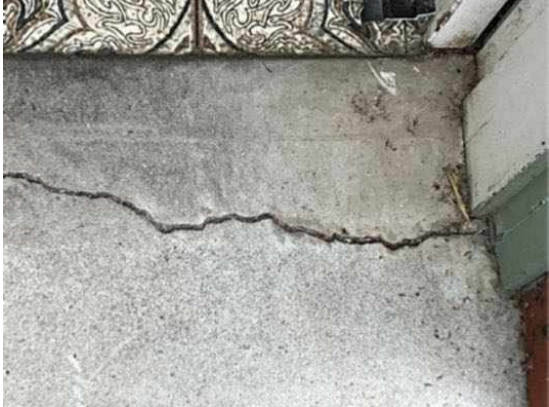
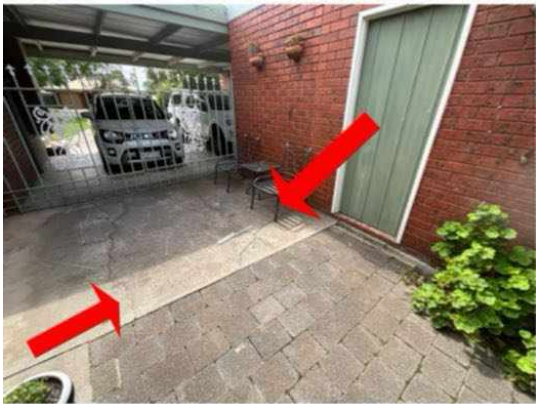
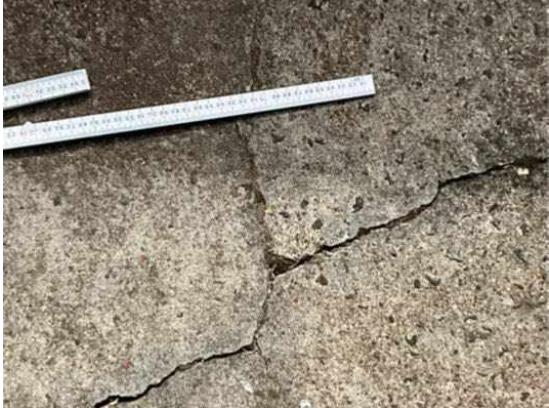
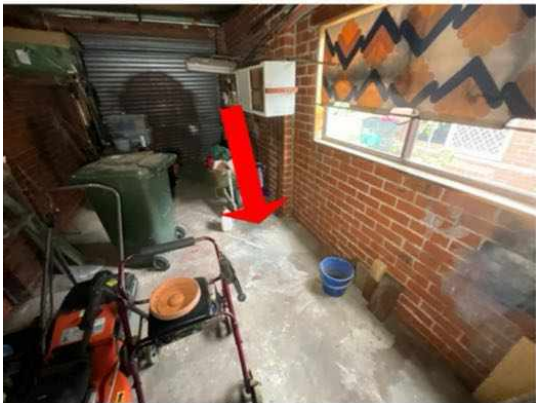
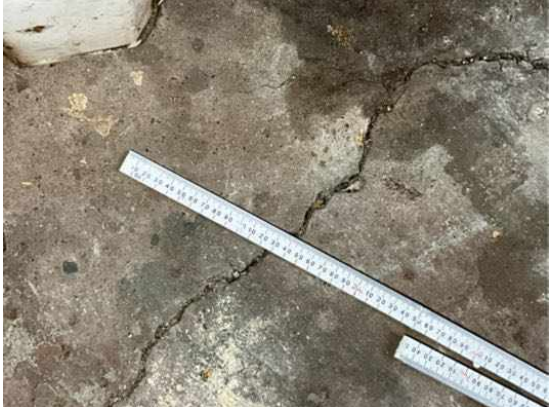
Finding 3.07

Building:	Building 1
Location:	Back door, yard, shed
Finding:	Cracking - External Concrete Paving Damage Category 3 - Wide Cracks (2mm - 4mm)
Information:	Wide cracks were identified in external concrete paving. Wide cracks are significant and are likely to lead to the development of safety hazards and secondary defects if left unmanaged.

General age and expected deterioration of the paved areas is a common cause of this type of cracking. However, expansion and contraction of the slab may also have occurred due to environmental factors. Such factors include variable moisture and weather conditions, the presence of trees and their roots having a settling or lifting affect on the soil, or the effect of load bearing, e.g. heavy vehicles over a sustained period of time.

Cracking to this degree may also be due to poor original installation of the concrete. Factors such as poor compaction of the sub surface and/or inadequate reinforcing of the slab may create cracking and other secondary defects. Wide cracks may also have a more significant structural cause, such as subsidence of soils.

Where the crack is located adjacent to structural elements of the building, the advice

of a Structural Engineer is advisable before undertaking repairs. Significant repair and likely replacement of the concrete paving is probable.

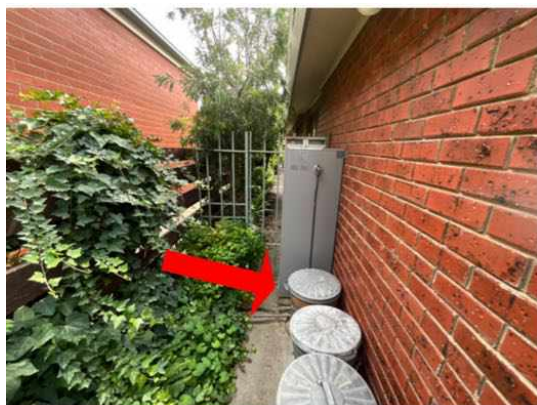
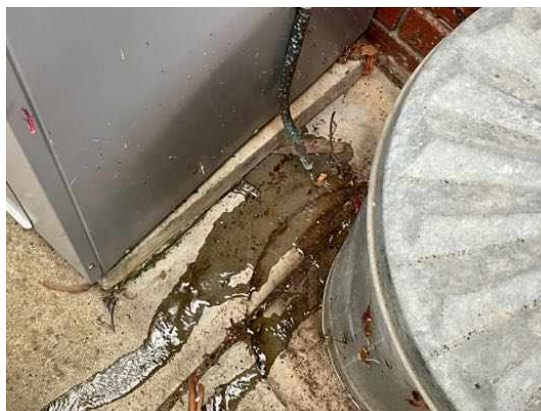
Finding 6.01

Building: Building 1
 Location: Yard - Side
 Finding: HWS Overflow - Not Connected
 Information: The Hot Water System (HWS) overflow was found to be disconnected from storm water drainage and is creating excessive moisture in the surrounding area.

These damp conditions can lead to secondary defects such as rot, rust or corrosion of associated building elements, the formation of fungal decay, or even the creation of potential slip hazards. When coupled with poor site drainage, pooling of water may also attract termite activity to this area.

It is highly recommended that a licensed plumber be appointed to connect the HWS overflow in order to prevent such an environment from being created. These minor works should be carried out as soon as possible.

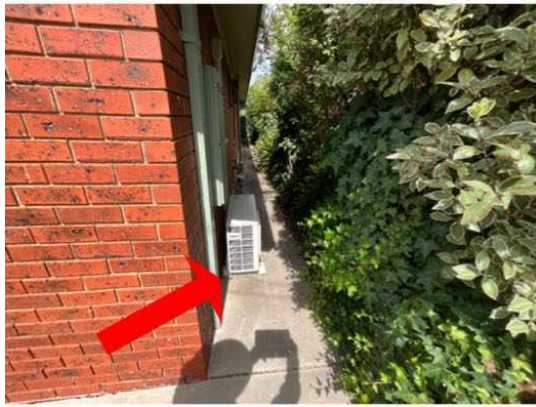
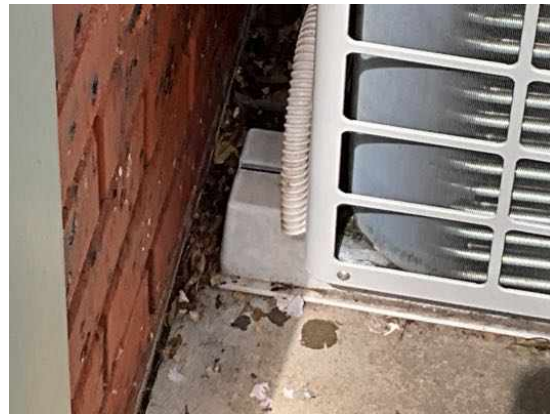
Finding 6.02

Building: Building 1
 Location: Yard - Side
 Finding: Air conditioner - Disconnected overflow
 Information: The Air Conditioner (A/C) overflow was found to be disconnected from storm water drainage and is creating excessive moisture in the surrounding area.

Such leaking creates an environment which is conducive to an array of defects, including water damage to associated building elements and the attraction of termite or timber pest infestation.

It is highly recommended that a licensed plumber be appointed to connect the A/C overflow in order to prevent such an environment from being created. These minor works should be carried out as soon as possible.

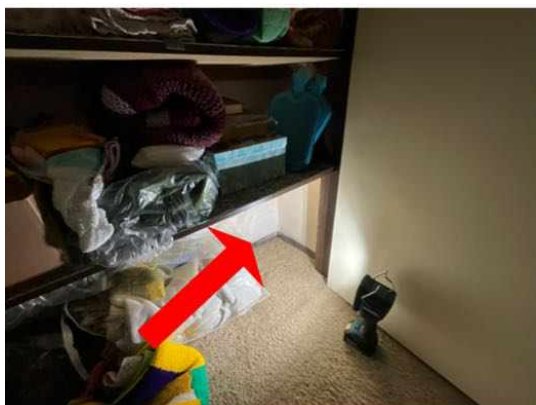
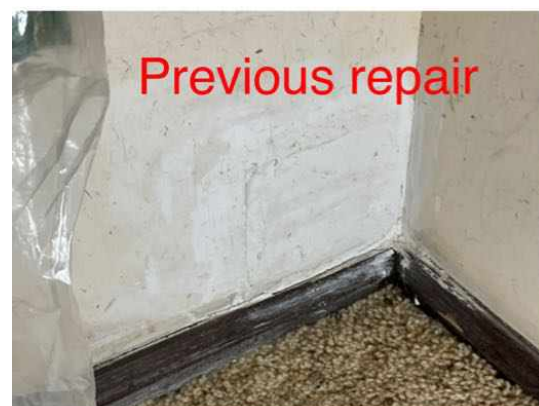
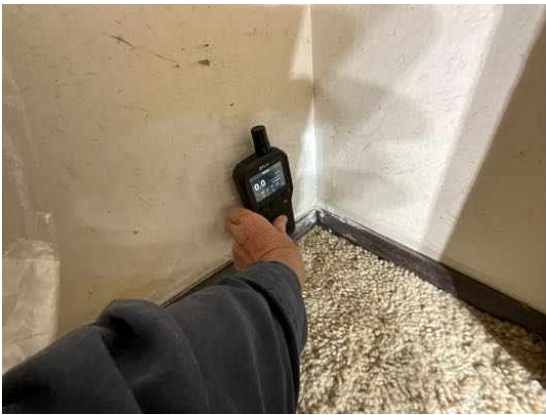
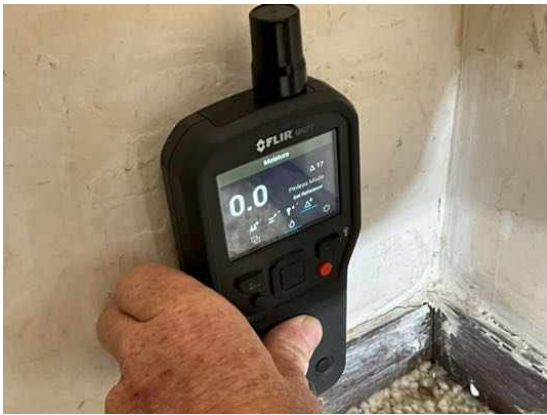
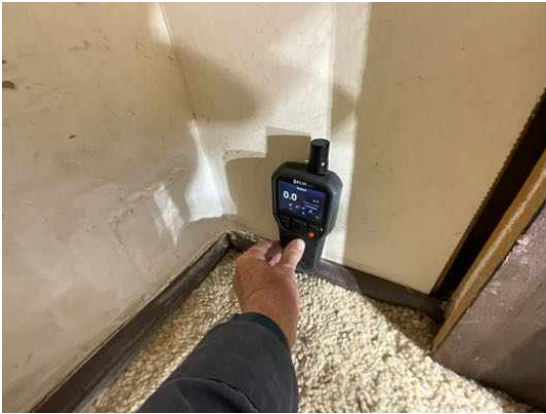
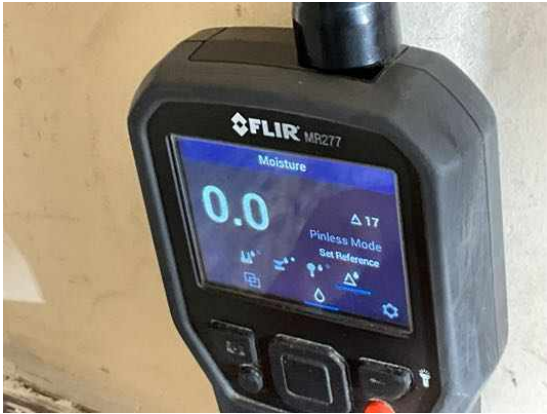
Finding 6.03

Building:	Building 1
Location:	Bathroom
Finding:	Shower damp- Monitor
Information:	Damp is evident to the lower 400mm of wall to the shower alcove.

This defect is quite common, and is suspected to have been caused by moisture permeating or leaching through the grouting and perhaps gaps in the sealant prior to repair.

Damp (or structural damp) refers to the presence of unwanted moisture in the structure of a building, either as the result of intrusion from outside, or condensation from within the structure. In the shower area, internal water leaks or other sources of excessive moisture are generally the cause of damp.

Monitoring the area is advised and if any visual signs of excessive moisture appear (peeling paint, mould) then consultation with a qualified plumber or bathroom specialist would be advised to identify the cause of damp and to perform remedial works as required.

Always ensure that sealant and grout is in good condition to prevent any moisture issues occurring in the future.

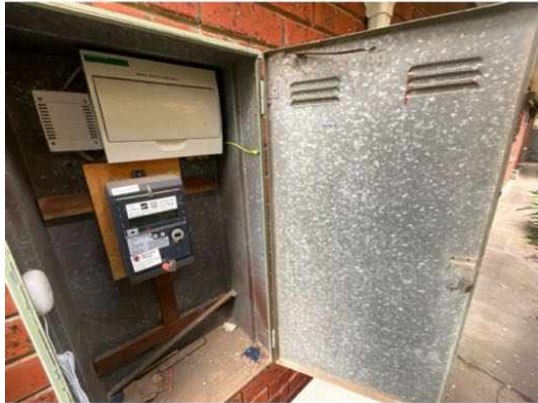
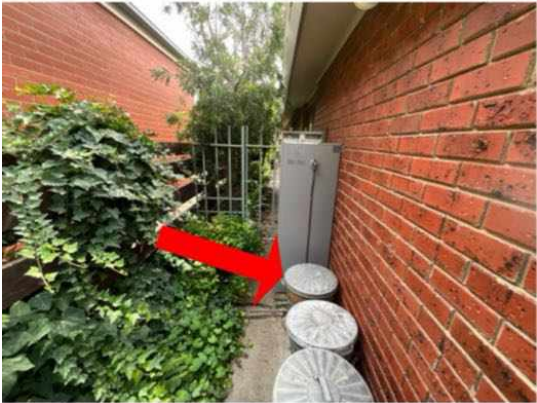
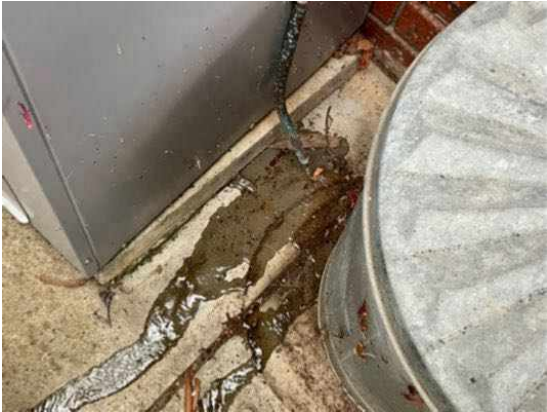
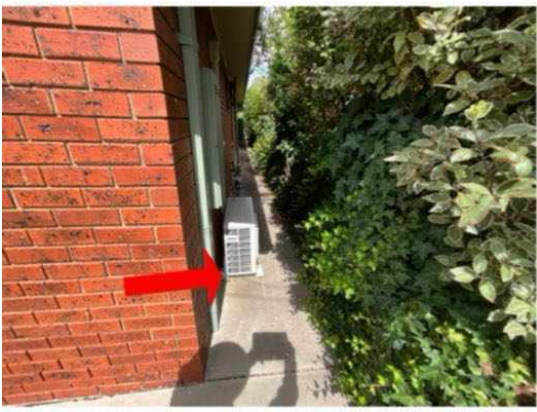
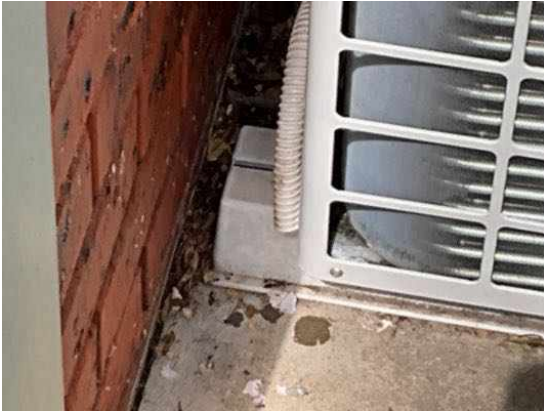
Finding 6.04

Building: Building 1
Location: All External Areas
Finding: Termite Management System - no evidence of a chemical installation
Information: The application of a post-construction chemical termite barrier is highly recommended for all properties, particularly if live termite activity has been found on the site previously. Such barriers are highly effective in preventing termite attack on any timber building elements throughout the property.

A durable notice should be placed in the switchboard unit to indicate current termite barriers. At the time of inspection, it appeared as though no termite management system has been installed, with no evidence to suggest preventative works taking place.

The client may consider gaining further advice from a pest controller as to the costs and procedures involved with this application. It is recommended that obtaining such advice be a short-term priority.

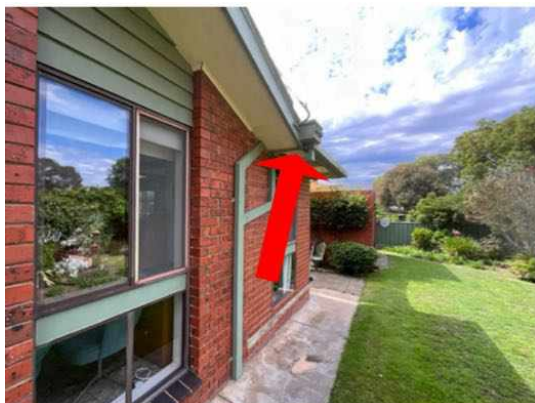
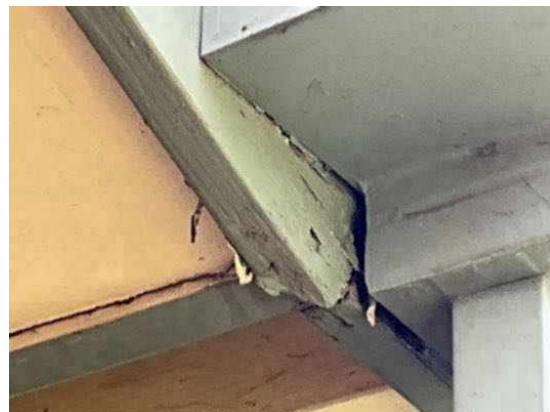
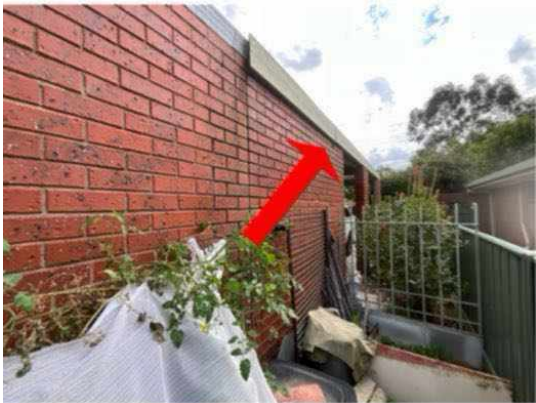
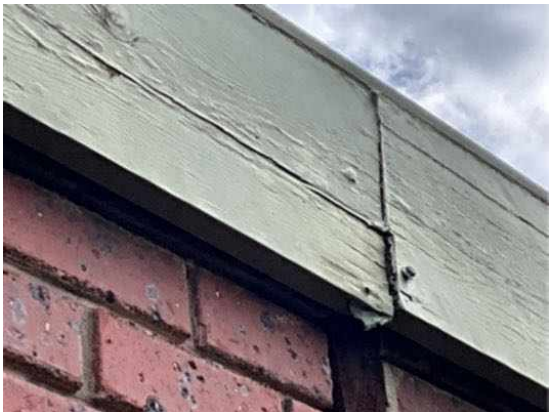
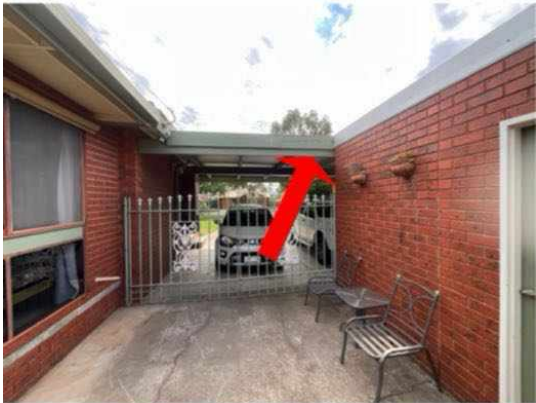
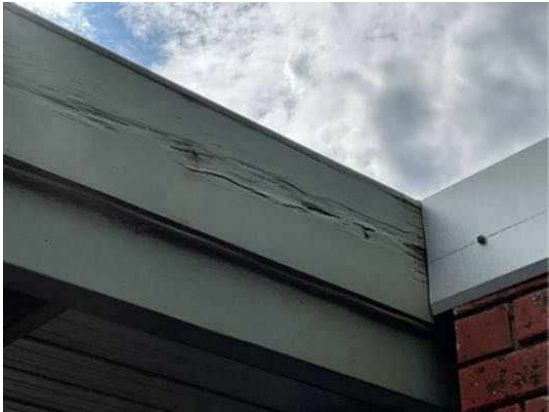
Finding 7.01

Building:	Building 1
Location:	Eaves, garage
Finding:	Fungal decay - present (localised)
Information:	Fungal decay also known as wood decay or wood rot generally refers to the deterioration of timber elements when in contact with excessive levels of moisture for a prolonged period of time.

The development of fungal decay is accelerated by temperatures in the range of 5degreeC to 40degreeC as well as the presence of oxygen. Generally fungal decay develops on timber elements that are in use in an external environment which are exposed to rain penetration.

In this case although the affected timber element is in a decaying state the extent of any visible damage appears to be localised to a specific area and is yet to spread to other parts of the building element or affect adjoining structures. The fungal decay is therefore likely to be of a relatively superficial nature with minimal impact on the structural integrity or tensile strength of the timber element.

The fungal decay in the various external timber areas is notable. A carpenter should be contacted soon to restore the areas and prevent further deterioration.

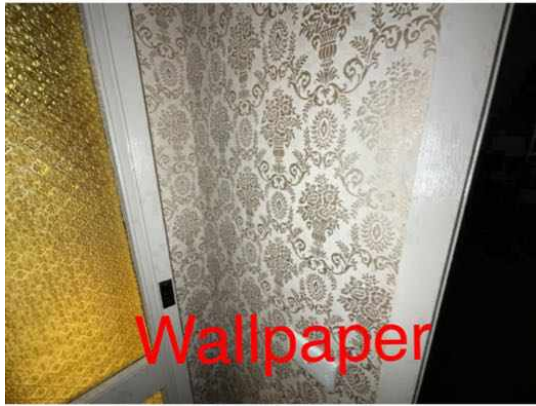
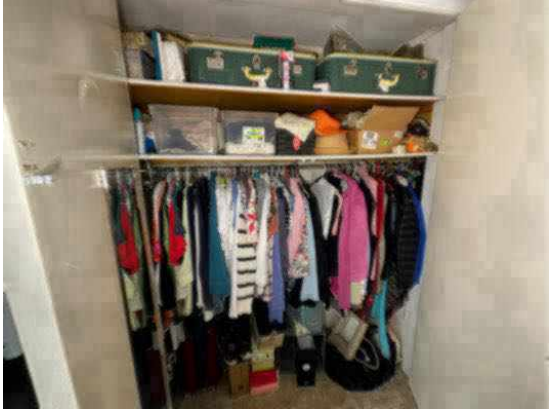
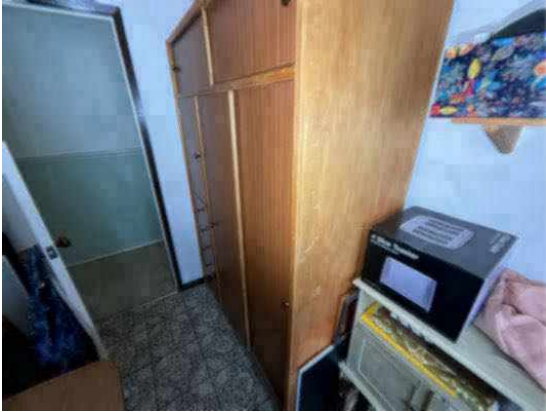
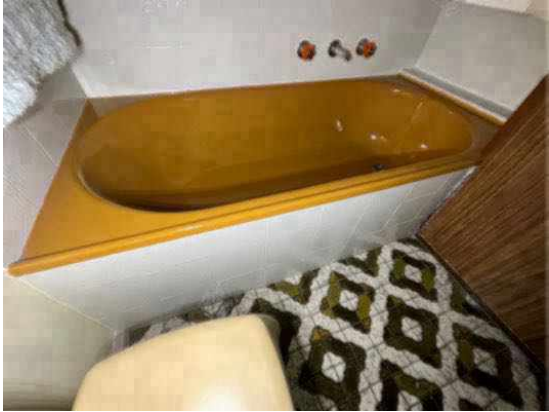
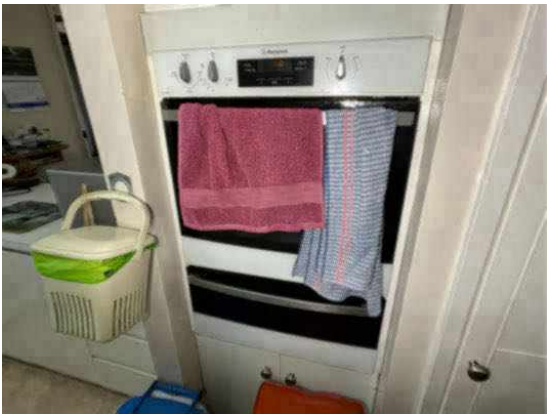
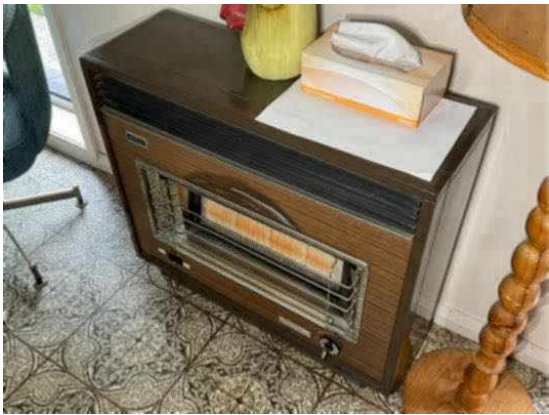
Noted Item

Building: Building 1
Location: All Areas
Finding: Additional Photos - Obstructions and Limitations
Information: These photographs are an indication of the obstructions and limitations which impeded full inspection of the property at the time of inspection. These obstructions can hide an array of defects and should be removed to allow full inspection to be carried out. A re-inspection is recommended once the areas are made accessible.
