## Building Inspection Report

Inspection Date: Fri, 20 Feb 2026

Property Address: 5/10-14 Rodd St, Dandenong VIC 3175,  
Australia

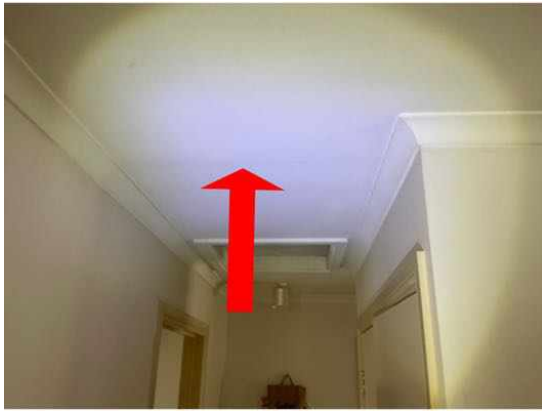
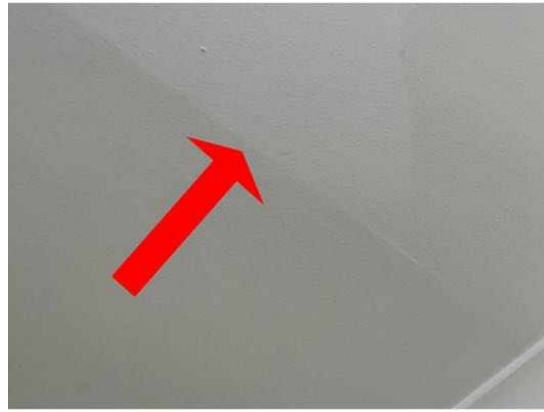
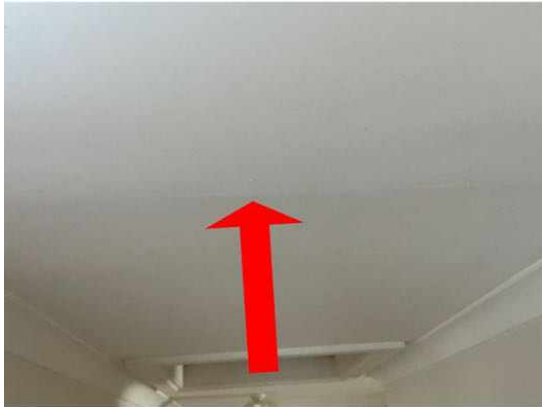
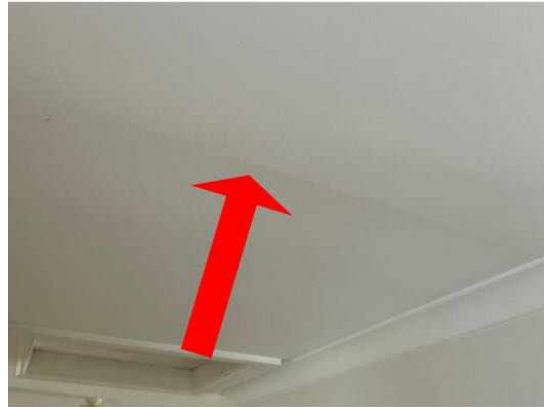
#### Defects 3.01

Building: Main Building  
Location: Hallway  
Finding: Cracking - Damage Category 2 - Noticeable (up to 5mm)  
Information: A Noticeable crack to the ceiling in the hallway next to the ceiling manhole was identified. Noticeable cracks are a common occurrence as a result of many primary defects. Such causes may include age, general wear and tear, expected building movement, general expansion/contraction of building materials in different weather conditions, and/or minor failings in the installation or application of building materials.

Noticeable cracks may result in minor sticking or jamming of associated doors and windows, which require easement. However, noticeable cracks are easily filled and repaired. A plasterer can be consulted to install an expansion joint at this point to allow for this movement during different weather conditions.

Monitoring of all cracking should be conducted frequently. Always contact a building inspector should cracks widen, lengthen, or become more numerous. Additionally, your building inspector should also be contacted if associated building elements such as doors and windows become more difficult to operate over time.

Relevant tradespeople, such as carpenters, painters and plasterers, should be appointed to perform remedial works, as deemed necessary.

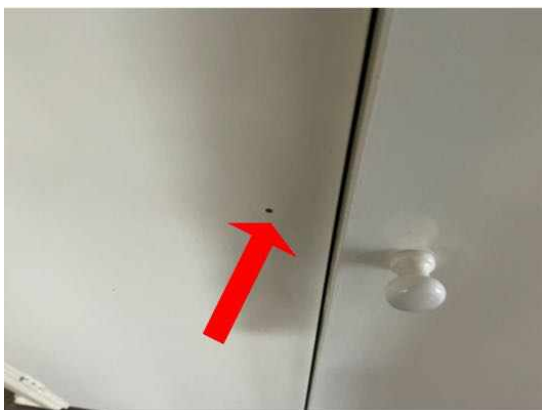
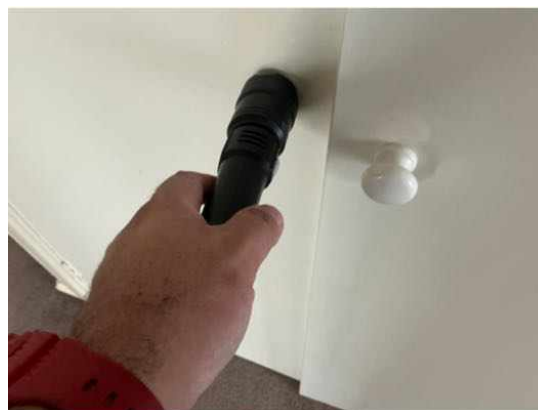
### Defects 3.02

Building: Main Building  
Location: Linen Cupboard  
Finding: Missing Linen Cupboard Door Handle  
Information:

The left-side door handle to the linen cupboard is missing at the time of inspection.

This condition restricts proper operation of the cupboard door and may cause inconvenience during regular use, as well as potential damage to the door surface from repeated manual pulling.

It is recommended that a suitable replacement handle be installed by a qualified handyman or carpenter to restore full functionality and prevent further wear to the door.

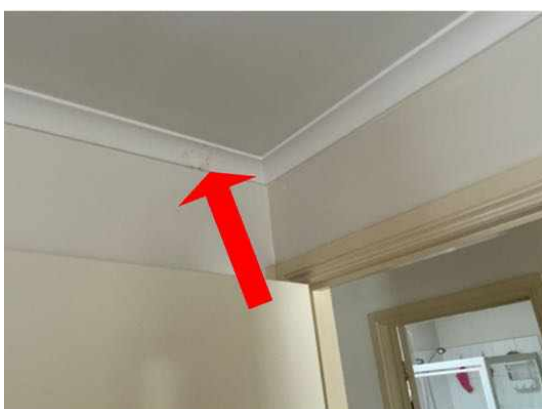
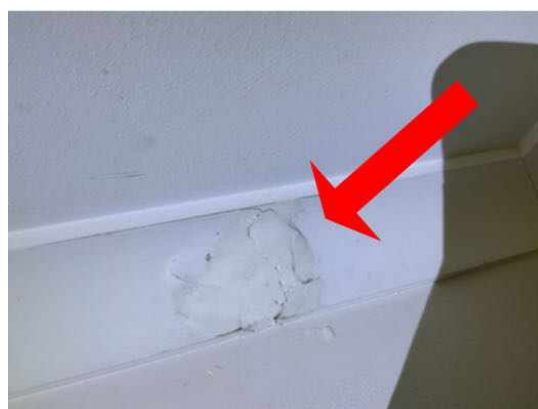
### Defects 3.03

Building: Main Building  
 Location: Living Room  
 Finding: A Poor Cornice Repair Finish – Living Room  
 Information:

The cornice in the living room has been previously repaired; however, the patchwork is of a poor and non-professional finish, with visible inconsistencies in alignment and surface smoothness.

This condition detracts from the overall finish quality of the area and may indicate inadequate workmanship, which can lead to further cracking or deterioration over time.

It is recommended that a qualified plasterer remove the defective patched sections and carry out proper reinstatement of the cornice, ensuring a smooth, consistent finish that matches the surrounding surfaces.

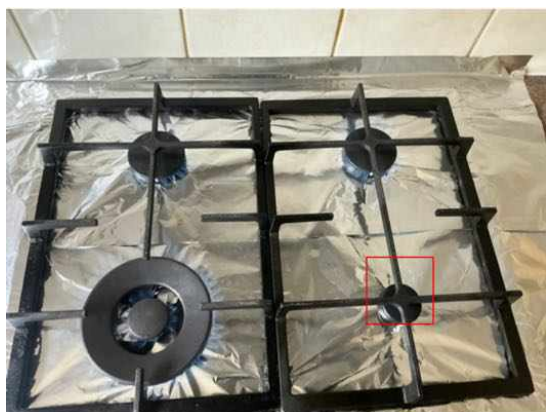
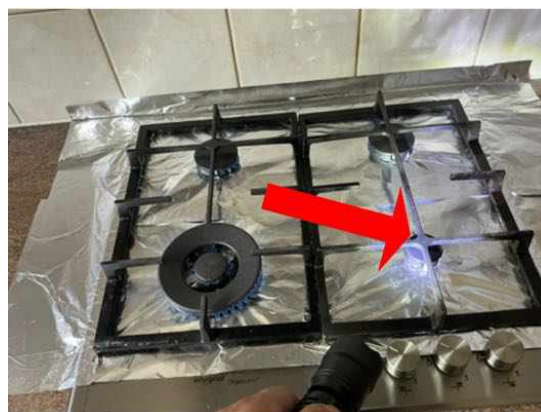
### Defects 3.04

Building: Main Building  
 Location: Kitchen  
 Finding: Non-Operational Stove Burner  
 Information:

One of the stove burners was not operational at the time of inspection.

This condition limits the functionality of the appliance and may indicate a fault with the ignition system, gas supply (if applicable), or internal electrical components.

It is recommended that a qualified appliance technician inspect, diagnose, and repair the faulty burner to restore full functionality and ensure safe operation.

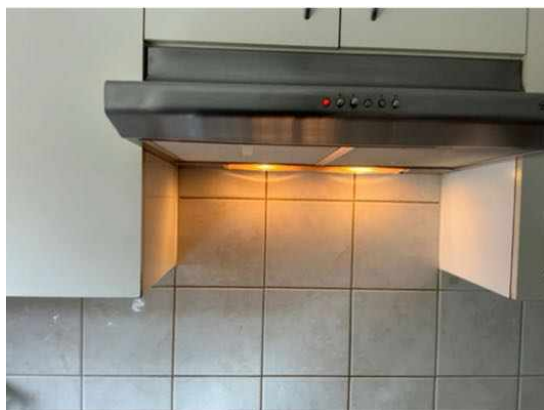
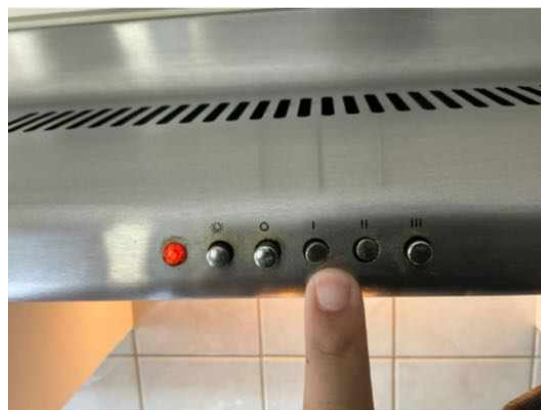
### Defects 3.05

Building: Main Building  
Location: Kitchen  
Finding: Range Hood Control Buttons Partially Non-Functional  
Information:

This condition indicates a fault within the control interface or internal switch mechanism, which may lead to limited functionality and potential further failure of the unit over time.

It is recommended that a licensed electrician or qualified appliance technician inspect the range hood control system and repair or replace the faulty buttons or control panel to restore full and reliable operation.

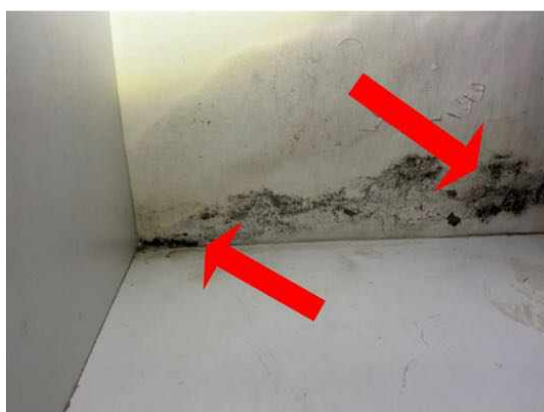
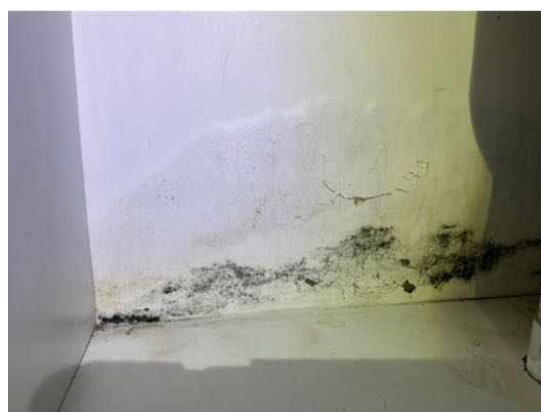
### Defects 3.06

Building:	Main Building
Location:	Kitchen
Finding:	Evidence of Mould Within Kitchen Cabinetry
Information:	Evidence of mould was identified within the kitchen cabinetry at the time of inspection. The staining and growth appear consistent with historic moisture exposure, likely from a previous leak; however, no active leak or elevated moisture readings were detected at the time of inspection.

The presence of mould indicates prior moisture ingress and may pose health concerns if not properly addressed. Residual contamination can persist within cabinetry materials even after the original moisture source has been resolved.

It is recommended that a qualified mould remediation specialist be engaged to assess the extent of contamination and carry out appropriate treatment and cleaning of the affected areas. Further investigation may be required if any concealed moisture sources are suspected.

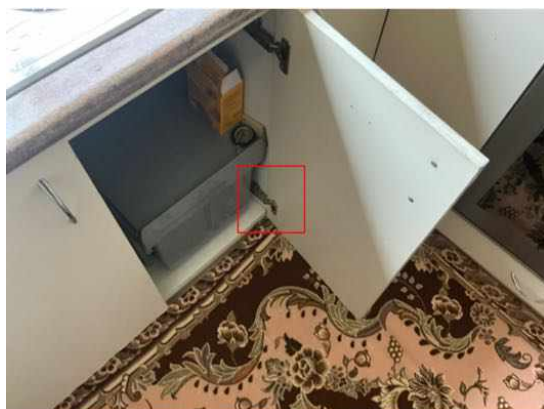
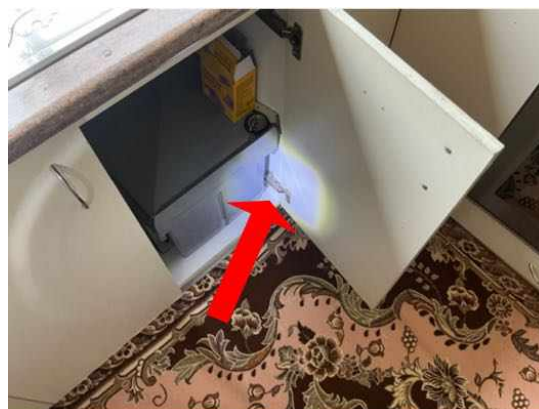
### Defects 3.07

Building:	Main Building
Location:	Kitchen

Finding: Loose kitchen Cupboard hinge – Hinge Adjustment Required  
 Information: The kitchen cupboard door was found to be loose and shaky due to a hinge that requires tightening. If left unaddressed, continued use may cause further wear or damage to the cabinet or hinge fittings.

It is recommended that the hinge be tightened or adjusted to restore proper function and prevent any long-term damage. If the hardware is worn or damaged, replacement may be necessary.

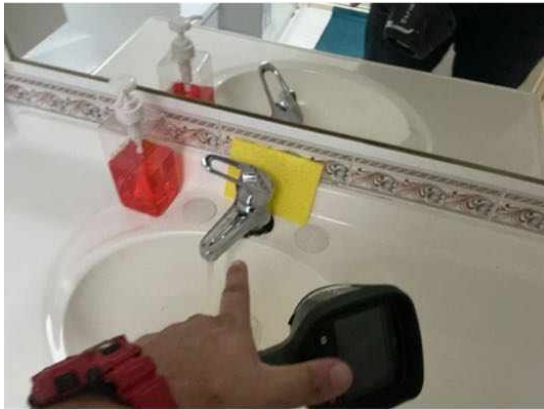
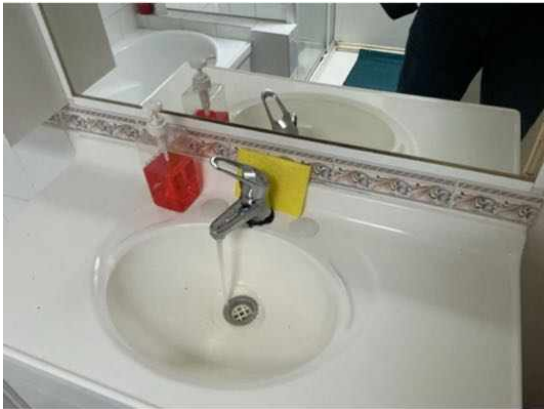
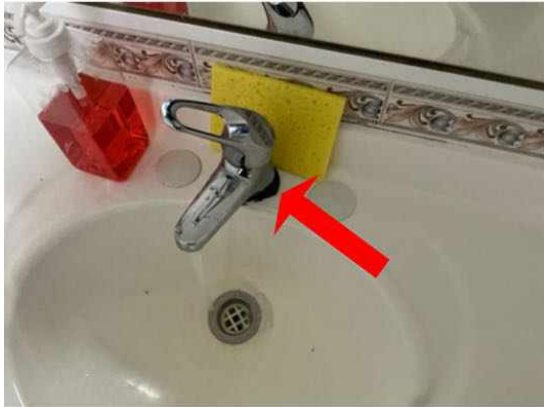
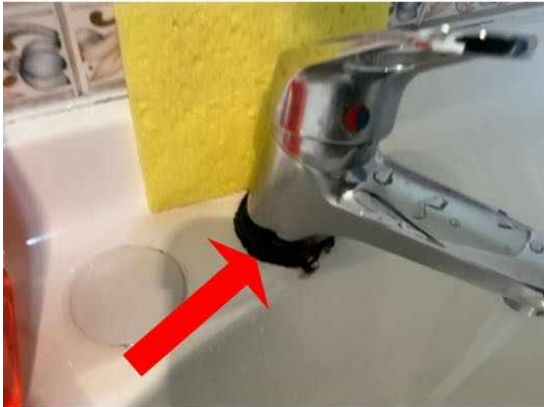
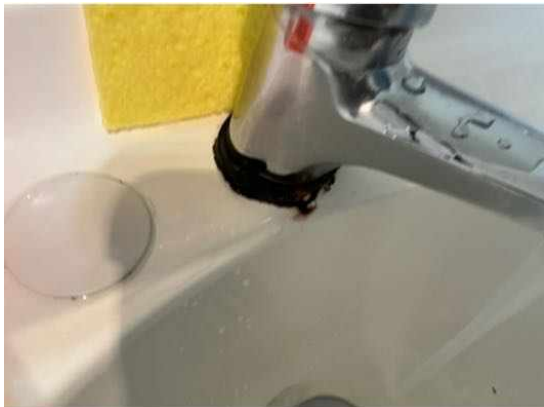
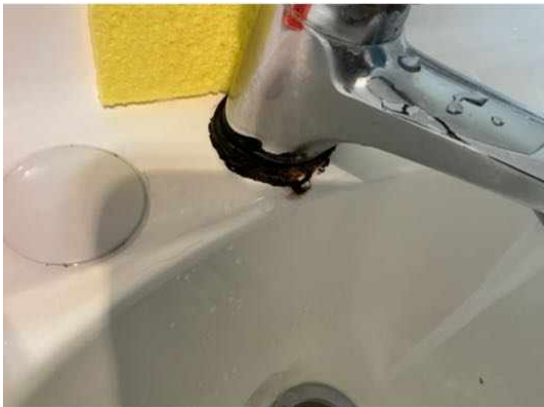
### Defects 3.08

Building: Main Building  
 Location: Bathroom  
 Finding: Loose Bathroom Basin Tap with Water Hammer and Suspected Mould  
 Information:

The bathroom basin tap was observed to be loose and not securely fixed to the basin, with noticeable movement during operation. Water hammer was also identified when the tap was used, and there is visible surface discolouration around the base of the tap consistent with possible mould growth.

This condition may indicate underlying installation defects or wear, and the presence of water hammer can lead to stress on pipework and fittings over time. The suspected mould suggests prior or ongoing minor moisture accumulation, which may contribute to deterioration of surrounding materials if not addressed.

It is recommended that a licensed plumber inspect the tap assembly, secure or replace the tap fixture as required, and investigate the cause of the water hammer. The affected area around the tap should also be cleaned and treated appropriately, with further assessment carried out if mould contamination is confirmed.

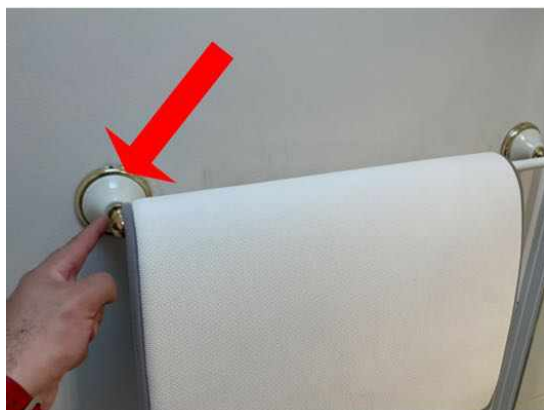
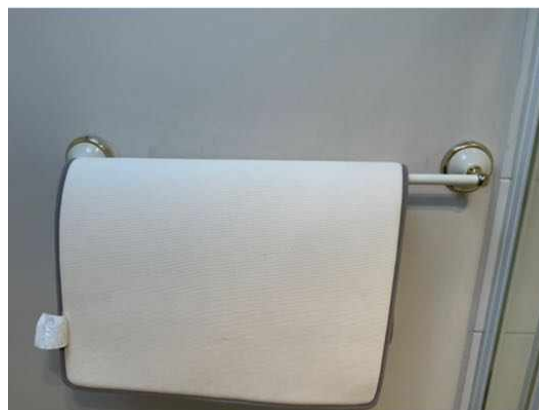
Defects 3.09

Building:	Main Building
Location:	Bathroom
Finding:	Towel rail - loose
Information:	The towel rail was found to be loose at the time of inspection. While not a major operational defect, function can deteriorate if the problem is left unmanaged.

It is advised that the homeowner performs remedial works to re-attach the towel rail to its original fixing. A general handyman may be required to perform these works.

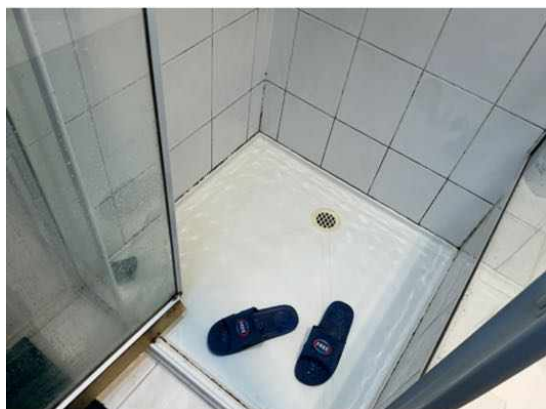
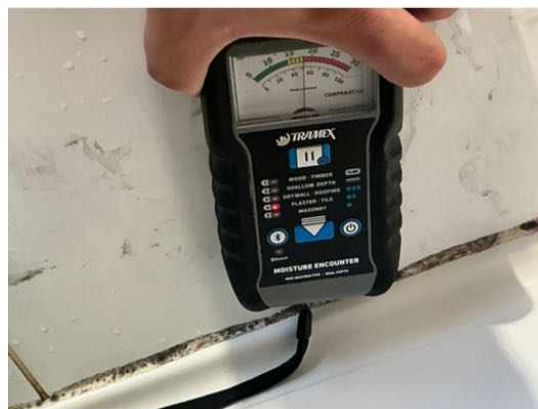
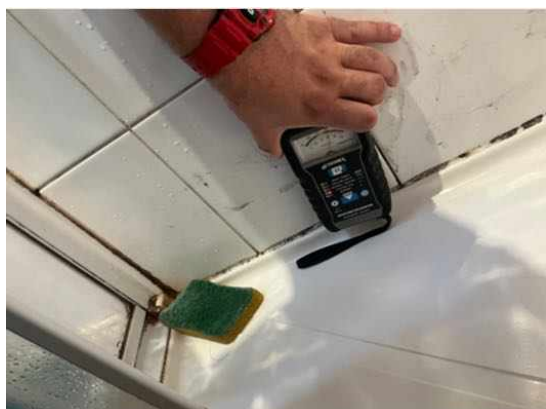
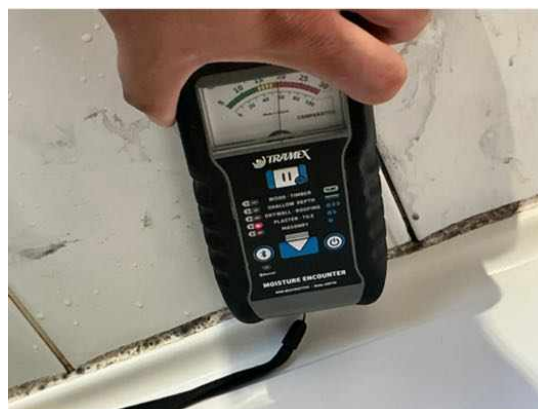
### Defects 3.10

Building:	Main Building
Location:	Bathroom
Finding:	Shower - Damp
Information:	Damp is evident to the lower 300mm of wall to the shower alcove. This defect is quite common, and is suspected to have been caused by moisture permeating through the grouting in this area, which shows evidence of deterioration. Leaking pipes within the adjoining wall is also a possible cause.

Damp (or structural damp) refers to the presence of unwanted moisture in the structure of a building, either as the result of intrusion from outside, or condensation from within the structure. In the shower area, internal water leaks or other sources of excessive moisture are generally the cause of damp.

Unmanaged damp in the shower recess is likely to facilitate the formation and development of mould and fungi growth, decaying associated building materials and compromising their structural integrity. It is important to address damp conditions, as the World Health Organisation notes that excess moisture leads - on almost all indoor materials - to growth of microbes such as moulds, fungi and bacteria, which subsequently emit spores and other matter into the indoor air. Exposure to these contaminants is associated with a wide range of respiratory and other health-related problems.

identify the cause of damp and to perform remedial works as required. Where excessive mould growth is present, further inspection by a specialist environmental health inspector should also be considered.

Always ensure that sealant and grout is in good condition to prevent any moisture issues occurring in the future.

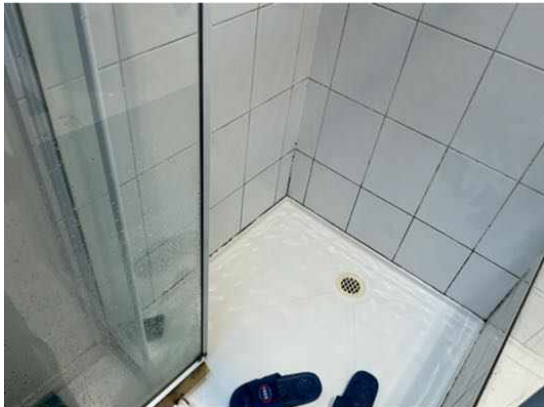
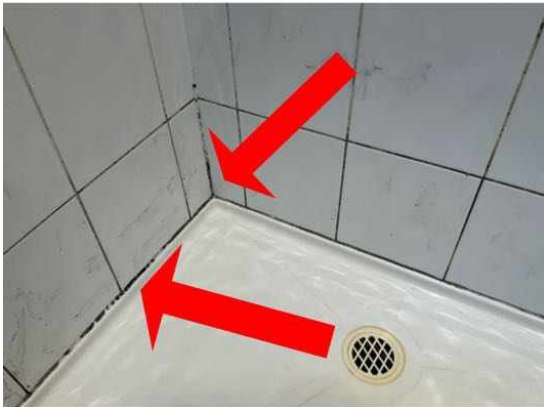
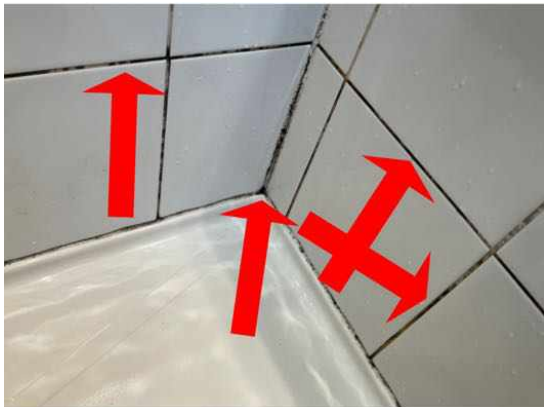
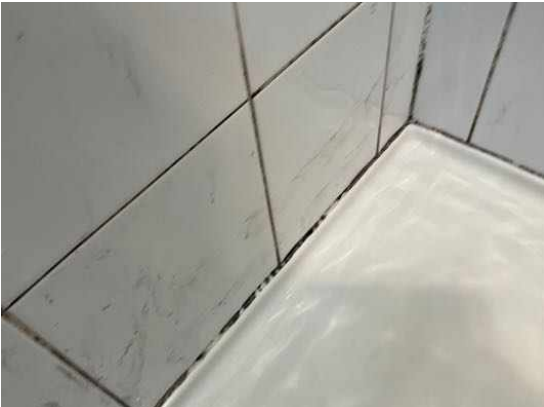
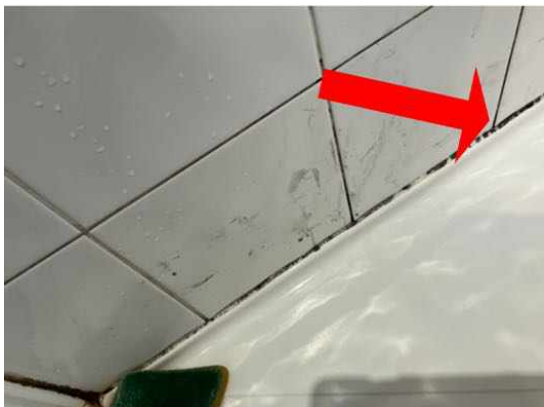
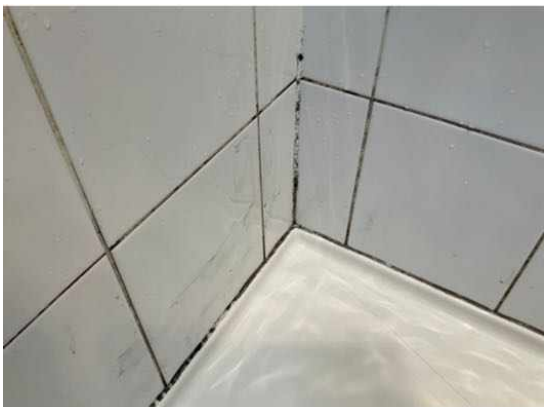
### Defects 3.11

Building:	Main Building
Location:	Bathroom
Finding:	Sealant and grouting - Deteriorated
Information:	It was noted on inspection that sealant or grout is degraded to the tiled shower alcove and or other areas of the bathroom.

Different materials and floor areas move at different rates, generally causing cracking to grout or sealant at this point. A flexible sealant is required to allow for expected expansion and contraction, while keeping the joint water tight and protective of all associated building materials.

There appears to be excessive mould to the sealant and grout which will likely require scraping out and replacement.

any subsequent water damage that is likely to occur. Regular maintenance and replacement of damaged or missing or damaged sealant and grout is highly recommended to the wet areas, as this is a regular wear and tear defect. Sealant and grouting in areas that come into regular contact with water should be maintained for the long term care of your property.

A sealant specialist or tiling contractor should be appointed to complete these works as soon as possible

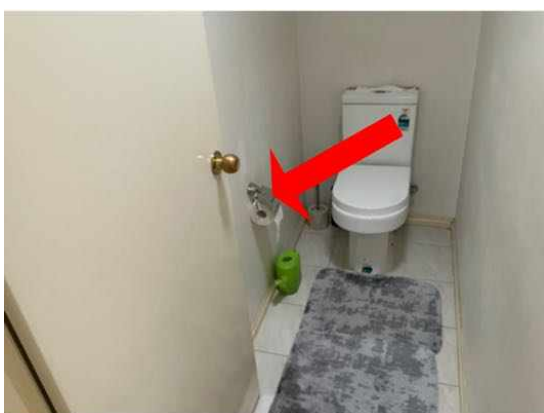
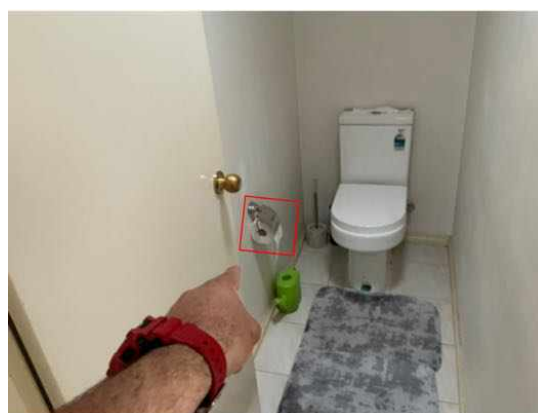
### Defects 3.12

Building: Main Building  
 Location: Bathroom  
 Finding: Toilet roll holder - Loose  
 Information: The toilet roll holder was found to be loose at the time of inspection. While not a major operational defect, function can deteriorate if the problem is left unmanaged.

It is advised that the homeowner performs remedial works to re-attach the toilet roll holder to its original fixing. A general handyperson may be required to perform these works.

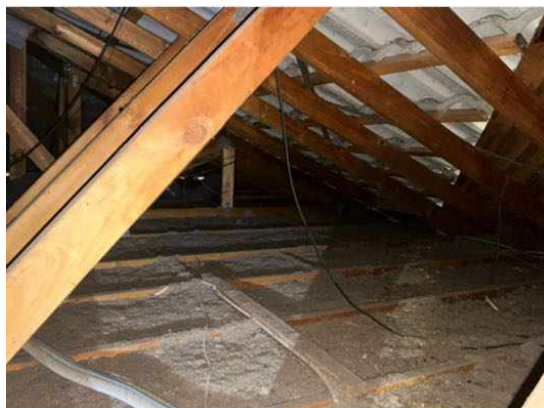
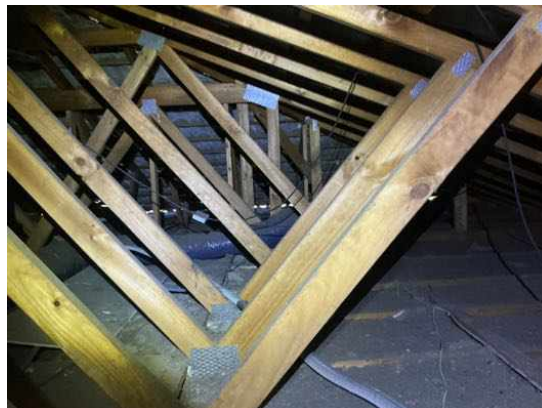
### Defects 3.13

Building: Main Building  
 Location: Roof Void  
 Finding: Poor Ceiling Cavity Ventilation  
 Information: During the inspection, the ceiling cavity space appeared to exhibit signs of elevated moisture levels, likely due to insufficient ventilation. The atmosphere within the cavity felt damp and stagnant, which may contribute to condensation build-up and the deterioration of internal roof framing or insulation materials over time.

Inadequate airflow in roof spaces can lead to mould growth, timber decay, and a

reduction in the overall energy efficiency of the home. To promote proper air circulation and reduce moisture retention, it is strongly recommended that a whirlybird or other appropriate roof ventilation system be installed.

Engaging a qualified roofing or ventilation specialist to assess the cavity and install the necessary ventilation will help maintain the integrity of the roof space and reduce the risk of long-term moisture-related issues.

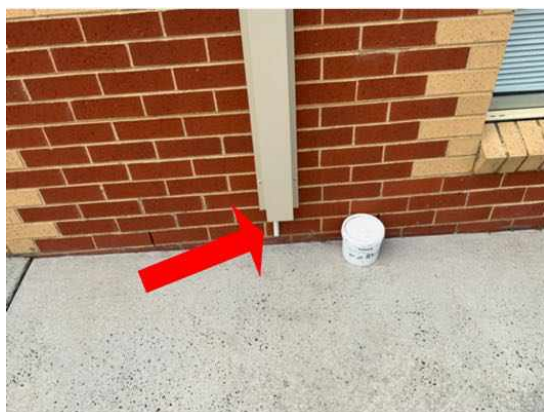
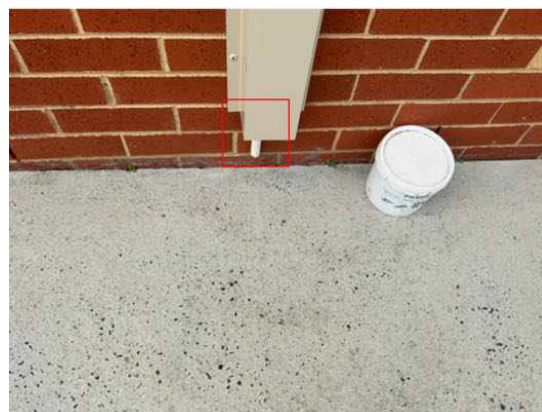
### Defects 3.14

Building:	Main Building
Location:	Yard - Back
Finding:	AC Overflows - Not plumbed to suitable drainage
Information:	Upon inspection, it was found that the AC overflow is not plumbed or connected to suitable drainage. This could lead to the surrounding area becoming excessively damp, which in turn may cause secondary defects such as rot, rust, corrosion of associated building elements, and the formation of fungal decay. In addition, prolonged damp conditions could create potential slip hazards. Poor site drainage may exacerbate the issue, potentially attracting termite activity to the area.

We recommend that a licensed plumber be appointed to properly plumb the AC overflow and connect it to suitable drainage. This will help ensure that the area remains dry and free from secondary defects.

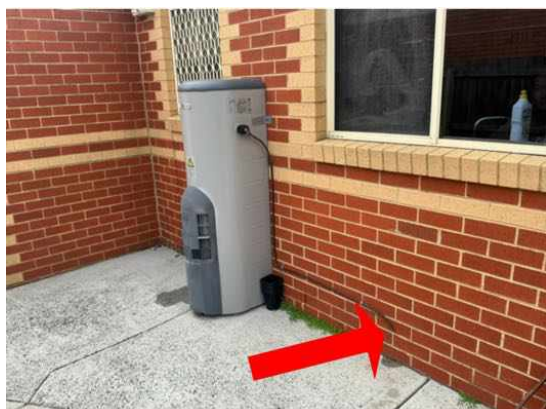
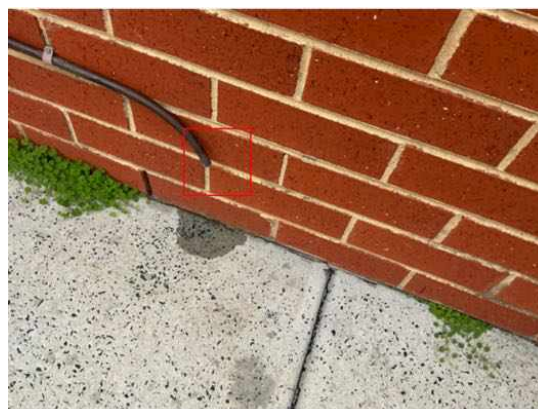
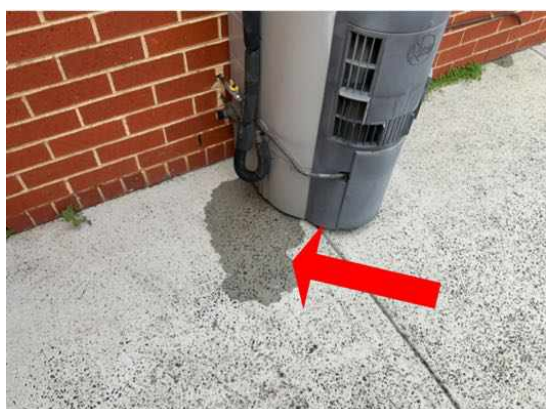
### Defects 3.15

Building: Main Building  
 Location: Yard - Back  
 Finding: HWS Overflow - Not Connected  
 Information: The Hot Water System (HWS) overflow was found to be disconnected from storm water drainage and is creating excessive moisture in the surrounding area.

These damp conditions can lead to secondary defects such as rot, rust or corrosion of associated building elements, the formation of fungal decay, or even the creation of potential slip hazards. When coupled with poor site drainage, pooling of water may also attract termite activity to this area.

It is highly recommended that a licensed plumber be appointed to connect the HWS overflow in order to prevent such an environment from being created. These minor works should be carried out as soon as possible.

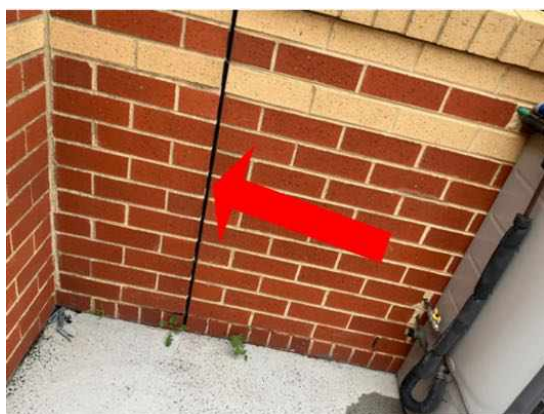
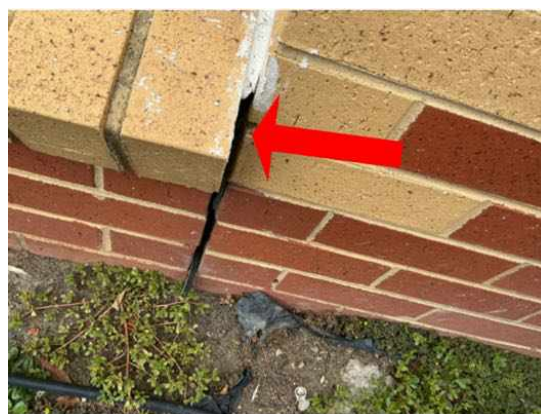
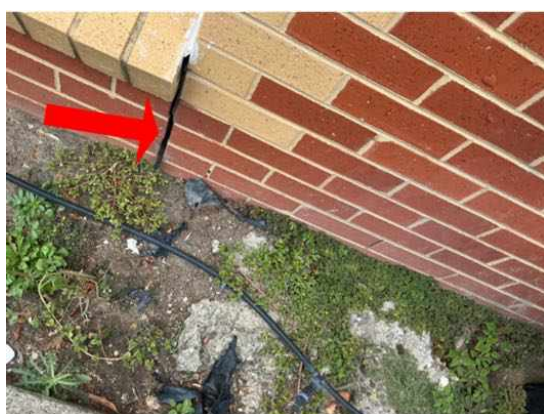
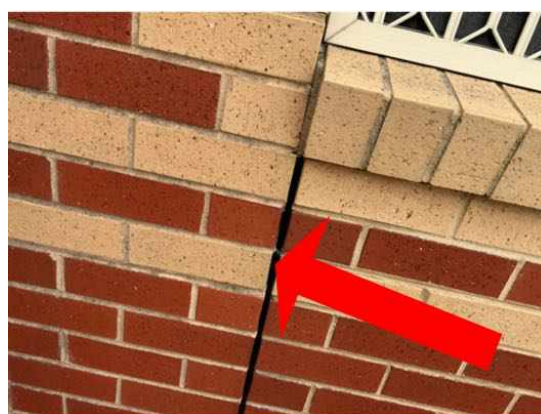
### Defects 3.16

Building: Main Building  
 Location: All External Areas  
 Finding: Brickwork expansion joint - Seal missing.  
 Information: During the inspection, it was noted that the seal for the brickwork expansion joint is

missing on all exterior walls. Expansion joints in brickwork are critical as they accommodate the natural movement of building materials caused by thermal expansion, contraction, and other environmental factors. The absence of a proper seal in these joints can lead to several issues:

- Water Penetration: Without a seal, water can penetrate the expansion joint, potentially leading to water damage within the wall cavity and interior spaces. This can result in dampness, mold growth, and deterioration of building materials.

- Energy Efficiency: Gaps in the expansion joints can affect the building's insulation properties, leading to increased energy consumption for heating and cooling.

To address this issue, it is recommended that a qualified handyman, caulking specialist, or bricklayer be engaged to inspect and reseal the expansion joint. This will help maintain the integrity, durability, and appearance of the brickwork, as well as prevent potential water ingress and structural problems.

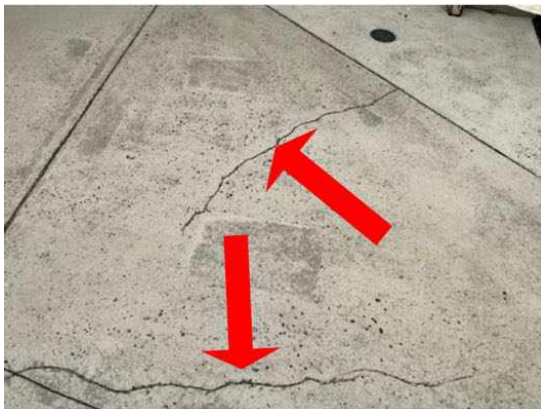
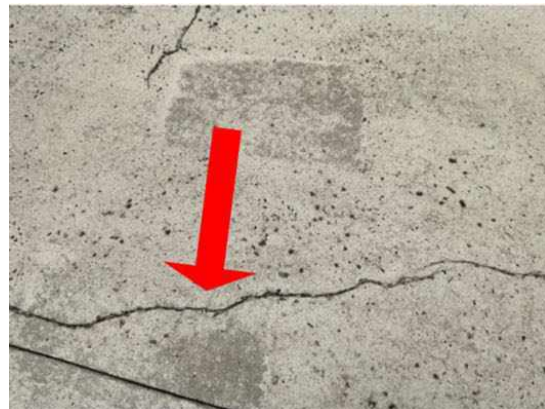
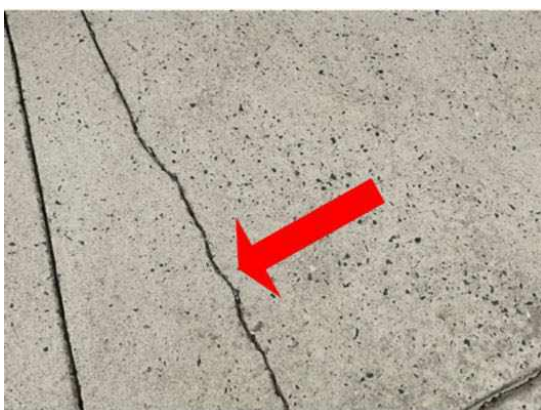
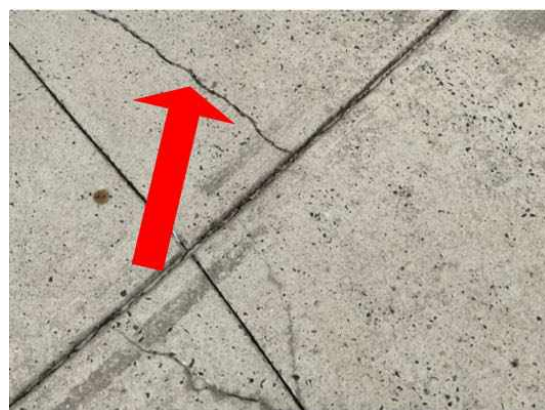
### Defects 3.17

Building:	Main Building
Location:	Yard - Back
Finding:	Cracking - External Concrete Paving Damage Category 2 - Distinct (less than 3mm)
Information:	Distinct cracks were identified in external concrete paving. Distinct cracks are

generally found in older concrete paving, and may also present as a trip hazard as consequence of an uneven or curved surface.

General age and expected deterioration of the paved areas is a common cause of this type of cracking. However, expansion and contraction of the slab may also have occurred due to environmental factors. Such factors include variable moisture and weather conditions, the presence of trees and their roots having a settling or lifting affect on the soil, or the effect of load bearing, e.g. heavy vehicles over a sustained period of time.

Cracking to this degree may also be due to poor original installation of the concrete. Factors such as poor compaction of the sub surface and/or inadequate reinforcing of the slab may create cracking and other secondary defects.

Repairs are likely to be required to prevent further cracking and to reduce hazards associated with cracking, such as tripping. Monitoring of all cracking should be conducted frequently. Always contact a building inspector should cracks widen, lengthen, or become more numerous.

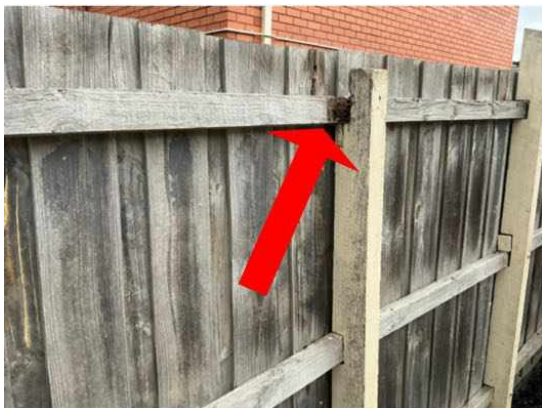
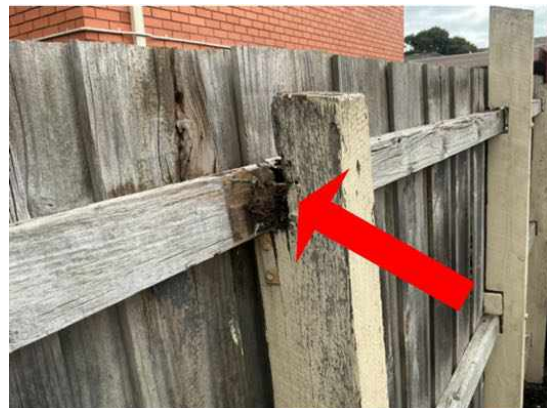
### Defects 3.18

Finding: Fencing - Deteriorated

Information: It was noted at the time of inspection that sections of the fencing throughout the property have deteriorated. Typically fencing deteriorates due to age and or wear, rot and or rust which is generally expected for a structure of this age, due to prolonged exposure to weather conditions. Sometimes inadequate installation or maintenance can be to blame.

If left unattended, it is likely that further damage will occur. It is suspected that repair of several elements of the fencing may be required however replacement may be a consideration of the client also.

A licensed fencing contractor should be appointed to provide further advice and perform rectification works as necessary.

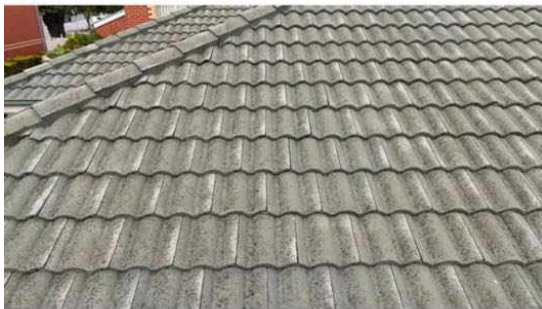
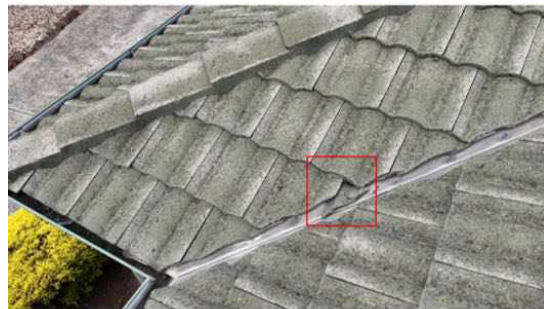
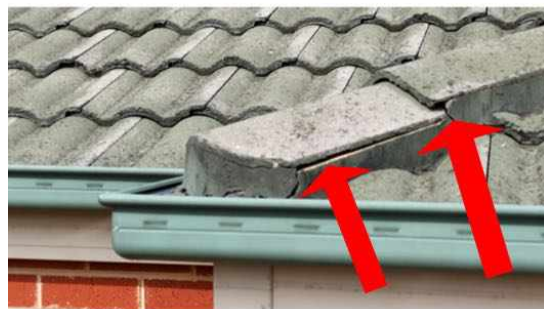
### Defects 3.19

Information: Upon inspection of the exterior roofing, the majority of roof tiles were considered to be in a fair condition. While weathering of the tiles is consistent with the age of the property, maintenance works are required.

Isolated areas of mortar have come loose in the valleys and minor cracking is also present. Re-pointing and re-sealing the may be considered as an interim solution by the client to help preserve and extend the life span of the tiles.

Where left unmanaged, deteriorating roof tiles are likely to lead to a number of secondary defects, including minor water leaks and weather exposure to internal roofing structures.

Consultation with a roofing contractor is highly advised to gain advice on cost of remedial works that may be required in the short to medium term. Remedial works are likely to increase the longevity of the exterior roofing structure.
