Building and Timber Pest Inspection Report

Inspection Date: Mon, 2 Feb 2026

Property Address: 2 Hill St, Rushworth VIC 3612, Australia

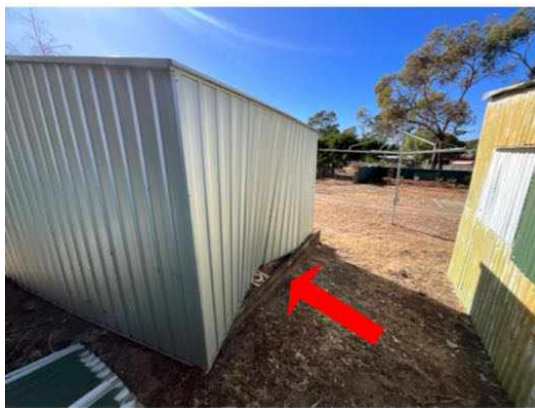
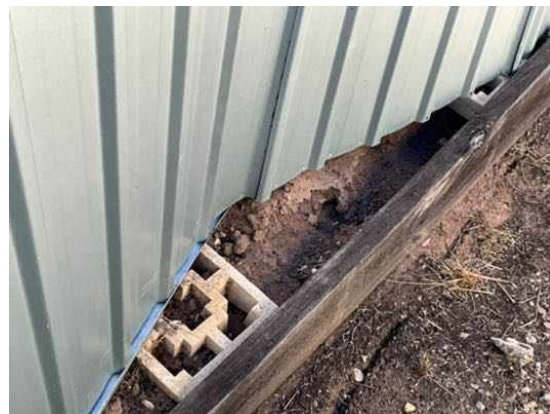
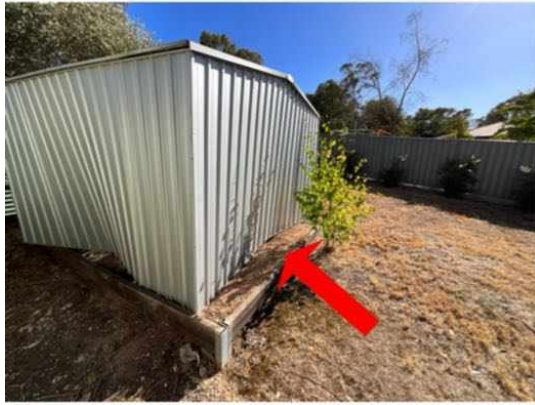
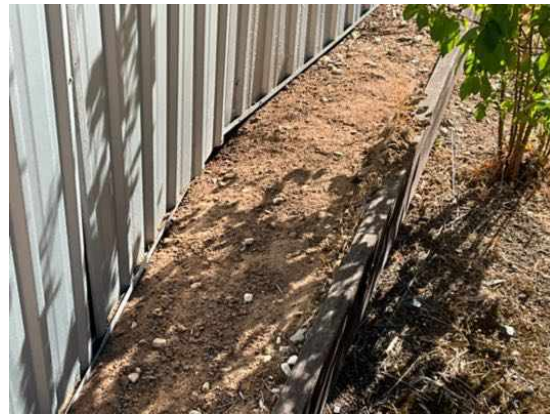
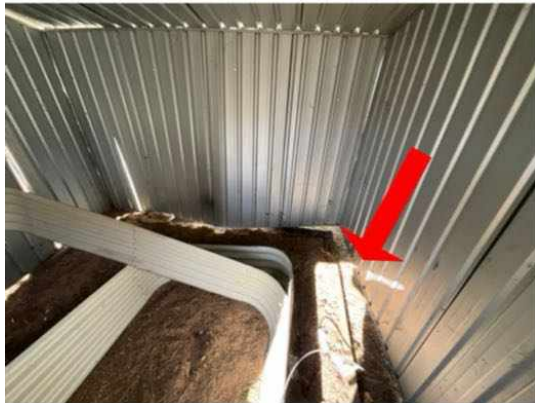
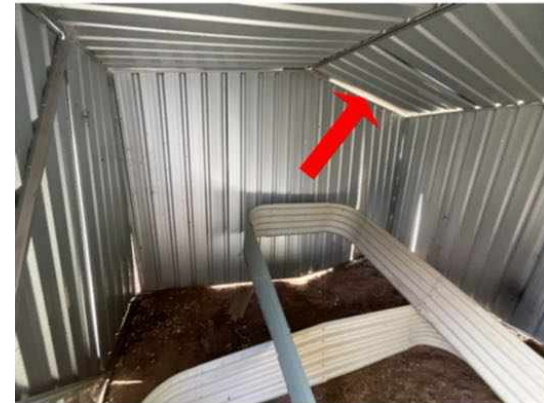
Building: Building 1
Location: Shed
Finding: Unfinished construction/ shed moving
Information: The construction of this structure appears to be incomplete. The safety of the structure can therefore not be ensured and the creation of secondary defects to surrounding building elements may be likely.

The shed has moved from its original location. This has caused minor structural damage.

A handyman or shed specialist should be appointed immediately to complete this construction process. Anchoring down the structure will prevent further damage.

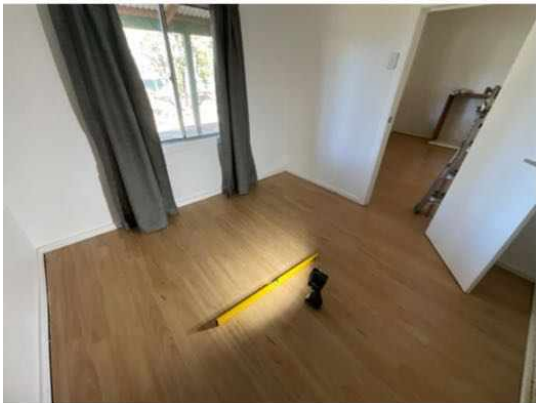
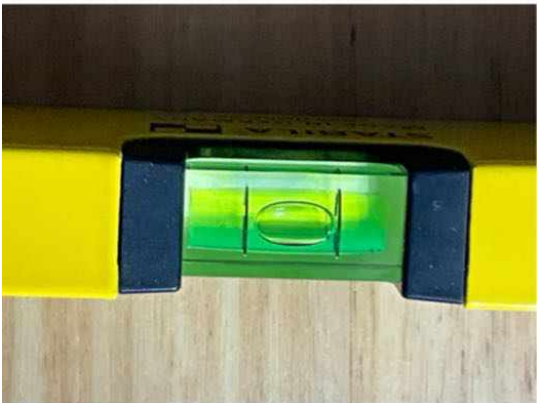
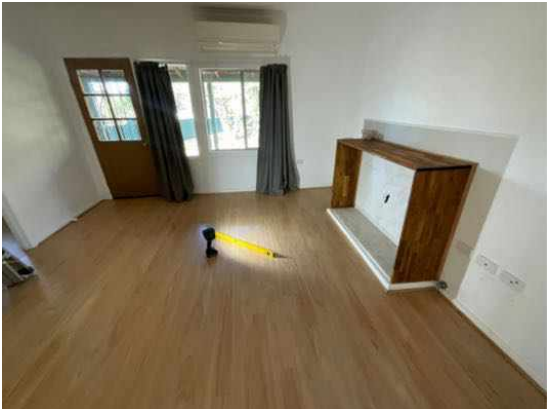
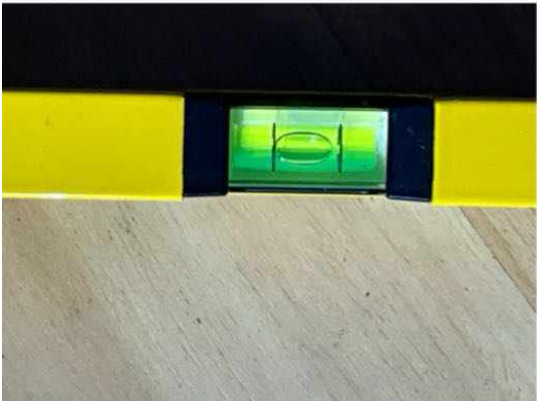
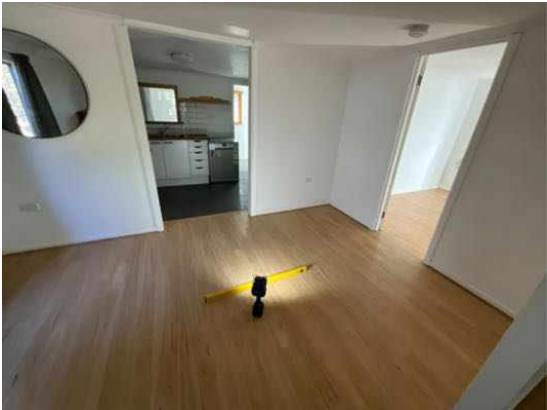
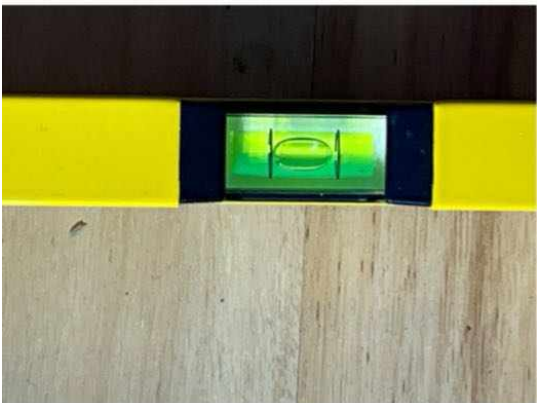
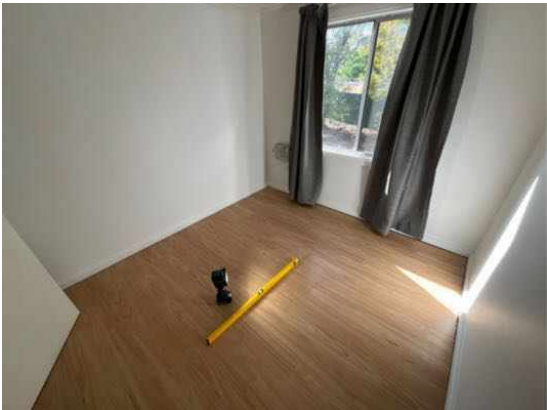
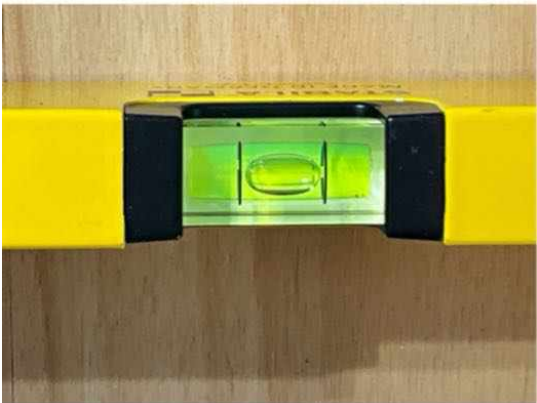
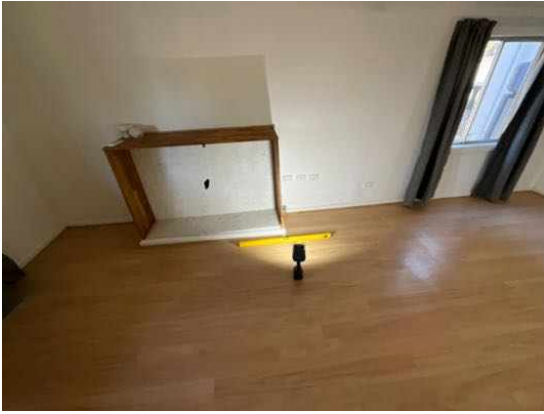
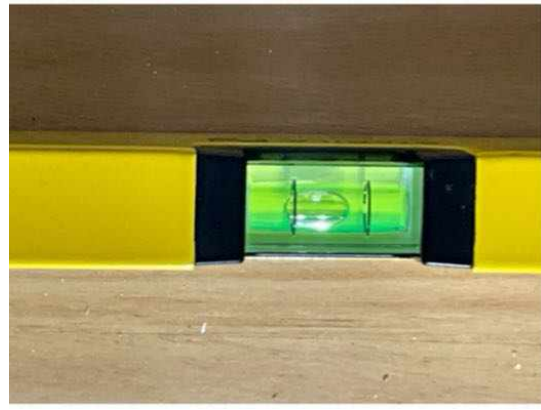
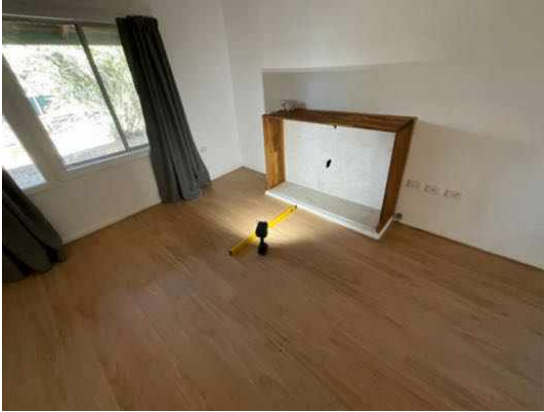
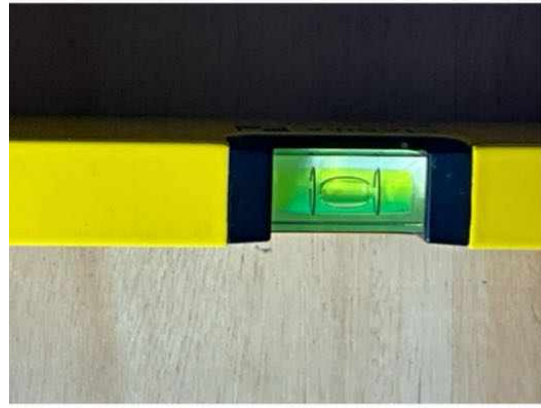
Finding 3.02

Building:	Building 1
Location:	All Internal Areas
Finding:	Flooring - Uneven
Information:	The internal flooring in this area is out of level and uneven. Uneven flooring is likely to indicate minor defects such as expected movement of the foundations of the property, but may also indicate subsidence of the associated subfloor stumps.

It is advised that the flooring be closely monitored to identify any further movement. Where flooring remains relatively unchanged for an extended period of time (i.e. several months), it is likely that this defect has been caused by expected movement of the foundations of the property.

However, where flooring is uneven further, potentially invasive inspection of the subfloor structures and stumps in this area is required. In this case, works to repair are likely to be required, and would be carried out by a registered builder specialising in re-stumping.

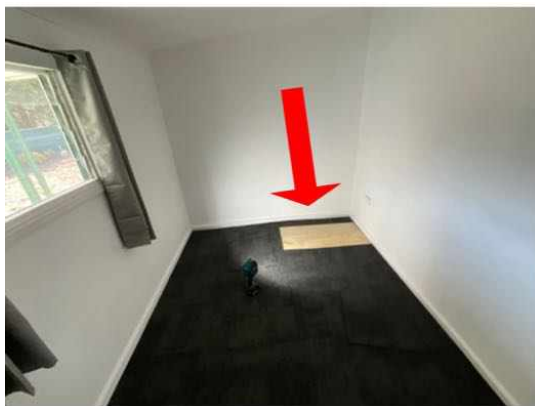
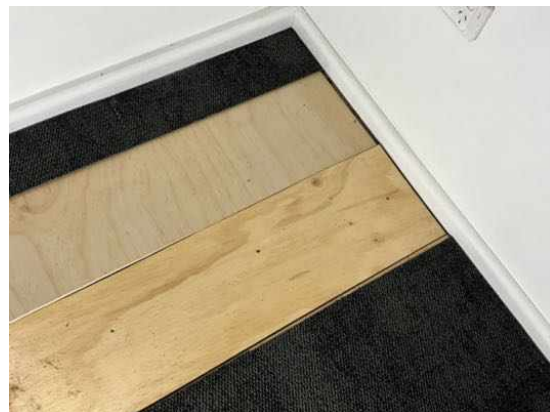
Finding 3.03

Building: Building 1
 Location: Bedroom 3
 Finding: Handyman work- unconventional
 Information: This handyman work appears to have been completed to a substandard level and does not comply with regular building practices. Where handyman work is not completed satisfactorily, accelerated deterioration of the associated building elements is likely to occur and secondary defects to surrounding structures may develop.

It is highly recommended that the substandard work be rectified by professional services as soon as possible.

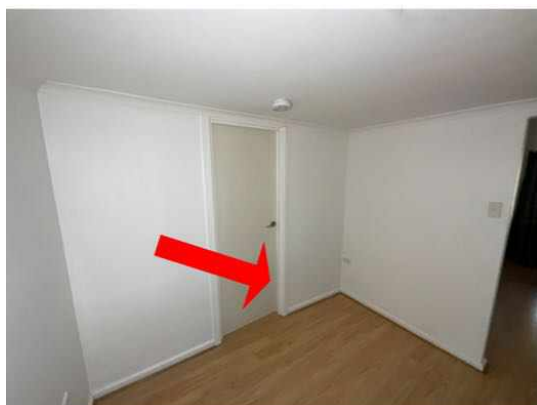
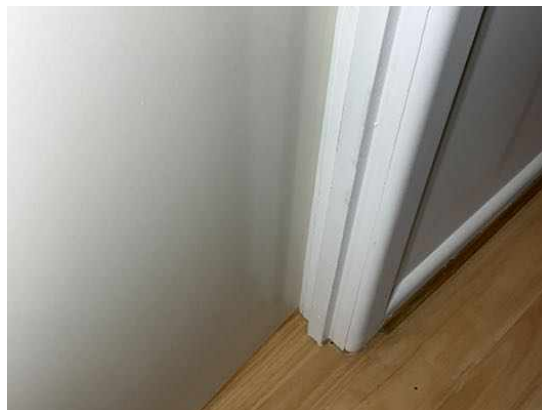
Finding 3.04

Building:	Building 1
Location:	Bedroom 2
Finding:	Door- Binding/jamming
Information:	Binding and/or jamming of this door is evident during standard operation. This defect inhibits the functionality of the affected door as well as creating potential for secondary defects to associated building elements, such as damage to the floor covering.

A door that binds to flooring or to the associated door frame may have several causes, ranging from minor defects, such as poor installation of the door or deteriorated hinges, through to major structural issues, such as damage to subfloor structures.

A qualified carpenter or general handyman should be appointed to perform minor rectification works at client discretion.

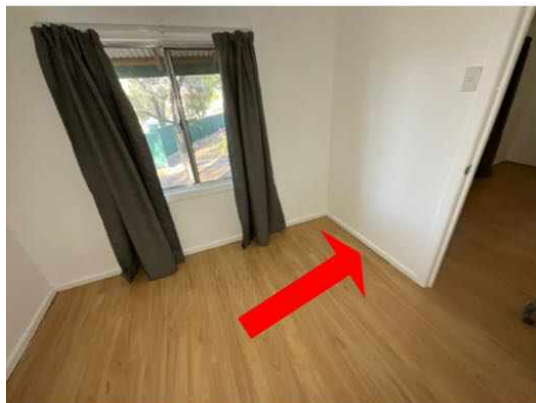
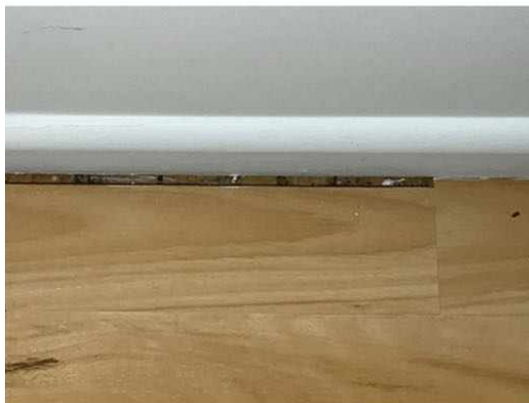
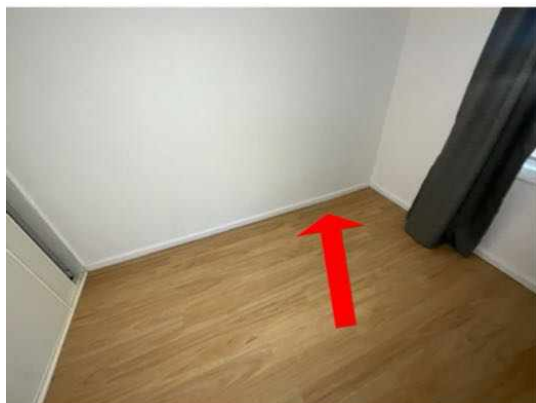
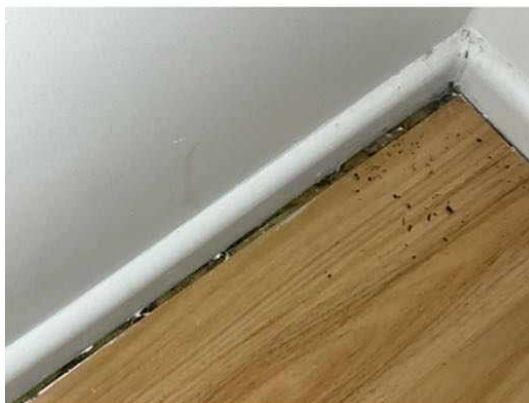
Finding 3.05

Building:	Building 1
Location:	Bedroom 1,2
Finding:	Timber flooring - Gaps to edges
Information:	Considerable gaps were noticeable around door jambs and edges of flooring. These gaps serve the purpose of allowing the flooring material to expand and contract, which is expected due to moisture levels and humidity.

While purposeful, these gaps make the adjoining building elements prone to water penetration, creating potential for the development of secondary damage.

While beading is used in most places to cover this gap around smaller corners, it is recommended that these gaps be filled with a coloured caulking compound. Such works should be performed by a qualified carpenter or general handyman, and should be completed at the discretion of the client.

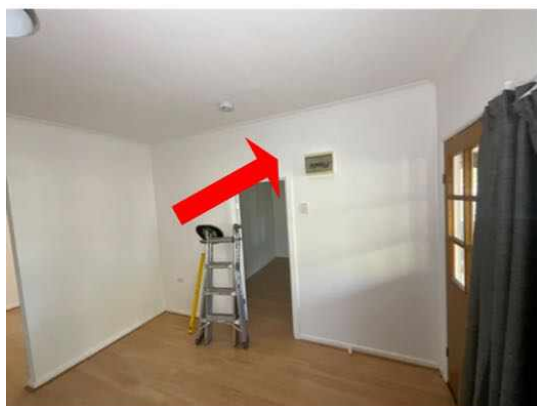
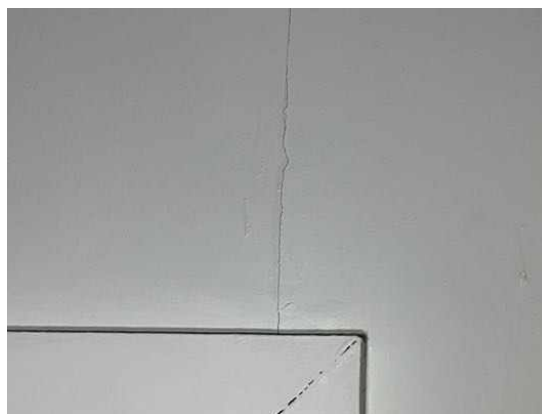
Finding 3.06

Building:	Building 1
Location:	Living Room
Finding:	Cracking - Damage Category 1 - Fine (up to 1mm)
Information:	Although fine cracks are quite noticeable, they are often only considered to be an appearance defect, and usually do not indicate any structural damage. Generally, the cause of a fine crack is indicative of a separation between building materials and finishes (e.g. paint, plaster, etc.) along joints.

Cracking of this nature can generally be repaired with minor sanding, filling and/or repainting. Such works should be performed by a qualified painter or a general handyman.

Monitoring of all cracking should be conducted frequently. Always contact a building inspector should cracks widen, lengthen, or become more numerous.

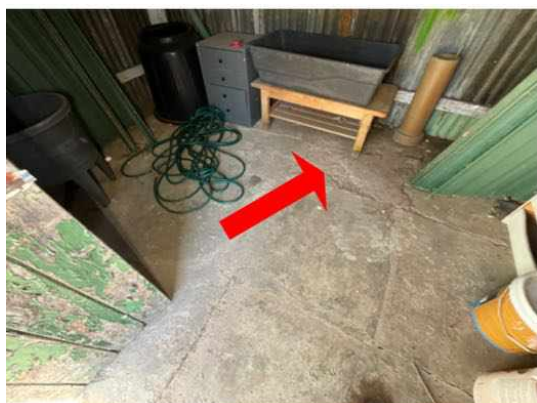
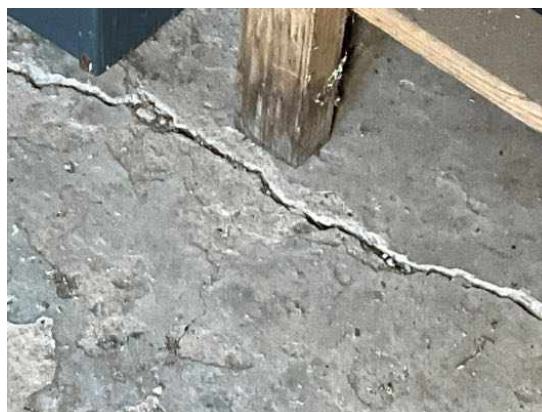
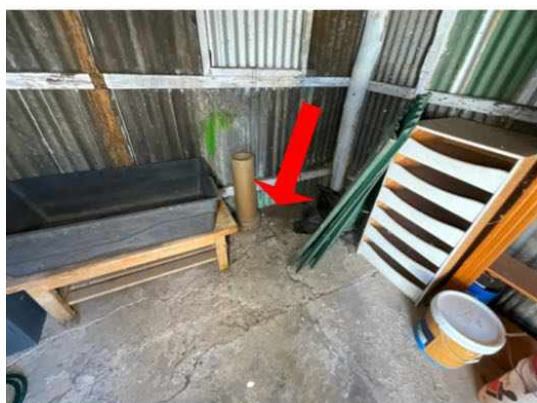
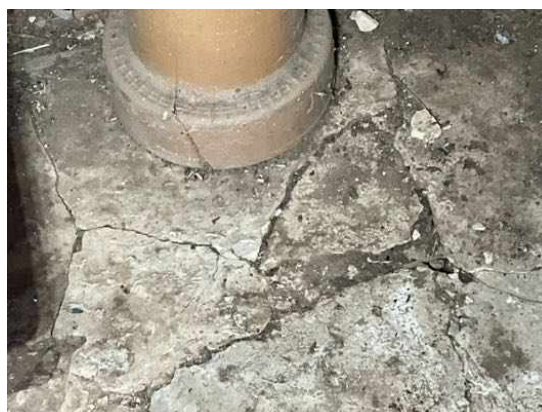
Finding 3.07

Building:	Building 1
Location:	Shed
Finding:	Cracking - External Concrete Paving Damage Category 4 - Gaps in Slab (4mm - 10mm +)
Information:	Gaps in the slab were identified in external concrete paving. Gaps in the slab are significant and are likely to lead to the development of safety hazards and secondary defects if left unmanaged, such as the creation of a trip hazard.

General age and expected deterioration of the paved areas is a common cause of this type of cracking. However, expansion and contraction of the slab may also have occurred due to environmental factors. Such factors include variable moisture and weather conditions, the presence of trees and their roots having a settling or lifting affect on the soil, or the effect of load bearing, e.g. heavy vehicles over a sustained period of time.

Cracking to this degree may also be due to poor original installation of the concrete. Factors such as poor compaction of the sub surface and/or inadequate reinforcing of the slab may create cracking and other secondary defects. Gaps in the concrete paving may also have a more significant structural cause, such as subsidence of soils.

Where gaps in the concrete paving are adjacent to structural elements of the building, the advice of a Structural Engineer is advisable before undertaking repairs. Significant repair and likely replacement of the concrete paving is probable.

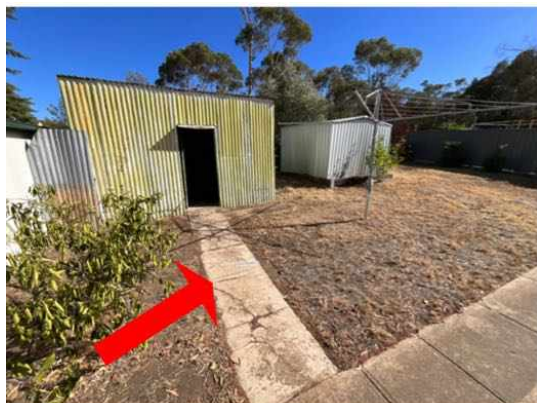
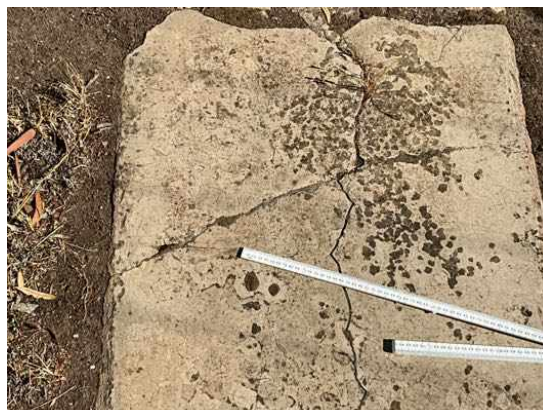
Finding 3.08

Building:	Building 1
Location:	Yard - Back
Finding:	Cracking - External Concrete Paving Damage Category 3 - Wide Cracks (2mm - 4mm)
Information:	Wide cracks were identified in external concrete paving. Wide cracks are significant and are likely to lead to the development of safety hazards and secondary defects if left unmanaged.

General age and expected deterioration of the paved areas is a common cause of this type of cracking. However, expansion and contraction of the slab may also have occurred due to environmental factors. Such factors include variable moisture and weather conditions, the presence of trees and their roots having a settling or lifting affect on the soil, or the effect of load bearing, e.g. heavy vehicles over a sustained period of time.

Cracking to this degree may also be due to poor original installation of the concrete. Factors such as poor compaction of the sub surface and/or inadequate reinforcing of the slab may create cracking and other secondary defects. Wide cracks may also have a more significant structural cause, such as subsidence of soils.

Where the crack is located adjacent to structural elements of the building, the advice of a Structural Engineer is advisable before undertaking repairs. Significant repair and likely replacement of the concrete paving is probable.

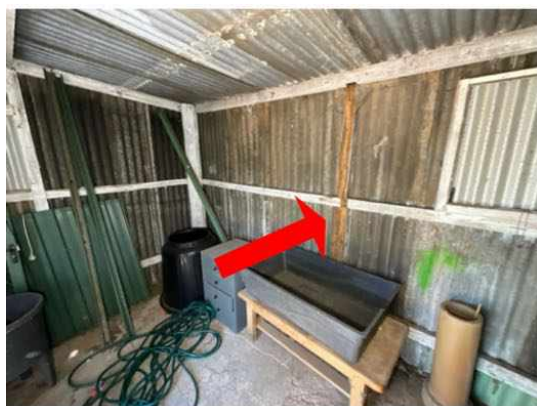
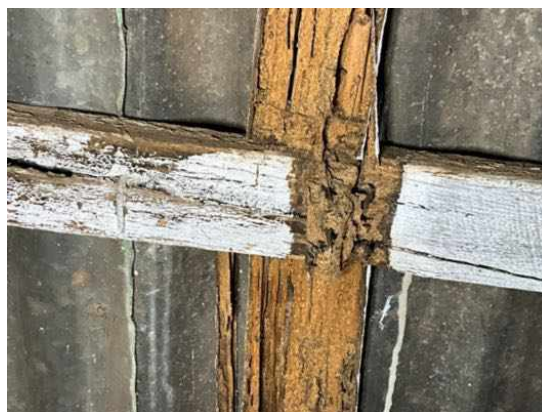
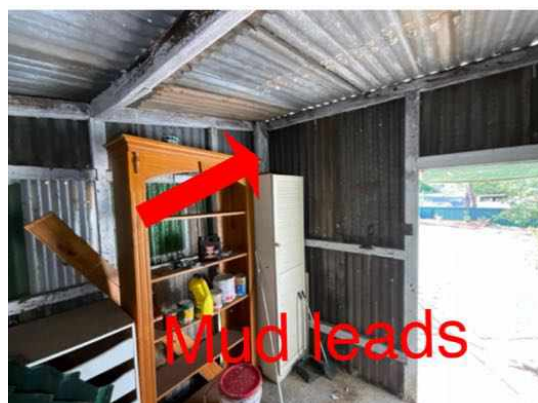
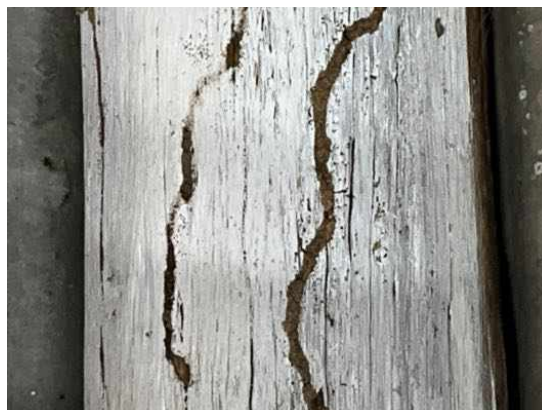
Building:	Building 1
Location:	Shed
Finding:	Evidence of termite damage - not structural
Information:	Despite no live termite or timber pest activity being indicated, previous termite damage was found to have affected this area. This damage is considered to be inactive and is minor in nature.

These built in cabinets are badly damaged and will require replacement. A cabinet maker needs to be contracted to remove and replace as soon as possible.

It is advised that the area be visually inspected frequently to ensure that the condition of affected building materials does not worsen. At the time of inspection, damage is not structural and is only considered to be superficial.

A building contractor may be appointed to provide a further invasive inspection if further damage is evident.

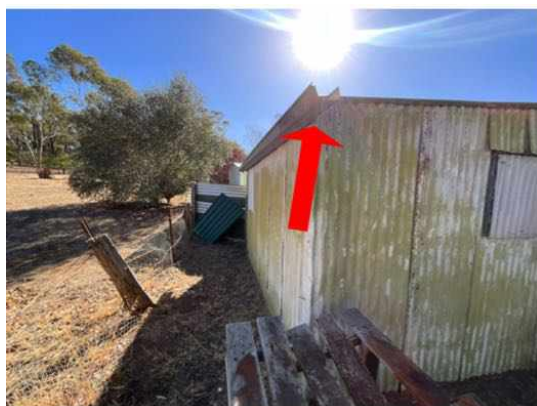
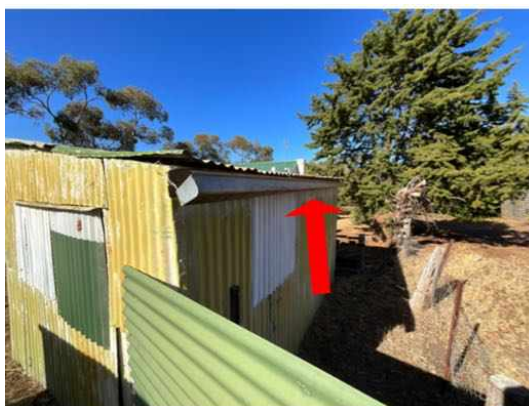
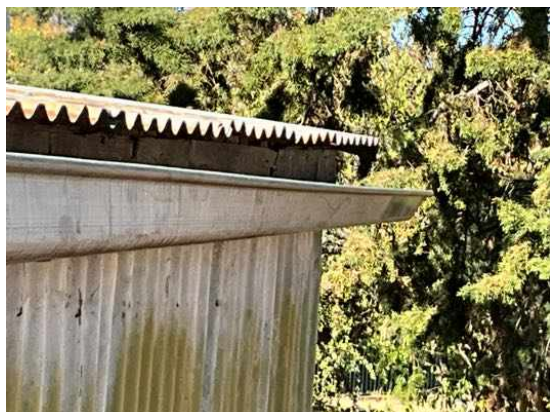
Finding 6.01

Where roof plumbing doesn't drain adequately, the area at the base perimeter can become excessively damp, potentially creating an environment that is susceptible to rust and corrosion of surrounding building elements, as well as attracting termites and other pests.

It is highly recommended that a plumber be appointed to further inspect the area and to install adequate drainage equipment where necessary.

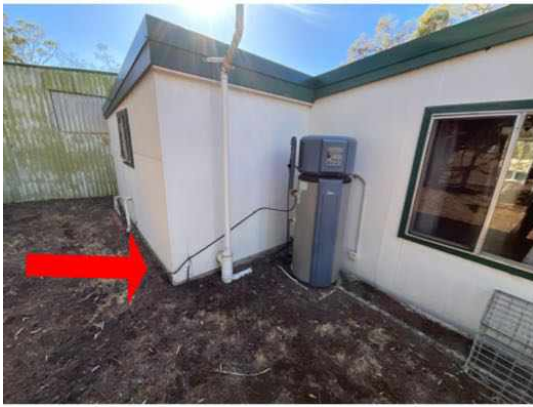
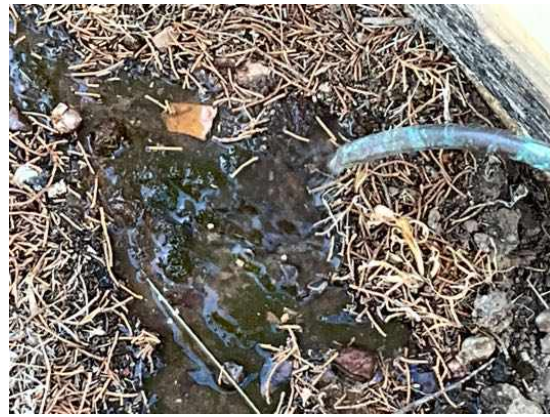
Finding 6.02

Building:	Building 1
Location:	Yard - Side
Finding:	HWS Overflow - Not Connected
Information:	The Hot Water System (HWS) overflow was found to be disconnected from storm water drainage and is creating excessive moisture in the surrounding area.

These damp conditions can lead to secondary defects such as rot, rust or corrosion of associated building elements, the formation of fungal decay, or even the creation of potential slip hazards. When coupled with poor site drainage, pooling of water may also attract termite activity to this area.

It is highly recommended that a licensed plumber be appointed to connect the HWS overflow in order to prevent such an environment from being created. These minor works should be carried out as soon as possible.

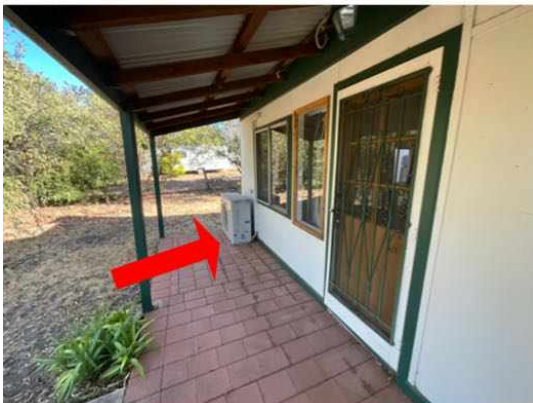
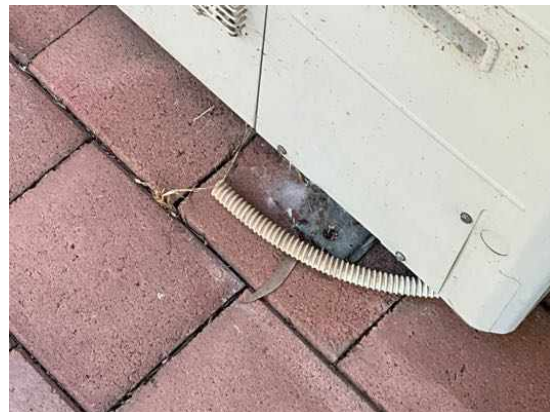
Finding 6.03

Building:	Building 1
Location:	Verandah
Finding:	Air conditioner - Disconnected overflow
Information:	The Air Conditioner (A/C) overflow was found to be disconnected from storm water drainage and is creating excessive moisture in the surrounding area.

Such leaking creates an environment which is conducive to an array of defects, including water damage to associated building elements and the attraction of termite or timber pest infestation.

It is highly recommended that a licensed plumber be appointed to connect the A/C overflow in order to prevent such an environment from being created. These minor works should be carried out as soon as possible.

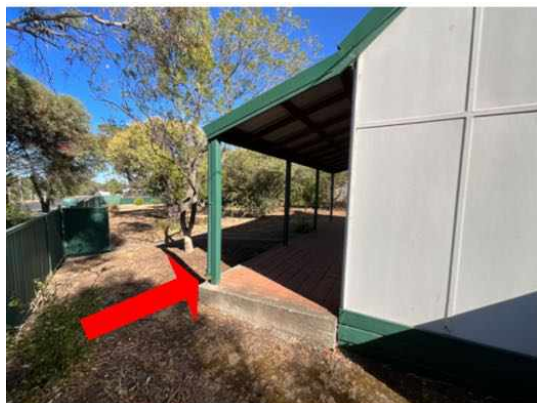
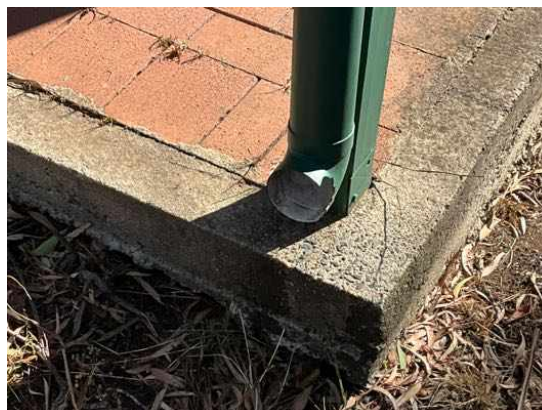
Finding 6.04

Building:	Building 1
Location:	Verandah
Finding:	Stormwater drain - Not connected
Information:	The roof plumbing is not adequately connected to stormwater drainage on the site. This disconnection negatively impacts the functional capacity of the roof plumbing.

Where roof plumbing doesn't drain adequately, the area at the base perimeter can become excessively damp, potentially creating an environment that is susceptible to rust and corrosion of surrounding building elements, as well as attracting termites and other pests.

It is highly recommended that a plumber be appointed to further inspect the area and to install adequate drainage equipment where necessary.

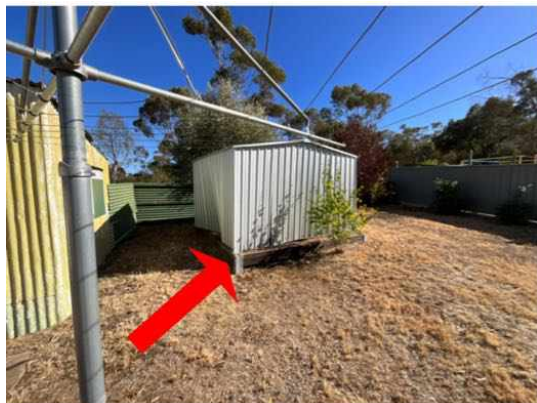
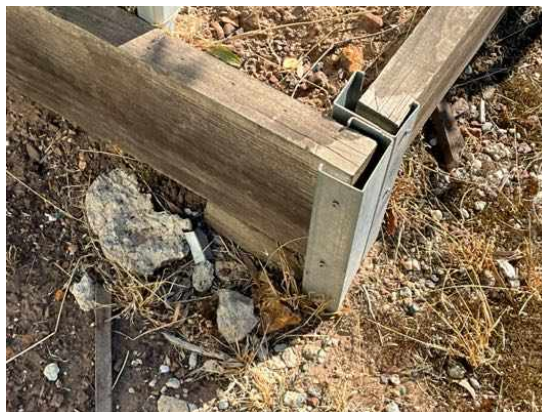
Finding 6.05

Building:	Building 1
Location:	Shed
Finding:	Untreated or non-durable timbers in a hazardous environment
Information:	To reduce the risk of timber pest attack it is essential that timber used in a hazardous environment (e.g. in direct contact with the ground or frequently exposed to damp conditions) is of sufficient durability and/or is adequately preservative treated.

Untreated timbers in direct contact with the ground are likely to develop severe wood rot and/or fungal decay if left unattended creating attraction for subterranean termites to infest the timbers from surrounding areas.

If untreated or non-durable timbers are found to be in a hazardous environment it is highly advised that replacement of these building elements be performed as soon as possible to aid the protection of the property against termite / timber pest attack.

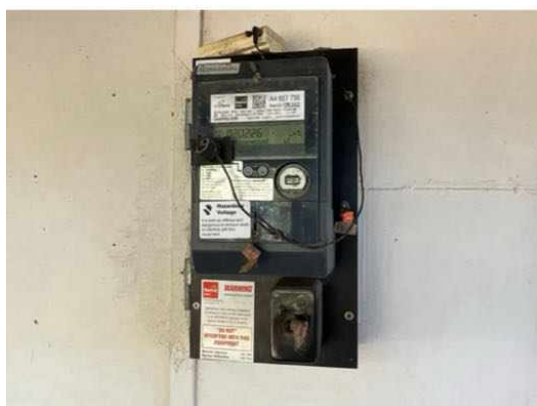
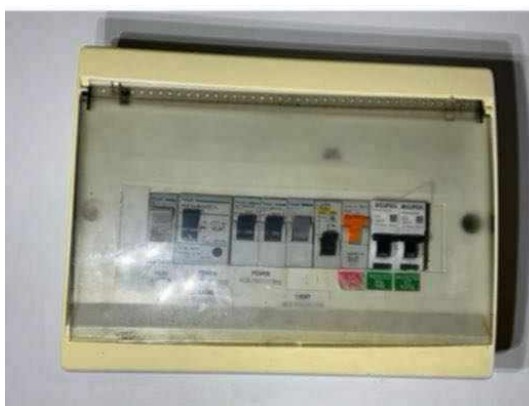
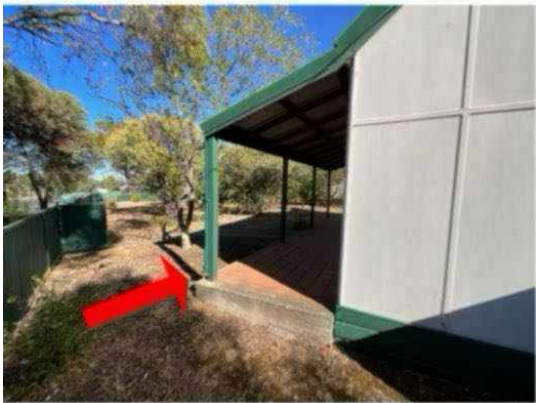
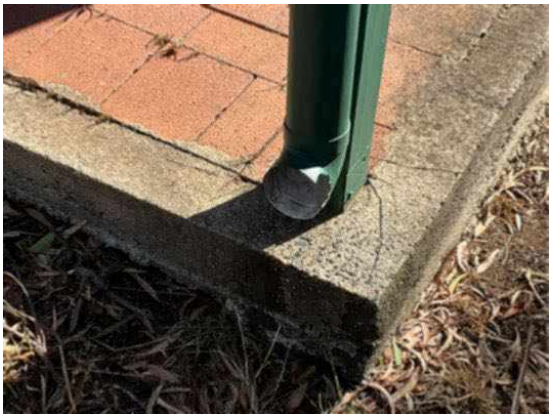
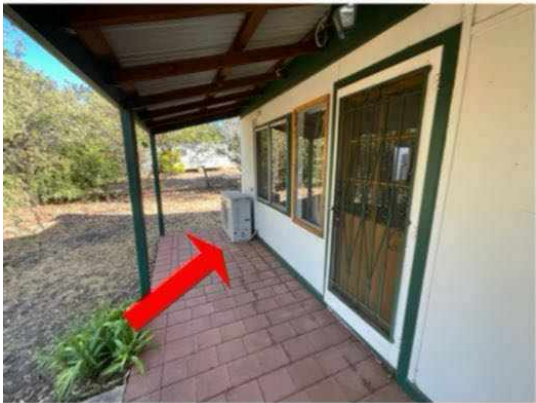
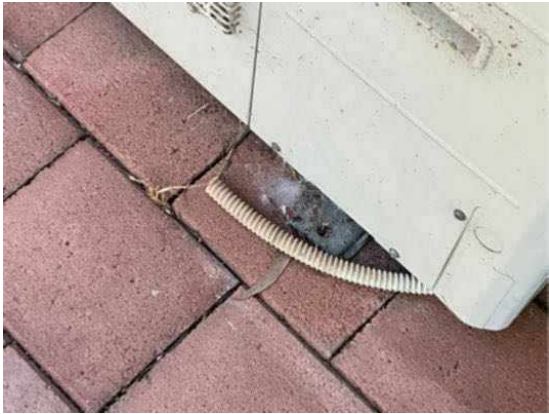
Finding 6.06

Building:	Building 1
Location:	All External Areas
Finding:	Termite Management System - no evidence of a chemical installation
Information:	The application of a post-construction chemical termite barrier is highly recommended for all properties, particularly if live termite activity has been found on the site previously. Such barriers are highly effective in preventing termite attack on any timber building elements throughout the property.

A durable notice should be placed in the switchboard unit to indicate current termite barriers. At the time of inspection, it appeared as though no termite management system has been installed, with no evidence to suggest preventative works taking place.

The client may consider gaining further advice from a pest controller as to the costs and procedures involved with this application. It is recommended that obtaining such advice be a short-term priority.

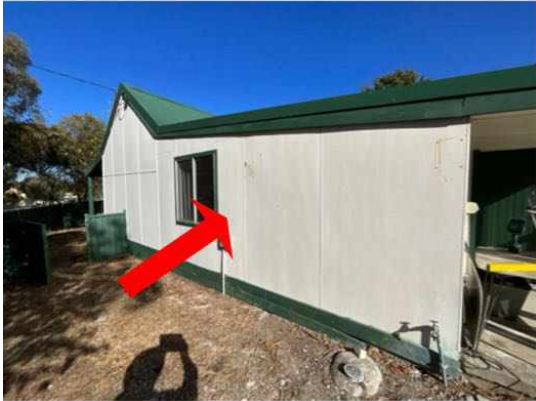
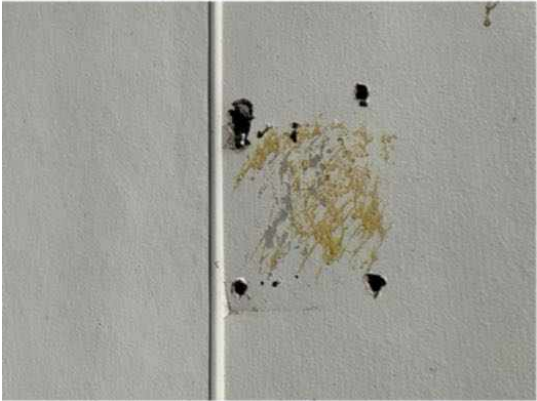
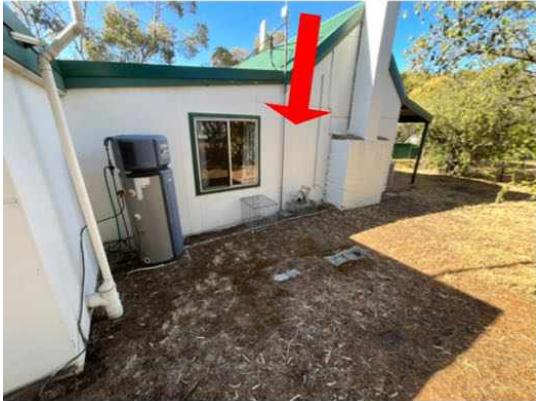
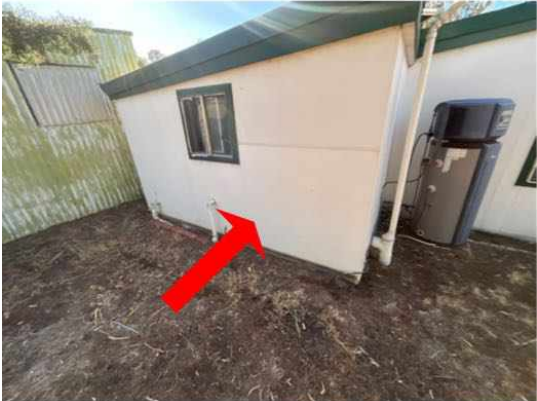
Building: Building 1
Location: All Areas
Finding: Asbestos - Suspected ACM Identified on Site
Information: Reporting on Asbestos is outside the Scope of this Report. This suspected defect is highlighted as a caution only. We suspect, based on our experience in the building industry, that there is a higher risk of the identified building element containing asbestos.

As Asbestos Reporting is outside the scope of this report, we advise that you consider a separate Asbestos Inspection and Condition Audit, which can include the taking of samples for definitive confirmation of the presence of Asbestos.

In the interim, the client is advised to act with caution, especially when considering any damage to building materials general wear and tear renovations extensions demolition and general maintenance activities due to the suspected presence of Asbestos.

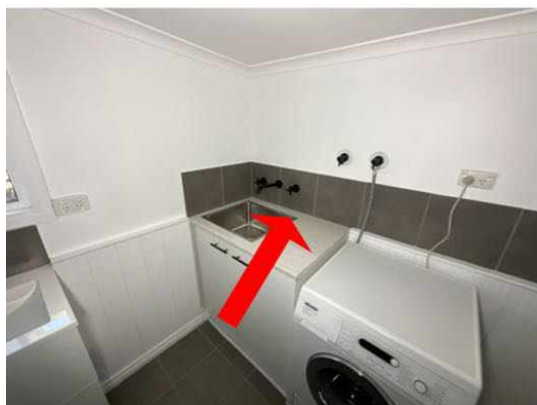
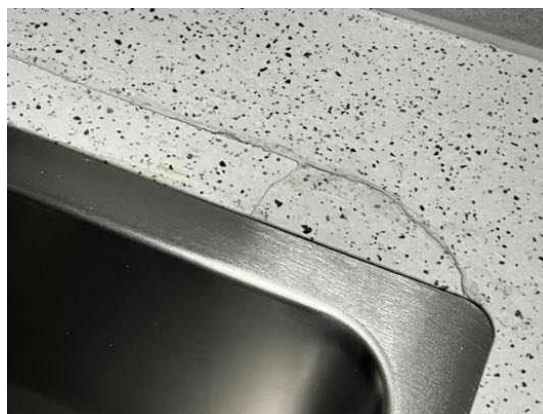
Building: Building 1
Location: Bathroom
Finding: Laminate - Cracked
Information: Cracked elements within the household detract from the overall appearance of the affected areas, as well as creating potential for water penetration to adjoining building elements. If left unmanaged, water damage may occur as a result of constant water penetration over a prolonged period of time.

While not considered a matter of urgency, replacement of this laminate material is advised as a solution. A Handyman may be appointed to perform these works at client discretion.

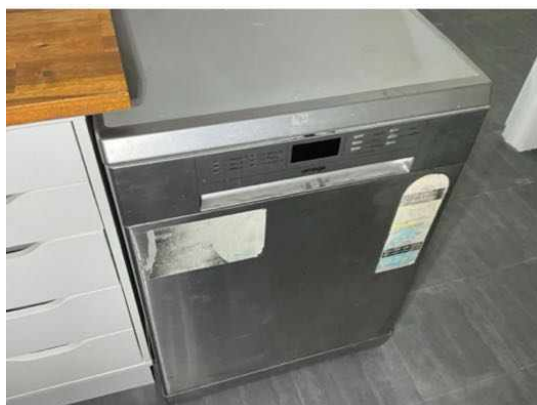
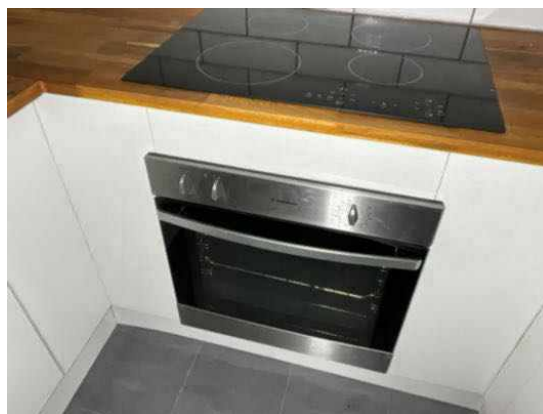
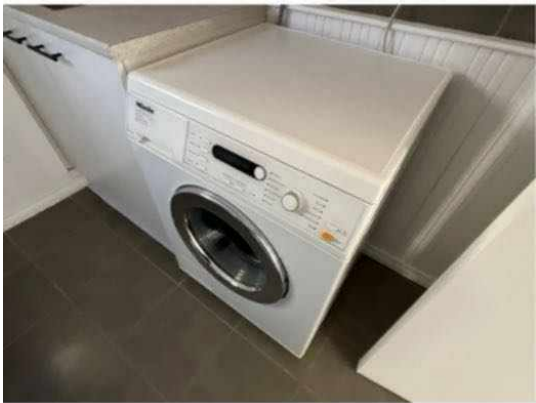
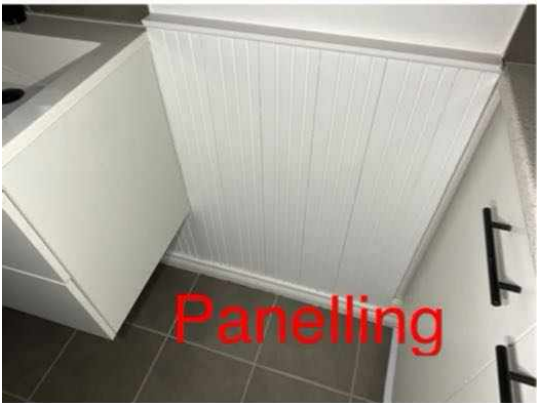
Building: Building 1
Location: All Areas
Finding: Additional Photos - Obstructions and Limitations
Information: These photographs are an indication of the obstructions and limitations which impeded full inspection of the property at the time of inspection. These obstructions can hide an array of defects and should be removed to allow full inspection to be carried out. A re-inspection is recommended once the areas are made accessible.
