# Building and Timber Pest Inspection Report

Inspection Date: Tue, 24 Feb 2026

Property Address: 33 Wood St, Drouin VIC 3818, Australia

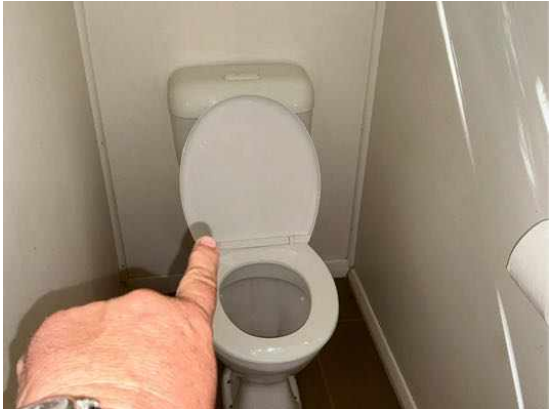
Building: Main Building  
Location: Toilet (WC)  
Finding: Toilet seat loose  
Information: It was observed that the toilet seat was loose and unstable.

Loose seats can cause fall injury to persons while in use and lead to serious injury

A licensed sanitary plumber should be engaged to review prior to use

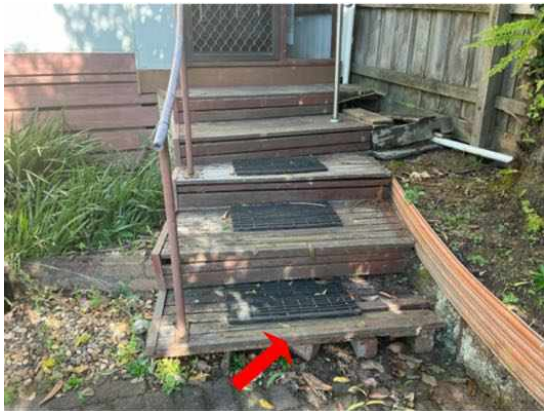
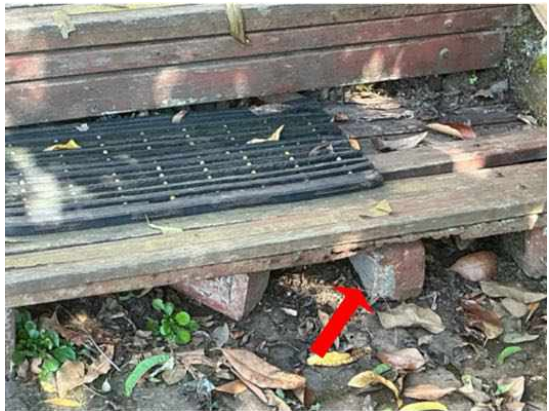
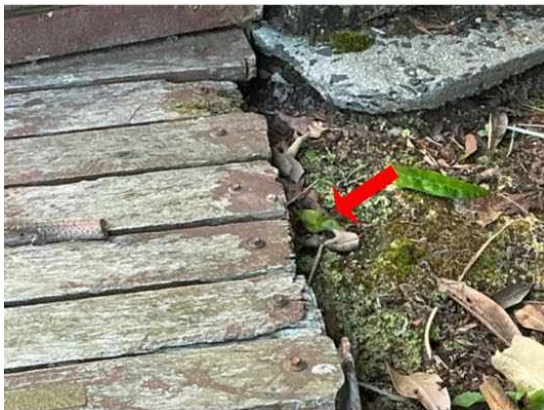
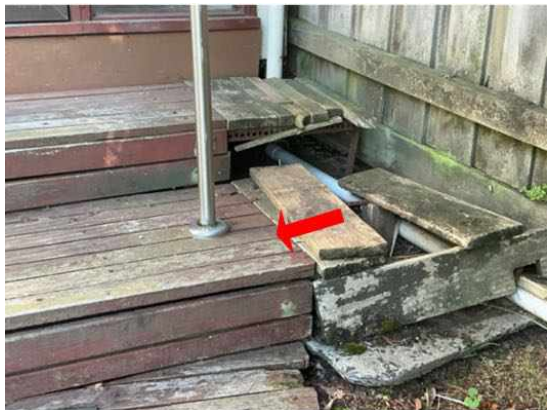
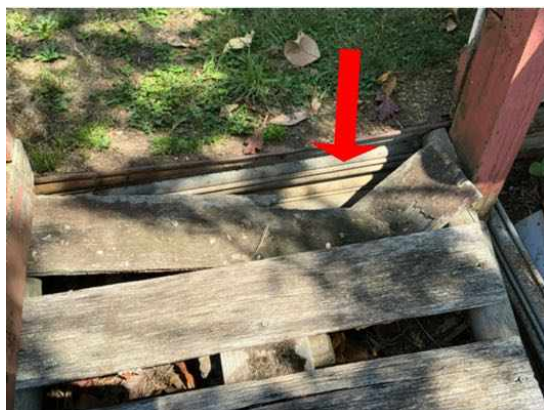
**Finding 1.03**

Building: Main Building  
Location: Yard - Back  
Finding: Timber stairs and ramp  
Information: It was observed at the time of the inspection that the timber stairs to the back door and the ramp in the back garden have become rotten and unstable. The ramps are in such a condition that a person could fall through the treads which are infected wood rot or fungal decay.

It is advised that a qualified carpenter should be engaged to review immediately

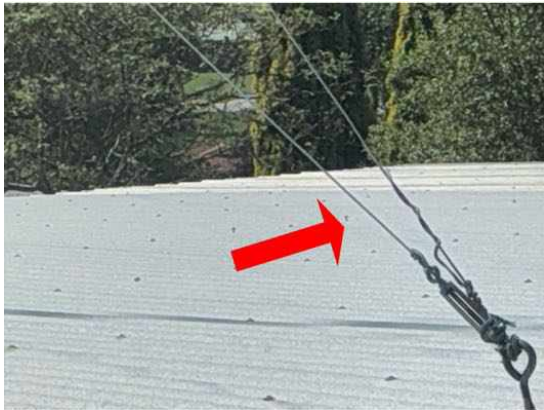
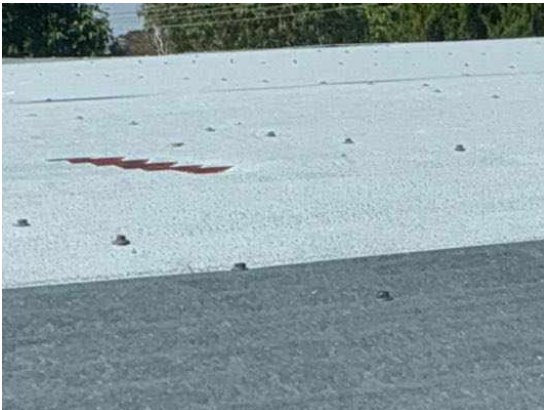
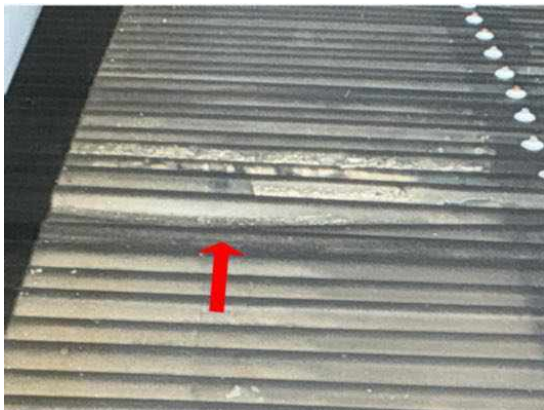
Building: Main Building  
Location: Roof Exterior  
Finding: Roof exterior – poor condition  
Information: It was observed at the time of the inspection that the metal roof sheet, associated flashings and fixings were in poor condition showing signs of age, rust and deterioration. There were roof leaks suspected to the bedroom areas.

Unattended to the condition of the roof covering could further deteriorate and provide further leaks to the building.

It is advised that a licensed roof plumber being engaged to review the condition of the

roof covering with consideration being given to replacement.

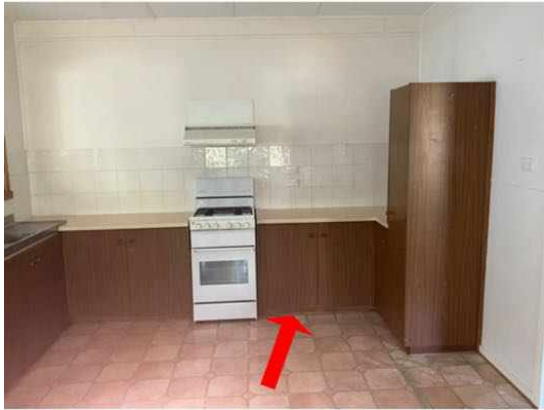
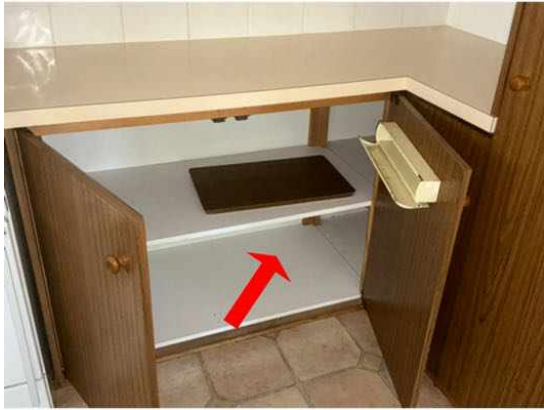
**Finding 3.01**

Building: Main Building  
Location: Kitchen and bathroom  
Finding: Dilapidated cabinets  
Information: It was observed at the time of the inspection that the cabinets in the kitchen and the bathroom were dilapidated. The cabinets were in poor condition with impact

damaged melamine showing excessive wear. The cabinets were also water damaged and swollen.

Damaged water resistant surfaces to cabinets can be un-hygienic and contribute to further deterioration of other cabinet components.

A qualified cabinet maker should review as soon as possible

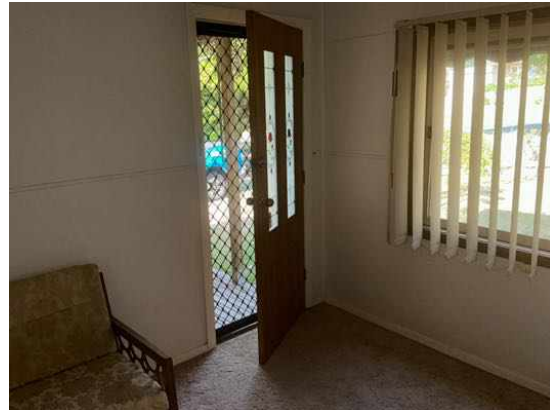
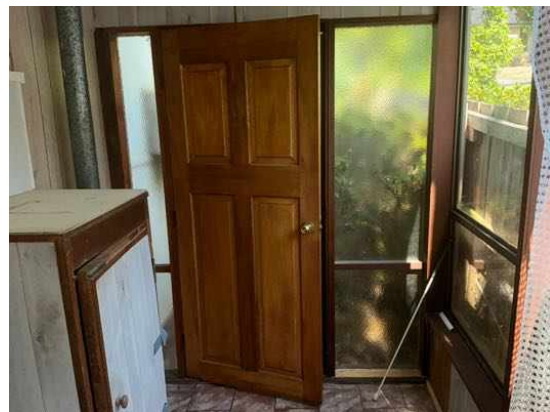
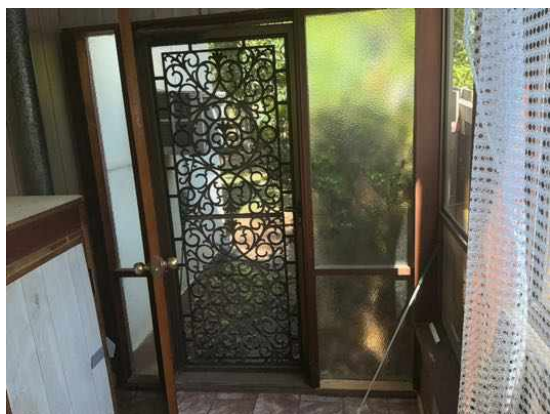
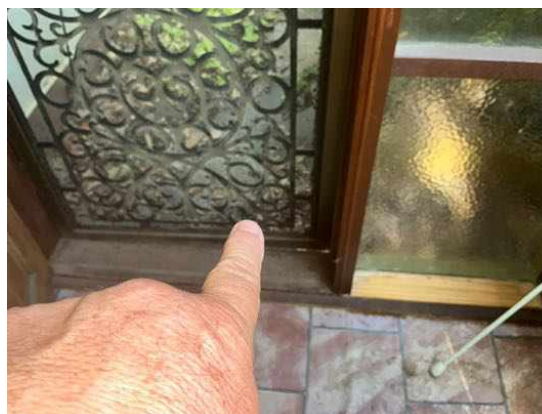
**Finding 3.02**

Finding: Doors - Binding/Jamming  
Information: Binding and/or jamming of several doors throughout the property were evident during standard operation. This defect inhibits the functionality of affected doors as well as creating potential for secondary defects to associated building elements, such as damage to the floor covering.

A door that binds to flooring or to the associated door frame may have several causes, ranging from minor defects, such as poor installation of the door or deteriorated hinges, through to major structural issues, such as damage to subfloor structures.

Where door binding/jamming appears to indicate major structural issues, a registered builder specialising in re-stumping should be appointed to provide an estimate on the cost of rectification.

For minor causes, a qualified carpenter or general handyman should be appointed to perform minor rectification works at client discretion.

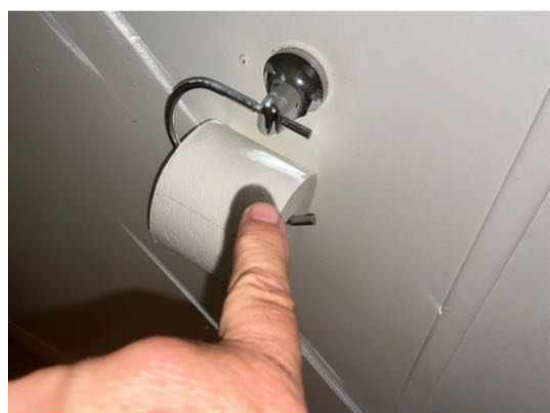
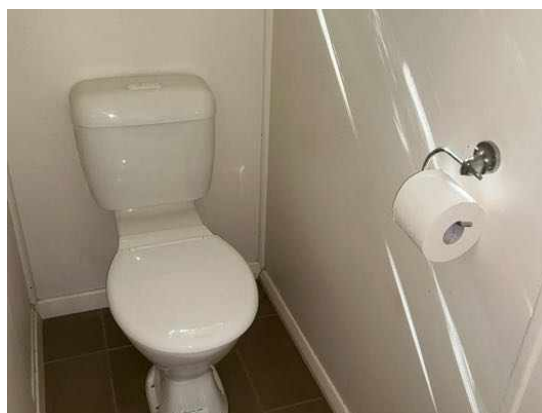
### Finding 3.03

Building:	Main Building
Location:	Toilet (WC)
Finding:	Toilet roll holder - Loose
Information:	The toilet roll holder was found to be loose at the time of inspection. While not a major operational defect, function can deteriorate if the problem is left unmanaged.

It is advised that the homeowner performs remedial works to re-attach the toilet roll holder to its original fixing. A general handyperson may be required to perform these works.

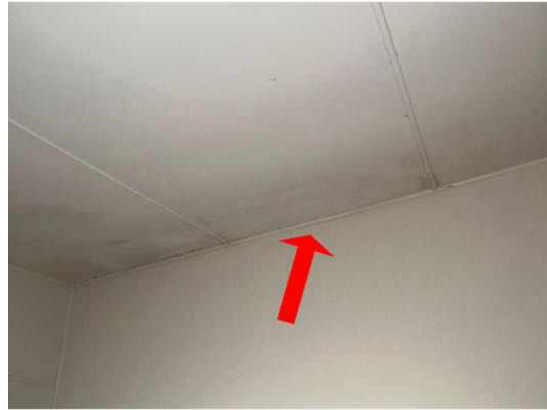
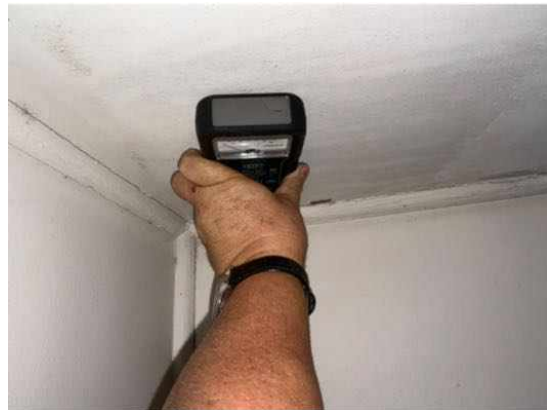
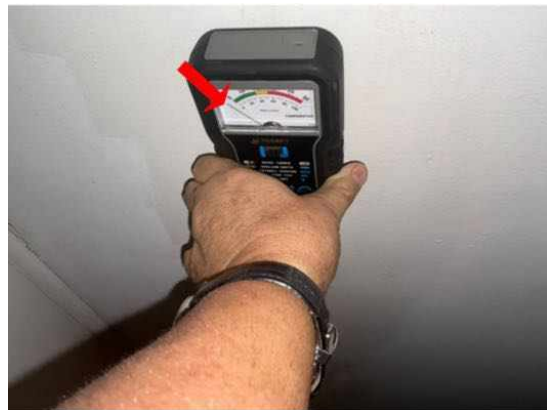
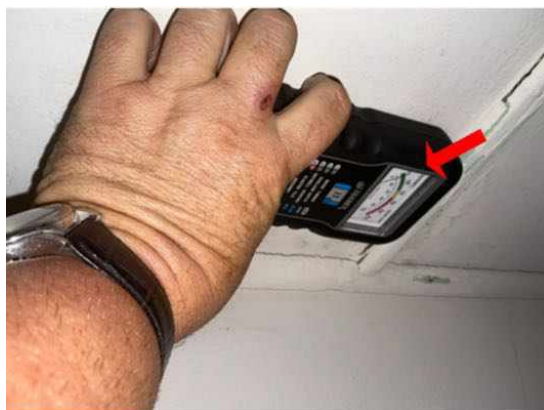
### Finding 3.04

Building:	Main Building
Location:	Roof Exterior
Finding:	Roof covering - Leaking
Information:	An active leak was identified to the roof covering, indicated by water ingress. It is suspected that the condition of the metal roof sheets and fixings are responsible for this leak, Leak staining was evident in the ceilings to the bedroom.

Where water leaks are active, rain penetration is likely to cause water damage to associated structures and building elements in this area, which can have a range of

implications. If left unmanaged, the development of major structural damage to the roofing and associated structures may occur.

The area was tested with a moisture meter and appeared to be dry. This is possibly due to dry conditions at the time of the inspection.

A roofing contractor should be appointed as soon as possible to primarily identify the cause of the leak, and to provide subsequent repair works as necessary. Depending on the extent of the damage, replacement of sections of the roof covering and/or roofing structures may be required.

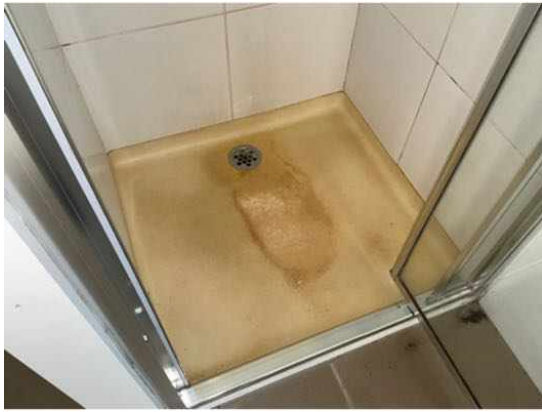
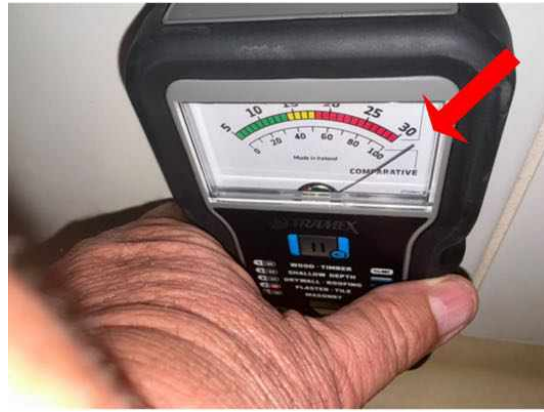
### Finding 3.05

Building:	Main Building
Location:	Bathroom
Finding:	Shower - Damp
Information:	Damp is evident to the lower 300mm of wall to the shower alcove. This defect is quite common, and is suspected to have been caused by moisture permeating through the grouting in this area, which shows evidence of deterioration. Leaking pipes within the adjoining wall is also a possible cause.

Damp (or structural damp) refers to the presence of unwanted moisture in the structure of a building, either as the result of intrusion from outside, or condensation from within the structure. In the shower area, internal water leaks or other sources of excessive moisture are generally the cause of damp.

Unmanaged damp in the shower recess is likely to facilitate the formation and development of mould and fungi growth, decaying associated building materials and compromising their structural integrity. It is important to address damp conditions, as the World Health Organisation notes that excess moisture leads - on almost all indoor materials - to growth of microbes such as moulds, fungi and bacteria, which subsequently emit spores and other matter into the indoor air. Exposure to these contaminants is associated with a wide range of respiratory and other health-related problems.

Consultation with a qualified plumber or bathroom specialist is advised immediately to identify the cause of damp and to perform remedial works as required. Where excessive mould growth is present, further inspection by a specialist environmental health inspector should also be considered.

Always ensure that sealant and grout is in good condition to prevent any moisture issues occurring in the future.

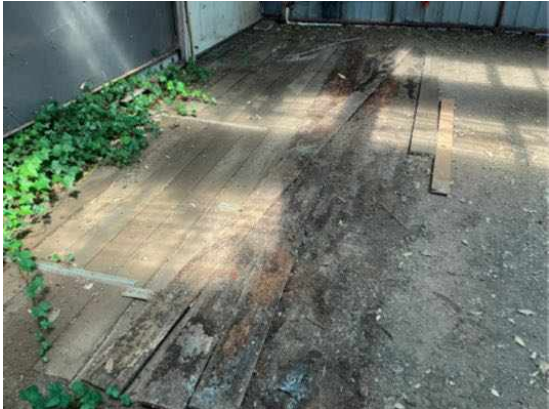
Building: Main Building  
Location: Metal garage and sheds deteriorated  
Finding: Metal garage and sheds deteriorated  
Information: It was observed at the time of the inspection that the sheds and metal garage were in poor condition. There were many rust damaged sheet and were generally in poor condition. Unattended to these outbuildings could soon be dilapidated.

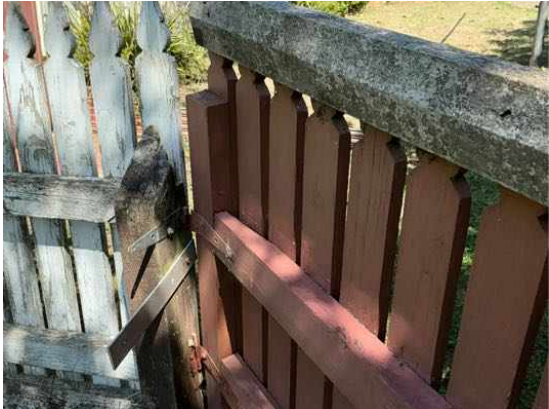
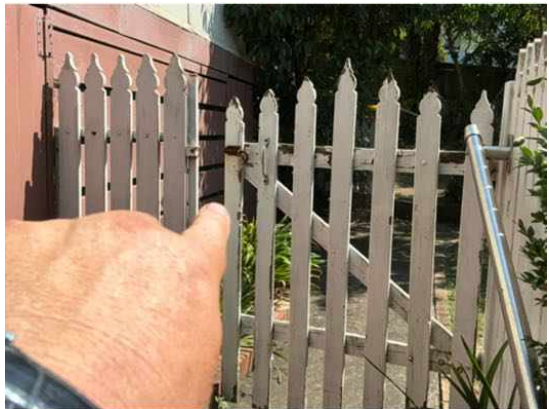
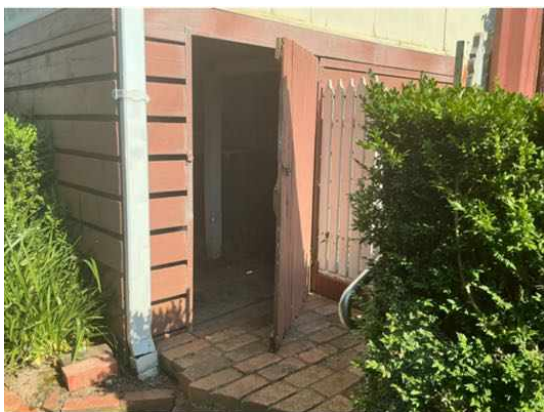
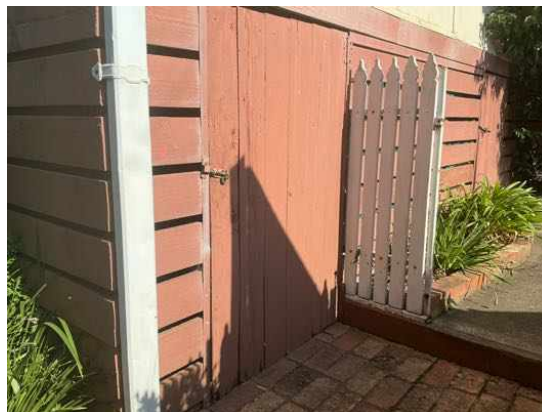
**Finding 3.08**

Building: Main Building  
 Location: Gate and subfloor doors  
 Finding: Gate and subfloor doors dilapidated  
 Information: It was observed at the time of the inspection that the pedestrian gate and the subfloor doors to the property were dilapidated. The hardware was showing signs of severe deterioration and the timber work was presenting with wood rot and fungal decay.

A qualified carpenter should be engaged to review as soon as possible

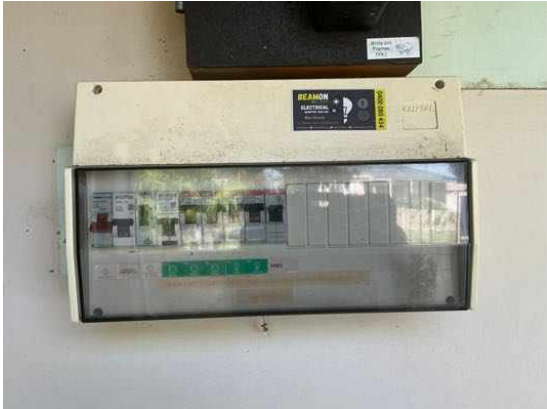
Building: Main Building  
 Location: Meter Box  
 Finding: Termite Management System - no evidence of a chemical installation  
 Information: The application of a post-construction chemical termite barrier is highly recommended for all properties, particularly if live termite activity has been found on the site previously. Such barriers are highly effective in preventing termite attack on any timber building elements throughout the property.

A durable notice should be placed in the switchboard unit to indicate current termite barriers. At the time of inspection, it appeared as though no termite management system has been installed, with no evidence to suggest preventative works taking place.

The client may consider gaining further advice from a pest controller as to the costs and procedures involved with this application. It is recommended that obtaining such advice be a short-term priority.

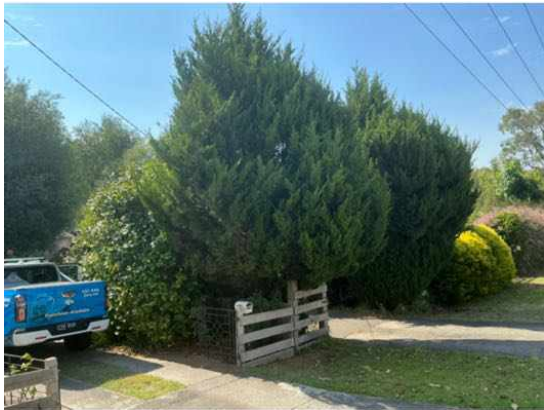
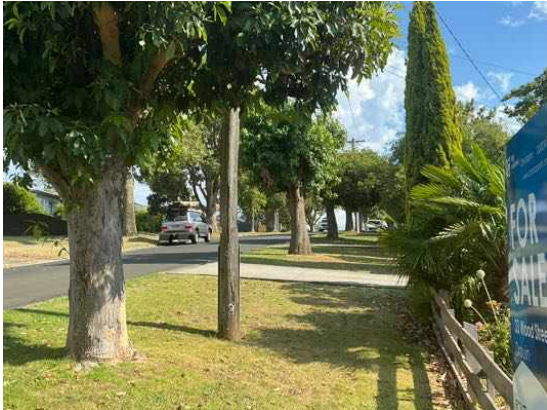
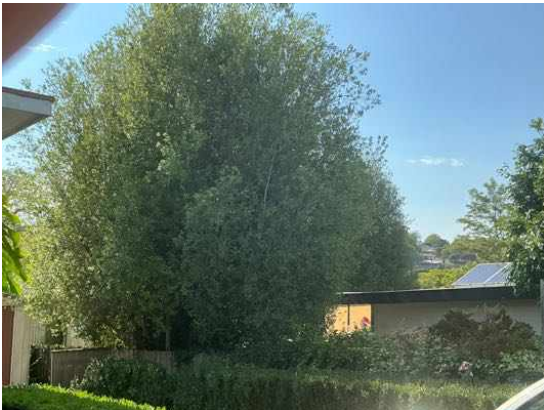
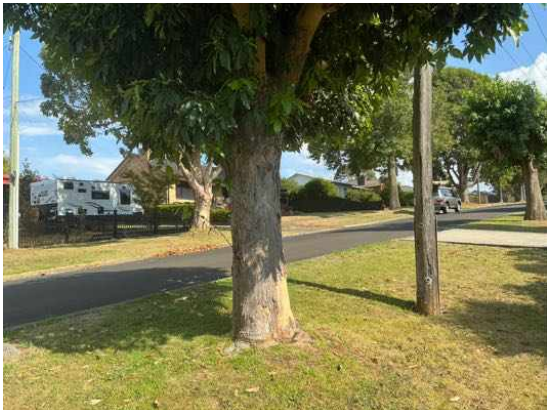
**Finding 6.02**

Building: Main Building  
Location: All External Areas  
Finding: Trees/large/termite  
Information: It was observed that there were several large trees next to or nearby the building.

The trees have the potential to provide conducive conditions for termite infestation

It is recommended that periodic 12 monthly inspections by a registered pest control contractor be undertaken and further reinstatement of outdated termite barriers as soon as possible.

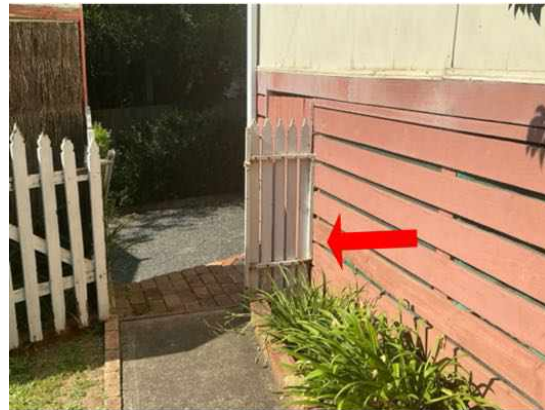
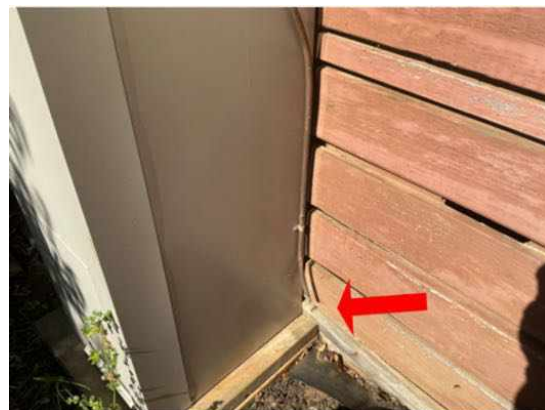
## Finding 6.03

Building: Main Building  
 Location: All External Areas  
 Finding: Bridging or breaching of termite barriers - damp course level  
 Information: Bridging is the spanning of a termite barrier or inspection zone so that subterranean termites are provided with passage over or around that barrier.

Damp proof course (DPC) is a barrier of impervious material built into a wall or pier to prevent moisture from moving to any part of the building. Where external ground levels are built up over this barrier ingress is provided for moisture from the exterior grounds into the in the structure or other building material and allowed to rise.

Such conditions attract termites into these damp areas which is likely to lead to infestation if left untreated.

Landscaping or re-paving of external grounds may be considered by the client. Regular annual inspections are strongly advised.

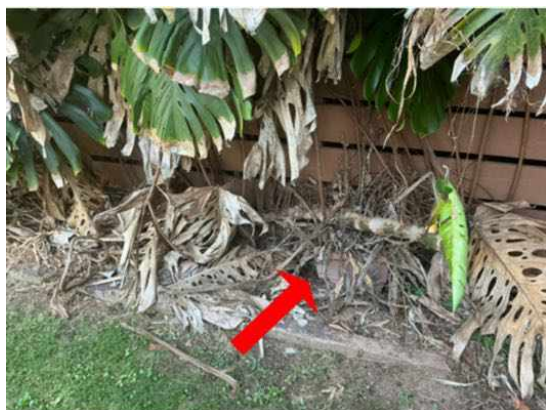
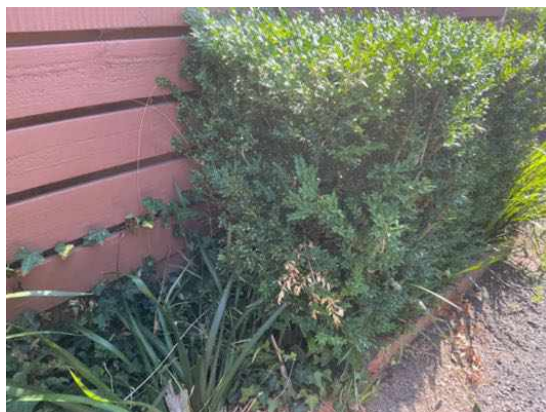
**Finding 6.04**

Building: Main Building  
Location: All External Areas  
Finding: Bridging - Vegetation  
Information: Where vegetation obstructs inspection of building elements, also known as bridging as it provides a bridging point for the access of termites, full inspection can not be achieved. Consequently moisture or dampness may be present and the areas becomes conducive to termite activity. Plants against or very close to buildings provide cover, shade and can provide an environment that is attractive to termite infestation.

The removal of any such materials that may be conducive to termite activity should be carried out as soon as possible and arrange re inspection to minimize the risk of termite attack.

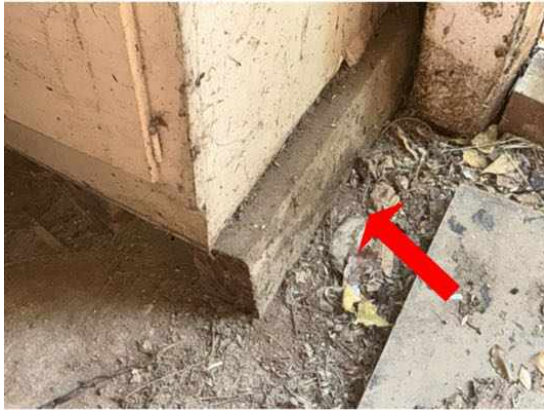
### Finding 6.05

Building:	Main Building
Location:	All External Areas
Finding:	Untreated or non-durable timbers in a hazardous environment
Information:	To reduce the risk of timber pest attack it is essential that timber used in a hazardous environment (e.g. in direct contact with the ground or frequently exposed to damp conditions) is of sufficient durability and/or is adequately preservative treated.

Untreated timbers in direct contact with the ground are likely to develop severe wood rot and/or fungal decay if left unattended creating attraction for subterranean termites to infest the timbers from surrounding areas.

If untreated or non-durable timbers are found to be in a hazardous environment it is highly advised that replacement of these building elements be performed as soon as possible to aid the protection of the property against termite / timber pest attack.

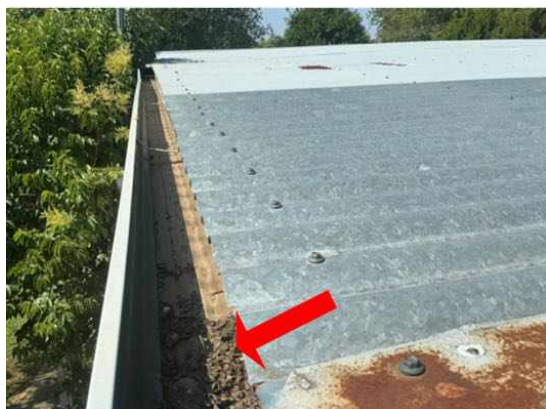
Blocked gutters are likely to lead to high levels of moisture in the affected areas. Such moisture will not only cause rust and decay of the associated building materials, but can also provide conditions that are conducive to termite and timber pest activity. Blockages in gutters should therefore be removed immediately to ensure dry conditions are maintained.

Consult a Licensed Plumber for further specific advice on remedial works that may be required. In the interim, it is highly advised that blocked gutters be removed by the homeowner or a general handyperson as a matter of urgency.

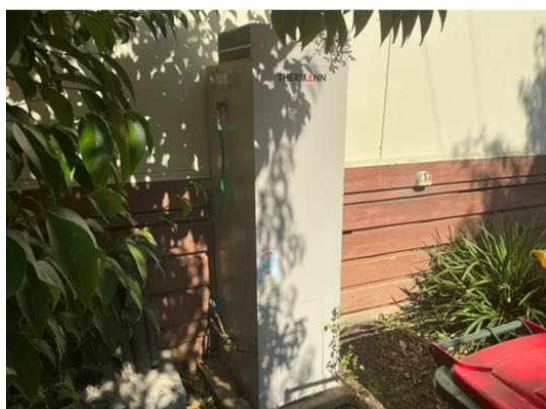
### Finding 6.08

Building: Main Building  
Location: Exterior walls - rear  
Finding: Hot water heater overflow pipe not connected  
Information: The water heater overflow was found to be disconnected from the stormwater system and is creating excessive moisture to the surrounding area.

Such leaking creates an environment which is conducive to an array of defects including water damage to associated building materials and the attraction of termites or timber pest infestation.

A Licensed plumber should be engaged to review as soon as possible

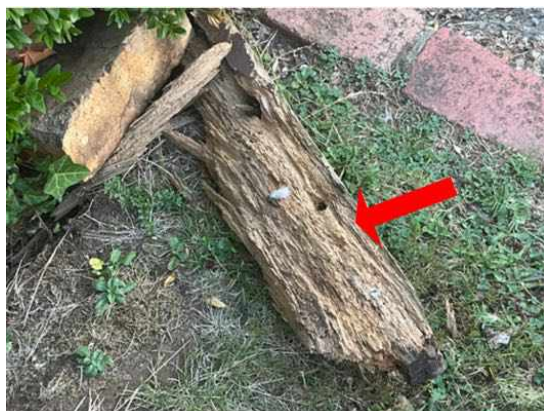
### Finding 7.01

Building:	Main Building
Location:	All External Areas
Finding:	Fungal decay - present (widespread)
Information:	Fungal decay is also known as wood decay or wood rot generally refers to the deterioration of timber elements when in contact with excessive levels of moisture for a prolonged period of time.

The development of fungal decay is accelerated by temperatures in the range of 5degreeC to 40degreeC as well as the presence of oxygen. Generally fungal decay develops on timber elements that are in use in an external environment which are exposed to rain penetration.

In this case, fungal decay appears to have become widespread and is likely to have affected any adjoining timber elements/structures. The widespread development of fungal decay is likely to have heavily impacted the structural integrity and tensile strength of the affected timber elements and the associated structure.

Timbers affected by widespread fungal decay should be replaced immediately. The cause of the moisture that has led to the development of such decay should also be identified and dealt with in an appropriate manner.

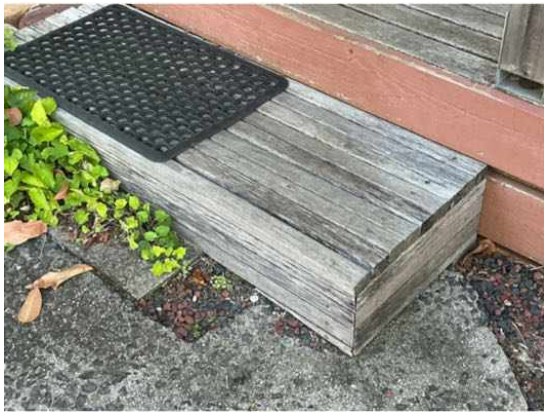
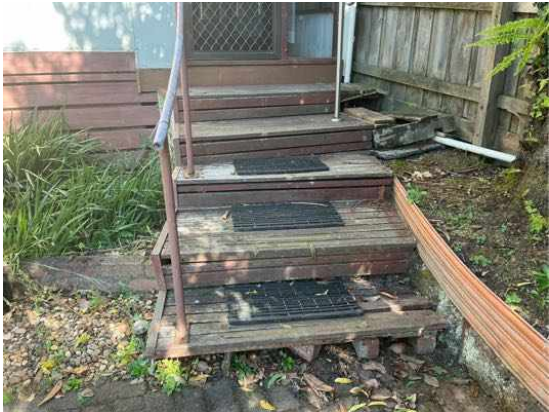
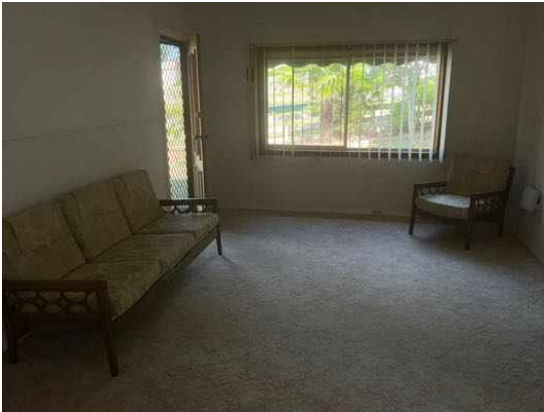
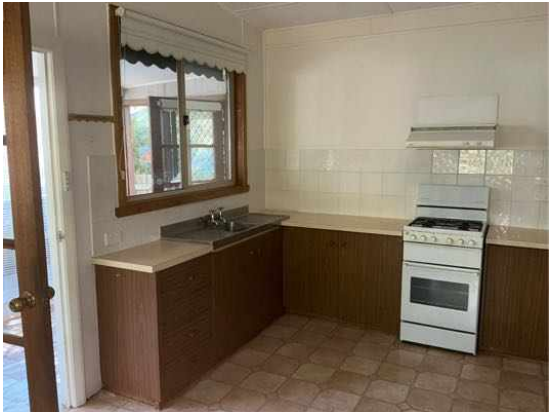
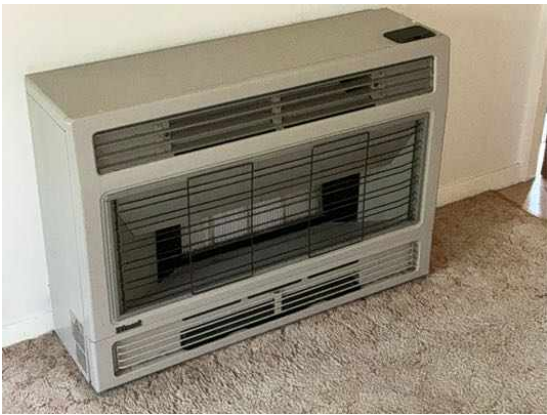
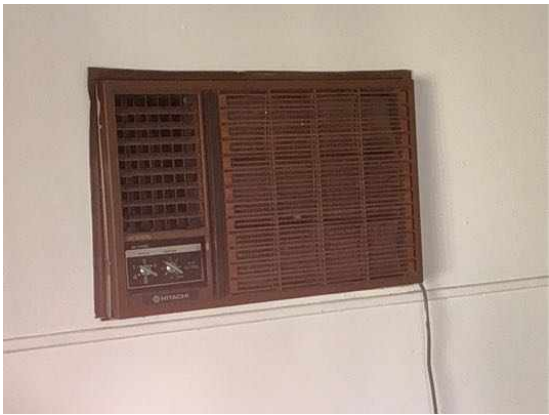
Building: Main Building  
Location: All Areas  
Finding: Additional Photos - Obstructions and Limitations  
Information: These photographs are an indication of the obstructions and limitations which impeded full inspection of the property at the time of inspection. These obstructions can hide an array of defects and should be removed to allow full inspection to be carried out. A re-inspection is recommended once the areas are made accessible.

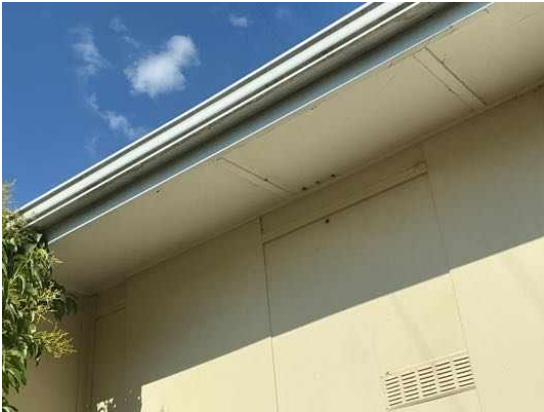
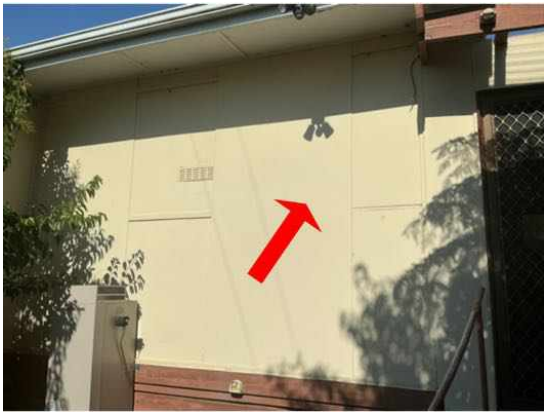
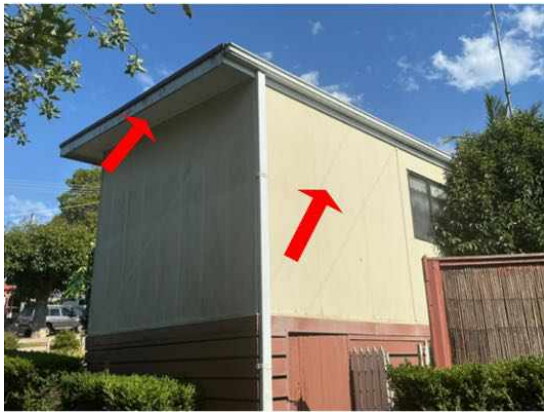
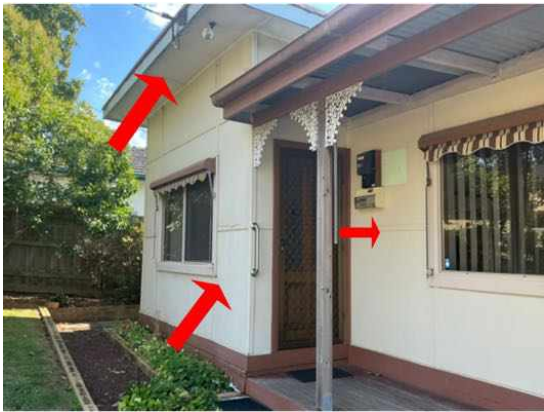
Building:	Main Building
Location:	All Areas
Finding:	Asbestos - Suspected ACM Identified on Site
Information:	Reporting on Asbestos is outside the Scope of this Report. This suspected defect is highlighted as a caution only. We suspect, based on our experience in the building industry, that there is a higher risk of the identified building elements containing asbestos.

In the interim, the client is advised to act with caution, especially when considering any damage to building materials general wear and tear renovations extensions demolition and general maintenance activities due to the suspected presence of Asbestos.
